MEMBURY COURT, MEMBURY, DEVON
CHAPEL AND CIDER HOUSE

ARCHAEOLOGICAL EVALUATION

STEWART BROWN ASSOCIATES
MARCH 2006

MEMBURY COURT, MEMBURY, DEVON
CHAPEL AND CIDER HOUSE
ARCHAEOLOGICAL FIELD EVALUATION, FEBRUARY 2006
by
Stewart Brown Associates

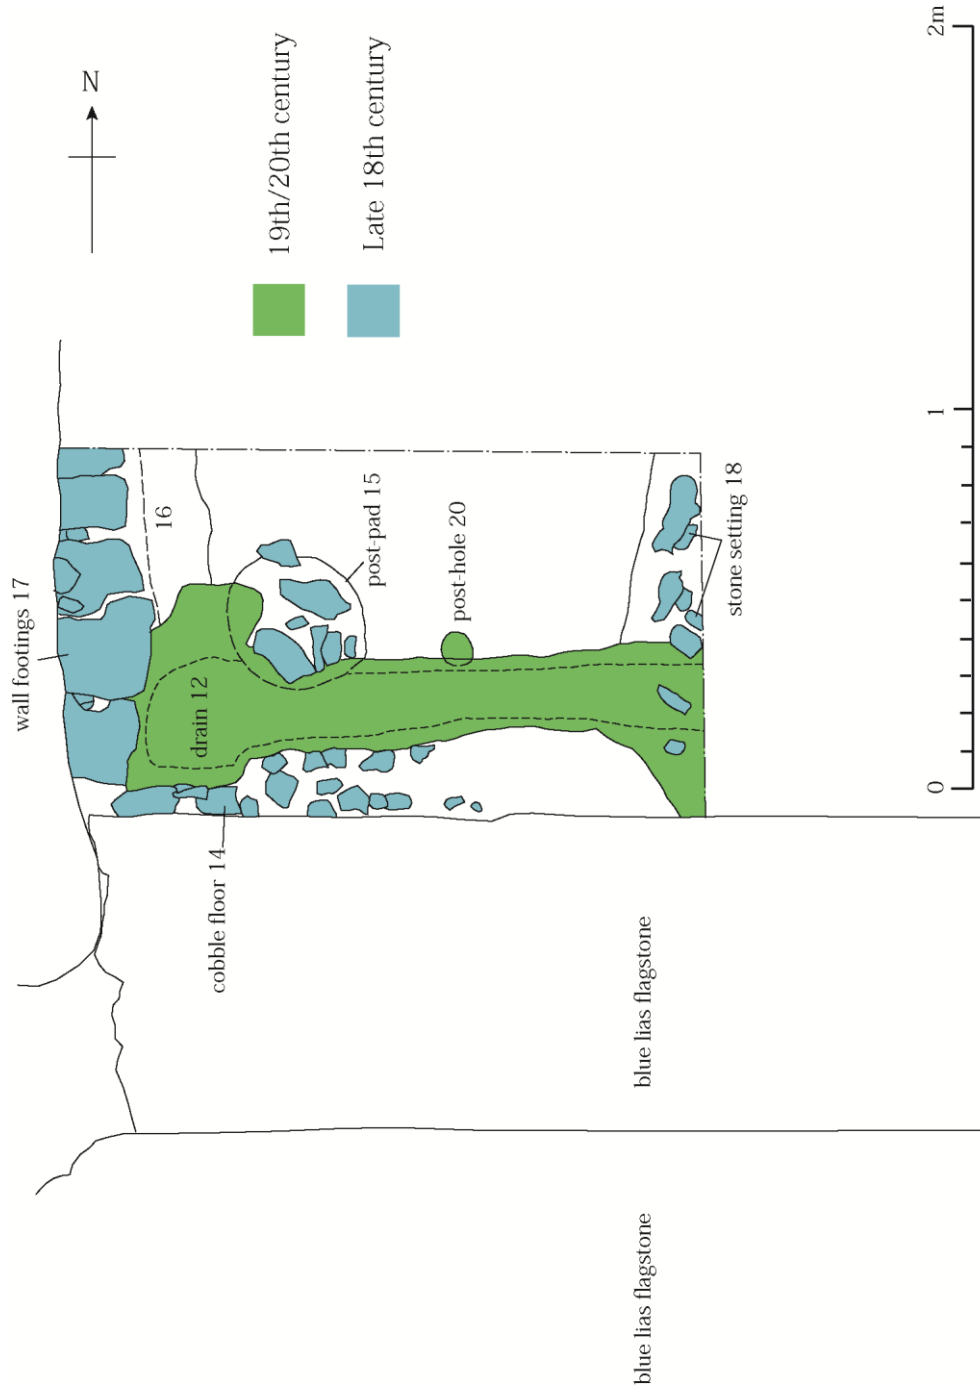
Fig. 4 Plan of Trench 3

Trench 3 was opened against the west wall of the building, next to the two large blue lias flagstones inside the west doorway.

Here, the modern concrete overlay a number of features dating from the construction of the late 18th-century cider house and later. The trench uncovered projecting stone footings for the west wall (17), together with their foundation trench (16), which was filled with clay, stones and mortar flecks. Along the southern side of the trench was a cobble floor (14) which extends southward beneath the adjacent blue lias flagstones. Excavation of the edge of the cobbles produced a sherd of early 19th-century white earthenware plus a residual sherd of S. Somerset red earthenware dating from the late 16th or 17th century. The cobble surface must therefore date from the early 19th century or later, whilst the lias flagstones must post-date the cobbles. The cobbles appears to have been laid for the most part across the threshold of the doorway, in the same manner as those uncovered in Trench 2, since they peter out away from the doorway toward the north and east.

A stone-filled pit (15) dug 0.5m to the east of the west wall was probably a post-pad. The post which formerly stood on the stone setting was in all likelihood associated with the cider press structure or machinery. A stone-filled linear feature uncovered at the east end of the trench (18) was also probably associated with the cider press, since it extends beneath the presently surviving press and was constructed on much the same alignment. A smaller post-hole (20) dug between the stone settings 15 and 18 produced a sherd of S. Somerset red earthenware dating from the 18th or early 19th century.

The latest feature uncovered was a drain trench dug from the west wall eastwards (12). This produced modern finds including lengths of broken asbestos pipe (discarded).

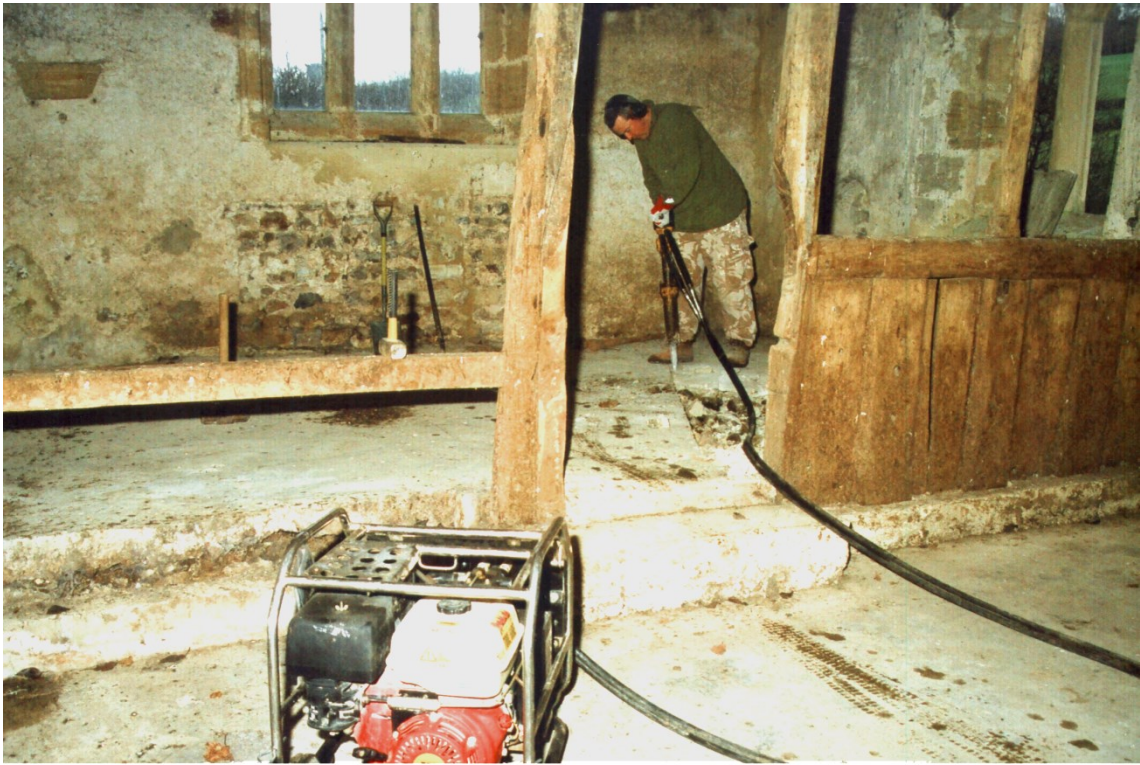
Plate 1 Removal of modern concrete, showing spin in the floor at the medieval screen.

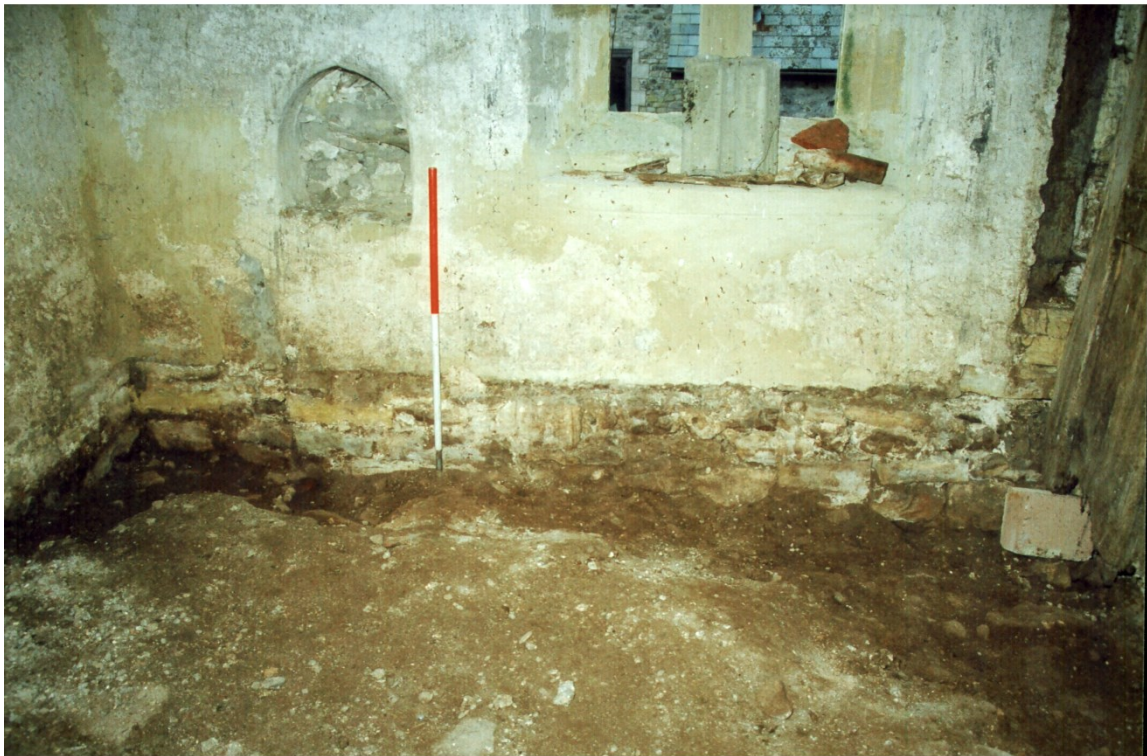
The original floor level of the medieval chapel is indicated by an internal plinth which was exposed at the base of the east and south walls following removal of the modern concrete (Plates 8 - 10). Above plinth level, the medieval masonry is faced and plastered; below it is uneven with no plaster. The plinth doubtless represents below-ground wall footings which were not intended to be exposed. The original medieval floor must therefore have been set at, or just above, this level.

Plate 8 South wall of the medieval chapel, showing plinth level, looking South.

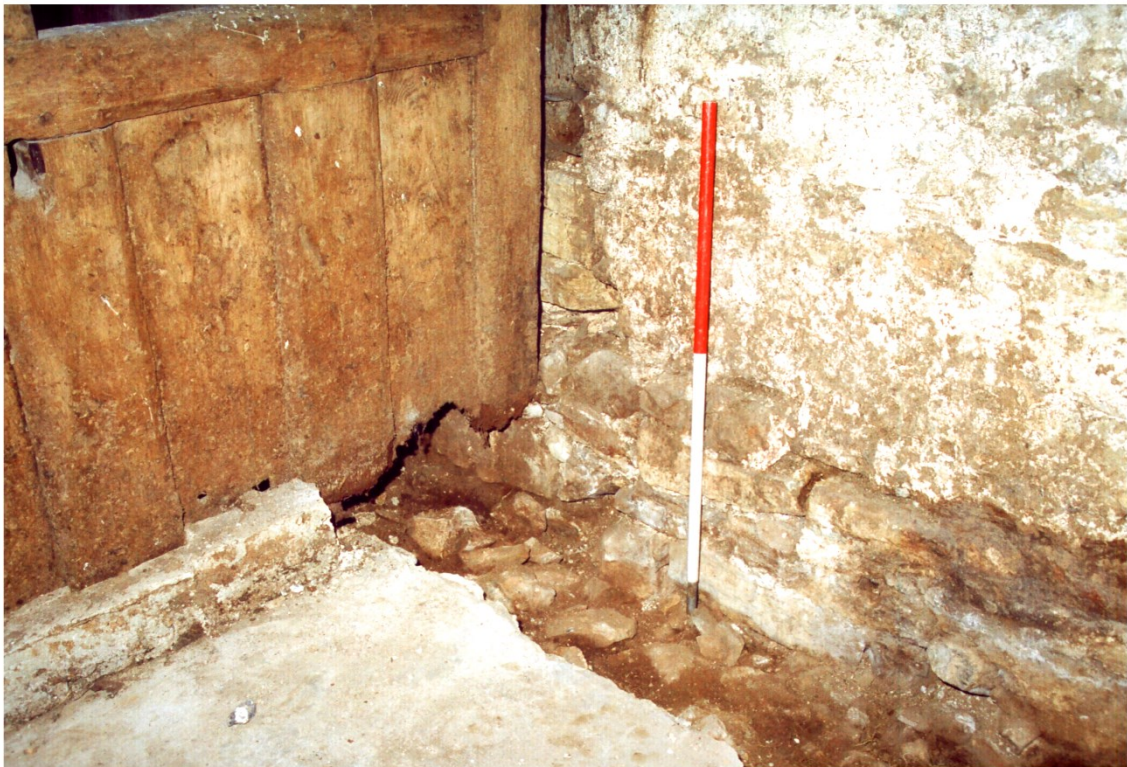
The late medieval timber screen would originally have been set on the medieval chapel floor. Today, the level of its sill beam, which survives in very poor condition, relates much more closely to that of the lower post-medieval floor to the west (Plates 9 and 10). This strongly suggests that the screen was lowered at the same time that the cider house floor was laid. Indeed, there are other indications that the screen was manoeuvred into a new position at this time, so that it could be used as support for a loft within the cider house. John Thorp argues that both the screen and a medieval timber-framed first-floor cross-wall above it have been moved from their original positions (Thorp, 1993, 100-102). Moreover, the first-floor cross-wall (Plate 12) once rose to meet the underside of a roof truss, forming a closed truss, but its present position is too low, showing that the cross-wall must have been lowered, probably when the medieval roof was dismantled. The present loft floor incorporates other old timbers which are also likely to have been moved from their original positions.

Plate 10 The late medieval screen and medieval plinth level, looking South-east.

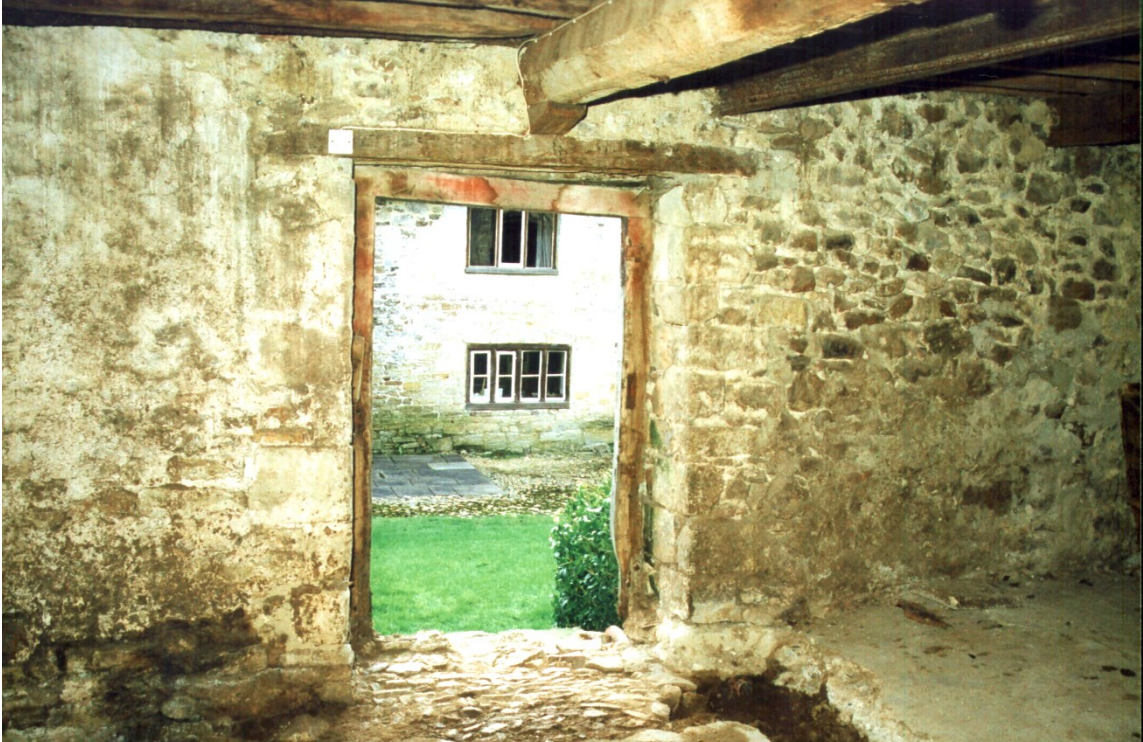
The plinth extends westward as far as the easternmost doorway in the south wall. This doorway (Plate 11) was largely rebuilt and its threshold lowered c. 1790 when the old chapel was converted to a cider house. The chamfered east jamb of the doorway is medieval, but its present timber lintel and unchamfered west jamb date from the post-medieval conversion, as does the remainder of the building to the west (see Alterations c. 1790, below). The east jamb descends to a lower level than the plinth, showing that a flight of steps formerly rose through the doorway from outside. The medieval doorway was probably wider and grander than the

present one, with a door head set considerably higher than the existing lintel. The medieval chapel clearly would have extended further westward than the doorway, but how far is at present unknown.

Plate 11 The easternmost doorway in the south wall, looking South.

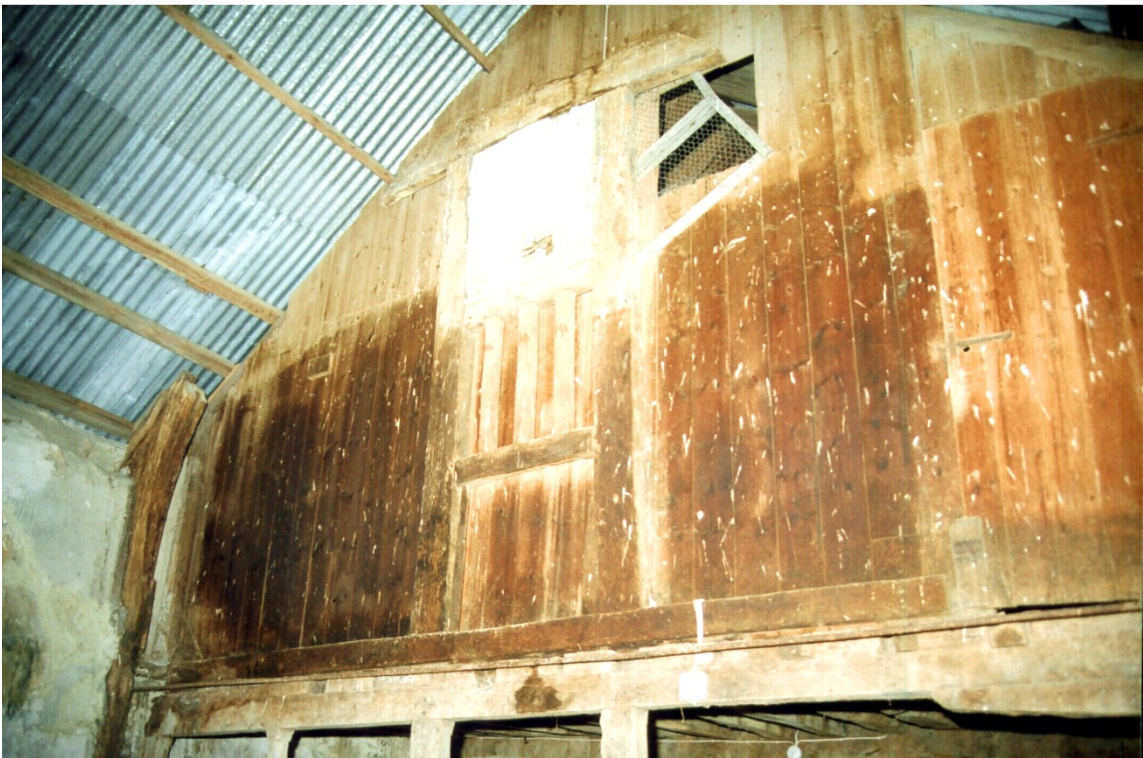
Plate 12 The late medieval timber-framed cross-wall above the screen, looking South-west.
