ST GILES AND ST NICHOLAS CHURCH, SIDMOUTH

ARCHAEOLOGICAL EVALUATION

*By*  
*Stewart Brown Associates, June 2004*

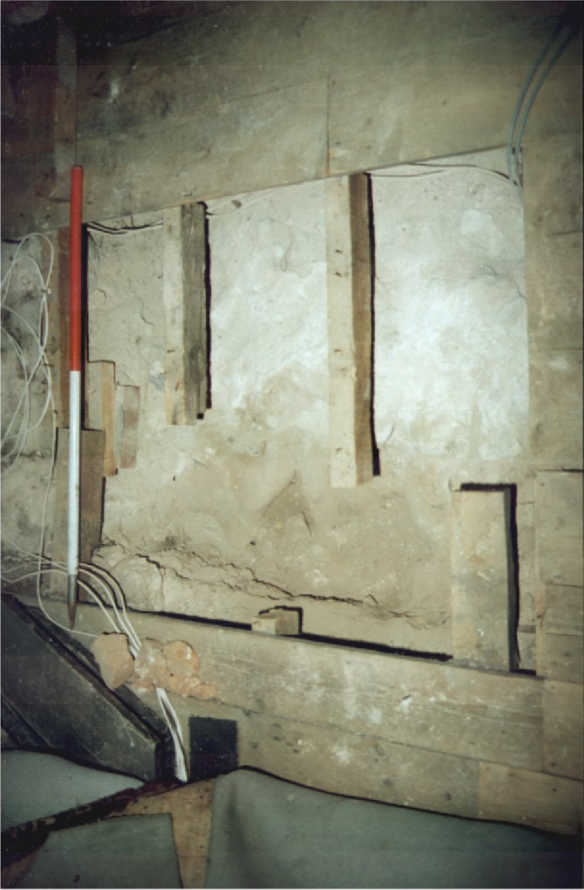
Medieval wall footing comprising stone rubble and cobbles bonded with white lime mortar with very little aggregate.

Stone foundation for mortared wall 4. Large cobbles set in light brown clay.

Plate 1 Trench 1, looking E

The stone wall foundations exposed in Trench 1 must represent the south wall of the medieval church chancel, since it is known that the former chancel wall lay in precisely this position (Fig 1). The foundations lie immediately below construction deposits associated with the present church built in the 1860's. The mortared masonry foundations (context 4) lie on average 0.2m below the present board floor (ranging from 0.16m to 0.24m). The cobble and clay footings (context 5) beneath the mortared masonry lie on average 0.36m below the board floor (ranging from 0.3m to 0.43m).

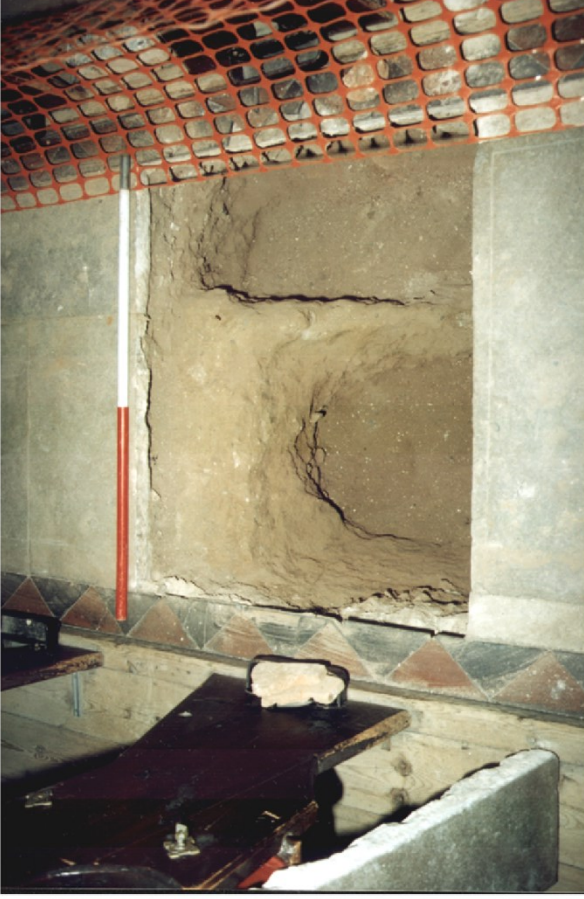
A post-medieval grave. The grave fill comprised light brown friable clay with mortar and slate flecks, and some stones. The fill produced two fragments of 18<sup>th</sup>- or 19<sup>th</sup>-century tile.

Plate 2 Trench 2, looking W

The grave (context 4) and possible second grave (context 3) both date from shortly before the church was rebuilt in the 1860's. Both were directly overlain by a make-up dump (context 2) associated with the laying of the present floor (ie contemporary with the rebuilding of the 1860's).

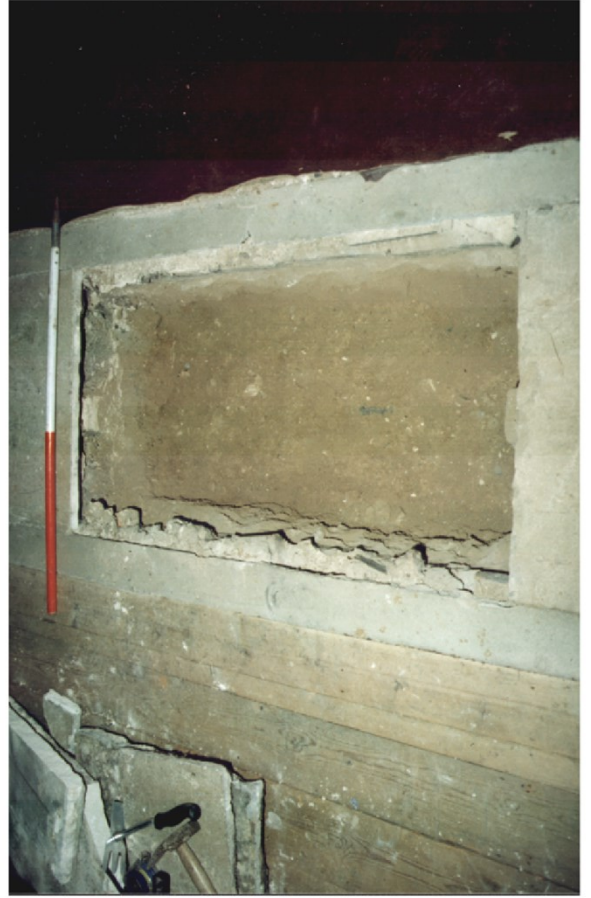
Three brick sleeper walls with thin slate capping, dating from the 1860's. The sleeper walls were made of local hand-made bricks bonded with white sandy lime mortar (no

aggregate). The walls extended E-W and were built 0.11m wide (one brick's width) and 0.12 - 0.15m high. They were spaced 0.3m apart.

Plate 3 Trench 3, looking E

Graveyard soil - undated, although probably post-medieval. Light brown friable clay with white mortar flecks and grit. The uppermost part of this deposit was trampled and compacted as well as hardened by lime seepage from the white mortar skim (context 3) above. The graveyard soil contained one articulated human infant skeleton (with teeth) as well as numerous scattered human infant bones (from two or more other infant burials). The complete skeleton was lifted and handed to David James (Vicar) for reburial in the churchyard. The soil also contained occasional adult human bones.
