ST. NICHOLAS AND ST. GILES CHURCH, SIDMOUTH
ARCHAEOLOGICAL MONITORING AND RECORDING

STEWART BROWN ASSOCIATES
AUGUST 2009

ST. NICHOLAS AND ST. GILES CHURCH, SIDMOUTH, DEVON
ARCHAEOLOGICAL MONITORING AND RECORDING, 2009

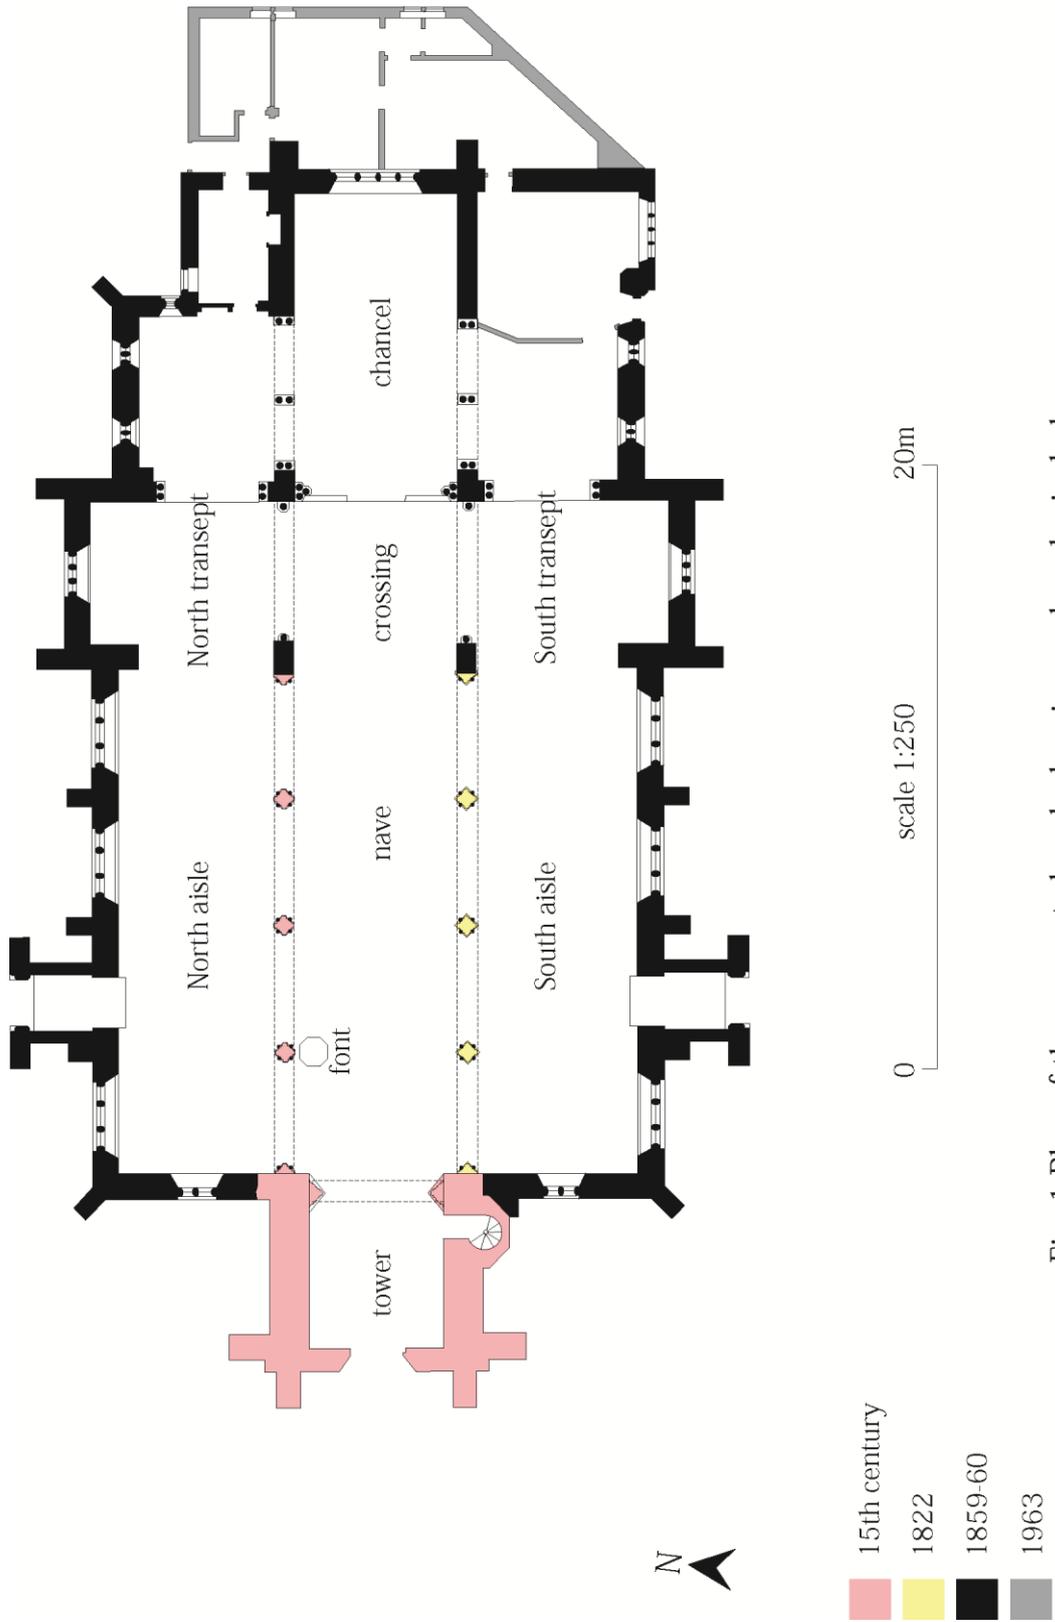
Fig. 1 Plan of the present church showing archaeological phases.

THE PRESENT CHURCH (Fig. 1)

The oldest parts of the present church are its west tower and aisle arcade on the north of the nave, which date from the 15th century. The south aisle arcade is an addition of 1822. The remainder dates from a restoration of 1859-61 by William White.

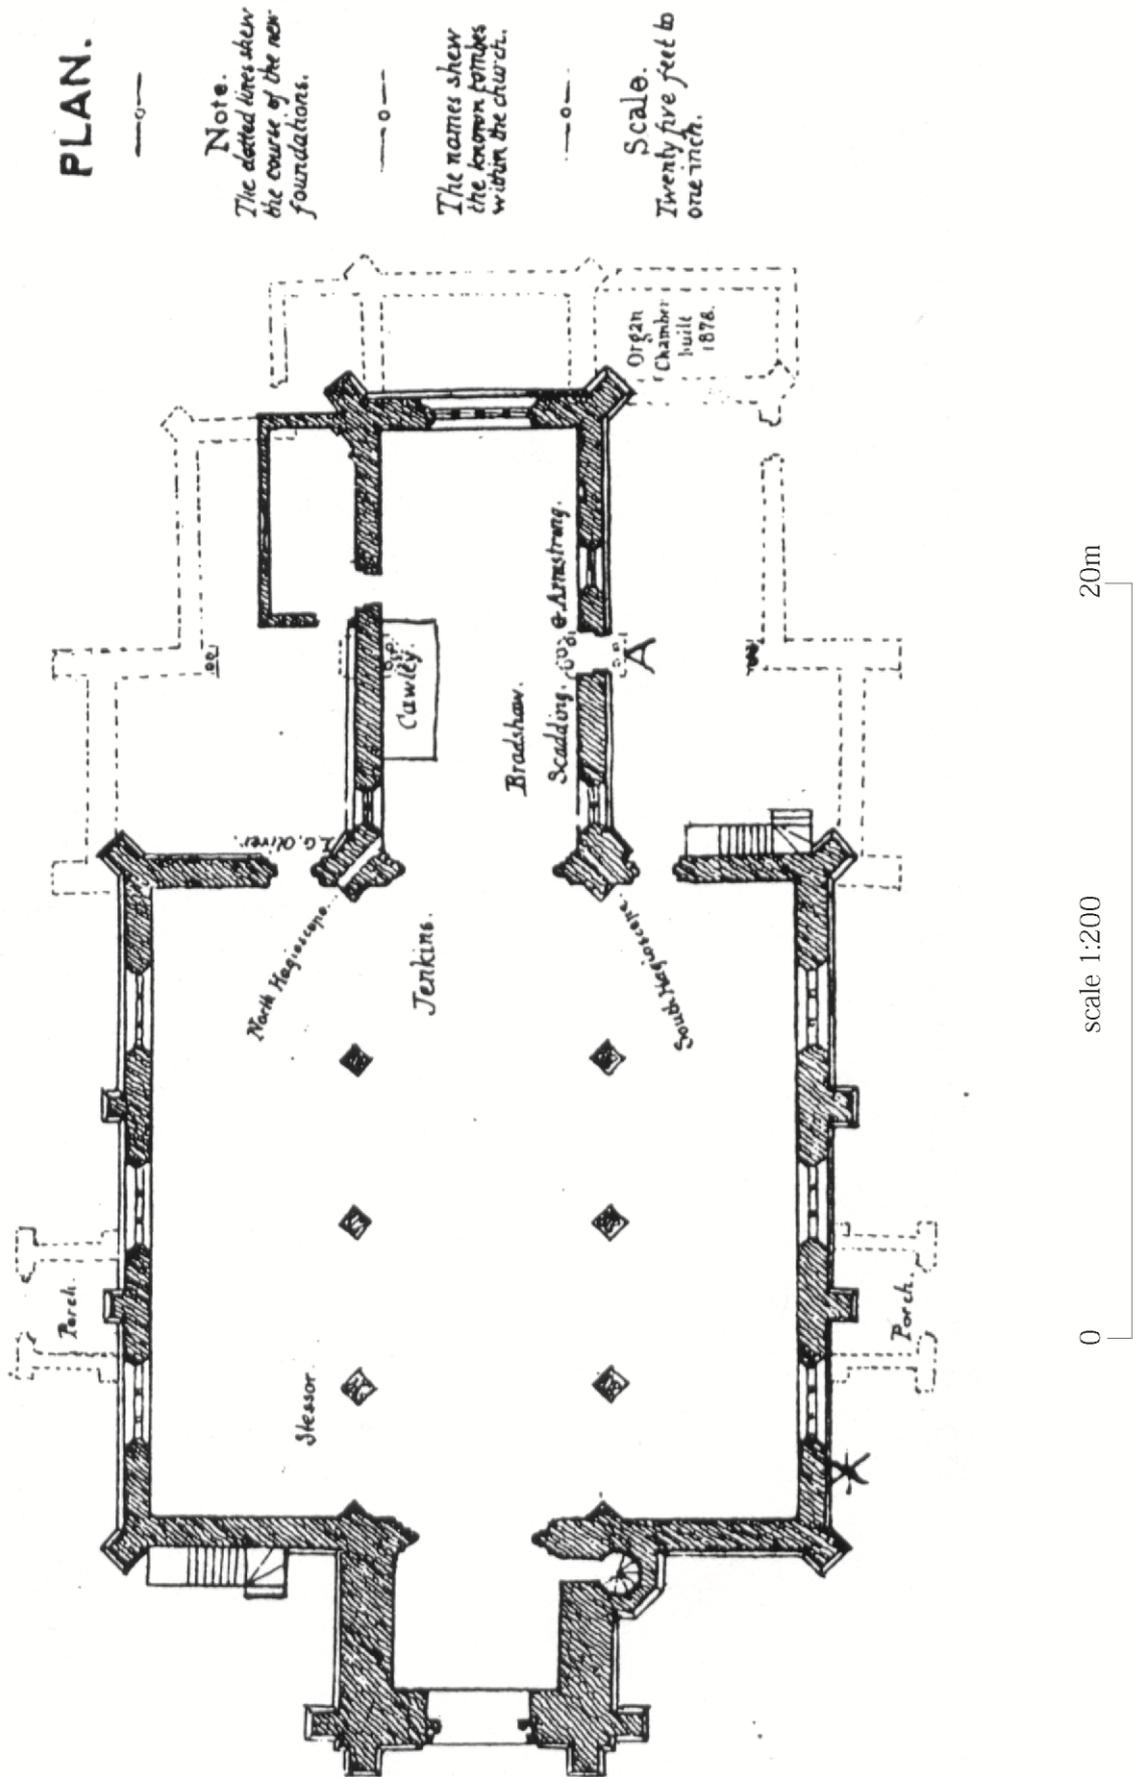
Fig. 2 Plan of the church in 1859 before restoration - the dotted lines show the course of foundations built 1859-61. Reproduced from Hutchinson's MS History of Sidmouth, Vol IV, by kind permission of the Westcountry Studies Library.

Hutchinson's plan of the church before restoration shows the location of known tombs associated with particular names (Fig. 2). Some names can be associated with the vaulted burial chambers exposed by excavation (Fig 4). Hutchinson's manuscript history records details concerning other burials disturbed by the building works and by an associated lowering of the ground level in the surrounding graveyard, which took place between 1859 and 1861.

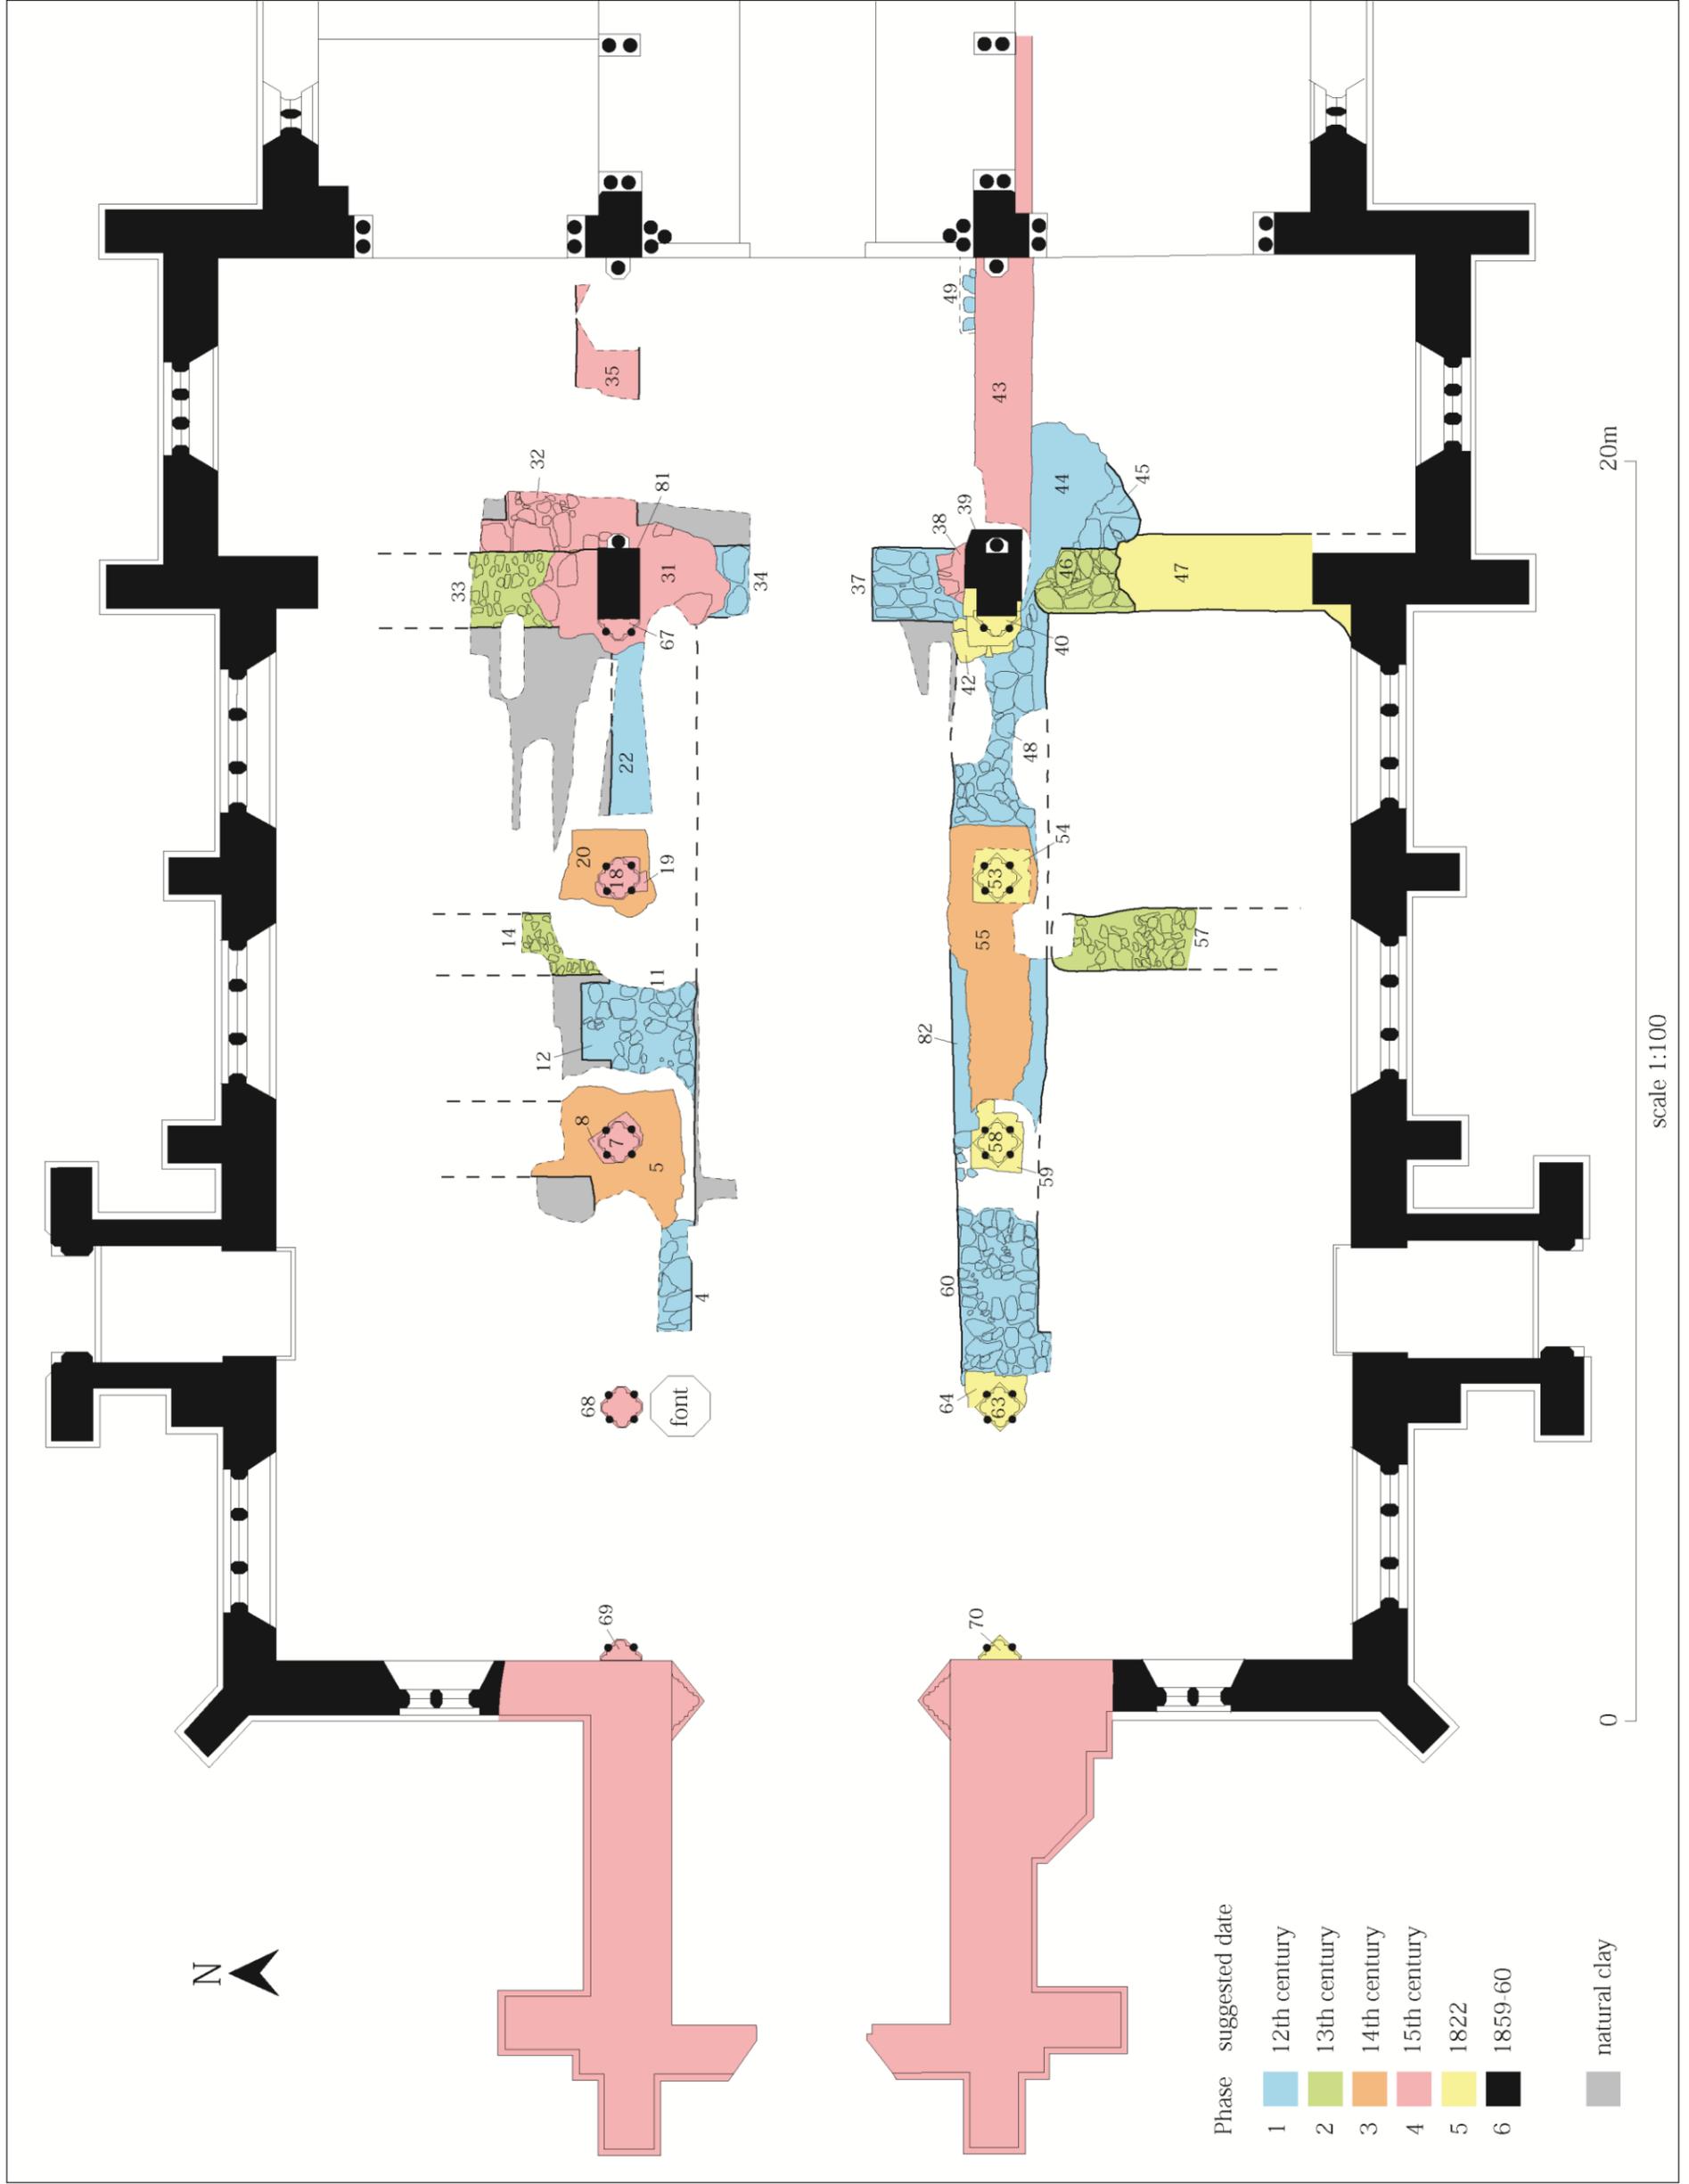
Fig. 3 Plan showing located masonry wall foundations and their phasing.

Wall foundations (Fig. 3)

The earliest wall foundations were built in a very distinct manner. They comprise large water-worn boulders, cobbles, and beach pebbles set in friable brown clay and laid in a trench 1.2m – 1.5m wide and more than 0.4m deep (Plates 2-6). Their extent is shown in Fig. 1 (coloured blue; foundations 4, 11, 34, 37, 44, 45, 48, 49, and 60). In places the foundations

In Phase 3 the nave was rebuilt and the north transept was enlarged to form an aisle. The Phase 3 foundations overlie those of Phase 1, and were built of mass masonry bonded with white mortar containing gravel aggregate (Fig. 3 coloured brown; foundations 5, 20, and 55). The stone types comprise Salcombe stone, local Greensand, Beer stone, and beach cobbles.

The church was extensively rebuilt in Phase 4. At the east end, the old Norman tower and sanctuary were taken down and replaced by a more open and spacious chancel. A new tower was built at the west end of the nave, and the north aisle was doubled in size. Both the tower and the north aisle arcade are still standing. Phase 4 foundations were built in a similar manner to those of Phase 3, ie Salcombe stone, local Greensand, Beer stone, and beach cobbles bonded with white mortar containing gravel aggregate (Fig. 3, coloured pink; foundations 8, 19, 31, 32, 35, 38, and 43).

It is known from documentary evidence that the south aisle was added to the church in 1822 (Keystone report 2002, 5). The present south aisle arcade survives from this time, but the aisle's external wall was rebuilt above plinth level in 1859-60 (Phase 6, below). Construction of the south aisle swept away the south transept which had survived from the 13th century (Phase 2) until 1822. The foundation of the aisle's east wall was built of stone rubble bonded with white mortar, the stone types comprising Salcombe, Beer, Greensand, and beach cobbles (Fig. 3, coloured yellow; foundation 47; Plate 6).

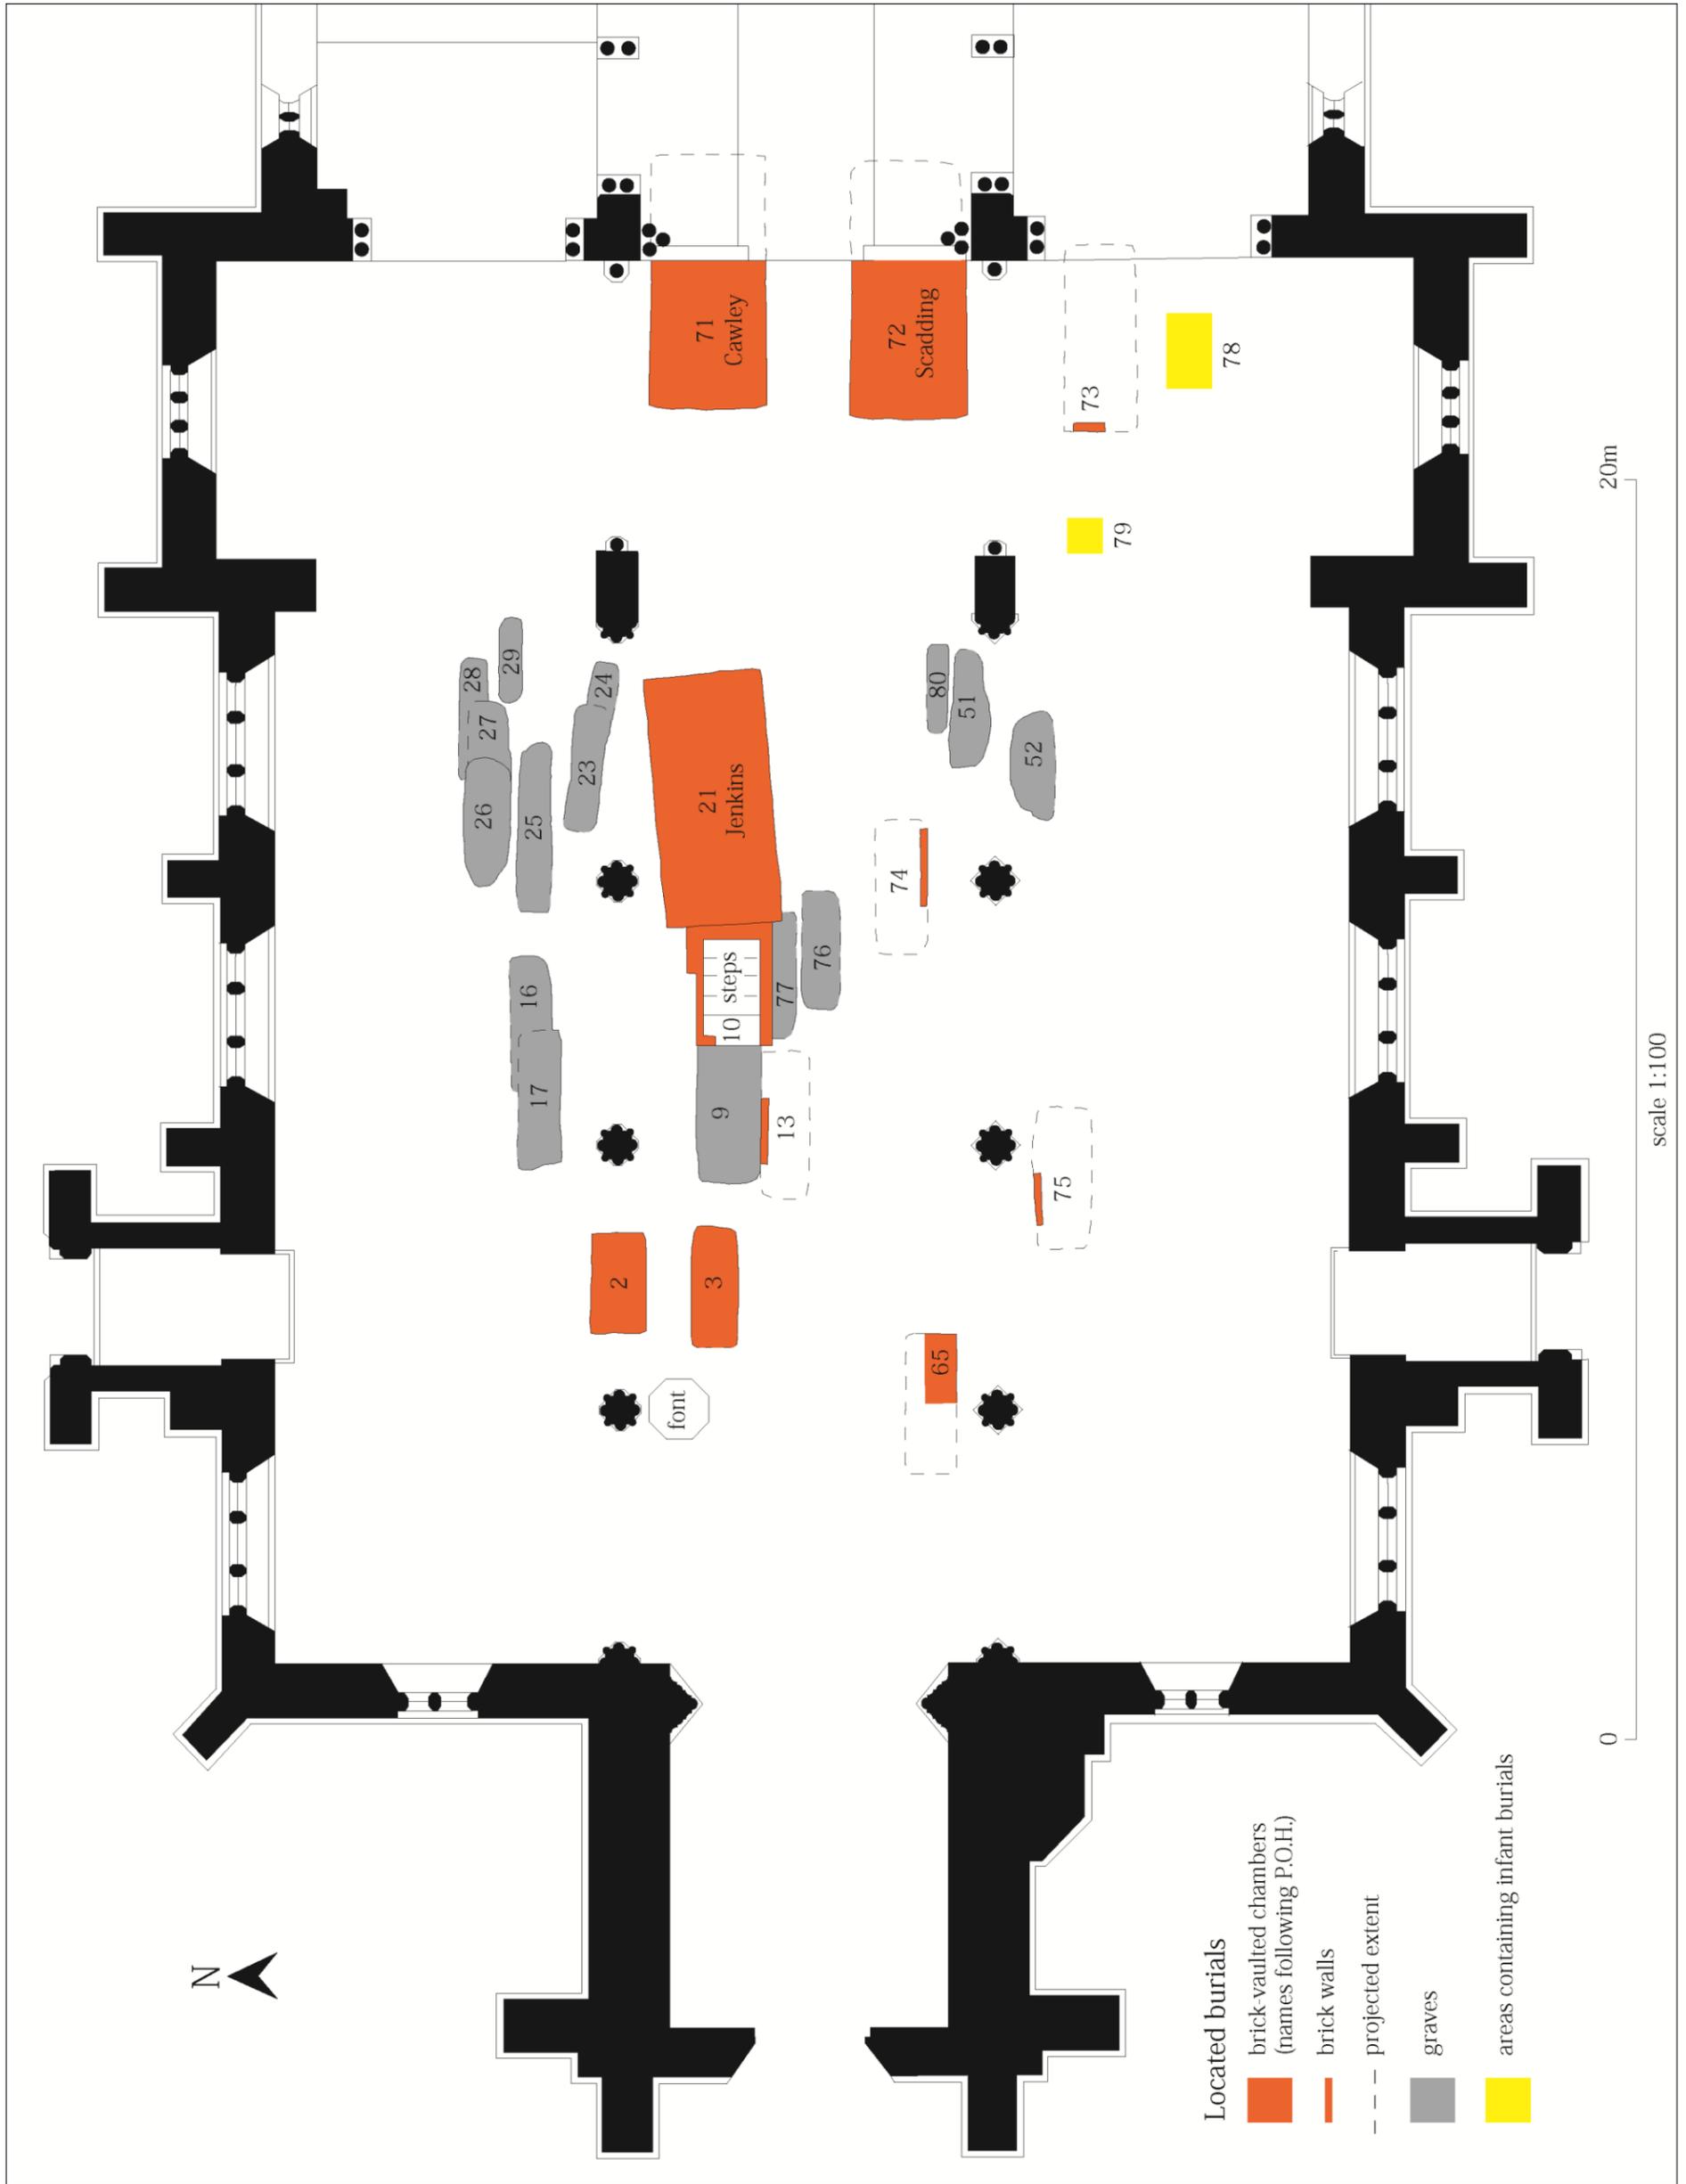
Fig. 4 Plan showing located burials.

Burials (Fig. 4)

Numerous burials were located across the site. These were uncovered only so far as to identify their nature, but not fully exposed or excavated, owing to the limitations of the project (see The Project, above). Those which were located were plotted in outline (Fig. 4). Further burials doubtless survive in parts of the site which were not cleared of Victorian construction levels.

A number of burials had been interred within brick-vaulted chambers. These date from the late 18th and early 19th centuries. The bricks are hand-made local bricks dating from this period. The condition of the burials inside was investigated as part of the works programme. Small openings made through the vaults showed that these contained lead coffins, some with wooden outer coverings (the vaults were soon afterwards re-sealed and strengthened prior to laying the new floor). The largest brick-vaulted chambers were built to contain two tiers of four coffins (21, 71, and 72). One of these had a flight of brick steps leading down to it (burial chamber 21, steps 10; Plate 10). Other vaulted chambers contained only single lead coffins (2, 3, and 65; Plate 11). At least one contemporary brick-lined burial was covered by flat stone slabs rather than a vault (75). Two other similar burials appear to have been disinterred in Victorian times for reburial elsewhere (13 and 74), since their backfilling comprised loose building waste comparable in composition with the Victorian construction levels.

Other burials had been made in earth-dug graves (9, 16, 17, 23-29, 51, 52, 76, 77, 80). Most of these probably date from the post-medieval period, although some may possibly be earlier. Three had been dug through medieval wall foundations (17, 51, 52), as had one of the brick-vaulted burial chambers (2).

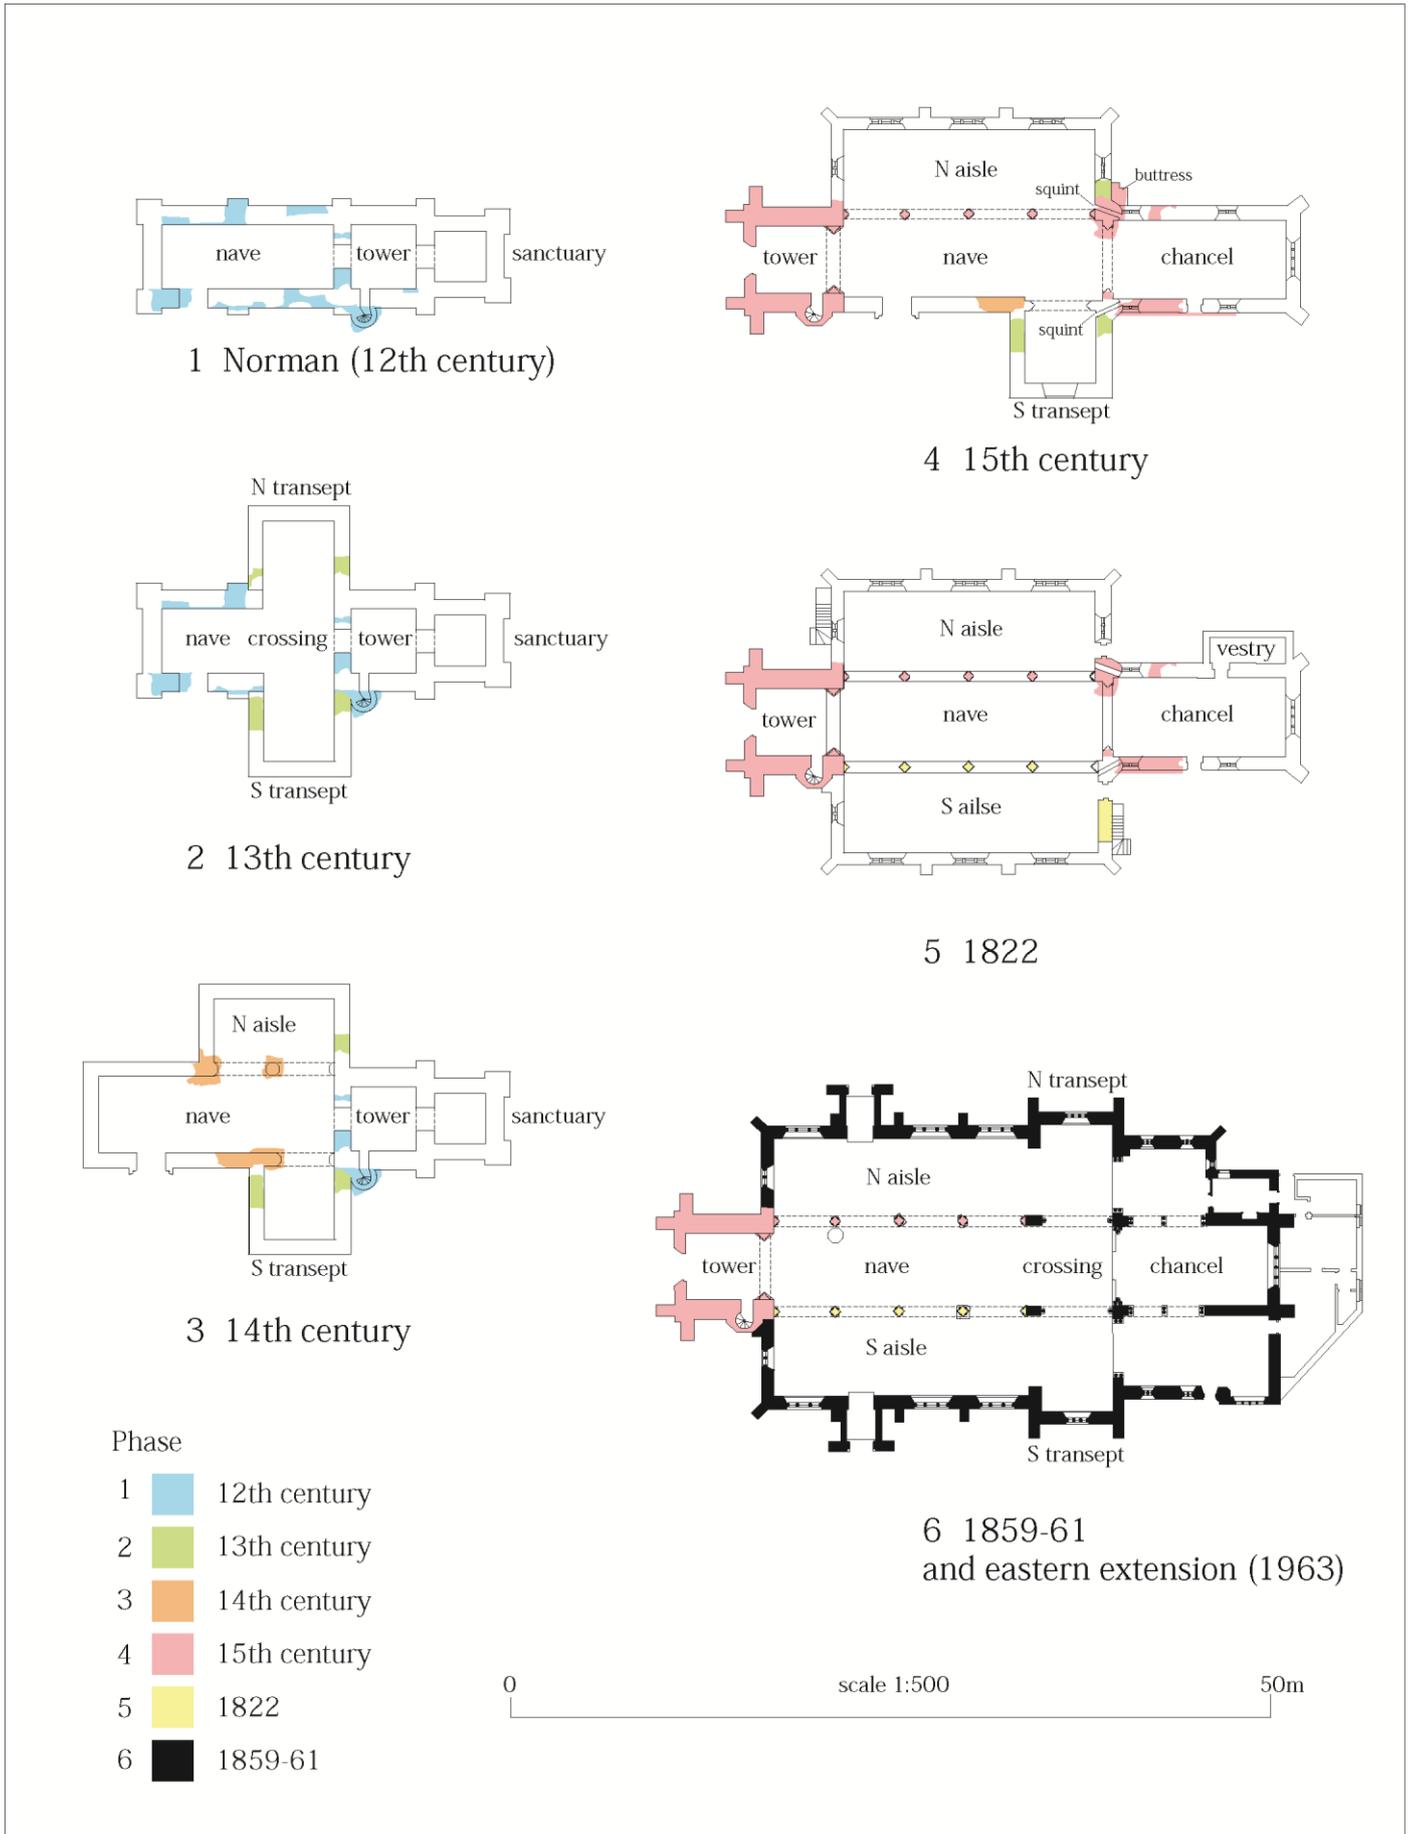
Fig. 6 Phase plans showing development of church.

Structural development of the church (Figs. 3 and 6)

The surviving foundations represent a number of different phases of construction. Some phases can be dated by association with standing parts of the church, ie the present north and south aisle arcades date from the 15th century and 1822 respectively. The foundations underlying the arcades are clearly earlier, but difficult to date closely. There are, however, physical relationships existing between the foundations, ie some were built overlying or against others, which allow a relative chronology to be built up showing which are earlier and which later. The earliest building phase (Phase 1) has been ascribed to the 12th century on the basis of documentary evidence for a vicar at Sidmouth by the year 1175 and finds of Norman masonry made during the Victorian restoration (Historical Background, above). Phases 2 and 3 are earlier than the 15th-century north aisle, so must date from the 13th and/or 14th centuries.

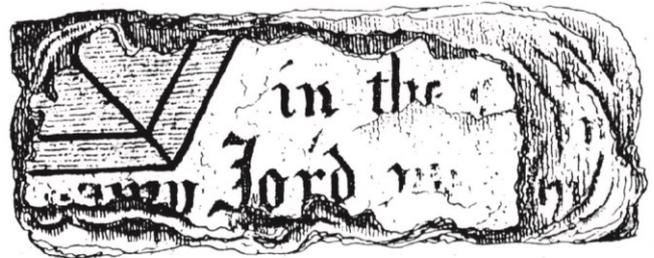
Successive coats of plaster coloured and inscribed,
found under the whitewash over the old Chancel
arch in the nave. — since gone to pieces.

Plate 1 Architectural fragments and painted plaster found during the restoration of 1859-61.
Reproduced from Hutchinson's MS History of Sidmouth Vol IV, by kind permission of the
Westcountry Studies Library.

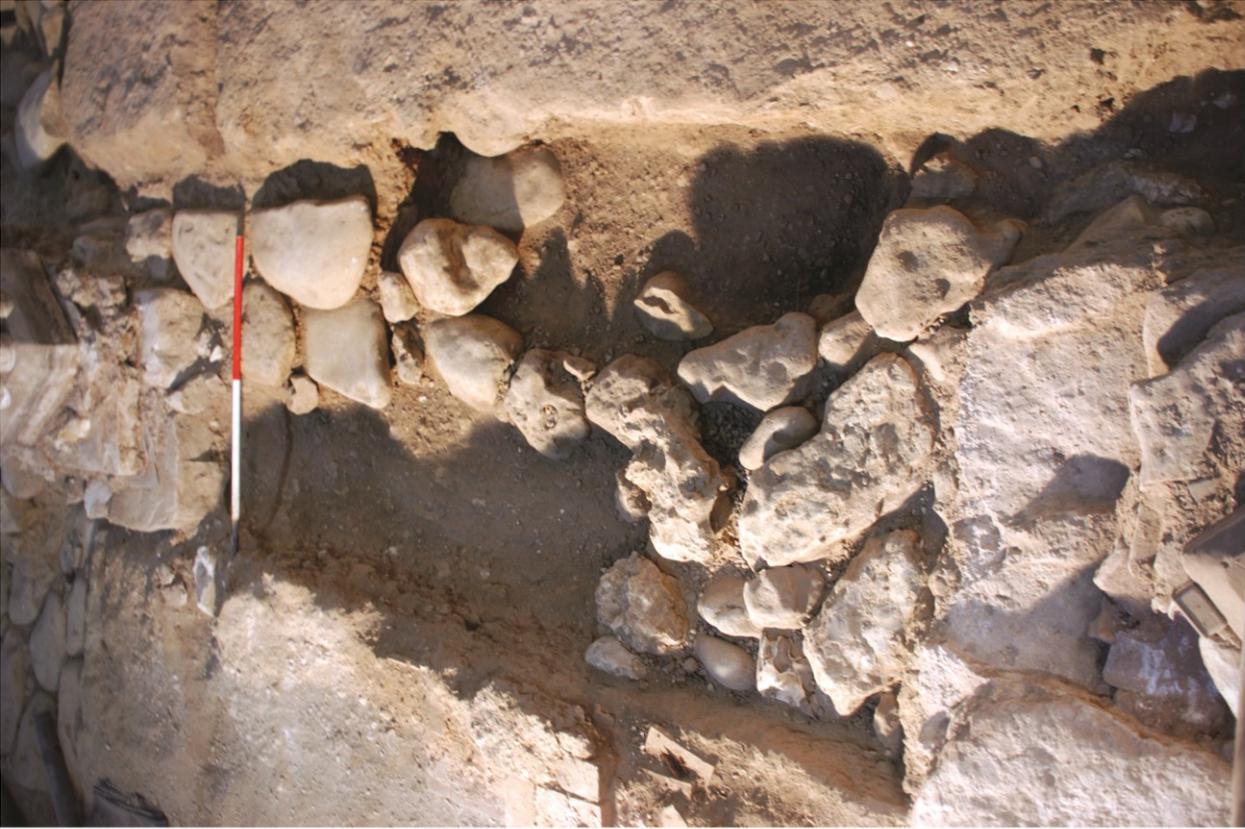
Plate 3 12th-century foundation (48)
cut by two graves, looking east.

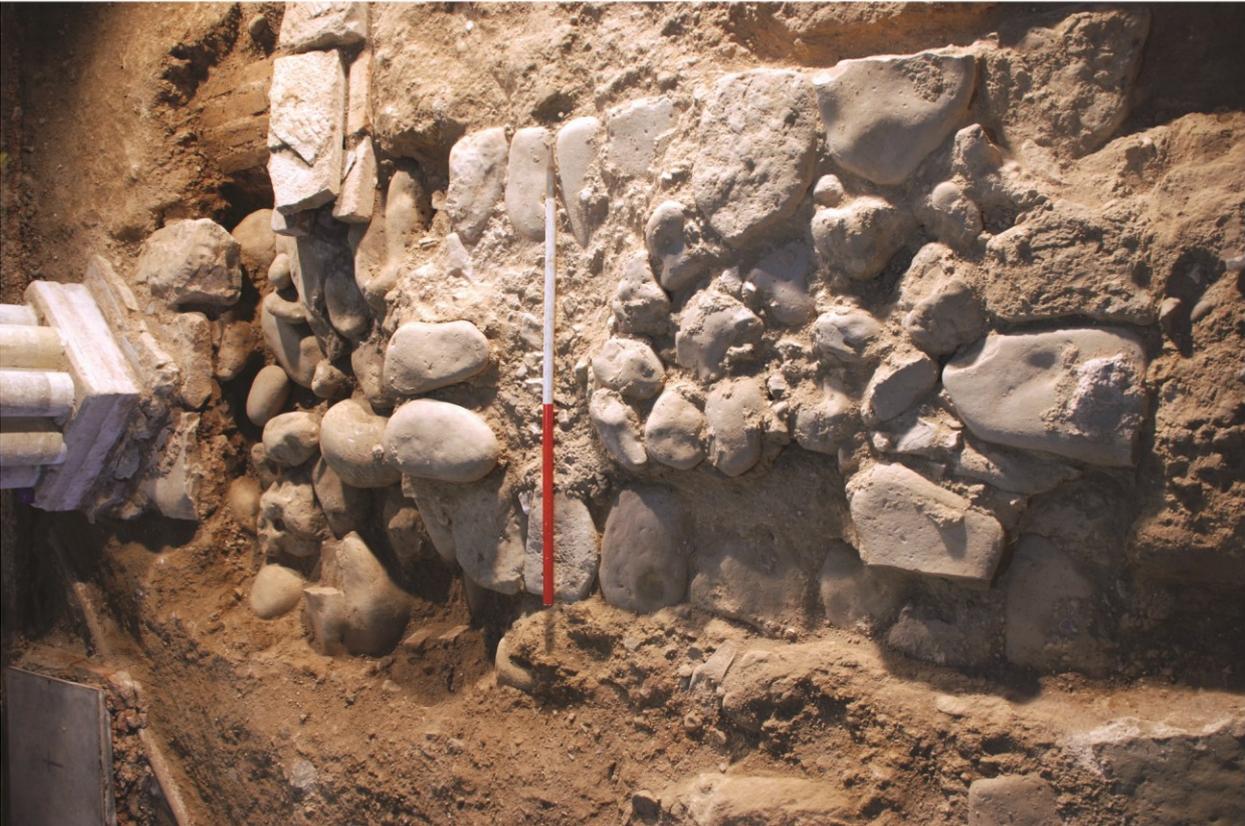
Plate 2 12th-century foundation (60), looking west.

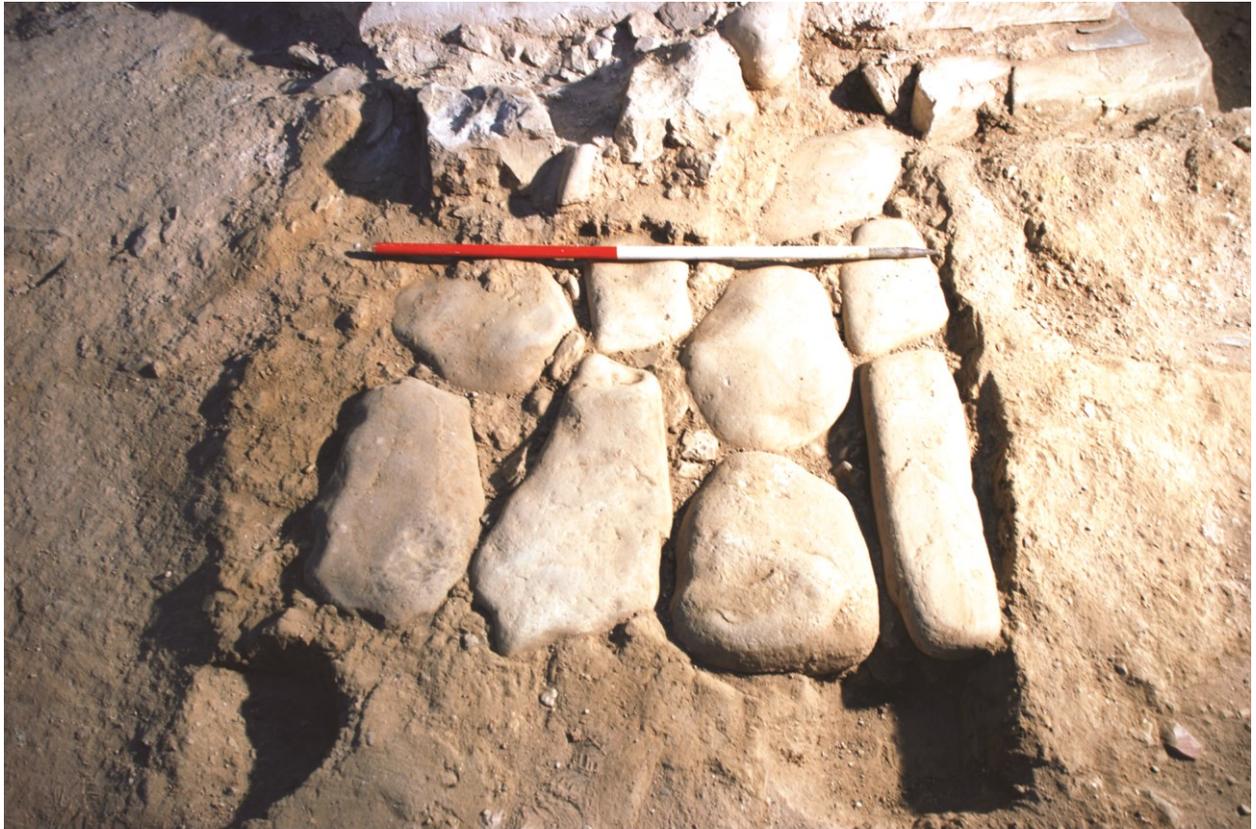
Plate 4 12th-century foundation (37), looking south.

It seems clear that the foundations once extended continuously along both sides of an aisleless nave. At the east end of the nave, the foundations turn inward to form a cross-wall interrupted by an opening at its centre (Plate 4), where there must have been an archway some 2m wide above ground. To the east of the archway there would have been a chancel, choir, or tower. It is likely that there was a tower in this position since foundations for what appears to have been a round stair-turret were found projecting 1.5m to the south (foundations 44 and 45; Plate 6). Foundation 45 consisted of large water-worn boulders like those used in the phase 1 foundations elsewhere. The overlying masonry (foundation 44) was bonded with white mortar containing coarse gravel aggregate, evidently remains from the above-ground Norman masonry. A small remnant of the tower's southern foundations was located a little further to the east, where large cobbles (49) projected from beneath a later medieval wall.

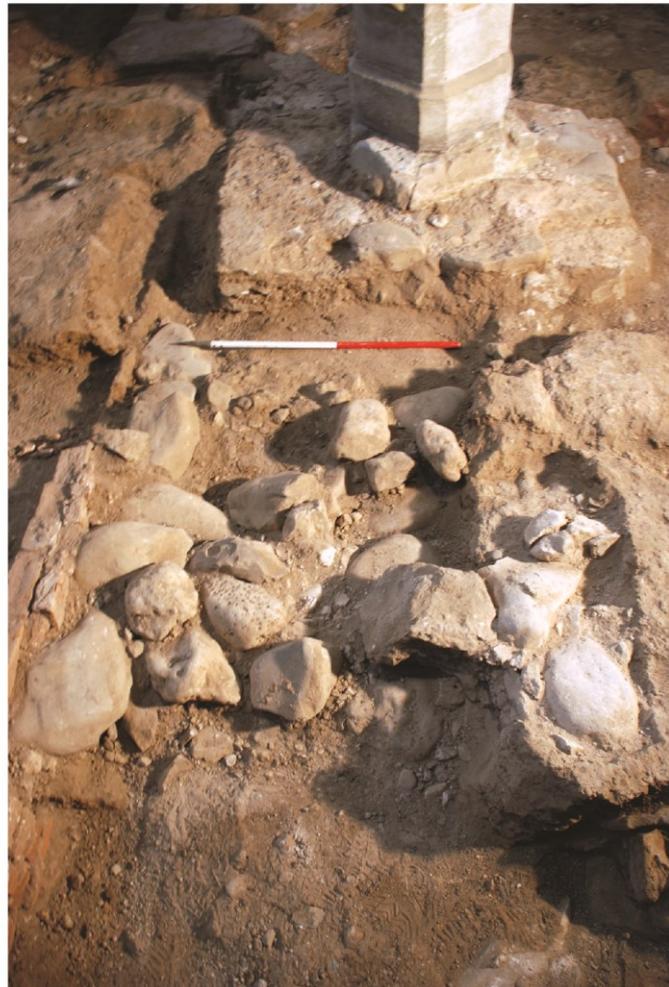
Plate 5 12th-century foundations (11 and 12), and 14th-century aisle foundation (5), to rear, looking west.

The north wall of the nave was taken down and replaced by foundations 5 and 20 (Plate 5). These were built a little further to the north than the old north wall, thereby increasing the width of the nave. Foundation 5 originally extended further to the north and west, but was reduced in size by the digging of later graves. However, the right-angled corner surviving on its northwest side indicates the point at which the aisle projected outward from the nave. Foundation 20 was roughly square and isolated from the other foundations. It clearly supported a free-standing pier. The foundations at the east end of the aisle were replaced in Phase 4 (below). The aisle comprised two bays with an arcade of two arches supported by the central free-standing pier and a respond at each end. Some of the east wall of the earlier north transept (foundation 33) appears to have been left standing and incorporated into the new aisle.

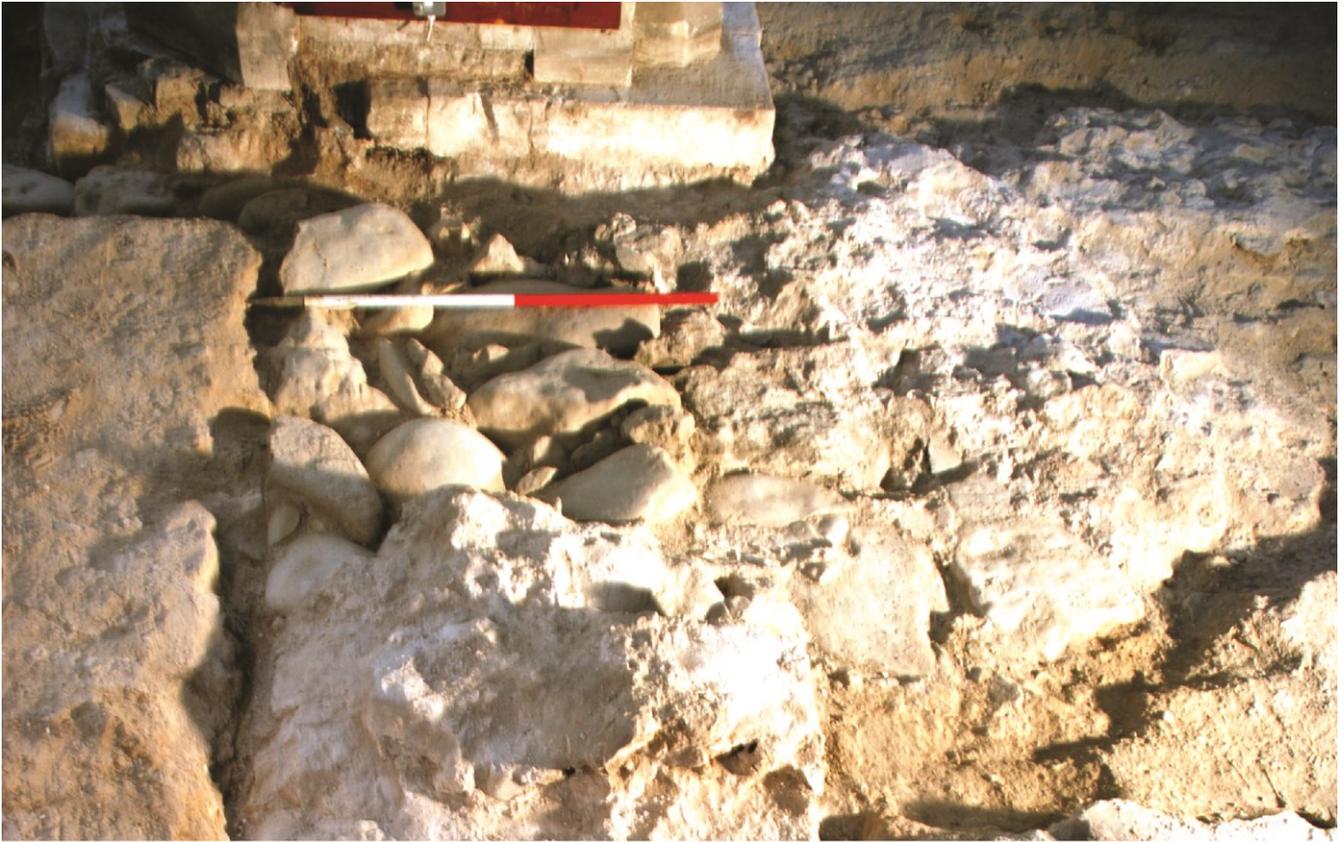
Plate 6 12th-century stair turret foundations (45 and 46) to right, 13th-century transept foundation (46), centre, and 1822 south aisle wall foundation (47) in foreground, looking north.

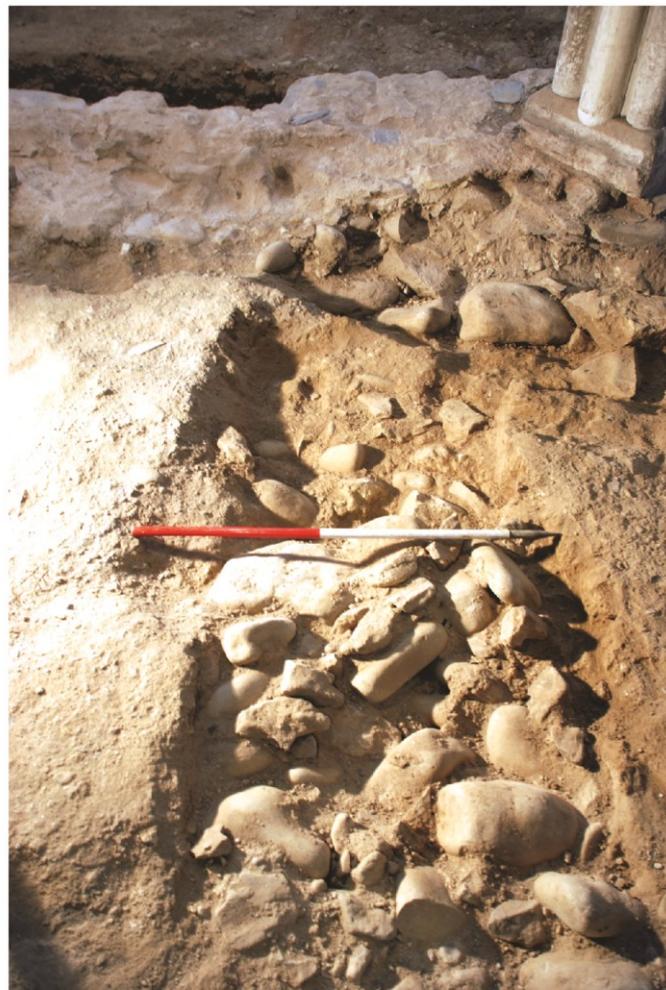
Plate 7 13th-century transept foundation (57), looking north.

Phase 2 foundations are associated with the addition of north and south transepts to the west of the tower. The foundations were built largely of cobbles with inclusions of local Greensand stones set in compact red-brown clay, and are on average 1m wide (Fig. 3, coloured green; foundations 14, 33, 46, and 57; Plate 7). The foundations are different in character from those of phase 1, indicating that they belong to a subsequent phase of construction. Foundations 46 and 57 have rounded ends typical of walls built up against an earlier standing structure.
