ST. NICHOLAS AND ST. GILES CHURCH, SIDMOUTH
ARCHAEOLOGICAL MONITORING AND RECORDING

STEWART BROWN ASSOCIATES
AUGUST 2009

ST. NICHOLAS AND ST. GILES CHURCH, SIDMOUTH, DEVON
ARCHAEOLOGICAL MONITORING AND RECORDING, 2009

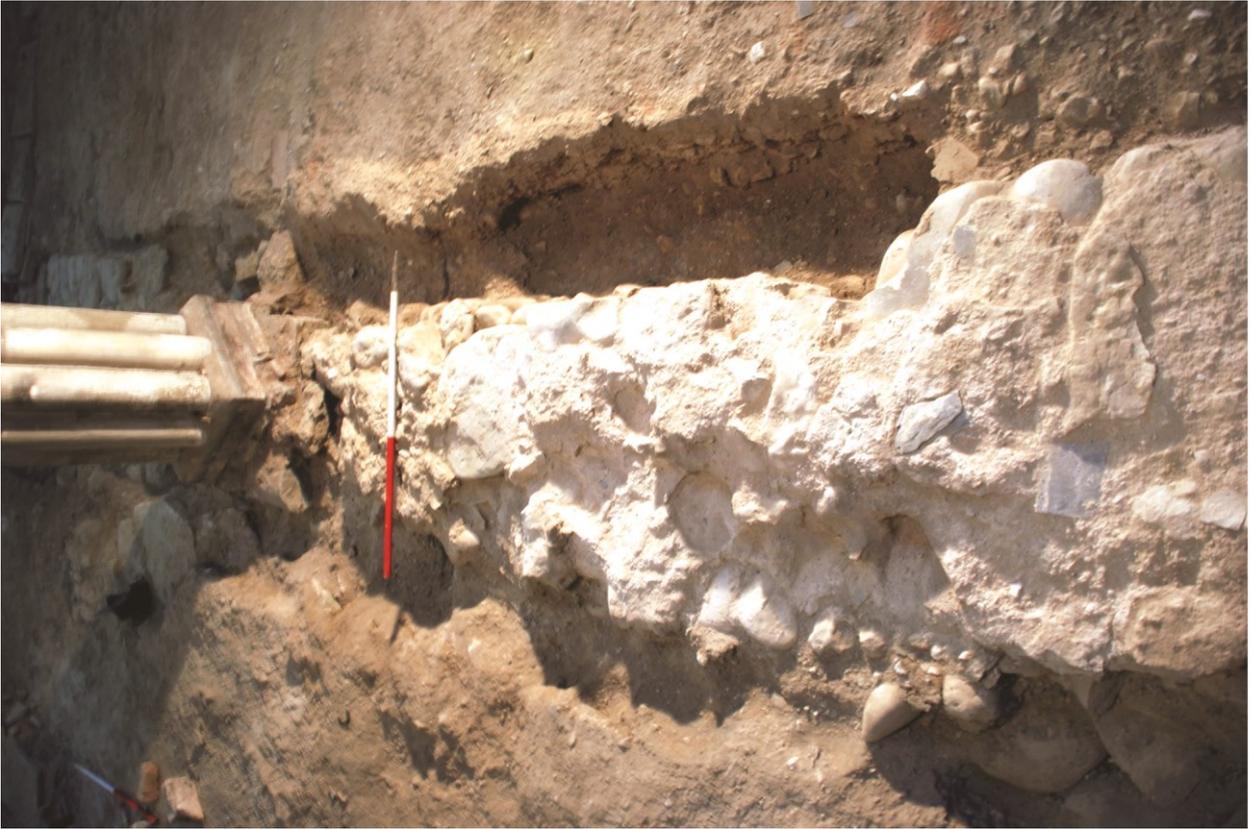
Plate 8 14th-century nave foundation (55), looking west.

The south wall of the nave was rebuilt on its former line. Some of the large cobbles from the Phase 1 foundations were lifted and re-used in the construction of the new wall foundation 55, which was a little narrower (1m; Plate 8). At its east end, foundation 55 terminated in a square-shaped pad of mass masonry similar to foundation 20 on the north of the nave, with which it aligns on a north-south axis. This probably provided a base for the jamb and respond of a new stone archway leading into the south transept.

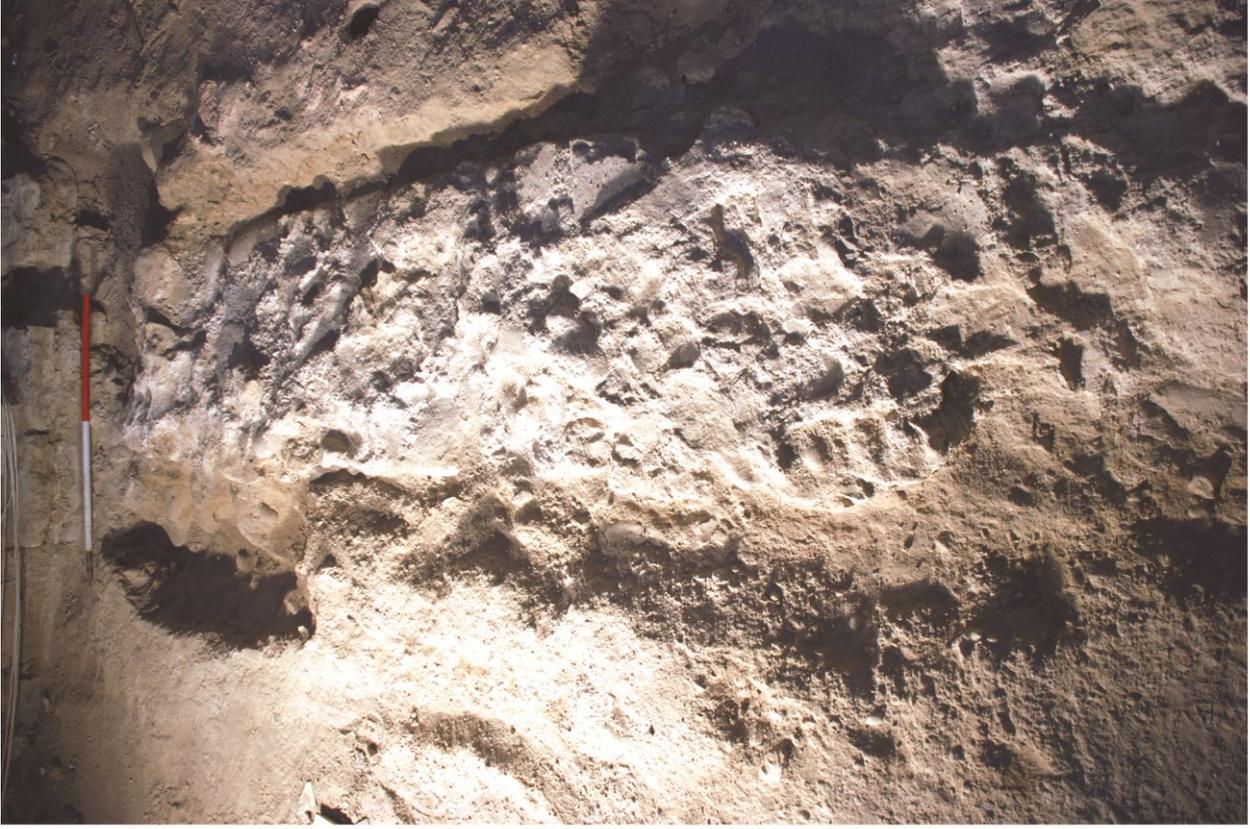
Plate 9 15th-century chancel foundation (43), looking east.

The foundations for the north and south walls of the new chancel (35 and 43 respectively) were 0.9m-1m wide (Plate 9). At the junction of the chancel with the nave, foundation 35 turned southward to form a projecting base for a chancel arch (foundation 31). Remnants of another base for the corresponding jamb of the arch survived to the south (foundation 38). Projecting from the north side of foundation 35, and built into the external corner between the chancel and north aisle, was a further contemporary foundation (32), probably for a buttress.

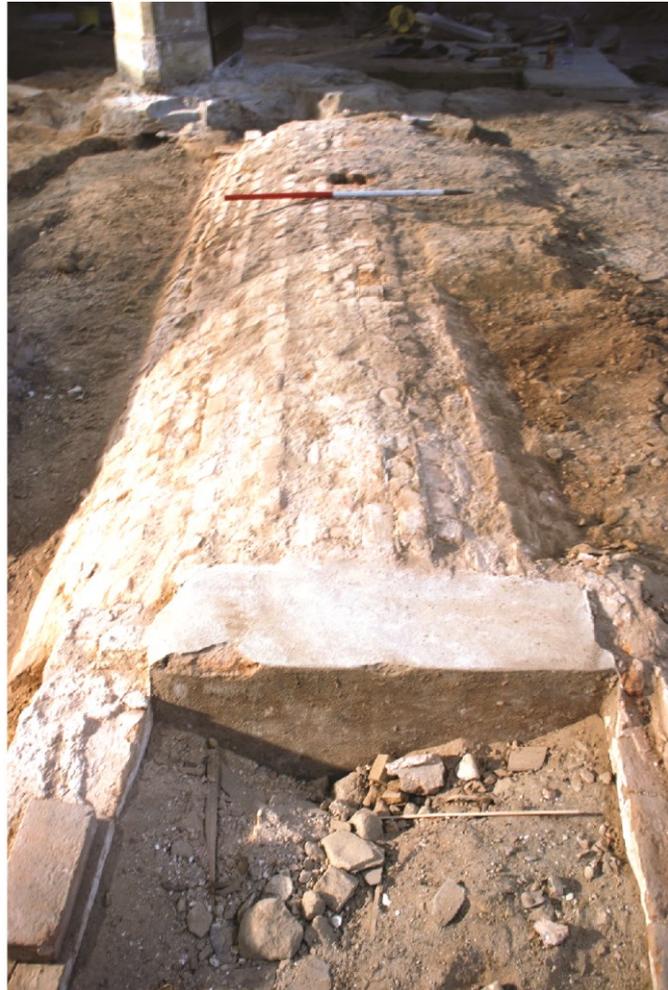
Plate 10 Late 18th-/early 19th-century brick-vaulted burial chamber (21), looking east.

A number of burials had been interred within brick-vaulted chambers. These date from the late 18th and early 19th centuries. The bricks are hand-made local bricks dating from this period. The condition of the burials inside was investigated as part of the works programme. Small openings made through the vaults showed that these contained lead coffins, some with wooden outer coverings (the vaults were soon afterwards re-sealed and strengthened prior to laying the new floor). The largest brick-vaulted chambers were built to contain two tiers of four coffins (21, 71, and 72). One of these had a flight of brick steps leading down to it (burial chamber 21, steps 10; Plate 10). Other vaulted chambers contained only single lead coffins (2, 3, and 65; Plate 11). At least one contemporary brick-lined burial was covered by flat stone slabs rather than a vault (75). Two other similar burials appear to have been disinterred in Victorian times for reburial elsewhere (13 and 74), since their backfilling comprised loose building waste comparable in composition with the Victorian construction levels.

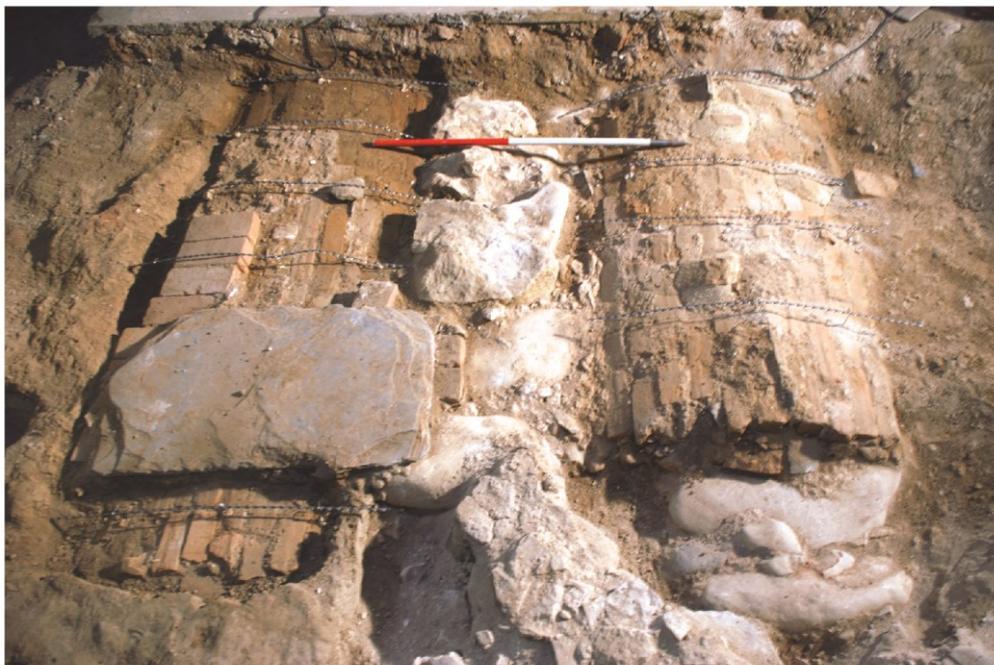
Plate 11 Late 18th-/early 19th-century brick-vaulted burials (2 and 3), and between them, a remnant of 12th-century foundation (4), looking west.
The slate stone bridging burial 3 provided a base for the font.
The metal ties were inserted in 2009 to strengthen the vaults.

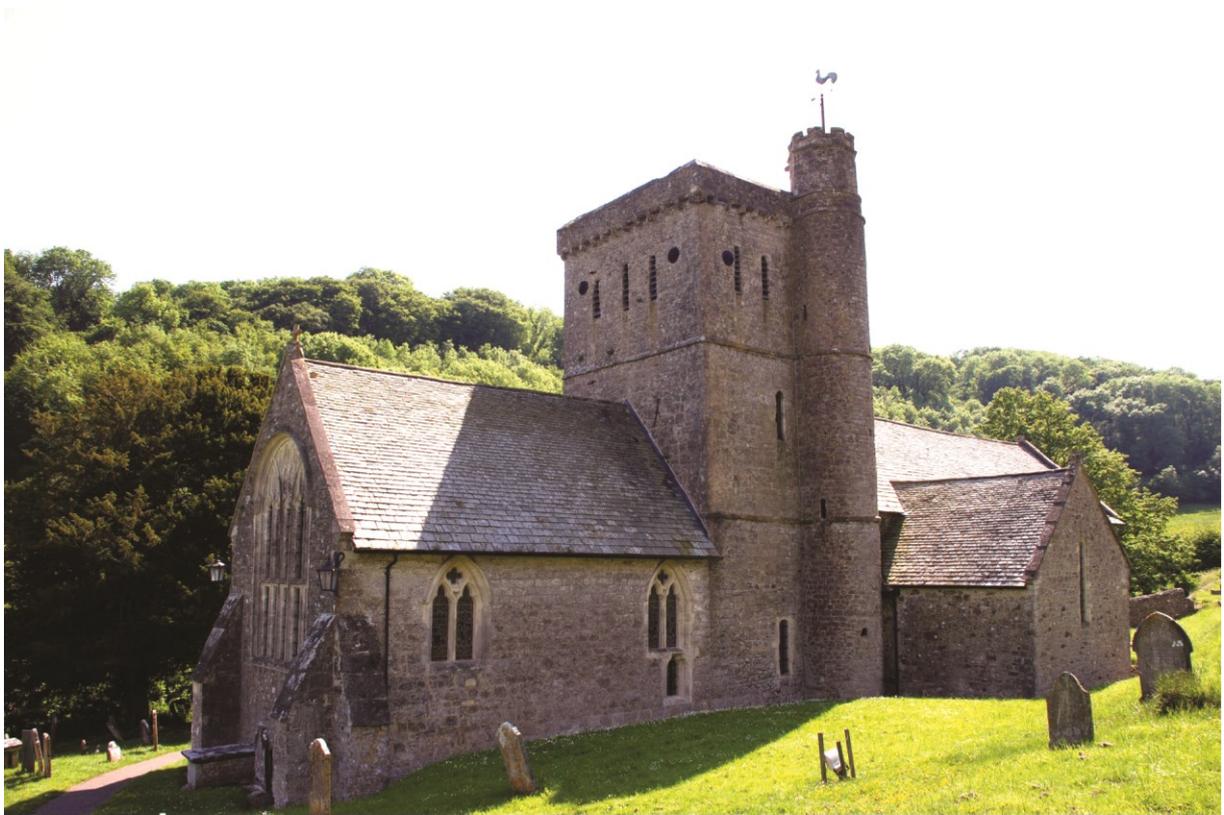
Plate 12 Branscombe church Norman tower and stair turret, looking southwest.

The addition of transepts in Phase 2 transformed the church into one with a cruciform plan. This type of plan increased in popularity during the 12th and 13th centuries and continued into the later medieval period. When new churches were built in this manner, they had central towers ingeniously supported only at their corners, with arches leading into the transepts as well as the nave and chancel. At Sidmouth, the tower already existed, and it was probably considered too dangerous to open new arches through its north and south walls, so the transepts were added to its west. This is an unusual arrangement, but one paralleled at Branscombe, where both the north and south transepts are still standing, having been added to the west of the tower in the mid 13th century (Plate 12). It would not be surprising if this was
