BERRY POMEROY DEERPARK WALL

Evaluation trench inside wall section 1.21

Stewart Brown Associates March 2015

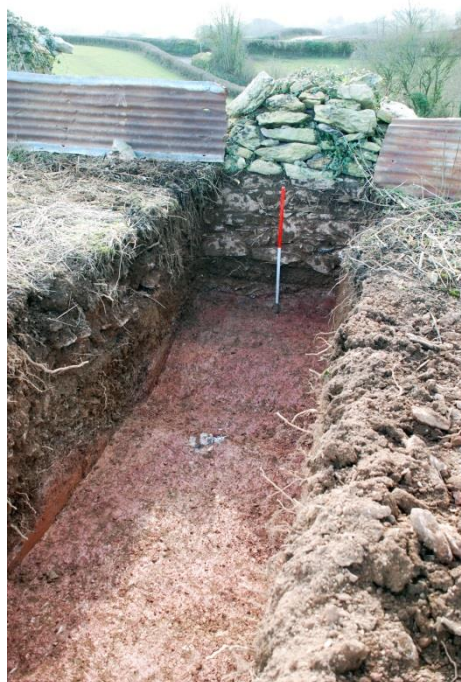
Fig. 2 The evaluation trench looking south.

The trench was located at the SW corner of the field known as West Summerhill, nearby a presently dilapidated shed (Figs. 1 and 2). It was 1m wide and up to 1.15m deep. It located undisturbed geological deposits at depths of between 0.5m and 0.9m. It was decided to excavate a little further into the geological deposits in order to provide a clear and unambiguous profile of the division between archaeological and natural, geological deposits. Section drawings were made of the two sides of the trench (Fig. 3).

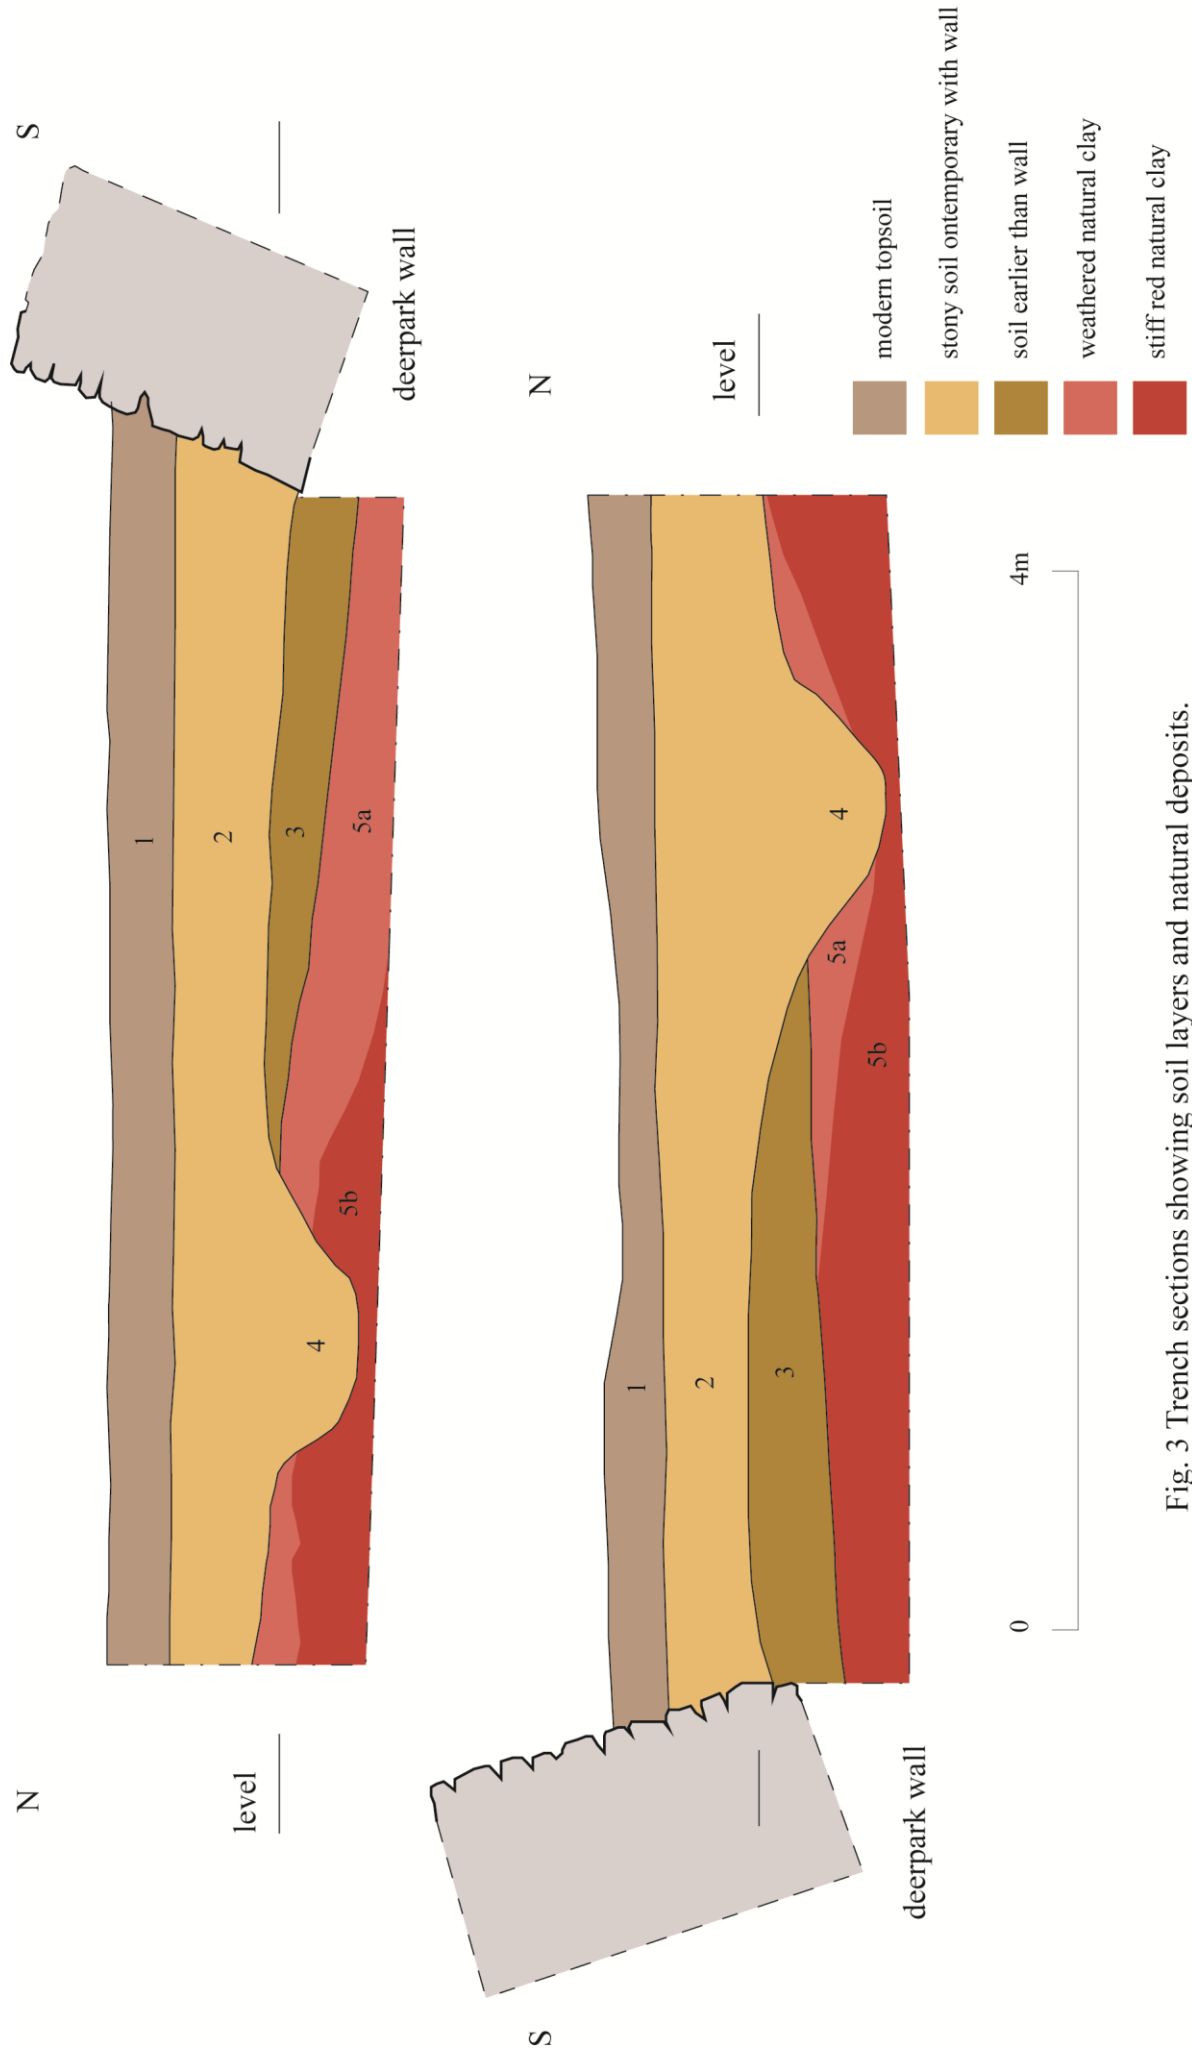
Fig. 3 Trench sections showing soil layers and natural deposits.

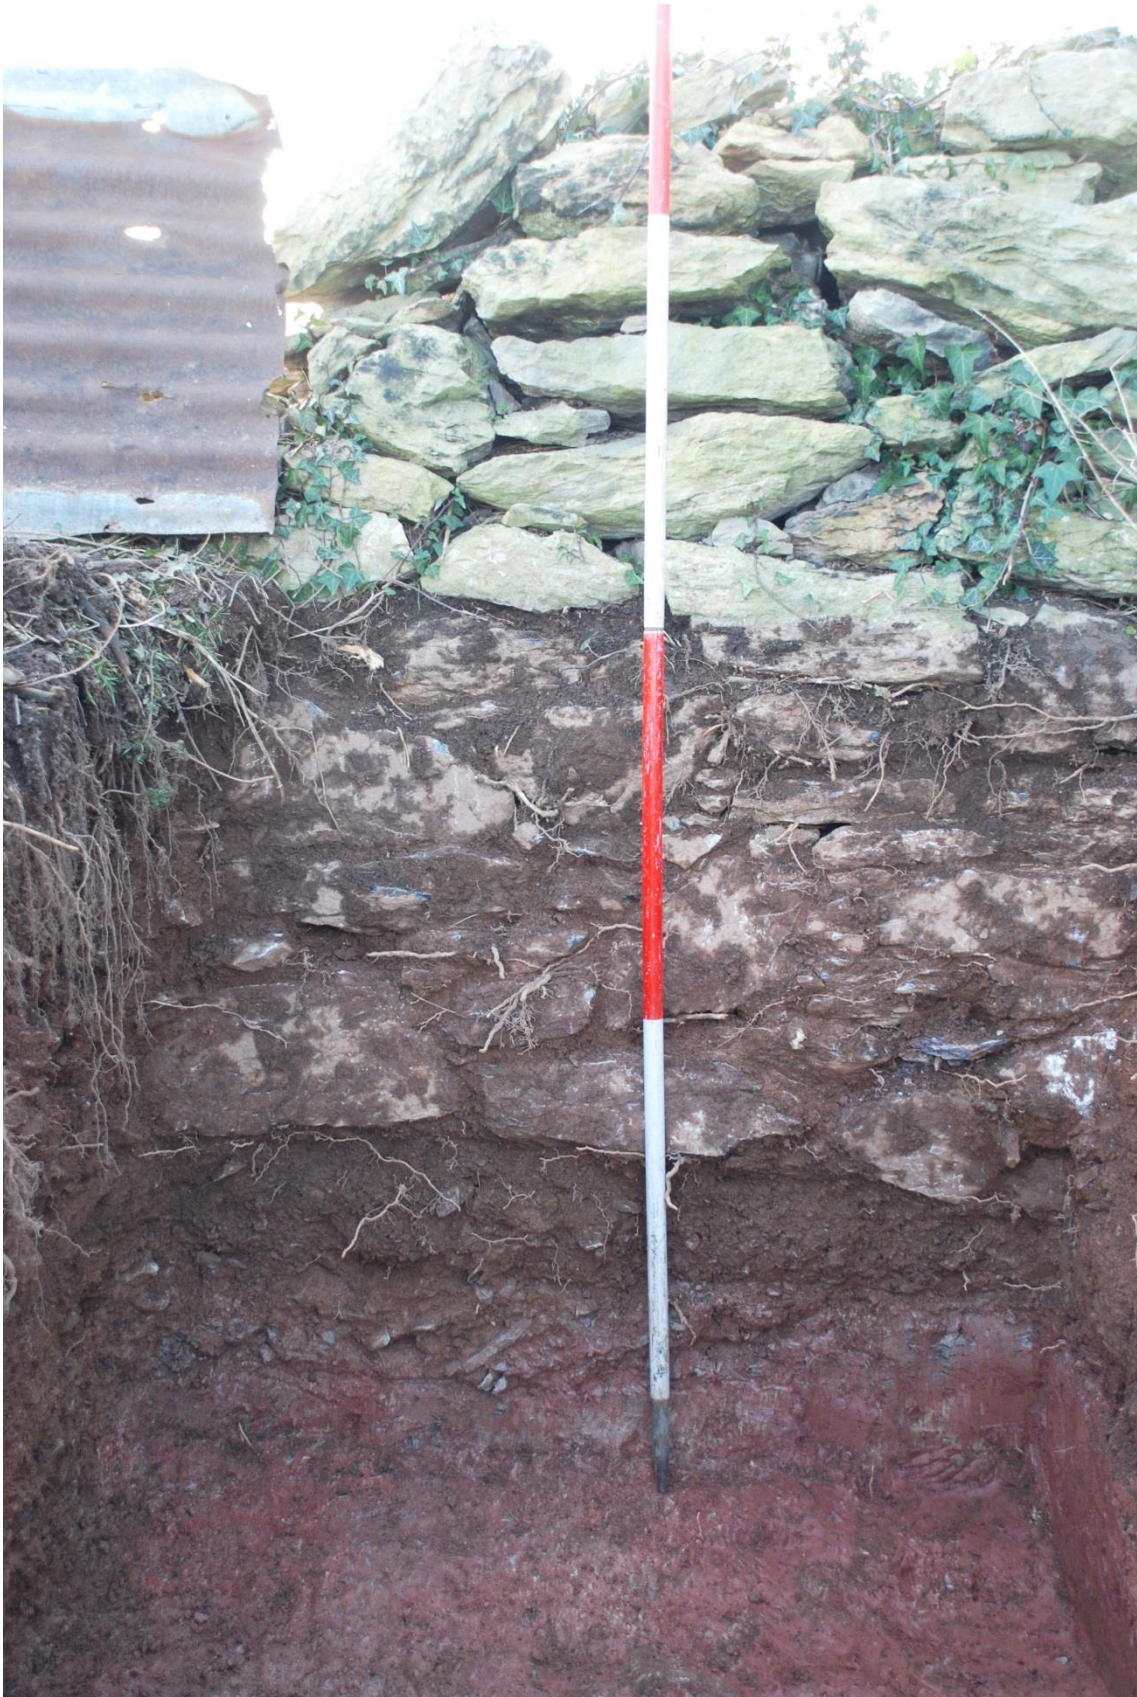
The deerpark wall leans out at this point to an angle of about 20 degrees. The wall is built of limestone rubble which is occasionally brought to course (Fig. 4). An observation made in 2014 during a site visit a little further to the east showed that it has red earthy clay in its core which may form part of its original construction. The wall was built directly on the ground with no foundation or plinth, at least on its inside.

Fig. 4 The deerpark wall exposed by the evaluation trench, looking south.

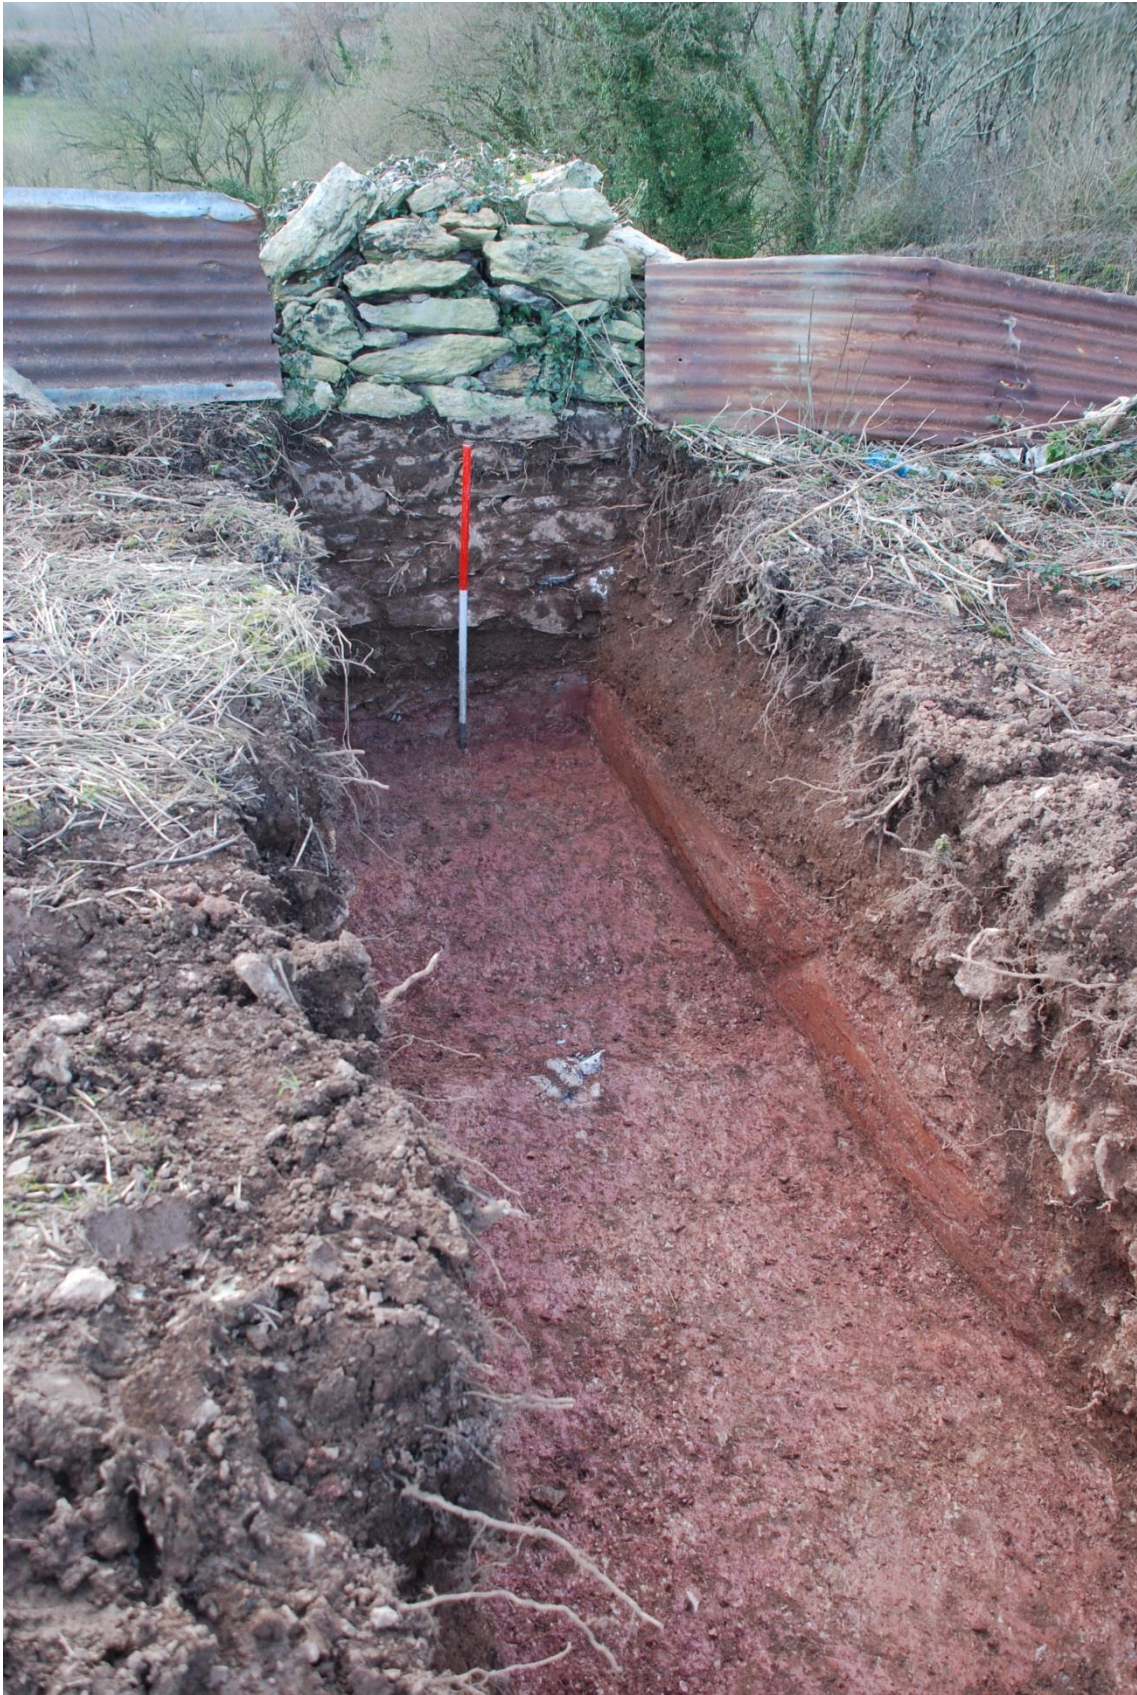
Inside the wall, the trench exposed three archaeological deposits. The uppermost is modern topsoil comprising mid brown aerated clay with organic content (1). The second is a light brown aerated clay containing many large and small stones (2). This extends down to the bottom of the wall face, showing that it accumulated against the inside of the wall from the time of its construction until fairly recently, ie it spans a very long period stretching from medieval times until almost the present. It shows no observable variation, so it is not possible to distinguish differences in its make-up relating to different times. Some of the stone may possibly have come from the wall but there is no distinct layer of collapse. It infills a ditch dug parallel with the wall 3m inside it (4). The ditch was evidently dug at about the time that the wall was constructed.

The lowest deposit is a mid brown aerated clay containing small stones and some silt (3). This extends southwards beneath the wall so must be earlier than it. It is either an ancient buried topsoil or ploughsoil, the latter being the most likely considering the depth to which the soil had accumulated (up to 0.32m - deeper than would be expected for topsoil). If this is indeed a ploughsoil, it demonstrates that the ground round about had been tilled for some time before the wall was built. It would not be surprising if cultivation of the area extended back to Norman, Saxon, or even Roman times, since Roman finds have been discovered in the Berry Pomeroy area (Brown 1998, 6).

Fig. 5 Evaluation trench opened in 2015 showing archaeological deposits above natural red clay, looking south.
