BERRY POMEROY CASTLE, DEVON
ARCHAEOLOGICAL WATCHING BRIEF DURING EXCAVATIONS
FOR FENCE-POST HOLES

By
Stewart Brown Associates
JULY 2005

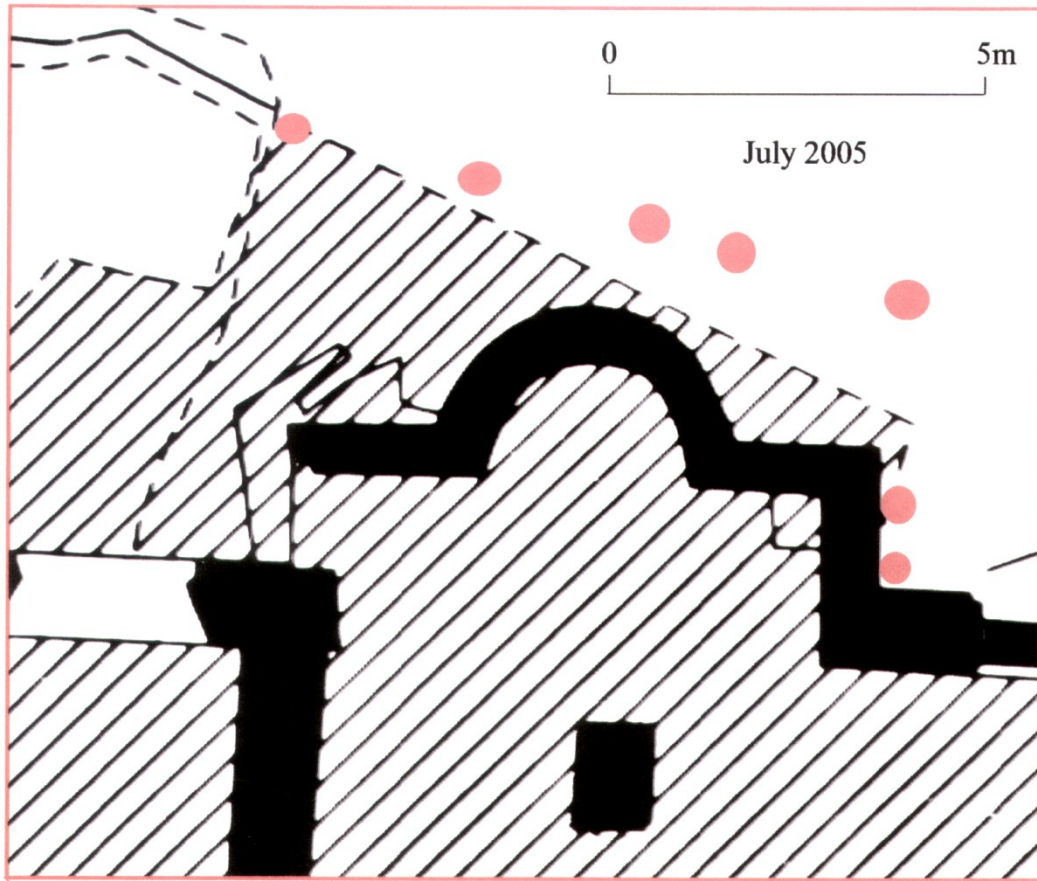
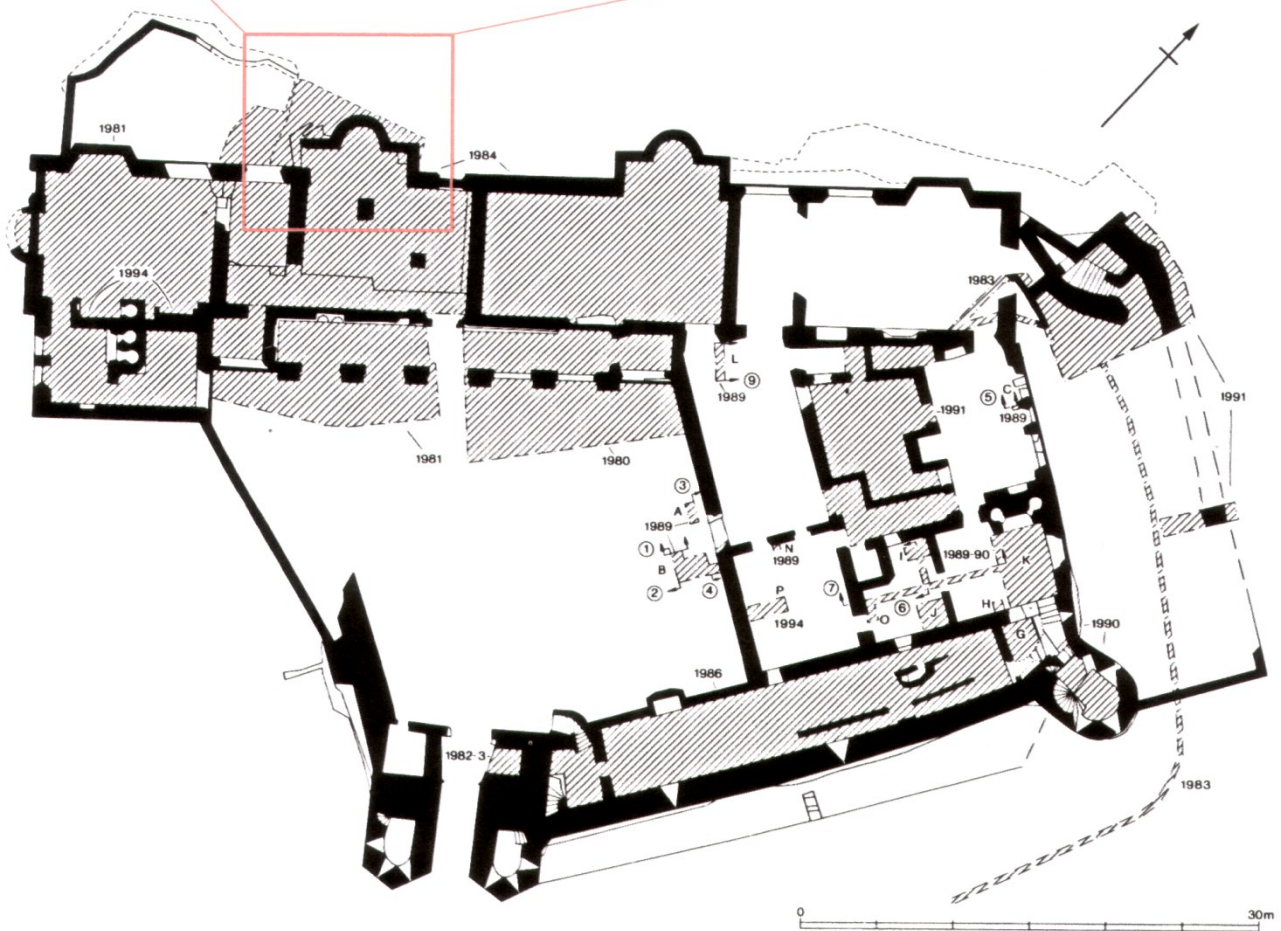
Fig. 1 Location of fence-post holes (shown in red)

The seven holes were approximately circular in plan (0.5m in diameter) and dug 0.7m deep (below present ground level). Fig. 1 shows their location. In all cases, excavation of the holes exposed only dark brown clayloam topsoil mixed with demolition material, comprising: local limestone and slate building stone fragments, Beer stone fragments, mortar, roofing slates and roofing tile. The soil also contained food remains comprising sea shells and animal bones.

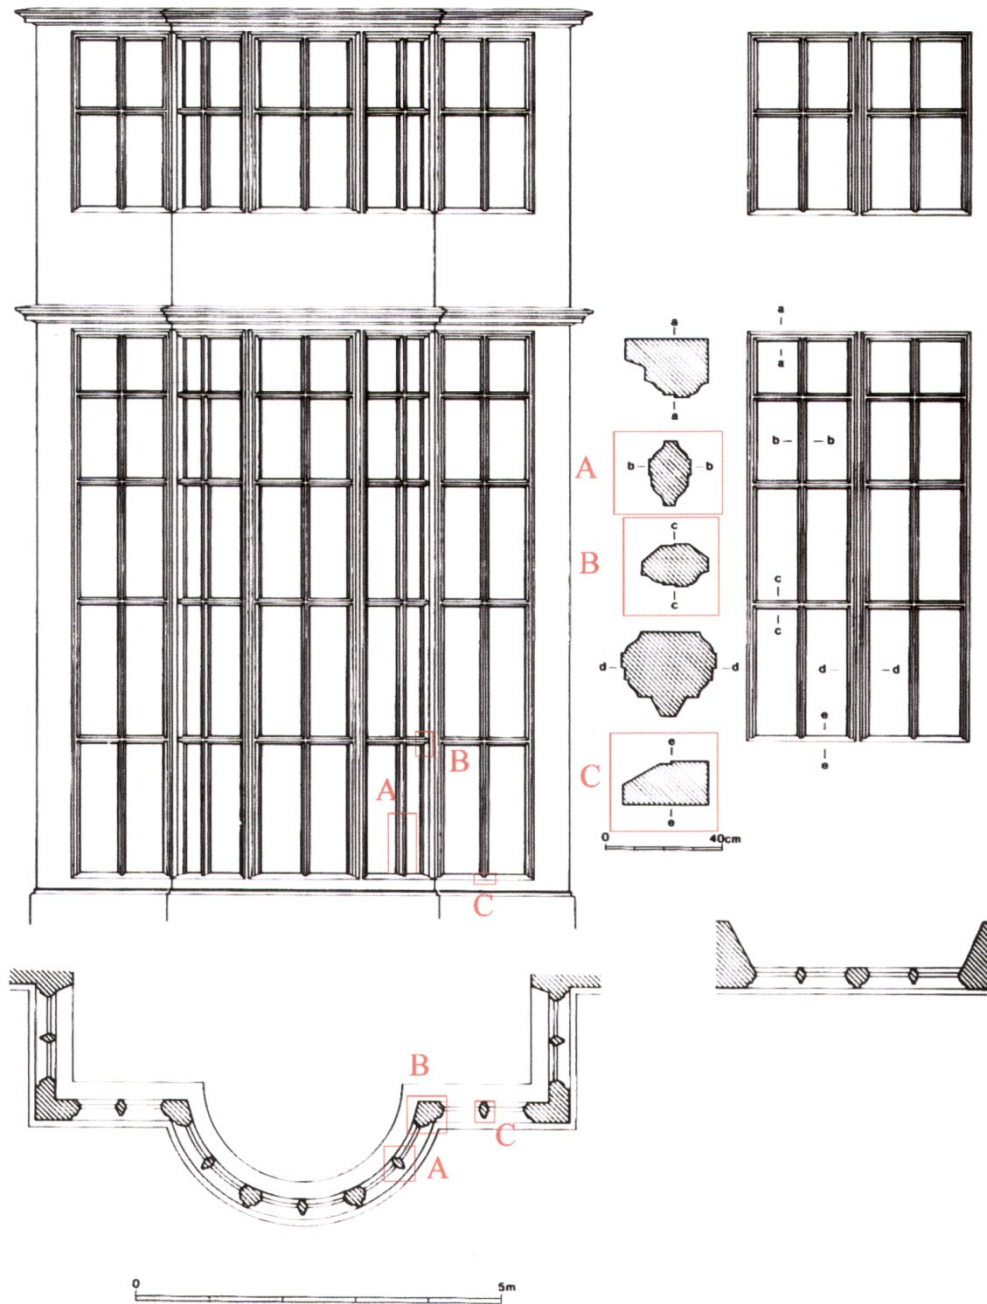
Stone window fragments found during excavation of fence-post holes:

Stone A 0.61m long fragment of window mullion

Stone B fragment of transome from corner of bow window

Stone C fragment of sill with seating for mullion

The diagram below shows whereabouts in the window the fragments could have come from.

Fig. 2 Diagram showing the original position of the three Beer stone window fragments found during excavation.

Three large stone fragments (A, B, and C) from a window or windows were recovered. These were all of Beer stone and date from c. 1600. They almost certainly came from the nearby bay and bow windows of the north range of the castle (built c. 1600, abandoned c. 1688-1701; see Brown 1996, 1). Fig. 2 shows a reconstruction drawing of the bay and bow windows, together with the likely positions from which the three fragments came (A, B, and C).
