**HERITAGE ASSESSMENT
LOWER MILL BUILDING, BUCKFAST, DEVON**

Archædia

Report 14.09 Project 1128 3rd July 2014

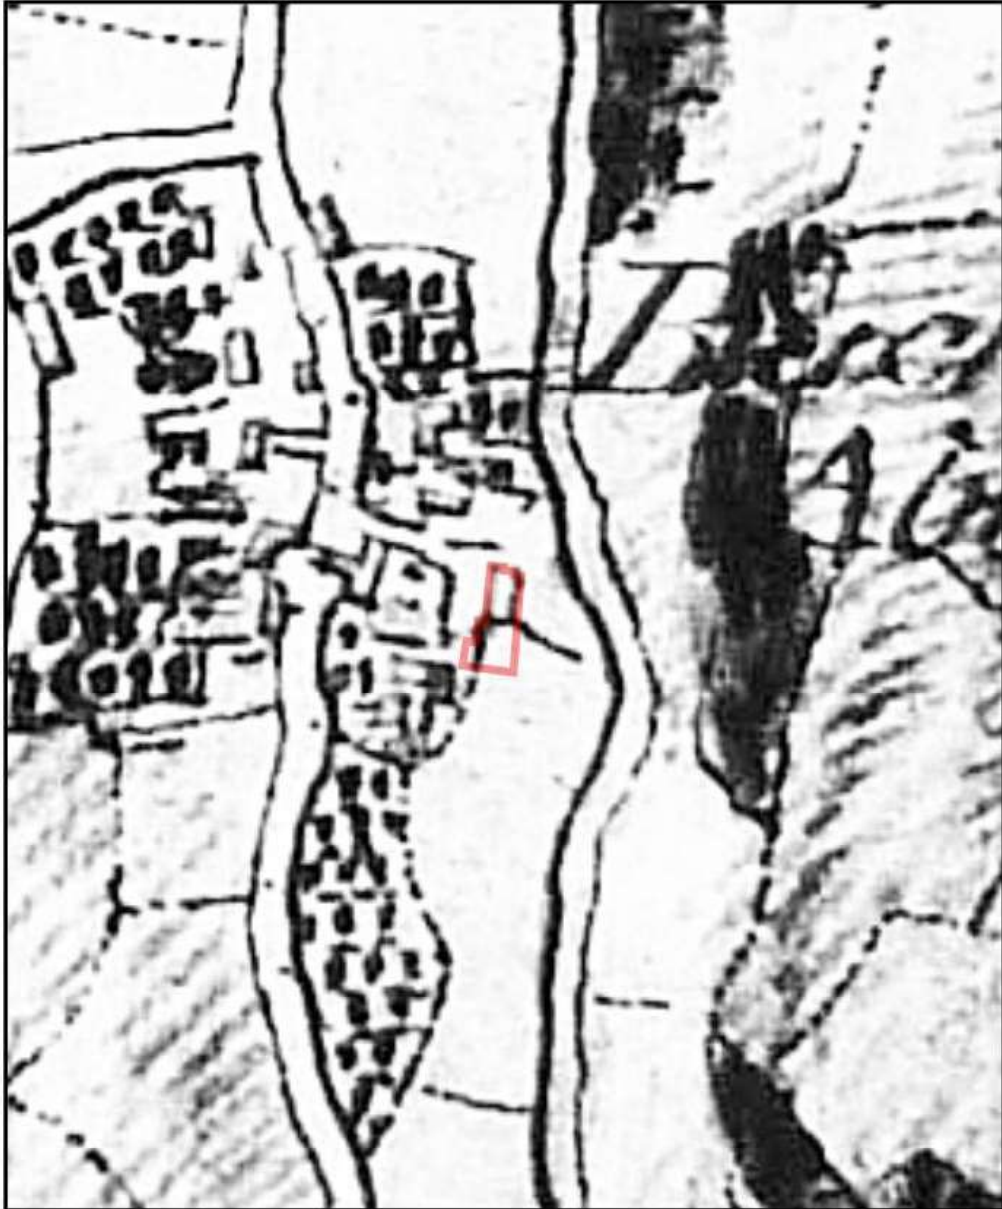
Lower Mill is indicated on the OS two-inch map of 1802-3 (Fig. 3) together with what may be the tail race to the east, although neither Higher Leat or Lower Leat are shown. To the west Higher Mill, or a building in the same position, also appears to be represented.

Fig. 3 OS surveyors' Two-inch drawing, surveyed 1802-03.

A building is shown in the position of the north range on the OS surveyors' drawing of 1802-03 (Fig. 3), although not in any useful detail. A building is shown in greater detail on the c. 1843 Buckfastleigh Tithe Map (Fig. 4). The stepped form of the north end is identical in plan to this end of the current building, representing the surviving two-part tower. This stepped end is evident in all subsequent OS maps. It is thought very likely therefore that this north range is the same building, predating the 1840s, and probably representing the mill constructed at the turn of the century. It is difficult to know how to interpret the 1827 documentary evidence for a wing and possible building of a small section of the mill itself. No indication of alteration was evident in the current building.

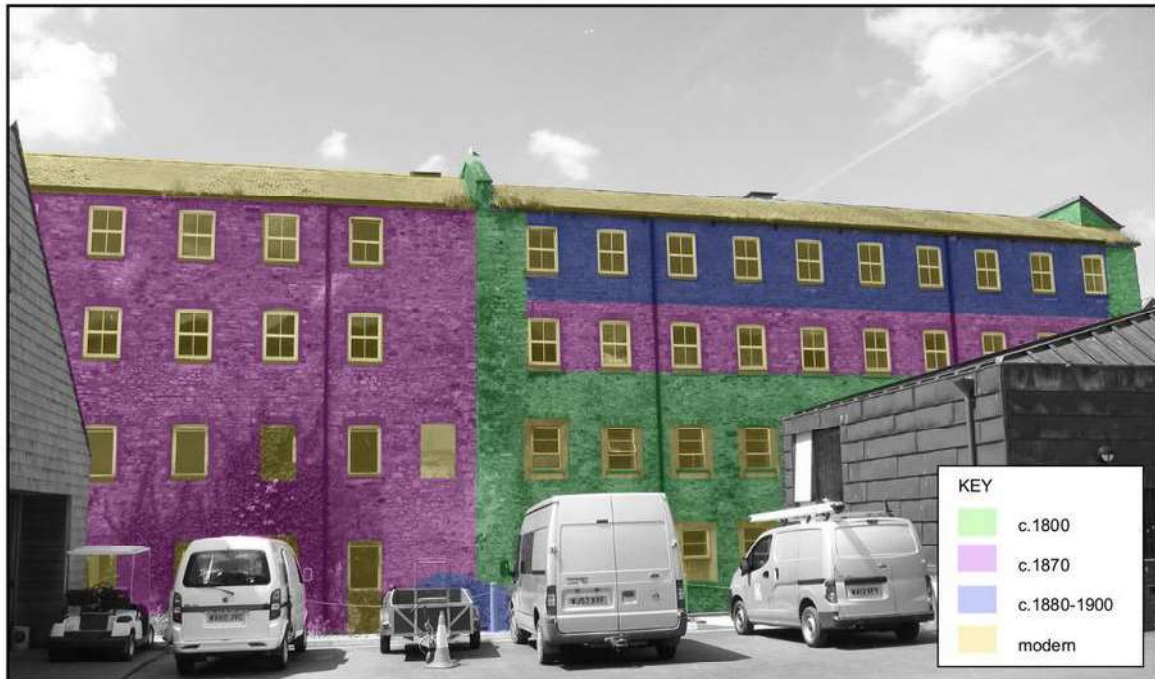
Fig. 11 West elevation construction phases (windows are shown as modern to denote recent replacements, not modern openings).

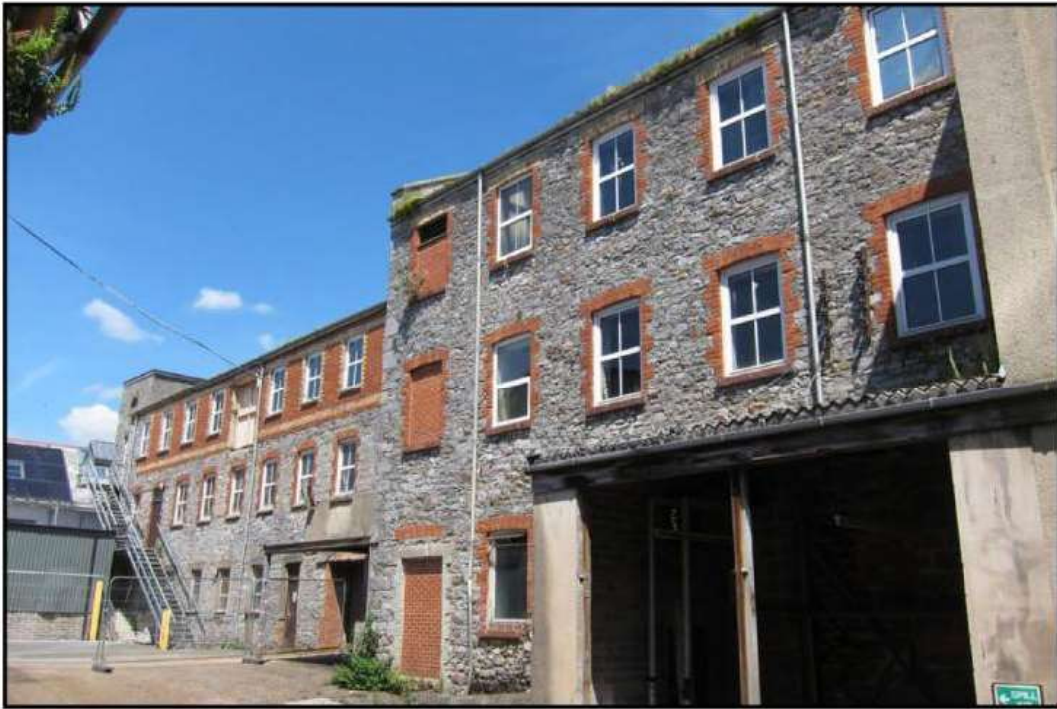
Both ranges are four storeys in height, with windows to only three floors, referred to as the ground, first and second floors, visible from the west (Photo. 1). The elevation overlooking Lower Leat to the east (Photo. 2) also contains windows to a lower, or basement, floor in both ranges.

Photo. 1 The west elevation, looking north-east.

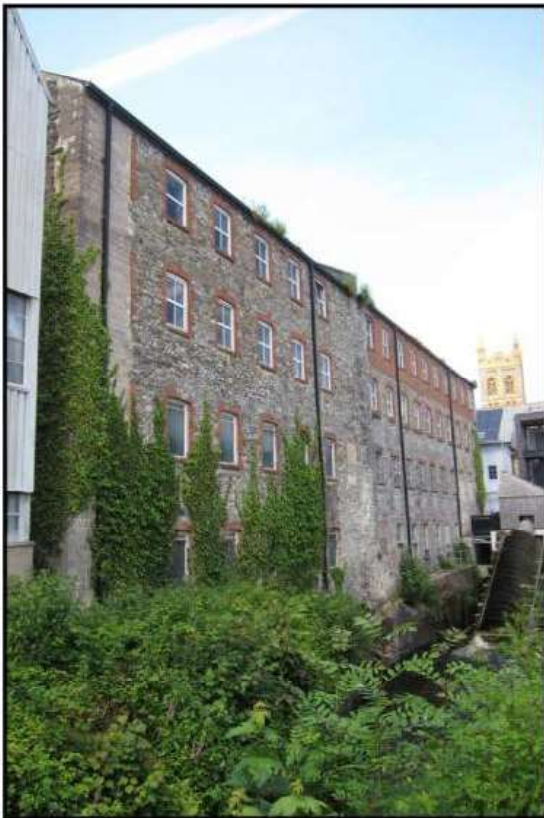
All of the southernmost windows in the east elevation have been blocked by a modern breeze-block rebuilding of this corner of the range (Photos 2 and 4), and windows at the southern end of the west elevation have either been blocked with brick or enlarged to form doorways leading to the modern stair tower.

Photo. 2 The east elevation, looking NNW.

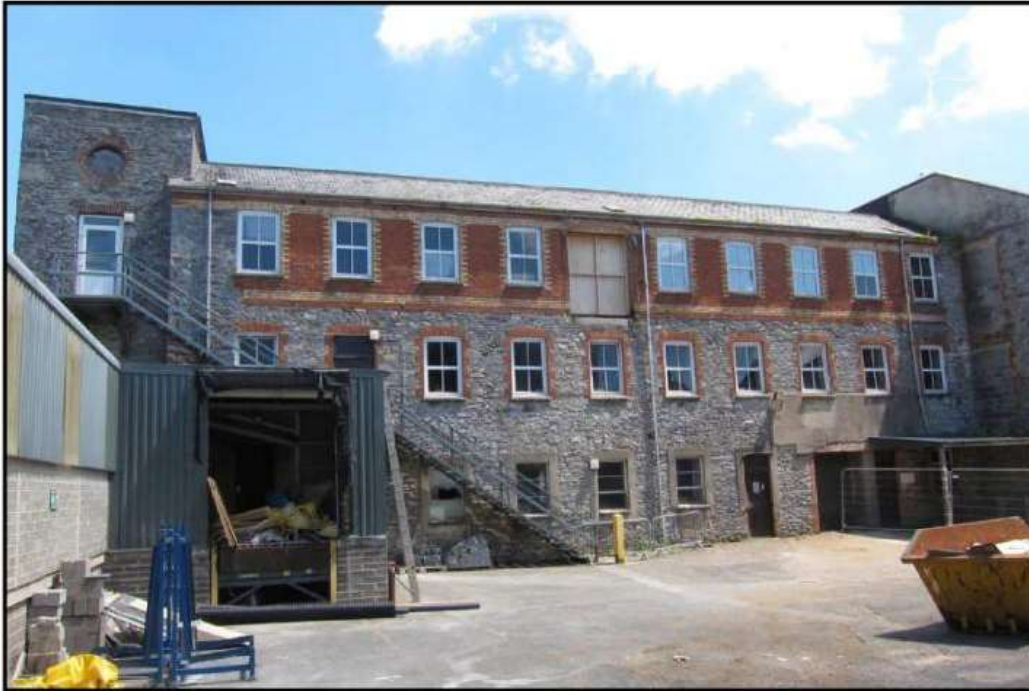
The north range is built, in the main, from limestone rubble bonded with lime mortar. The only variation is at second-floor level, where the east and west elevations are constructed from machine-made red brick, with yellow, ball-clay brick details to the west (Photo. 3).

A limestone tower (Photo. 3) represents an original element of the north end of the north range. The tower is in two conjoined parts, both extending beyond the roof height of the main range. The roof to both sections is modern. The main, western part of the tower is approximately square in plan, with a large stone arched opening (Photo. 5) near ground level on the west elevation. Two iron lower door pintles (Photo. 6) survive within the inner jambs to this archway. A circular light, now blocked, pierces the upper part of this elevation, with doorways at first and second floor level below, one blocked, the other with a modern door reached by a modern steel external staircase.

Photo. 3 The north range and tower, looking east.

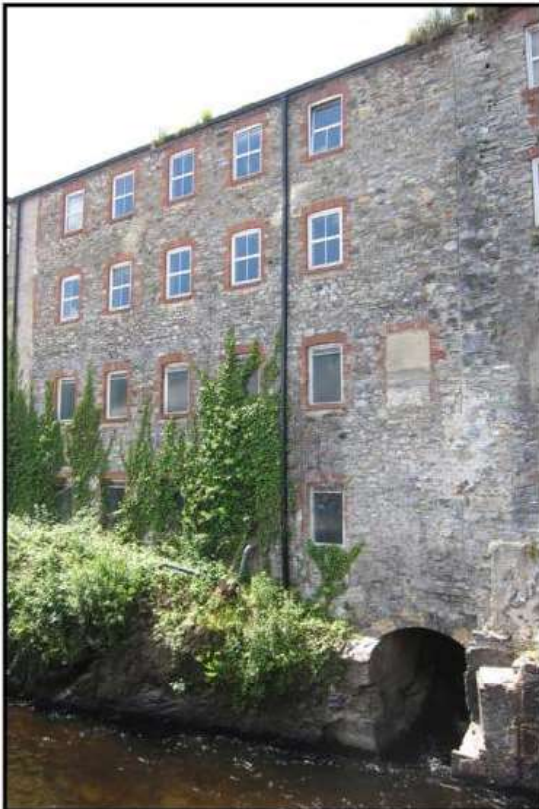
Two arched apertures are present below the level of the basement windows on the eastern elevation. The southern aperture (Photo. 4), arched in yellow brick, is situated below the north-east corner of the south range, and is known to have formed the outlet for a leat (from a mill pond to the west of the mill, itself fed by Higher Leat). The second aperture, arched in stone, is located a short distance to the north, below the second to last window, all but completely obscured by vegetation. Large, dressed limestone blocks form the corner quoins to the north range above the larger aperture. These do not, however, extend to the exposed natural geology, but are separated by a small area of limestone rubble that surrounds the aperture itself.

Each floor, of seven bays, would have been lit originally by six windows on the east side (seven on the ground floor) and up to seven to the west (Photo. 4). At least two windows to the basement floor would have been visible in the earliest form of the building on the western elevation. These are now obscured by a modern stair tower.

Photo. 4 The leat outlet at the north-east corner of the south range, looking south-west.

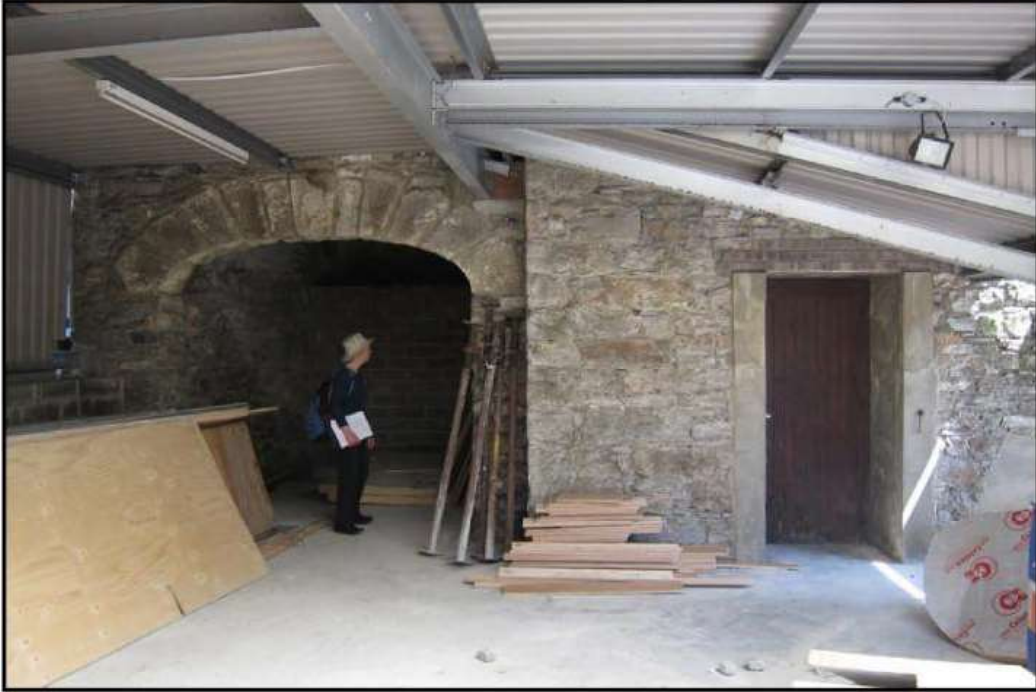
Photo. 5 The archway at the base of the tower, looking east.

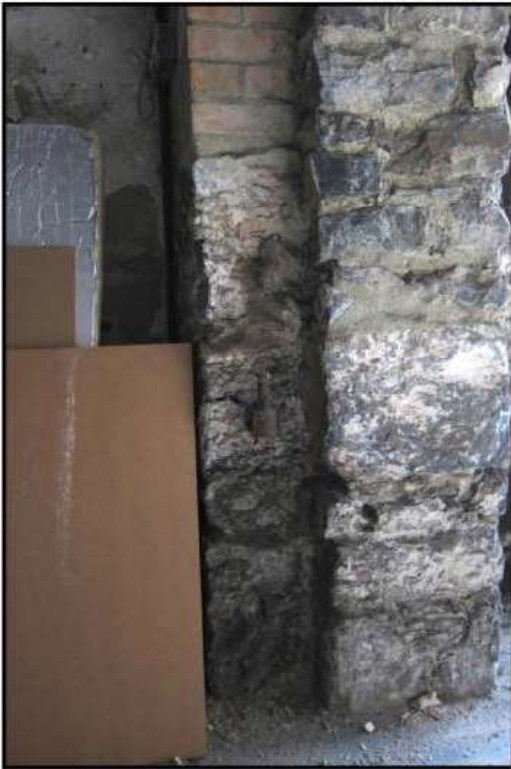
Photo. 6 The pintle within the tower entrance arch, looking south.

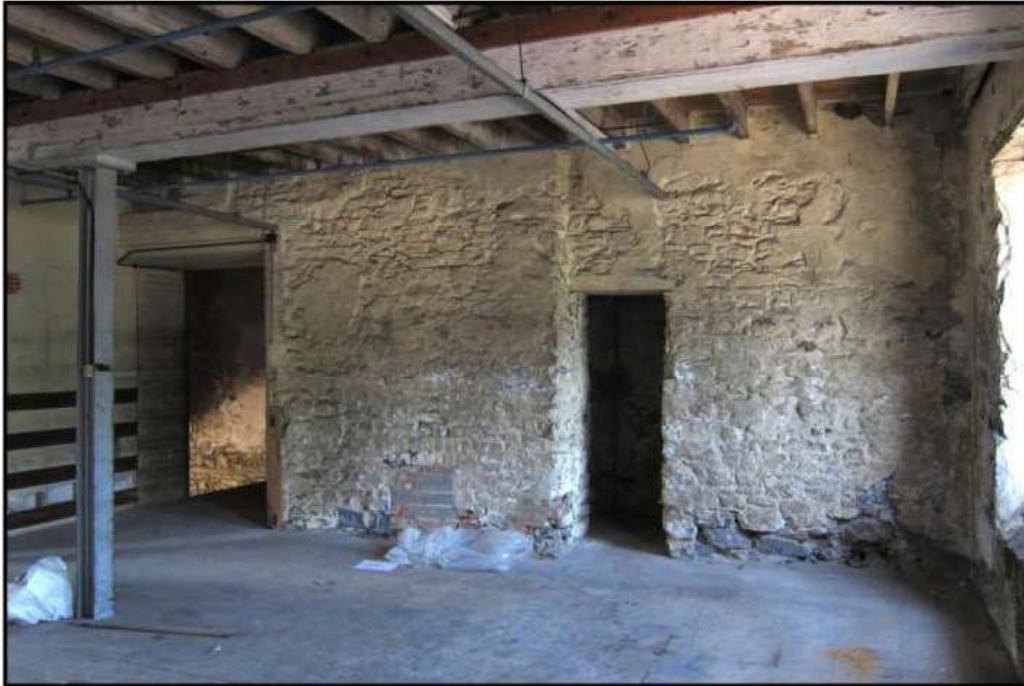
Internally, a large, modern doorway provides access from the main body of the tower to the ground floor (Photo. 7), the original doorway blocked to one side. An original doorway, with replaced modern door, still provides access to the second floor, from a room accessed by way of the modern external stairway. Internal floors to this part of the tower are modern, and recent steel and brick additions reinforce the lower levels. Sawn off floor joists (Photo. 8) indicate the former presence of a room or attic space above the current upper room.

Photo. 7 The north wall, ground floor, north range, showing the modern entrance to the tower on the left, and the doorway to the lavatory on the right.

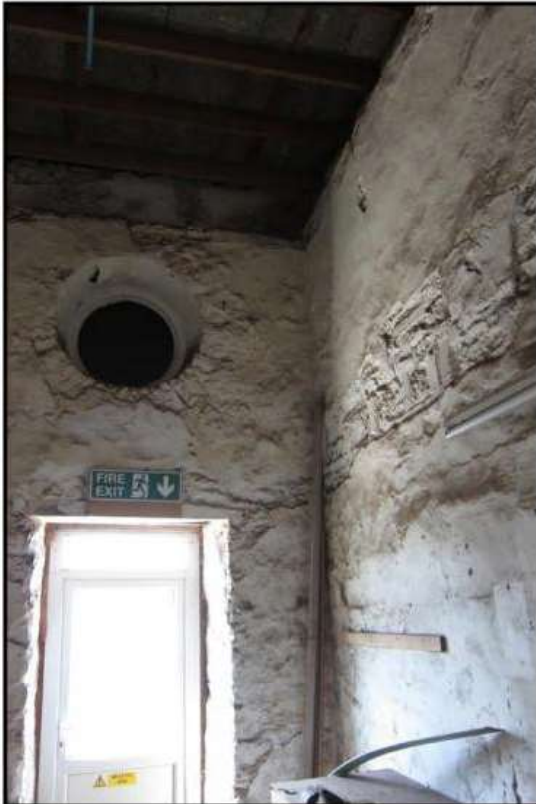
Photo. 8 The upper room in the tower, showing the blocked light, modern door (in an original opening) and the sawn off floor joists, looking west.

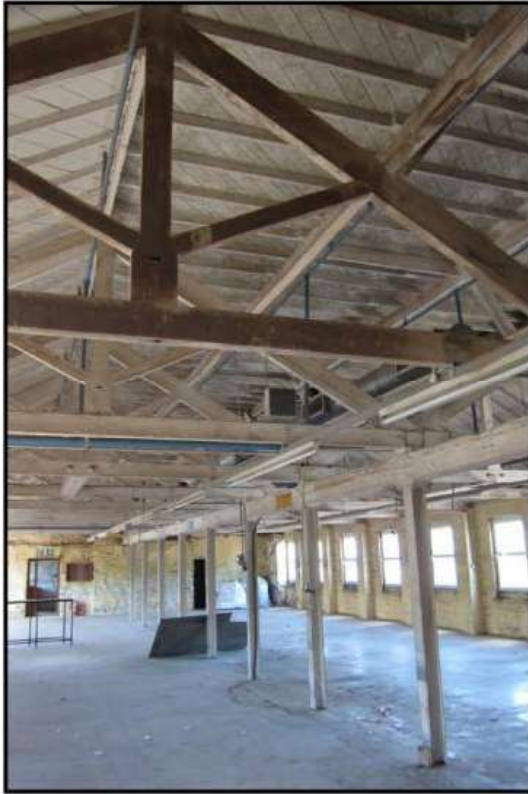
The roof (Photo. 9) was originally double ridged, the two longitudinal sections supported by ten pairs of king-post trusses. The intervening valley has since been infilled with timber bracing, and the whole range covered with a new roof. All timbers, including the underside of the roof, are whitewashed. The central beam supporting the inner end of each truss, itself supported by modern steel columns, appears to have been inserted into the limestone end walls as a later addition.

Photo. 9 North range roof, looking north.

While the internal roof timbers should be retained undisturbed, the outer cover, being of post-1950s date, could be replaced if deemed necessary.

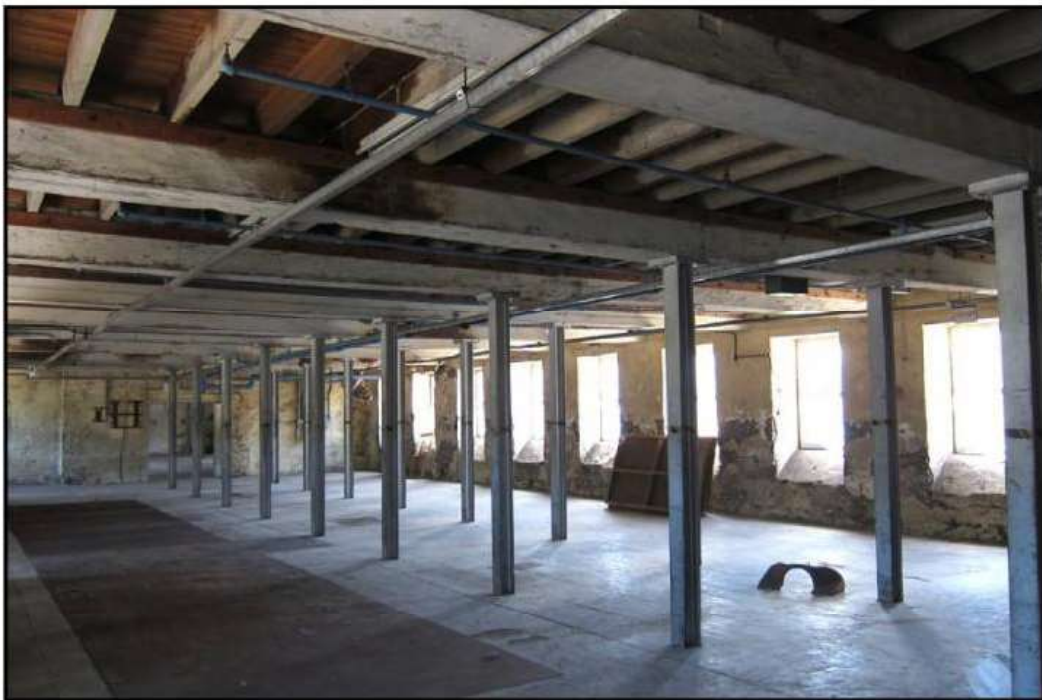
Other than at ground floor level, all floor construction is essentially identical, with massive timber bearer beams extending the full width of the building. These and many of the original joists have been whitewashed (Photo. 10). Both timber and steel reinforcement of the floor joist supports, and joist doubling up, can be seen at all floors. Modern steel columns support the first and second floor bearers. Floorboards, where visible, are usually replacements, and in some cases, obviously modern.

Internally, the window openings on the ground, first and second floors are splayed slightly on each side, with steeply sloping sills (Photo. 10). Internal walls have been plastered and painted.

Photo. 10 North range first floor, showing window and second-storey floor details, looking southwest.

- Replacement of all windows with age-appropriate substitutes and the unblocking of modern infilling. This would include the removal and lowering of modern brick sills to the level of the original sills.
- Replacements of modern doors, in particular the example at second floor level in the tower with something more suited to the building.
- If it was deemed appropriate, the building would also benefit from the removal of the modern concrete and steel structure obscuring the north-west corner of the building, principally the tower.

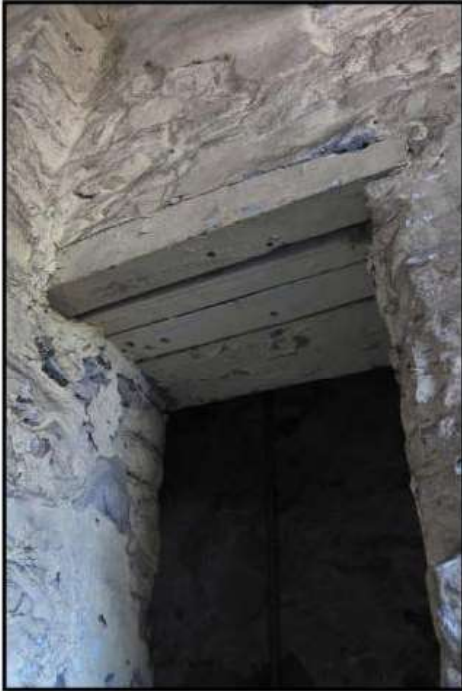
A small fireplace at the centre of the first floor north wall has been blocked. A small, unfurnished doorway, to the east of the fireplace, leads from the first floor to the smaller, eastern part of the north tower (Photo. 7). The lintel to this aperture comprises a number of reused, drilled timbers (Photo. 11). One of these drilled holes is threaded. The tiny rectangular space within this part of the tower has a narrow plastered plinth at the farthest end, partly encasing a jointed ceramic pipe that projects through the ceiling above (Photo. 12).

Photo. 11 North range, first floor lavatory doorway.

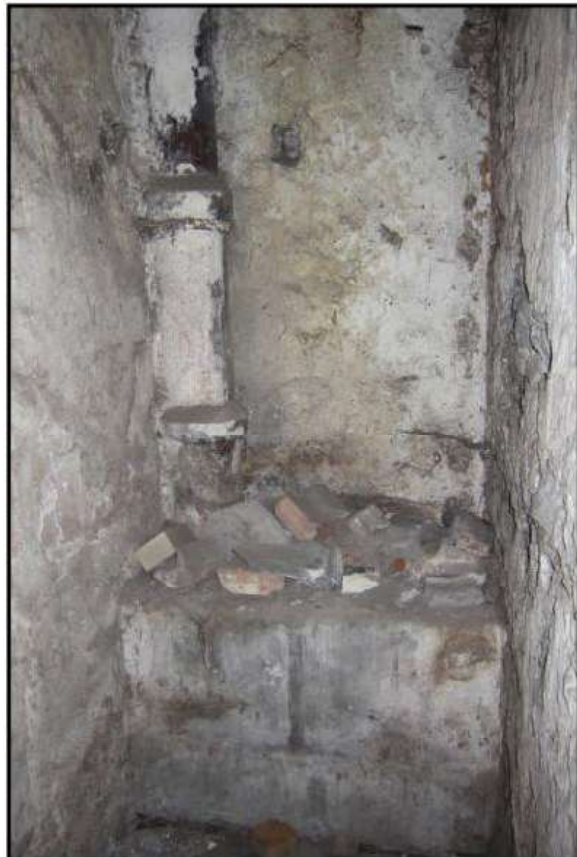
Photo 12. North range, first floor lavatory interior.

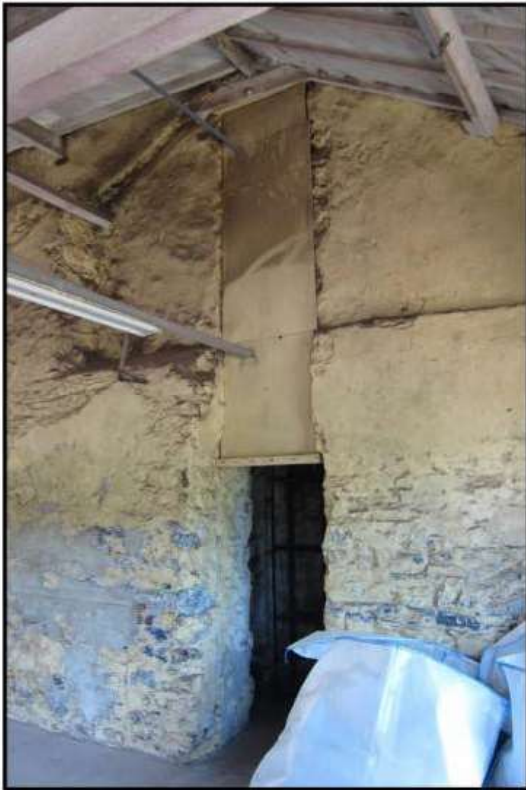
At the second floor, a similar space within this tower is accessed by another unadorned doorway, although this access has no lintel, and modern, hardboard blocking fills an open void that extends above to roof height (Photo. 13).

Photo. 13 Lavatory entrance on the second floor of the north range.

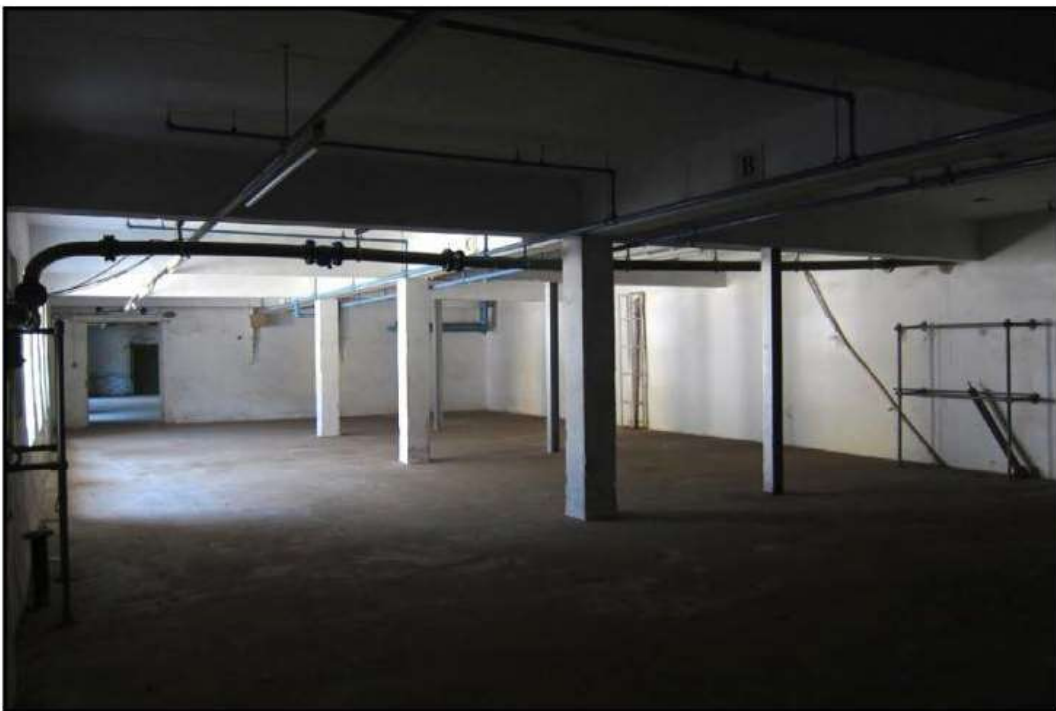
The interior to the open basement of this range (Photo. 14), accessed by a modern staircase with double steel safety doors at the northern end, has been substantially rebuilt. Although modern plaster covers all surfaces, it would appear that all columns are modern steel or reinforced concrete replacements. These support joists of probably similar construction. The only notable feature within this lowest floor is a short tunnel through and beyond the western wall, originally arched with brick, but now closed by another steel safety door with an overhead steel valve (Photo. 15). The internal walls are plastered, with the end blocked by modern red brick.

Photo. 14 Basement of the north range, looking south-west.

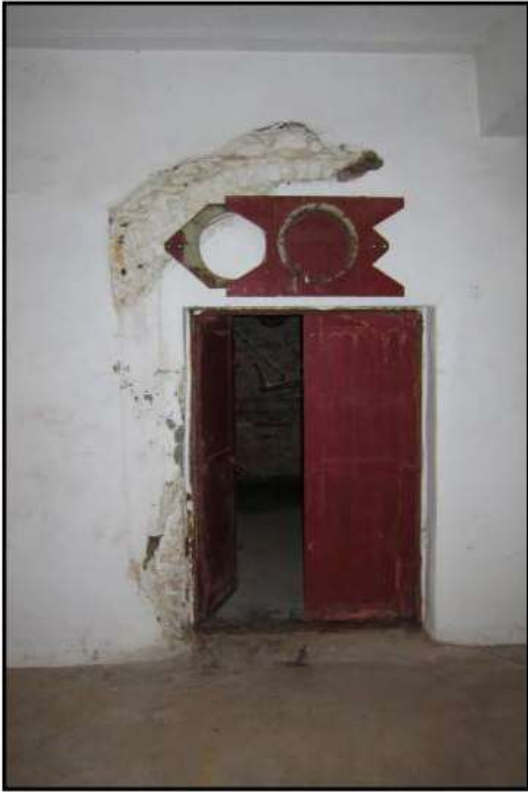
Photo. 15 Tunnel entrance in north-west corner of the north range basement.

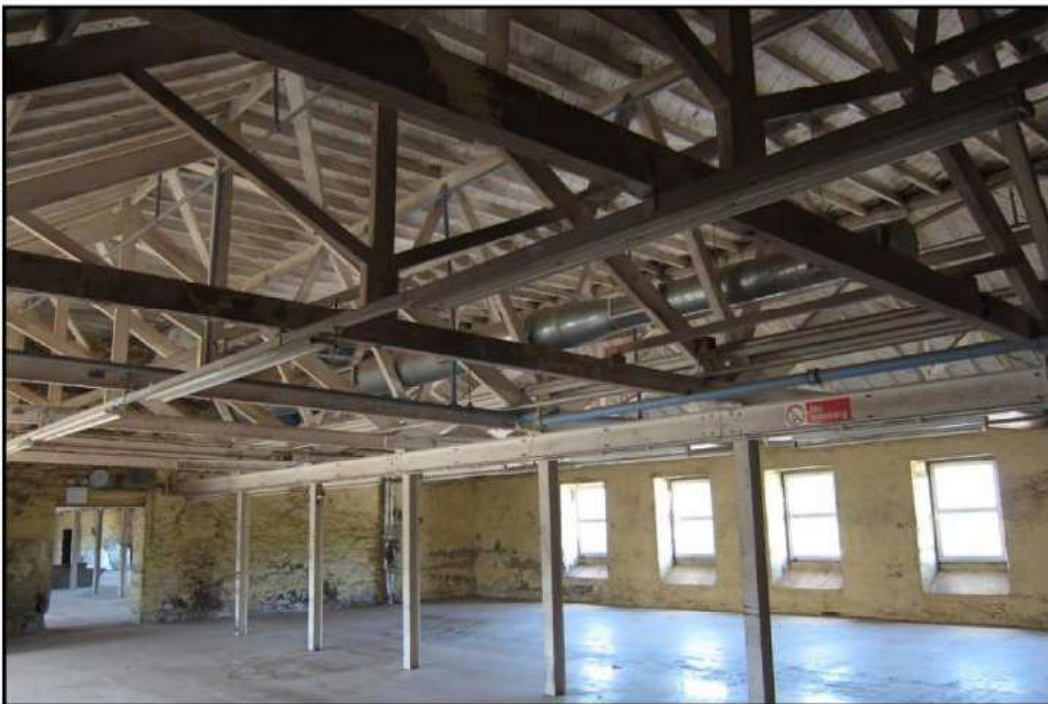
The roof (Photo. 16) is apparently identical in material and design to that in the north range. Again, the intervening valley has since been infilled with timber braces and the whole range covered with a new roof. All timbers, including the underside of the roof, are also whitewashed. The central beam has though been replaced by a steel girder, itself supported by steel columns.

Photo. 16 South range roof, looking north-east.

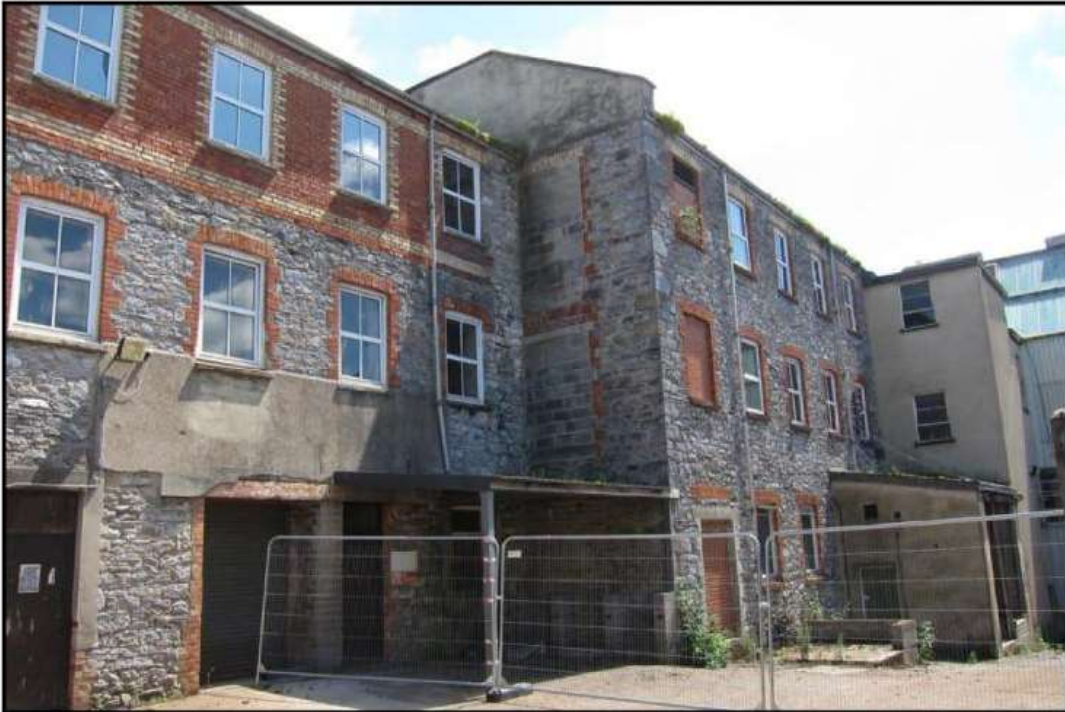
Photo. 17 Junction between the north and south ranges on the west side, showing the blocked entrances on the south range north elevation, looking SSE.

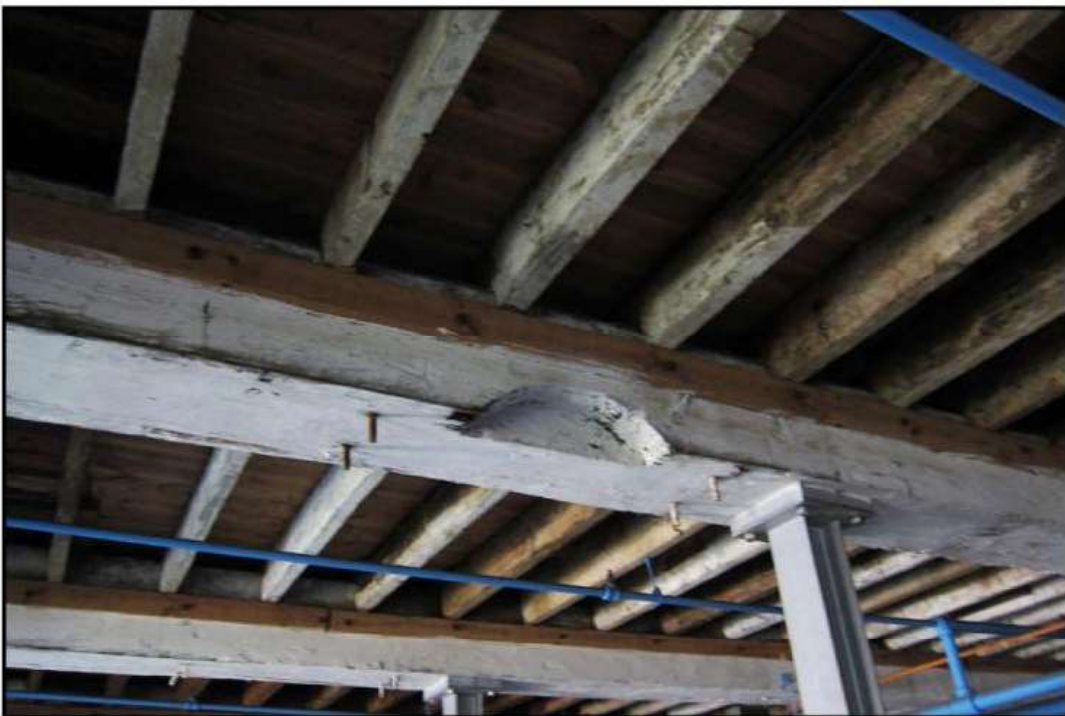
Although iron bolts survive in a number of locations, projecting from the base of main floor joists on different floors, no other power transmission features remain. An arched cut-out on the lower side of a bearer beam on the ground floor (Photo. 18), situated between a set of bolts, shows where a ?belt-wheel once hung close to the timber.

Photo. 18 The power transmission retaining bolts and cutout floor bearer in the basement of the south range, looking SSW.

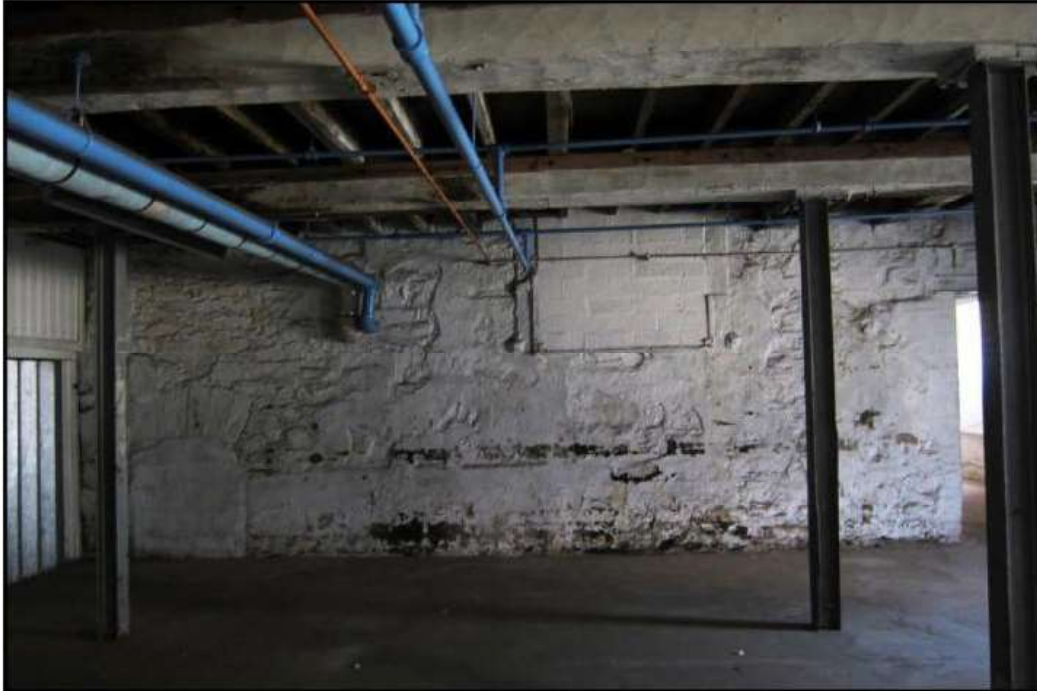
The only other feature of note is a small blocked aperture with a stone arch (Photo. 19), visible in the limestone north wall at basement floor level (originally the south elevation of the north range). This may represent a drive-shaft opening from an earlier water wheel known to have stood at this end of the north range.

Photo. 19 The north wall of the south range (formerly the south elevation of the north range), showing the blocked archway to the left, close to the modern lift, looking north.
