TOTNES CASTLE LANDSLIP 1999

ARCHAEOLOGICAL WATCHING BRIEF
AND RECORDING

by
Stewart Brown Associates

TOTNES CASTLE NORMAN MOTTE - LAND SLIPPAGE JANUARY-FEBRUARY 1999 – ARCHAEOLOGY- INTERIM REPORT

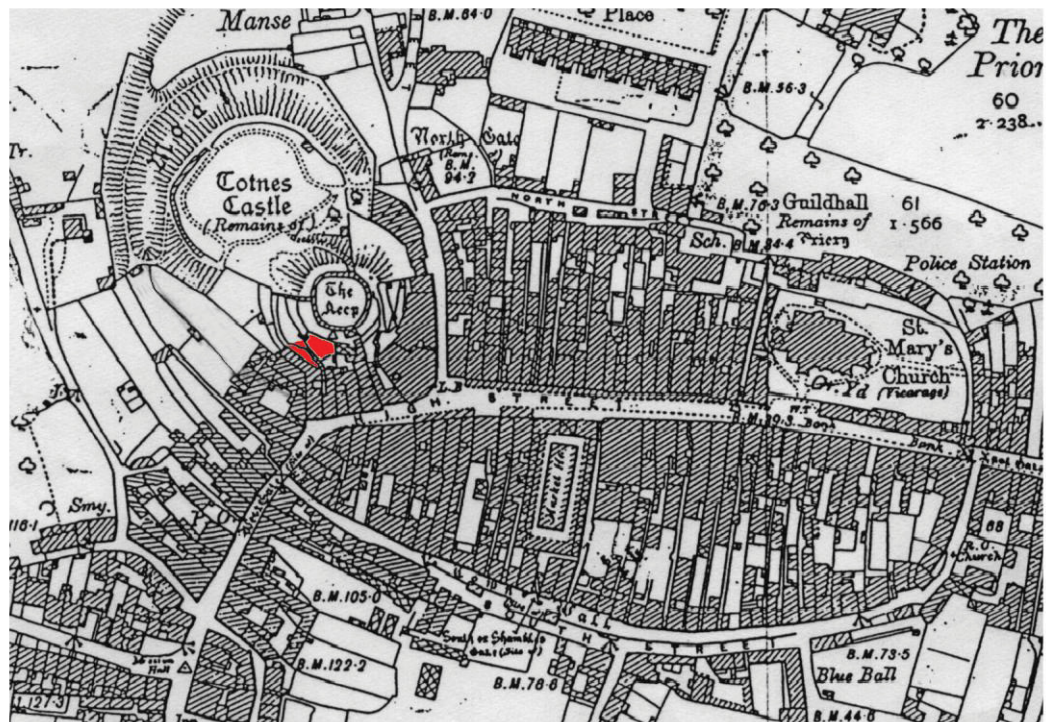
Fig 1 plans showing 1. location and 2. walls in area of collapse.

The area of slippage/collapse is shown in Fig. 1, together with 19th- and 20th-century walls removed for safety reasons, and earlier wall footings uncovered by the removal of topsoil and slump material. Fig. 3 shows a photographic aerial view of the castle made into a postcard sometime before 1936; the area of collapse has been indicated (thanks are due to James Bellchambers for this find). Fig. 4 shows an extract of a survey made of the castle in 1962, with additional coloured areas indicating plots acquired by the Ministry of Works from individual owners, and the dates of

A plan has been made of all the terrace walls in the area of the land slip, including the newly exposed footings of early walls which collapsed in the past (Fig. 1). A section (Fig. 2) has been compiled from the 1986 survey and a new survey made of the motte

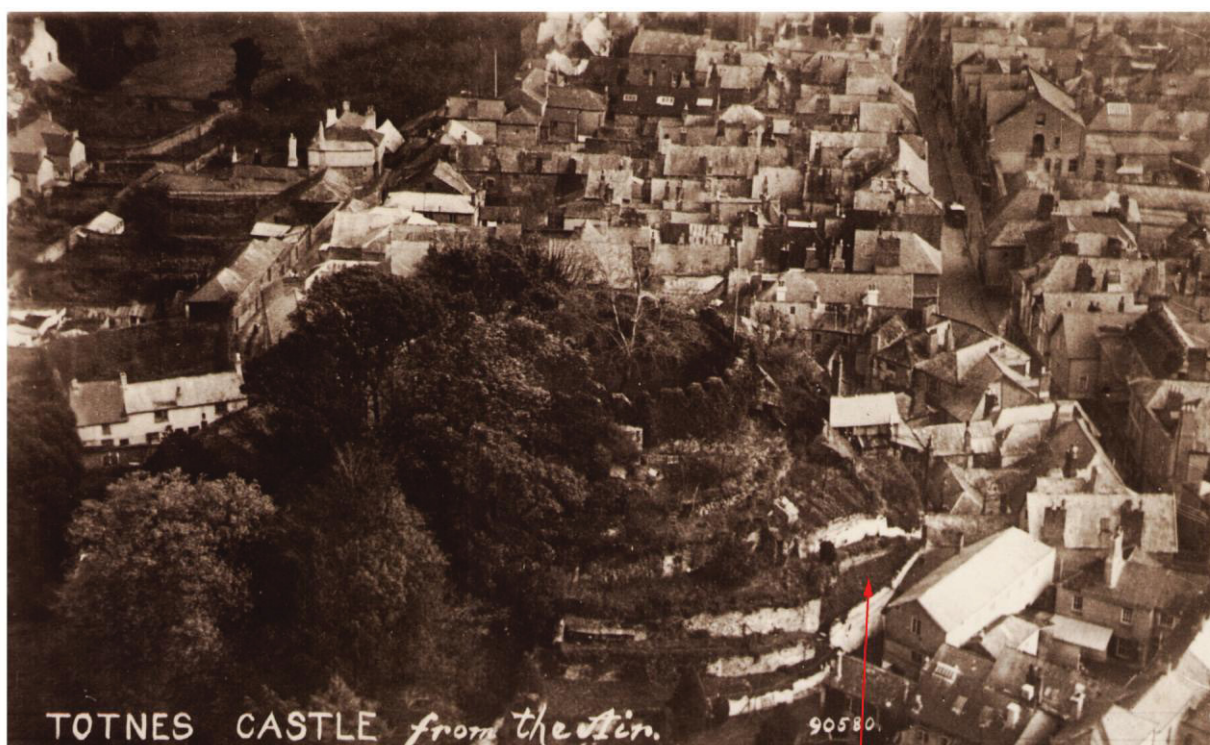
area of collapse

Fig 3 The castle from the air taken before 1936.

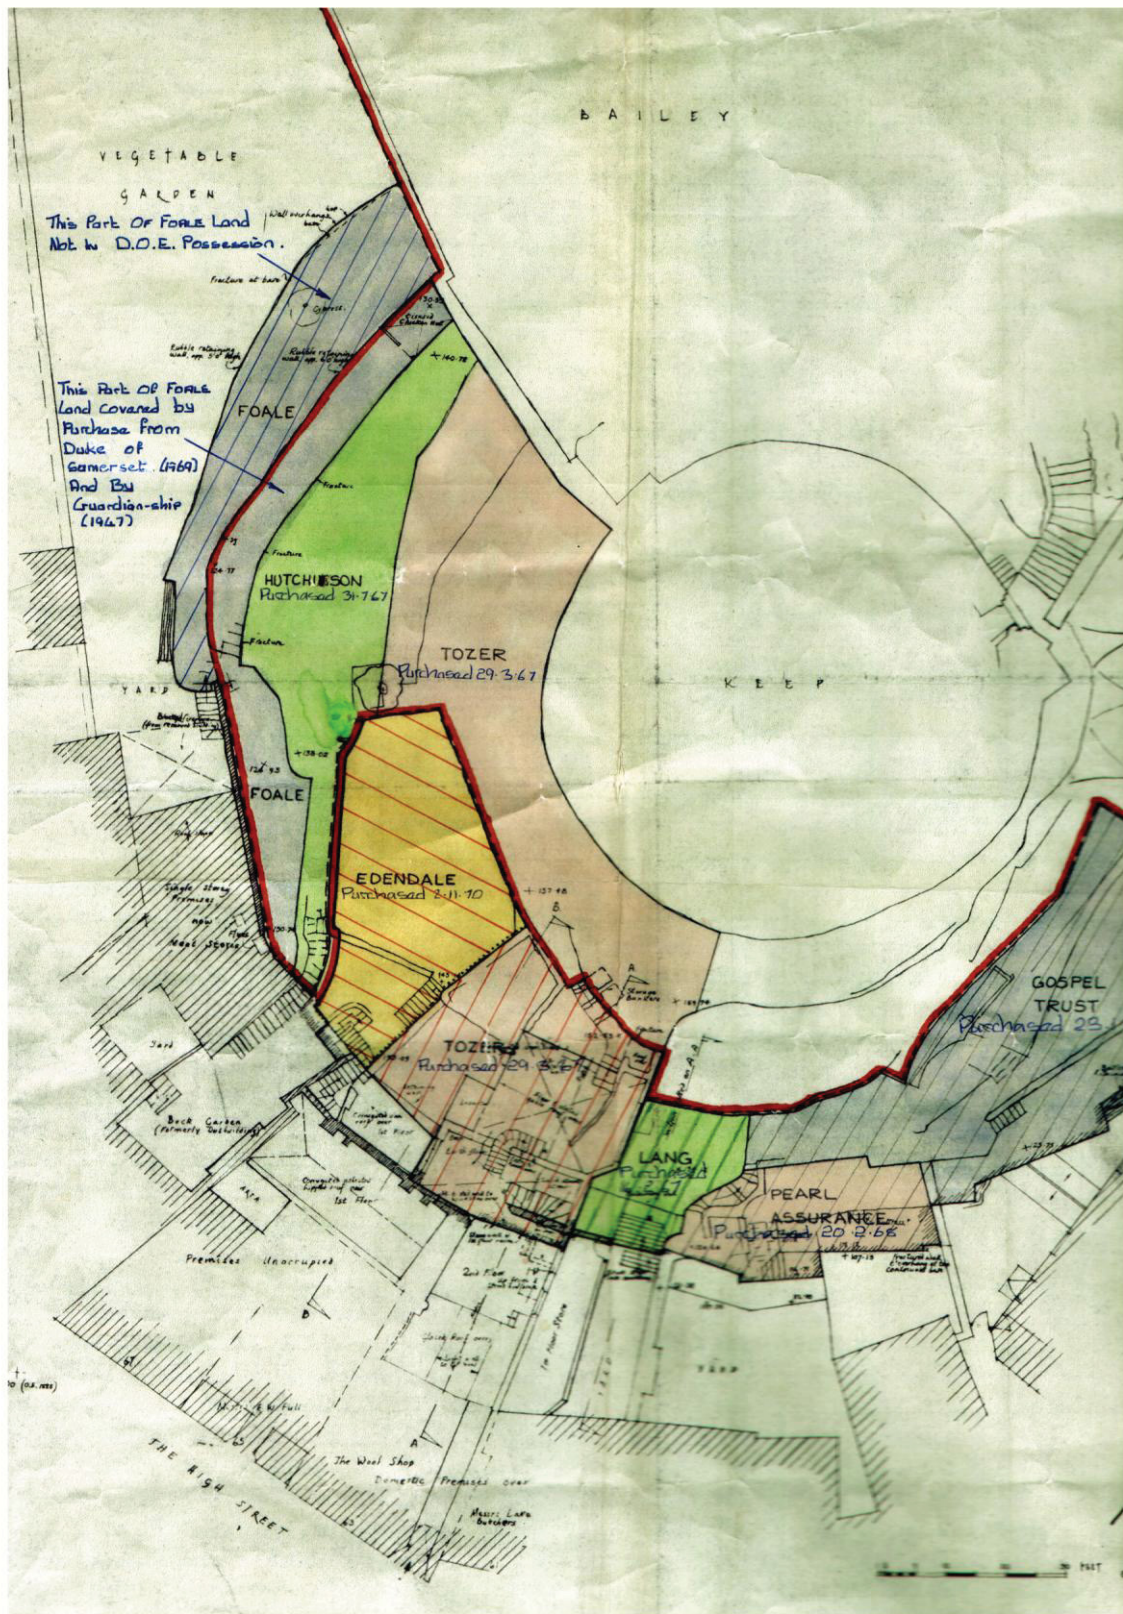
Fig 4 An extract of a survey of Totnes Castle from February 1962.

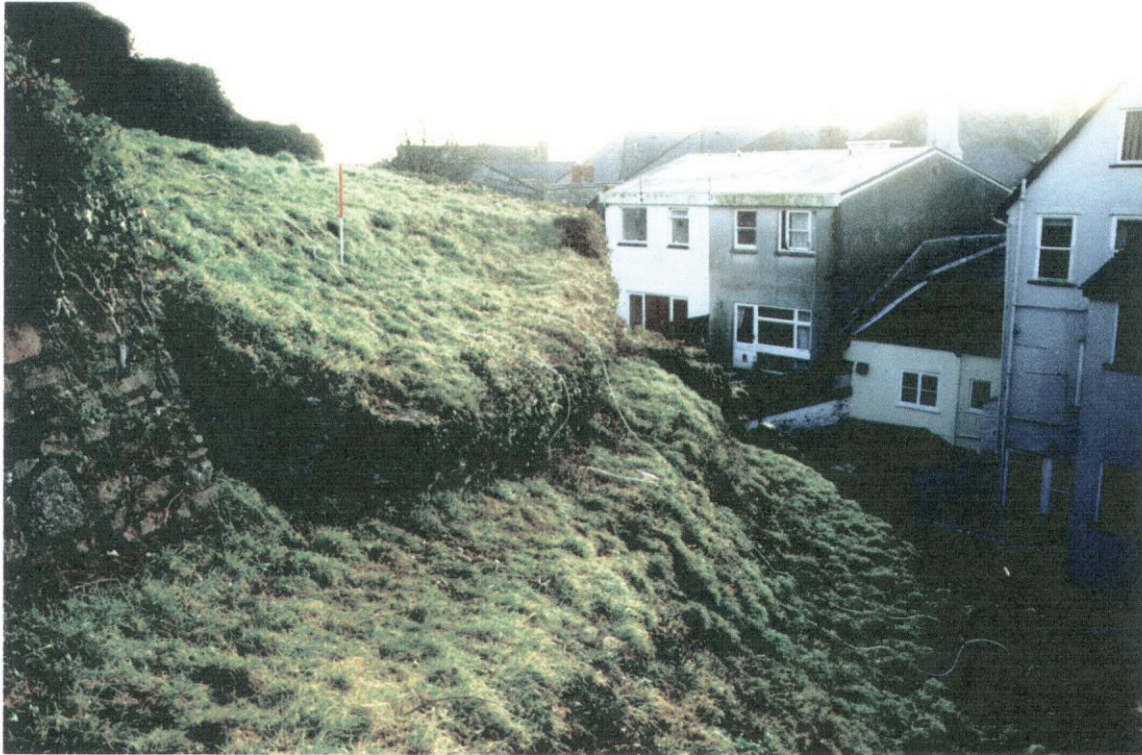
Plate 1 The site before excavation.

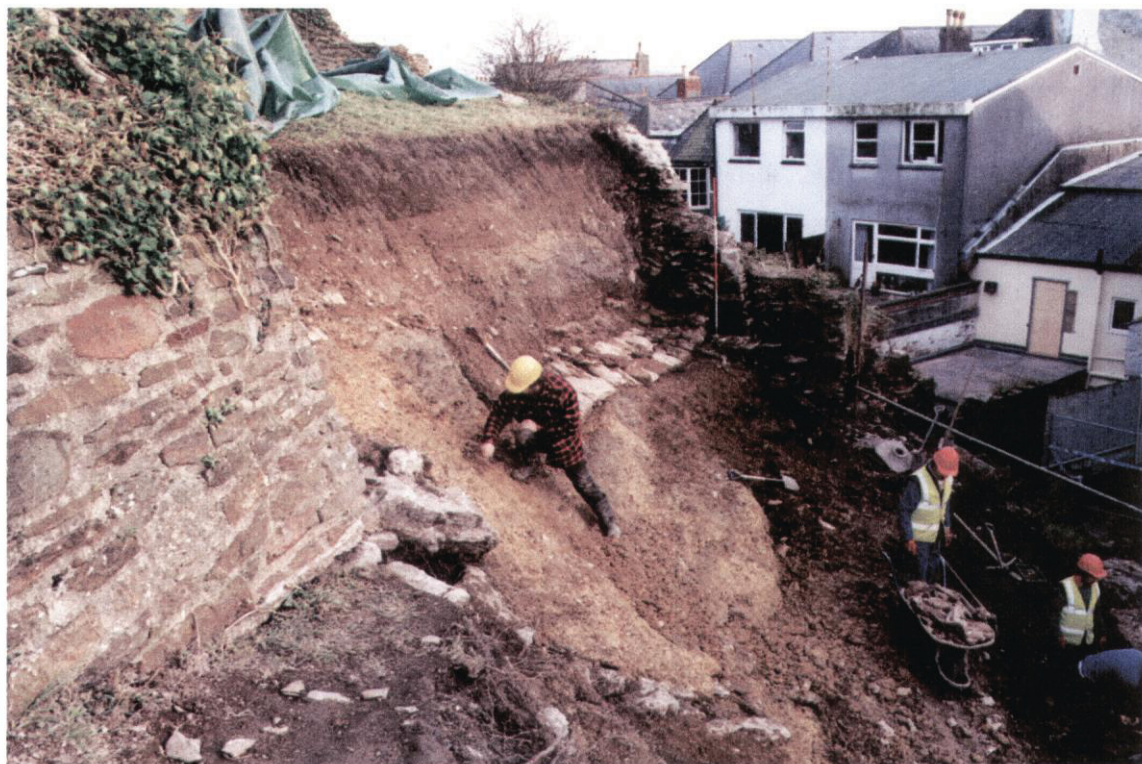
Plate 2 The site after the soil removal.

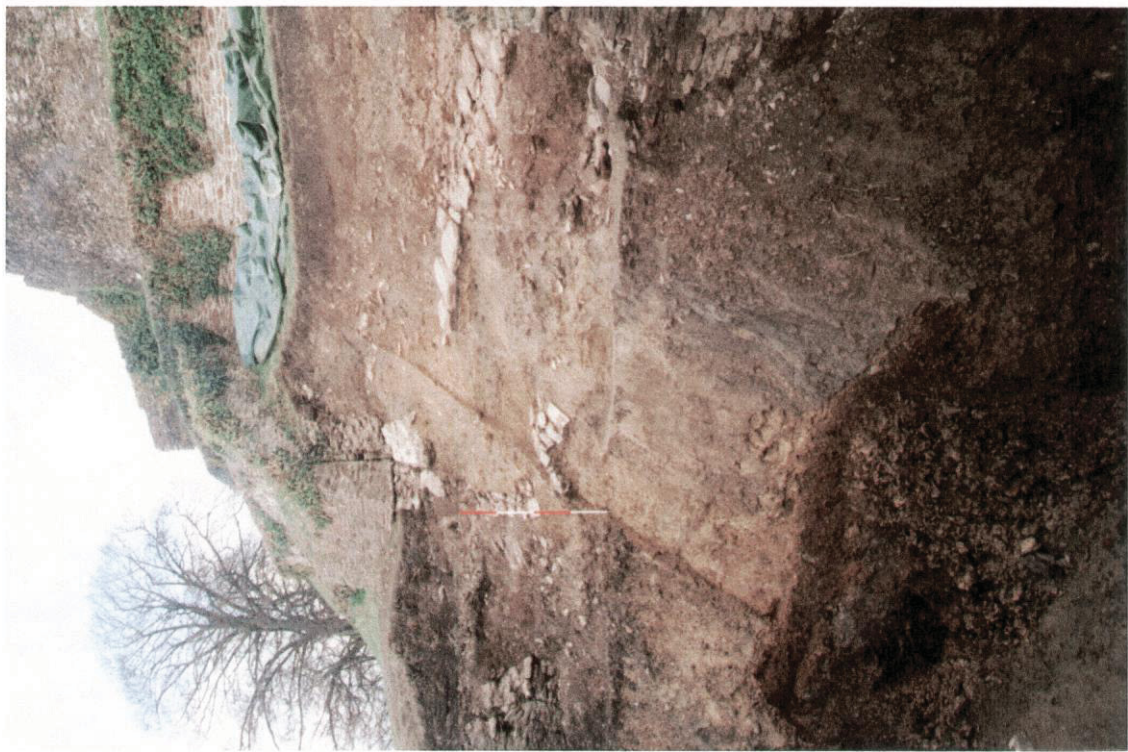
Plate 3 The site after clearance.

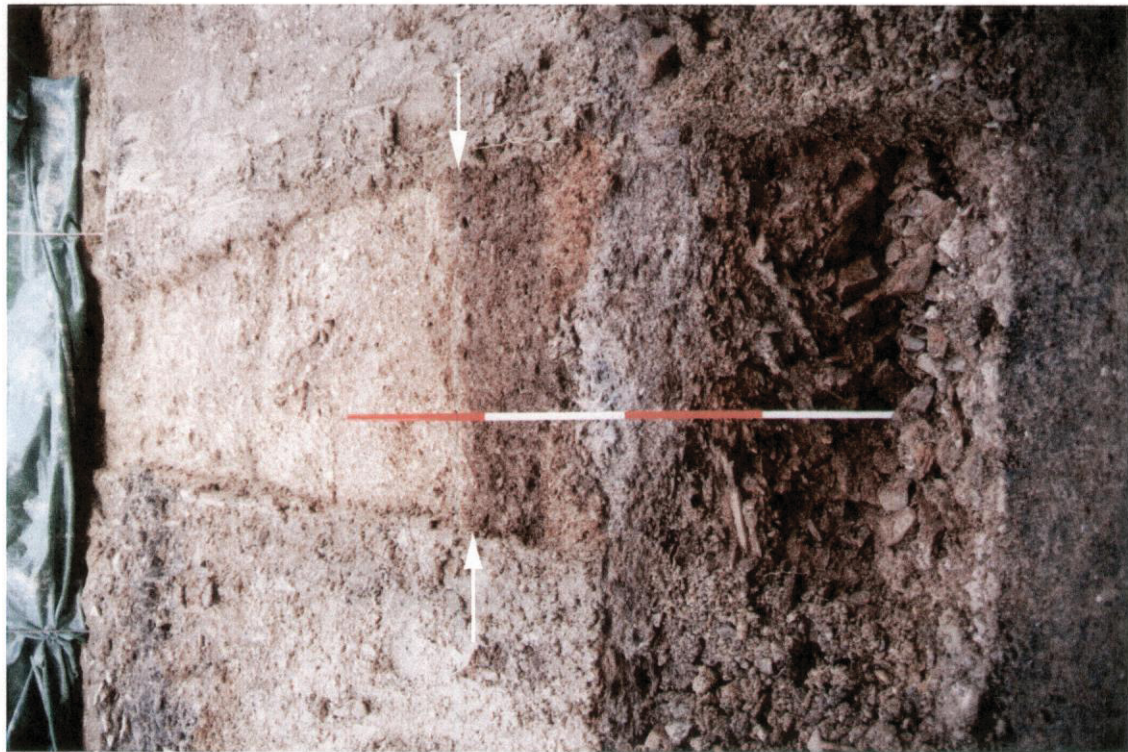
Plate 4 A section showing the level of the motte's construction (indicated by arrows).

Beneath the series of clay constructional deposits of the Norman motte lies a 0.35m deep layer of mid brown, aerated, stony clay (context 38). This contains numerous charcoal flecks and lumps, animal bone, and pottery sherds, clearly domestic refuse. Archaeological cleaning of its exposed section produced three more late Saxon/early Norman chert-tempered pottery sherds. The layer is stony throughout, but has a pronounced stony surface, presumably trampled prior to the construction of the motte. The layer overlies and infills at least one earlier (?Saxon/?Early Norman) archaeological feature, a square-bottomed trench-like feature 0.2m wide and 0.3m deep cut into the underlying natural clay (Plate 4). Whether the layer and feature are associated with the Saxon town of Totnes, or with the first occupation of the castle site, before the motte was erected, is an intriguing question. The layer also overlies a band of orange gravelly clay up to 0.2m deep which may possibly be an archaeological deposit (context 39), although it could be natural in origin. Beneath this is a stony layer with a purple colouration (context 40) directly overlying bedrock. The latter stony layer is probably natural in origin.
