TOTNES CASTLE MOTTE:
ARCHAEOLOGICAL WATCHING BRIEF
AND EVALUATION

TOTNES CASTLE MOTTE - ARCHAEOLOGICAL WATCHING BRIEF DURING THE CONSTRUCTION OF NEW RETAINING WALLS

By
Stewart Brown and Timothy Gent

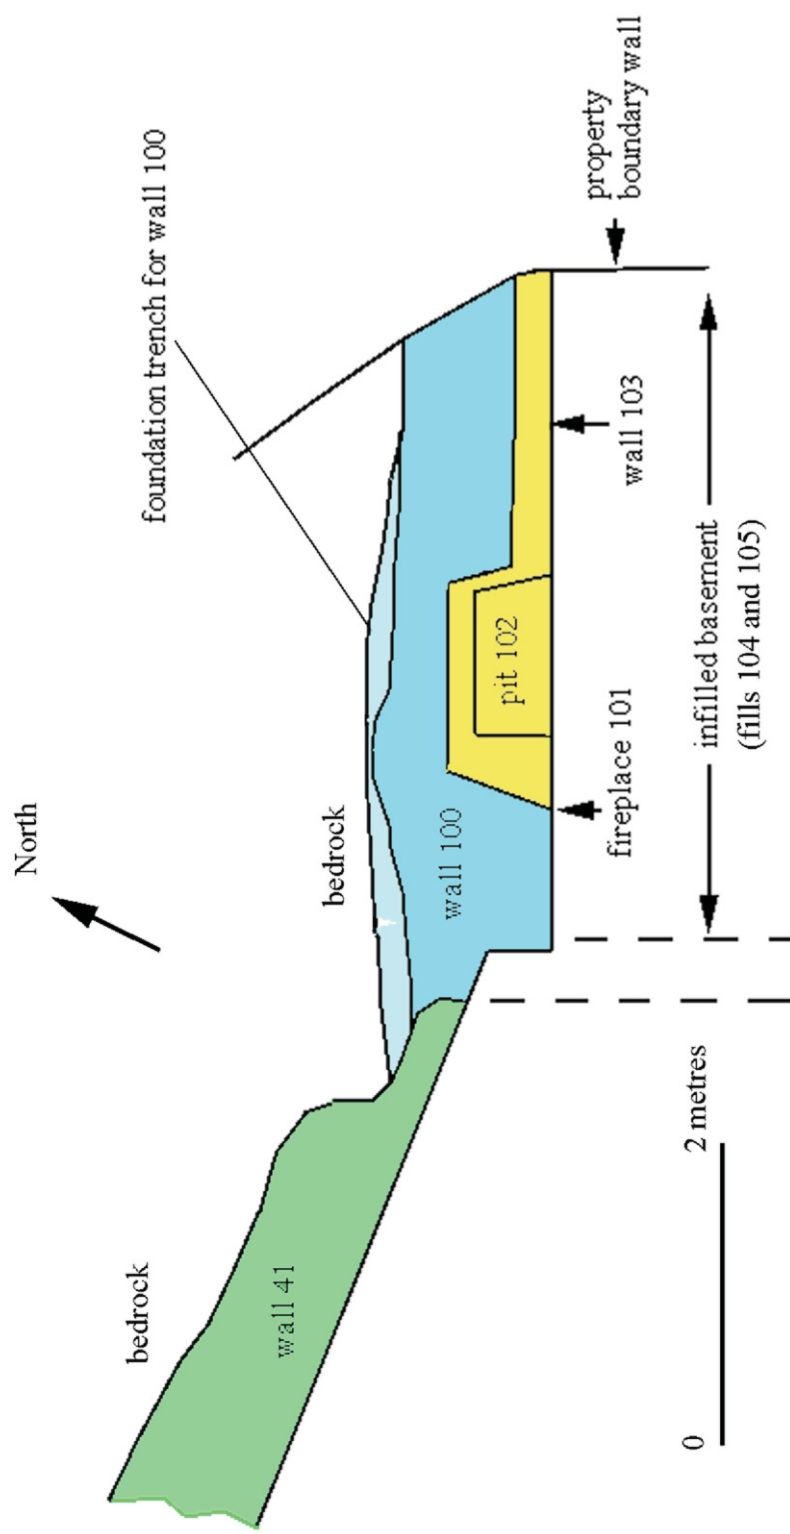
At the east end of wall 41 another, shorter length of revetment wall was exposed (wall 100: Fig. 2). This projected 0.4m to the south of wall 41 and followed a different alignment. Wall 100 was earlier than wall 41 (which abutted it), and had been built to the rear of the property adjoining on the east. Wall 100 in turn abutted the property boundary wall at its east end.

The rubble and clay footings for wall 100 were much deeper (1.5m deep) than those of wall 41, and included a splayed recess near its west end (101), probably a fireplace (an above-ground feature at this position is marked as 'flue' on the Survey for Boundary West, South, and East of keep job no. 619 drawing no 10, March 1963). Both the wall and recess were faced and plastered on their south sides to a depth of 1.5m below the present yard surface, showing that the back block was built with a sunken floor level, or possibly a basement. The recess was later narrowed by the insertion of a secondary stone and lime mortar lining with plaster render.

Fig. 2 Features associated with a back block and basement to the south and east of the lower retaining wall.

Excavations for the footings of the new lower wall removed mostly geological deposits comprising stony clays and bedrock. At the west end, however, the excavations also removed archaeological deposits comprising motte constructional materials together with some of the underlying Saxo-Norman soil. These latter deposits had slipped from their original position due to post-medieval slumping on the side of the motte. At the east end, the excavations uncovered one end of an infilled post-medieval basement (Fig. 2).

It seems clear that a back block with basement extended to the rear of the house on the easternmost property within the area covered by the present works. The property wall standing to the east of the infilled basement is certainly the oldest of the standing walls in the area (it is abutted by wall 100). It incorporates the remains of a window and shows at least one phase of rebuilding. The wall rises onto the lower slope of the motte and must have bounded a property that took in land on the motte, probably as soon as it became available in the late 16th or early 17th century (Brown and Matthews, 1999b). Wall 100 probably dates from soon after this time. It abuts the standing property wall and contains a fireplace, showing that it formed the back wall of a roofed structure. The infilled basement is contemporary with wall 100 since the wall is faced and plastered to its full depth.

There can be little doubt that a structure in this position represents a back block of a house fronting the High Street to the south. It was built over the infilled castle moat or ditch, and took advantage of the soft ground by including a basement. The basement was heated by fireplace 101.

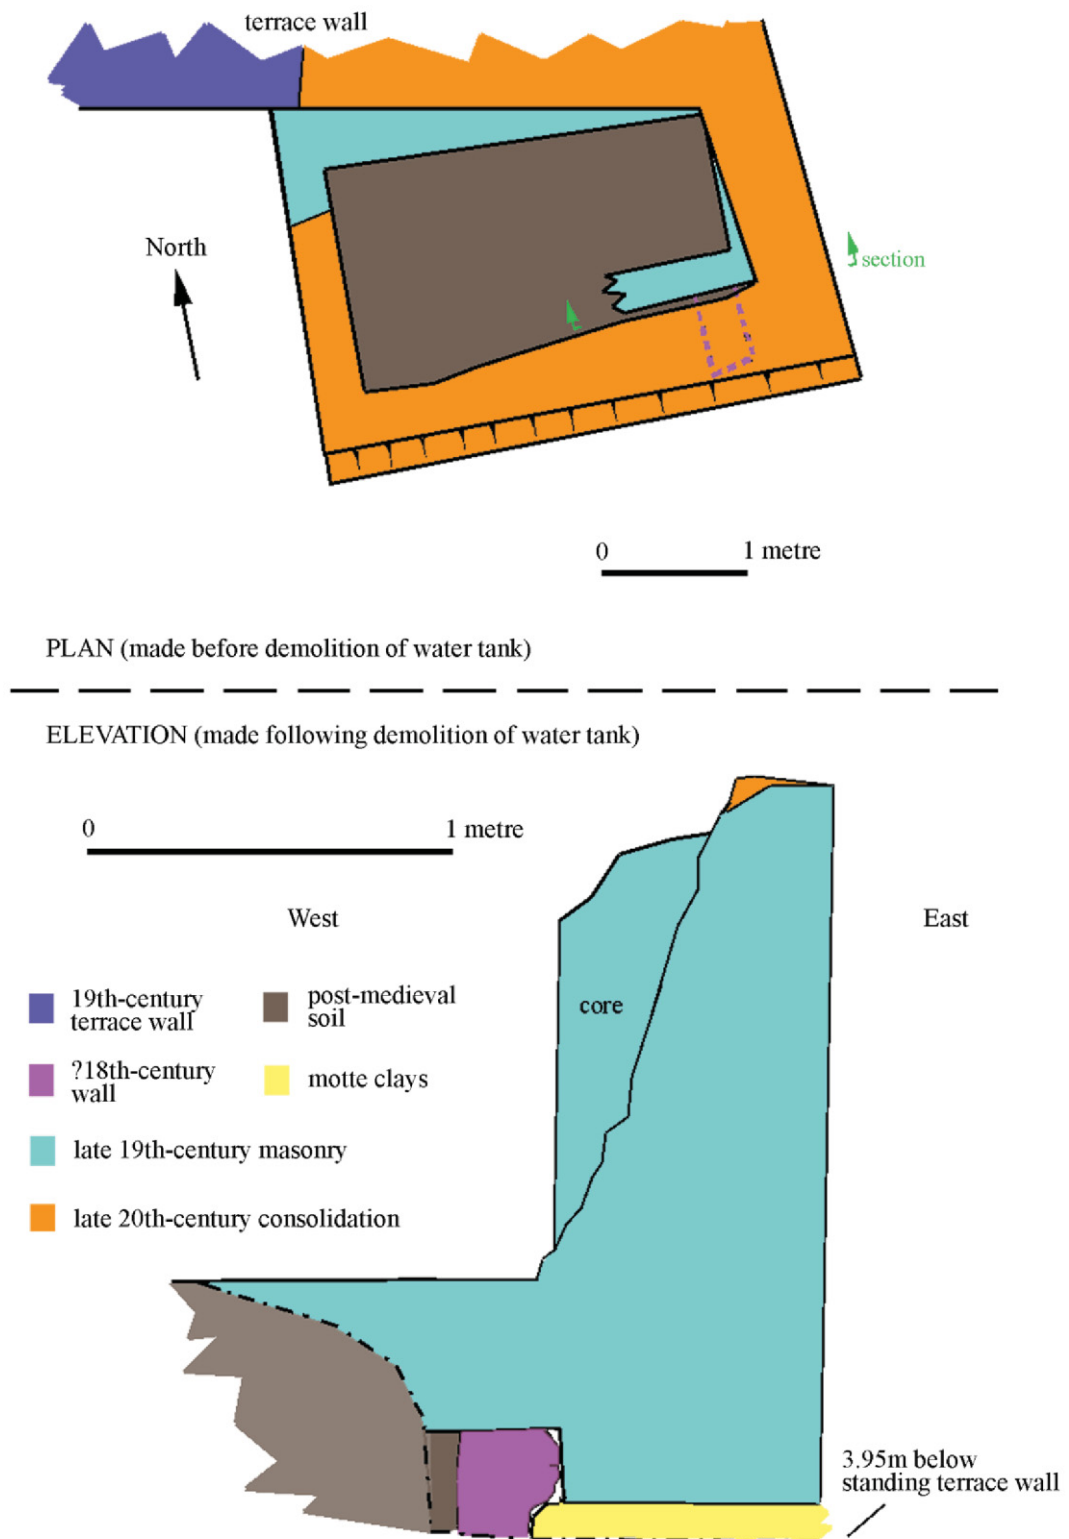
A small rectangular stone structure (200) up to 3.5m long by 2.5m wide that stood immediately to the west of the slippage area proved too unstable to conserve without considerable additional engineering works and expenditure. Following detailed archaeological inspection, it was decided that the structure was a water tank dating originally from the late 19th century (similar water tanks survive on the north side of the motte), and that the tank had undergone extensive consolidation and rebuilding within the last 30 years. An archaeological record was made of the tank before its partial demolition, and further measurements and observations concerning its structure added both during and after.

The original water tank was built of stone rubble bonded with lime mortar, and had internal dimensions 2.5m by 1m. Lime plaster adhered to the inside of its east and south walls. Its south-west corner had collapsed or been dismantled. An area of loose rubble at its north-east corner may possibly have represented infilling of an original small opening. The west wall of structure abutted the earlier terrace wall to the rear (north). The latter wall contains industrial brick and ceramic drain pipe, so must date from the second half of the 19th century. The original water tank therefore must date from this period or later.

Once the modern, outer skin of masonry had been dismantled it was possible to record an exterior elevation of the original tank's south wall (Fig. 3, Elevation looking north). This wall had been built directly on yellow clay forming part of the Norman motte core, but also overlay some remains of a wall footing that was probably associated with earlier terracing.

Fig. 3 Plan and elevation of the water tank to the west of the middle wall

Late 19th-century stone water tank (Fig. 3; Plate 4)

The water tank remains were enclosed within a secondary stone rubble wall bonded with modern cement mortar dating probably from 1970's conservation work. The infilling of the tank produced mid or late 20th-century finds including electric batteries and steel wire mesh. A meerscham pipe bowl in the form of an African head was also recovered.

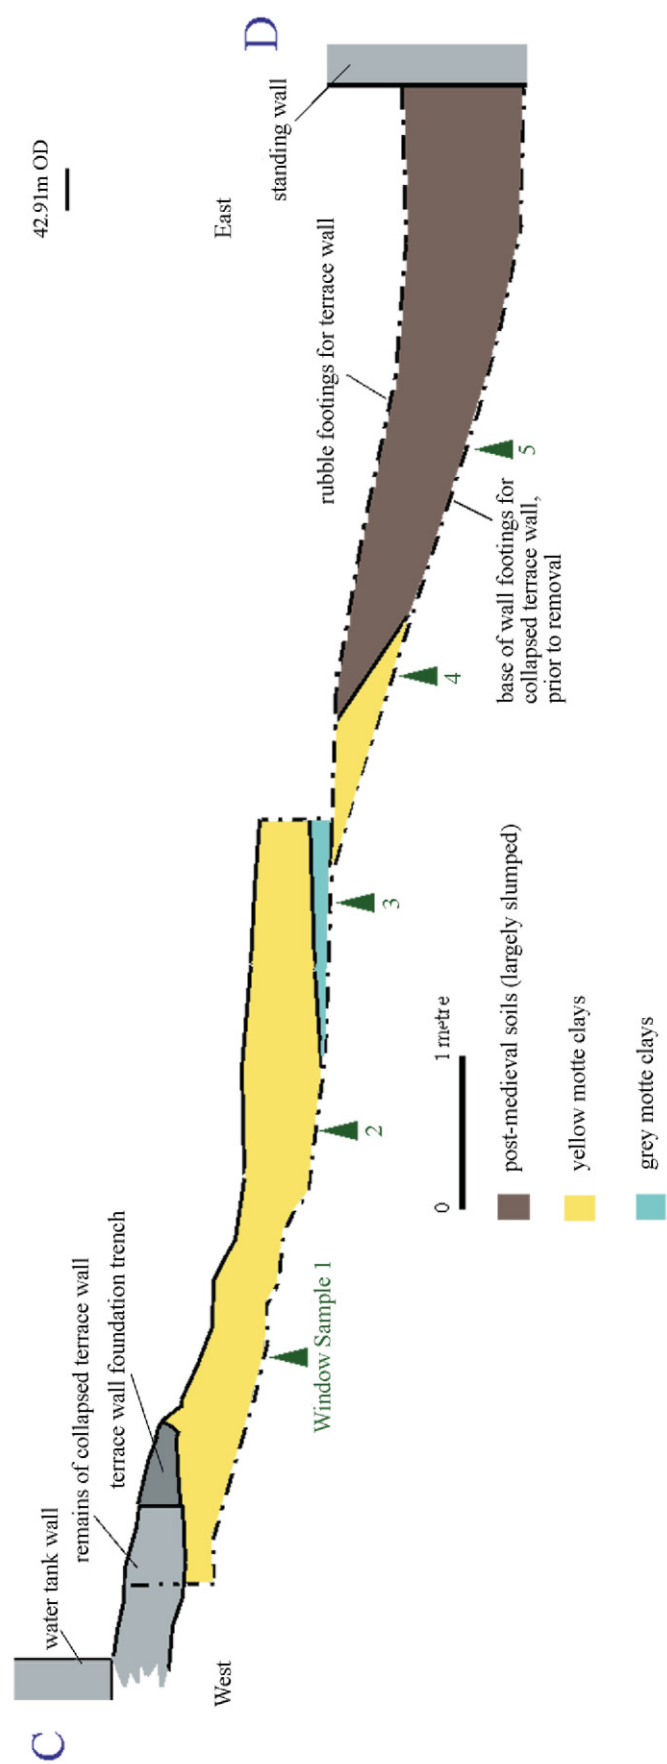
A narrow terrace was excavated across the slope to provide a suitable foundation base for the new retaining wall, and for preparatory works associated with piling. This entailed removing the remains of a post-medieval terrace wall that once stood in this position, but which had collapsed (Brown and Matthews 1999a, Fig. 1 wall 7). The wall's stone rubble and earth footings were 0.75m deep at the east end, becoming more shallow to the west, showing that the wall had been erected on a considerable slope.

The rear section of the modern terrace revealed post-medieval soils overlying Norman motte materials, the latter comprising two horizontal layers of yellow stony clay separated by a narrow band of grey clay (Fig. 5).

Fig. 5 Rear section of trench cut for middle wall.

Foundation trench for the new retaining wall (Fig. 5)

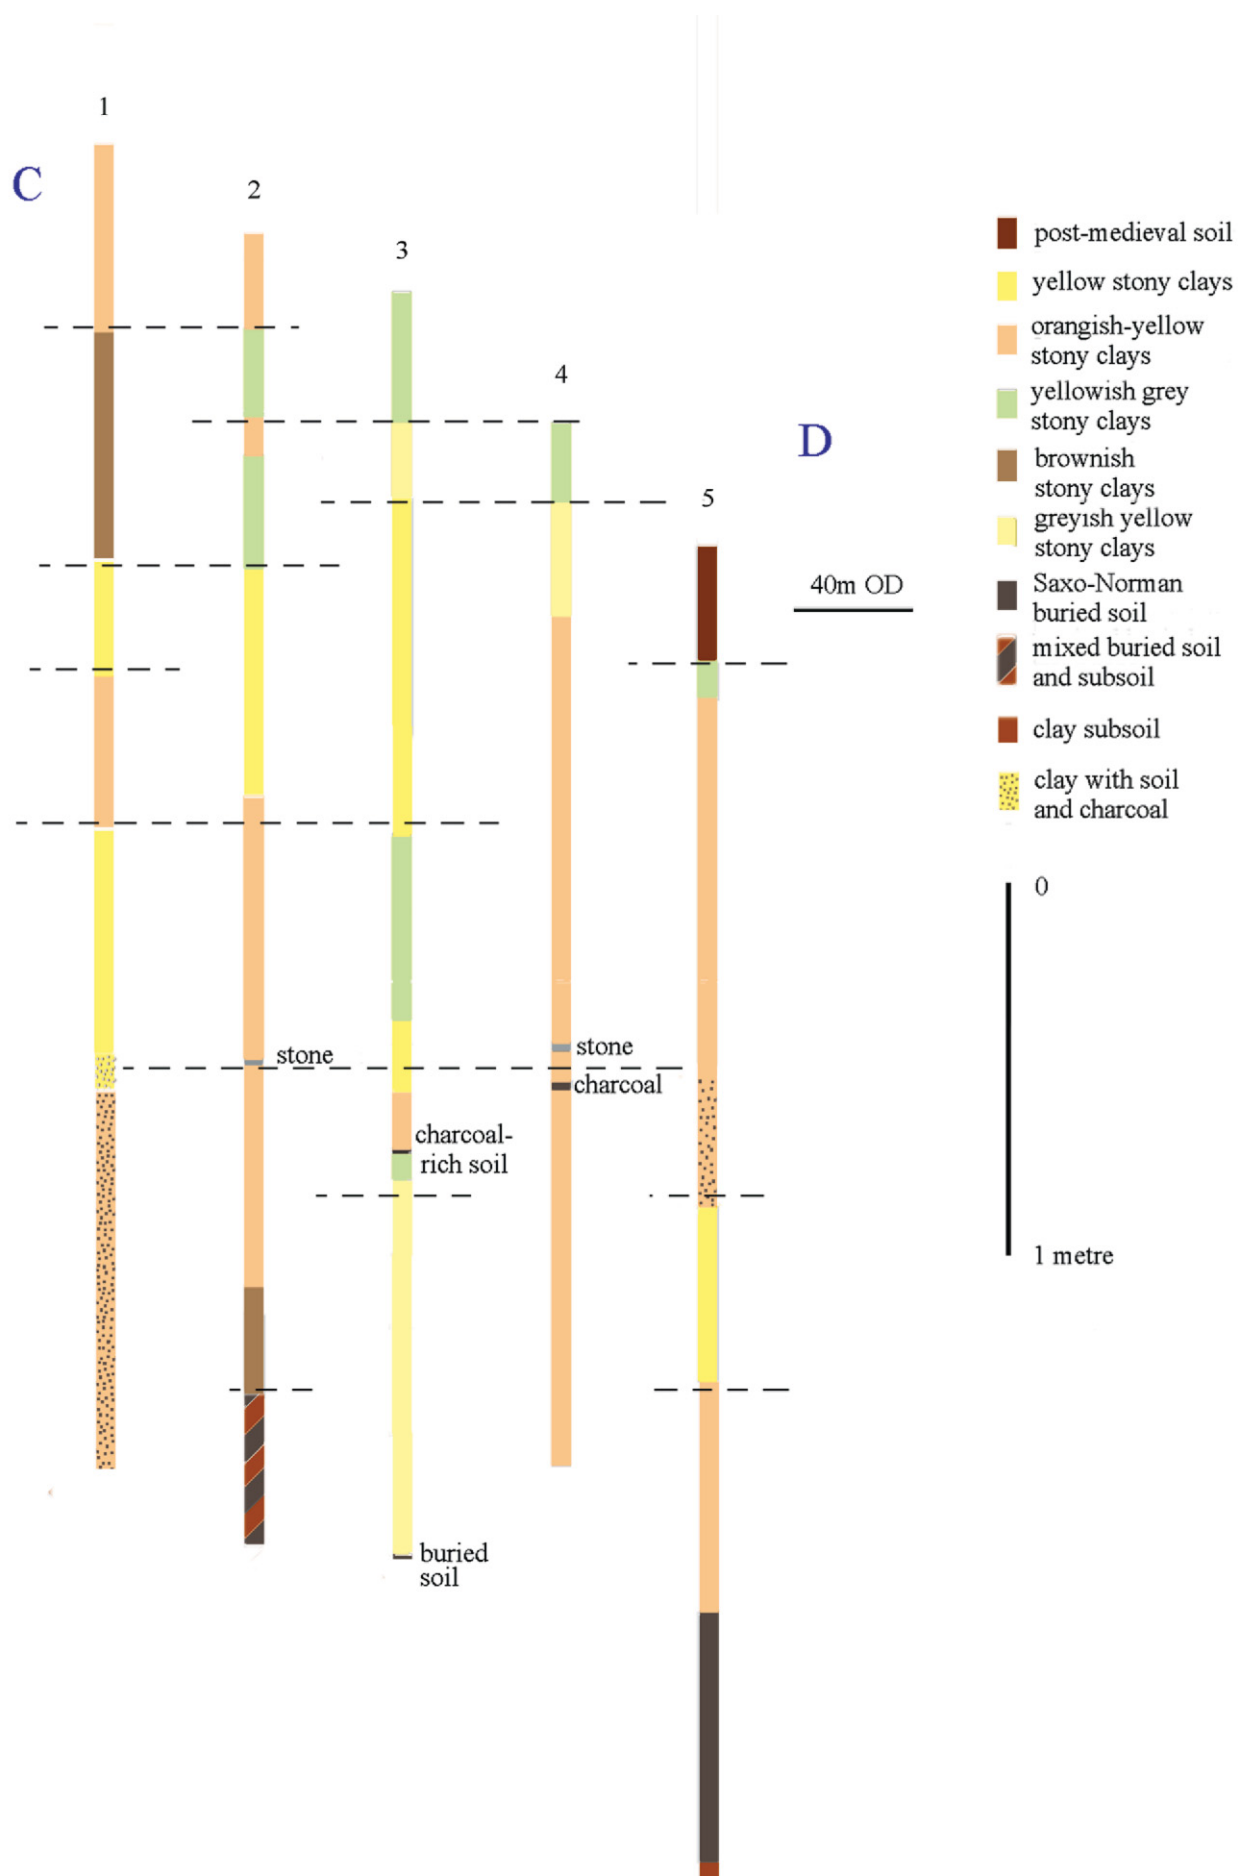
Five pile positions were cored using a percussion system to recover sealed samples. Window sampling was not undertaken at the extreme ends of the modern terrace owing to difficulties in setting up the equipment. Fig. 6 illustrates the five sample cores as vertical columns of varying materials (detailed results of the window sampling are given in Appendix 1). The columns are arranged on the page so that each is positioned correctly in relation to a level of 40m OD (for comparison, however, the columns have been spaced closer together than the sample sites were on the ground).

Results were obtained to depths of between 3m and 4m below ground level. Samples 3 and 5 extended to sufficient depths to include the Saxo-Norman buried soil beneath the Norman motte. Sample 5 included 0.65m depth of the Saxo-Norman soil. At the bottom

All the samples included Norman motte material. This comprised stony clays and claysilts that almost certainly derive from the local clay subsoil and underlying geology. Most deposits were yellow or orangish yellow and contained varying proportions of crushed shale. A number of layers within the Norman motte produced soil and charcoal fragments, notably at the base of sample 1, and midway down sample 5. Sample 5 also produced two very small sherds of chert-tempered coarseware cooking pot that had been buried with the Norman motte stony clay material 2.8m below the surface. Sample 3 included a pocket of charcoal-rich soil from a depth of 3.1m. Sample 4 included a thin layer containing an even greater proportion of charcoal from a depth of 2m.

Some boundary horizons between layers were clear, but others were difficult to discern, especially between two almost identical yellow stony clay deposits. Some horizons can be traced across two or more of the core columns (shown in Fig. 6 by dashed lines), suggesting that some layers within the motte's core extend horizontally for some distance, even if the clay and stone construction materials at corresponding levels vary to some degree. The results however do not show uniform horizontal levels throughout, so the deposits comprising motte's core cannot be stratified in an even and consistent manner.

Fig. 6 Window samples on the line of the middle wall

Window Samples (Fig. 1, transect C-D; Fig. 6)

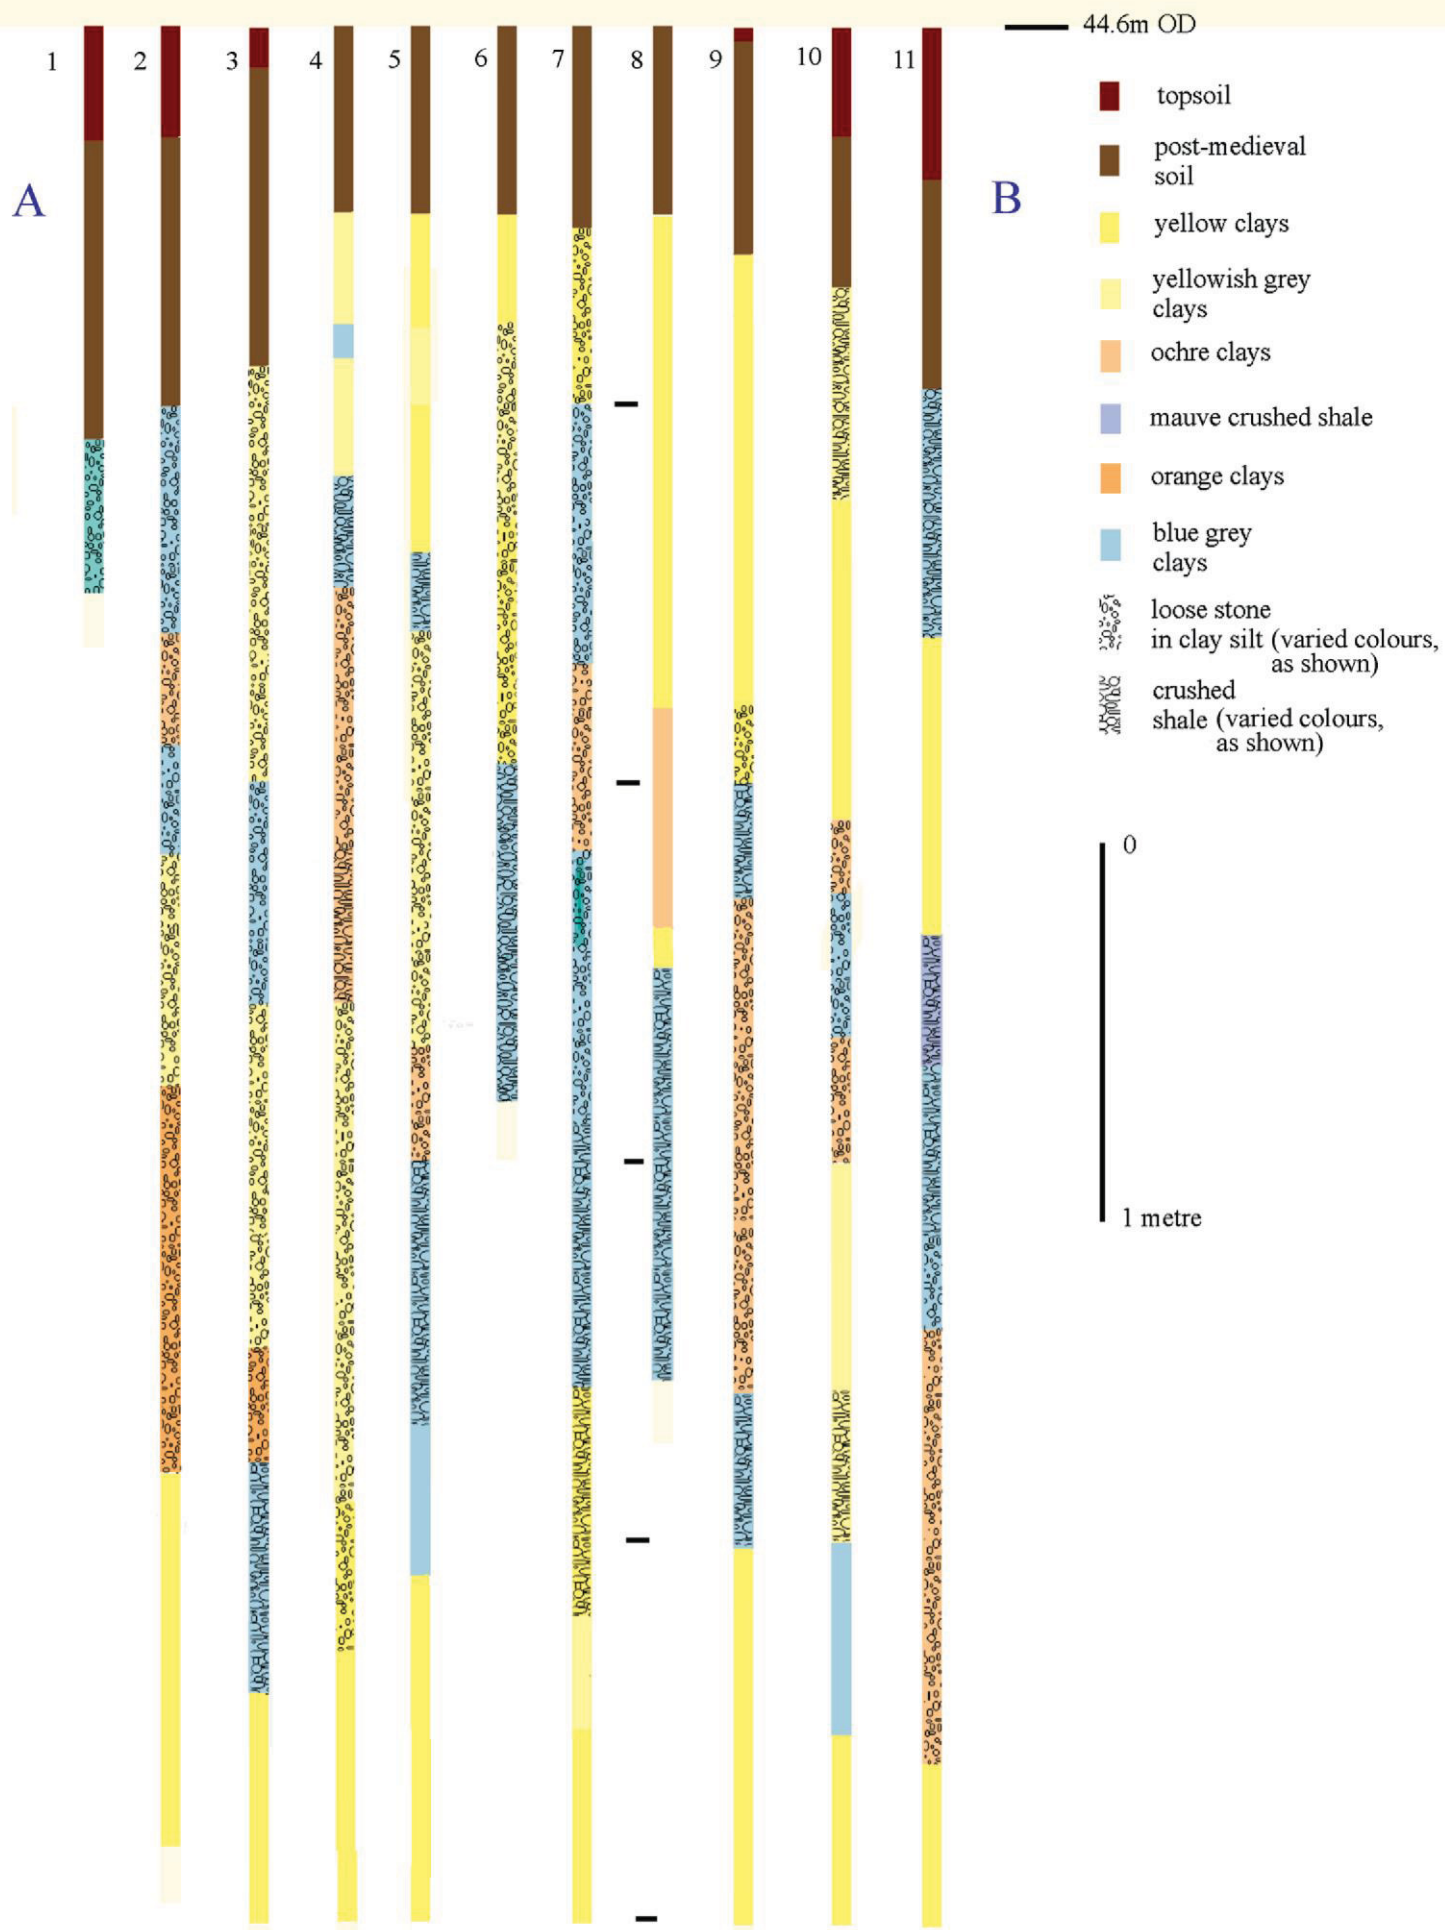
Eleven pile positions were cored to recover sealed samples. Fig. 7 illustrates the sample cores as vertical columns that have been arranged so that each is positioned correctly in relation to a level of 44.6m OD (as in Fig. 6, the columns are spaced closer together than the sample sites were on the ground).

Eight of the cores were approximately 5m deep. Core samples 1, 6, and 8 were terminated at shallower depths due to obstructions met by the sampling system.

The uppermost portions of all the samples comprised modern topsoil and post-medieval garden soils. Beneath these, the Norman motte core material again proved to comprise largely yellow or orange/yellow silty clays and clay silts, with varying proportions of shale fragments. These samples were however more friable than those taken on the line of the middle wall, and contained a much higher proportion of shale. Indeed, many layers consisted of clean broken shale stone and little else. Sample core 4 contained occasional charcoal flecks from a deposit directly below the post-medieval soils, but otherwise, inclusions of soil and charcoal were negligible.

Fig. 7 Window samples on the line of the upper retaining wall.

Window Samples (Fig. 1, transect A-B; Fig. 7)

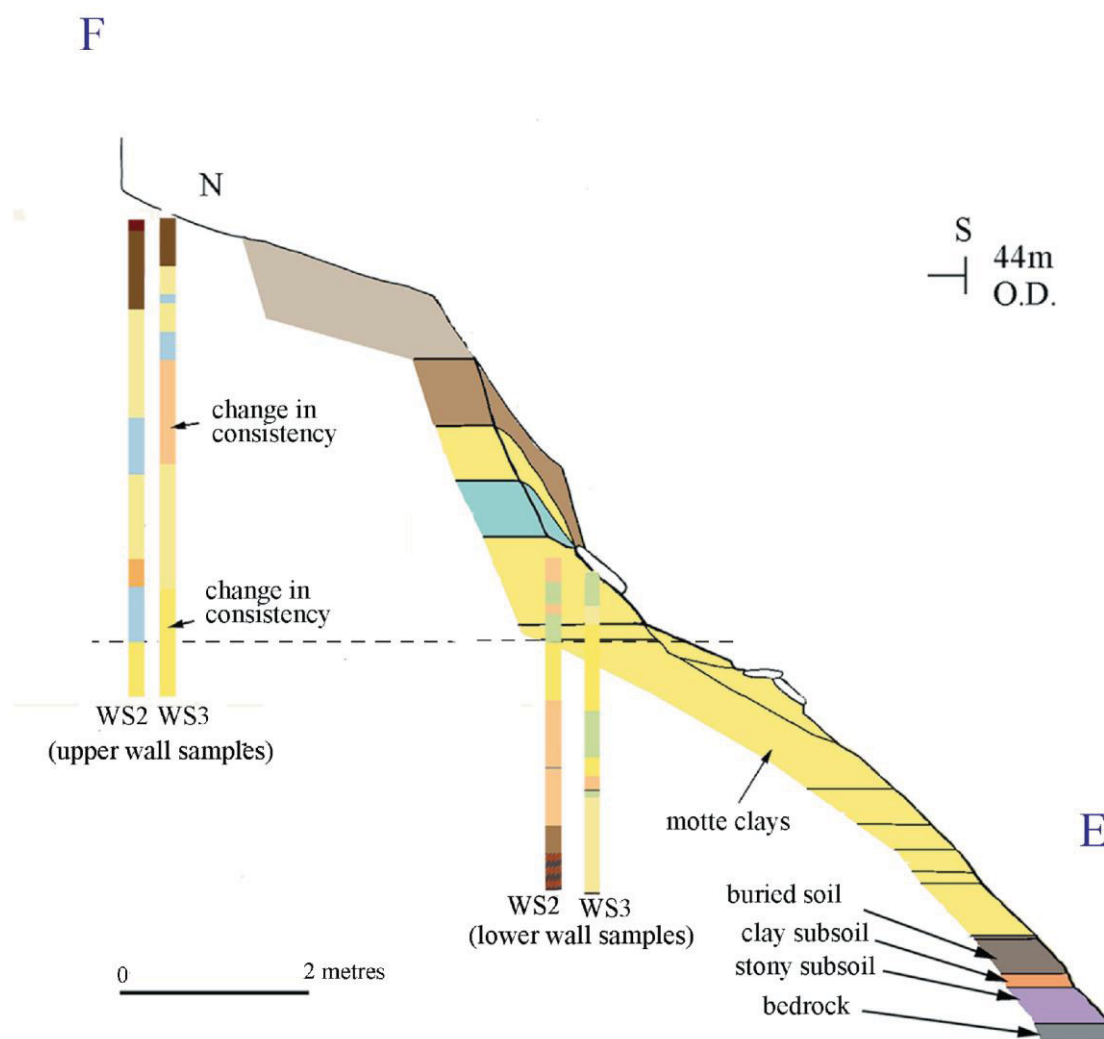
In summary, it would be a reasonable assessment of the window sampling method to say that it proved useful to locate major changes in the archaeological deposits, and to confirm the varied nature and generally layered composition of the motte interior. But it was not sufficiently accurate to establish whether or not the interior is truly banded throughout, nor whether any of the broad stratigraphic horizons identified on the exterior extend very far into the motte interior (Fig. 8).

Fig. 8 Upper wall window samples 2 and 3 and middle wall window samples 2 and 3 superimposed on the profile through the landslip area produced in 1999 (Brown and Matthews 1999b, Fig 2).

Previous archaeological work exposed the Saxo-Norman buried soil at three positions beneath the Norman motte (Brown and Matthews 1999b, Fig. 2; Brown and Gent 1999, 3-4). This work suggested that the surface of the buried soil was generally level. Window samples taken in the year 2000 on the line of the middle retaining wall again encountered the soil at the base of samples WS3 and WS5. By comparing levels, it now appears that the surface of the buried soil rises at an angle of 3.5° between these latter two points, and at a shallower angle of 2.5° between points E and B shown in Fig. 1. The depth of buried soil also varies between points E and B, measuring 0.4m deep at test pit ATP, 0.65m deep at WS5, and 0.5m deep at deep borehole DEB2. In addition, the surface of the underlying geology rises between WW5 and DEB2, but can be shown to remain level over the 5m distance between pit ATP and WS5.

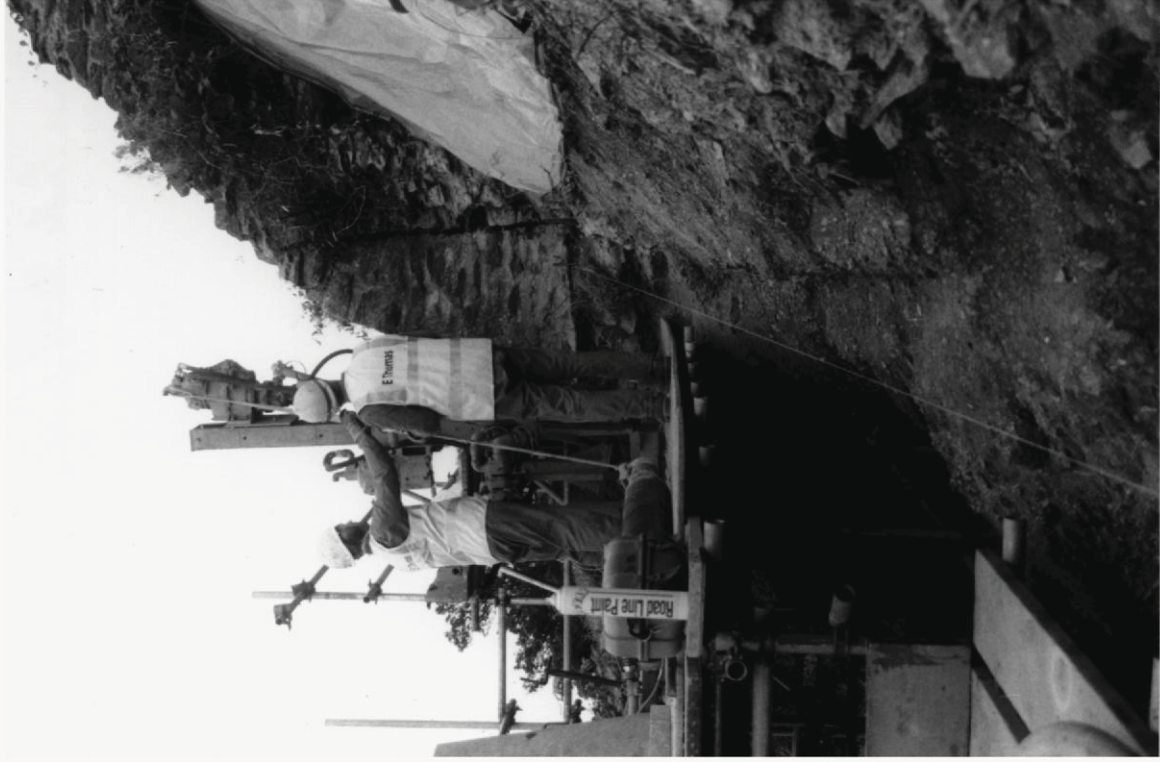
The installation of Odex piles is a destructive process that produces no core samples. In mitigation for the damage caused to archaeological deposits, Odex pile-driving was preceded by a percussive sampling method (Window Sampling) that did produce cores, the cores providing a series of individual sample profiles through the deposits making up the motte (Plate 1).

Plate 1. Window sampling on line of middle wall.

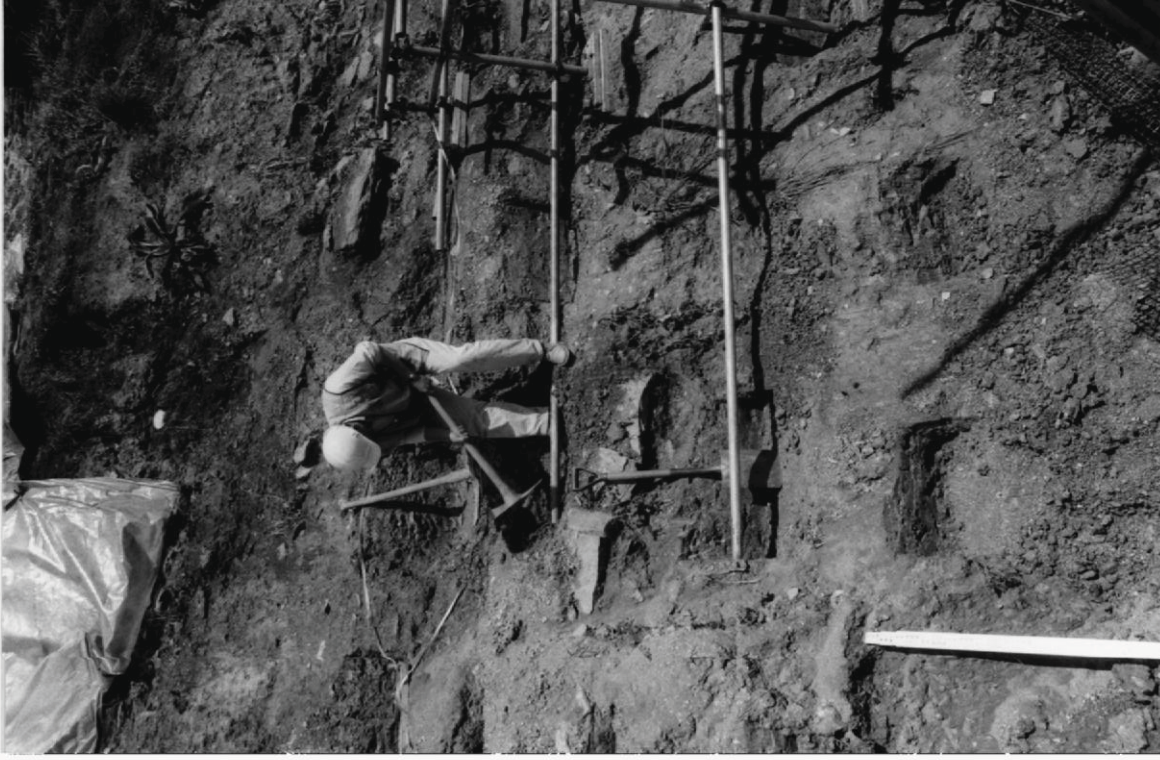
Plate 2. Pits for scaffolding feet being excavated.

The majority of the platforms for scaffold feet were excavated and recorded archaeologically (Fig. 3; Plate 2). A small number between the middle and upper walls were so shallow that only modern topsoil was disturbed. These were excavated by the contractors under archaeological supervision. In total, 35 platforms were excavated and recorded, 34 below the middle wall, and one above.

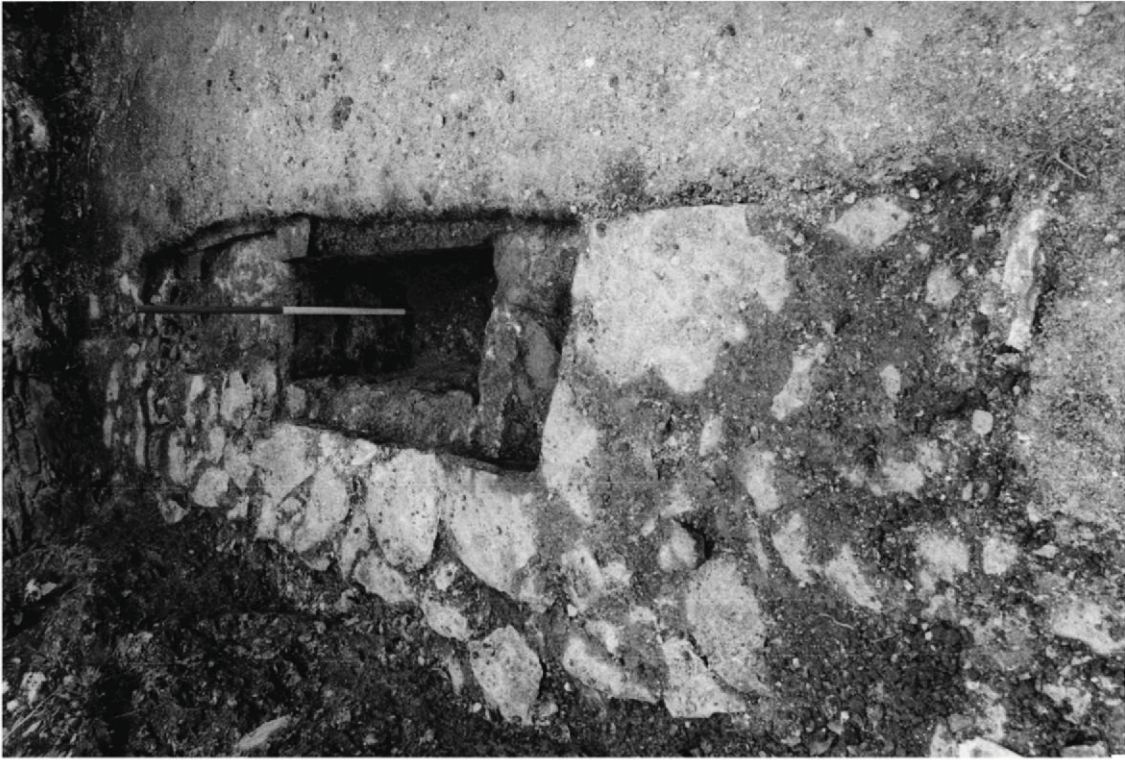
Plate 3. Fireplace of 17th-century back block.

Features associated with a house 'back block' (Plate 3)

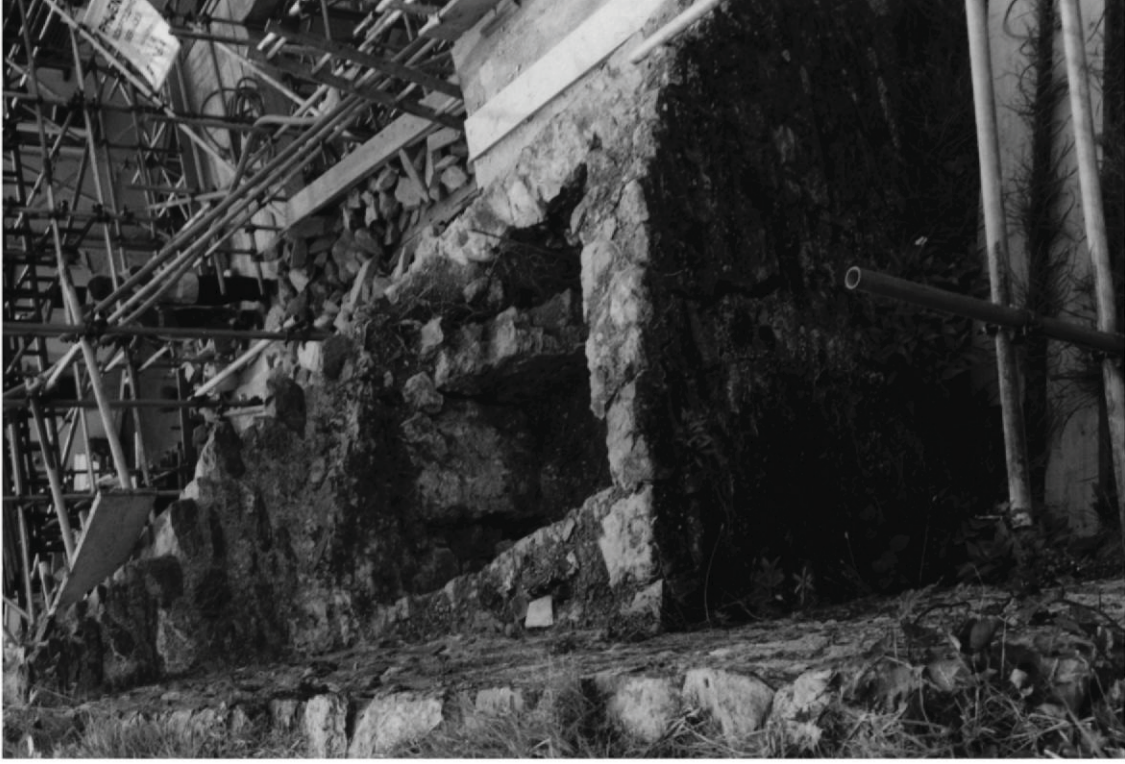
Plate 4. Late 19th-century stone water tank.
