**Historic building recording
at Church Hill Farm,
Church Hill
Beoley,
Worcestershire,**

WSM 47384

Historic building recording at Church Hill Farm, Church Hill, Beoley, Worcestershire

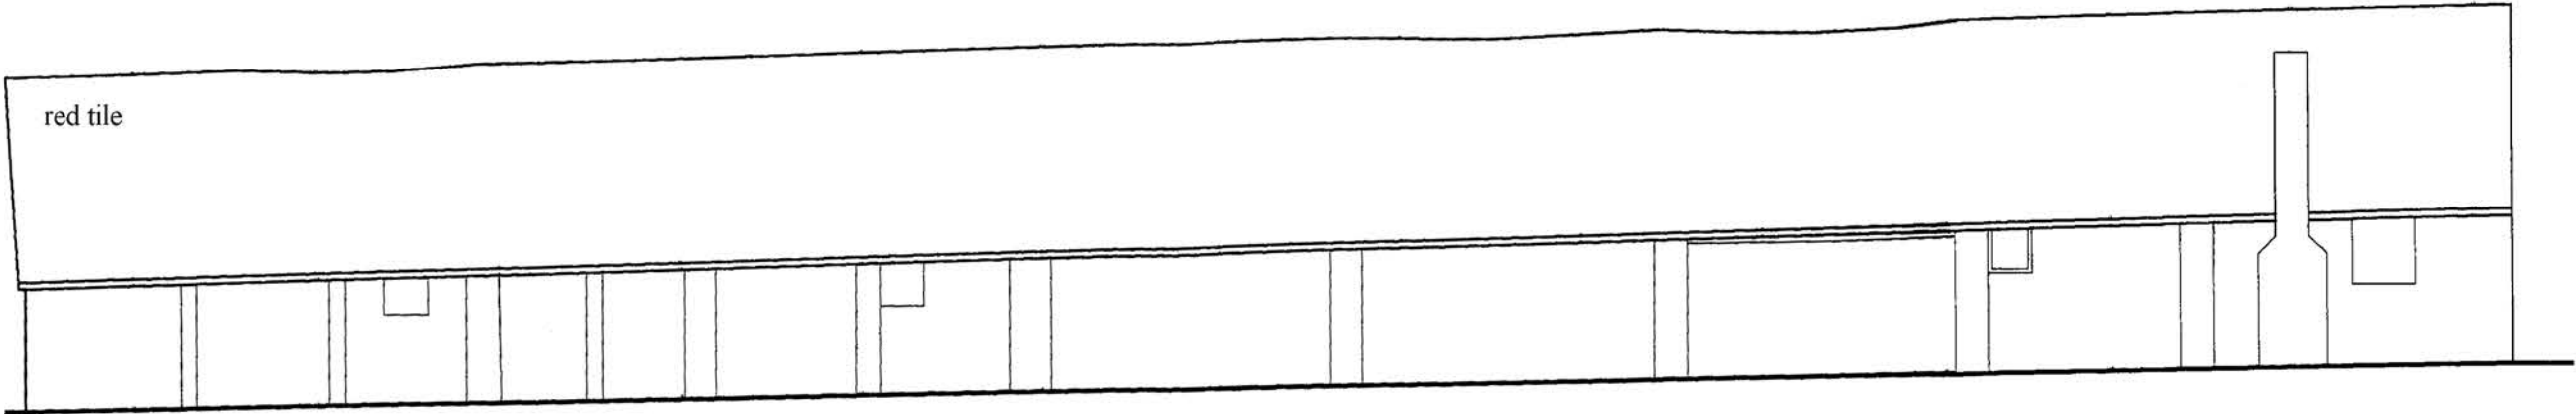
South-east elevation

all brickwork is a somewhat irregular Flemish garden wall bond
mostly covered by render

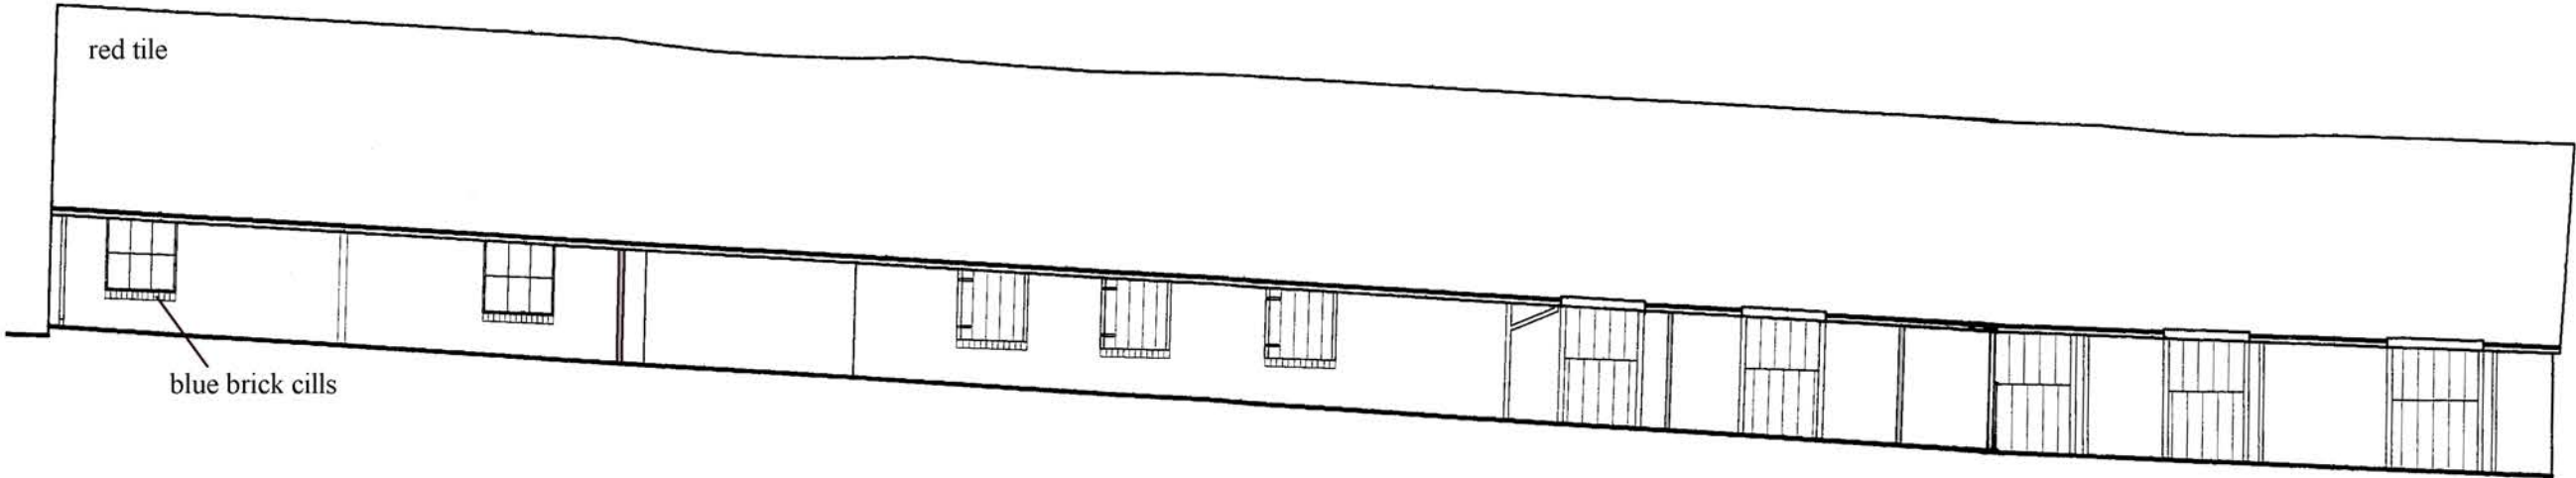
North-west elevation

blue brick cills

all brickwork is a somewhat irregular Flemish garden wall bond
mostly covered by render

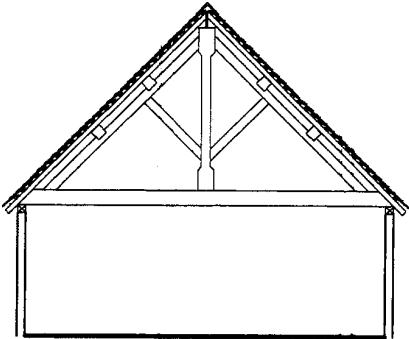
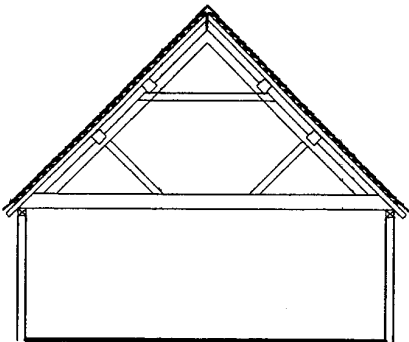
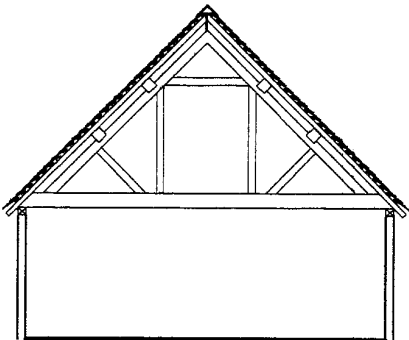
Fig 3.4: Types of roof truss

Truss type A

Truss type B

Truss type C

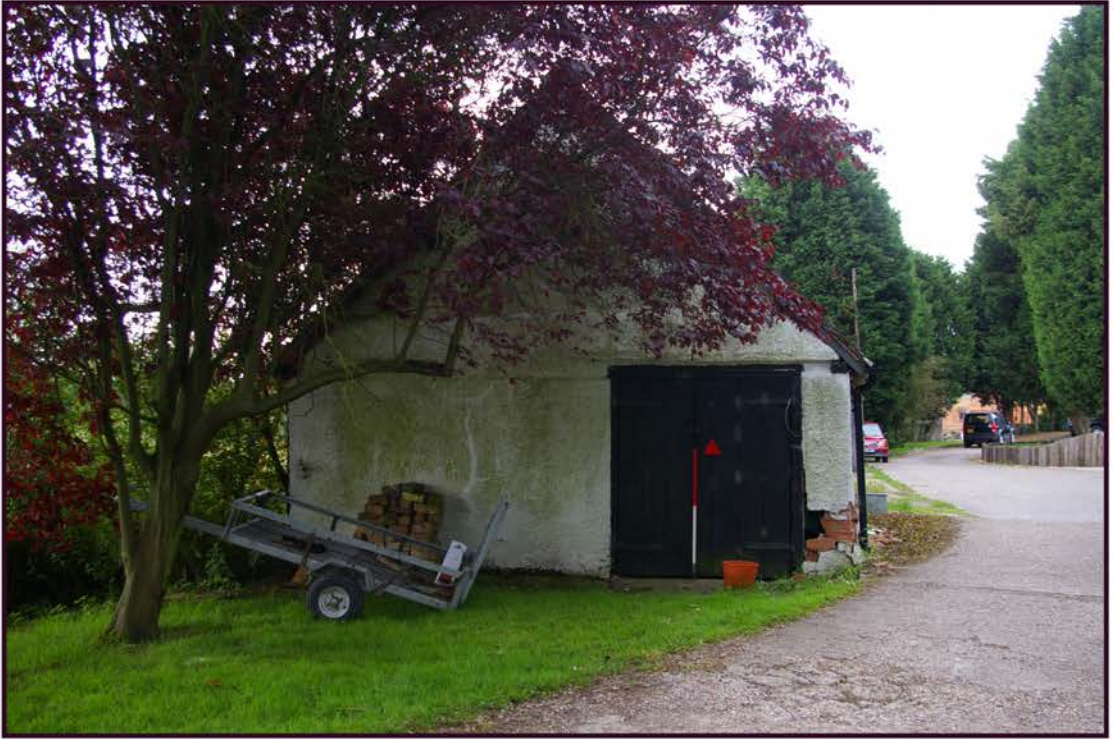
Fig 4: North-east elevation

A tack room was built onto the northern end of the stable (Figs 3.1, 4 and 5). It was provided with a small fireplace (Fig 11). It seems likely that the fire surround was reused from somewhere else as it is not a very practical design for a tack room. When heating was provided in situations such as this it was usually for the purpose of assisting in the cleaning of the horse equipment and only indirectly for the comfort of the stable hands. This fire surround does not have the simplest provision for the heating of water. A single, wooden, harness hook survives from this time (Fig 10).

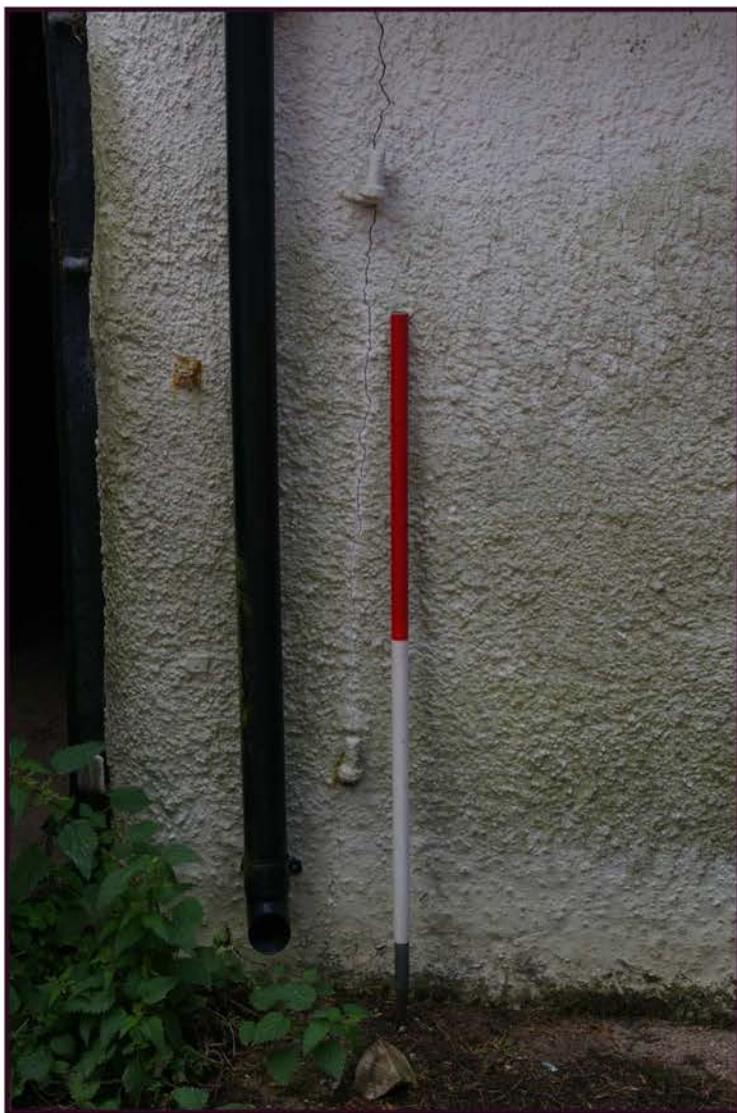
Fig 8: North-west elevation; detail of redundant hinges

A pair of gate hinges was noted on the exterior of the north east elevation (Fig 8). These presumably relate to some sub-division of the surrounding yard. However, such a division does not appear on the Ordnance Survey maps and this sub-division probably pre-dates them. Various items of stable equipment were noted in the building including horse harness, riding hats and a measuring stick marked in 'hands' (Fig 16).

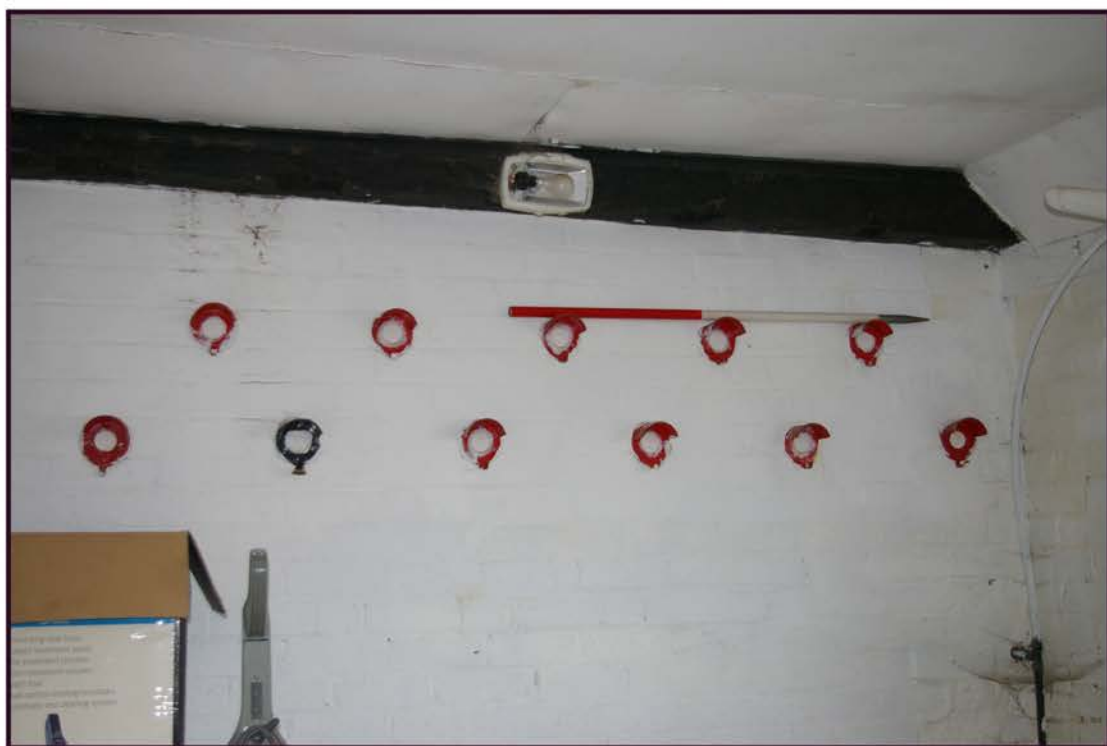
Fig 12: Phase 2 tackroom; detail of modern harness hooks

This phase sees the reorganization of the interior of the building (Fig 3.1). An ante-room was provided within the tack room by the means of a stud partition and plastic harness hooks replaced the wooden ones (Fig 12). However the greatest change was within the stable. The number of loose

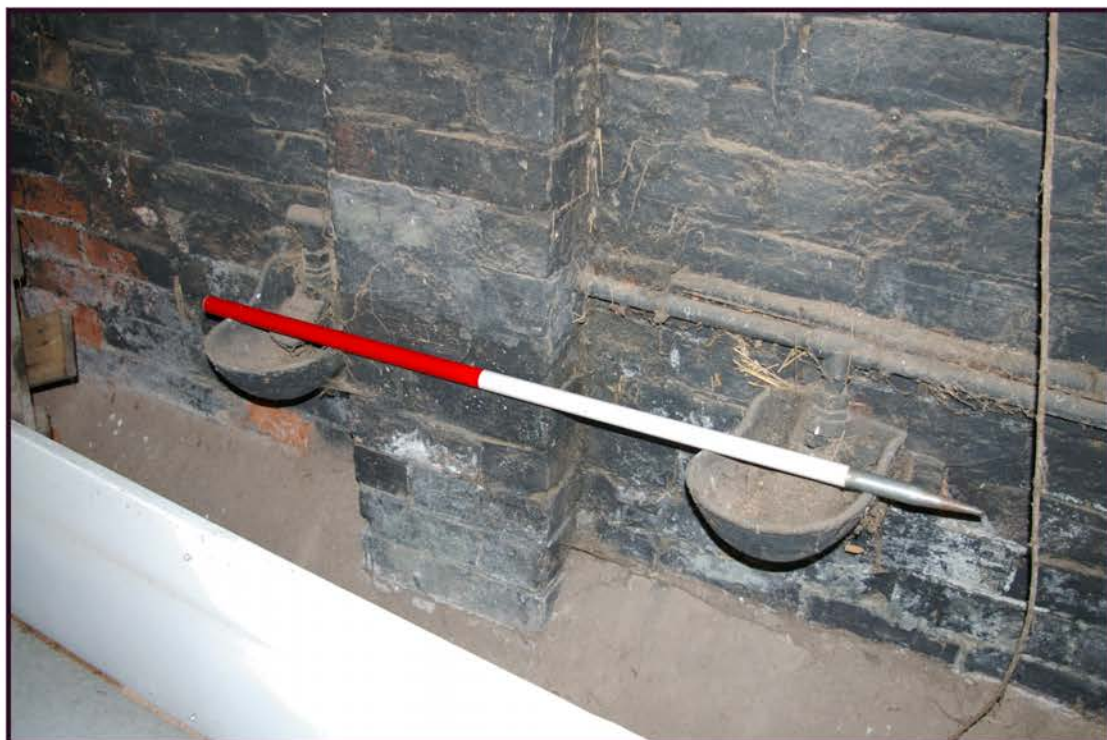
Fig 13: Phase 1 stable; detail of water trough

The building probably originally comprised a single stable (Fig 14) with two loose boxes at its southern end (Figs 19 and 21). There would have been a feeding trough, probably of wood, along its eastern side with water troughs above (Fig 13) and with the tack for each horse kept behind it on the western wall. It is likely that the stable space would have been sub-divided into stalls to prevent adjacent horses from kicking or biting each other. It is possible that at its northern end, until the construction of the tack room in phase 2, there was a hay loft over the first two bays as the roof trusses, from the north, are types C and B (Figs 3.4 and 14) which, due to their more open design, would have provided relatively easy access at tie beam level.

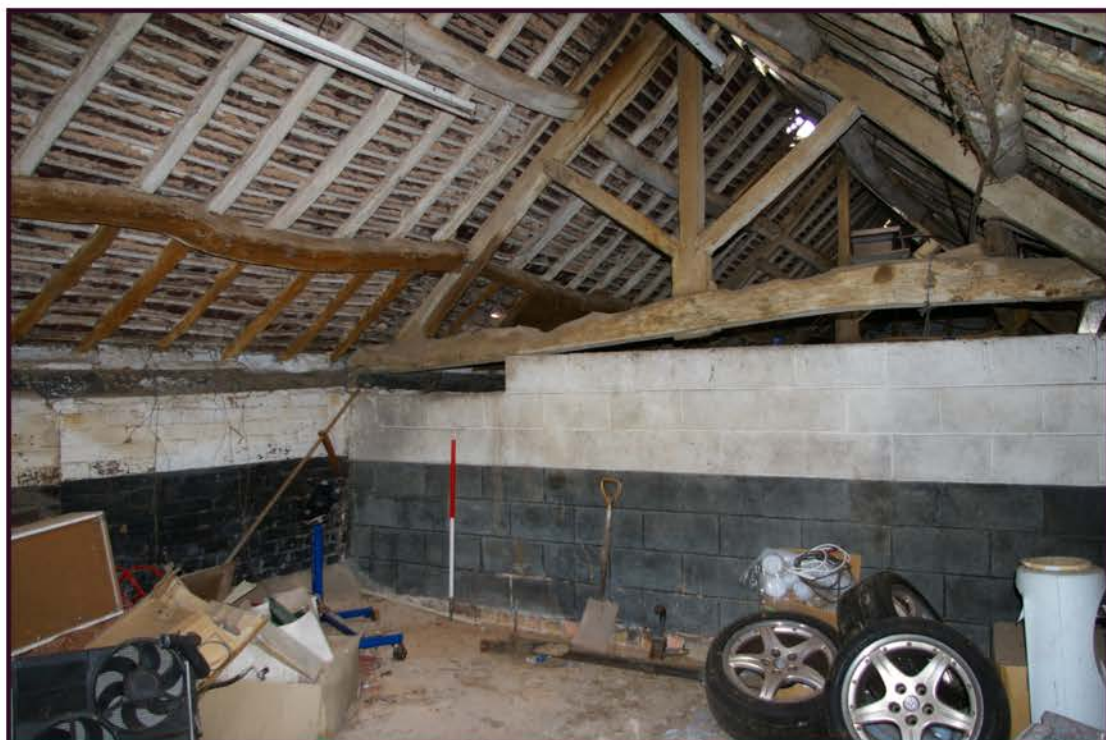
Fig 15: Phase 1 stable; general view showing truss type A

boxes was increased by the insertion of block partition walls (Figs 15, 16, 17, 18 and 20). They may be identified as loose boxes, as opposed to stables, by the location of the water troughs which are positioned just inside the entrances. If these were stables the water would have been inaccessible to the horses. Loose box provision now took up more than half of the equine accommodation.
