**Watching brief at
Darlaston Community and Science College
(Grace Academy),
Herbert's Park Road,
Darlaston,
Walsall ,
WS10 8QJ**

Martin Cook BA MifA

15th January 2013
Minor revision 18th January 2013
Further revision 1st May 2013

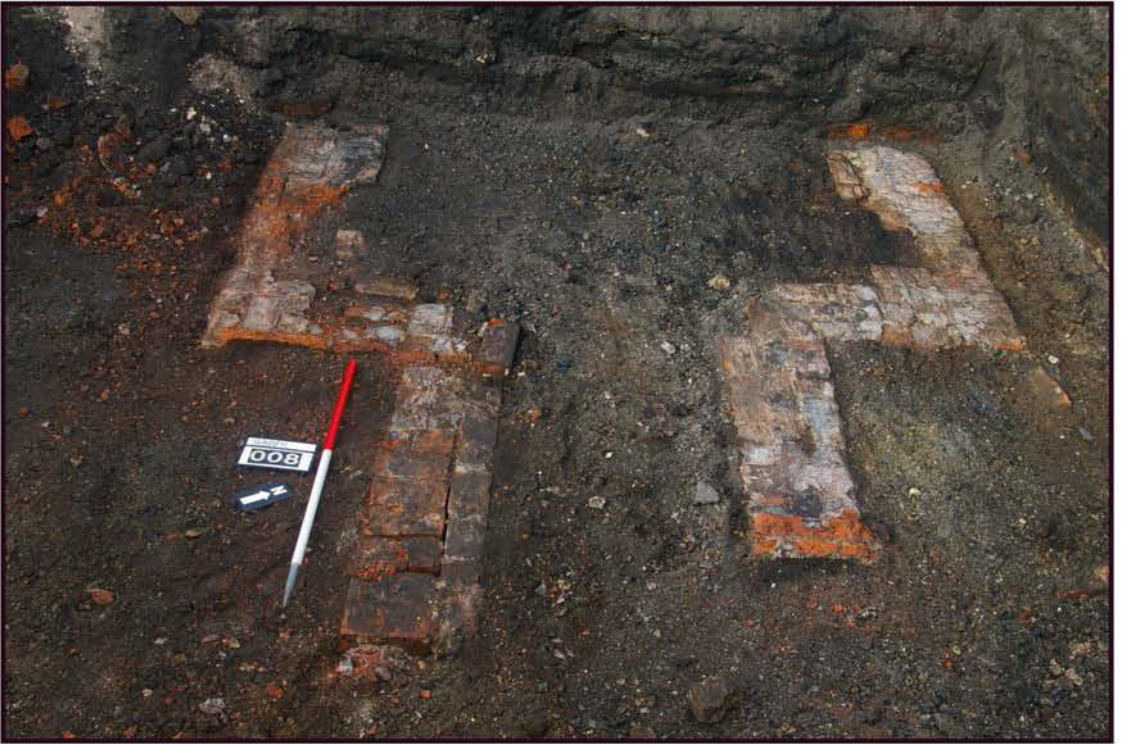
Fig 4.2: Brick structure; context 008

It was only when excavation reached a metre or (sometimes significantly) more below existing ground level that undisturbed deposits were encountered. The first of these was a rectangular brick structure (context 008; Figs 4.1 and 4.2) which lay towards the southern side of the site (Fig 3). This was quite small, approximately 3m across the single complete dimension that was exposed, with a smaller rectangular protrusion to its south. It was built within an ashy, coaly deposit on the edge of a pit (context 011) which itself was filled with a light grey sandy ash (context 009). The function of the structure is unknown but it is believed to be associated with the gasometer shown on the 1st edition Ordnance Survey map of 1886 (Fig 2.2).

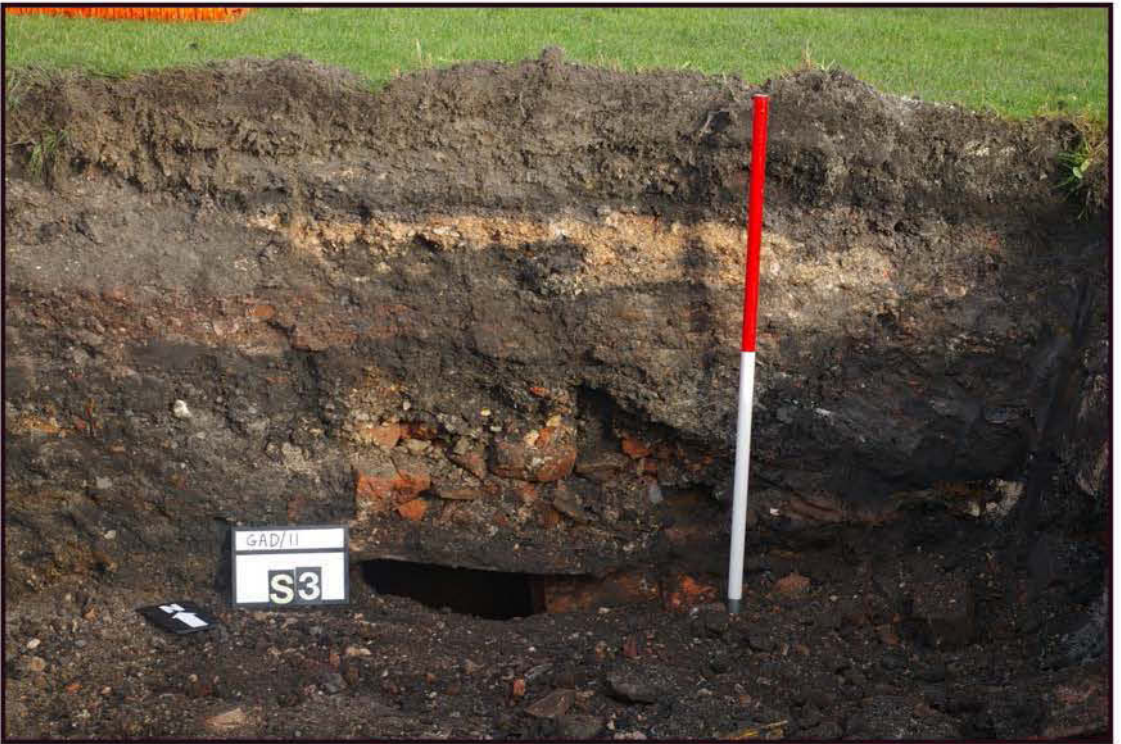
Fig 4.3: Section 3; see also Fig 4.4

The section of the excavation that exposed the above brick structure was drawn (Figs 4.3 and 4.4). The topsoil (context 001) lay above a layer of light orange buff decayed stone or mortar (context 004) which in turn lay above a layer of light brown grey fragmented stone, thought to be demolition debris. Beneath this was context 006, brick rubble with lime mortar, which was clearly the fill of a small excavation. Beneath this was a cast iron plate (context 007) supported upon a brick structure (context 010). The whole was clearly an inspection pit presumably also associated with the gasometer.

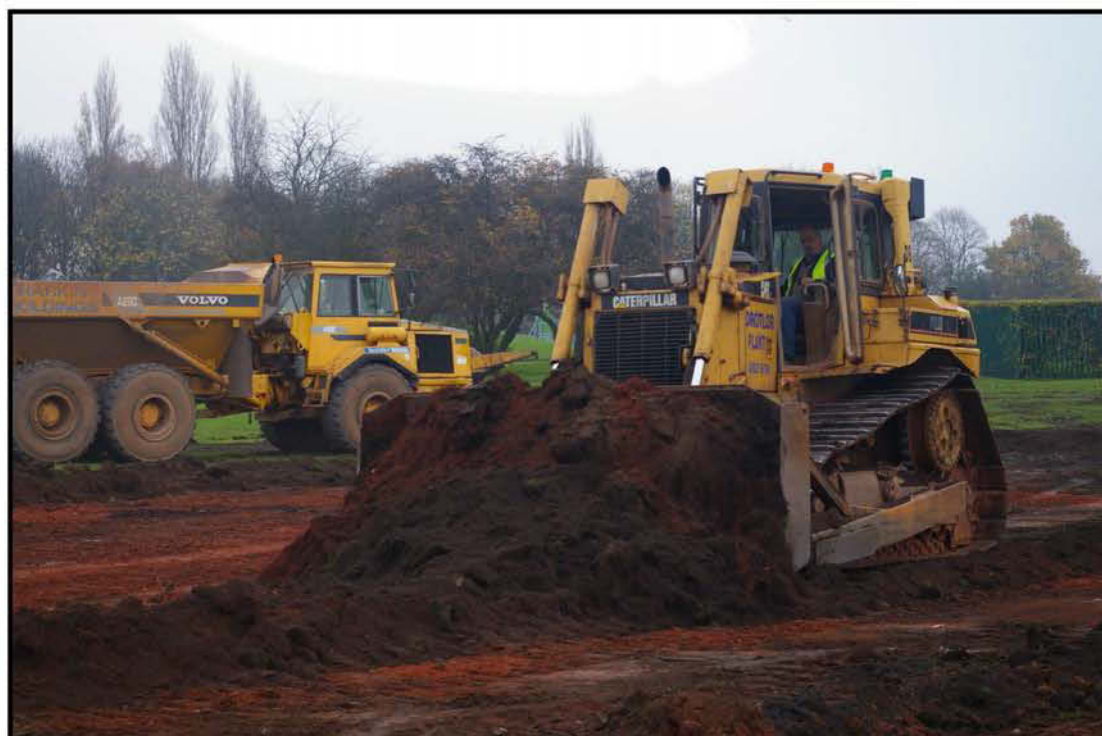
Fig 4.5: Initial site strip

The site was stripped of topsoil overall and this was stored temporarily at the southern extremity. Ground reduction was then carried out across the middle and eastern part of the site. These operations were carried out by the use of a bulldozer, backhoe excavator and six-wheeled articulated hauler (Fig 4.5). The northern part of the site was to be raised in level and only topsoil stripping took place there.

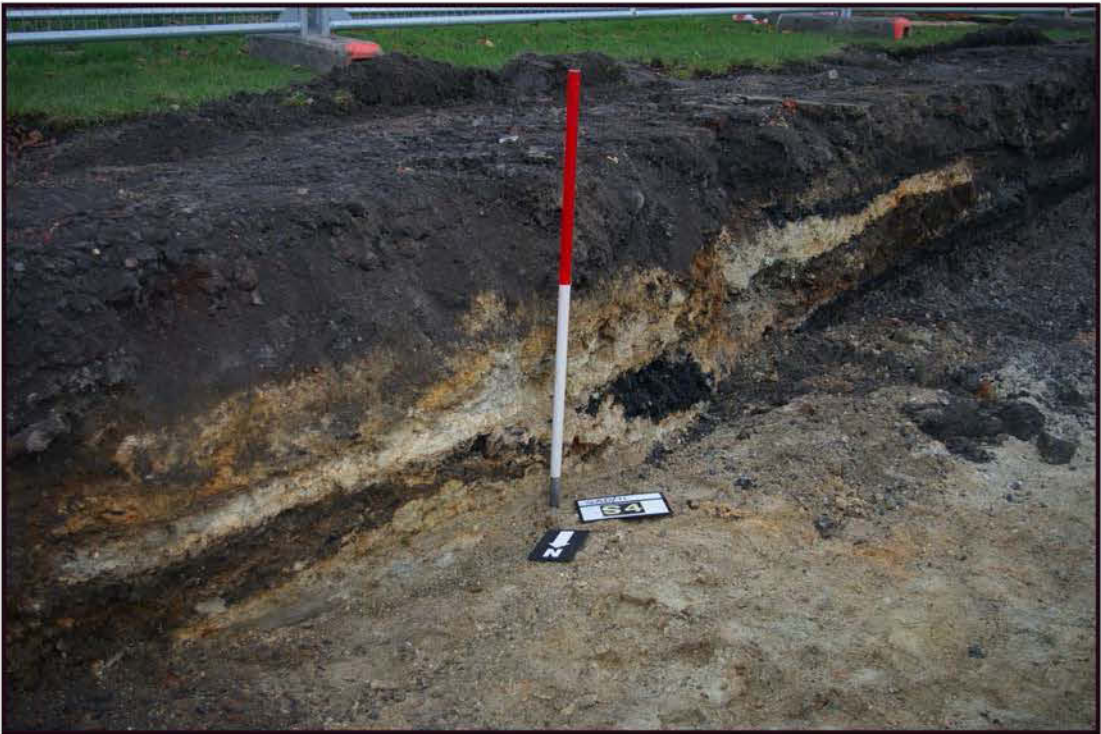
Fig 4.6: Section 4

A similar sized excavation to the north-east (Fig 3) resulted in the recording of another section (section 4; Figs 4.6 and 4.7). Beneath the ubiquitous topsoil (context 001) there was a layer of mid-grey gritty sand with abundant small to medium stone fragments (context 016). Beneath this a small, vertically sided, flat bottomed cut (context 018) had been excavated in a layer of very light yellow lightly cohesive sand (context 020). This in turn overlay a layer of very hard and compact dark orange slaggy stone (context 019). This appears to have been a 'capping' layer as beneath this was a substantial pit filled with a succession of layers of very light yellow lightly cohesive sand (context 022) and very hard and compact dark orange slaggy stone (context 023). A layer of light grey, loose, small angular ashy slag (context 025) lay at the limit of excavation. This feature appears to have been simply a large pit whose limits, in plan or section, were never discovered.

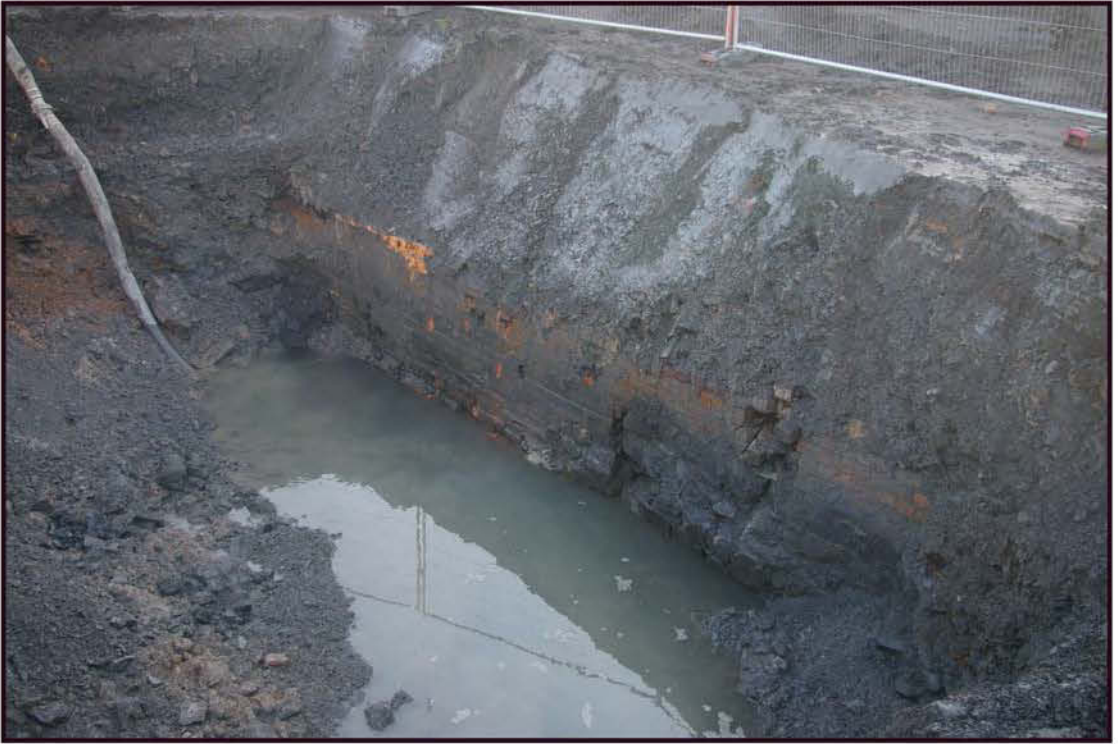
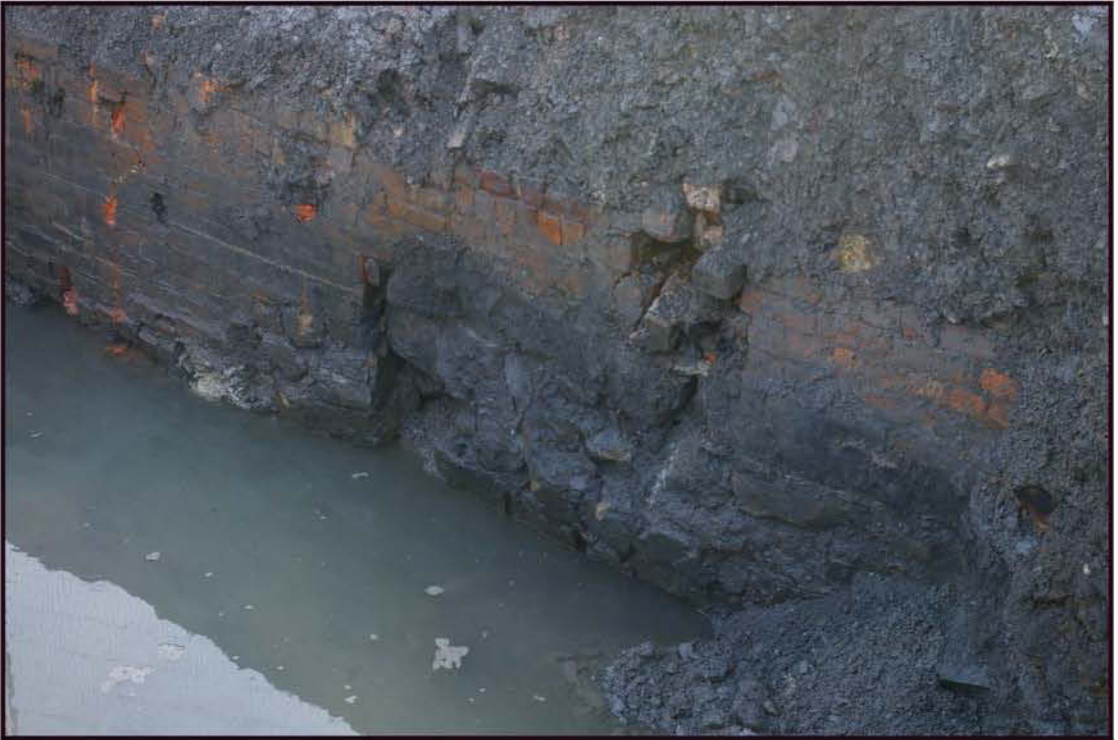
Completing the recording at the southern end of the site was the excavation of the canal basin in this vicinity (Figs 3, 4.8 and 4.9). This was done to locate its position and no entry to the excavation was possible. It was clearly built of brick in what appeared to be English bond.

Fig 4.8: Canal basin in south-west of site

Fig 4.9: Detail of wall; canal basin in south-west of site

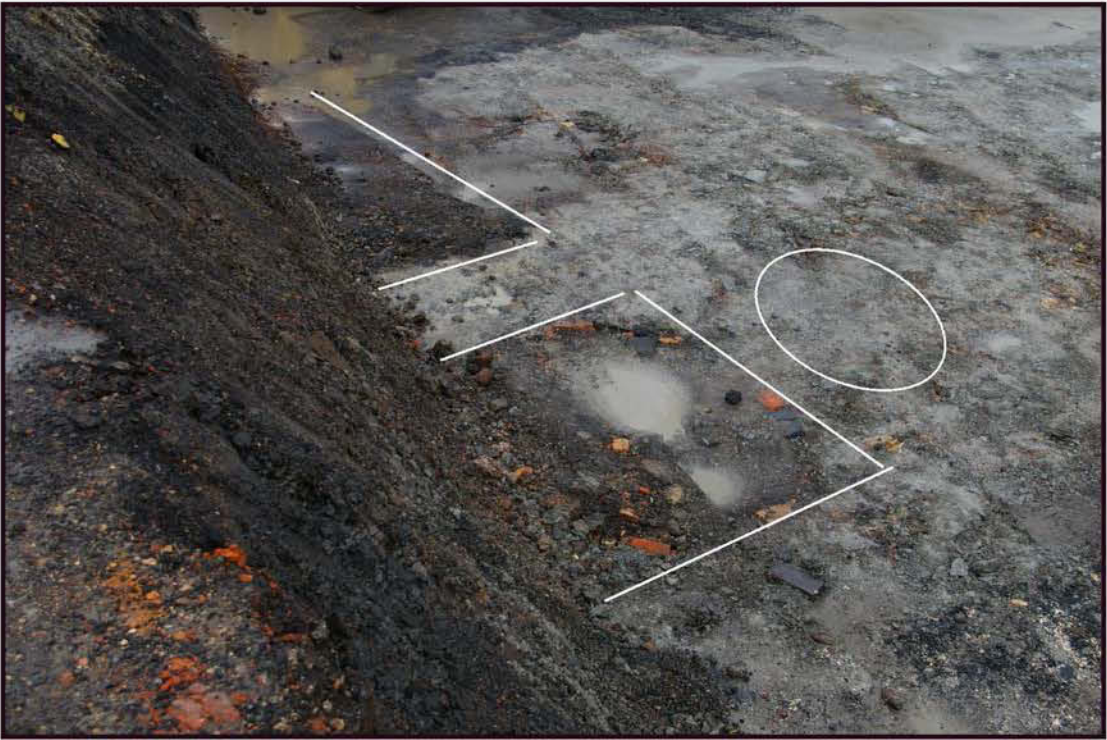
At the northern end of the site, adjacent to the canal, a substantial excavation for a storage tank to a depth of nearly 4m was carried out (Figs 3 and 4.10). Again, no entry to the excavation was possible, but it was clear that at this depth brick and cut features survived. A small rectangular building, an adjacent circular shaft and a large rectangular cut were evident.

Fig 4.10: View of storage tank excavation showing brick structure and possible shaft

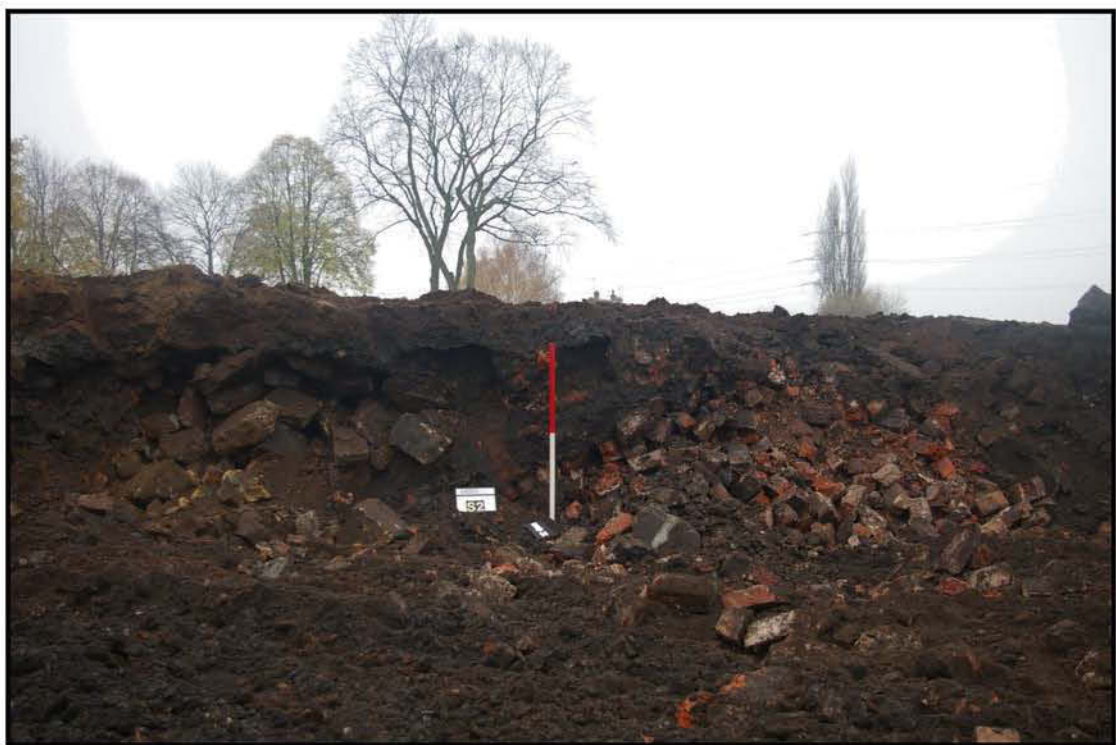
Fig 4.16: Section 2

In a similar way section 2 (Figs 4.16 and 4.17) which lay a little to the north-east of section 1 (Fig 3) demonstrated the way that buildings on the site had been demolished and buried. Beneath the topsoil and landscaped coal mining debris (contexts 001 and 015 respectively) were heaps of concrete rubble (context 013) and brick rubble (context 014).

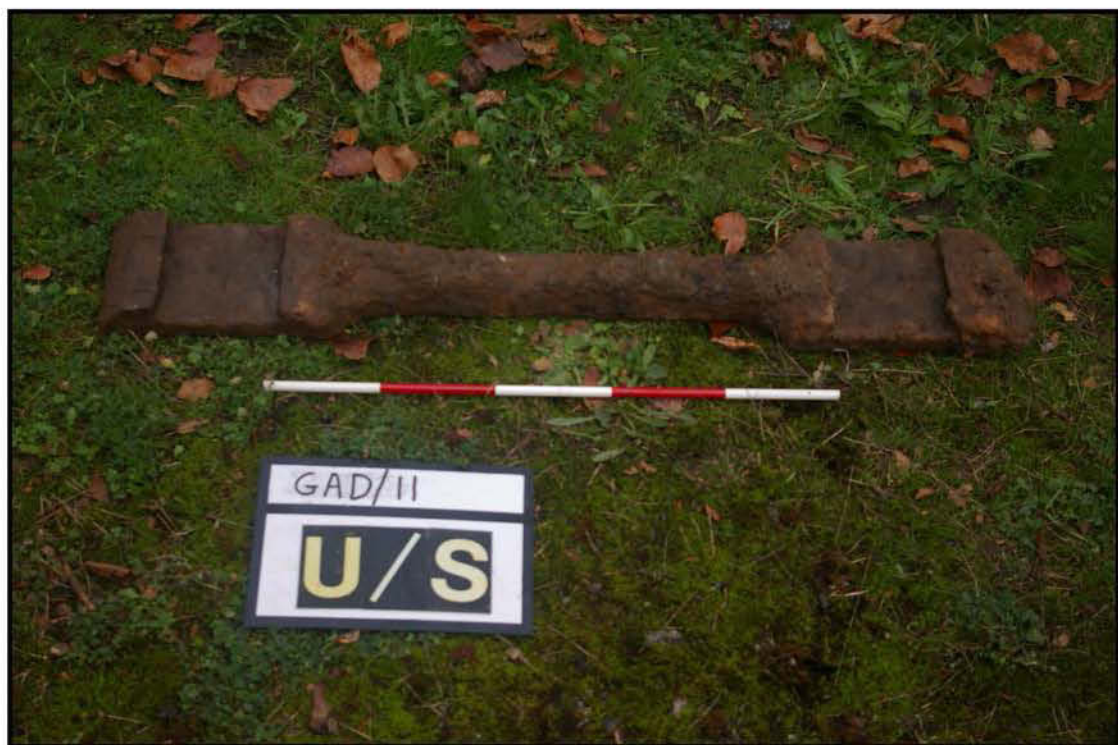
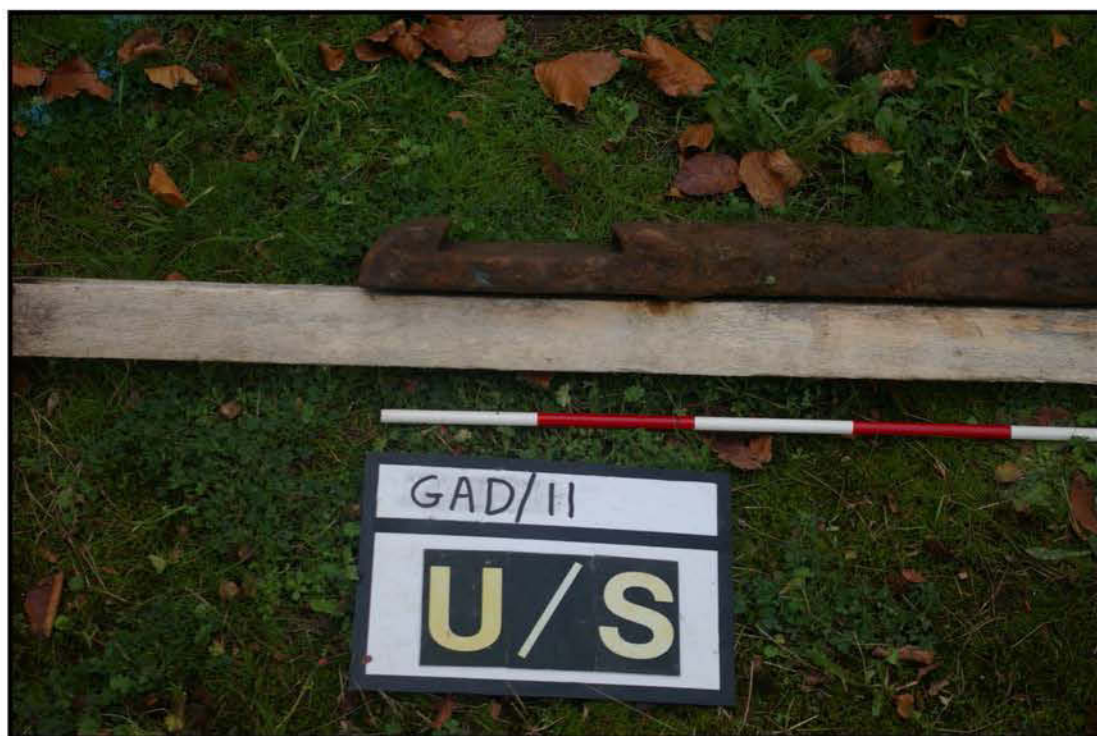
This overall site stripping also produced the best find of the project (Figs 5.1, 5.2 and 5.3). This was a cast iron tramway sill (a combined sleeper-chair) for a plateway (L-section rail for flangeless wheels) which was found at the position marked 'X' (Fig 3). This is believed to date from 1810-1820 (pers com David Gwyn *via* Paul Quigley - see also below).

Fig 5.1: Detail of tramway sleeper; scale is 0.5m

Fig 5.2: Dimensioned drawing of tramway sleeper

Fig 5.3: Detail of tramway sleeper; scale is 0.5m

The single find of particular interest, the cast iron tramway sill (a combined sleeper-chair) for a plateway (L-section rail for flangeless wheels), was found at the position marked 'X' (Fig 3). This is believed to date from 1810-1820 (Figs 5.1, 5.2 and 5.3; pers com David Gwyn *via* Paul Quigley), and has been commented upon above. Almost identical examples are on display at the Museum of Iron in Coalbrookdale (Fig 6.1) and the type of tramway that would have likely existed at the Grace Academy site has been reconstructed at the Black Country Museum (Fig 6.2). The arrangement of tramways that are known to have existed at the Grace Academy site is depicted in the Black Country Historic Environment Record (Fig 6.3). It is clear that a couple of legs of this tramway pass close to the find-spot of the sill that was found but there is no reason to believe that it was *in-situ*. It seems more likely that the tramway was taken up to be used elsewhere or possibly for scrap and this sill was accidentally left behind.

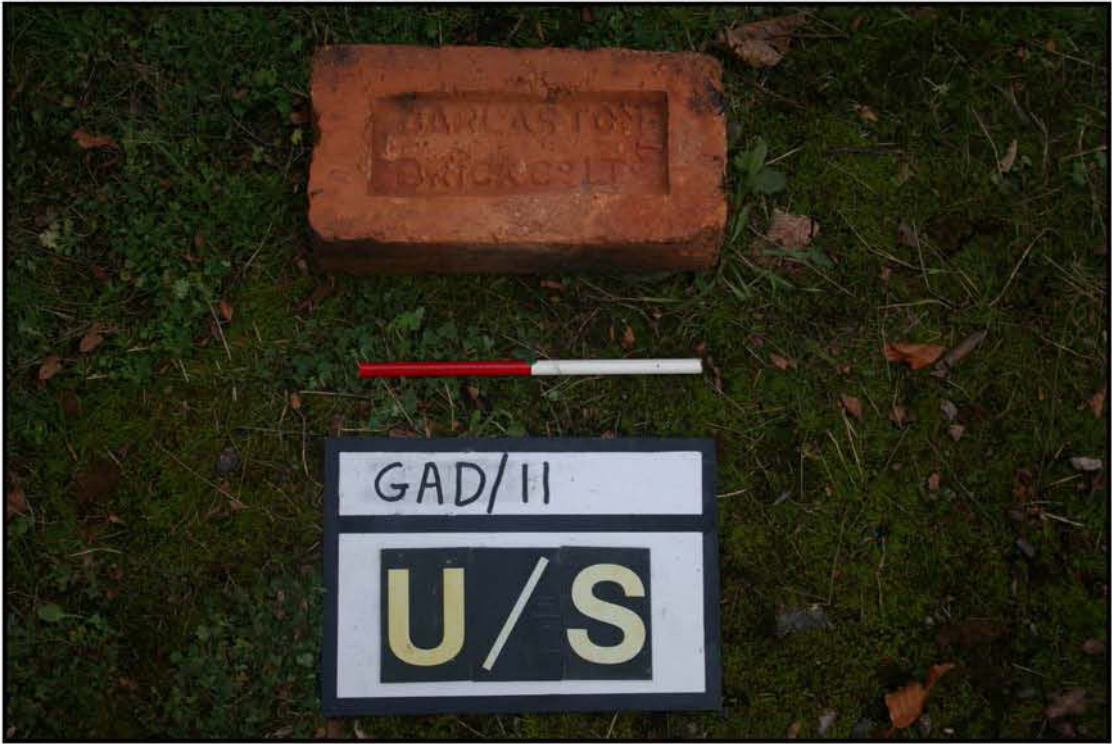
The only other finds of some interest were bricks which were present in super-abundance. A very considerable number were locally made by the Darlaston Brick Company Ltd (Fig 5.3) which is believed to still be in existence.

Fig 5.4: Brick of Dalaston Brick Company; scale is 0.2m
