**Programme of archaeological work  
at The Royal Oak,  
Oak Row/Oak Street,  
Upton -upon-Severn,  
Worcestershire**

20th October 2014

WSM 57457 and 57458

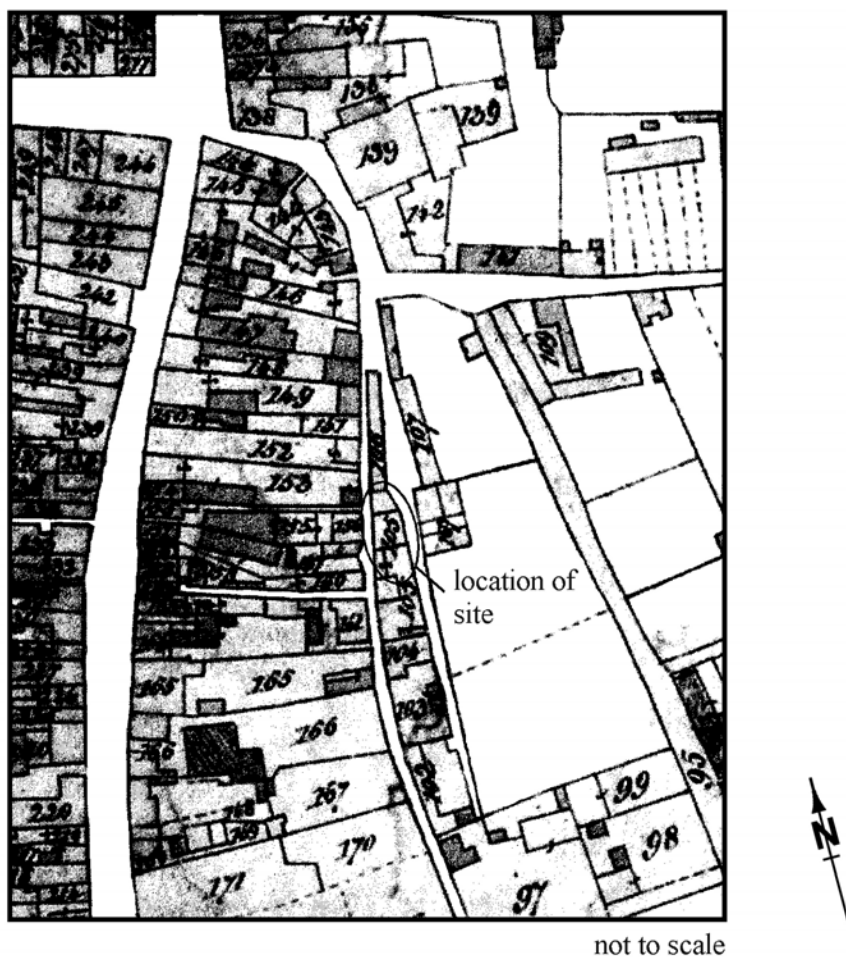
Fig 2.1: Upton-upon-Severn tithe; 1841

The earliest available map was the Upton-upon-Severn tithe map of 1841 (Fig 2.1). This shows the building at its 'phase 3' extent (see below: **The Royal Oak – building recording; description and commentary**). It also shows buildings to the north and south of this structure. The ones to the north are now gone and of those to the south, it is not the the phase 5 extension that is represented although a re-used chimney may be (see Figs 3.7, 12 and below). A common fields enclosure map of 1863 (Fig 2.2) shows no detail of the site and the 1st edition Ordnance Survey map of 1886 (Fig 2.3) shows the building's north, east and west sides as they appear today. The extension to the south is believed to be the same extension, later partly reused, referred to above. The building is marked as a public house. The Ordnance Survey map of 1904, which cannot be reproduced for reasons of copyright, shows that phases 5 and 6 have by this time been built (see below). The Ordnance Survey map of 1928 (Fig 2.4) shows nothing different.

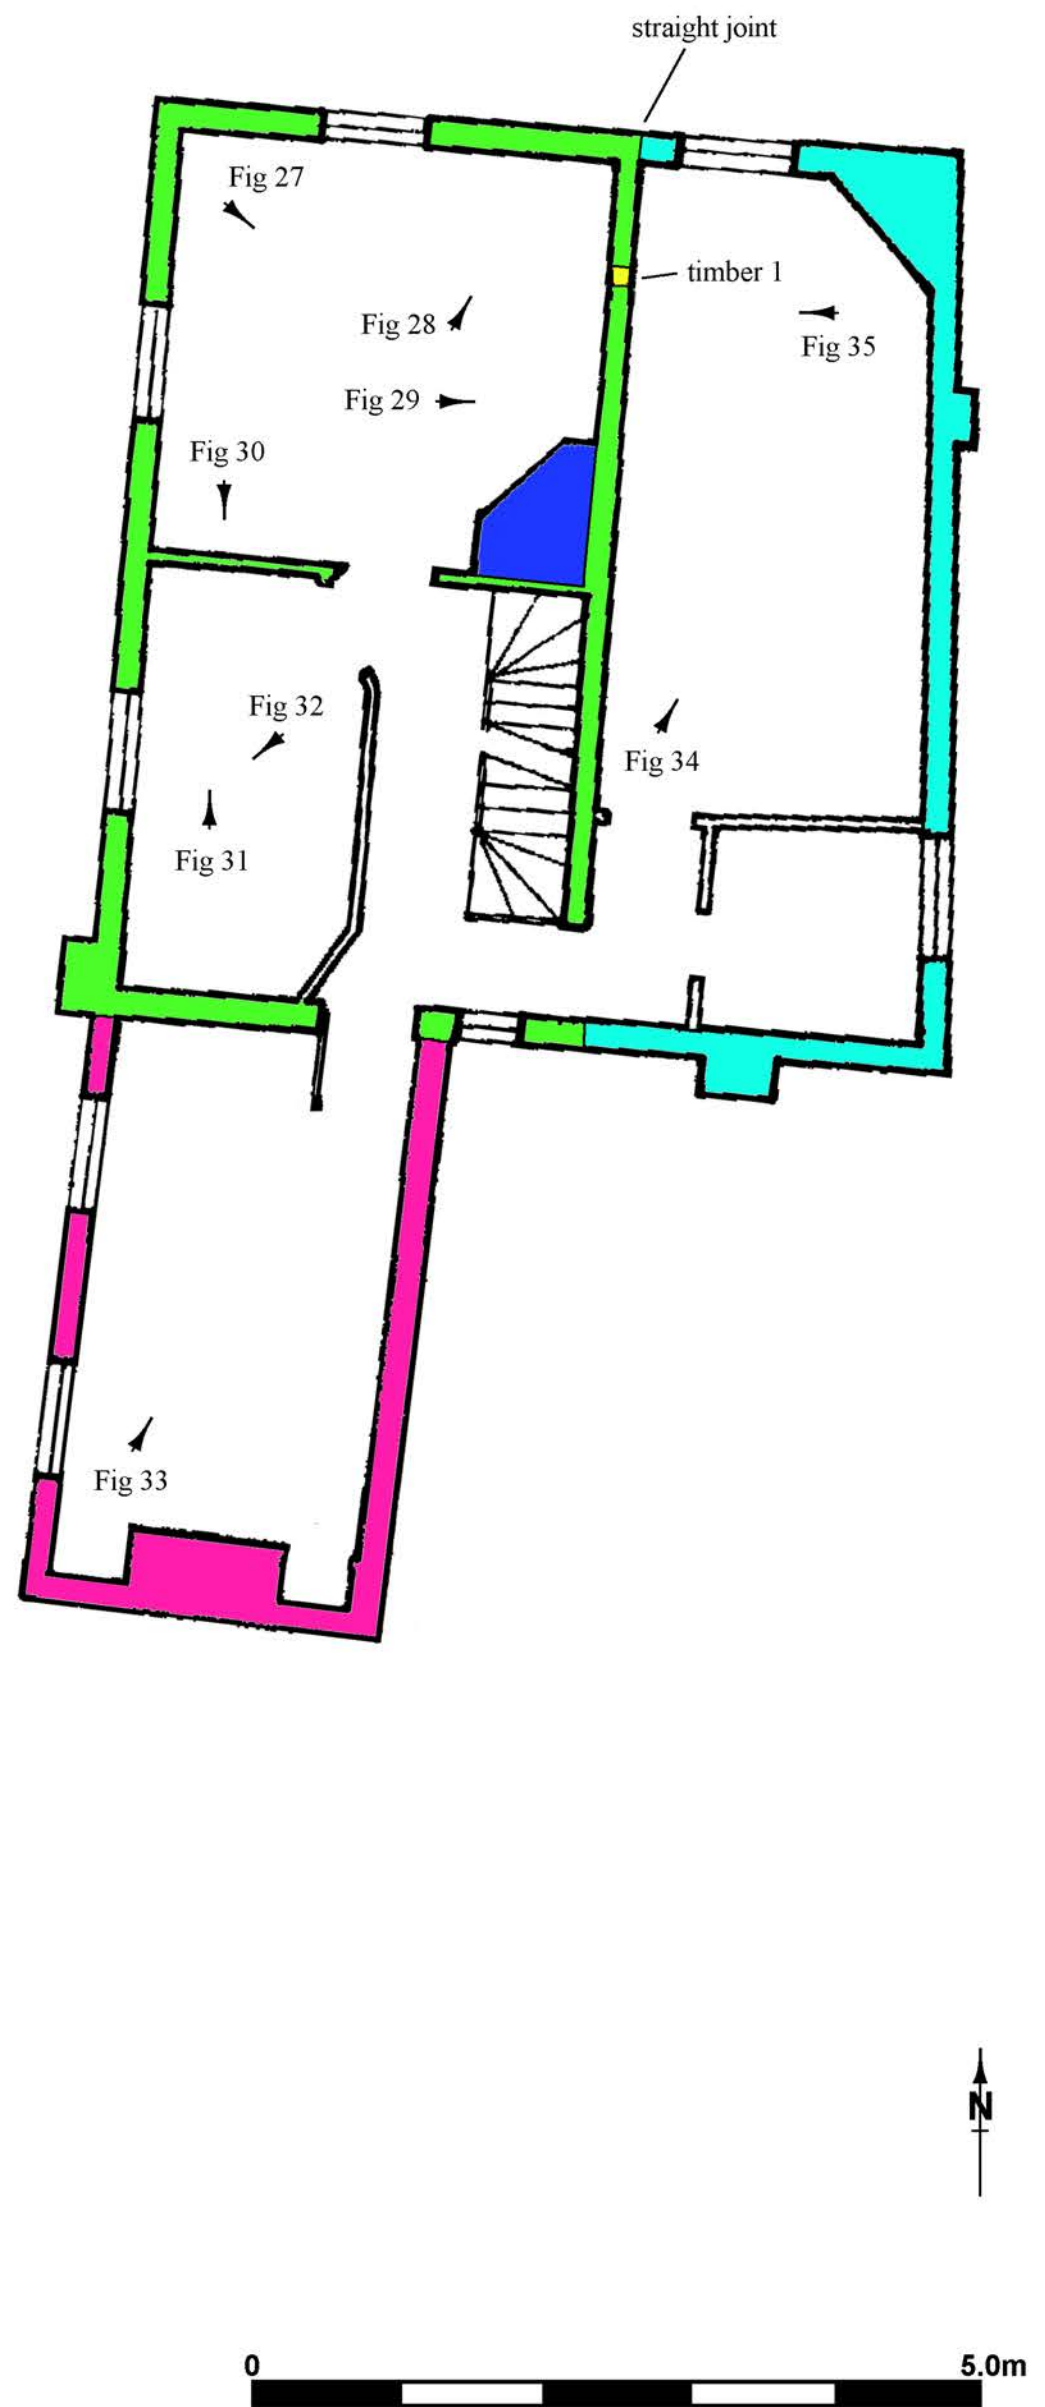
Fig 3.2: First floor

This building was of three floors (Figs 3.1, 3.2 and 3.3), although no evidence could be found regarding its original internal arrangements. It is likely that it was sub-divided but this could have been by insubstantial partitions or screens. Similarly, no evidence could be found regarding its original stair.

The flue for the corner hearth on the ground floor also served hearths on the first and second floors (Figs 3.2 and 3.3). Connections were also made with the phase 3 structure at first and second floor levels (Figs 3.2 and 3.3).

A two storey extension was added to the southern side of the phase 2 structure (Figs 3.1 and 3.2). This was a single room, at ground and first floor level (Figs 4, 20, 21 and 33). At ground floor level, a new barrel ramp and stair was provided to the cellar (Figs 3.4 and 40) and presumably this was the time at which the original barrel ramp of phase 2 was blocked. There must have been a previously existing extension on the same footprint as the phase 5 structure as its chimney appears to have been retained and incorporated in this later extension (Figs 3.1, 3.6, 3.7 and 12). The later extension was executed in stretcher bond.

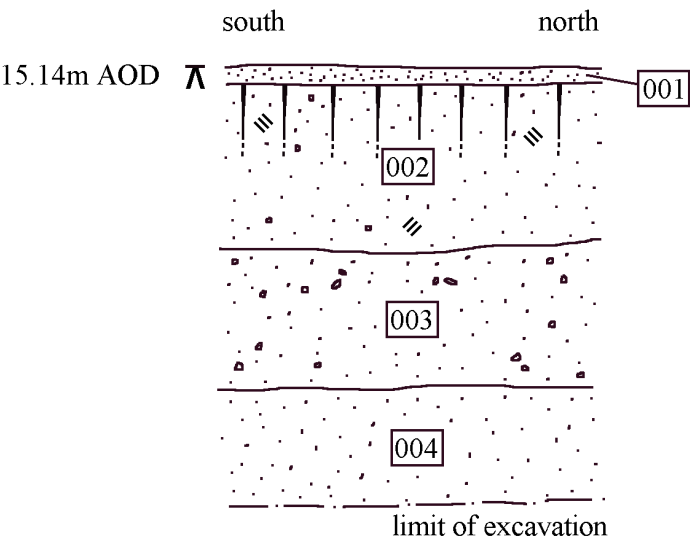
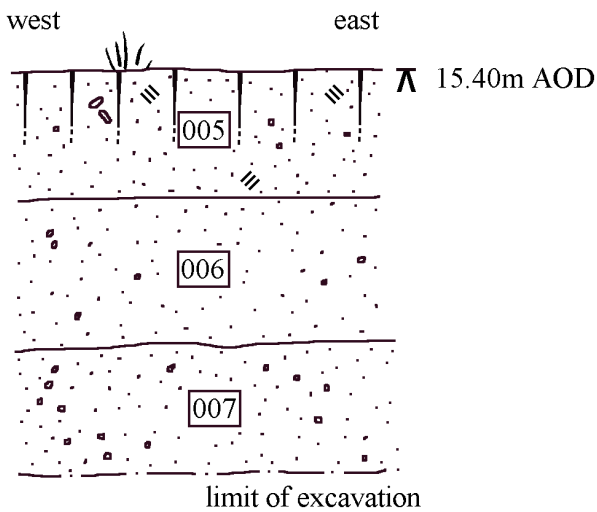
Fig 3.10: Sections

Section 1 (Figs 3.10 and 44) was topped by a thin spread of light yellow buff mortar (context 001). Since this occurred immediately adjacent to the southern extent of the recorded buildings, this was interpreted as a spread of surplus building material relating to construction activities, although it could not be determined to which phase this context belonged. Beneath this was a dark grey-brown slightly clayey loam (context 002) which was interpreted as a former topsoil. This was followed, in sequence, by the subsoil (context 003), a light grey brown sand with abundant small angular stones and the natural subsoil (context 004), a light grey brown sand. The contexts recorded in section 2 (Fig 3.10; contexts 005, 006 and 007) were similar in nature to those in section 1, although they appeared to have been disturbed. It is believed that this disturbance was due to the area to the south of the sequence of buildings being in use as a yard.

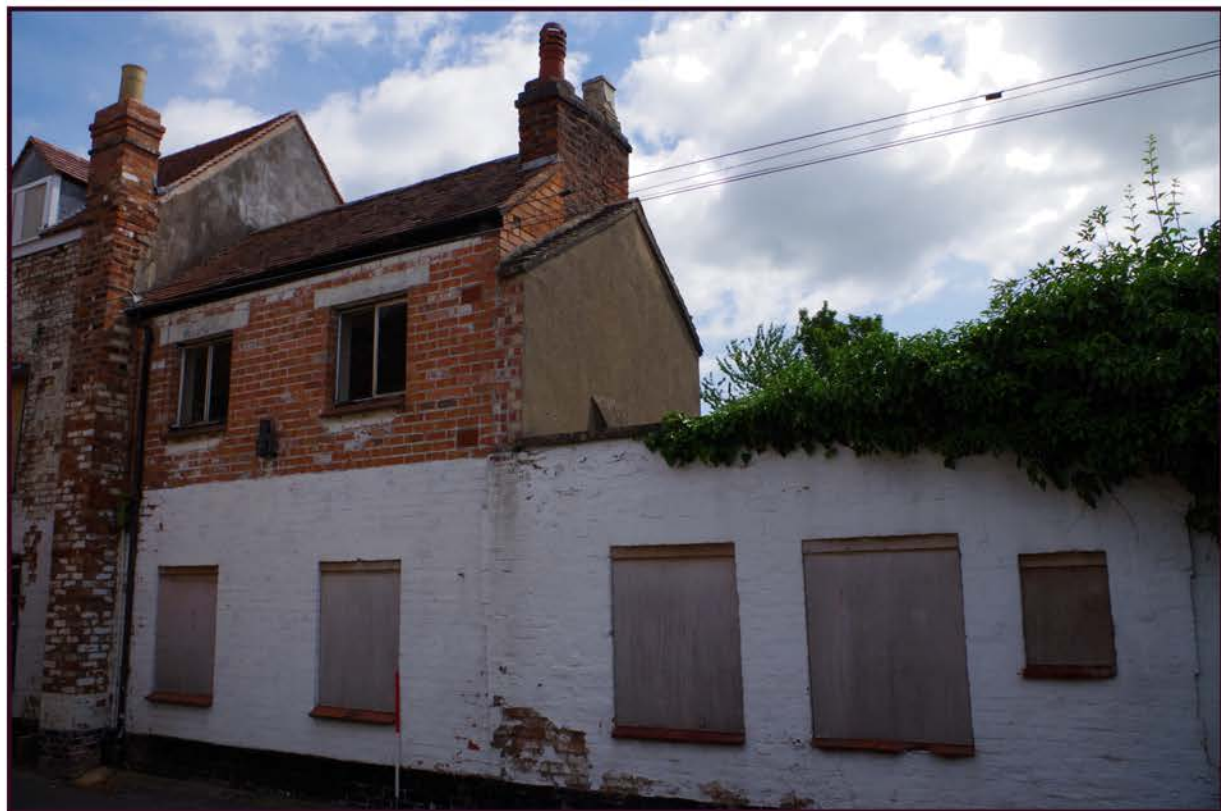
Fig 4: West elevation, south end

A further extension in a mixture of stretcher and English bond, this time of a single storey and with a flat roof, was provided to the south, access to which was gained by a corridor (Figs 3.1, 3.7, 3.8, 4, 10 and 22). This was intended to provide a sitting room and bathroom facilities (Figs 23 and 24).

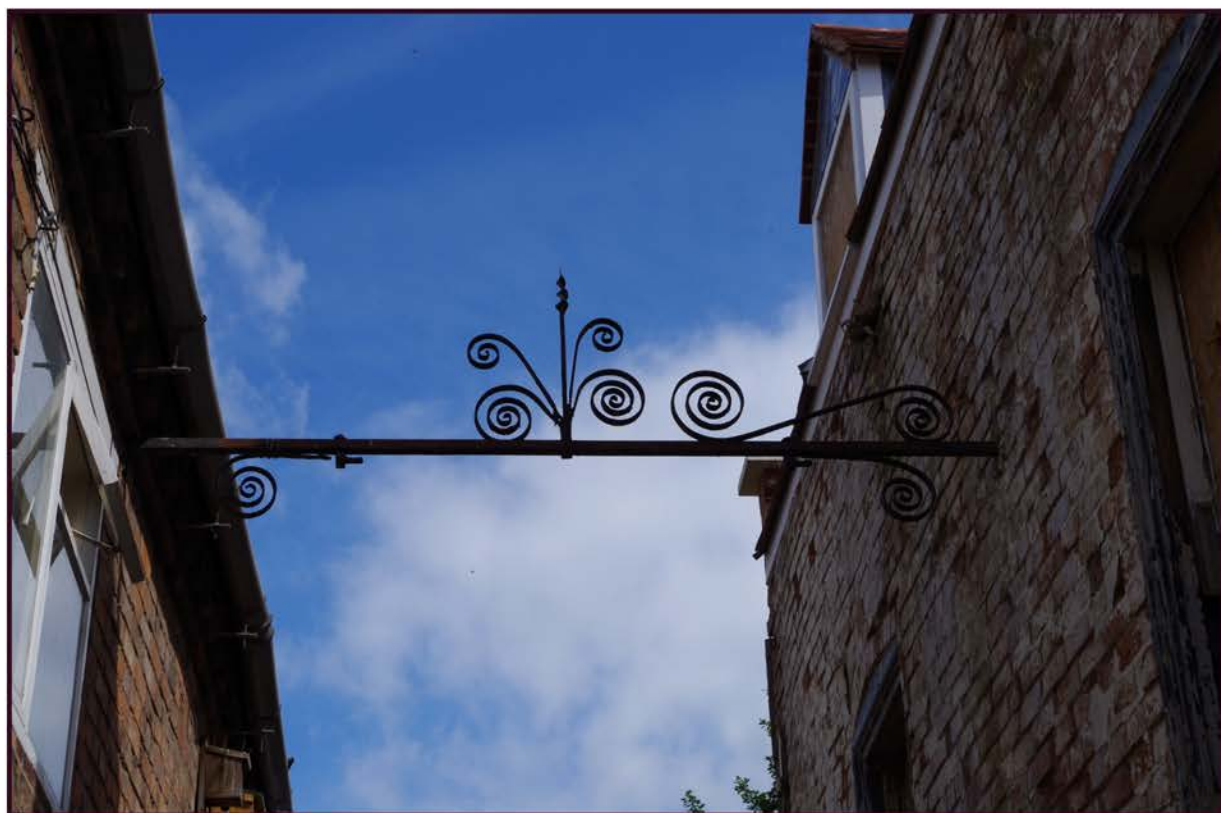
It is possible that this phase saw the construction of the cellar (Fig 3.4) with a brick vaulted roof and the conversion of the building as a whole into a public house. A barrel ramp (Fig 41) was constructed with access from the north elevation, supporting the view above that, at this stage, the north elevation was clear of other development. It is also possible that the supporting framework for the public house sign (Fig 5) was erected at this time.

The position and form of the Royal Oak's sign, hung between the pub itself and the adjacent building, was probably chosen so that it would be easily visible from the north and south, as these were the directions, from which customers would have approached.

Fig 5: Support for hanging public house sign

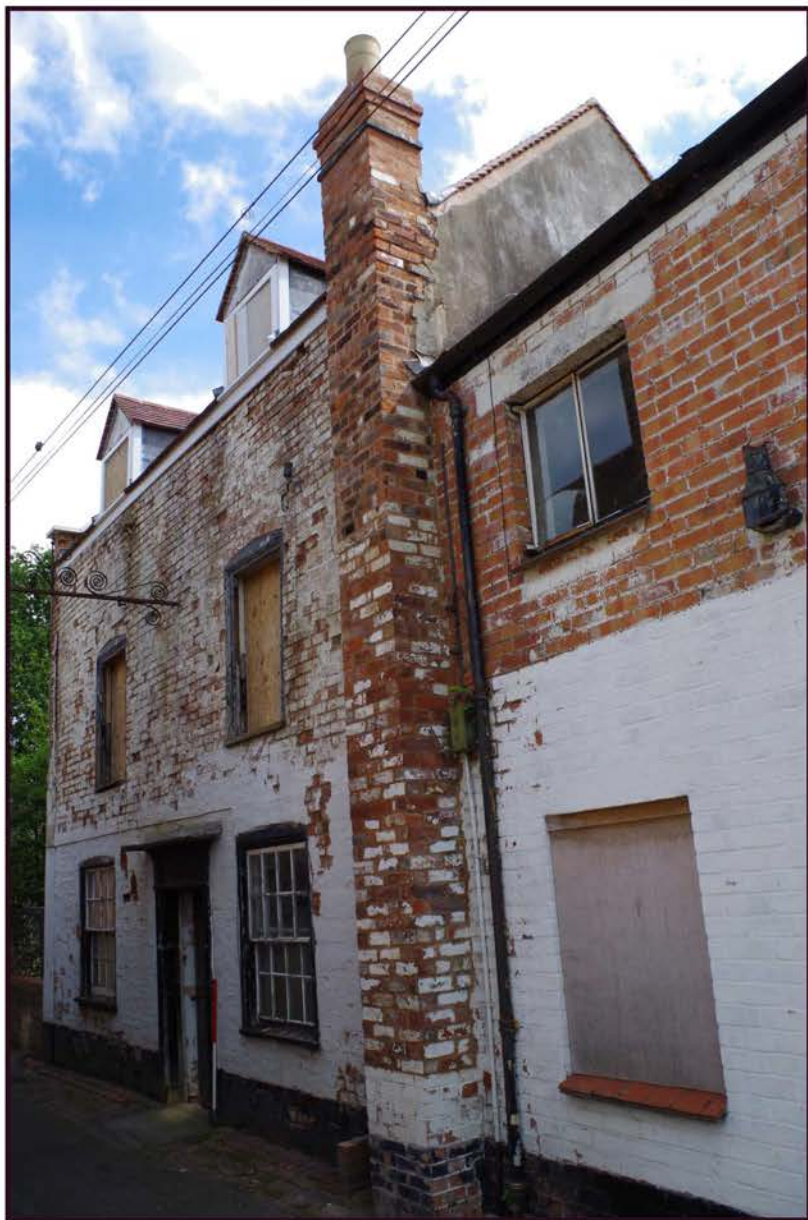
An attempt was clearly made to create a classic small Georgian house with a central doorway and evenly spaced windows (Figs 3.7 and 6), at least on what would have then been thought of as the front elevation. The brickwork was English garden wall bond which would have been thought of as being a less 'heavy' and generally more attractive looking version of English bond, whilst not having the fashionable qualities of Flemish or Flemish garden wall bond. At this period the north elevation was probably clear of the obstructing development seen on the historic map of 1841 (Figs 2.1 and 7) as there is the partial remains of a single brick arch, indicating an opening, on the north elevation at first floor level (Fig 3.5). The eastern limit of the phase 2 building is indicated by the straight joint on the northern elevation (Fig 3.5) running most of the height of the structure.

Fig 6: West elevation, northern end

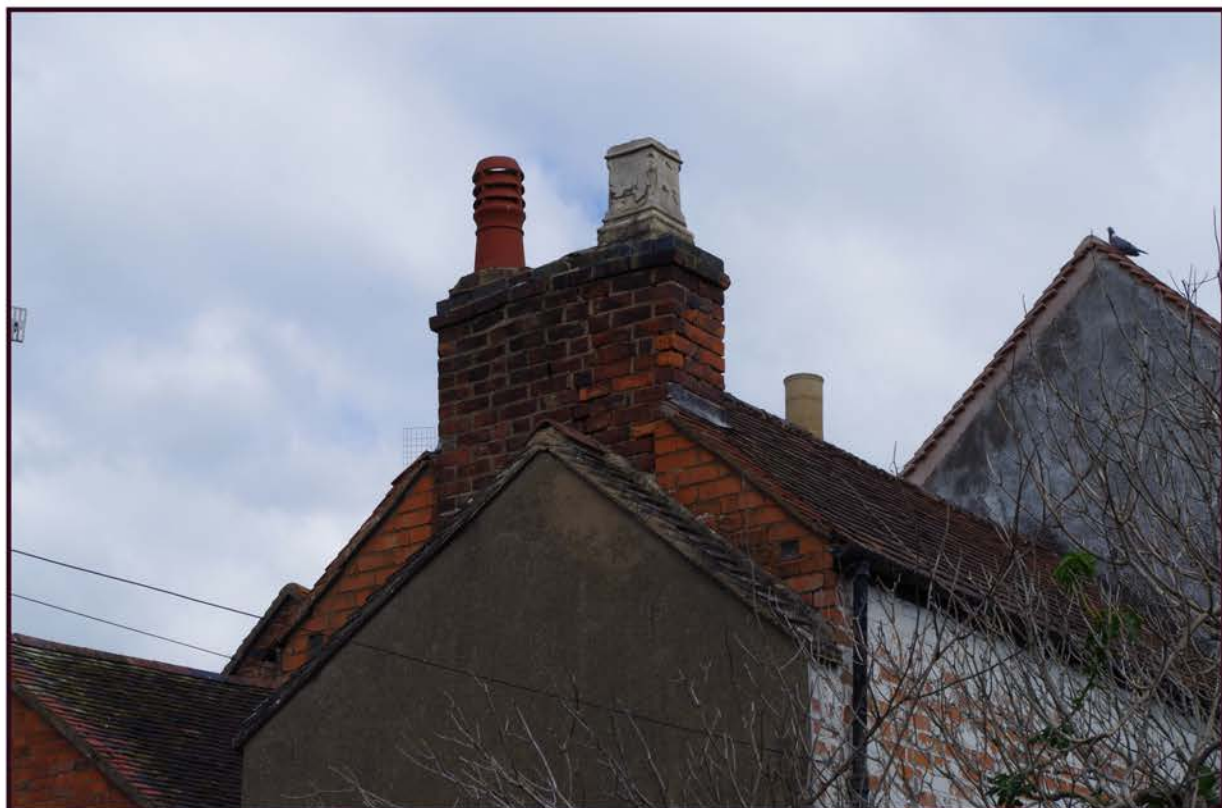
Fig 12: South elevation, detail of re-used chimney

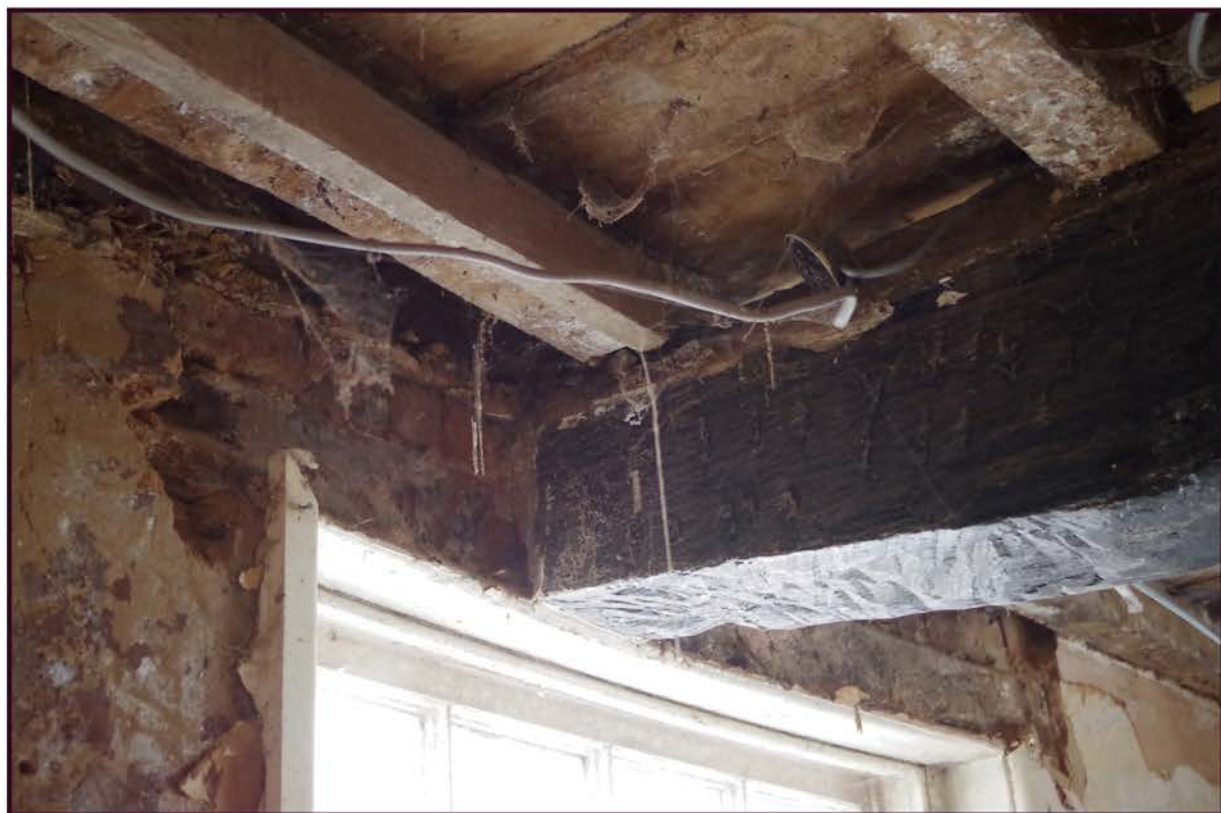
This comprised the fragmentary remains of a timber frame structure, mostly embedded in the eastern wall of the phase 2 structure (Figs 3.1: timbers 1, 2 and 3, Fig 3.2: timber 1, Figs 17, 29 and 35) but including a now redundant, roof truss (Figs 30 and 31) and a floor beam (Fig 32).

Fig 15: Ground floor; phase 1 timber frame re-used in phase 2 structure

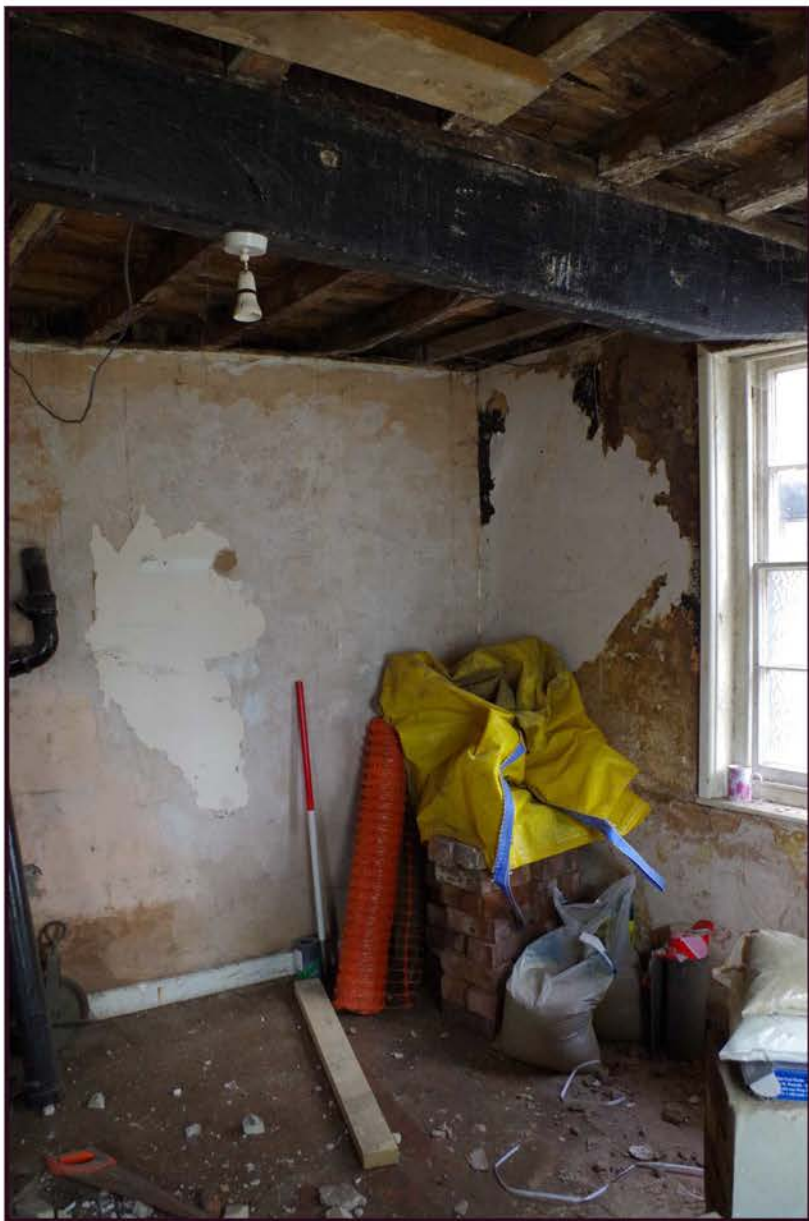
Fig 16: Ground floor; phase 2 structure with phase 1 timber frame

The internal arrangements are unknown but it is likely that the earlier arrangement of two-up-two down was retained, access being provided by a stair at the rear of the entrance hall (Fig 26), although a full-height first floor was adopted (Figs 27 and 28) with a former roof truss becoming part of a dividing wall (Figs 30 and 31) and a second floor being added (Figs 3.3 and 36). It was on the interior, however, where compromises clearly had to be made. The need for symmetrical window positions, occasioned by the Georgian house pattern, combined with the retention of elements of the earlier timber frame made clashes inevitable. On the ground floor, a floor beam terminates over a window opening (Figs 15 and 16) and a similar thing happens, though a little less dramatically, on the first floor (Fig 32).

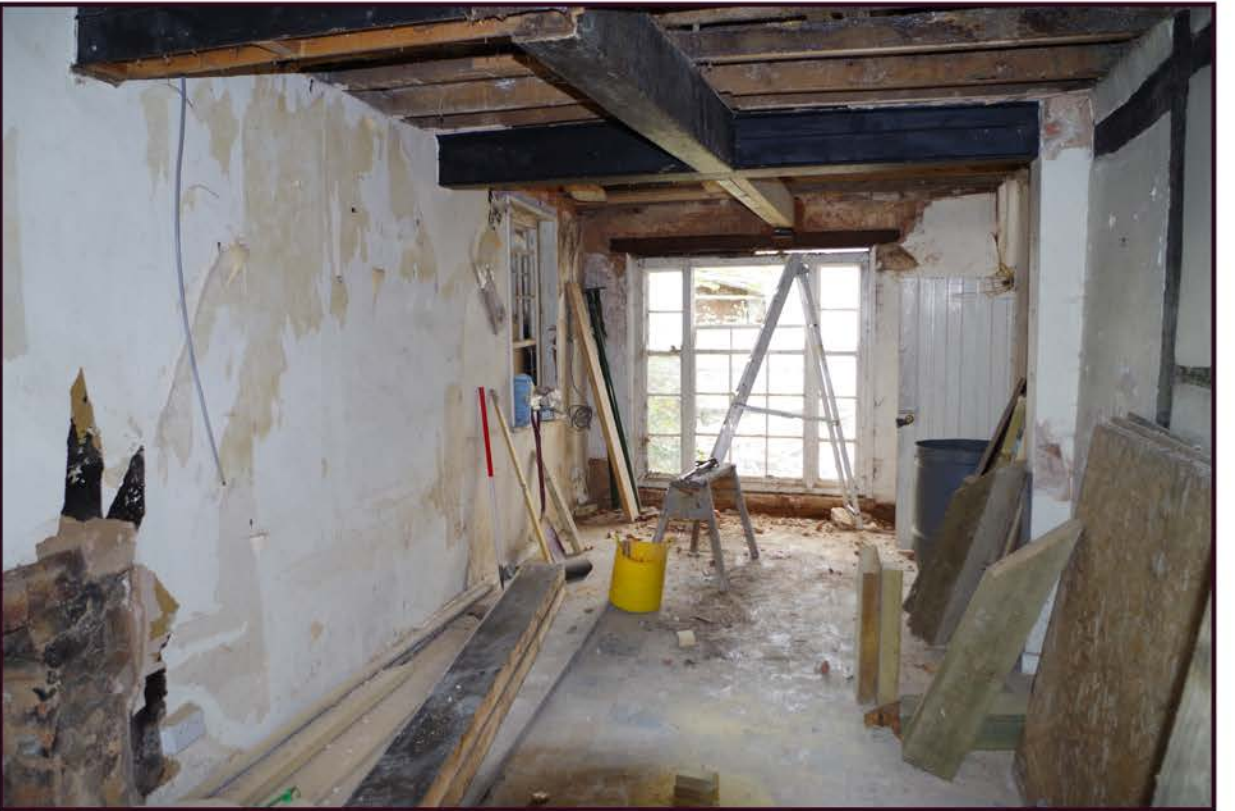
A rather awkwardly shaped dwelling was added against the eastern side of the phase 2 structure (Figs 3.1 and 25). This had to be fitted onto the available plot, which was an irregular quadrilateral, and this is reflected in the design. The front elevation (Figs 3.8 and 8), executed in English garden wall bond (the same as phase 2) had a central doorway (Figs 3.1 and 9; now blocked) and a window each on the ground and first floors on the southern end of the elevation. The windows were surmounted by single brick arches (again the same as the phase 2 structure). No windows were possible on the northern end of the elevation as this was occupied by a chimney.

Fig 25: Ground; phase 3 structure

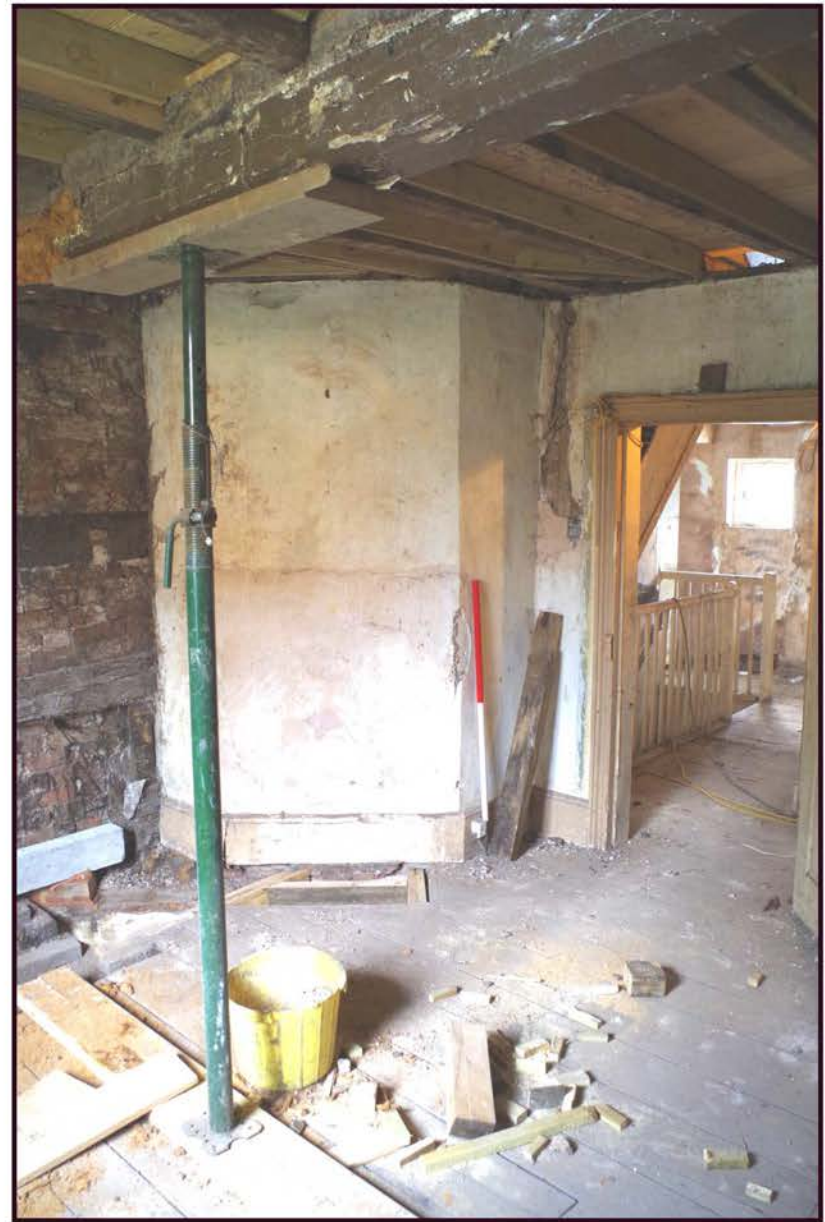
This phase relates entirely to internal conversion. A substantial corner hearth was added in the corner of the northern rooms of the phase 2 building (Figs 3.1 and 27). At the same time the northern wall of the entrance passage was re-aligned to meet the new hearth (Figs 3.1 and 18). The original door from the entrance passage to the southern room was blocked (Figs 3.1 and 19) and a new one made adjacent to the stairwell. It is believed that the entrance door to the phase 3 structure was blocked at this time and the two properties were linked by the creation of a new doorway at the northern end of the dividing wall between them. At the same time, the cellar was extended to the east and a coal chute provided (Figs 3.4 and 42).

Fig 27: First floor; phase 2 structure with phase 4 fireplace

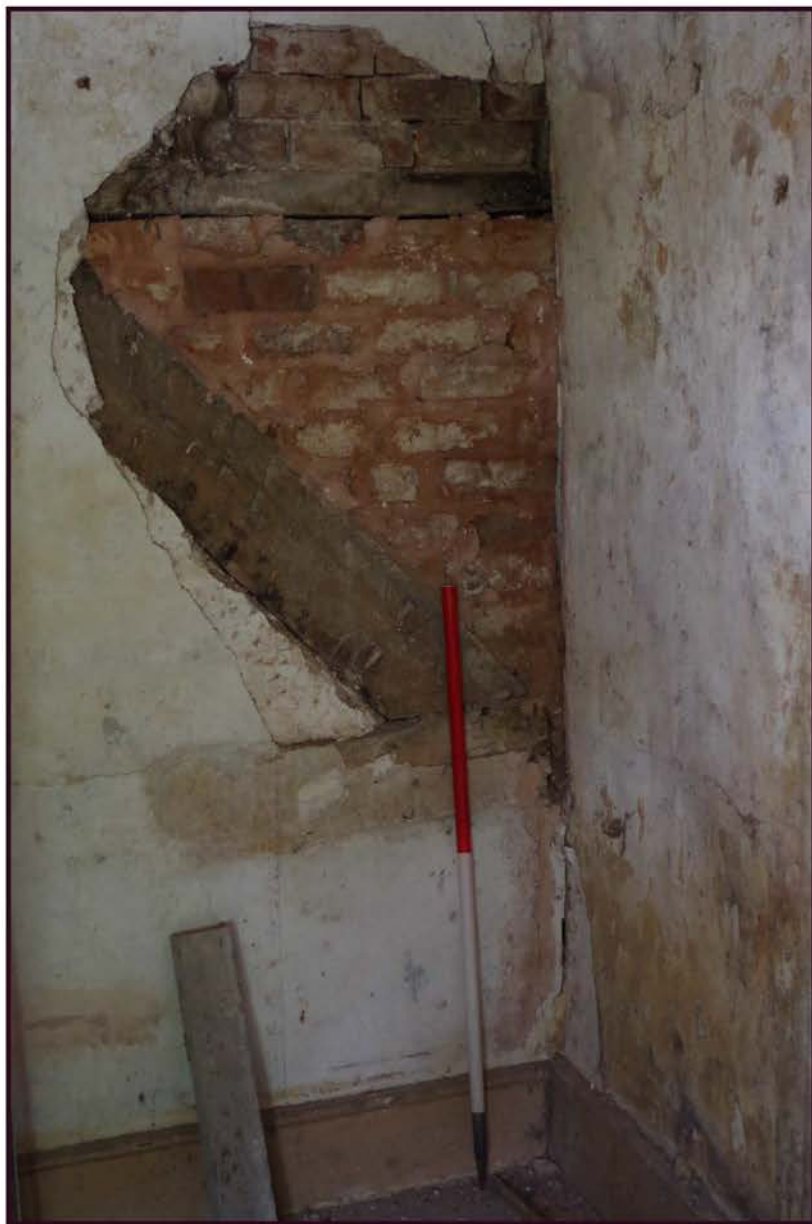
Fig 30: First floor; phase 1 roof truss

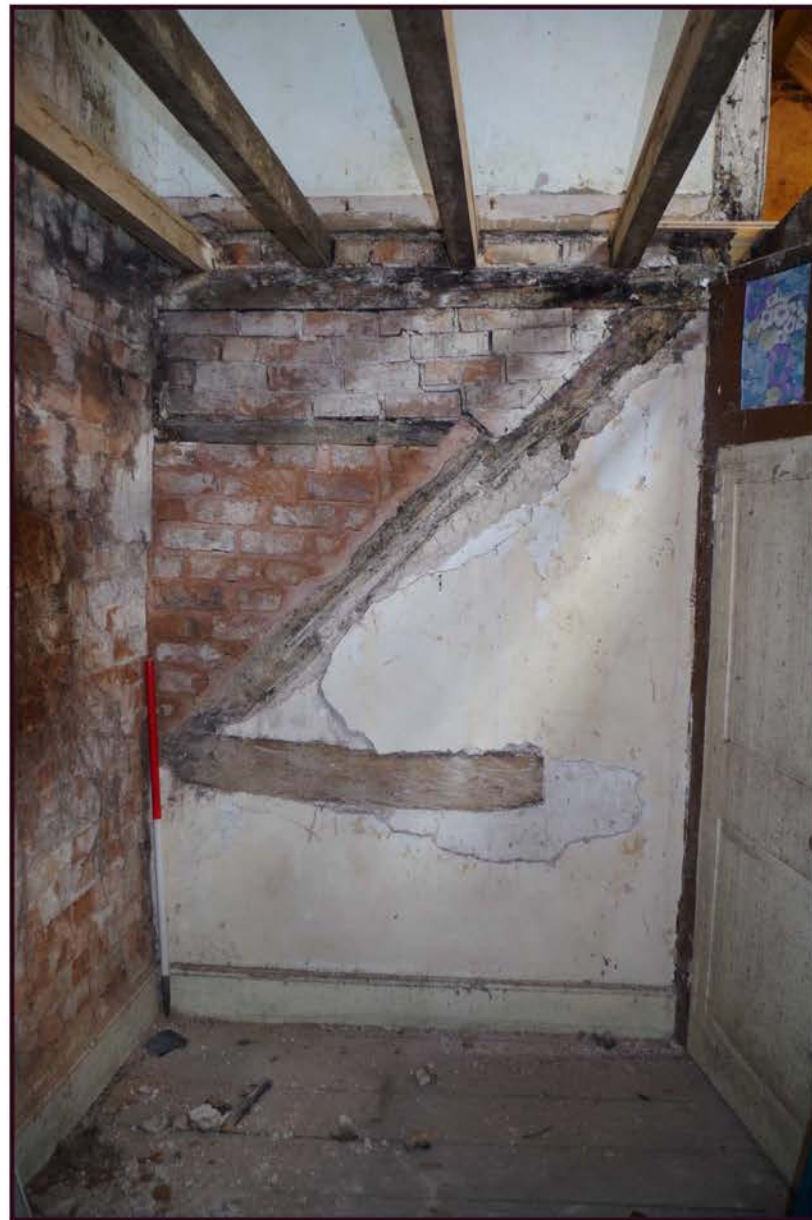
Fig 31: First floor; phase 1 roof truss

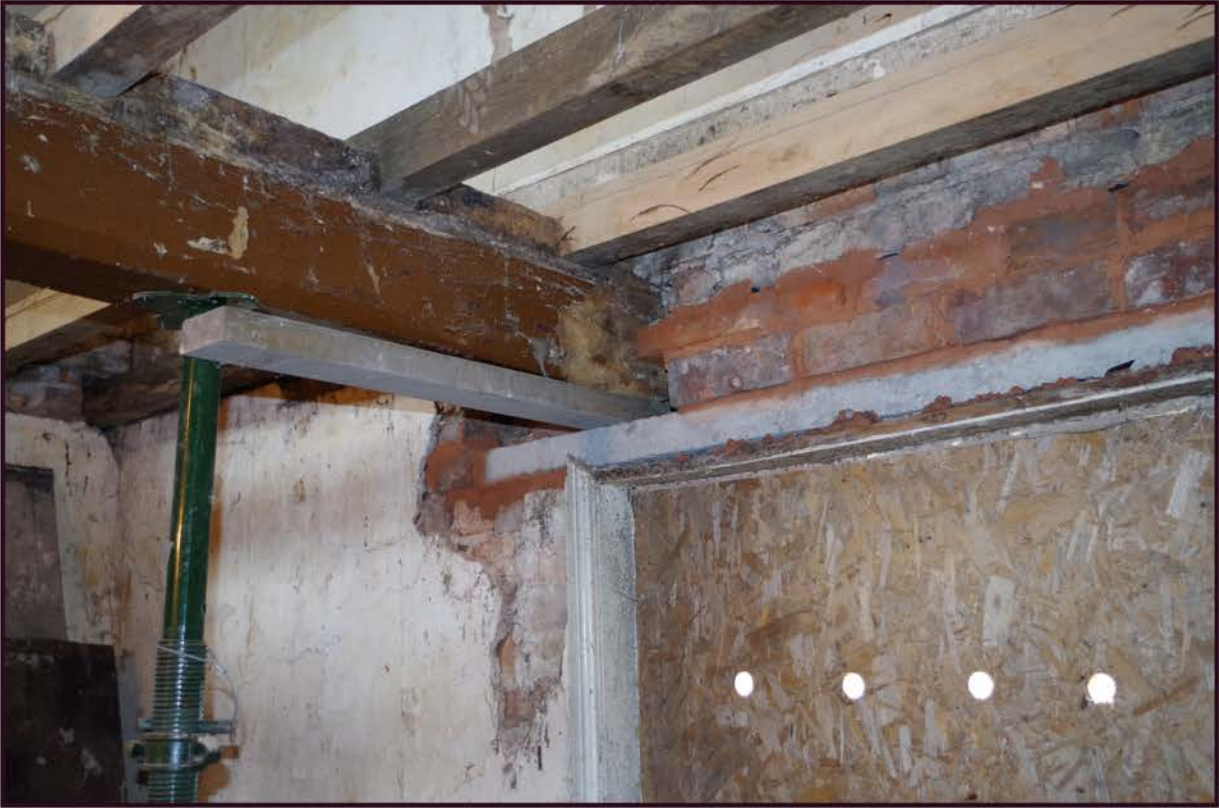
Fig 32: First floor, phase 1 floor beam

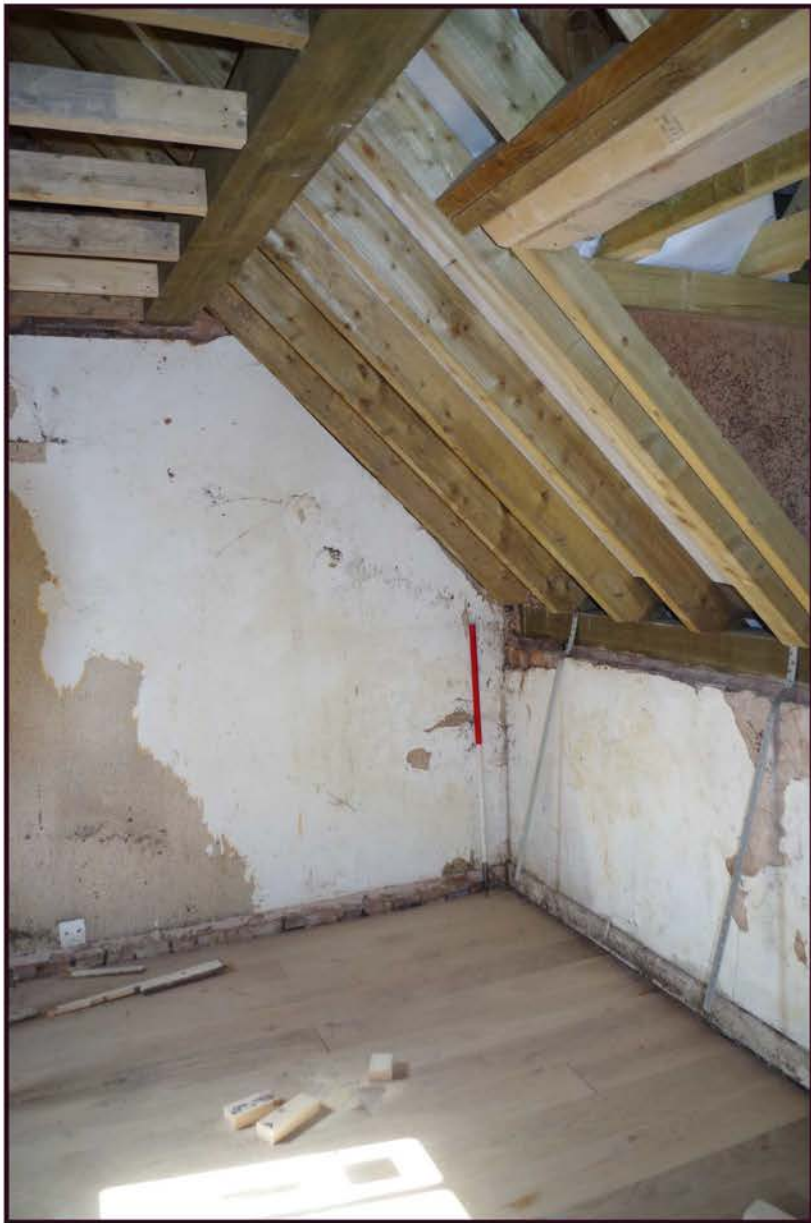
Fig 38: Second floor; phase 2 structure

Heating was limited. On the ground floor was a hearth, served by the chimney already referred to above. This was near the northern end of the accommodation and must have been ineffective towards the south. Similarly, on the first floor, an entirely separate hearth was provided in the north-eastern corner of the floor (Figs 3.2 and 34). There did not appear to be any means of heating provided for the second floor (Fig 37) which, in addition, had only the smallest of windows in its southern wall (Figs 3.6, 11, 13, 38 and 39).

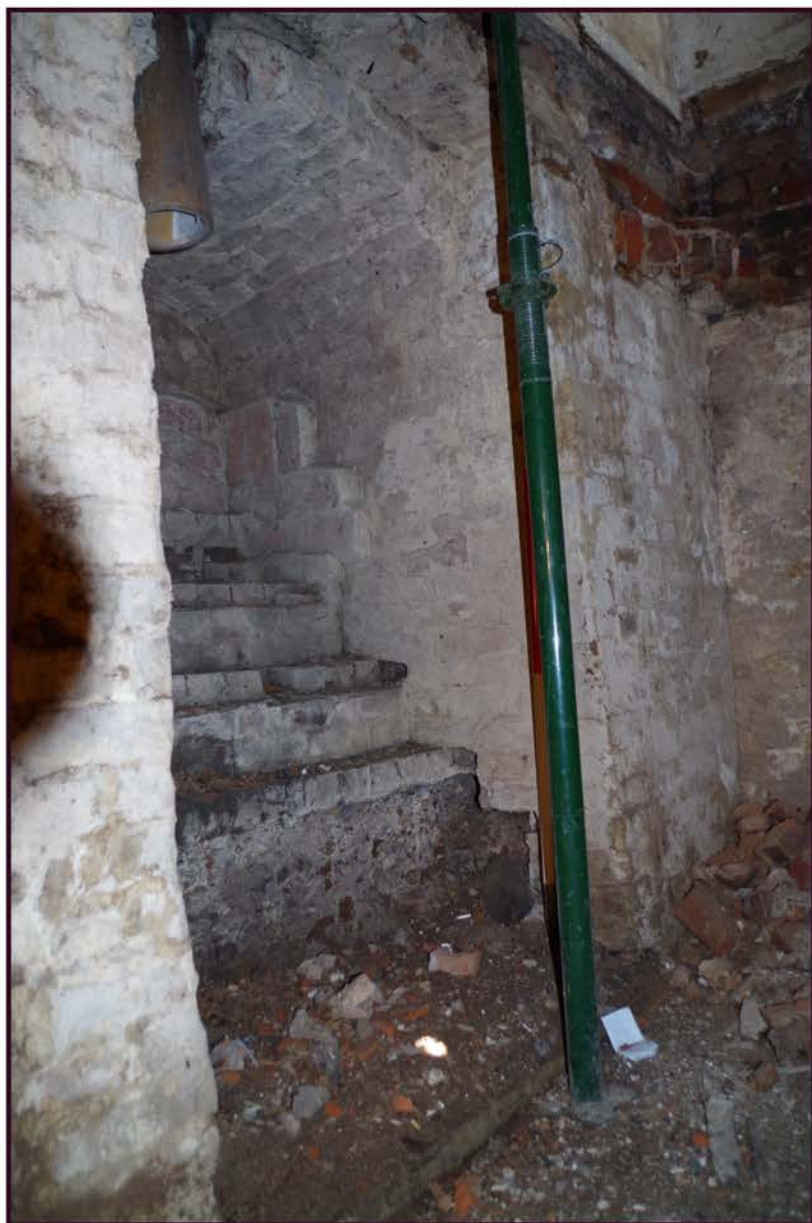
Fig 42: Cellar; coal chute associated with phase 3 structure

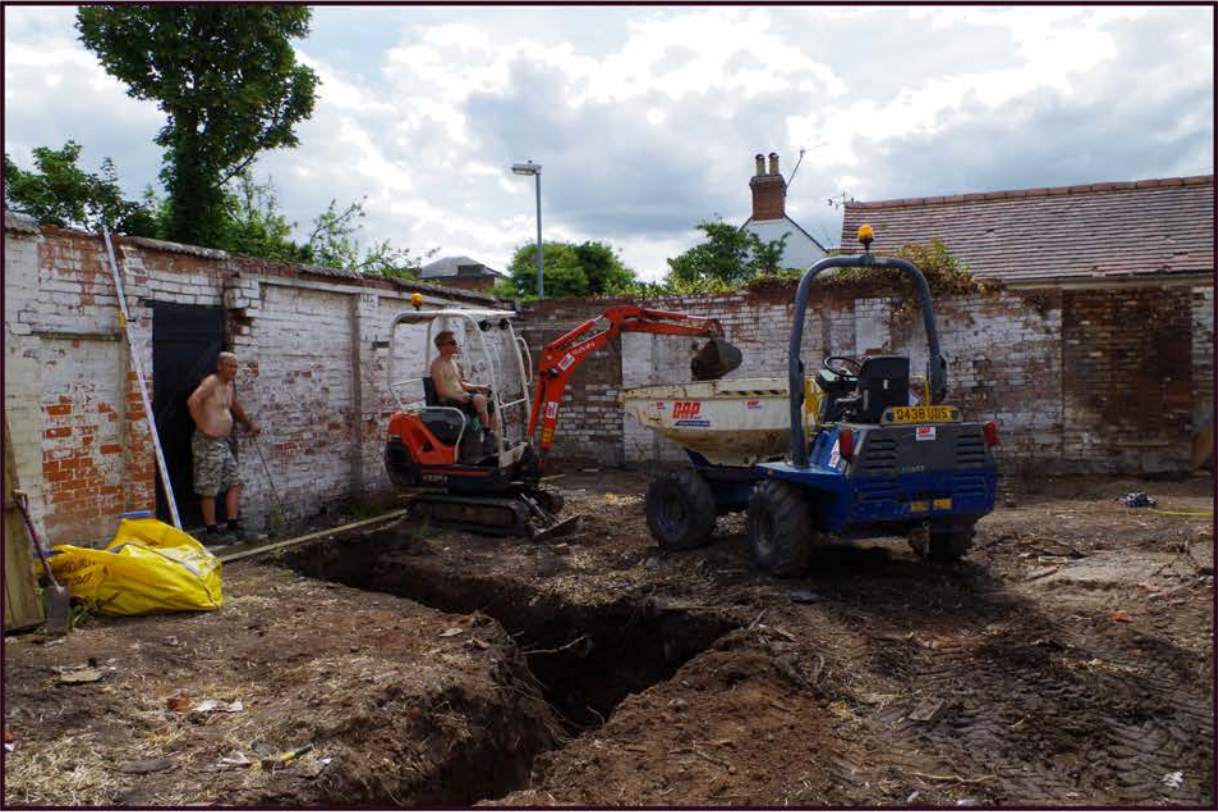
A watching brief was maintained on the excavation of the footings for the new-build properties at the southern end of the property (Figs 3.9 and 43). Two sections were drawn, at either end of the development (Fig 3.10, sections 1 and 2 and Fig 44). Although various structures are shown on the historic mapping (eg Fig 2.4), these were insubstantial in nature, (eg Fig 14) and were not reflected in the below-ground deposits.

Fig 43: General view of excavation of footings

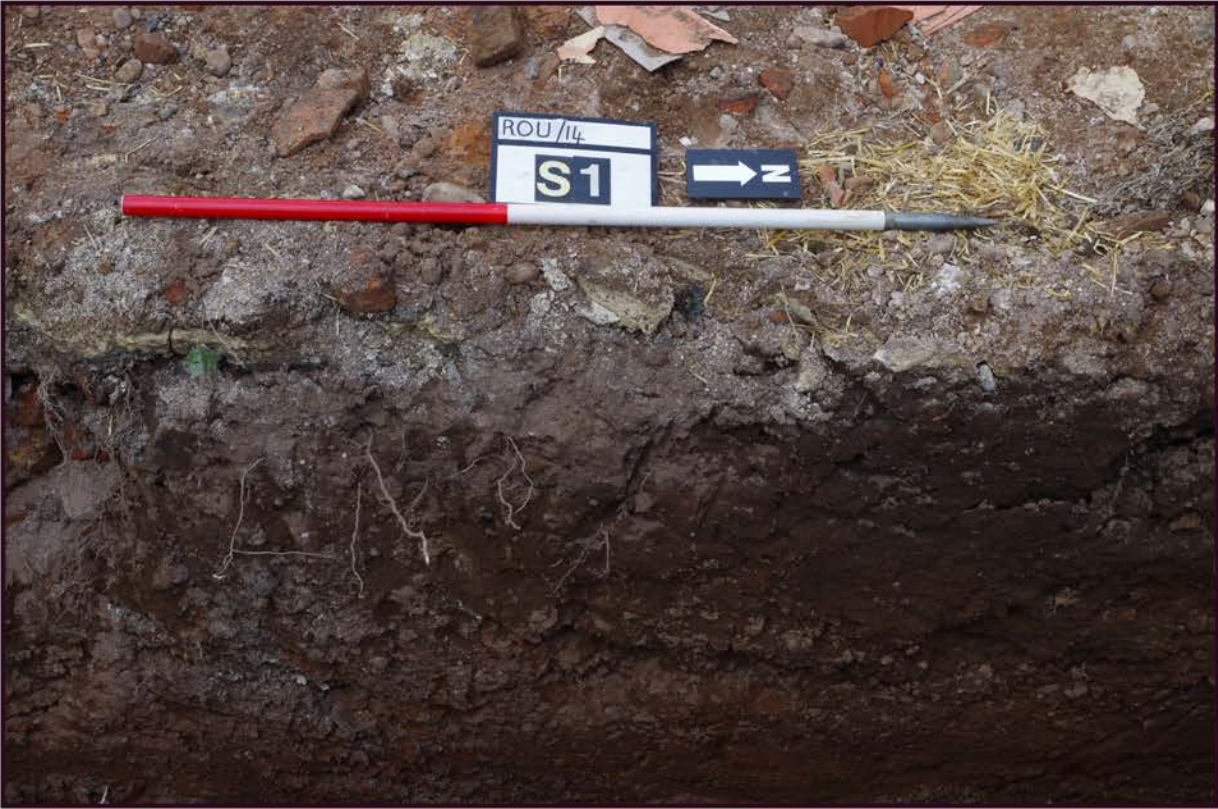
Fig 44: Section 1
