# Programme of archaeological work at Whitehouse, Church Street, Eckington, Worcestershire

10th April 2015 Revised 27th April 2015

WSM 46071 and 46072

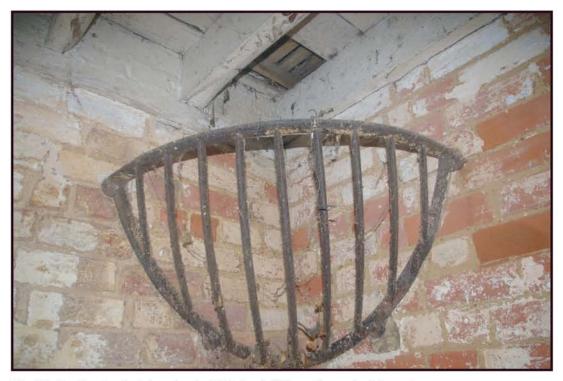
The interior was plain except for a hay basket in the north-west corners of both cells (Figs 4.3, 17 and 18). The hay basket in the northern cell (Figs 4.3 and 17) had a small, closable trapdoor in the floor above it.

Fig 17: Feeding basket showing hatch in hayloft floor for replenishment

The form of the rack and manger were the subject of some discussion. The normal sloping rack was generally condemned, as it allowed seeds to fall into the horses' eyes and ears. The difficulty was avoided if the rack were vertical. There were objections to the racks and mangers being carried across the stalls as they were always filled, providing more than the horse needed and so wasting hay. There was also the danger of poll-fever from having the smell of hay under their noses all the time. To resolve this issue corner racks were proposed which contained only enough for feeding. This was the arrangement at the White House.

Lofts are found in all stables surviving from before 1773 in lowland Staffordshire. They were generally provided to contain hay or straw, which was dropped into the rack from above, provision for which was made at the White House. The loft helped to keep the stable warm. The reason for this was that whilst cows would probably be tied up most of the winter and so keep the cowhouse warm, horses were out during the day and would return warm to a cold stable. Charles Waistell, an agricultural commentator of the early 19th century, while objecting to a ceiling over a waggon stable, preferred one over the hackney, as these horses were more susceptible to cold (Waistell 1827). The floor of the loft was generally well-made to prevent dust falling onto the horses below. Sometimes a plaster floor or ceiling was used.

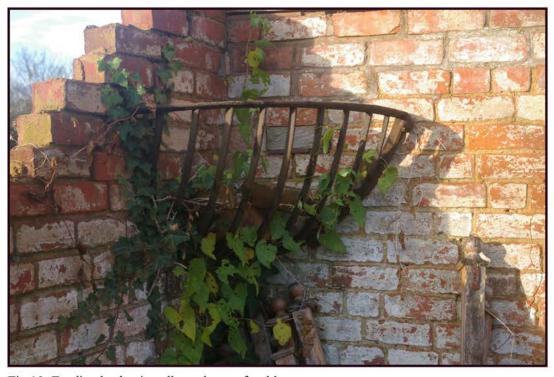
Fig 18: Feeding basket in collapsed part of stable
