**Historic building recording  
at Market House,  
New Road,  
Kidderminster,  
Worcestershire,  
DY10 1AE**

# **Historic building recording at Market House, New Road, Kidderminster, Worcestershire, DY10 1AE**

The project was undertaken in advance of the proposed alteration of the building (Wyre Forest District Council, planning ref 15/0119/FULL). A Level 3 project was undertaken.

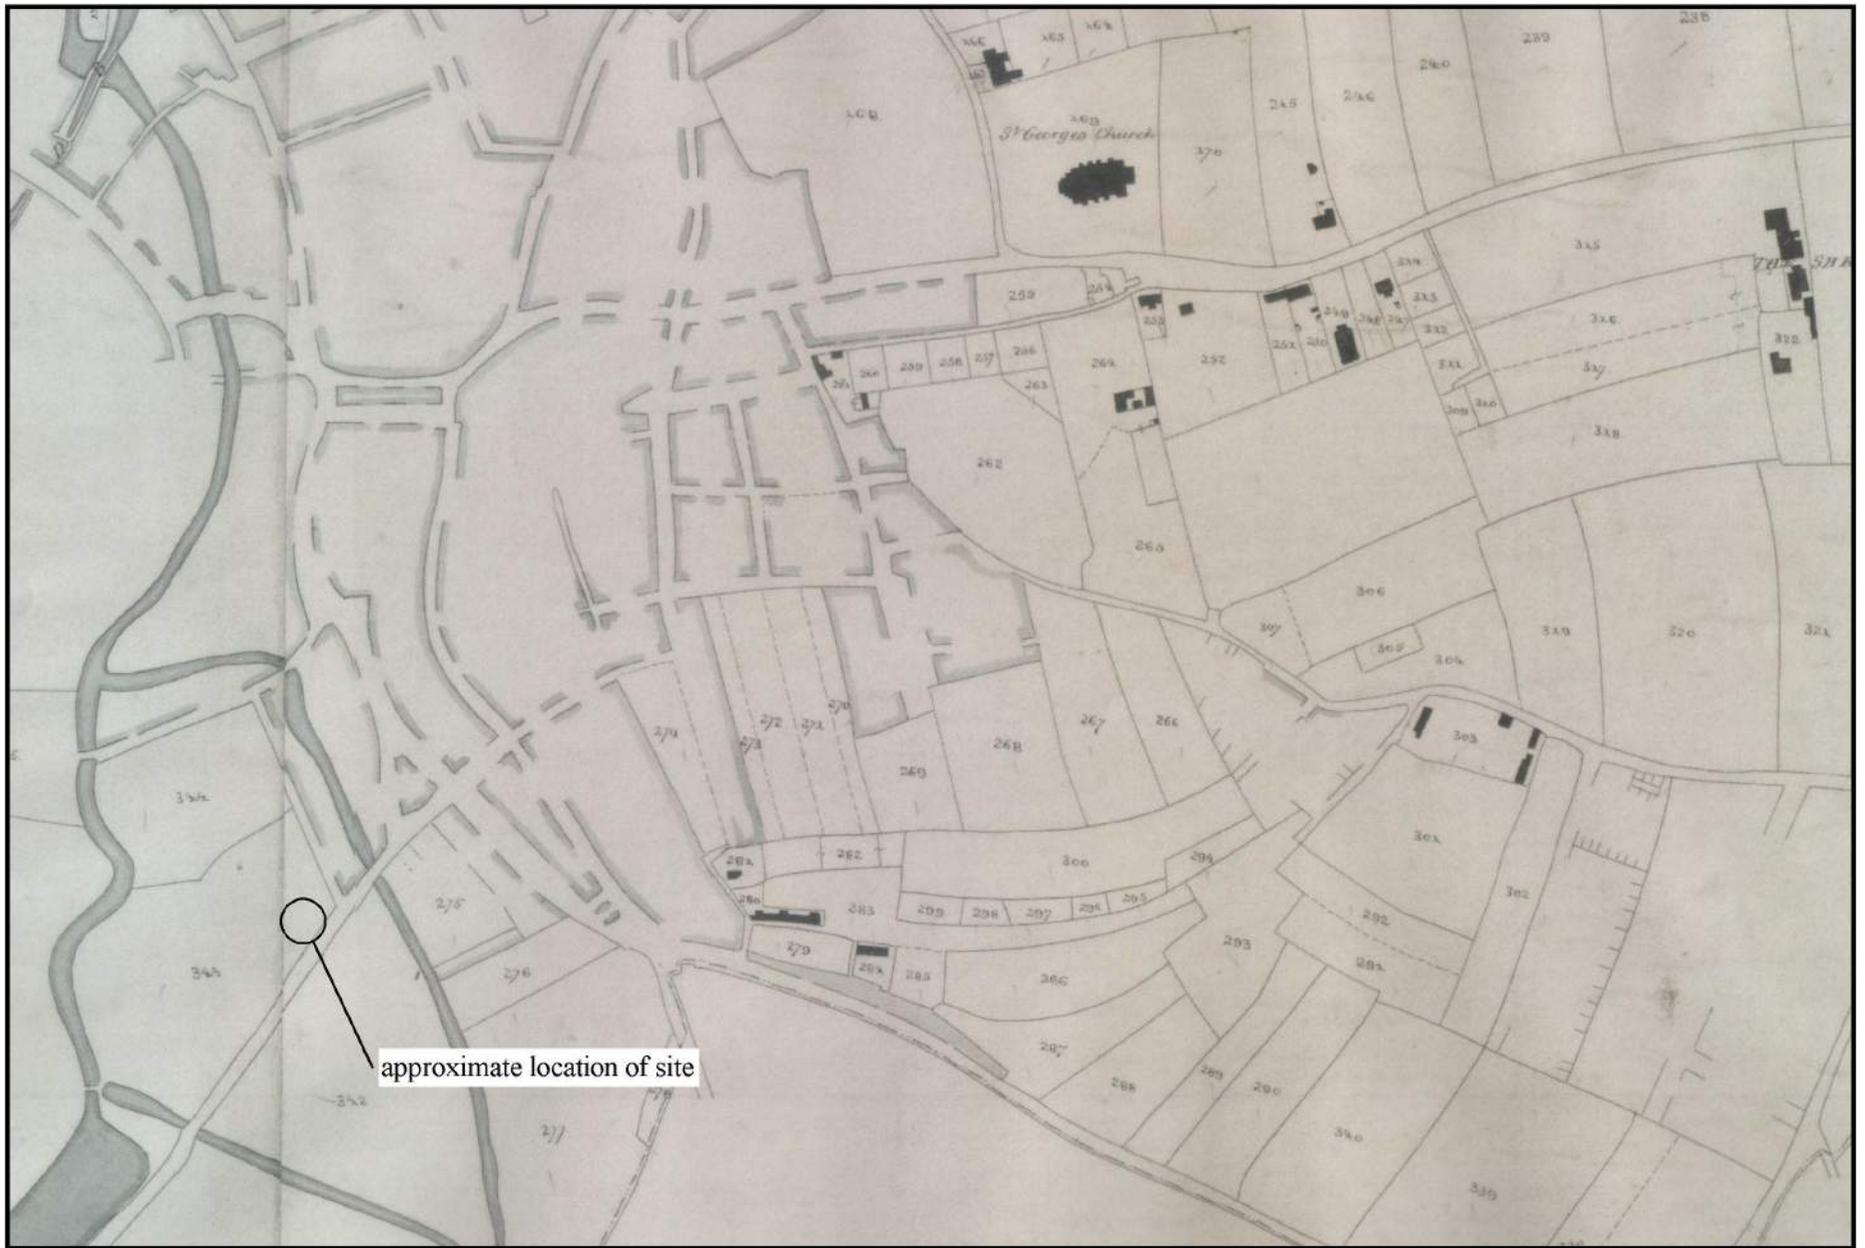
Fig 2.1: Kidderminster tithe map of 1829

The earliest available map was the Kidderminster tithe map of 1829 (Fig 2.1). This shows New Street and Market Street but no details of any buildings. The area where Market House now stands was known as Brick Kiln Meadow. The 1st edition Ordnance Survey map of 1889 (Fig 2.2) shows the Market House, its associated stable and the adjacent cattle and vegetable market. The Ordnance Survey maps of 1902, 1924 and 1938 (Figs 2.2 and 2.3) show no significant changes.

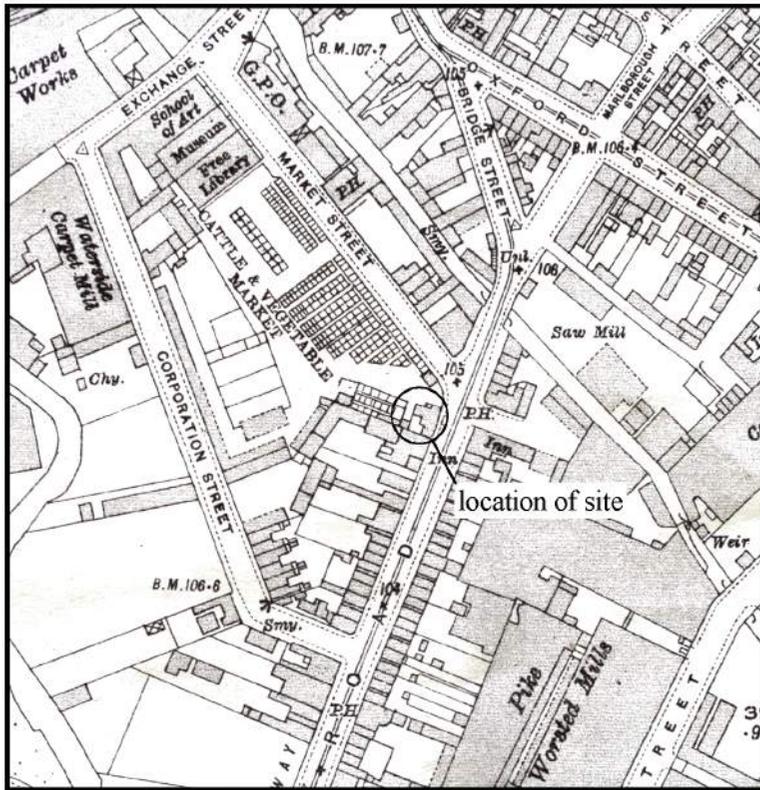
1924

Fig 2.3: Historic mapping

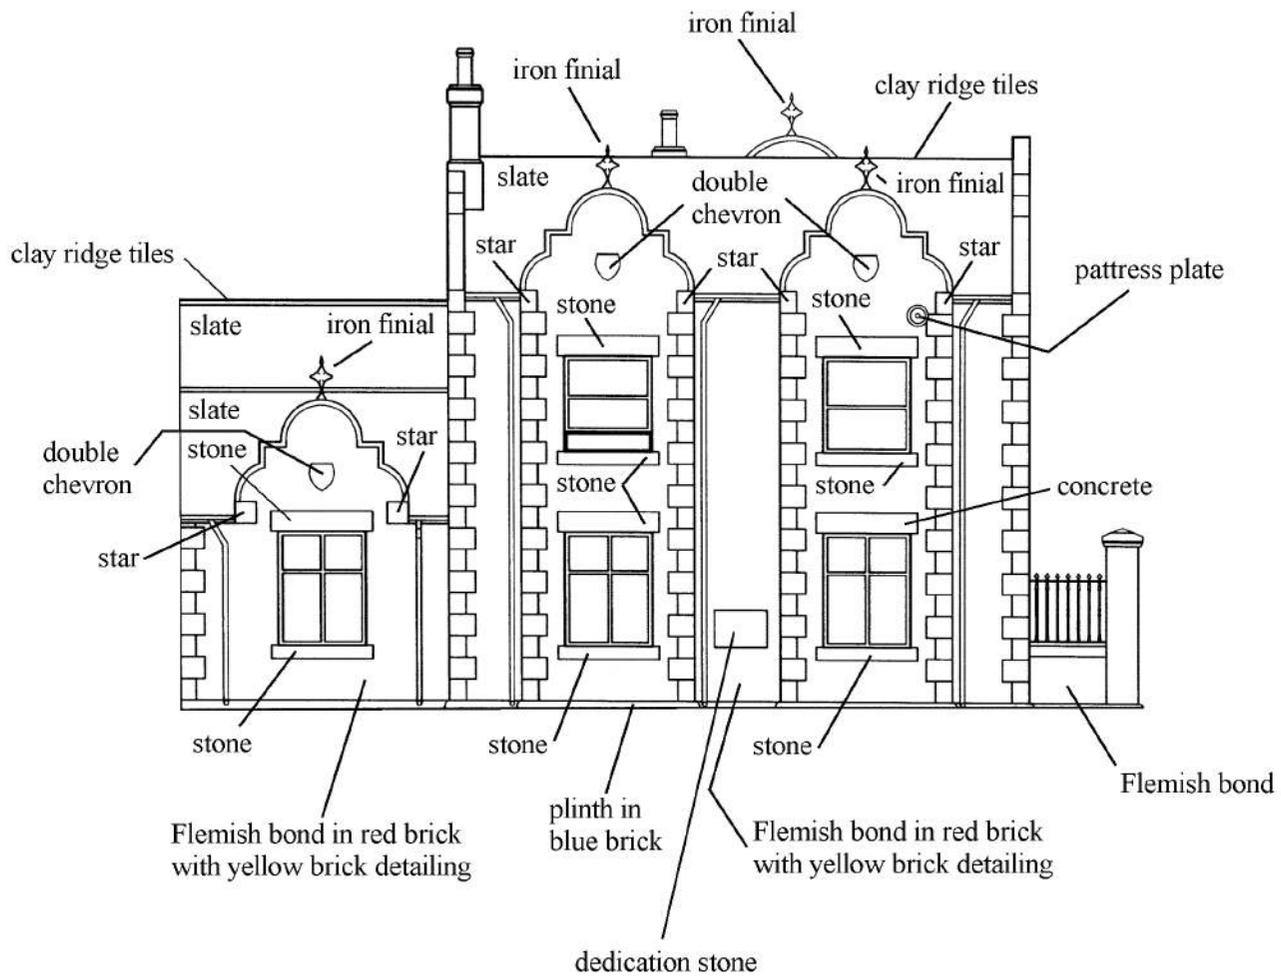
Fig 3.1: East elevation

The principal part of the east elevation (Figs 3.1 and 5) is symmetrical and executed in an Italian Renaissance style, previously popular in the late 16th and early 17th centuries. There is a contemporary, single storey extension on its southern end. Both were executed in Flemish bond in red brick with yellow brick detailing. Arrises, lintels and sills are of stone. Decoration comprises stone shields with double chevrons in the centre of each pediment (Figs 3.1 and 13). These are a representation of the coat of arms of Kidderminster Borough Council (*Azure two Chevrons Or each charged with five Pellets between in chief two Shuttles chevronwise Or threaded Gules and in base a Bee volant Or*).

There are stars on the springing of the pediment coping (Figs 3.1 and 12). The top of each pediment is further enhanced with an iron finial (Figs 3.1 and 11). In the centre of the principal part of the elevation is a dedication stone (Figs 3.1 and 14):

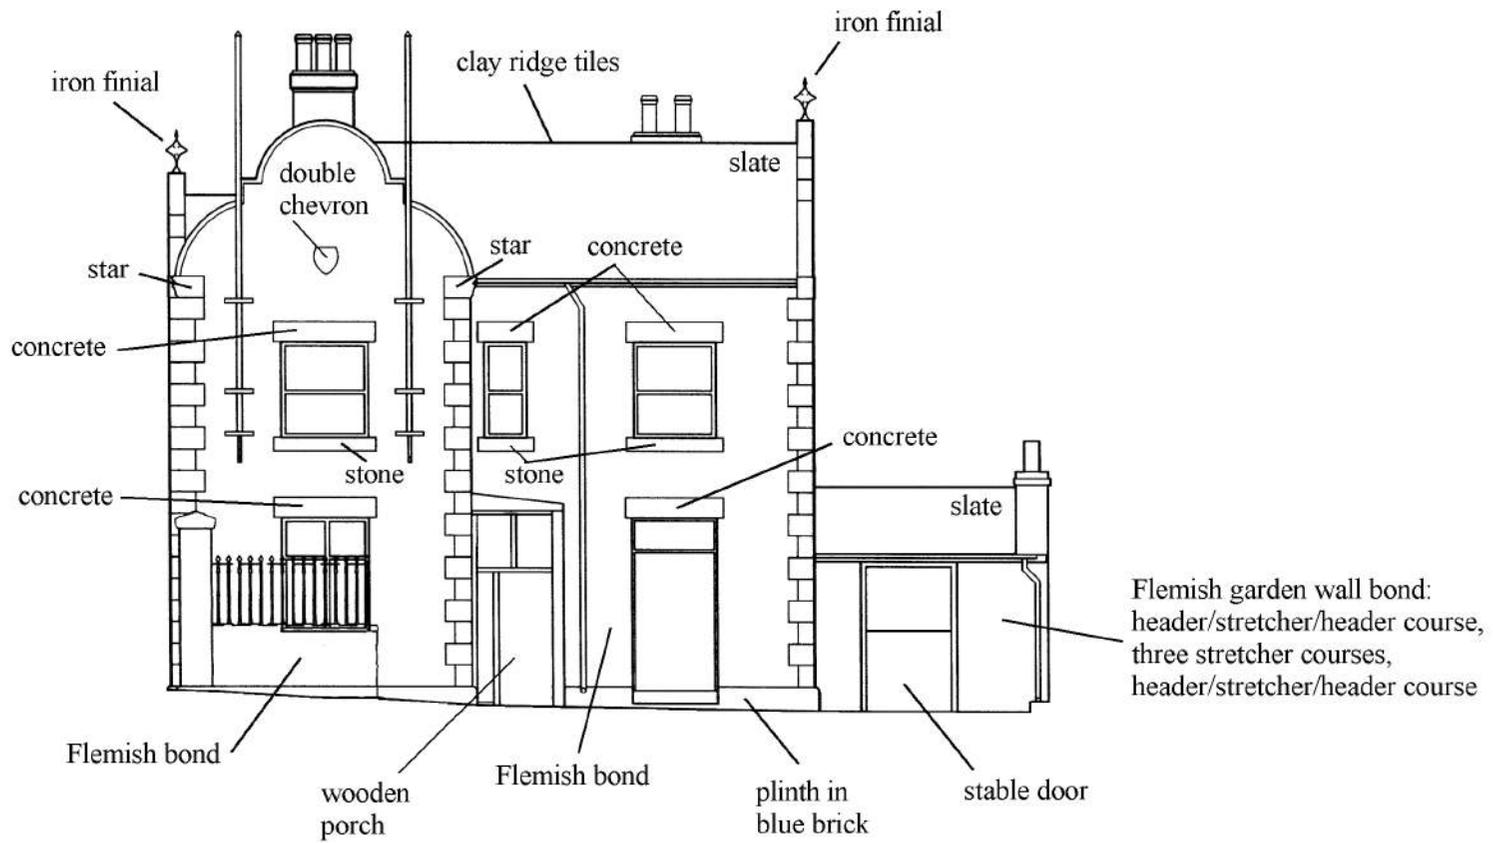
Fig 3.2: North elevation

All the principal features of the north elevation are the same as the east elevation (Figs 3.2 and 6). All of the lintels, however, have been replaced with concrete. Unlike the east, this elevation is a 'working' elevation and has two entrances, one now blocked. The surviving entrance in the centre of the elevation (now obscured by a wooden porch - see below - *Phase 2*) is the entrance to the domestic areas of the building. The other gave access to the north-west room from the exterior, without having to pass through the domestic apartments. This was the room devoted to the business of the market. This point will be returned to below (**Discussion**).

The western doorway was blocked and a wooden porch was erected in front of the central doorway (Figs 3.2 and 6). These changes are believed to relate to the conversion of the building to the Royal Air Force Association (RAFA) Club (see below - **Discussion**).

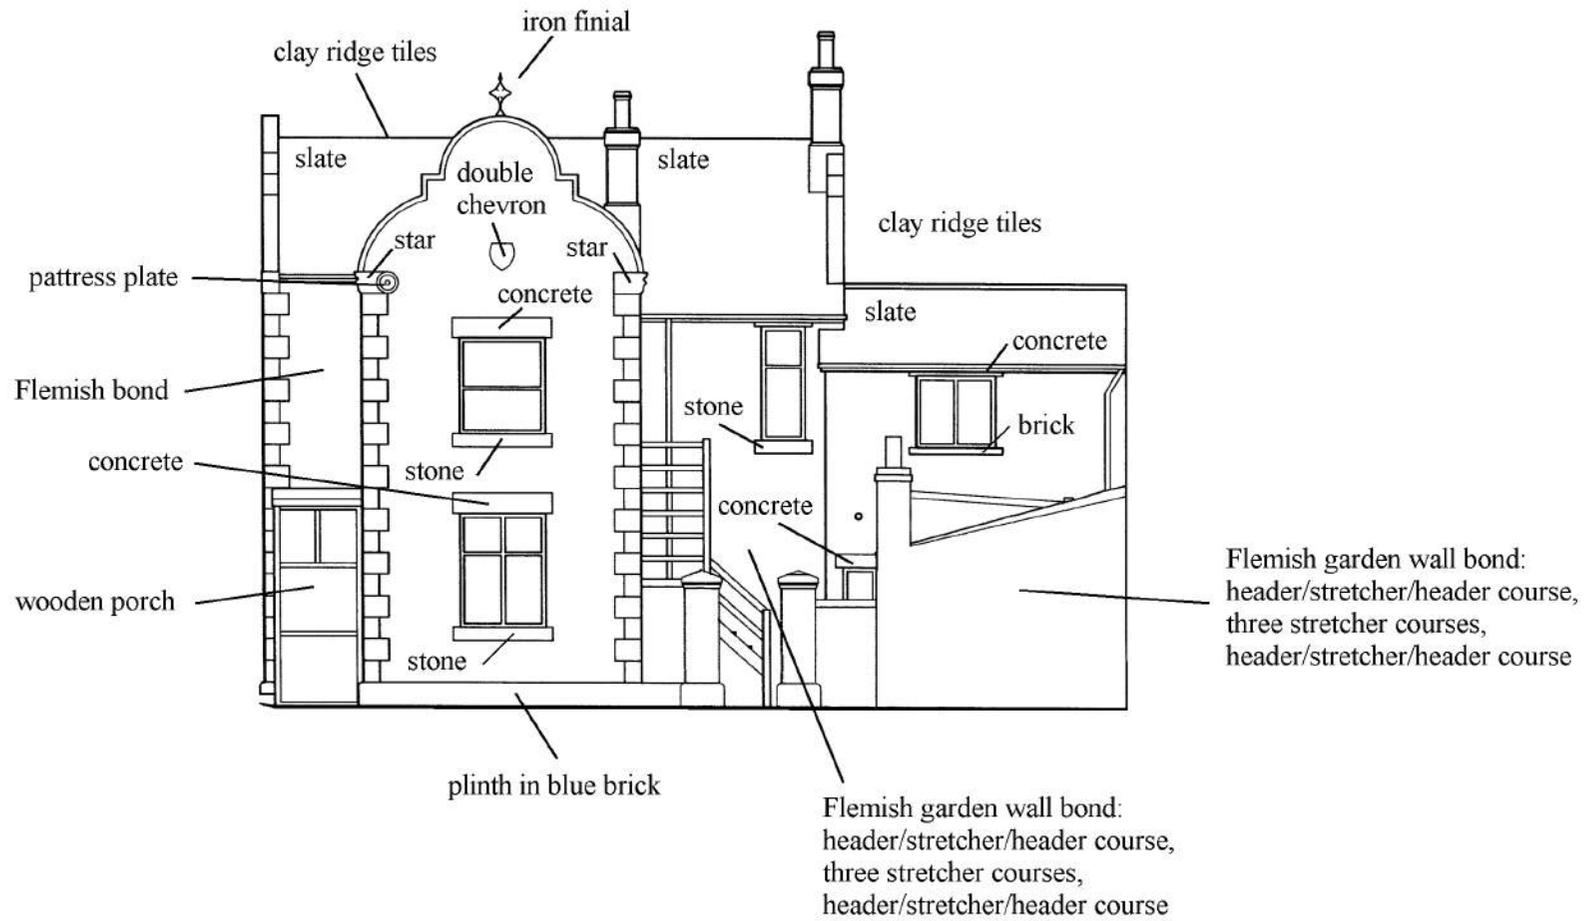
Fig 3.3: West elevation

Similarly, all the principal features of the west elevation are the same as the east and north elevations (Figs 3.3 and 7), although the southern half of the elevation (that part of it behind the

stable and within a yard) is rendered in Flemish garden wall bond. Again, all of the lintels have been replaced with concrete

Apart from the porch already referred to above, a fire escape was erected in the yard, presumably associated with the RAFA Club (Figs 3.3 and 9).

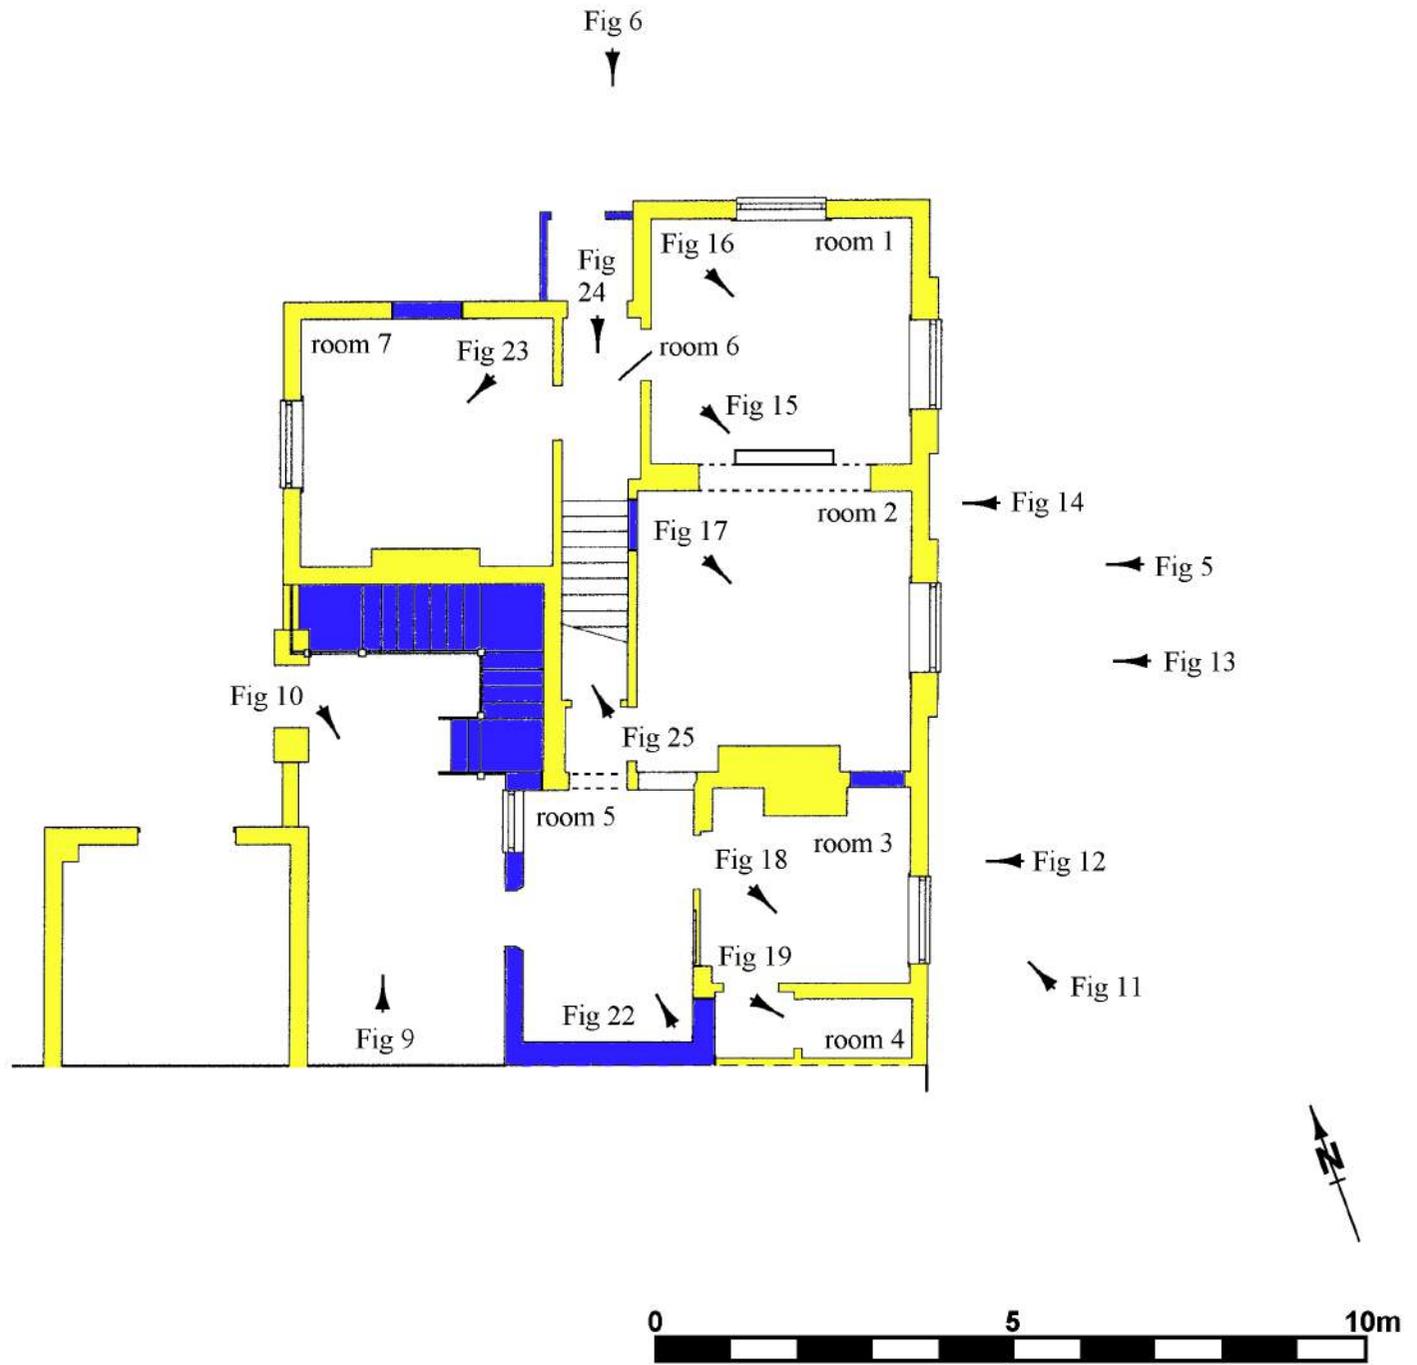
Fig 3.4: Ground floor

Room 1 is entered from the left-hand side of the hallway (Room 6) and has windows on its north and east sides. In phase 1 there was a continuous wall on its south side with a fireplace, now marked by the remains of the hearth (Fig 15). Being immediately adjacent to the principal entrance, it is likely that this was the 'sitting room' of the domestic accommodation.

Room 2 has a window in its east side only (although it is possible that it had another in its south-west corner, converted to a serving hatch in phase 2) and was originally entered from a door in its north-west corner, at the foot of the original staircase; that door now blocked and a new staircase (phase 2 – see below) inserted across it. It had a fireplace in its south wall. Having direct access to the original kitchen (room 3) *via* a now blocked doorway, it is likely that this was the 'dining room' of the domestic accommodation.

Room 3 had a window in its east and west sides and doors in its north (from room 2), south (giving access to the outside toilet; room 4) and west (giving access to the yard).

This was approached *via* a doorway from room 3, by a doorway in its west wall and also, originally, from the yard. It had no windows but made use of a vent above its doorway to provide some illumination.

Room 6 is entered from a doorway in its northern end and originally gave access to rooms 1, 2 and 7 and also to the stair to the first floor. The original stair had to accommodate the original entrance to room 2 at its foot and must, therefore, have been steeper (Fig 25).

Room 7 has a window on its west side only (over looking the market) and originally had doorways in its east side (to room 6) and in its north side giving access from the market without having to pass through the domestic accommodation. It had a fireplace on its south wall. This would have been the 'settling room' for the market where buyers paid the sums that they had bid for the animals and produce.

The south wall and its associated fireplace was removed to form a large meeting/dining room.

The north wall was removed to form a large meeting room for the RAFA Club. Its original doorways in its north-west and south-east corners were blocked, the former to accommodate a new staircase; the latter because alternative access to an enlarged kitchen (see below, room 5) was to be provided. The window in its south-west corner was remodelled to form a serving hatch.

The original doorway in its north-east corner was blocked. The original doorway into the yard was opened-up to provide better access to the enlarged kitchen (room 5).

An extension was erected in the original yard, providing an enlarged kitchen. This blocked the access to the toilet from the yard.

As noted above, the original staircase was replaced, presumably with one with modern rises and goings.

The doorway in the north wall was blocked.

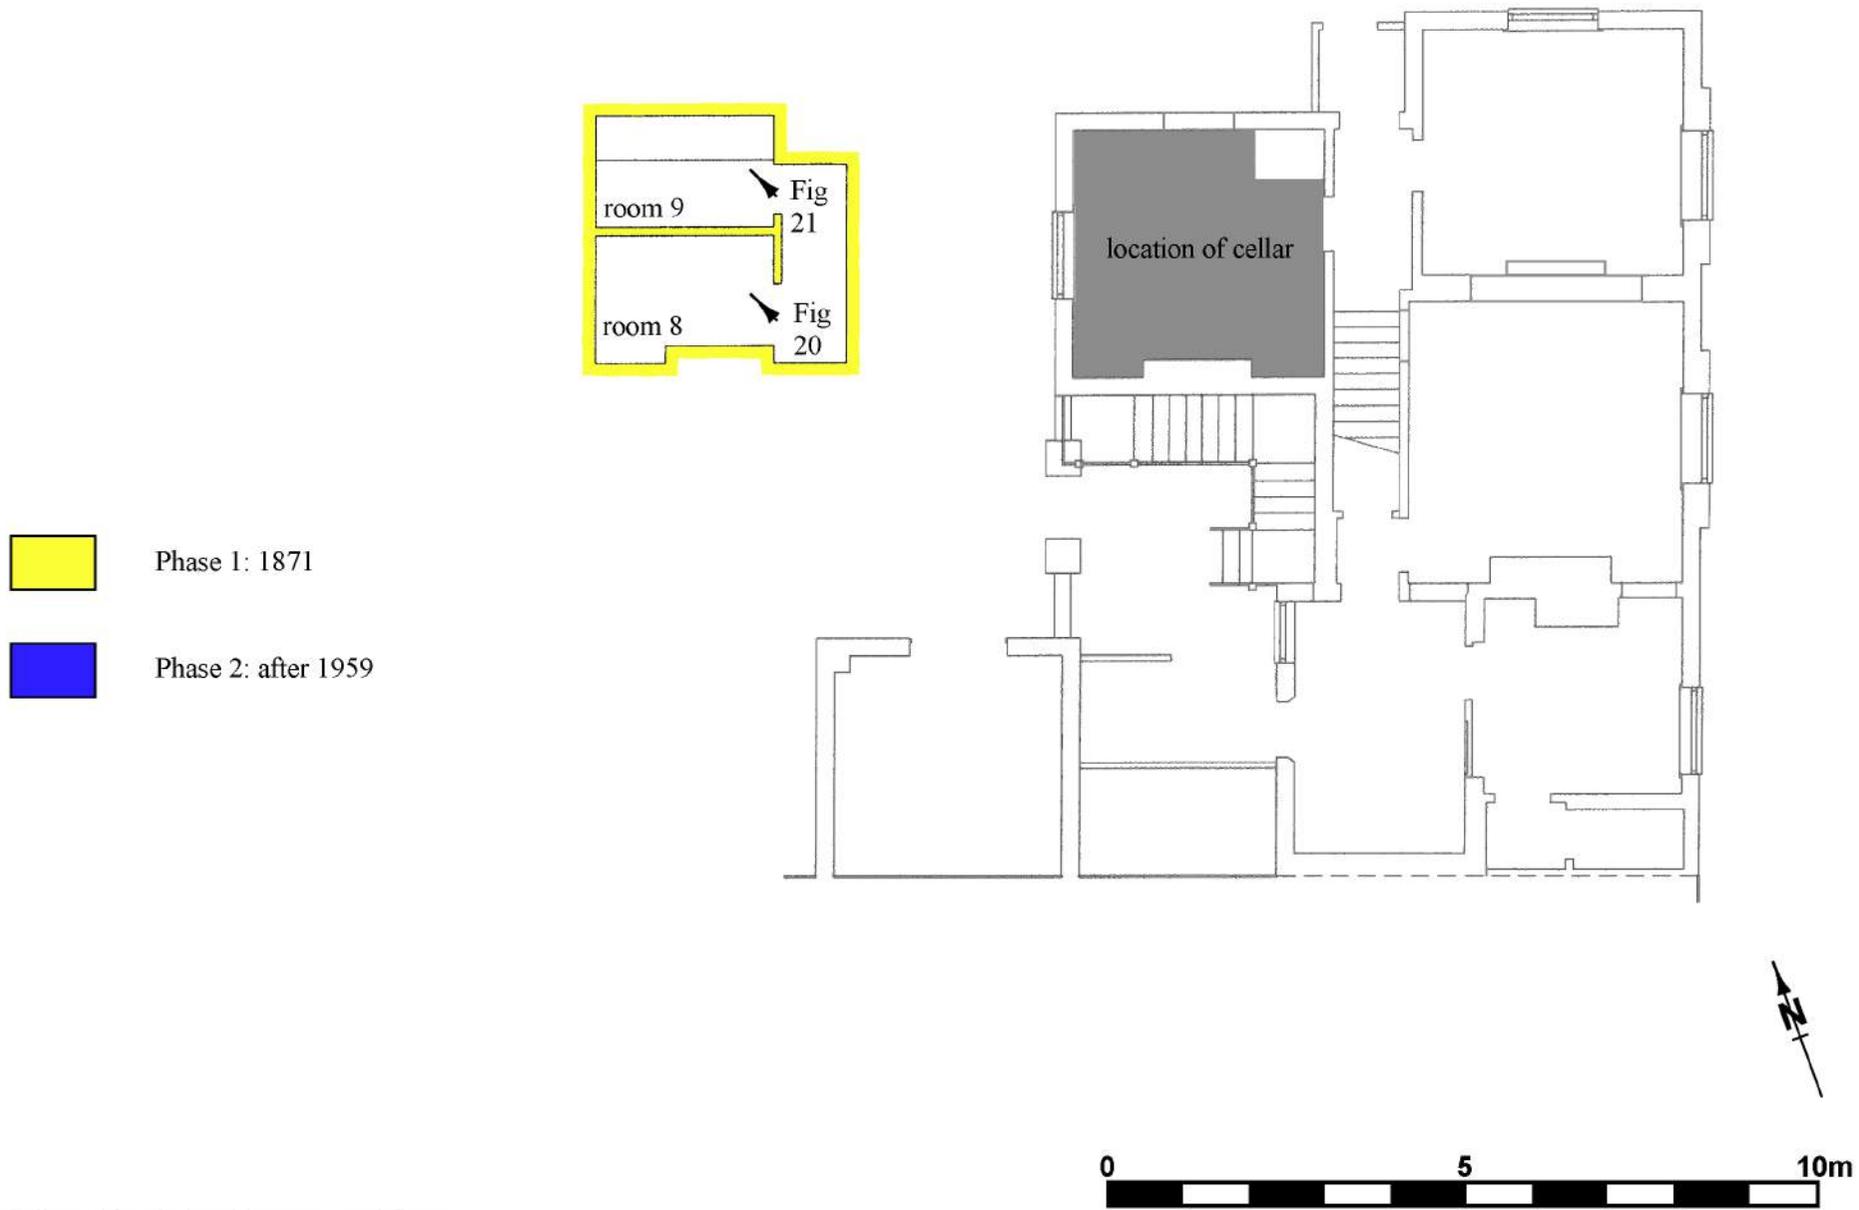
Fig 3.5: Cellar with relationship to ground floor

This rectangular space was used for coal.

This rectangular space was used as a larder and cool store.

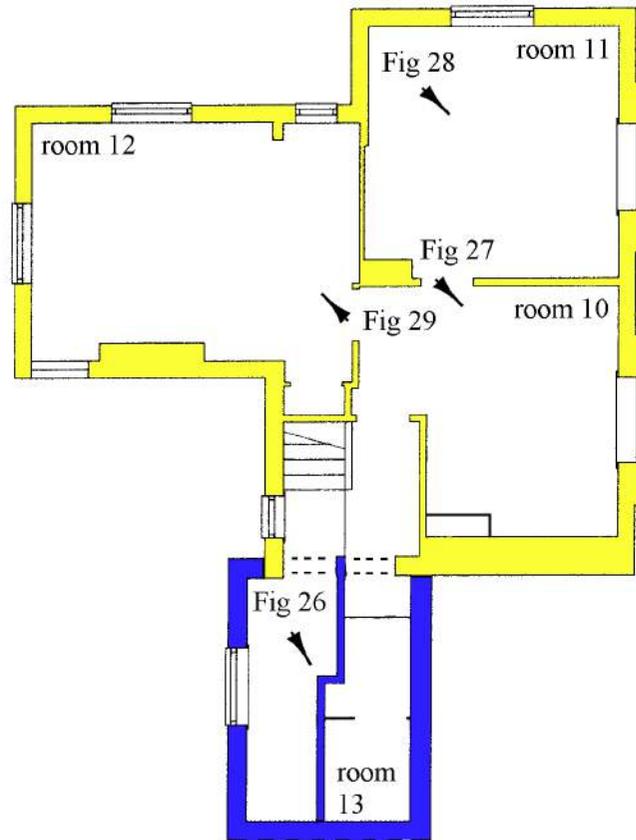
Fig 3.6: First floor

Room 10 is entered from the landing. The position of the original doorway would have been in its north-west corner but this has been lost. The room has a window in its north and east sides.

Room 11 is entered from the landing. The room has a window in its east side and a former hearth in its south-west corner.

Room 12 is entered from the landing. The room has two windows in its north side and a single window in its west side. There is a blocked fireplace in the south wall.

The extension to the kitchen on the ground floor was of two stories, the upper floor of which provided additional toilet facilities.

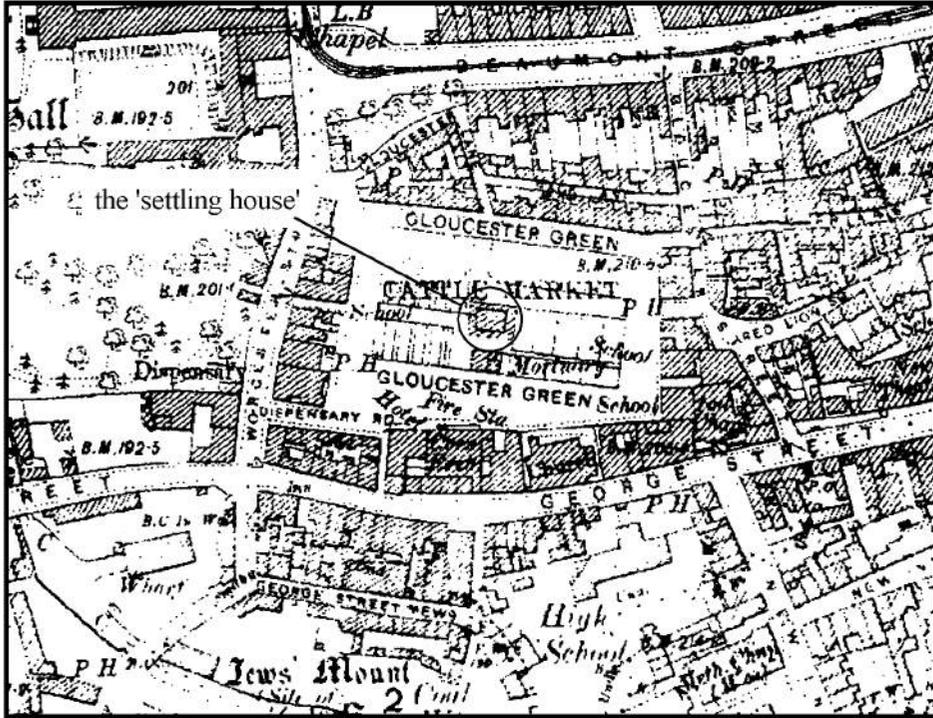
The 2nd edition Ordnance Survey map of 1900 of the centre of Oxford shows the livestock market formerly held at Gloucester Green (Fig 4.2). In 1818 a cattle market was held at Carfax and was moved from there to Gloucester Green, where in 1835 it was re-established on a monthly basis. From 1860, when it was already developing as a general market, it was held fortnightly. The site was enlarged in 1877 when the prison was demolished and the market was rebuilt with money raised by mortgaging the tolls. It was fitted with pens and stalls in seventeen avenues with a settling-house in the centre (Cooper 1979). Unfortunately, no details of this 'settling house' could be located but it was clearly a substantial building, located in a prominent place in the market.

Fig 4.2: The 'settling house', cattle market, Gloucester Green, Oxford; 1900

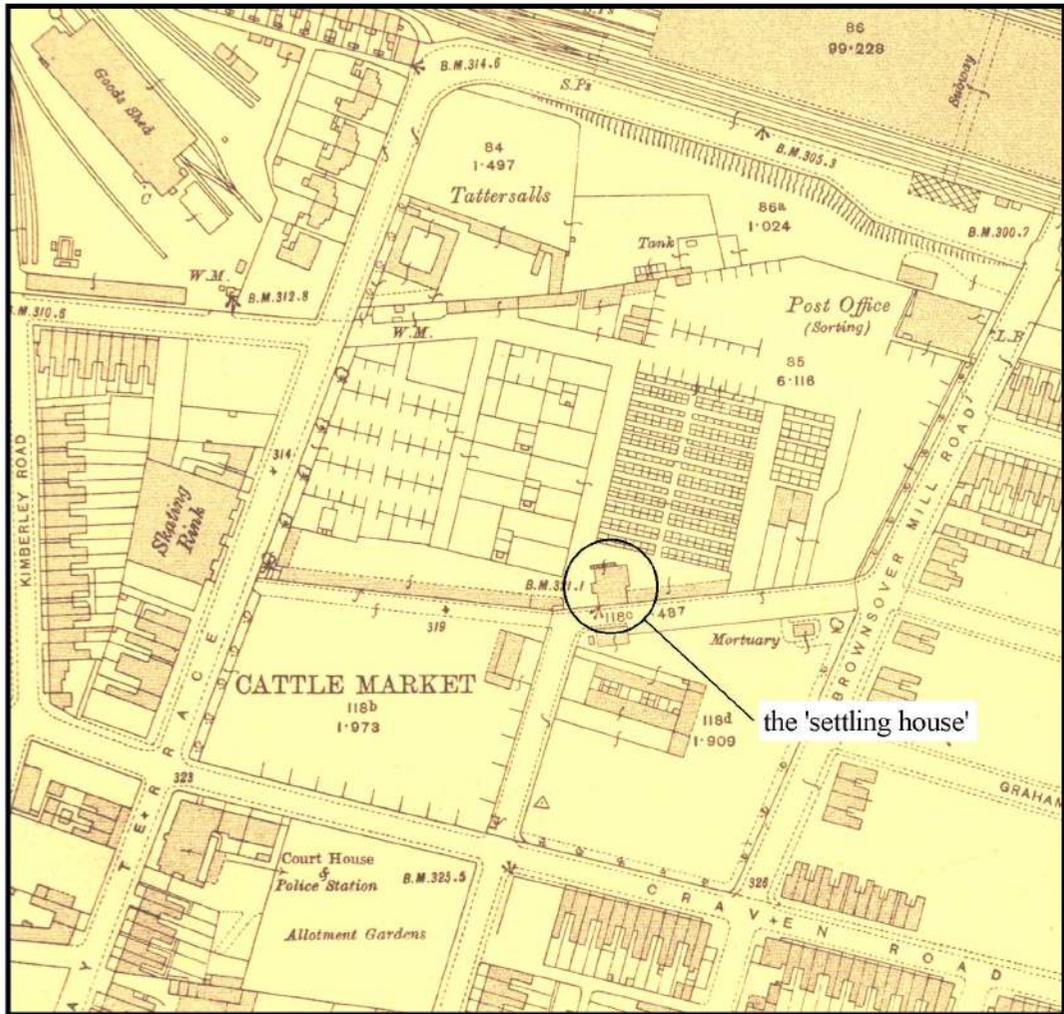
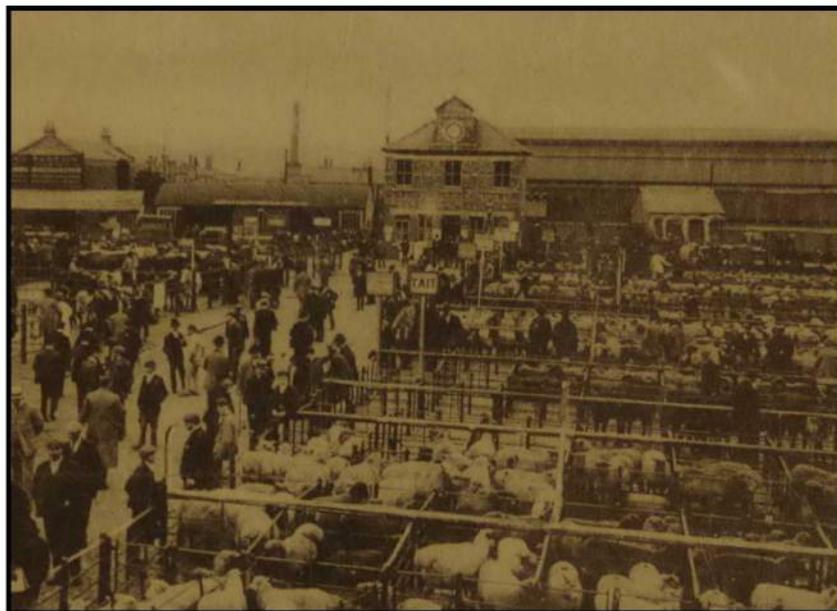
Fig 4.3: Cattle market, Rugeley

At Rugby, a similarly substantial building is shown, by the Ordnance Survey map of 1913, at the entrance to the former livestock market adjacent to Brownsover Mill Road (Fig 4.3). Fortunately, a postcard of this market, taken before 1906 (Fig 4.3), shows a solidly built rectangular building with a symmetrical front elevation and a substantial dormer carrying what appears to be a clock.

The 'settling house', cattle market, Rugeley, before 1906

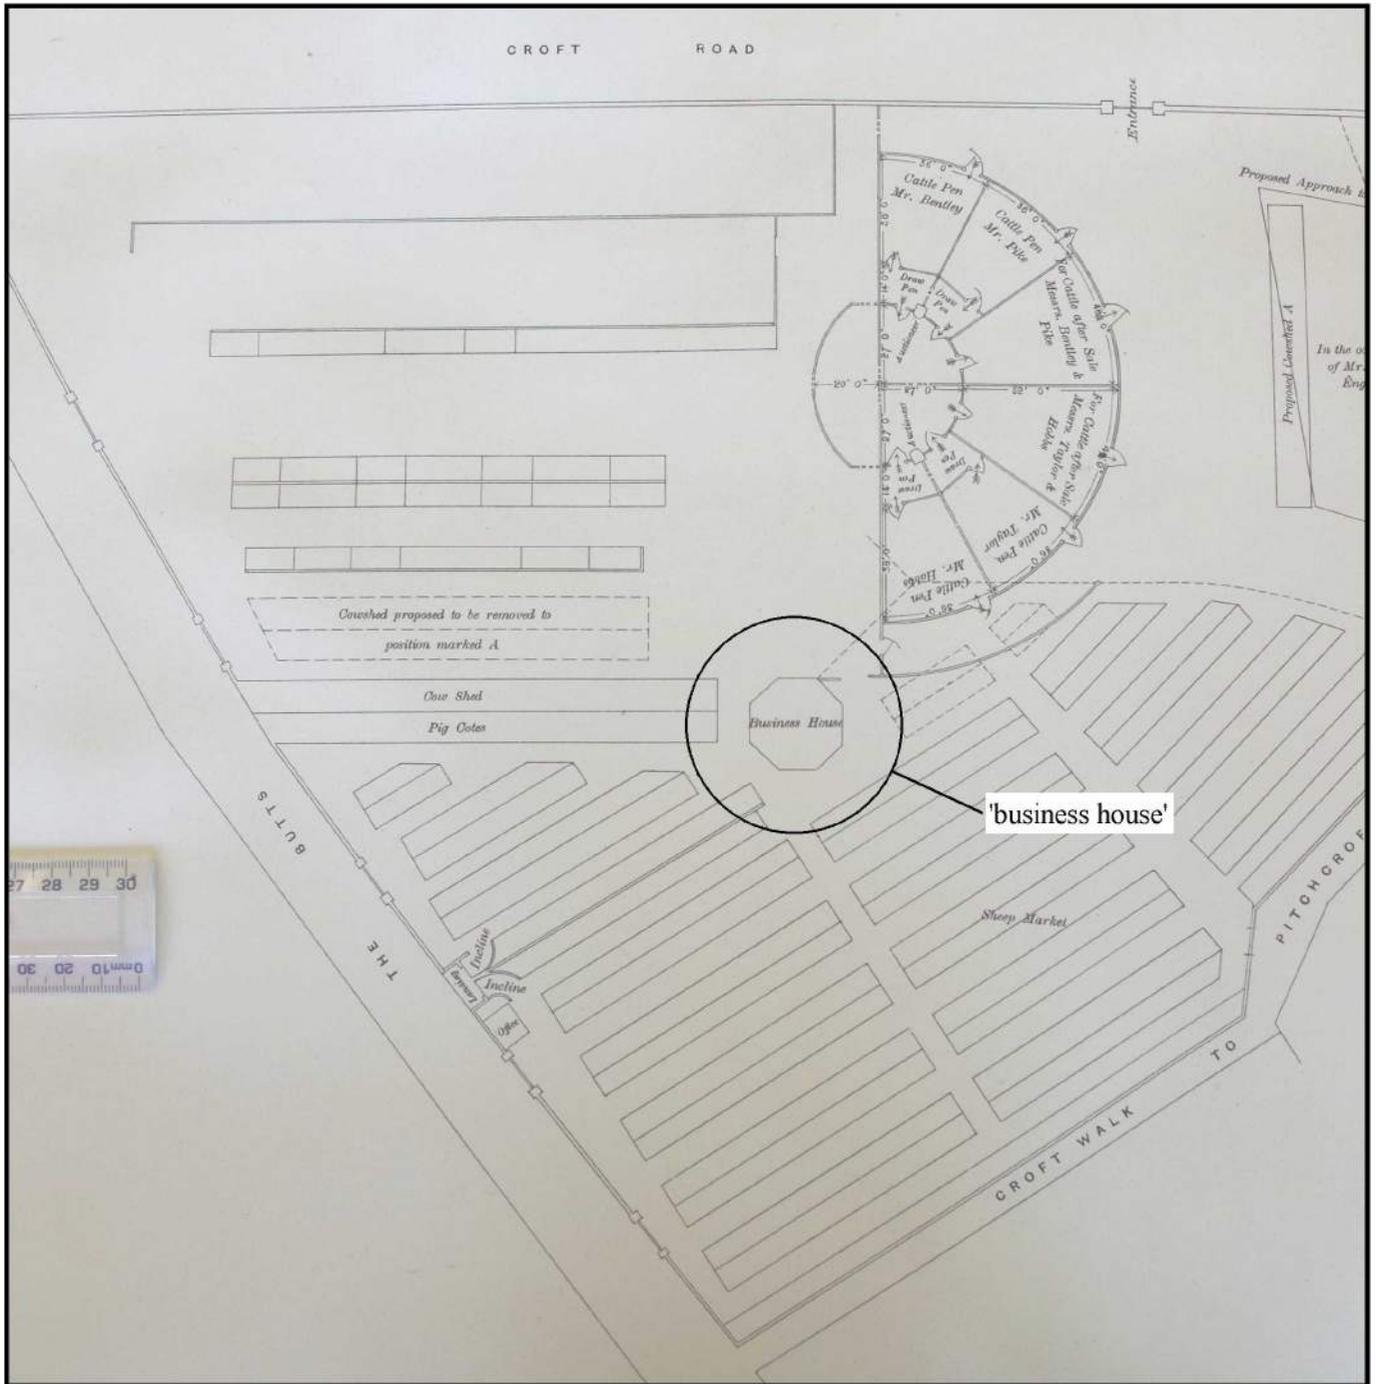
An architect's plan of 1890 shows a proposal for Worcester livestock market (Fig 4.4) in the area between Croft Road, The Butts, Croft Walk and the Worcester and Malvern Railway line. This shows an octagonal building, called the 'Business House' near the centre of the market. As with Oxford, no images of this building could be traced but by association with the examples above and from the example at Kidderminster, it may be presumed to have been intended to have some architectural pretension.

Fig 4.4: Worcester livestock market, 1890, showing 'business house'

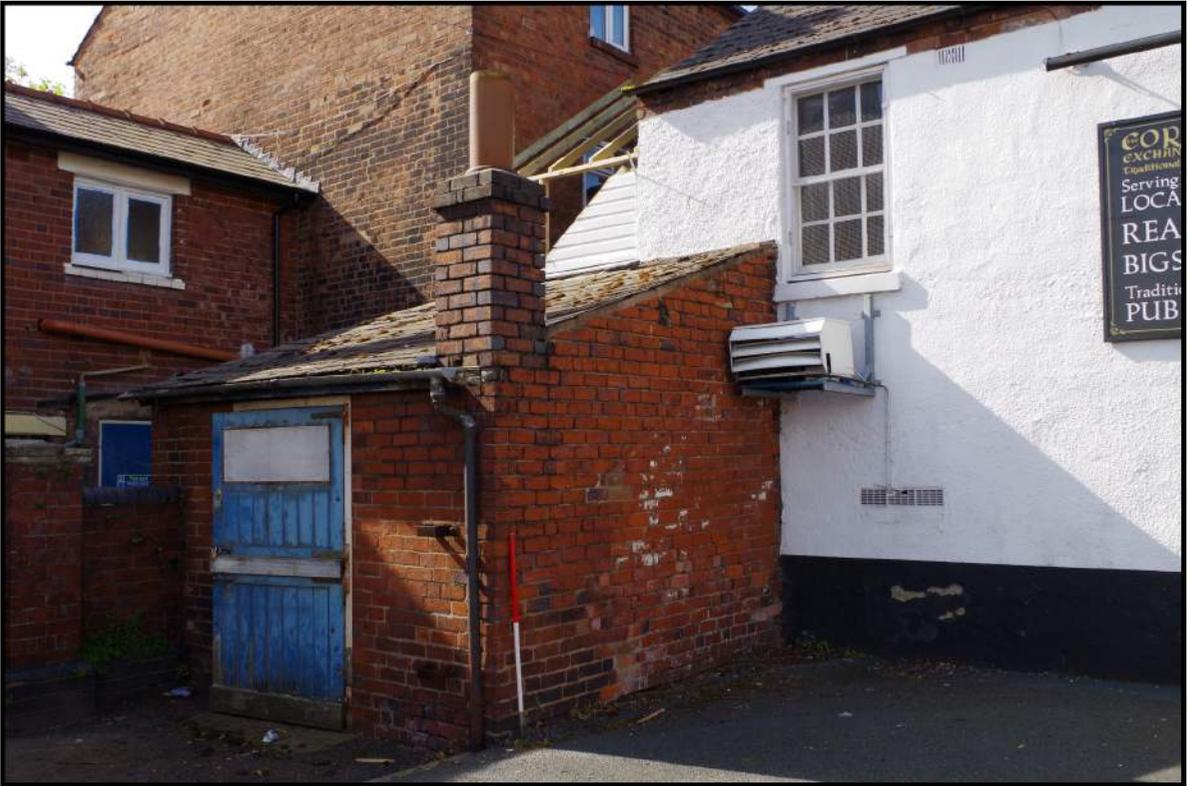
At the western end of the north elevation is a small, single storey, single cell structure, executed in Flemish garden wall bond with a slate roof. It has a small chimney in its north-west corner (Figs 3.2 and 8). It has a door divided in half at mid-height and was clearly a stable for the accommodation of the market superintendent's horse. The chimney would have served a small stove for the provision of hot water for cleaning the animal's tack.

Fig 8: Small stable behind west elevation

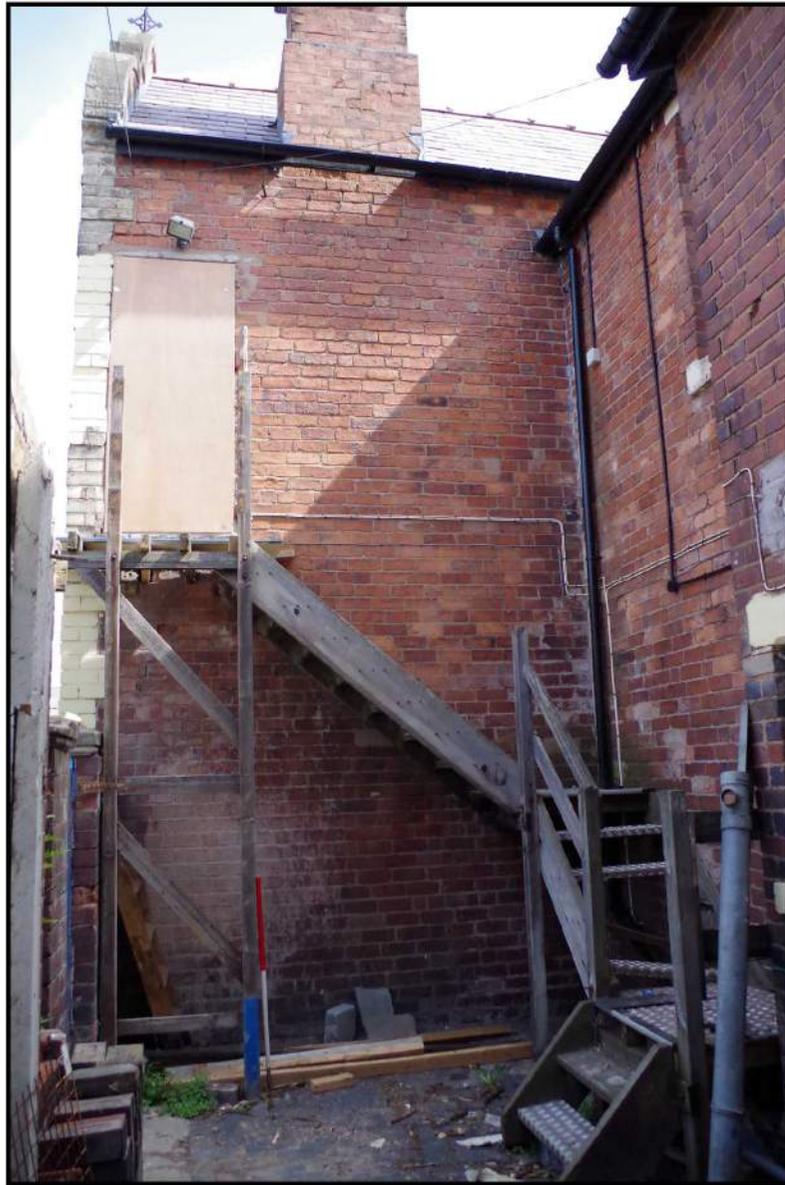
Fig 9: Yard looking north behind west elevation

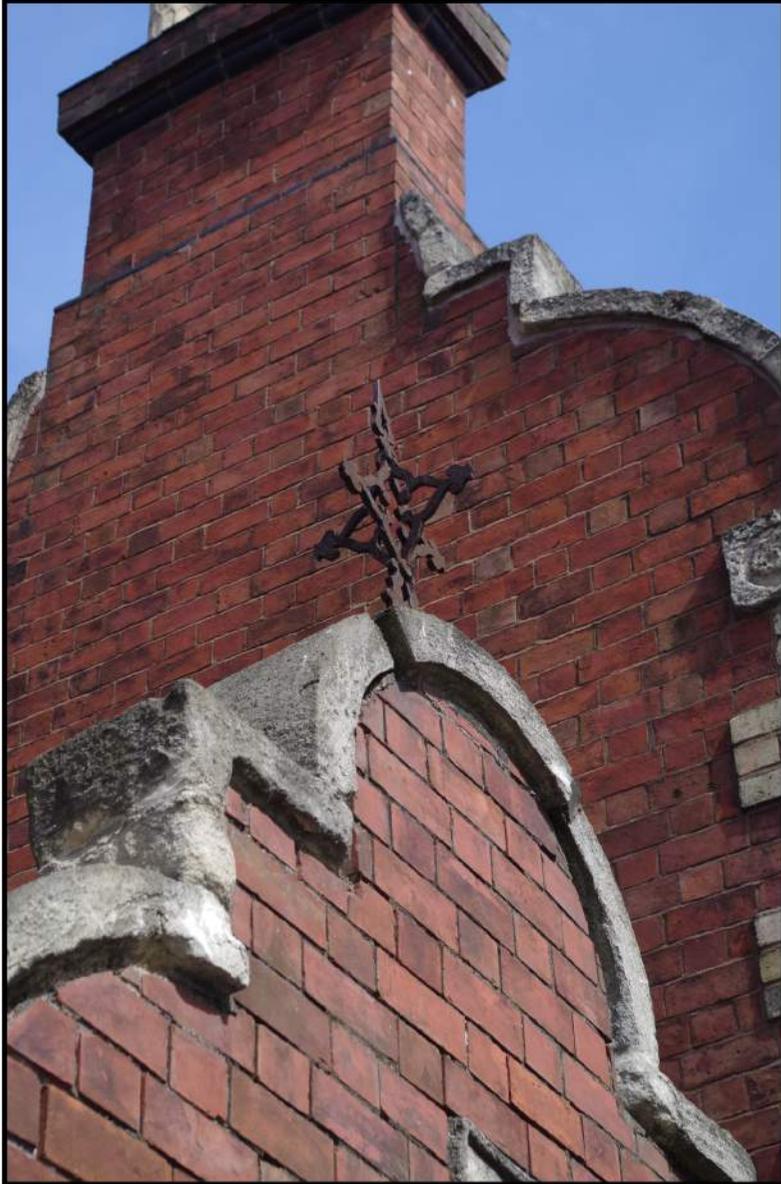
Fig 11: Detail of iron finial on east elevation

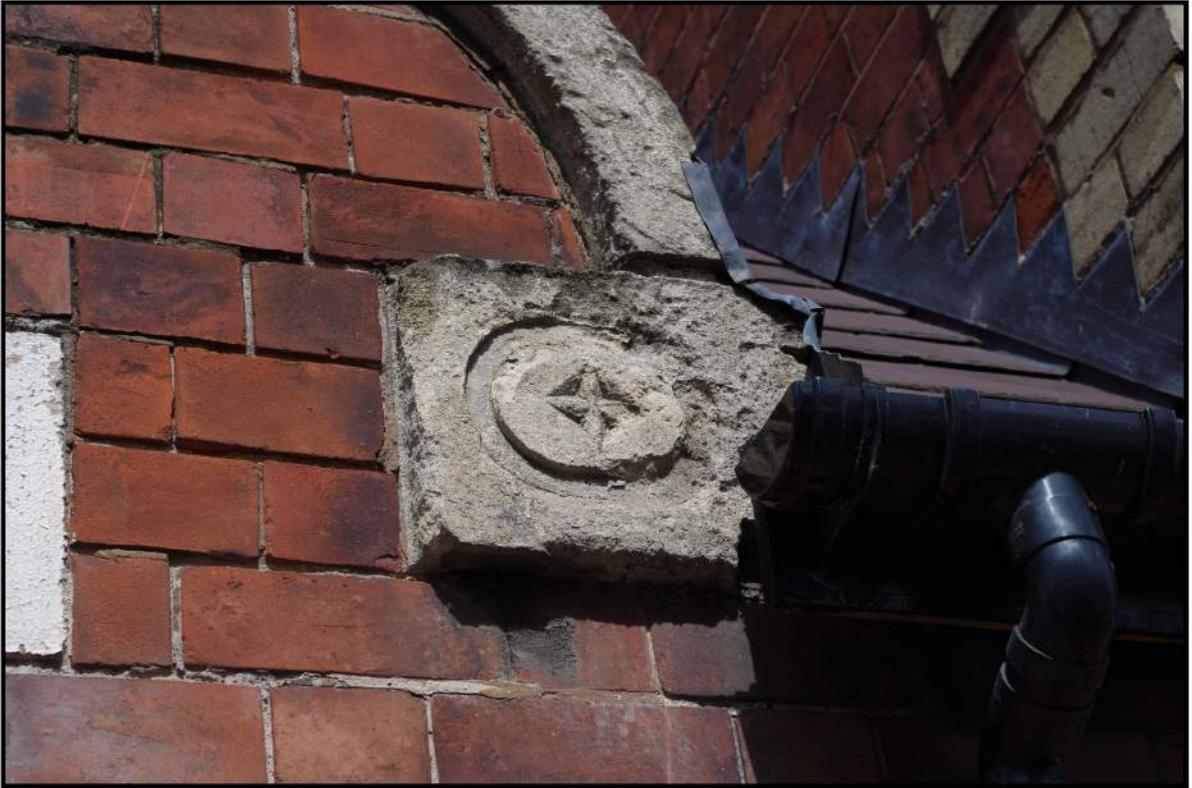
Fig 12: Detail of decorated springing stone on east elevation
