**Historic building recording  
at Market House,  
New Road,  
Kidderminster,  
Worcestershire,  
DY10 1AE**

# **Historic building recording at Market House, New Road, Kidderminster, Worcestershire, DY10 1AE**

The project was undertaken in advance of the proposed alteration of the building (Wyre Forest District Council, planning ref 15/0119/FULL). A Level 3 project was undertaken.

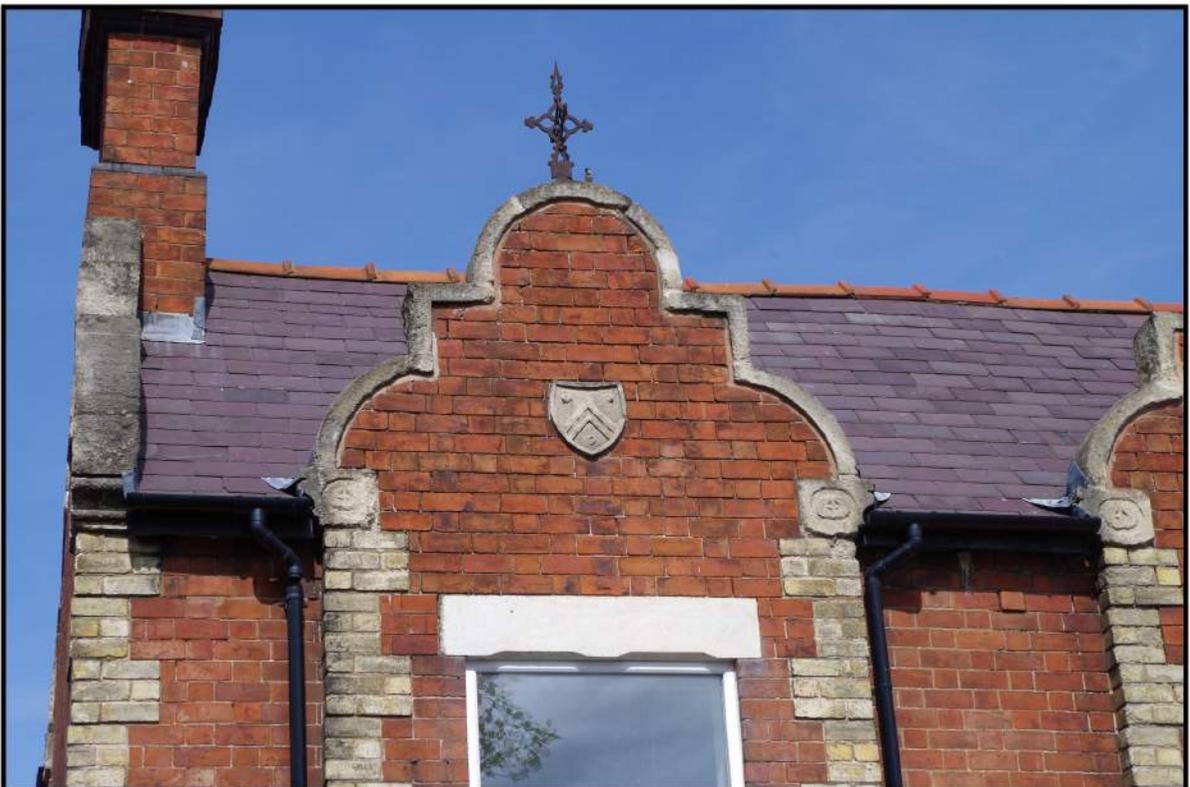
The principal part of the east elevation (Figs 3.1 and 5) is symmetrical and executed in an Italian Renaissance style, previously popular in the late 16th and early 17th centuries. There is a contemporary, single storey extension on its southern end. Both were executed in Flemish bond in red brick with yellow brick detailing. Arrises, lintels and sills are of stone. Decoration comprises stone shields with double chevrons in the centre of each pediment (Figs 3.1 and 13). These are a representation of the coat of arms of Kidderminster Borough Council (*Azure two Chevrons Or each charged with five Pellets between in chief two Shuttles chevronwise Or threaded Gules and in base a Bee volant Or*).

Fig 13: Detail of shield-shaped plaque (double chevron) on east elevation

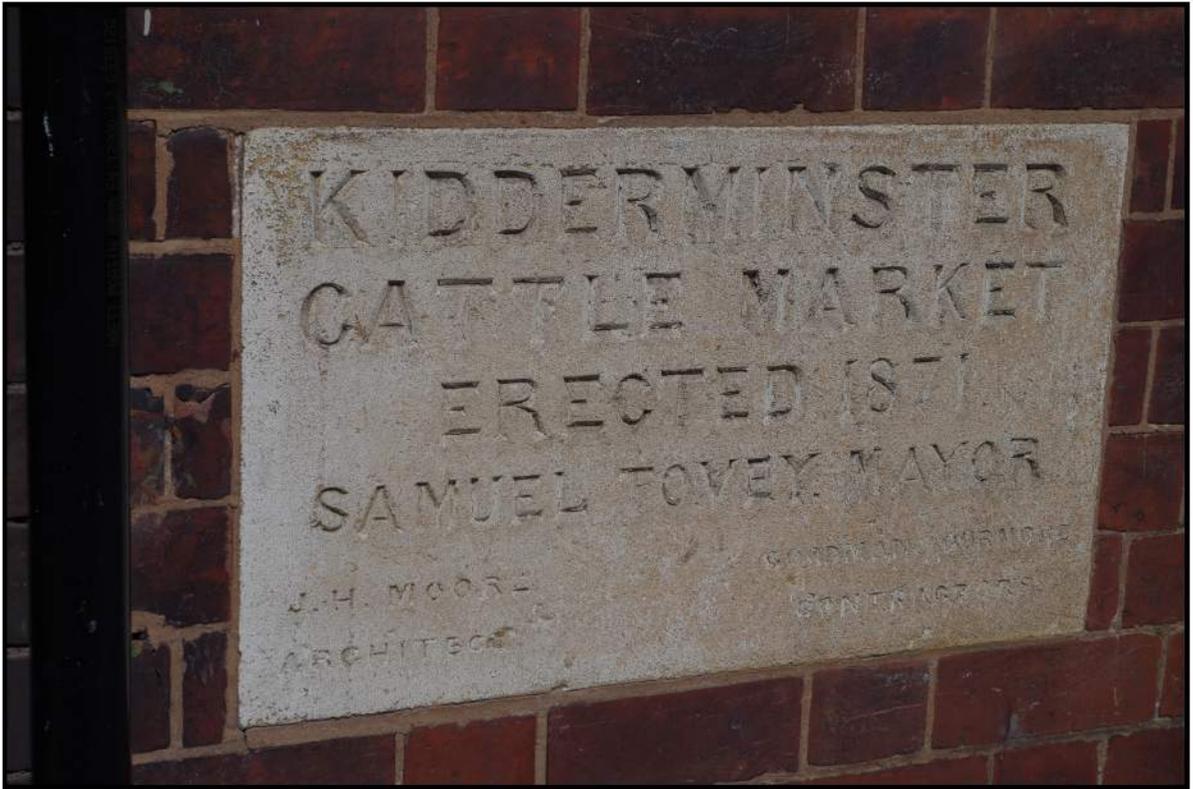
There are stars on the springing of the pediment coping (Figs 3.1 and 12). The top of each pediment is further enhanced with an iron finial (Figs 3.1 and 11). In the centre of the principal part of the elevation is a dedication stone (Figs 3.1 and 14):

KIDDERMINSTER  
CATTLE MARKET  
ERECTED 1871  
SAMUEL TOVEY MAYOR

It also gives the names of the architect, J H Moore, and the building contractor, Goodman and Durmore.

Fig 14: Dedication stone on east elevation

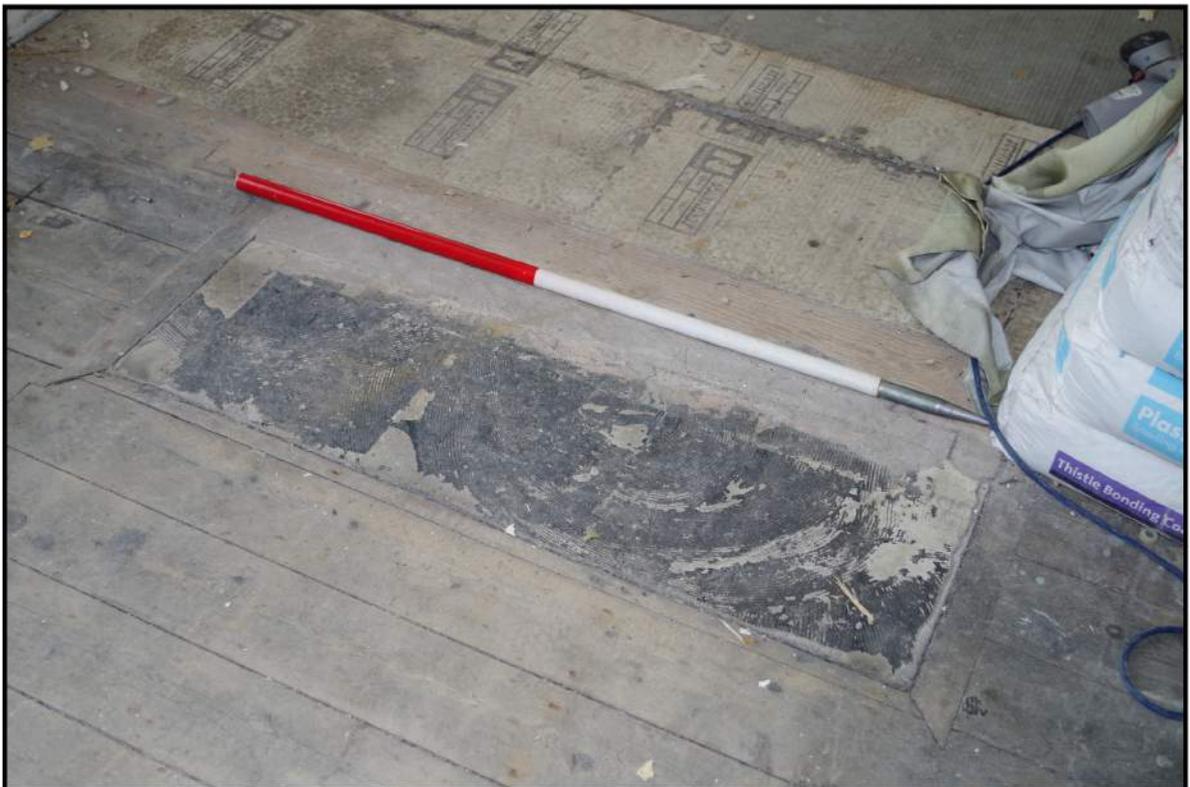
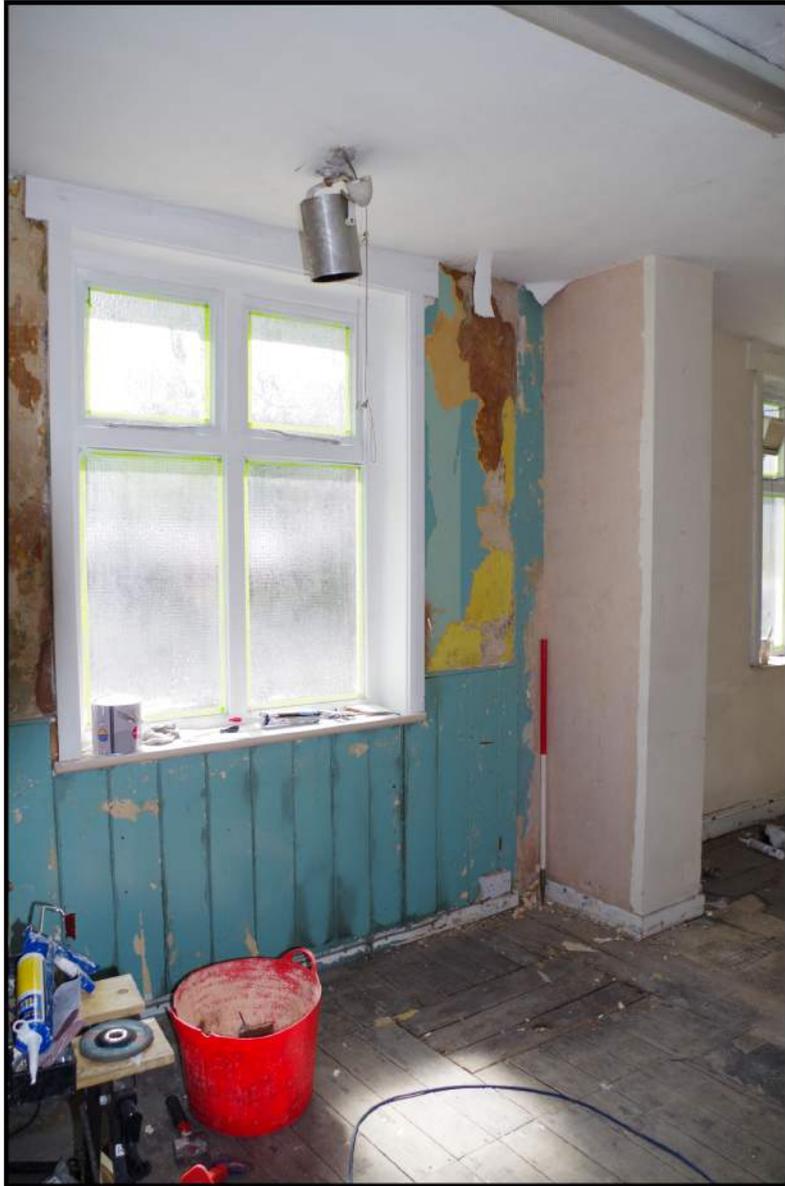
Room 1 is entered from the left-hand side of the hallway (Room 6) and has windows on its north and east sides. In phase 1 there was a continuous wall on its south side with a fireplace, now marked by the remains of the hearth (Fig 15). Being immediately adjacent to the principal entrance, it is likely that this was the 'sitting room' of the domestic accommodation.

The south wall and its associated fireplace was removed to form a large meeting/dining room.

Fig 15: Ground floor, room 1; position of former hearth

Fig 16: Ground floor, room 1; detail of wall cladding

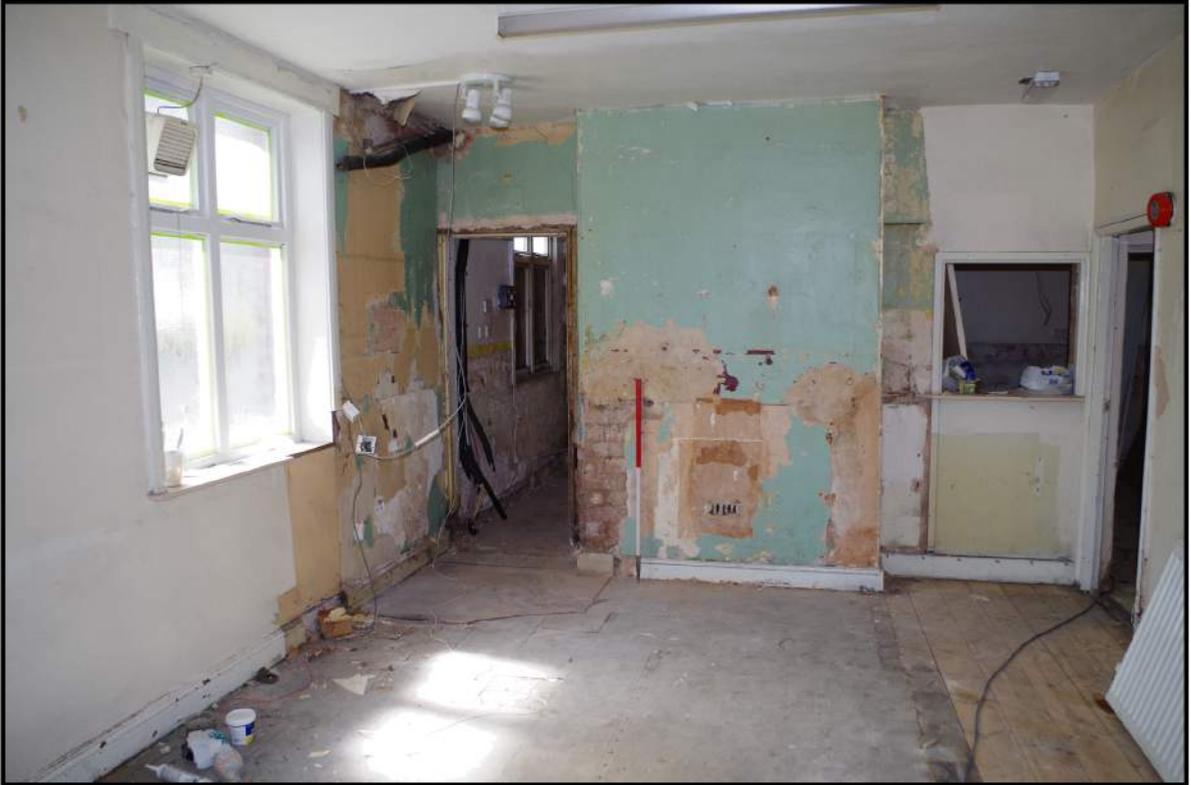
Fig 17: Ground floor, room 2

Room 2 has a window in its east side only (although it is possible that it had another in its south-west corner, converted to a serving hatch in phase 2) and was originally entered from a door in its north-west corner, at the foot of the original staircase; that door now blocked and a new staircase (phase 2 – see below) inserted across it. It had a fireplace in its south wall. Having direct access to the original kitchen (room 3) *via* a now blocked doorway, it is likely that this was the 'dining room' of the domestic accommodation.

The north wall was removed to form a large meeting room for the RAFA Club. Its original doorways in its north-west and south-east corners were blocked, the former to accommodate a new staircase; the latter because alternative access to an enlarged kitchen (see below, room 5) was to be provided. The window in its south-west corner was remodelled to form a serving hatch.

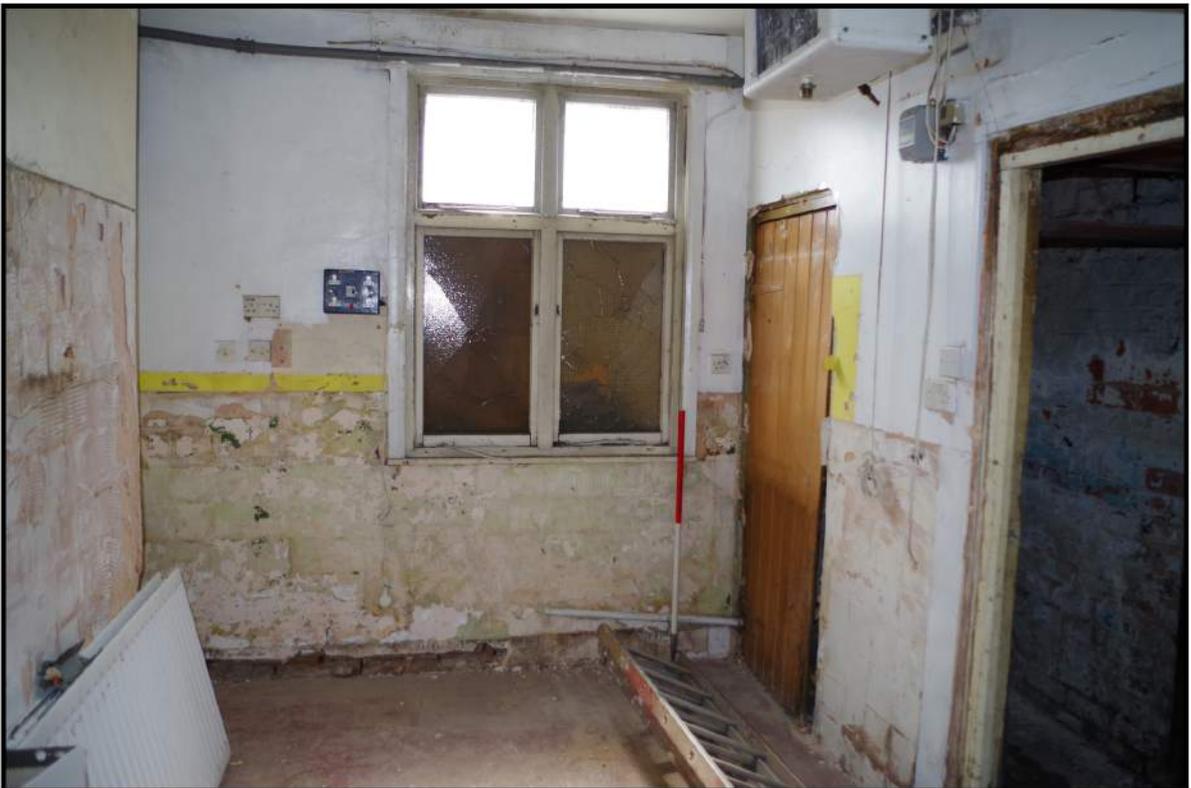
Fig 18: Ground floor, room 3

Room 3 had a window in its east and west sides and doors in its north (from room 2), south (giving access to the outside toilet; room 4) and west (giving access to the yard).

The original doorway in its north-east corner was blocked. The original doorway into the yard was opened-up to provide better access to the enlarged kitchen (room 5).

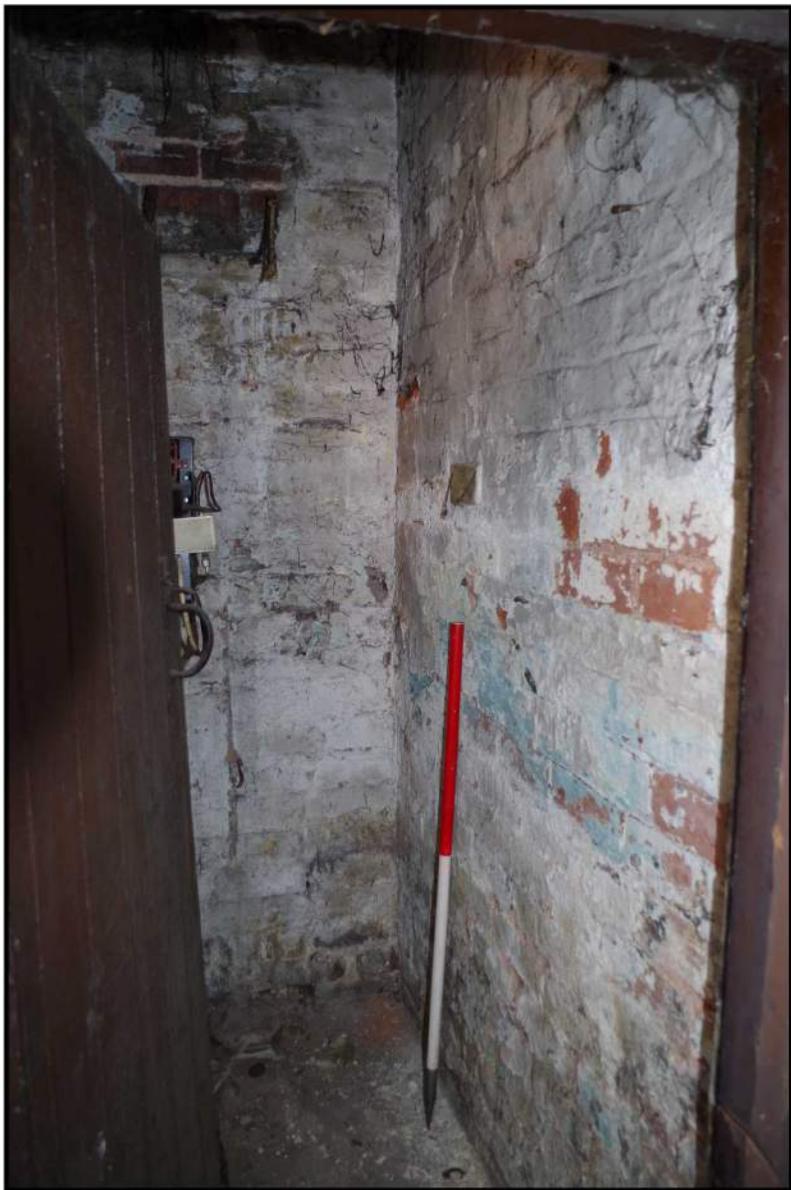
Fig 19: Ground floor, room 4

This was approached *via* a doorway from room 3, by a doorway in its west wall and also, originally, from the yard. It had no windows but made use of a vent above its doorway to provide some illumination.

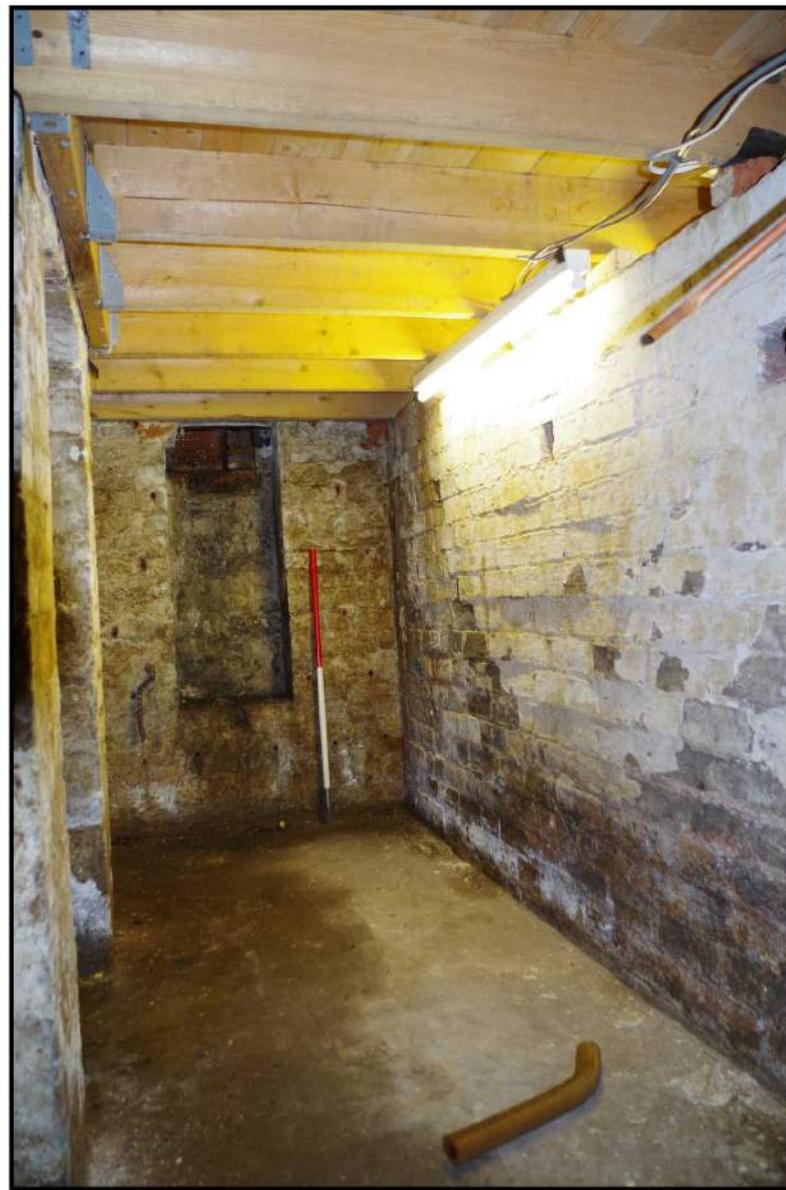
Fig 20: Cellar, room 8

This rectangular space was used for coal.

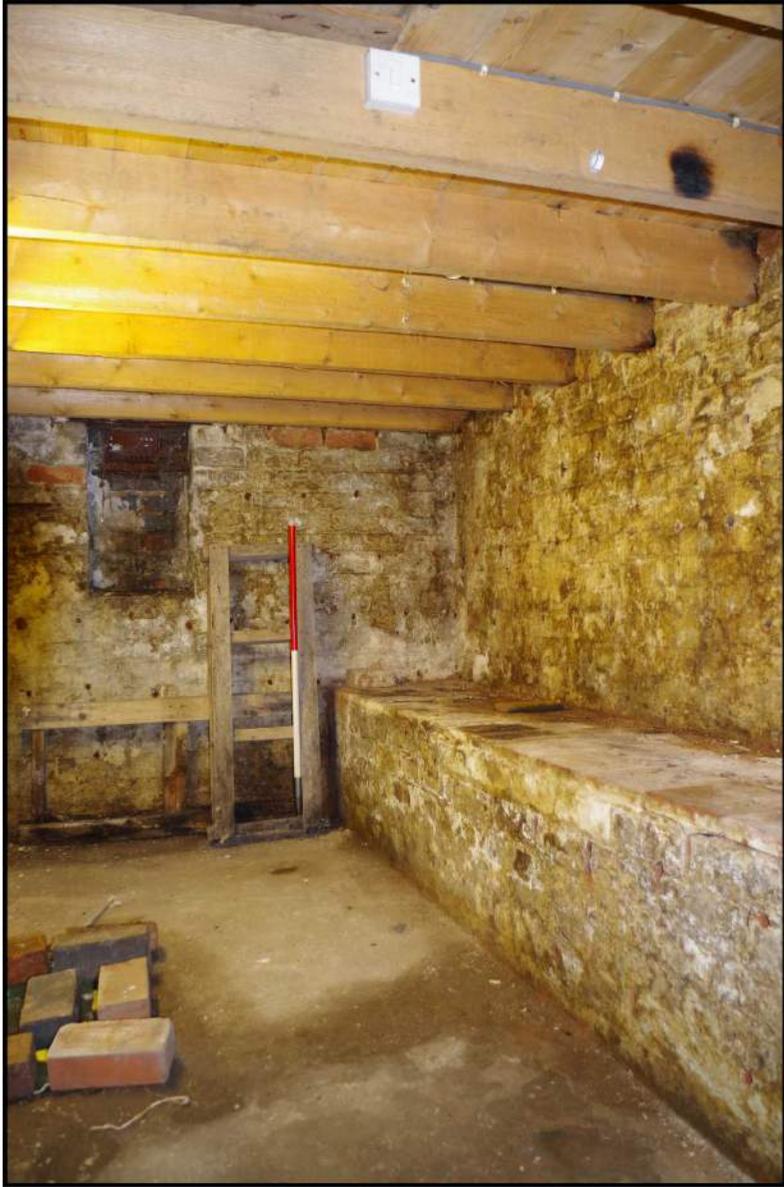
Fig 21: Cellar, room 9

This rectangular space was used as a larder and cool store.

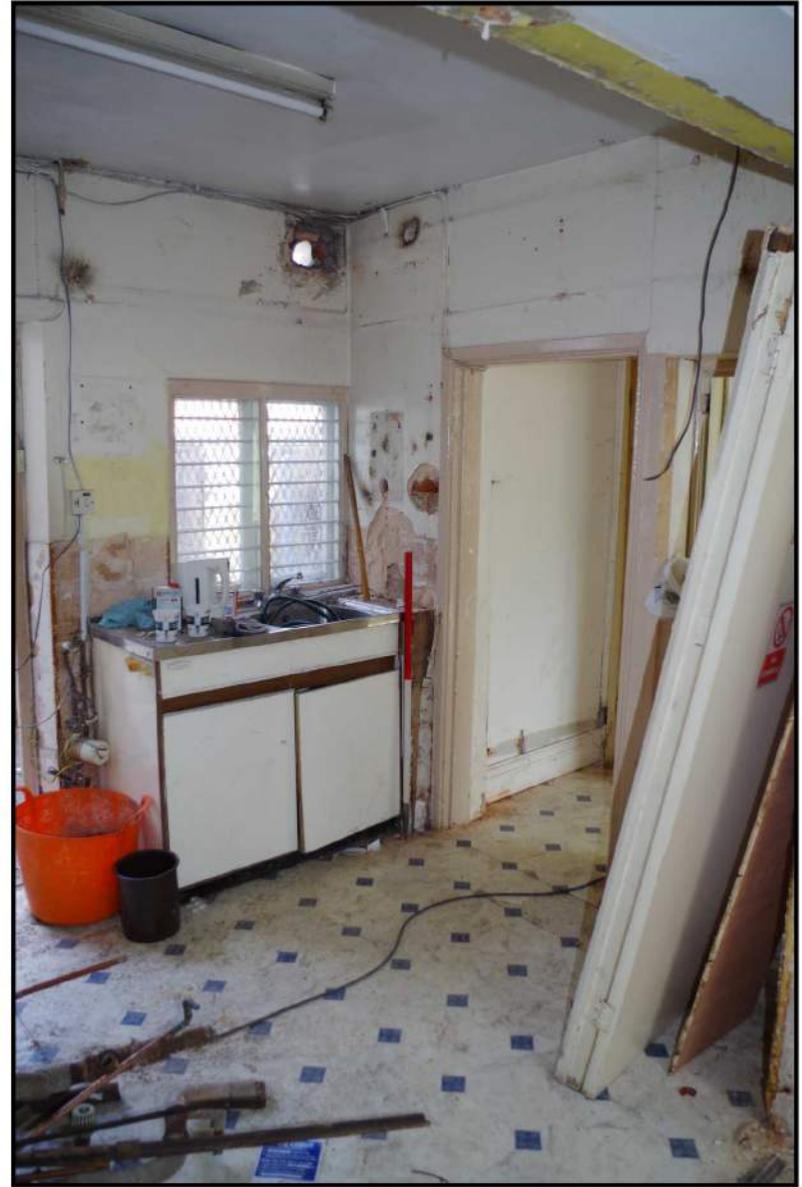
Fig 22: Ground floor, room 5

An extension was erected in the original yard, providing an enlarged kitchen. This blocked the access to the toilet from the yard.

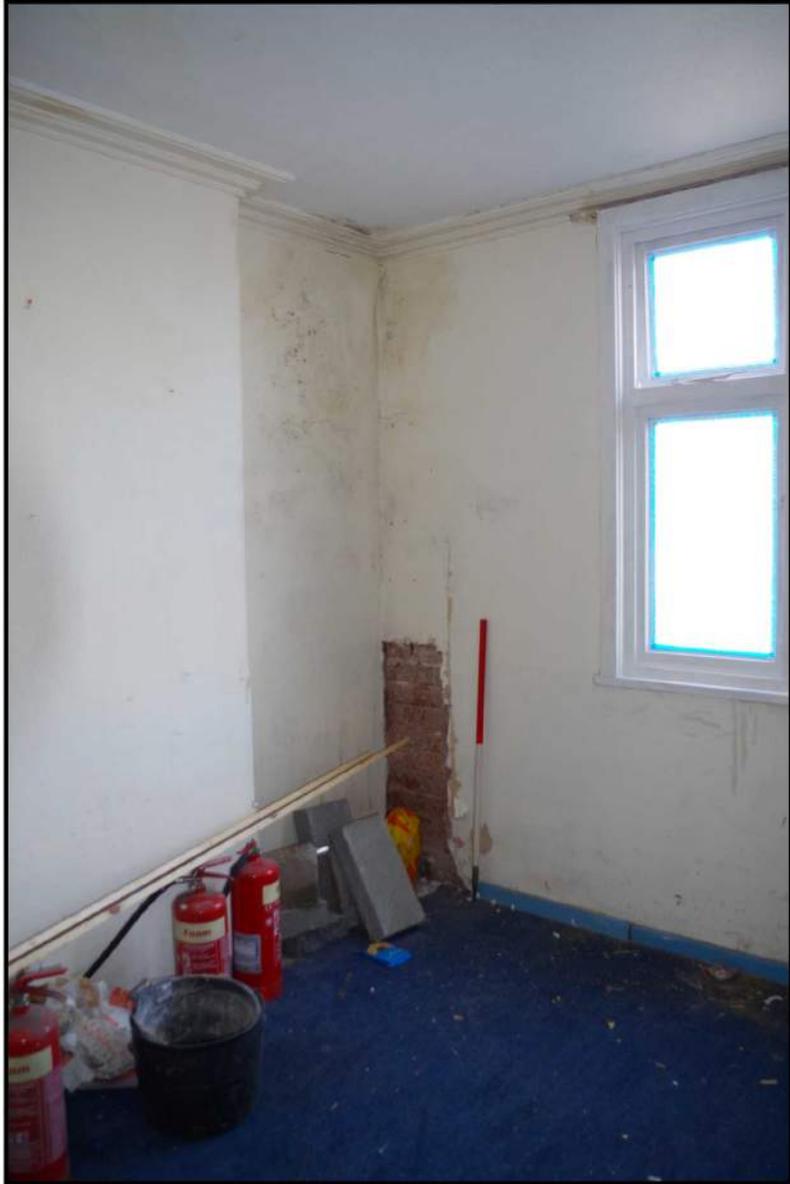
Fig 23: Ground floor, room 7

Room 7 has a window on its west side only (over looking the market) and originally had doorways in its east side (to room 6) and in its north side giving access from the market without having to pass through the domestic accommodation. It had a fireplace on its south wall. This would have been the 'settling room' for the market where buyers paid the sums that they had bid for the animals and produce.

The doorway in the north wall was blocked.

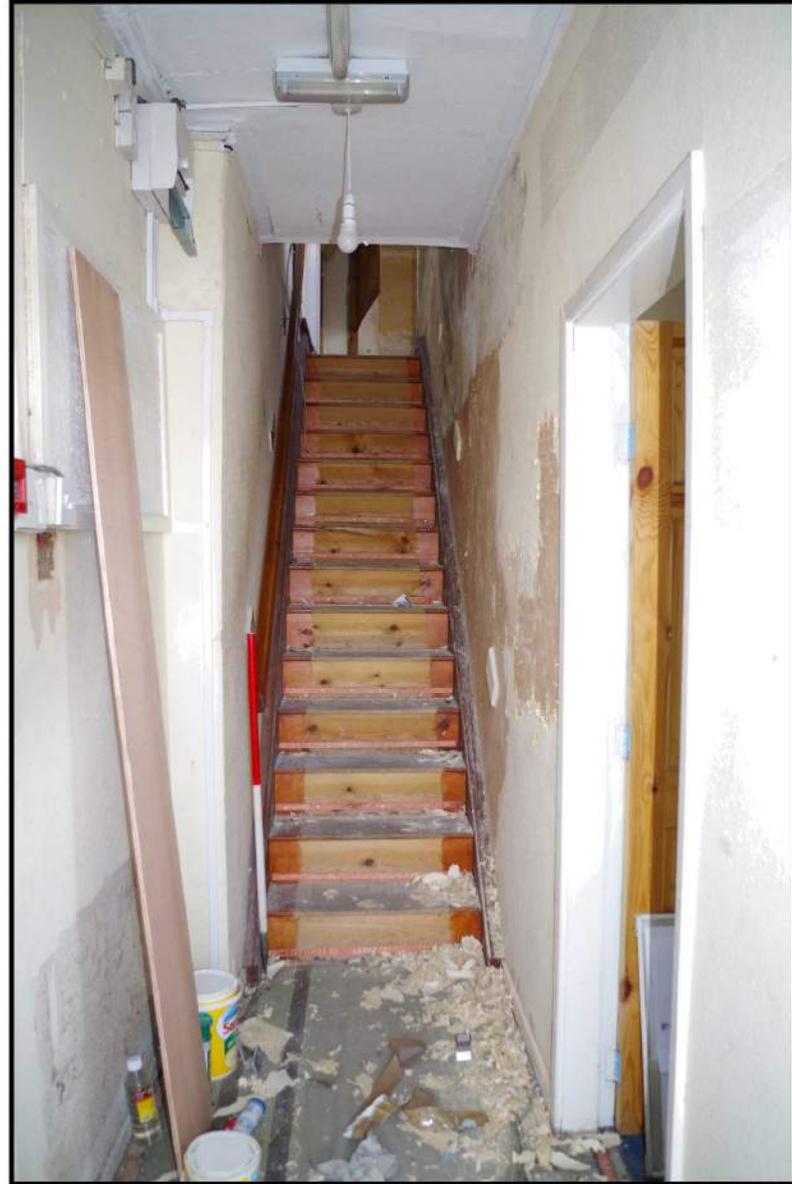
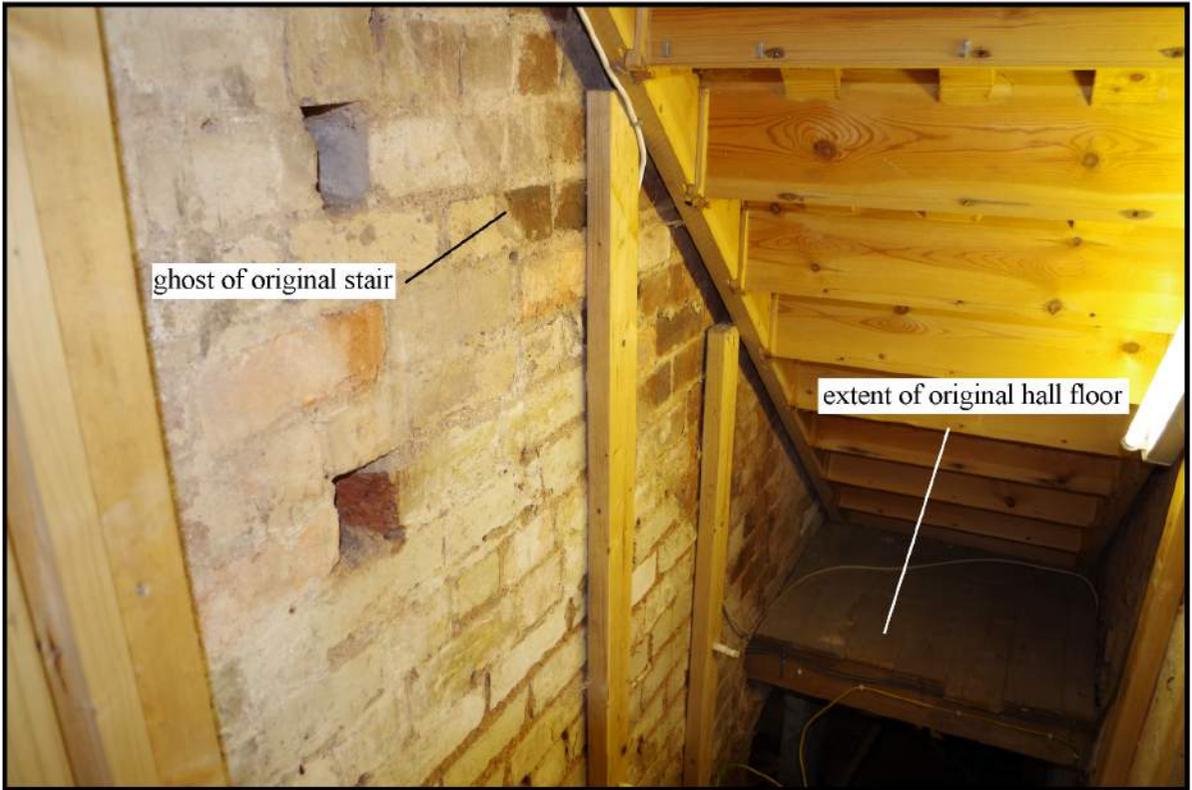
Room 6 is entered from a doorway in its northern end and originally gave access to rooms 1, 2 and 7 and also to the stair to the first floor. The original stair had to accommodate the original entrance to room 2 at its foot and must, therefore, have been steeper (Fig 25).

As noted above, the original staircase was replaced, presumably with one with modern rises and goings.

Fig 24: Ground floor, room 6, showing existing position of stair

Fig 25: Ground floor, room 2; showing former position of stair and extent of room 6 floor

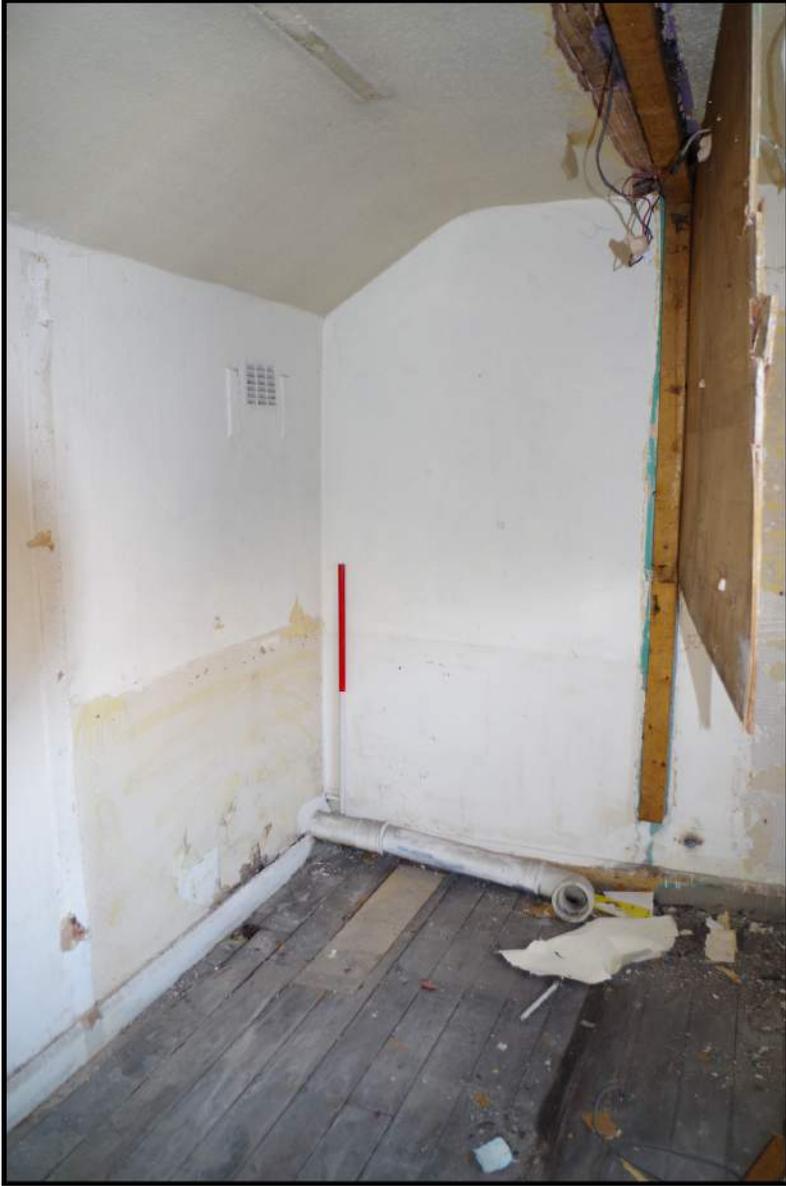
Fig 26: First floor, room 13

The extension to the kitchen on the ground floor was of two stories, the upper floor of which provided additional toilet facilities.

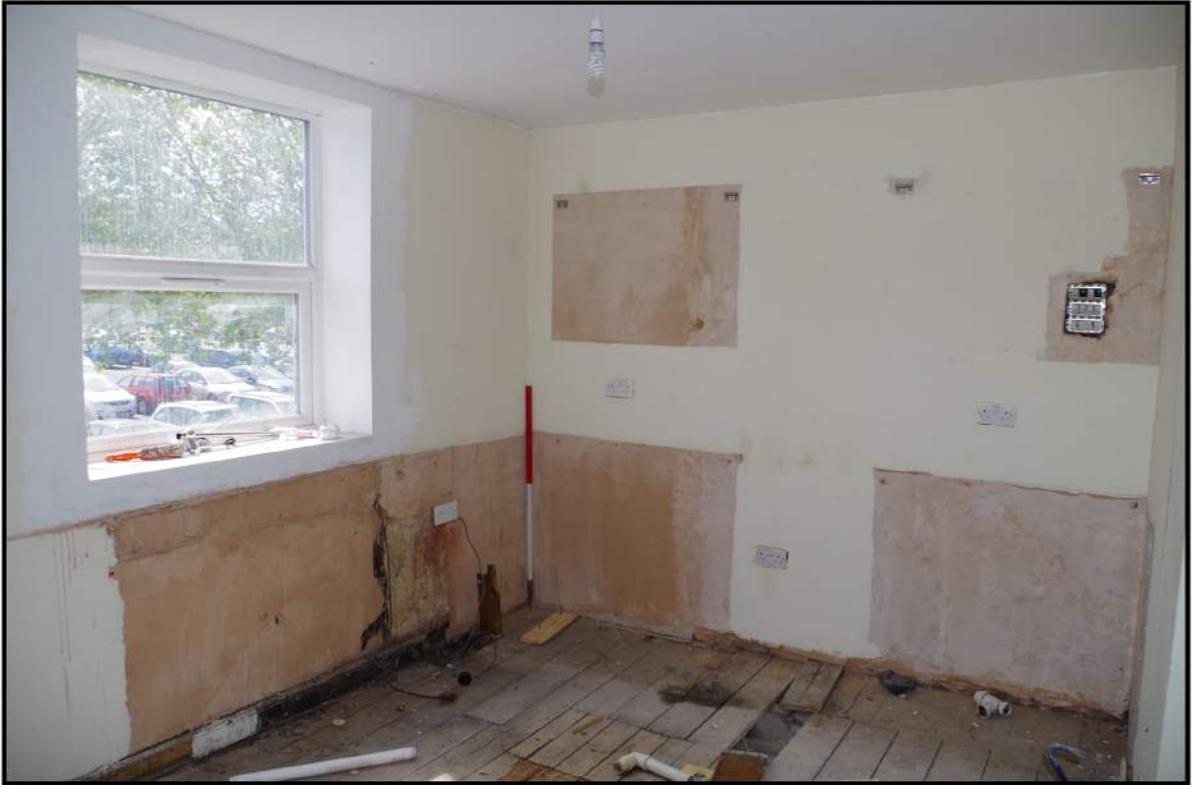
Fig 27: First floor, room 10

Room 10 is entered from the landing. The position of the original doorway would have been in its north-west corner but this has been lost. The room has a window in its north and east sides.

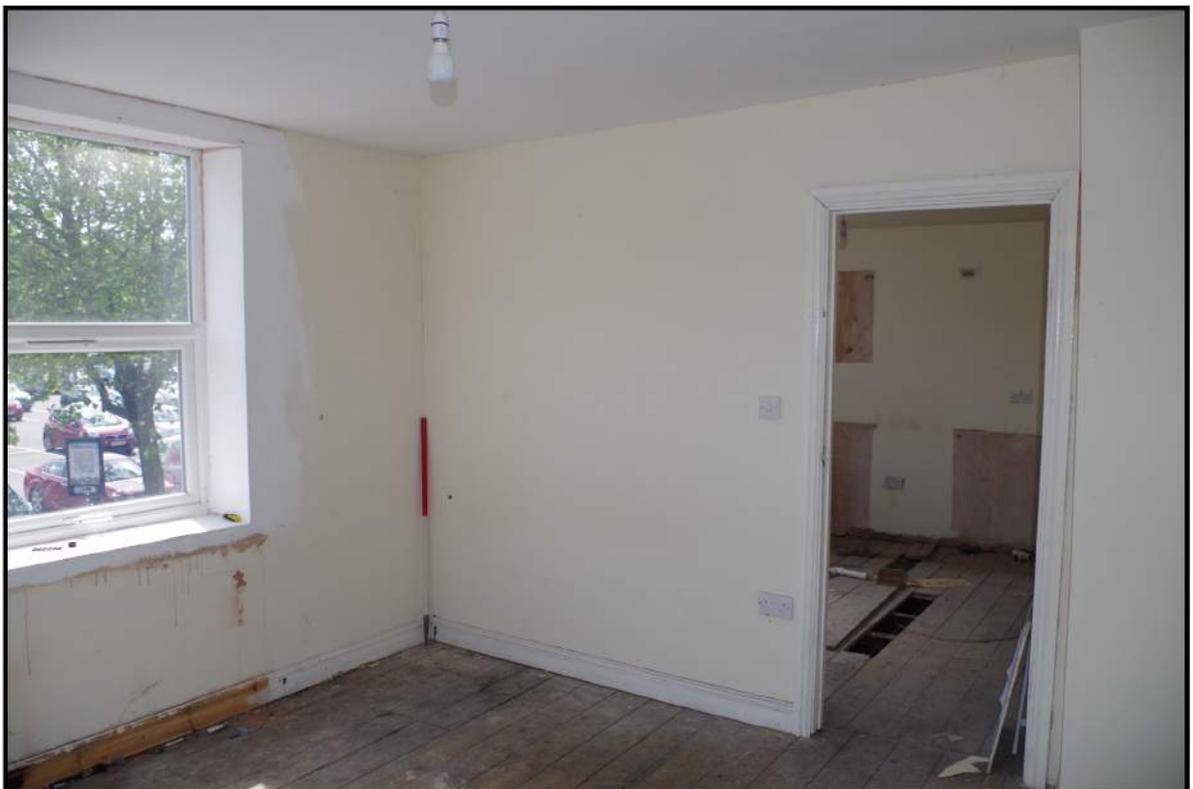
Fig 28: First floor, room 11

Room 11 is entered from the landing. The room has a window in its east side and a former hearth in its south-west corner.

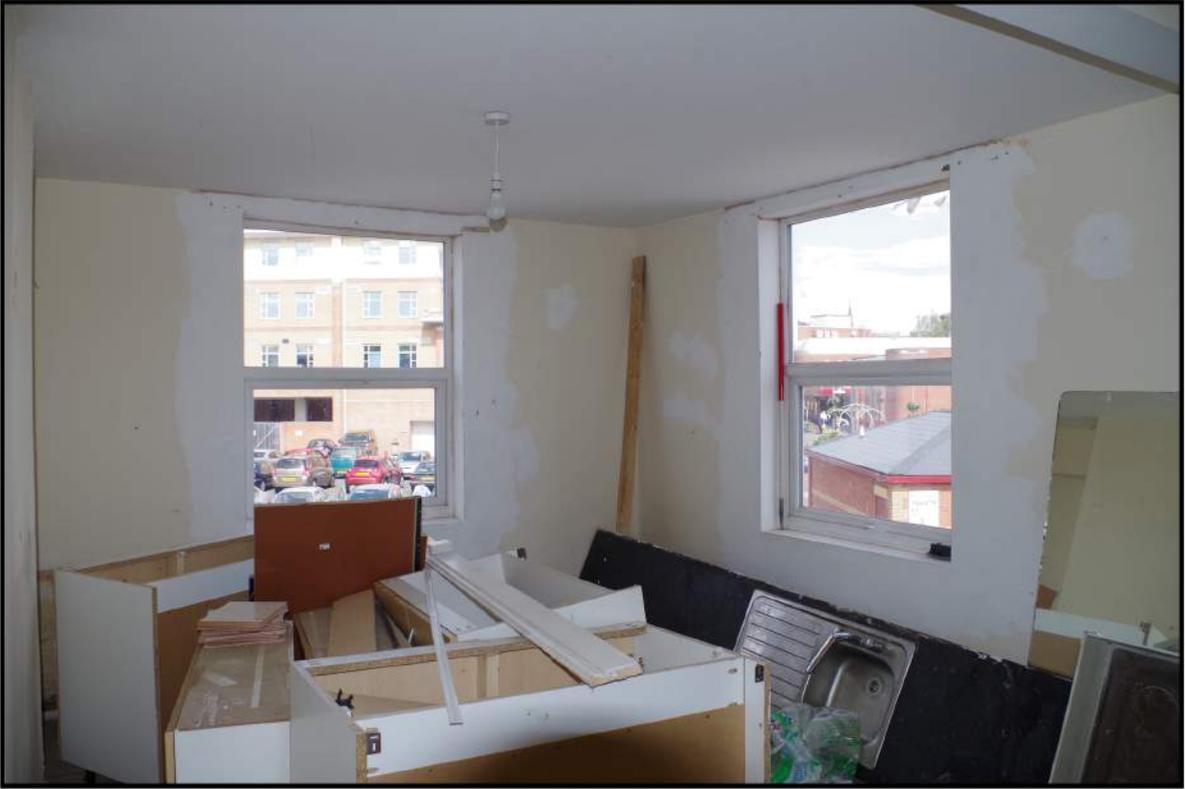
Fig 29: First floor, room 12

Room 12 is entered from the landing. The room has two windows in its north side and a single window in its west side. There is a blocked fireplace in the south wall.

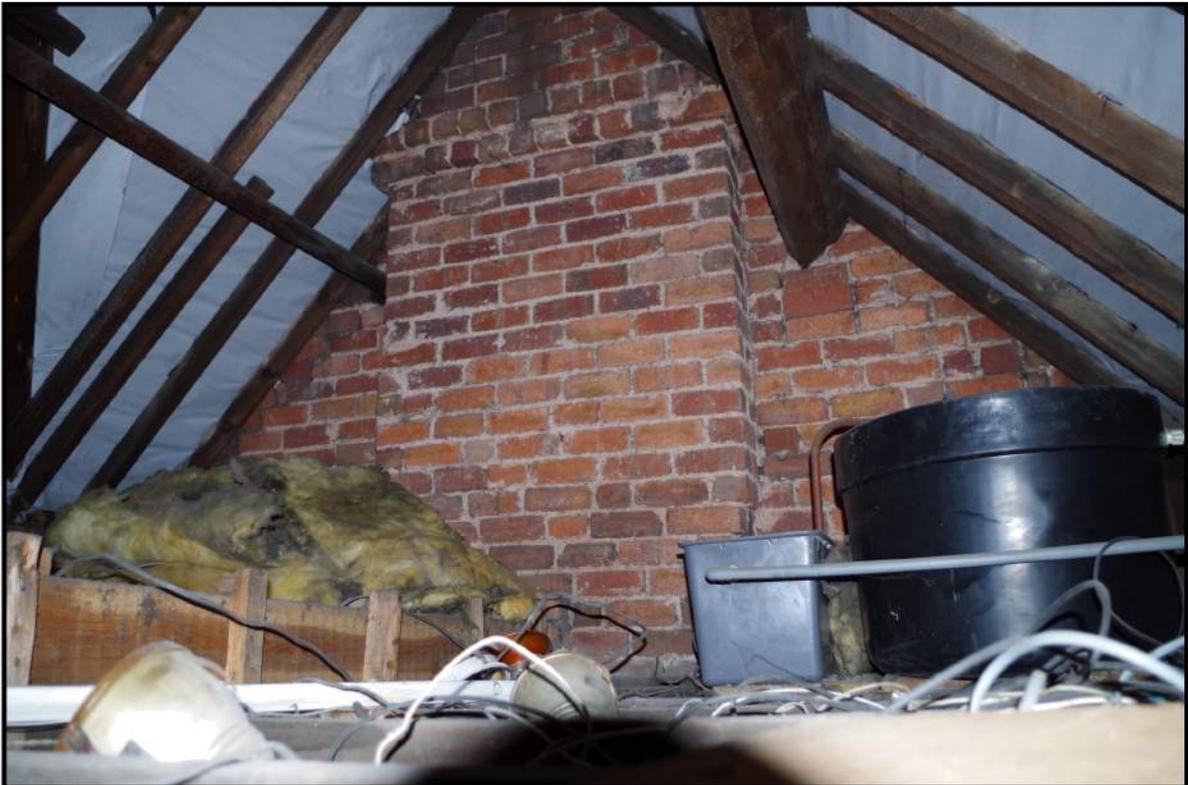
Fig 30: Roof space; showing common rafter roof with purlins
