**Historic building recording  
at Tanwood Cottages,  
Tanwood Lane,  
Blunton,  
Chaddesley Corbett,  
DY10 4NT**

30th June 2016

WSM 67962

The project was undertaken in advance of the proposed demolition of the building (Wyre Forest District Council, planning ref 16/0169/FULL). A level 3 project was undertaken.

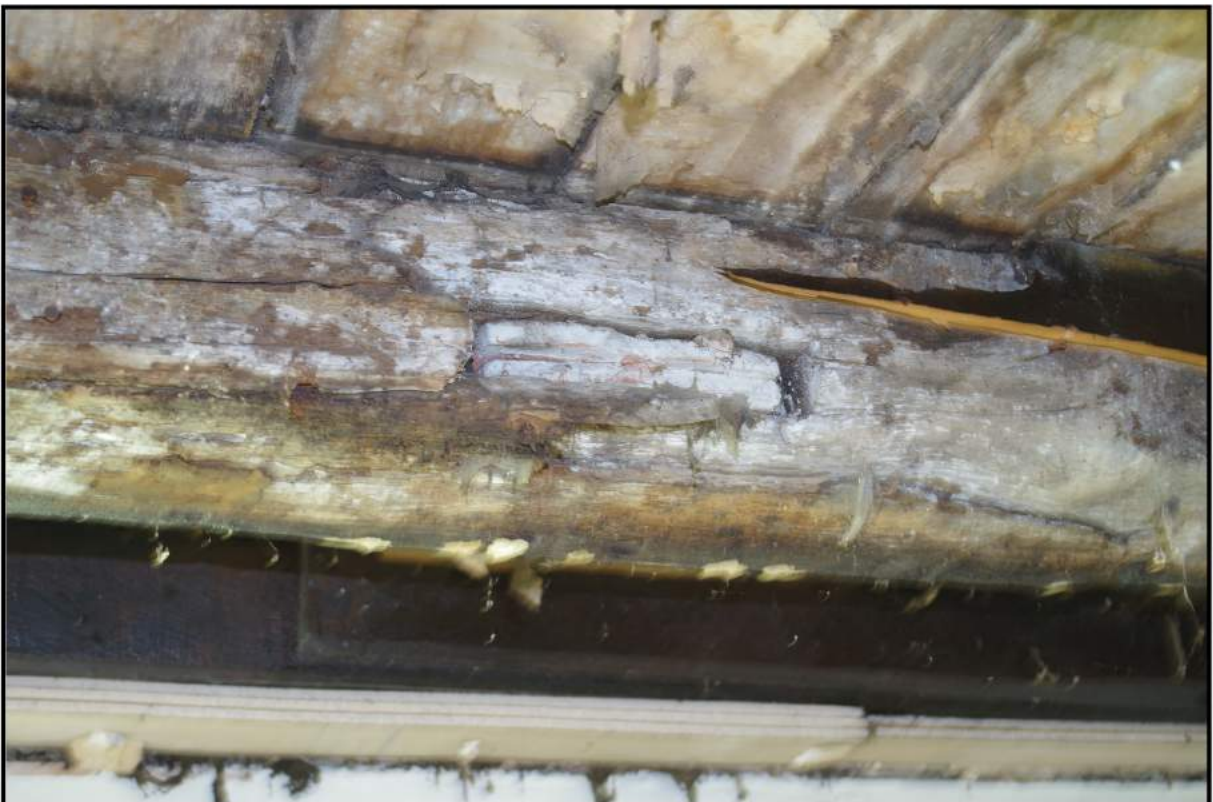
The joists supporting the first floor have redundant mortice and tenon joints (Fig 9) suggesting that these timbers are reused from a timber-framed structure.

Fig 9: Phase 1, ground floor; showing re-used ceiling joist with redundant mortice and tenon joint

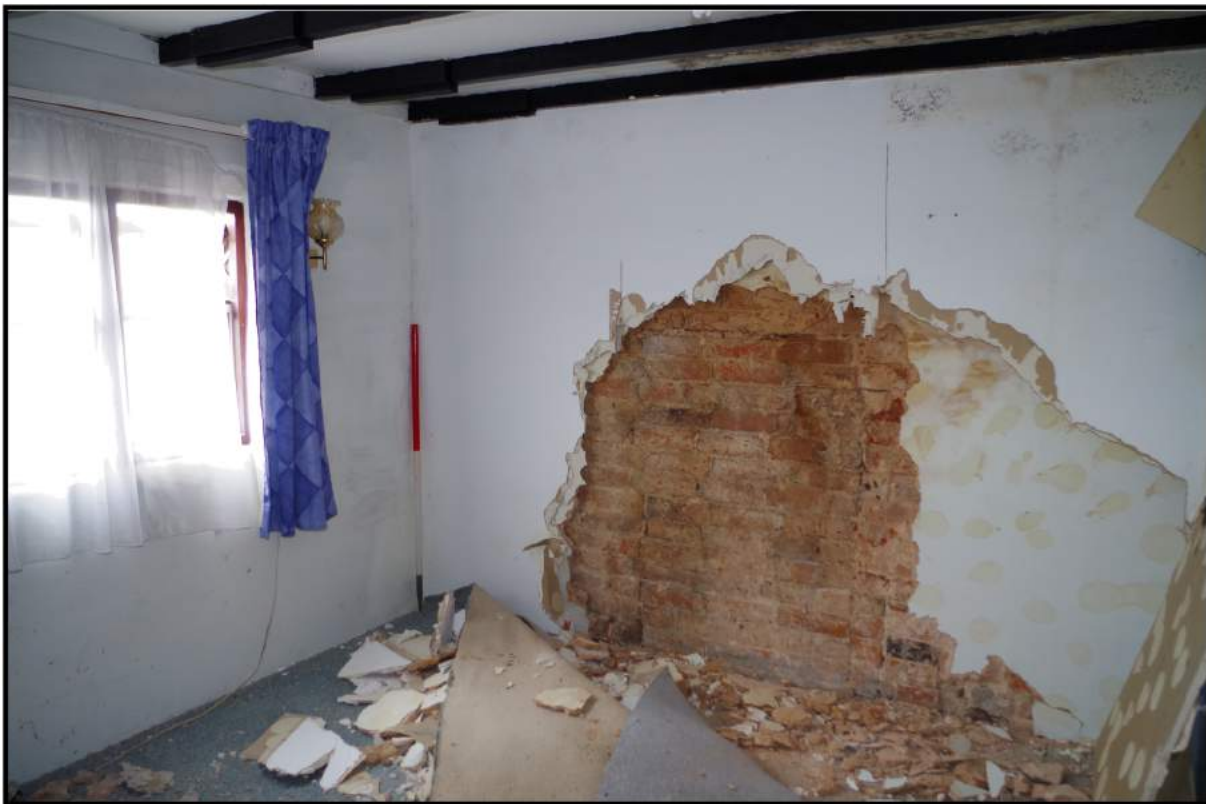
On the first floor there was no clear sign of a hearth in the corresponding position to the one on the ground floor. The plaster was removed from the wall (Fig 10) and what appeared to be a blocked opening was revealed. Curiously, the blocking brickwork was partially built-in to the adjoining walls. It was not possible to be certain whether:

- there was originally a hearth that was subsequently blocked or
- the position of the hearth was covered with brickwork that could be easily removed if it was desired to install a hearth in this position at some later date

Fig 10: Phase 1, first floor; showing blocked fireplace

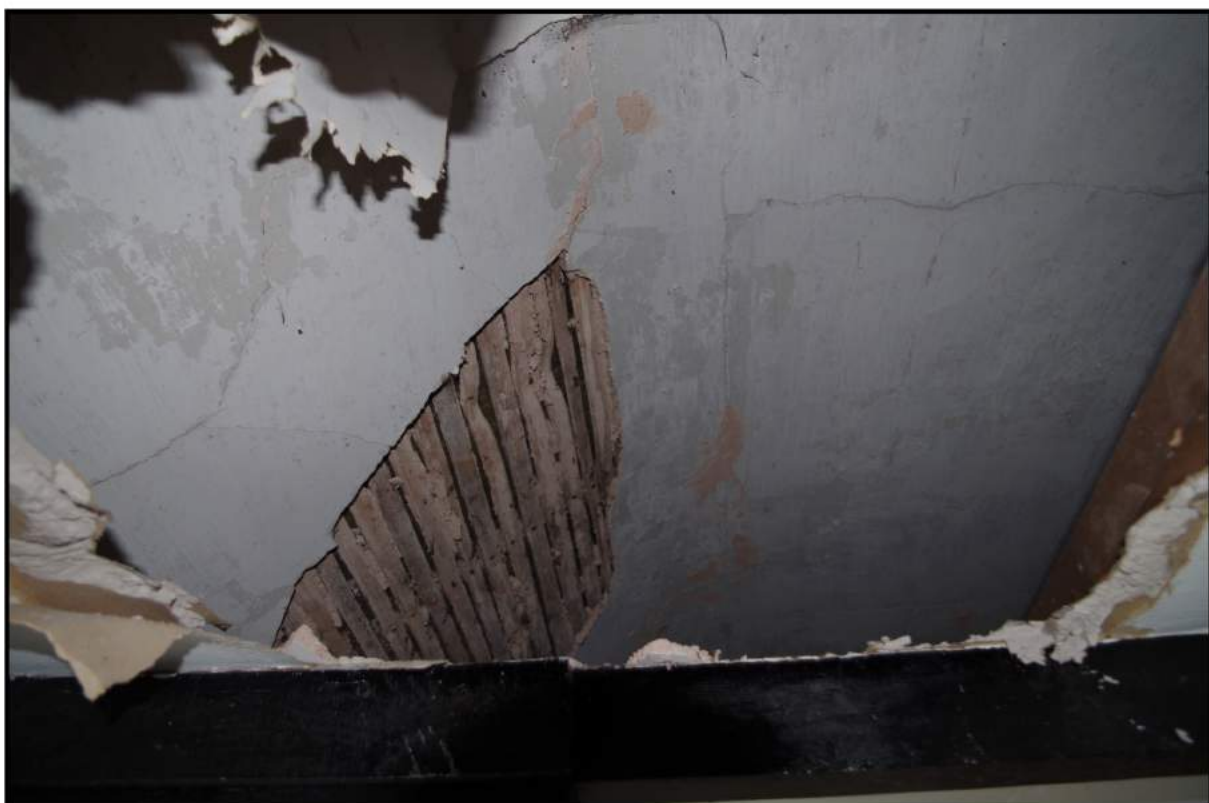
The existing ceiling to the first floor was a false one which, once removed, revealed a lathe and plaster ceiling (Fig 11) installed directly upon the roof timbers.

Fig 11: Phase 1, first floor; showing lathe and plaster ceiling

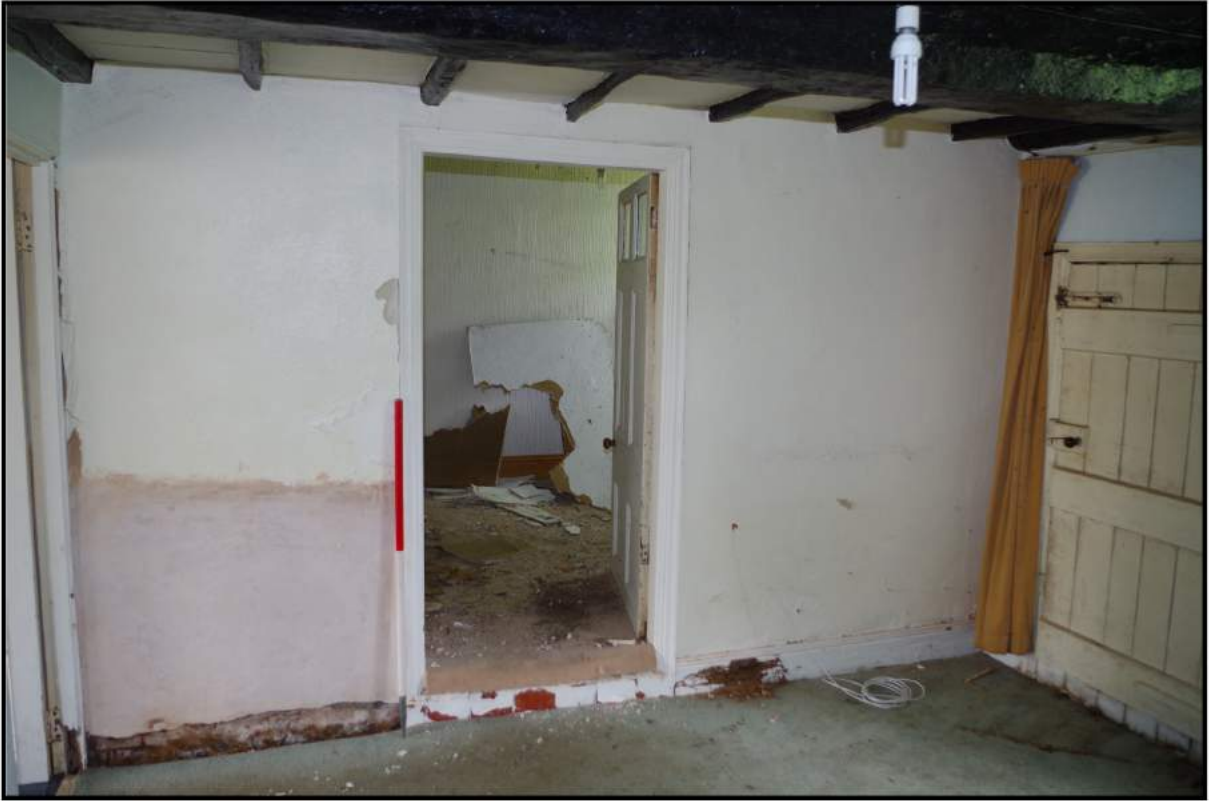
Fig 12: Phase 2, ground floor; showing original entrance to phase 1

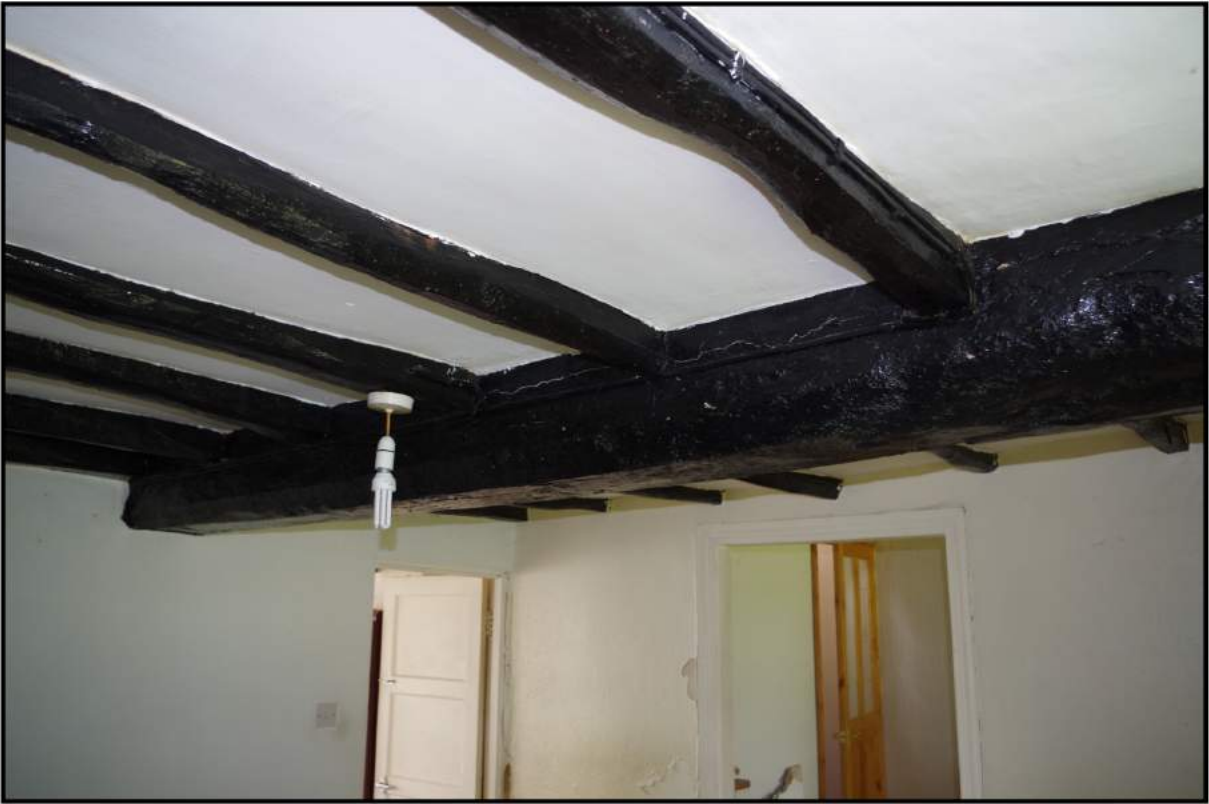
The substantial wooden beam (Fig 14) provided the principal support for the first floor. This beam was massively over-sized for the task it was required to perform and it is practically certain that it was reused from a higher status and probably older building.

Fig 14: Phase 2, ground floor; showing massive timber supporting first floor

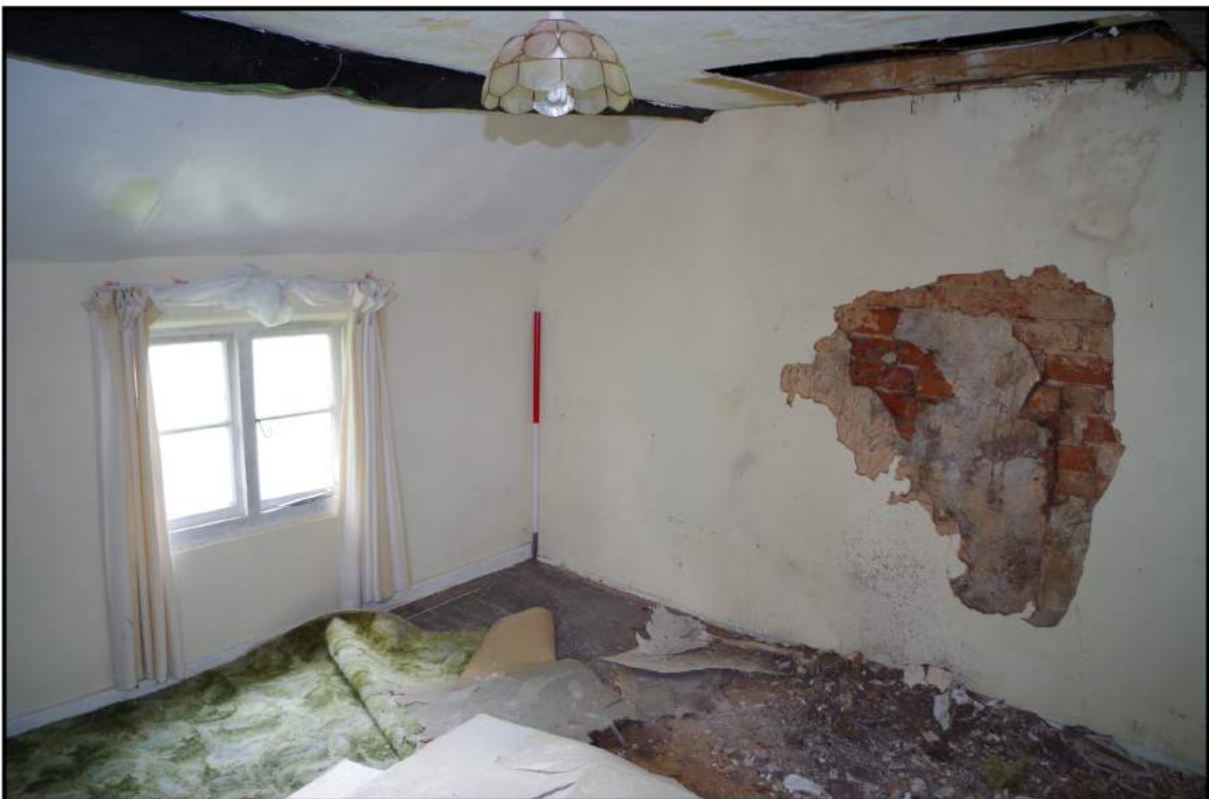
Fig 15: Phase 2, first floor; showing blocked fireplace

On the first floor, the floor boards were variable in width, from approximately 170mm to 240mm wide. These were probably also reused from elsewhere. Removal of the plaster in the middle of the south-east wall revealed a blocked hearth (Fig 15). The existing ceiling was, again, a false one and its removal exposed a lathe and plaster ceiling immediately behind (Fig 16).

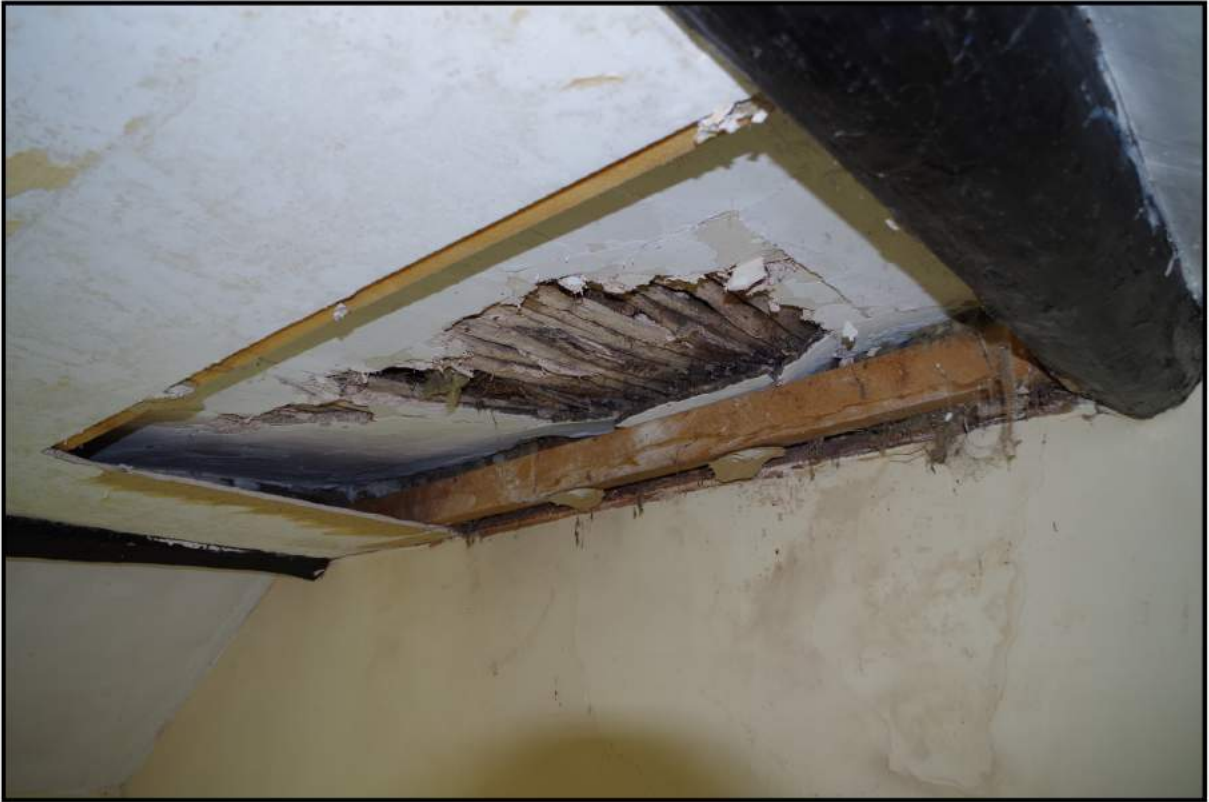
Fig 16: Phase 2, first floor; showing lath and plaster ceiling

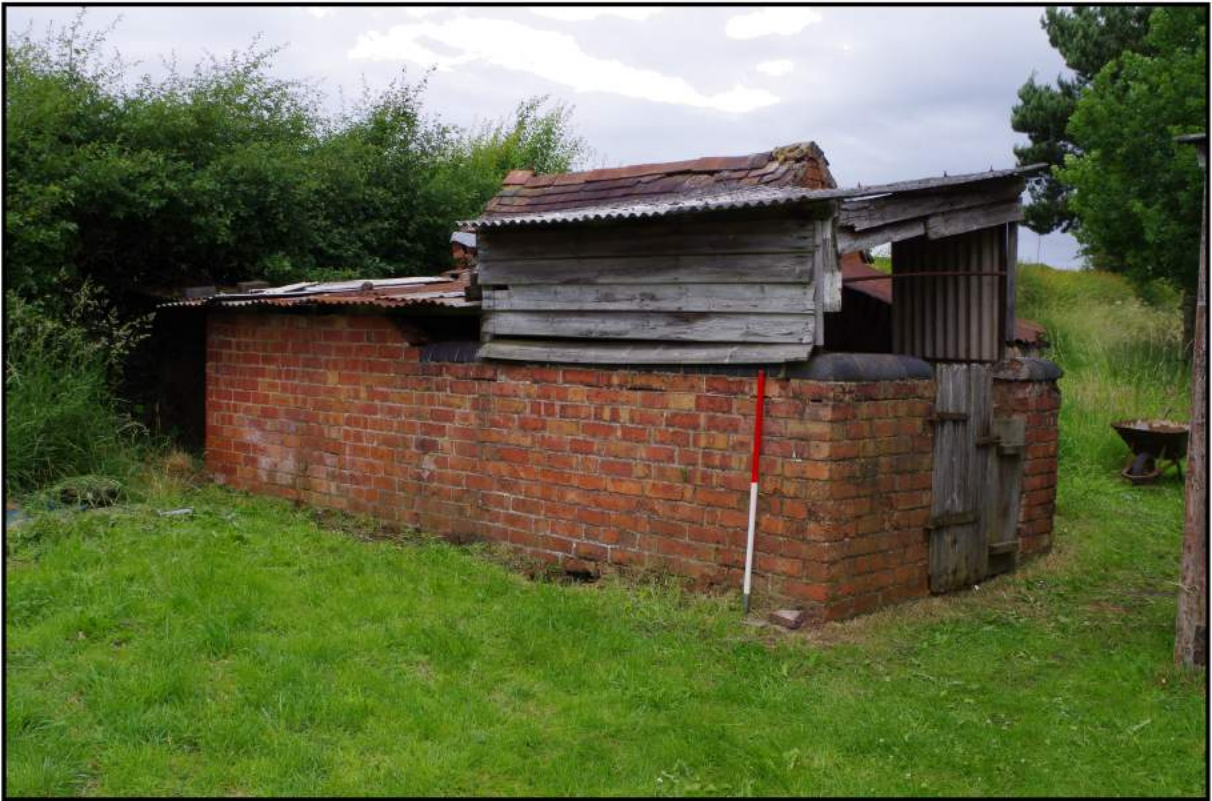
Fig 23: South-west elevation of privy and pig sty

This building was first extended to the south-east to create a coal/wood shed, also in stretcher bond (Figs 3.3, 3.8 and 22). Subsequently, a pig sty was added to the south-west (Fig 3.3). This was built in Flemish garden wall bond with half-round blue coping stones (Figs 3.8, 22, 23 and 24). The rear wall (south-west elevation) had a steel shutter closing a rectangular opening at ground level. A concrete trough was added later (Figs 3.3 and 24).

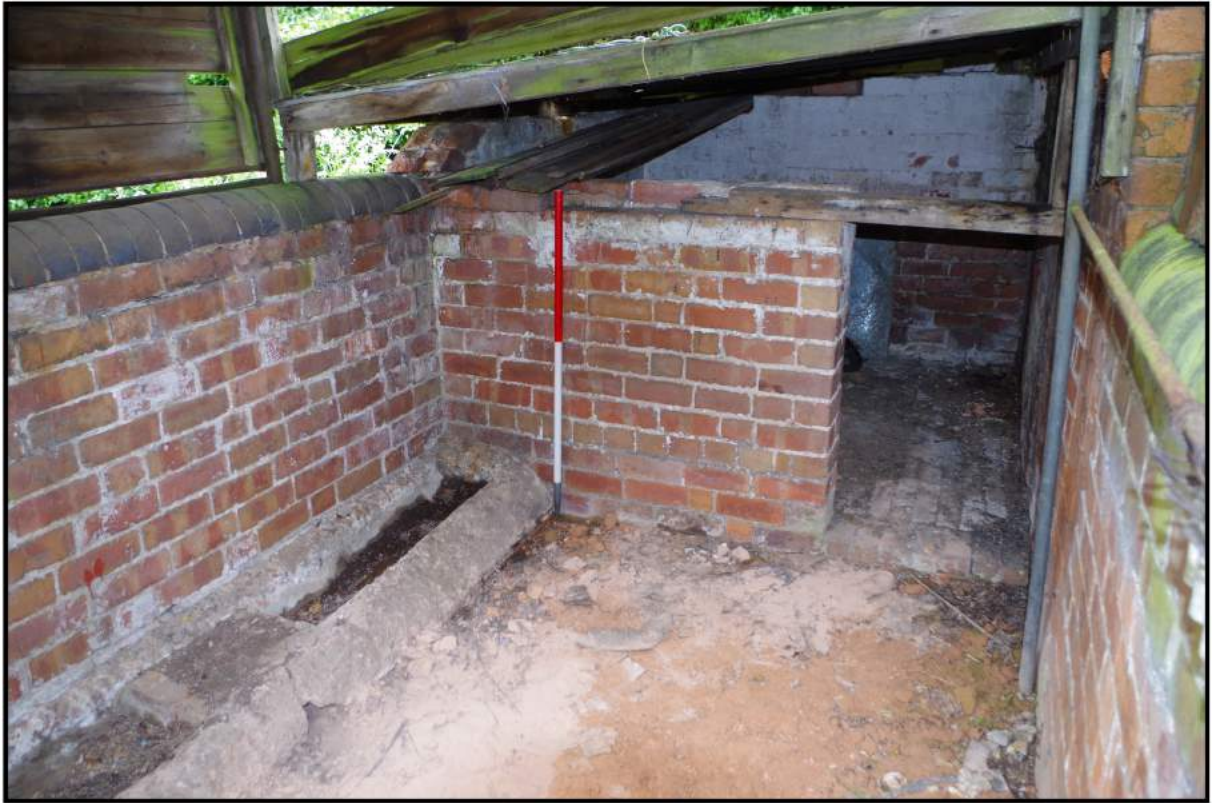
Fig 24: Interior of pig sty showing trough

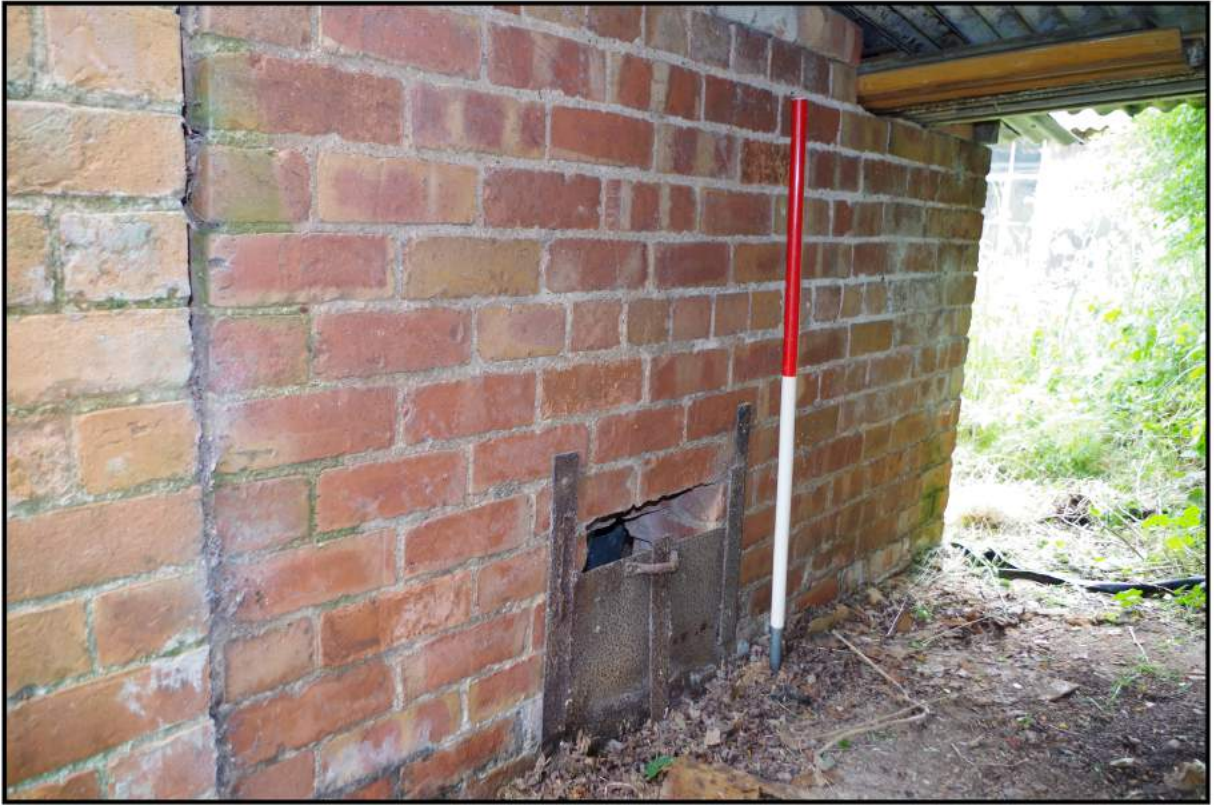
Fig 26: Hatch access to rear of pig sty

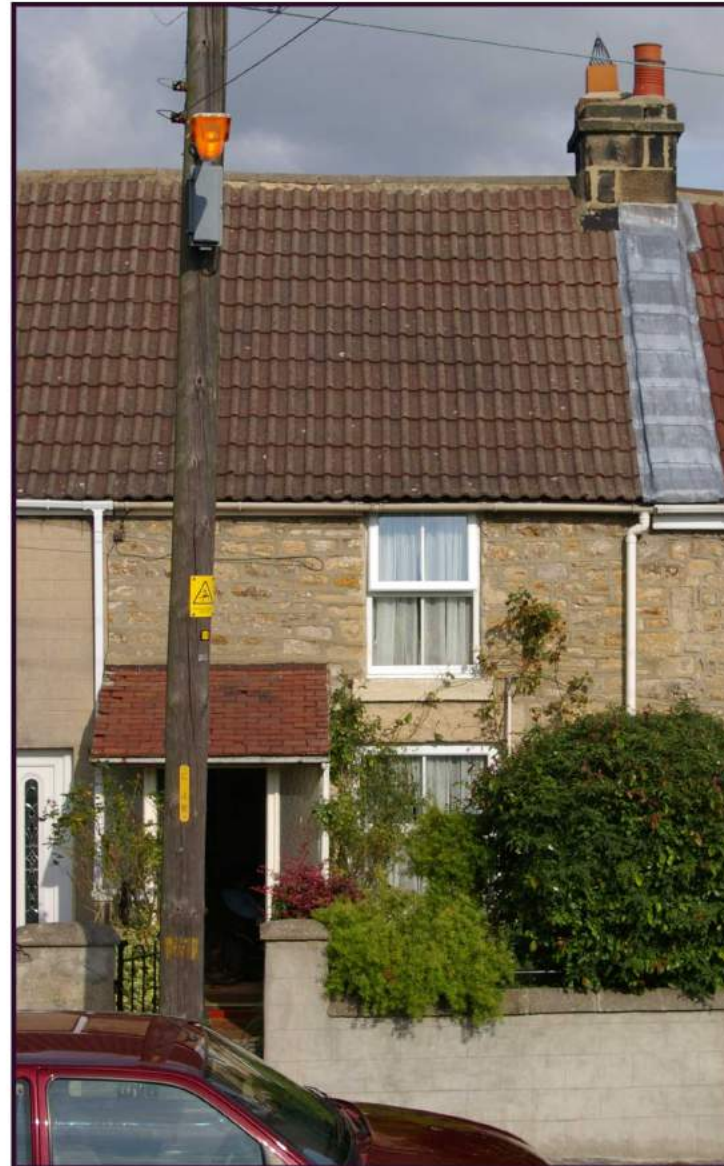
Fig 27: Comparative material, one-up-one-down cottage, Cockfield, County Durham

The consequence of this is that the opportunity to record such buildings occurs infrequently. The author had to go a considerable way (geographically) to provide an example of a comparable cottage with which he was familiar. Although much altered, like the example at Chaddesley Corbett, a cottage in Church Square, Cockfield, County Durham (Figs 27 and 28) has many points of similarity. Reliably dated to c 1624, this one-up-one-down example originally had a single entrance facing the road and a single window on each floor. There was a hearth, or provision for a hearth, in both ground and first floor rooms. The stair was integral with both rooms. A noticeable difference is that the walls are considerably thicker than the Chaddesley Corbett example but this is due to their being of stone rather than brick construction.
