**Historic building recording
at New House Farm,
Cheltenham Road,
Hinton-on-the-Green,
Worcestershire**

27th October 2017

WSM 69398

The project was undertaken to a level three standard, in advance of the conversion of the building to domestic accommodation.

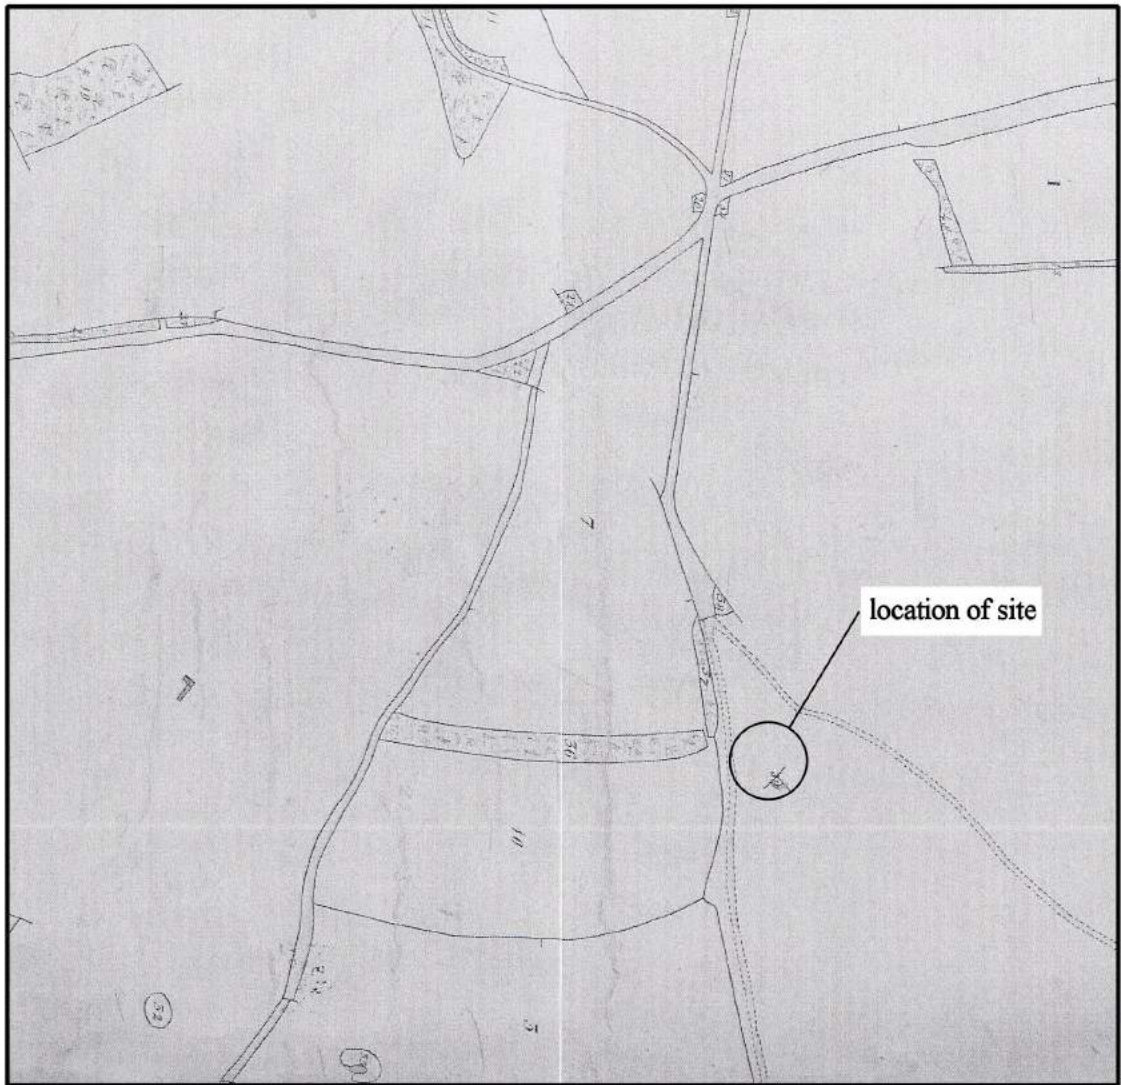
Fig 2.1: Hinton-on-the-Green tithe map of 1841

The earliest available map was the tithe map of Hinton-on-the-Green of 1841 (Fig 2.1). This shows no buildings in the location of New House Farm. However, it shows only one other building, at some distance from the site, and it is entirely possible that buildings generally were not included on the map as they were not relevant to the map's purpose of assessing the tithe return. The 1st edition Ordnance Survey map of 1884 (Fig 2.2) shows the farmhouse that exists to this day and the farm buildings to its north-east which form a courtyard, open to the south-west. Only the 'L' shaped component to the north-west is extant today; the 'L' shaped component to the south-east has gone. The Ordnance Survey map of 1900 (Fig 2.2) shows an extension taking the form of an 'L' shaped building to the north-east. The part of this extension that adjoins the building shown on the 1st edition map is open to the south-east. Together with the buildings shown on the 1st edition map, this extension formed a second courtyard, open to the south-east. The Ordnance Survey map of 1921 (Fig 2.3) shown nothing different, nor does the 1951, 1: 25000 Ordnance Survey map (Fig 2.3).

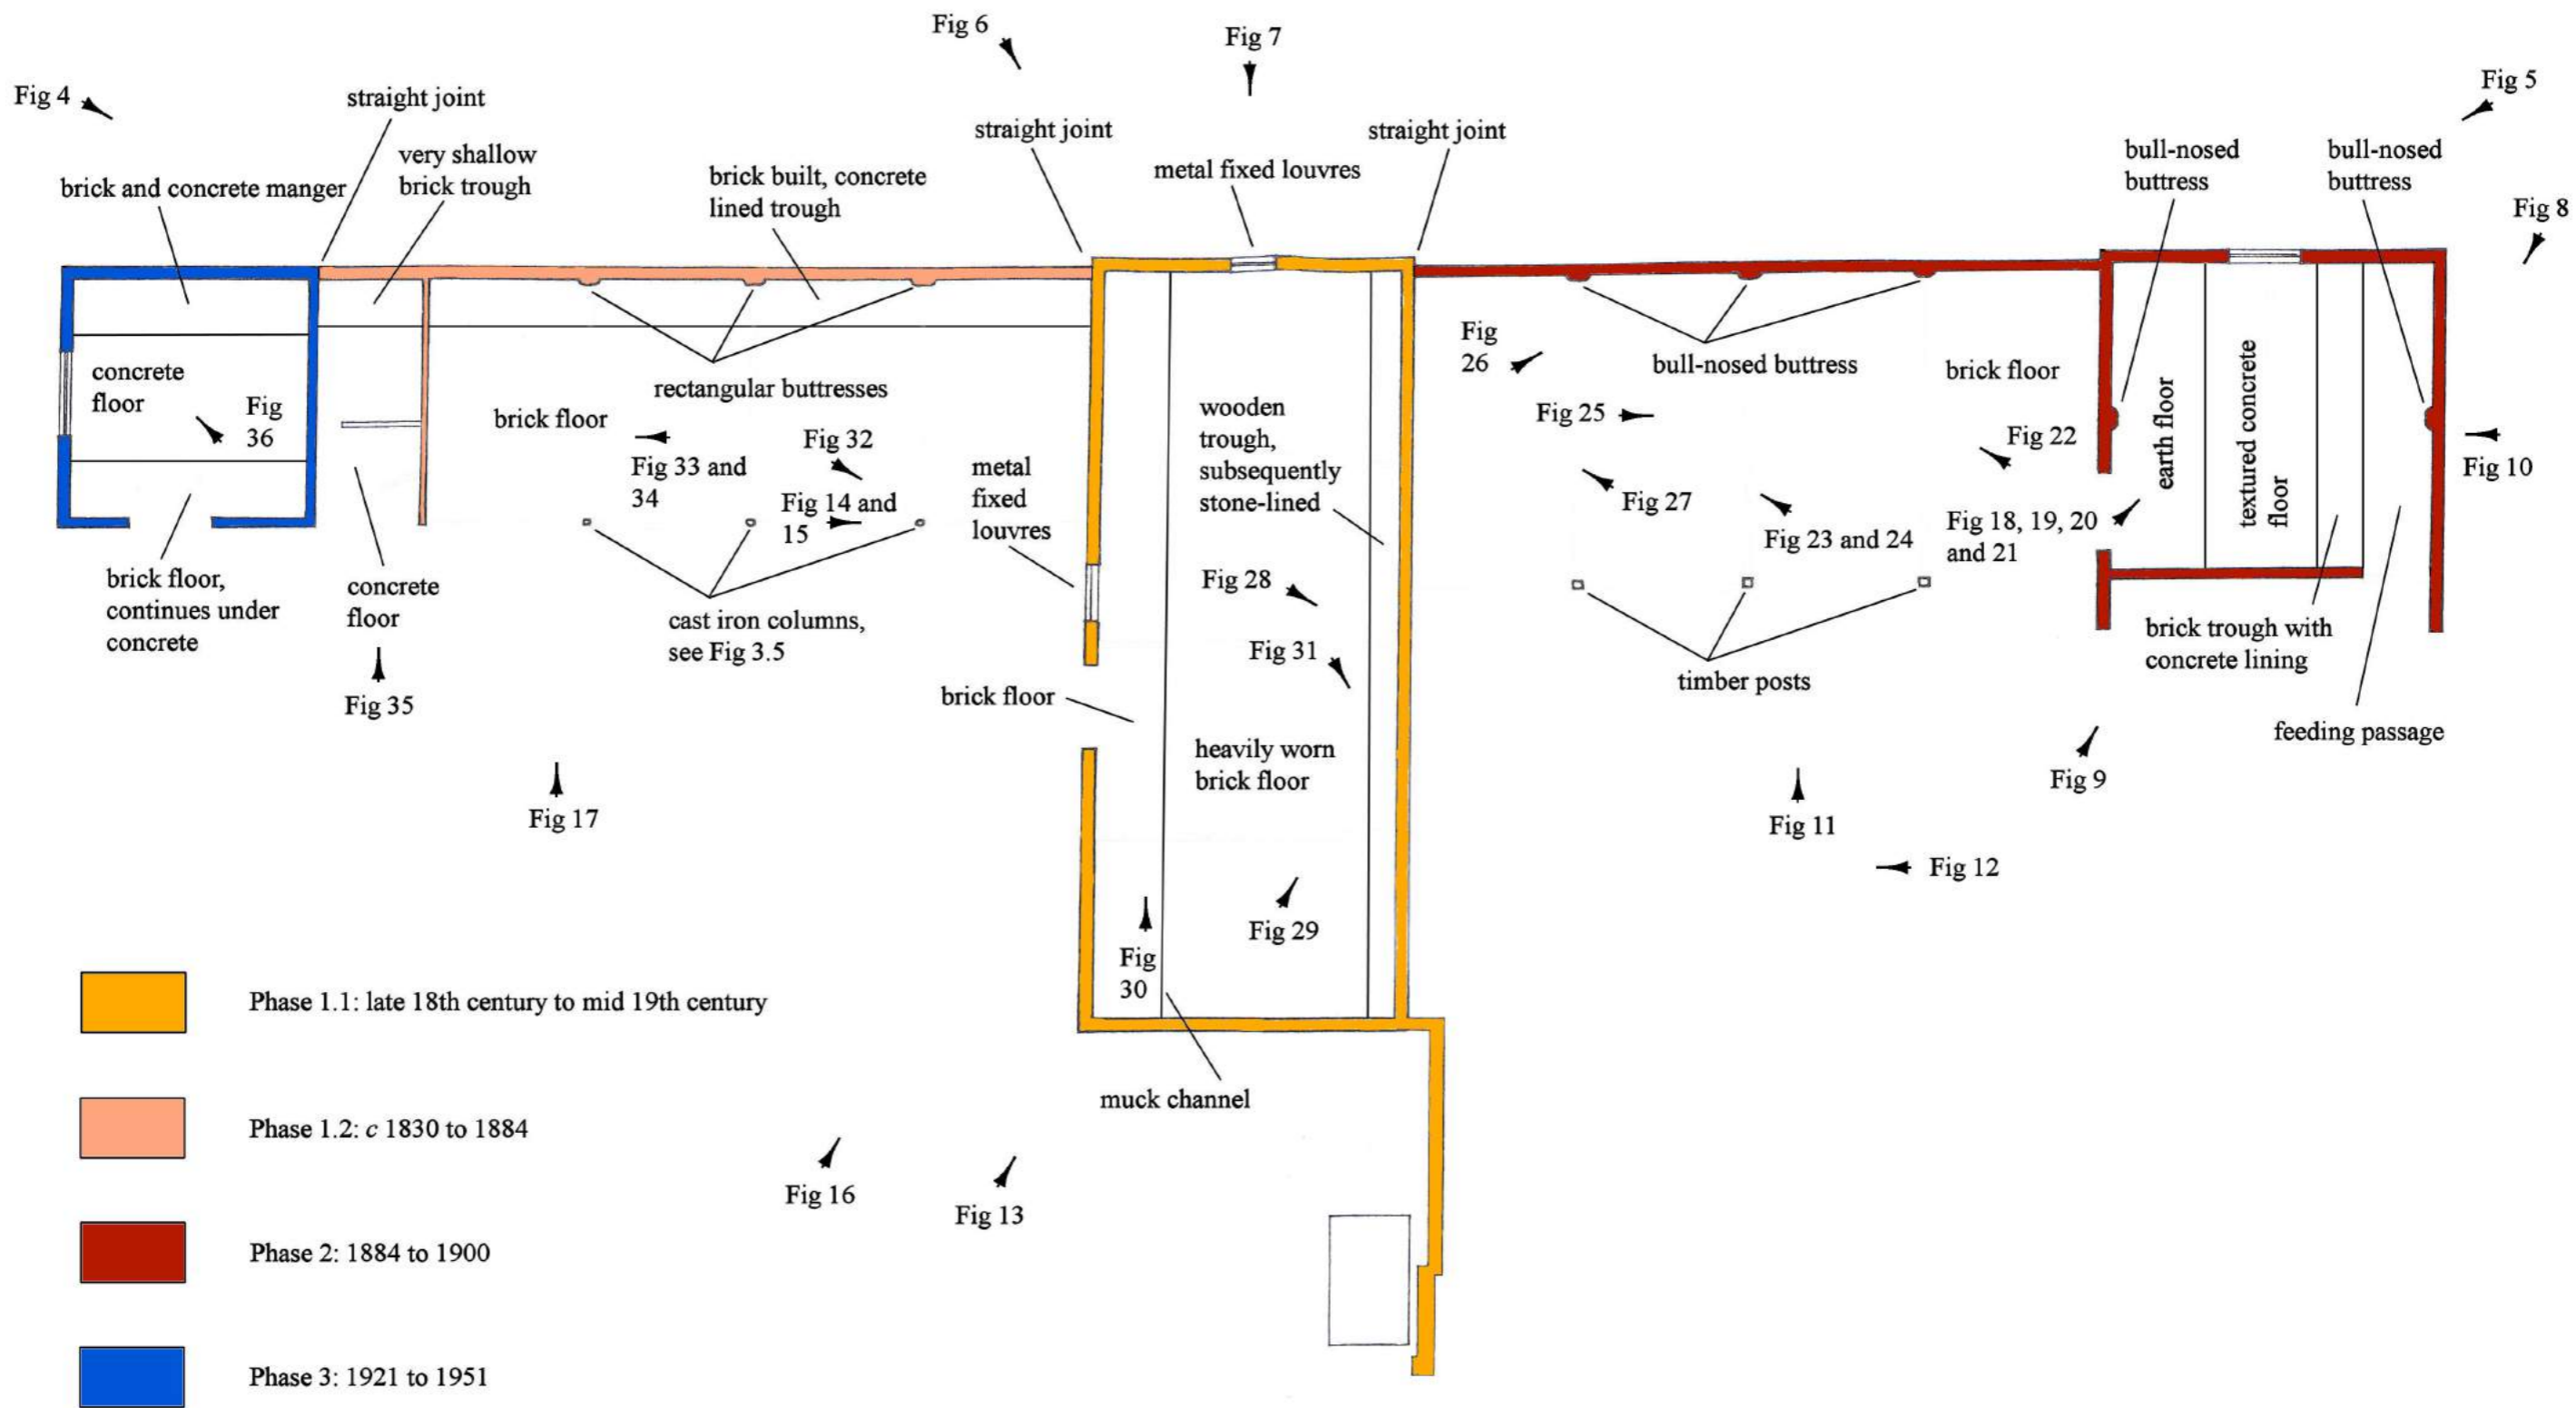
Fig 3.1: Ground floor plan

Structurally monolithic with this shelter shed is the remains of a wing running east-south-east (Fig 3.1). Also built in Flemish bond with cogs on the eaves, this now has a roof of corrugated material.

A square, two storey brick structure, also in Flemish bond with cogs at the eaves, was added to the south-south-west end of the phase 1.2 shelter shed (Figs 3.1 and 3.2). The interior has a brick and concrete trough across the whole of its west-north-west wall (Fig 3.6). It originally had a brick floor across the whole of the interior but this has been partially covered with a concrete floor against the trough. There is a single window in the south-south-west gable, now partially blocked. The single entrance has a two-leaf stable door and the first floor has a hay loft with access in the south-south-west gable. The first floor was in a parlous condition, propped-up by a single small scantling timber, and access could not be obtained to determine the form of the roof structure.

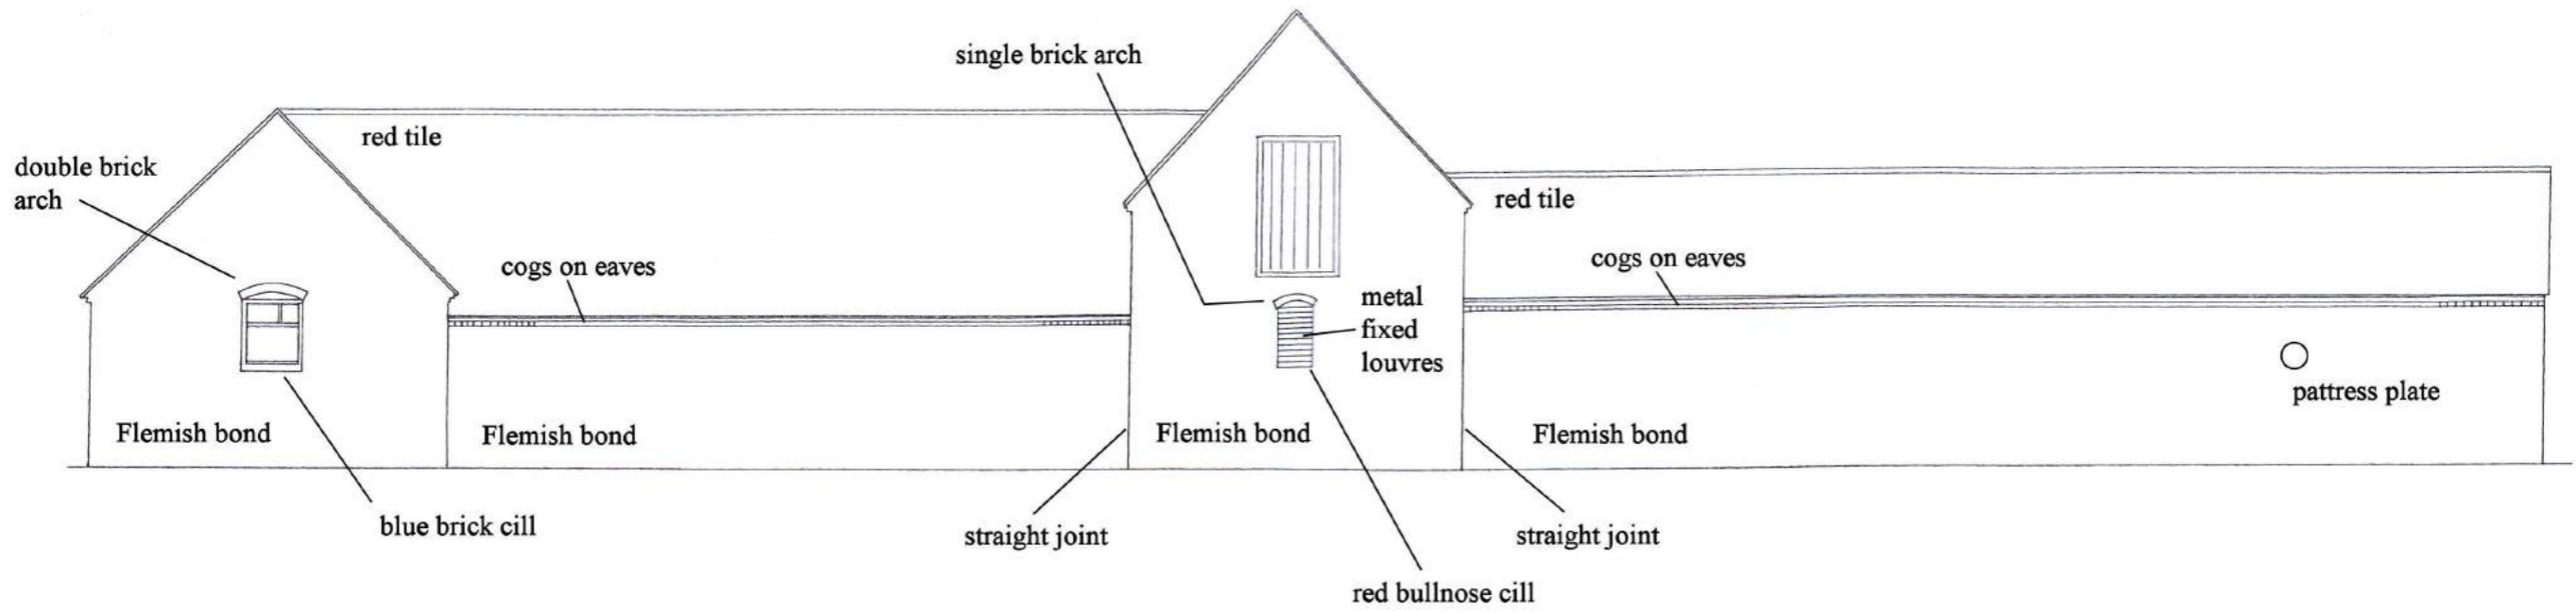
Fig 3.3: West-north-west and east-south-east elevations

The first floor is windowless but has a single door in each of its west-north-west and east-south-east walls (Figs 3.3, 6 and 13). It is spanned by queen post roof trusses, also known as attic trusses, which support purlins carrying common rafters (Fig 3.6).

Bull-nosed buttressed in the centre of the east-south-east/west-north-west walls supported a beam which in turn supports two struts which bear against two purlins (Fig 3.6). This can hardly be called a truss and the roof structure is only stable because the purlins pass through the walls at both of their ends and are supported by them (Fig 3.3; east-south-east elevation).

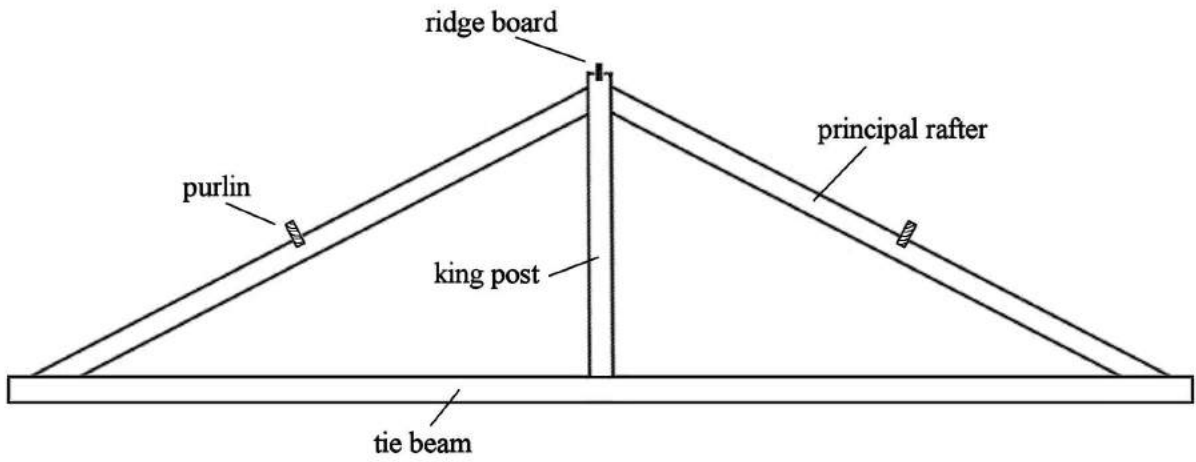
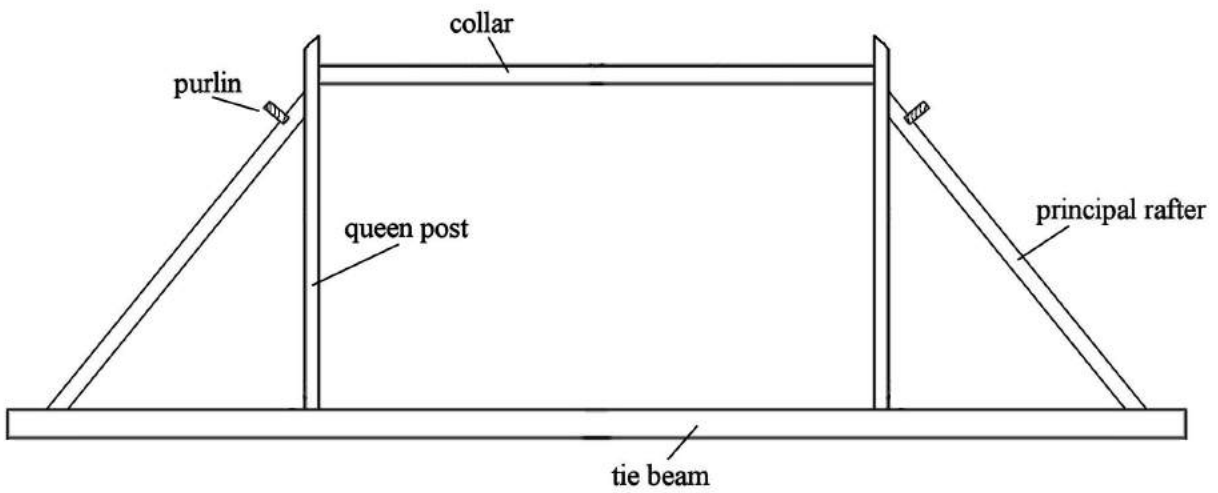
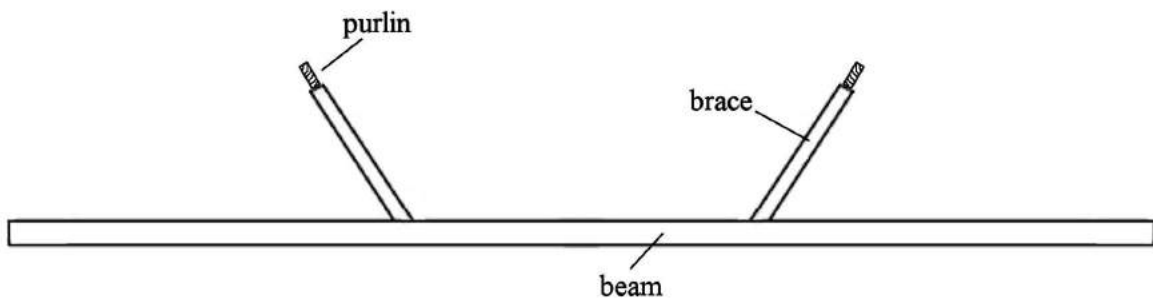
Fig 3.6: Types of roof truss employed at New House Farm (for locations see Fig 3.1)

It is spanned by a king post roof truss (Fig 3.6) which supports purlins carrying common rafters. The roof covering is red tile.

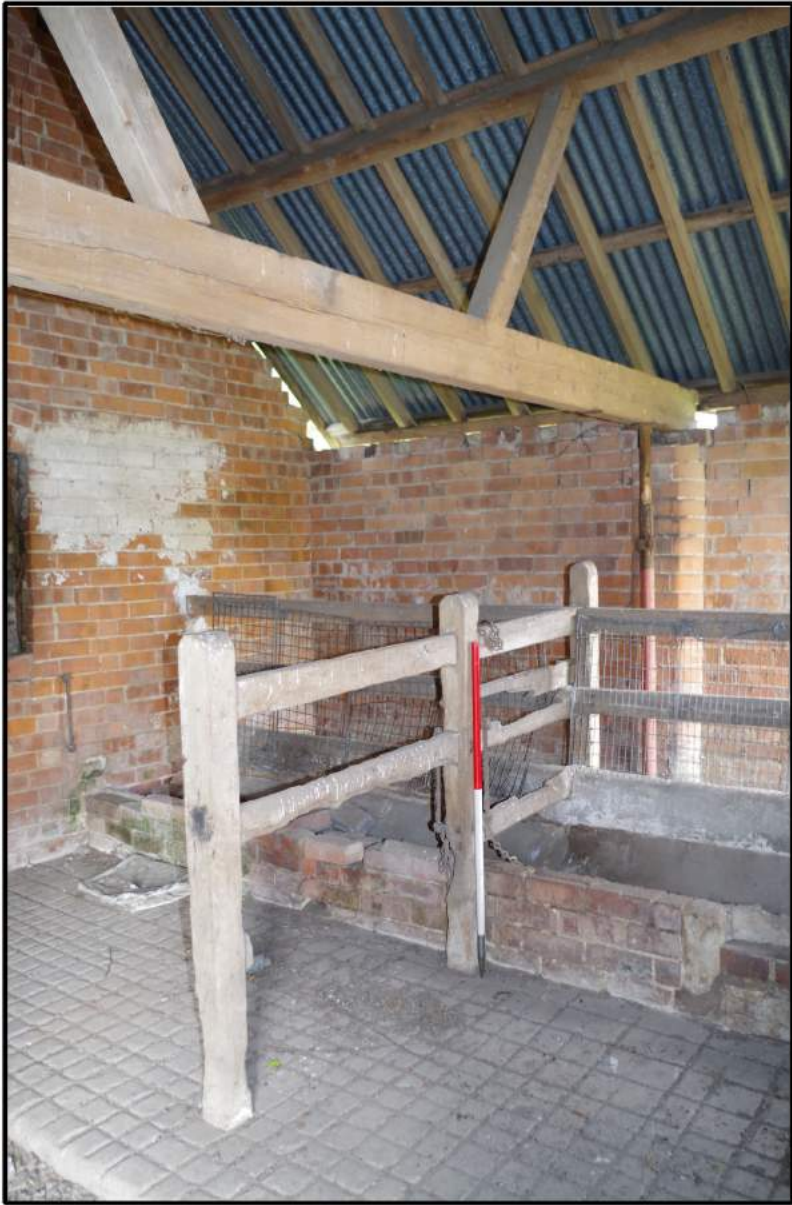
Fig 18: Interior, north end, showing trough and feeding passage

The interior comprises a feeding passage on the north-north-east side accessed by a door in the east-south-east wall. The feeding passage gave access to a brick trough with a concrete lining. Beyond this, was an area of textured concrete floor followed by an area of earthen floor (Figs 18, 19, 20 and 21).

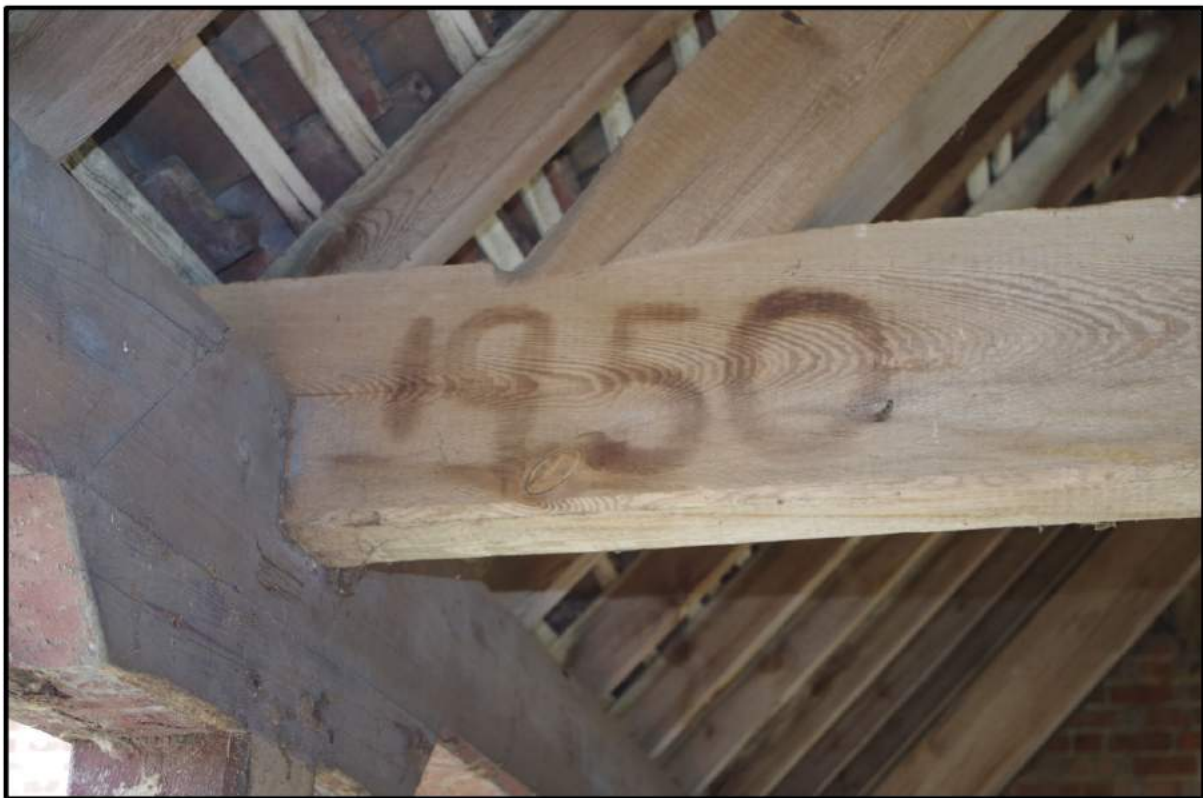
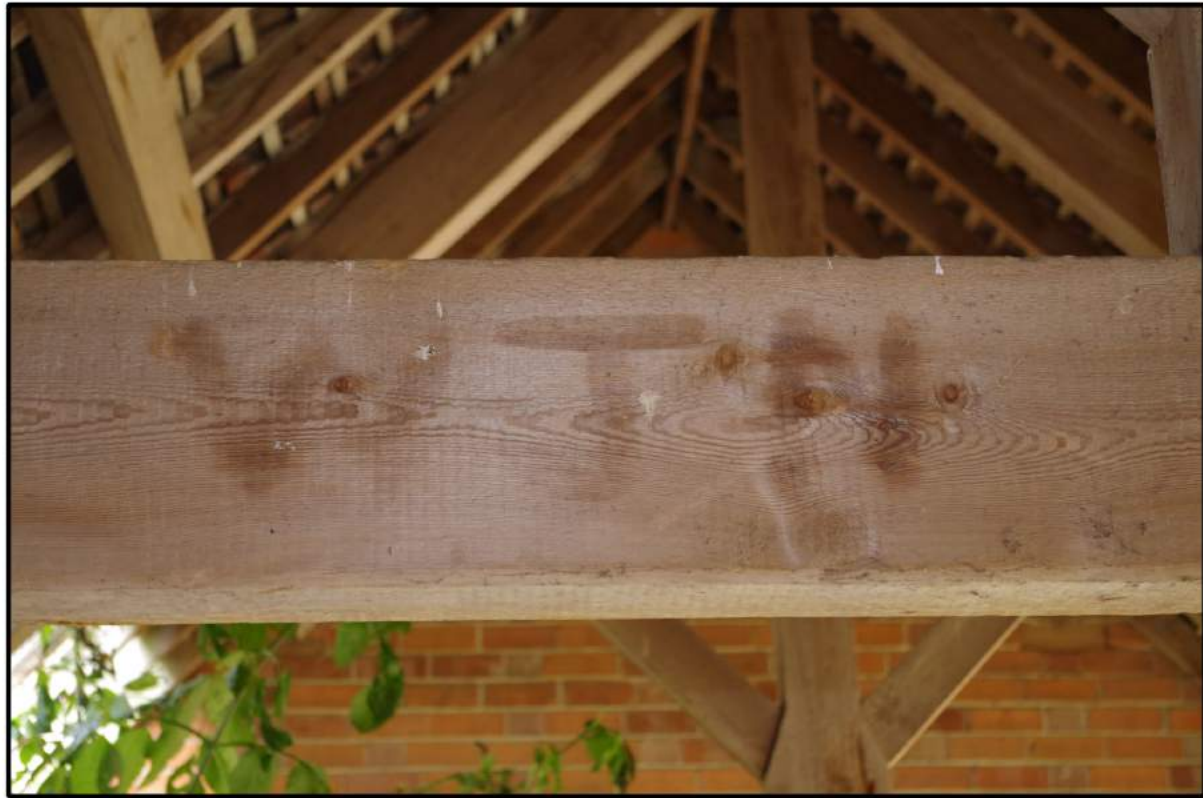
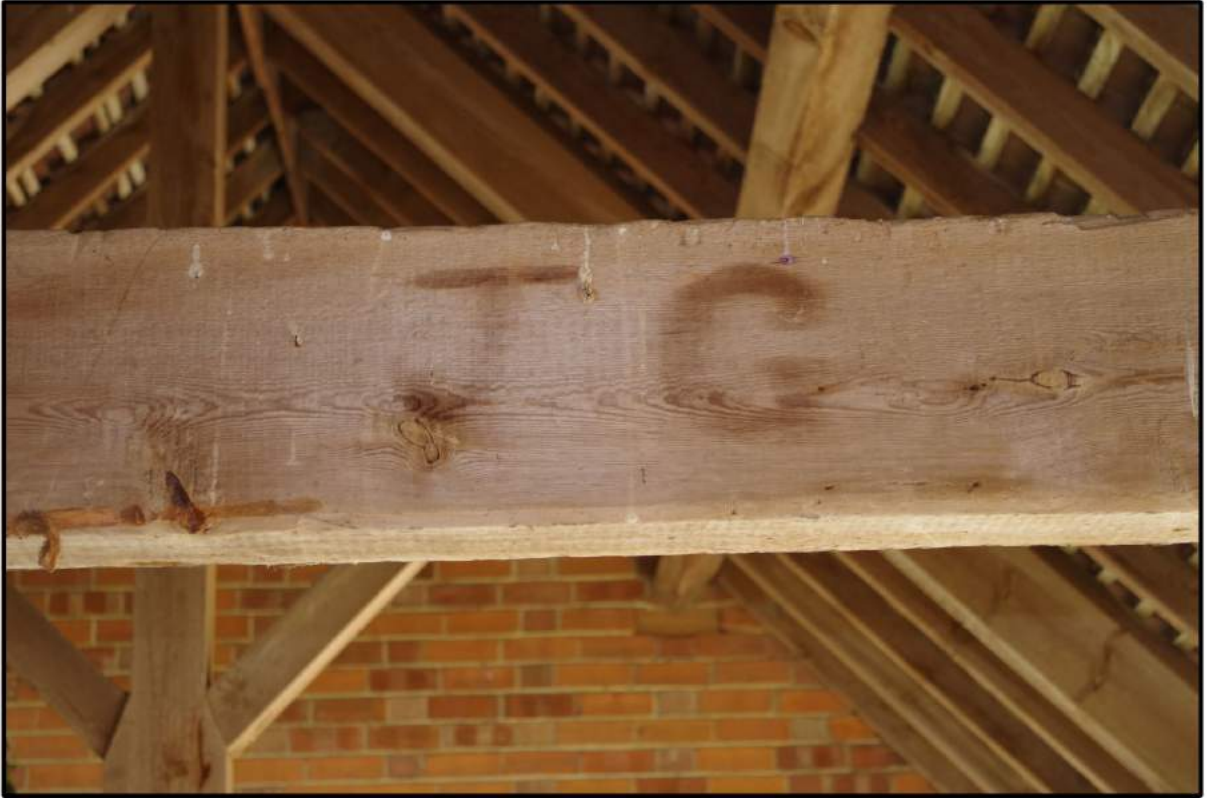
It is spanned by a king post roof truss which supports purlins carrying common rafters. On one of the tie beams is some graffiti: '1950', 'WTN' and 'JG', clearly applied using spray paint (Figs 3.6, 23, 24 and 25). Although the modern aerosol spray can was patented in 1927, it wasn't until 1949 that it was used to apply paint. It is therefore just possible that '1950' represents the actual date of application. The roof covering is red tile.

Fig 23: North end, showing graffiti on tie beam

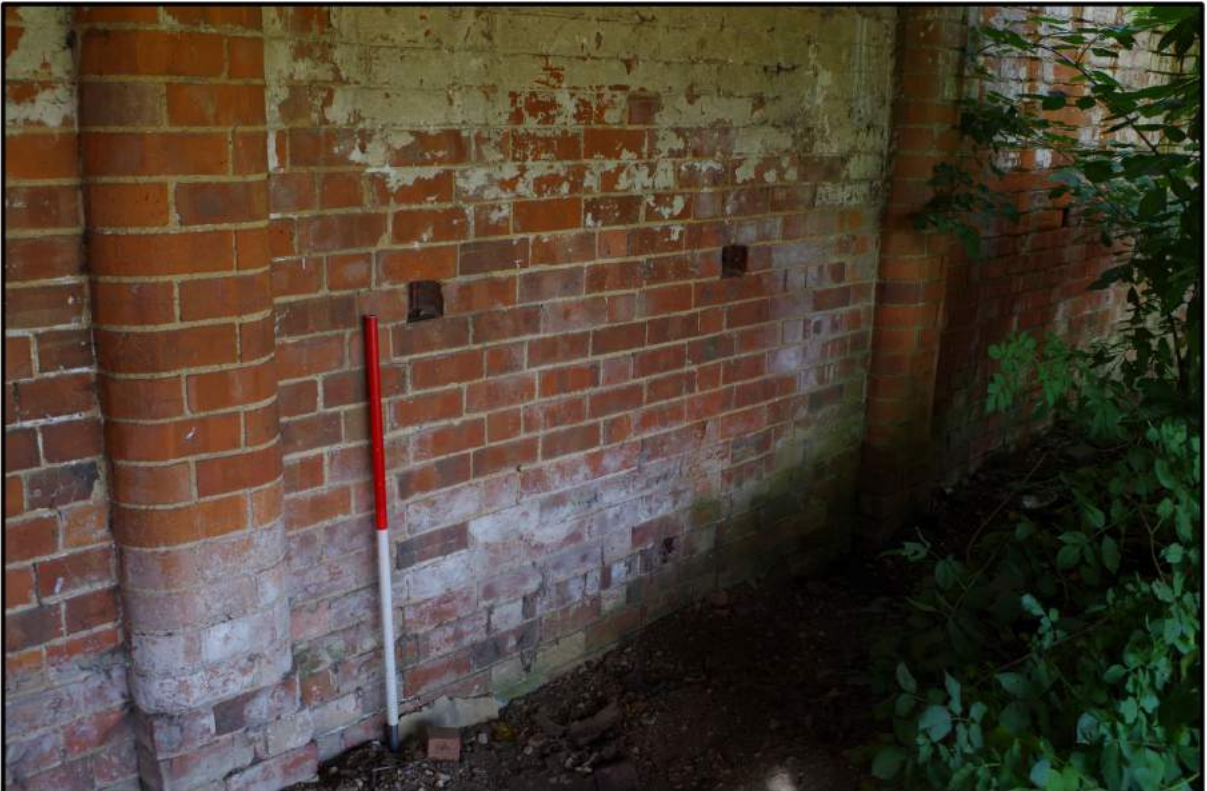
Fig 26: North end interior showing sockets for trough and limewash

In this phase an open-fronted shelter shed supported by a brick wall of Flemish bond on its west-north-west side, with bull-nosed buttresses on the interior, cogs at the eaves and timber posts supporting the roof on its open side was added to the phase 1.1 building (Figs 3.1, and 11). It was lightly bonded-in to the phase 1 building at its south-south-west end. It has a brick floor and sockets in the wall show that there was formerly a trough extending its entire length (Figs 26 and 27).

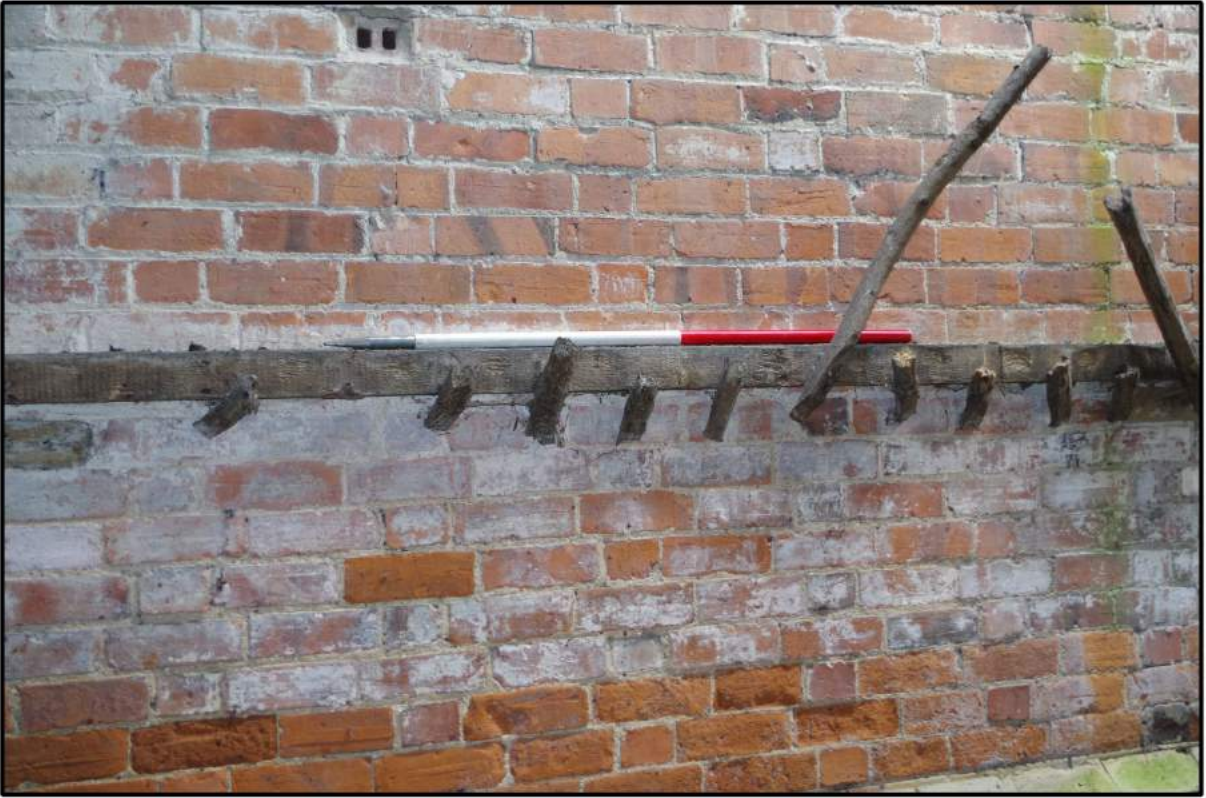
Fig 28: Central block, interior, showing hay rack

The ground floor has a heavily worn brick floor with a muck channel running along its south-south-western side and a trough occupying the whole of its north-north-eastern wall (Figs 29 and 30). There is a single door in its south-south-western wall and a single small window in each of its east-north-east and south-south-western walls. Over the trough there is a hay rack (Fig 28) with provision for refilling from the first floor.

front to prevent seeds falling into the cows' eyes and ears. This was not the case at New House Farm where the rack, although in a fragmentary condition, clearly sloped (Fig 28).

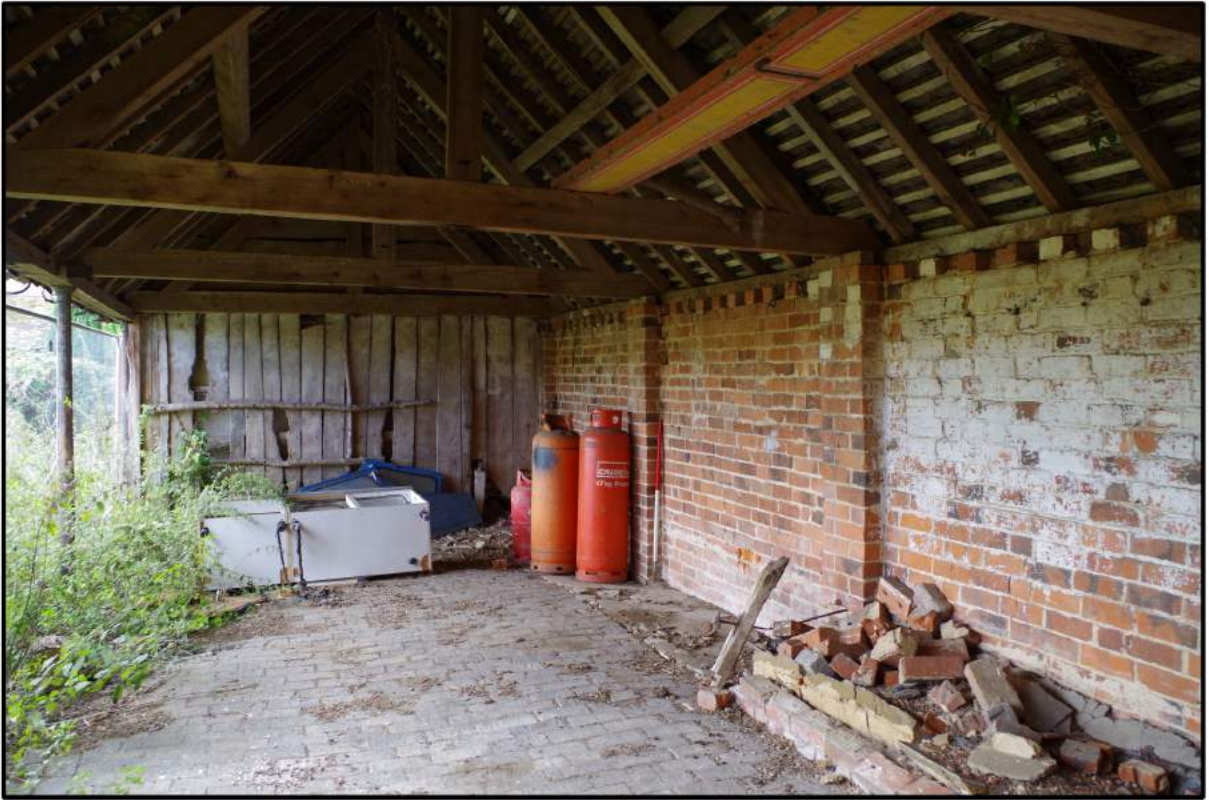
Fig 33: South end interior

In this phase an open-fronted shelter shed supported by a brick wall of Flemish bond on its west-north-west side, with rectangular buttresses on the interior, cogs at the eaves and cast iron columns supporting the roof on its open side was added to the phase 1.1 building (Figs 3.1 and 17). It was lightly bonded-in to the phase 1.1 building at its north-north-east end. It has a brick floor and it formerly had a trough extending its entire length (Fig 33).
