**Archaeological watching brief  
at St Andrew's Church,  
Allensmore,  
near Hereford**

10th February 2018

An archaeological watching brief was carried out at land at St Andrew's Church, Allensmore, near Hereford (SO 466 358; Fig 1) at the request of Mr John Goom. This work was undertaken during excavations in the graveyard for an drainage trench and soak-away, under a Faculty from The Bishop of Hereford's Registry, dated 23rd January 2017 (reference 7152/HJD/SKMB/F2016/102; Appendix 2).

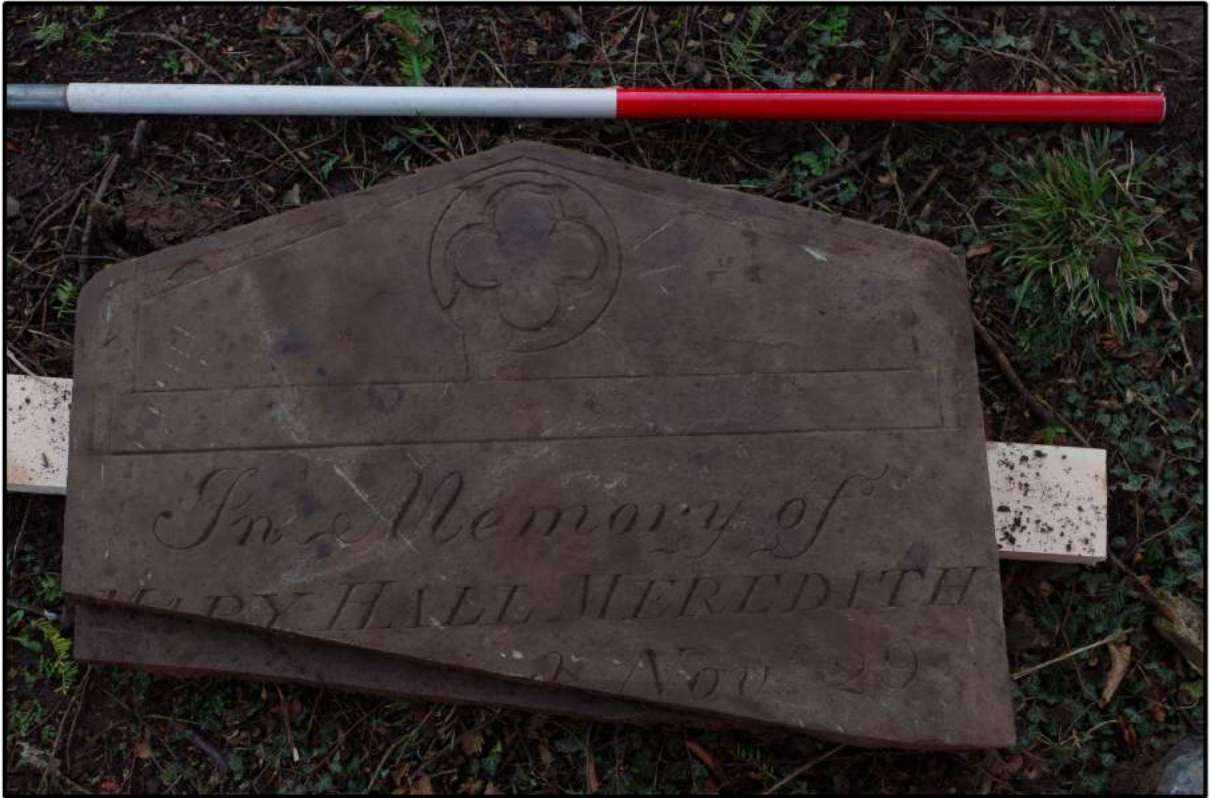
Fig 4: Part of grave slab recovered from trench (see Fig 3.1 for location)

There were almost no finds from the excavations, including any human remains, disturbed or *in situ*. The corner of a grave slab was encountered in the drainage trench, approximately 0.1m beneath the existing ground level. That part of the inscription that was exposed was recorded:

In memory of  
Mary Hall Meredith  
who died Nov<sup>r</sup> 29  
1841  
Aged
