**Archaeological building recording at
a valve house
at the foot of the dam
of Upper Bittell Reservoir
Worcester and Birmingham Canal**

25th February 2018
Revised 6th March 2018

Archaeological building recording at a valve house at the foot of the dam of Upper Bittell Reservoir Worcester and Birmingham Canal

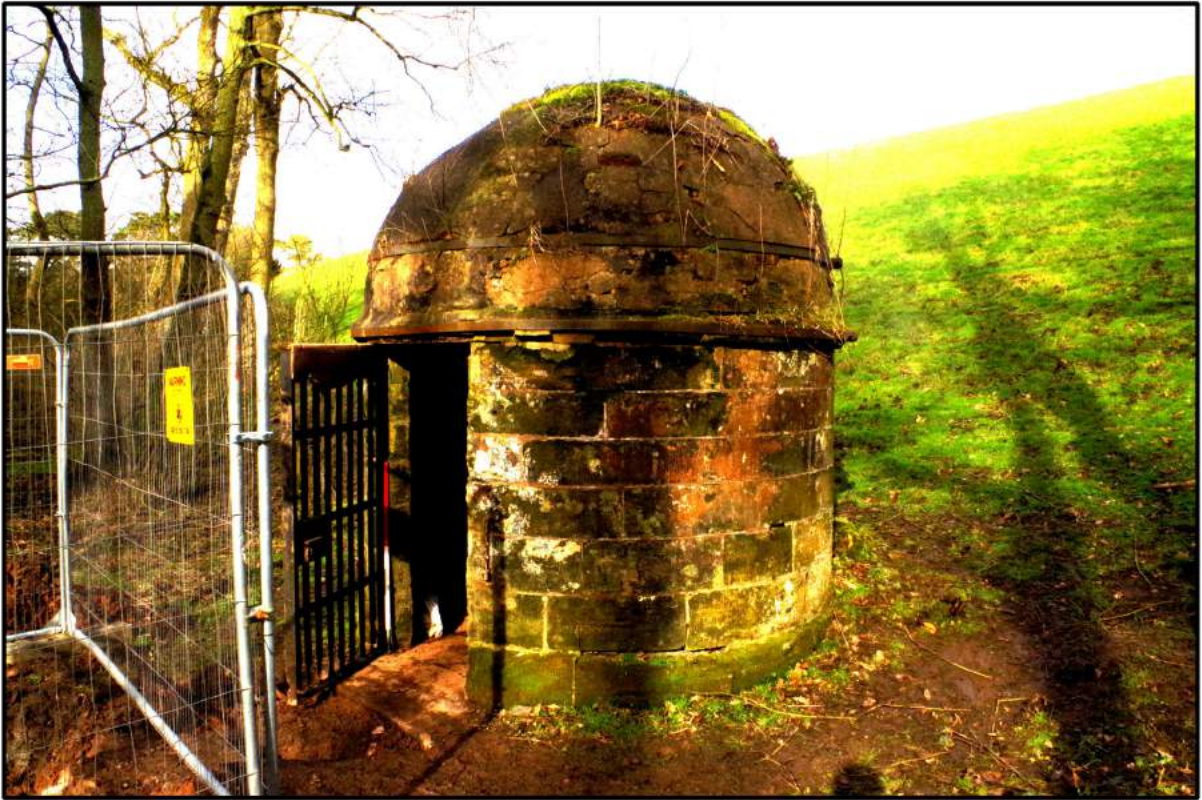
The roof is a dome of brick, over-pointed on the inside and rendered on the outside (pers com David Viner). This too is much decayed and has been repaired with non-matching bricks (Figs 4, 5, 6 and 10). The render may originally have been lime but the current covering appear to be cementitious. It butts against the upper iron strap (see below) suggesting this bracing was added some time before the early 20th century.

There are two iron straps around the building, one around the roll moulding and the other around the lower part of the dome (Figs 4, 5 and 6). It is possible that the dome showed signs of distortion after construction and the straps were added to counteract lateral pressure. The age of the straps is unknown but they are secured with square-headed bolts (Fig 7). Square-head bolts were common in early applications because they were easier to make with the tools, metals and techniques of the time. Square heads required less accurate tolerances, so that a wrench that was not the exact size of a bolt might be near enough to turn a hand-machined square bolt head. Square heads, however are large and require more room to turn. By 1841, British toolmaker Joseph Whitworth and his American counterpart, William Sellers of the Franklin Institute had proposed creating a system of standardized screw threads. Standardized bolts and nuts soon followed as toolmakers developed new techniques for making them in quantity. Therefore, it is possible that the bolts and straps predate the early 1840s. However, it is equally possible that there was an ample supply of such bolts available to the waterway maintenance crews and that existing stocks would have been used-up before they were replaced with hexagonal headed bolts, which only started to become common in the 1880s.

Fig 4: View from the south

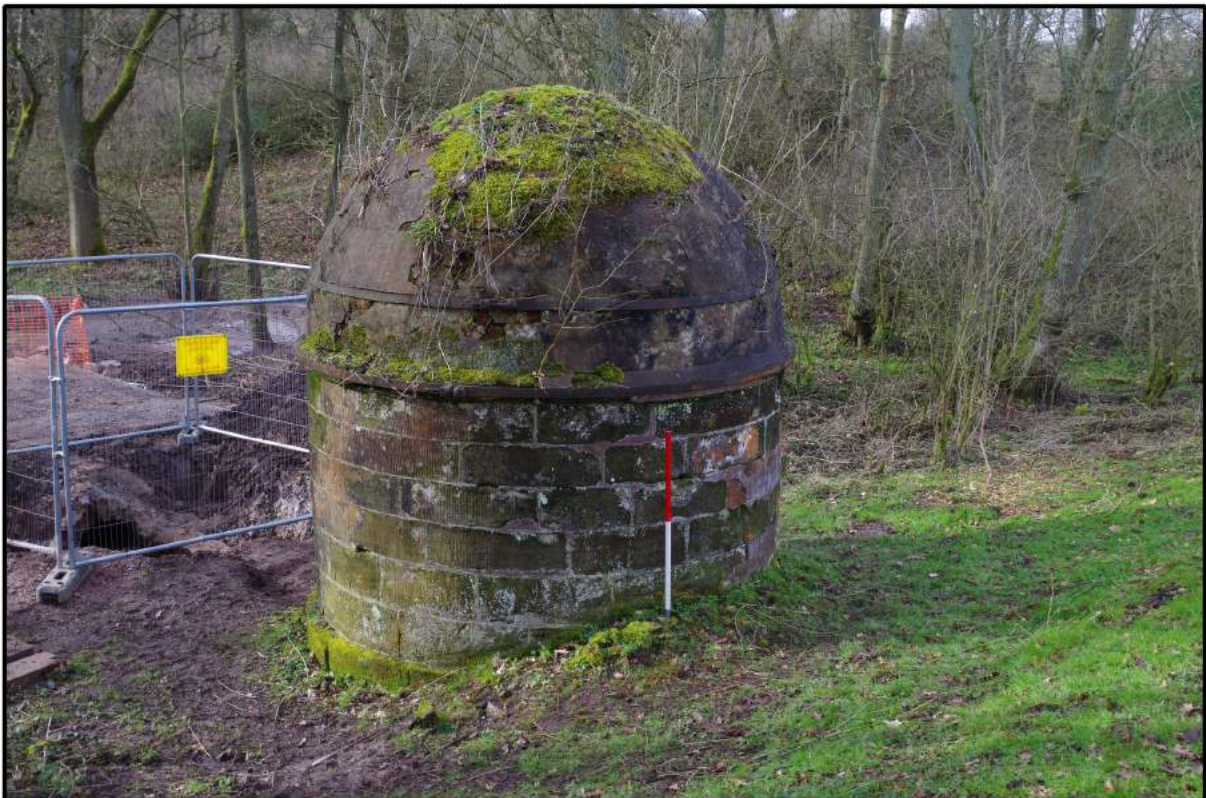
Fig 5: View from the north

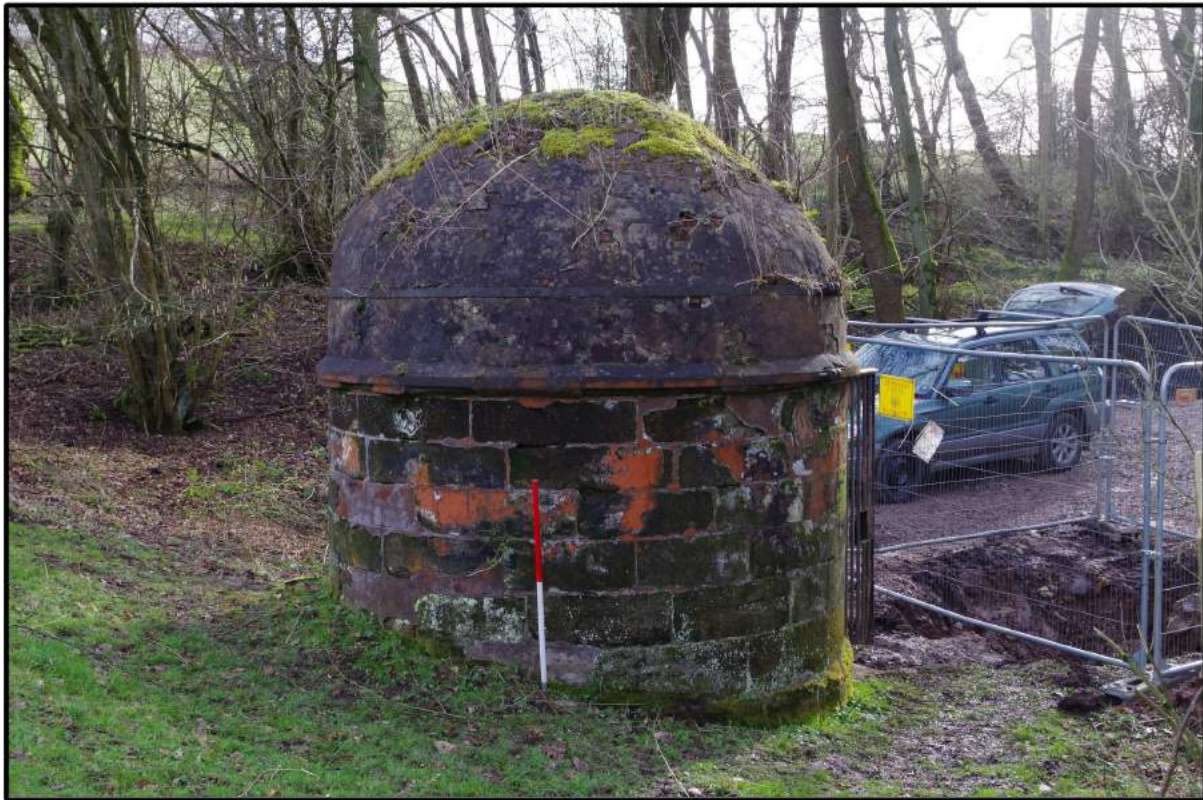
Fig 6: View from the south

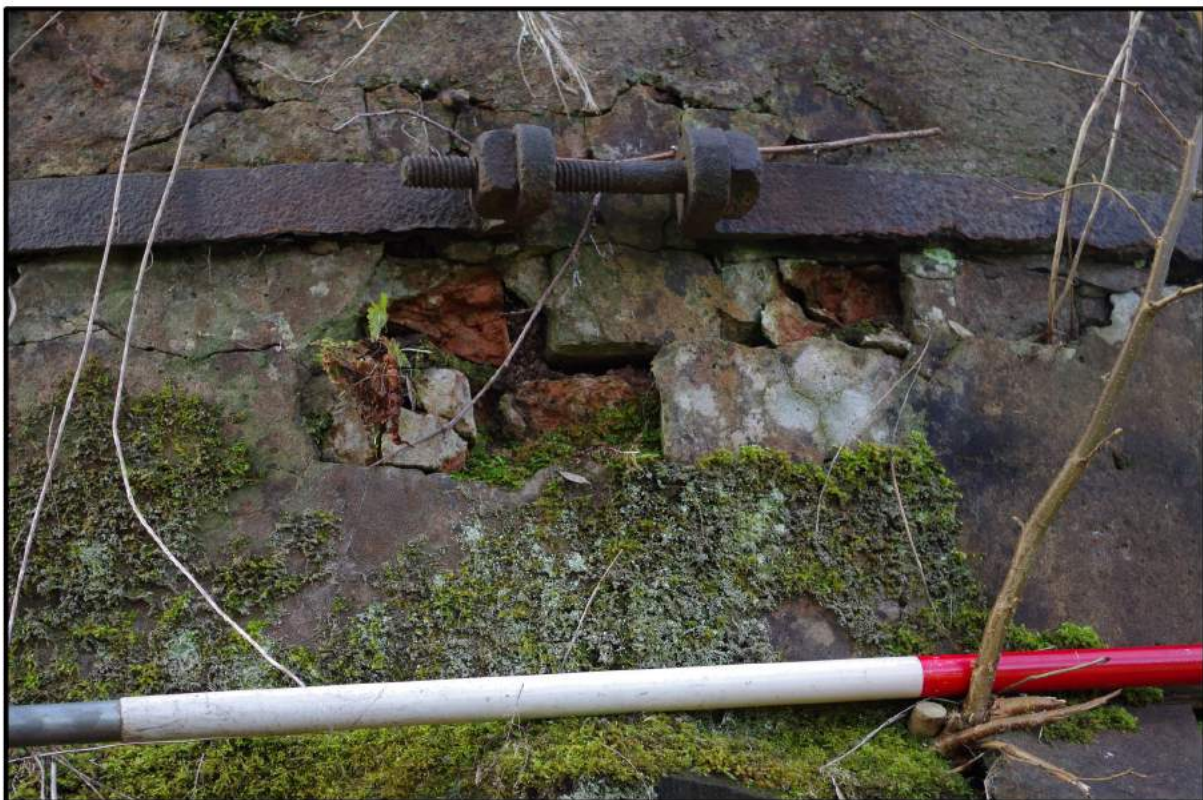
Fig 7: Detail of bolt securing one of the iron straps

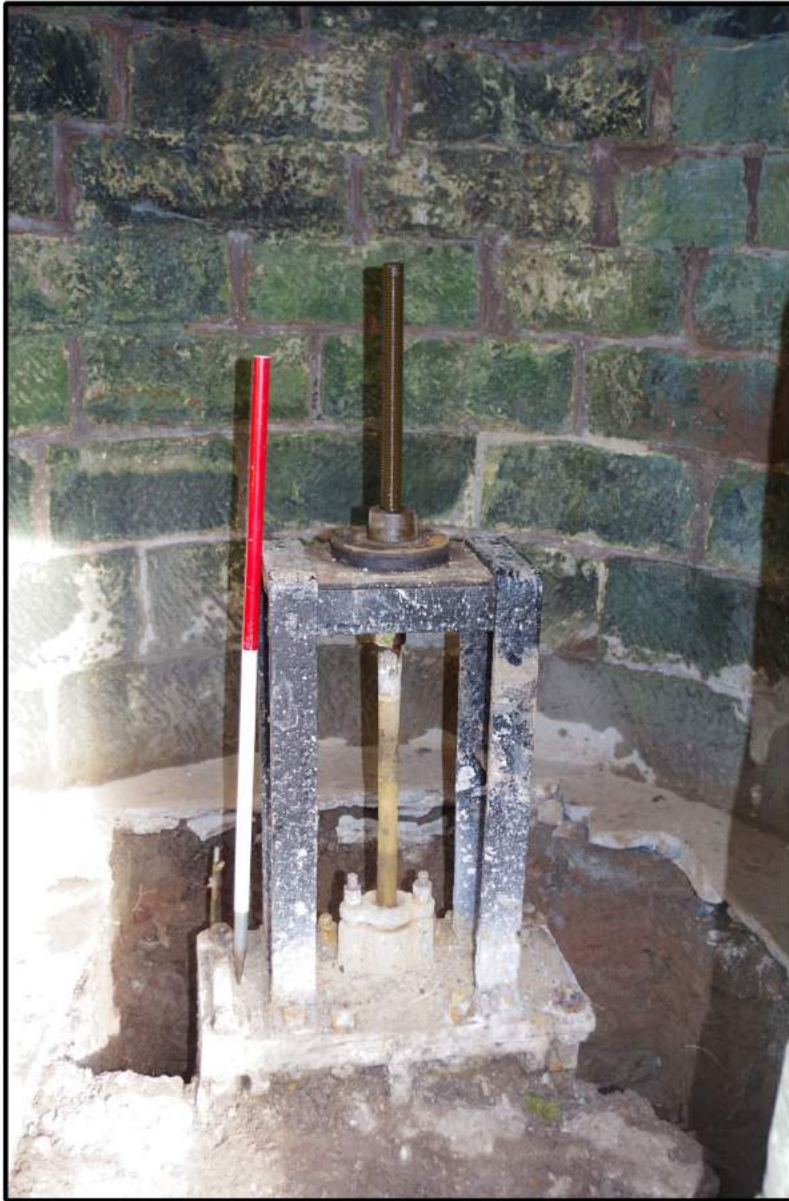
Within the valve house is the valve mechanism. This comprises the valve box (Fig 9), a rectangular fabrication in iron, into which the pipe from the reservoir enters and the discharge pipe leaves. The valve box supports an iron framework (Fig 8) which in turn supports a threaded shaft that enters the valve box *via* a stuffing box or gland. It is the rotation of this shaft that opens and closes the valve. It was noted that this mechanism is orientated at a slight angle to the axis of the valve house that passes through the doorway.

Fig 8: View of the valve support

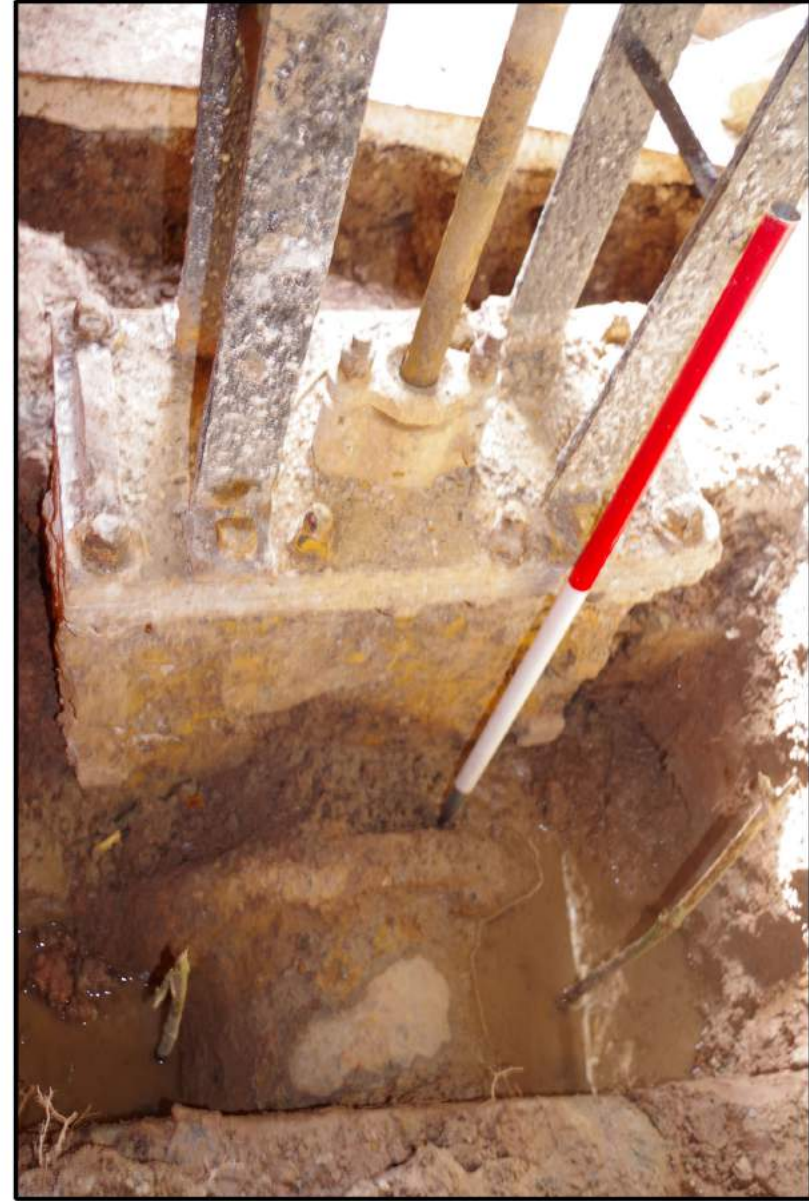
Fig 9: View of the valve base and pipe

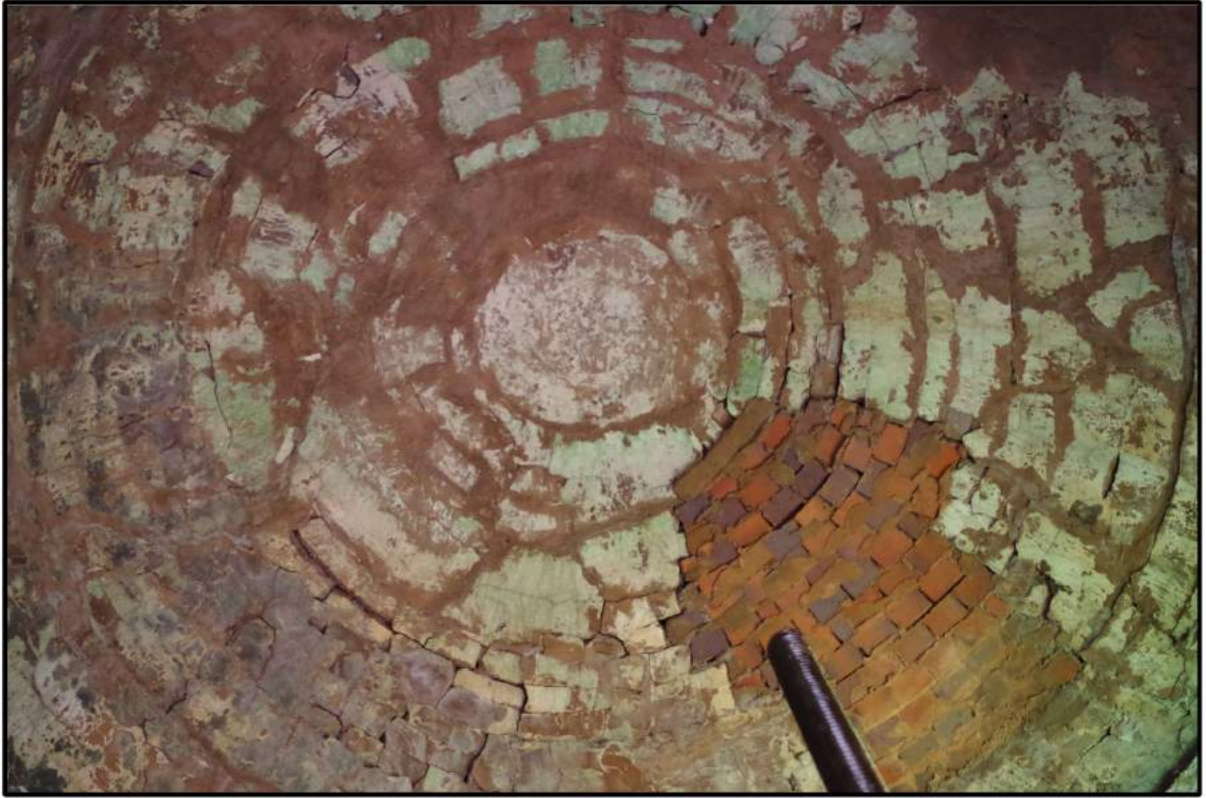
Fig 10: View of the inside of the dome

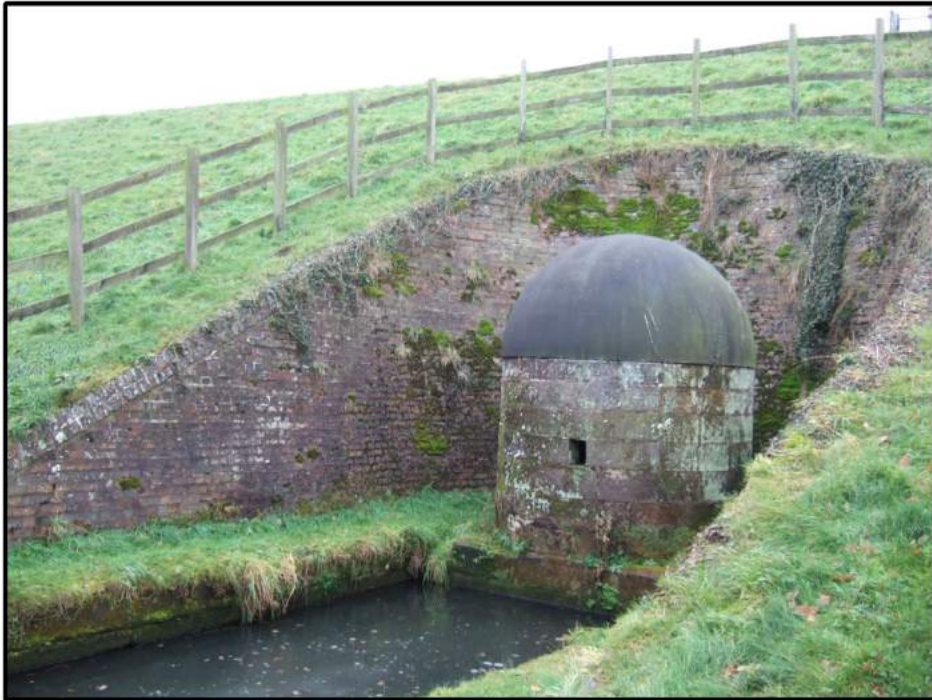
At Belvide reservoir, which supplies the Shropshire Union in Staffordshire there is a similar valve house to the one at Upper Bittell. This is listed Gd II*, built in 1833 with a cast iron dome (Fig 11.5).

Fig 11.5: Valve house at Belvide reservoir, Shropshire Union Canal
