**Archaeological watching brief at
Crickheath Wharf
Montgomery Canal**

30th August 2018
Revised 12th October 2018
Revised 22nd October 2018

Archaeological watching brief at Crickheath Wharf, Montgomery Canal, Shropshire

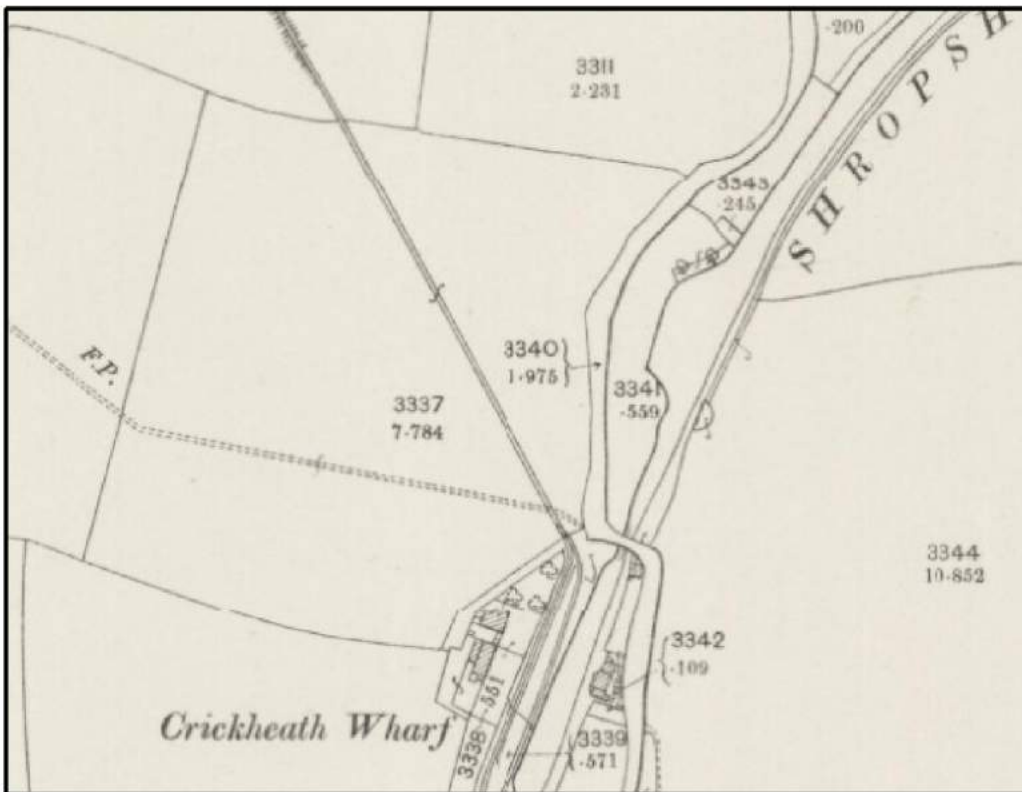
Fig 2.1: Historic mapping

1901

The Ordnance Survey map of 1875 (Fig 2.1) shows Bridge 85, the canal and the winding point. The parcel of land which comprises the current site is shown divided into three, the northern-most element of which (Parcel 3736) has no hard boundary with the adjacent road. A tramway is shown

crossing the field to the west from Crick Wharf, on the southern side of Bridge 85. The only significant difference between the Ordnance Survey map of 1875 and those of 1901 and 1926 (Figs 2.1 and 2.2) is that the boundary between Parcel 3736, on these maps shown as Parcels 3343 and 3342 respectively, and the adjacent road is now a formal one.

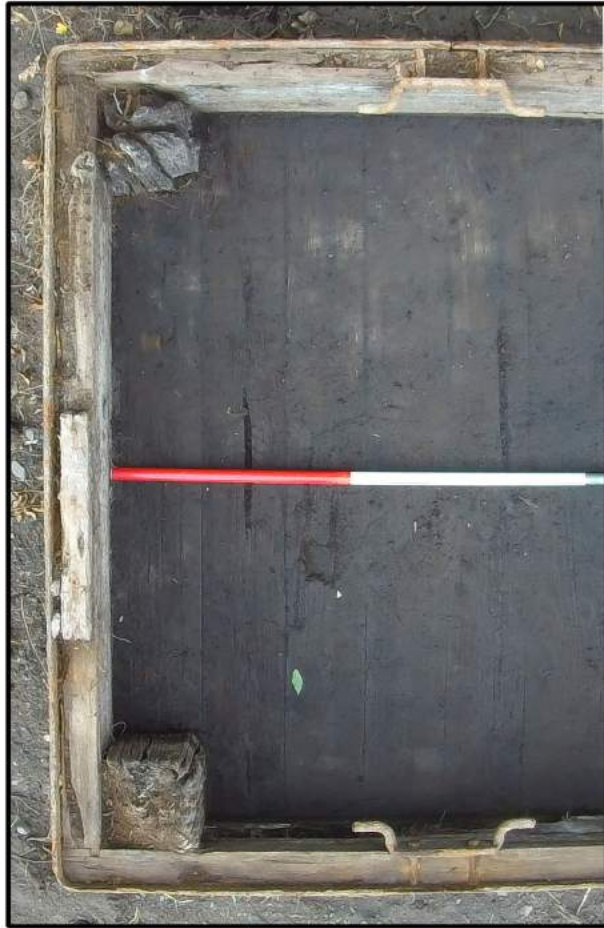
Fig 3.1.1

This had been abandoned in the winding hole. It was a simple craft, taking the form of a shallow rectangular box, being 6.17m long, 1.7m wide and 0.37m deep overall (Fig 3.1.3). Four, square posts formed its corners (Fig 3.1.1) and the sides and ends were secured to these with screw bolts (Fig 3.1.2). Right-angle brackets secured the sides to the floor and reinforced the structure. The floor comprised a double layer of wooden planks (Fig 3.1.4). Double cleats were provided near each end (Fig 3.1.1). A rubbing strake was provided all around the gunwale and at the corners (Fig 3.1.3).

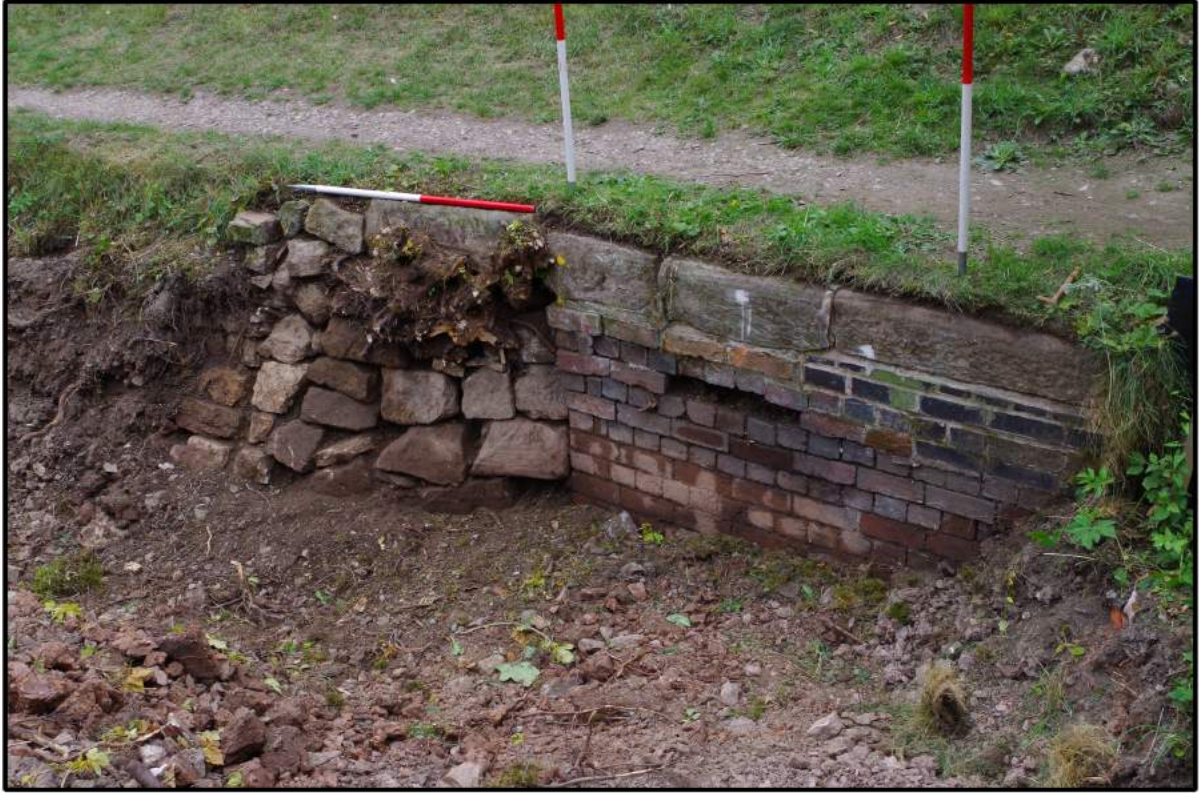
This was constructed in brick, in English bond (Figs 3.2 and 3.3). On the towpath side this was surmounted by a stone coping. On the offside a similar wall was surmounted by a concrete coping (Figs 3.3 and 3.4). The concrete coping was protected by a steel plate secured to its face. Although the two brick walls appear similar, the depth of the bricks on the towpath side is less than those on the offside.

This was constructed of large, dry, irregular, uncoursed rubble stone (Fig 3.2). This was surmounted by a single stone coping adjacent to the brick construction of the forebay. It is unknown if these copings continued along the length of the towpath wall.

Fig 3.2: View of the nearside towpath retaining wall and Bridge 85 forebay wall

Dry stone walling of this kind is common across the canal network where stone is available. A similar example has been recorded at Hillmorton on the Grand Union Canal where it is also unknown if there was a coping (Cook 2017; Fig 4). Rubble stone walling on the towpath side is also a feature of the Oxford Canal.

It is clear that the two forebay walls are of different construction. It is uncertain which is the earlier but it is thought that it is the towpath side. This wall seems to be the more deeply founded, the offside apparently being of more shallow construction.

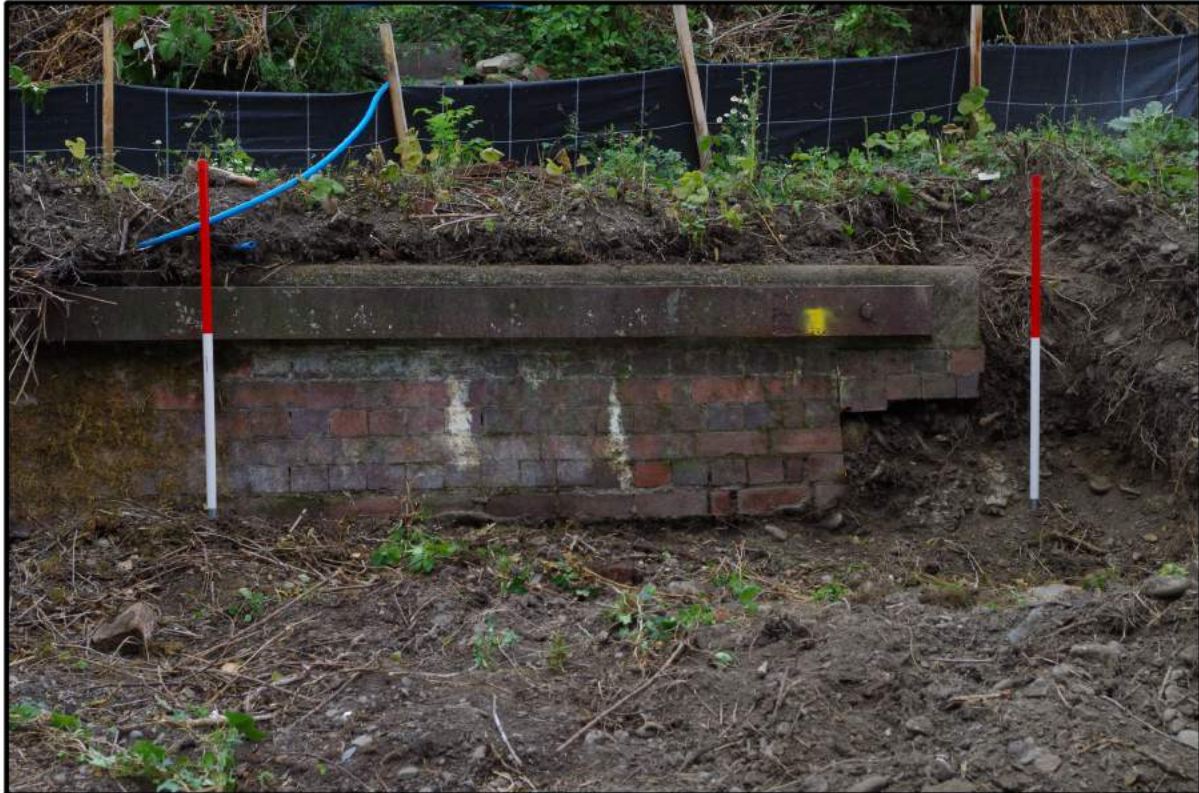
Fig 3.3: View of the offside Bridge 85 forebay wall

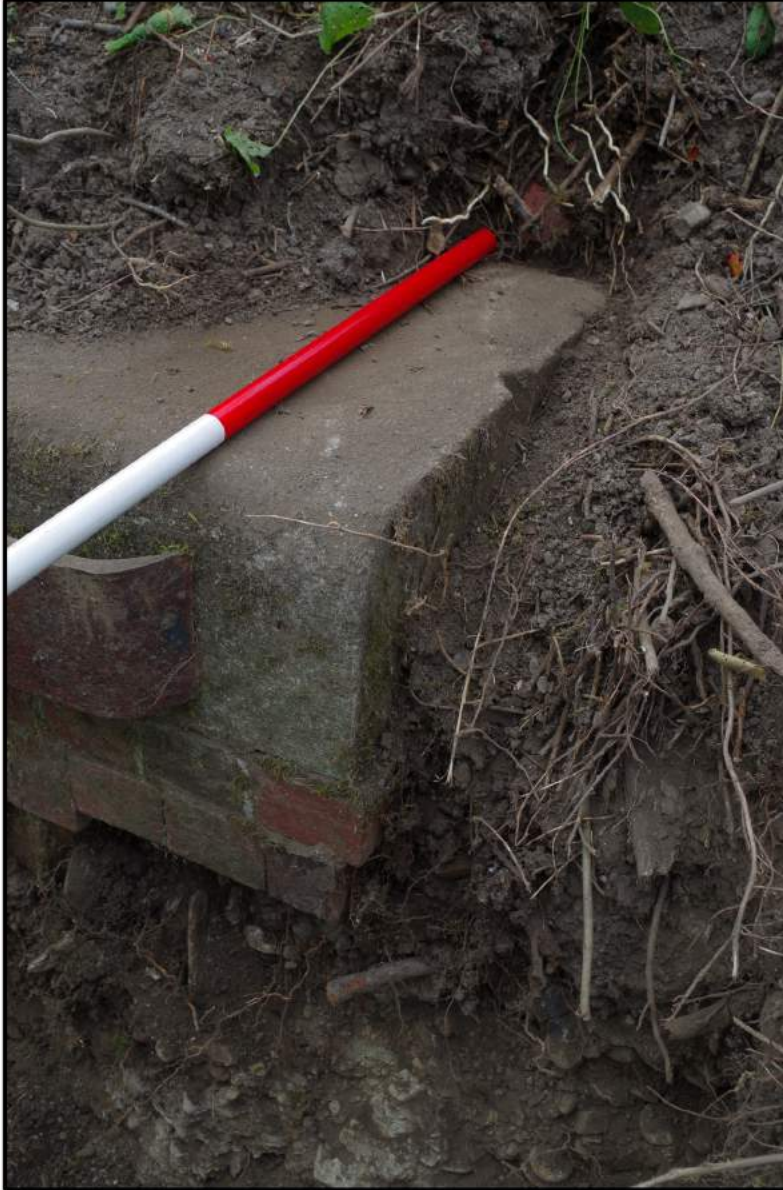
Fig 3.4: Detail of the Bridge 85 offside forebay wall; coping

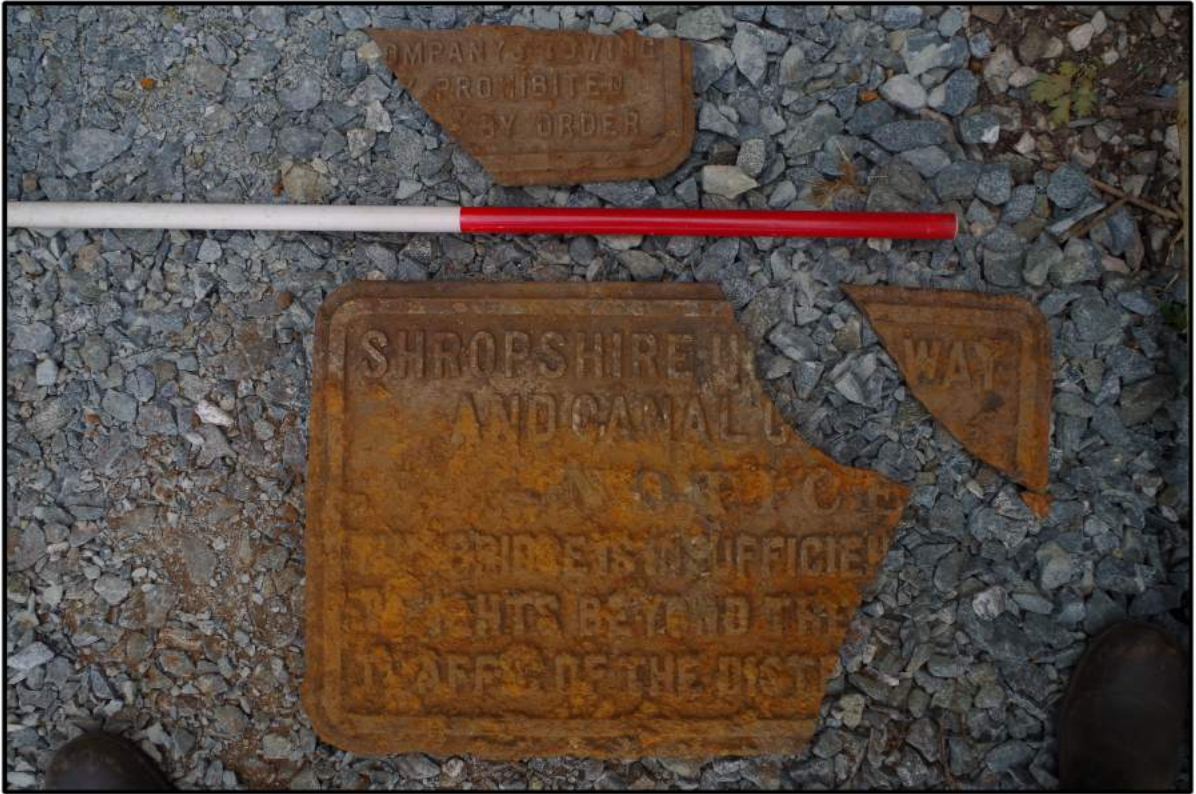
There was also a small iron hoop, possibly a tyre for a wheel barrow (Fig 3.6) and the fragments of two cast signs (Fig 3.5). These were of typical canal design and read:

COMPANYS TOWING
PROHIBITED
BY ORDER

SHROPSHIRE U... WAY
AND CANAL C
TH.. BRIDGE IS INSUFFICIE..
WEIGHTS BEYOND THE
TRAFFIC OF THE DIST....

Fig 3.5: Cast signs of canal design

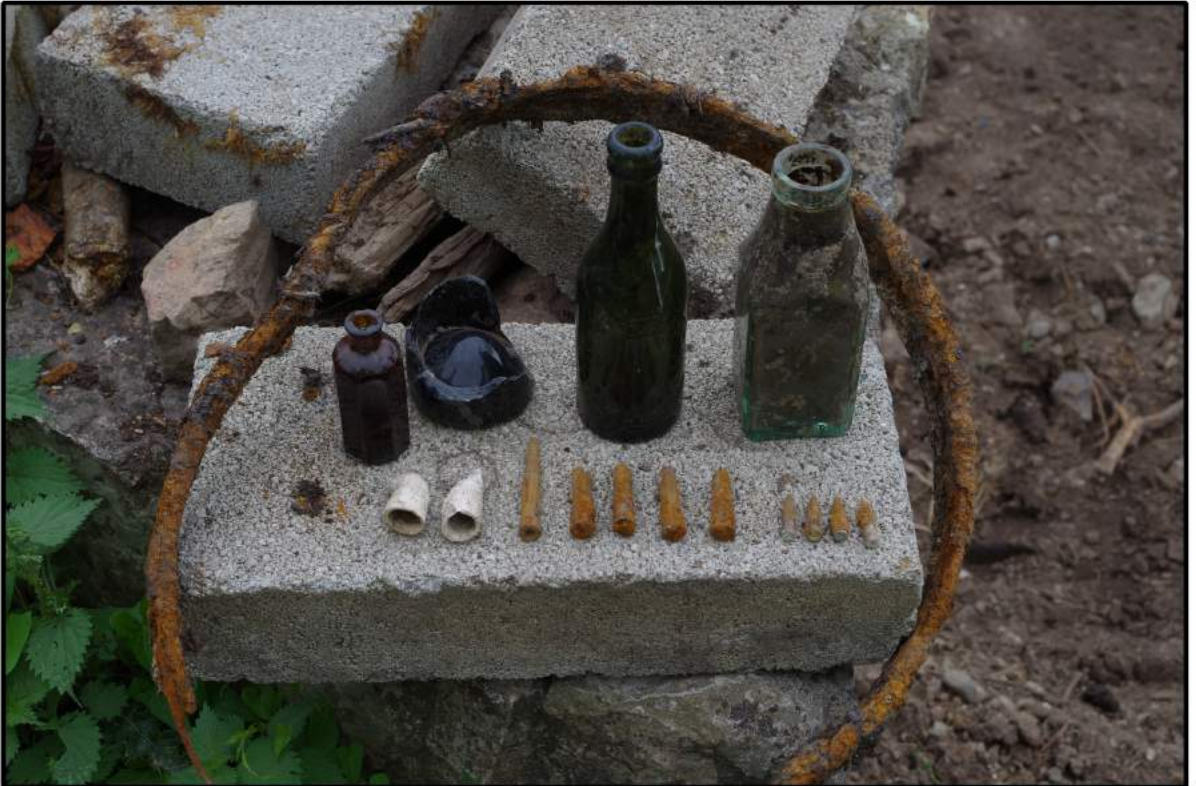
There were four bottles (Fig 3.6), a green, cylindrical one embossed with

There were nine bullets or their cases and two clay pipe bowls (Fig 3.6). The pipe bowls were reported on by Laura Griffin:

Fig 3.6: Small collection of finds from the excavations

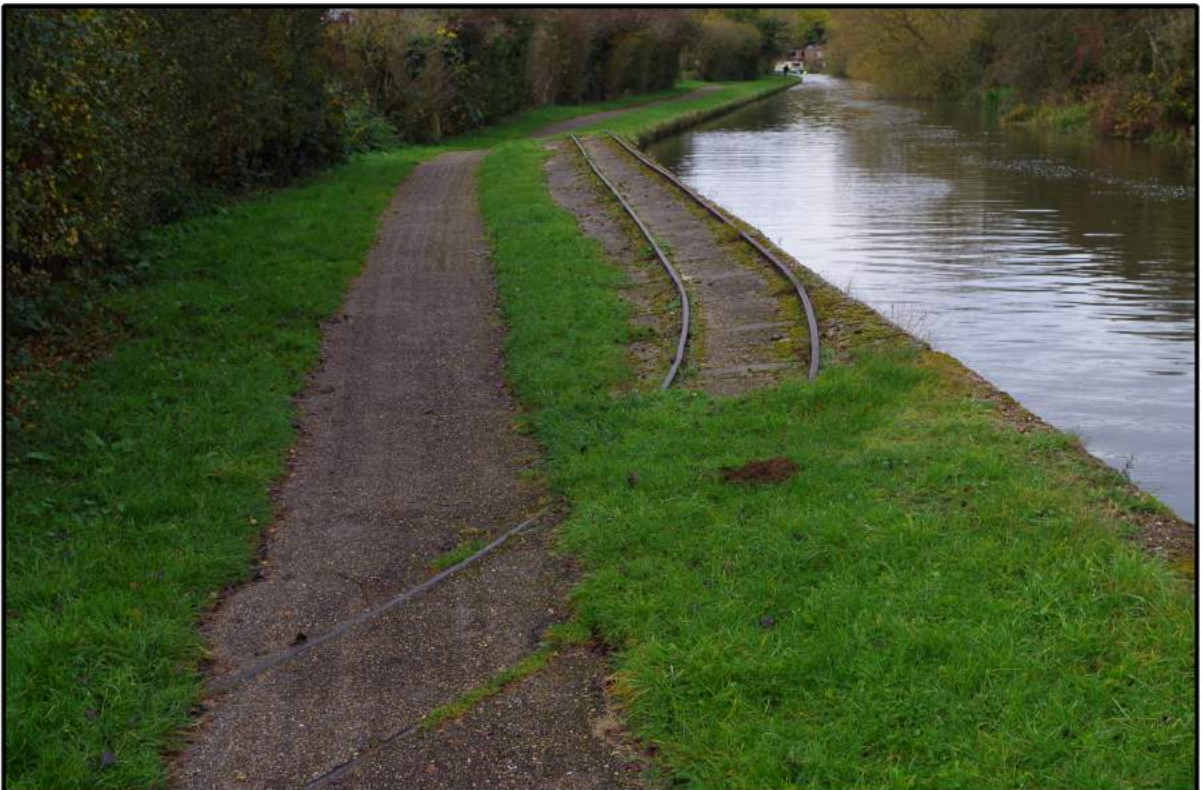
Finally, there was a short length of tramway rail. It is likely that this came from the nearby Crickheath Wharf tramway. Such tramways were common in association with canals and a few short lengths still survive, such as the example near Leighton Buzzard on the Grand Union Canal (Figs 5 and 6).

Fig 5: Wharf side tramway near Leighton Buzzard, Grand Union Canal

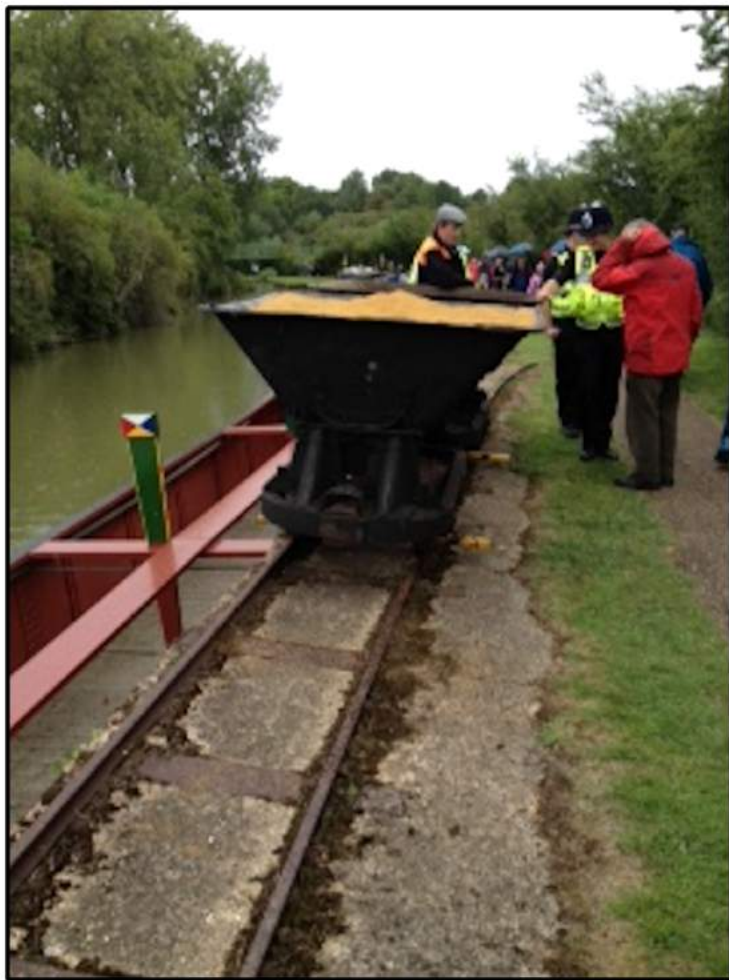
Fig 6: Wharf side tramway near Leighton Buzzard; Leighton Buzzard Canal Festival, showing wagon with load on tramway and adjacent narrowboat
