**Historic building recording
of an ancillary storage building
adjoining the Bakehouse,
Back Lane,
Broadway,
Worcestershire
WR12 7BP**

Martin Cook BA MCIfA

23rd November 2019

WSM 71720

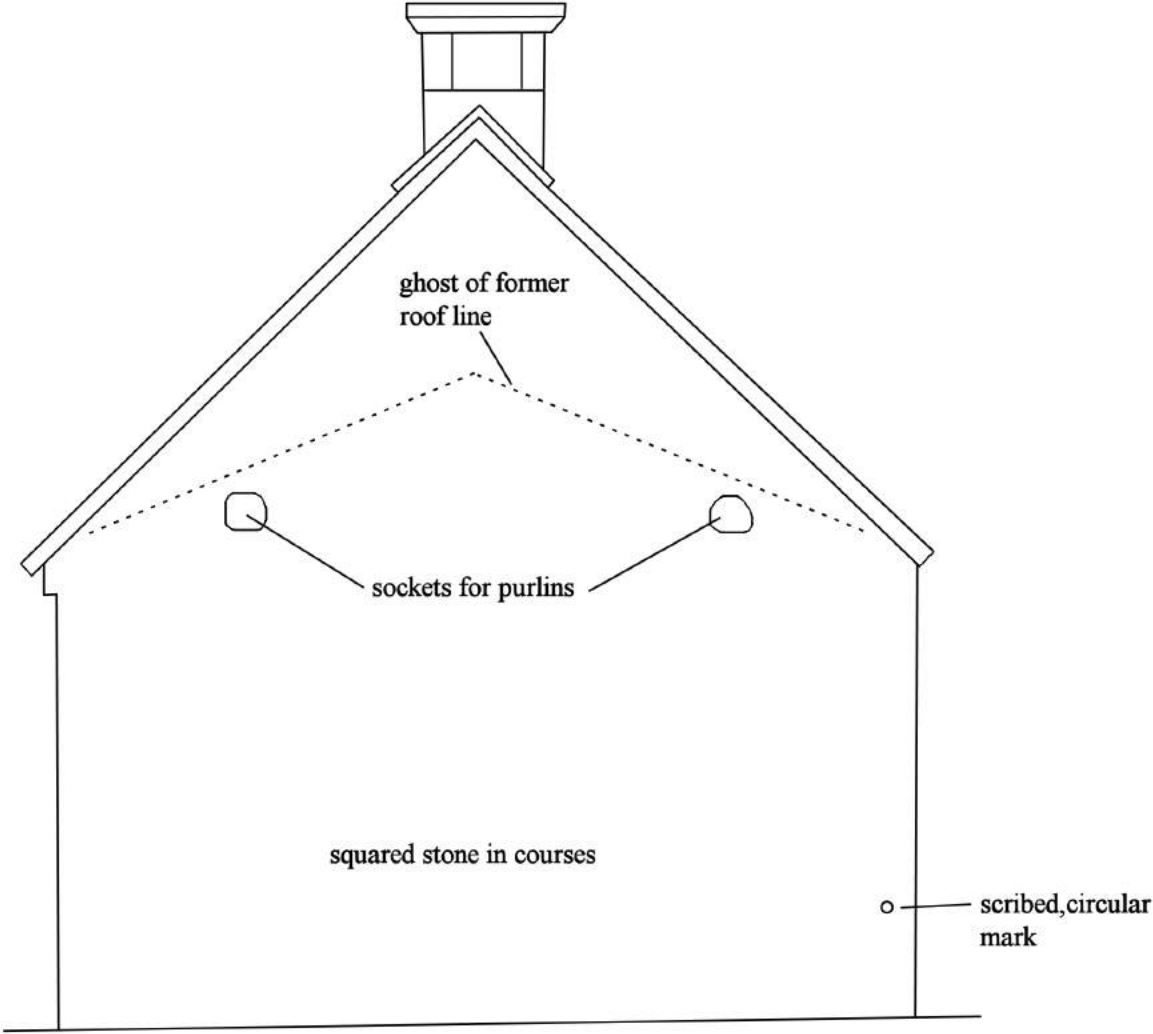
Fig 3.4: North-east elevation

The north-east elevation (Figs 3.4 and 4) was built of squared stone in courses with large quoin stones at the corners. There is a small, scribed circular mark near ground level on the north-east corner (Fig 5).

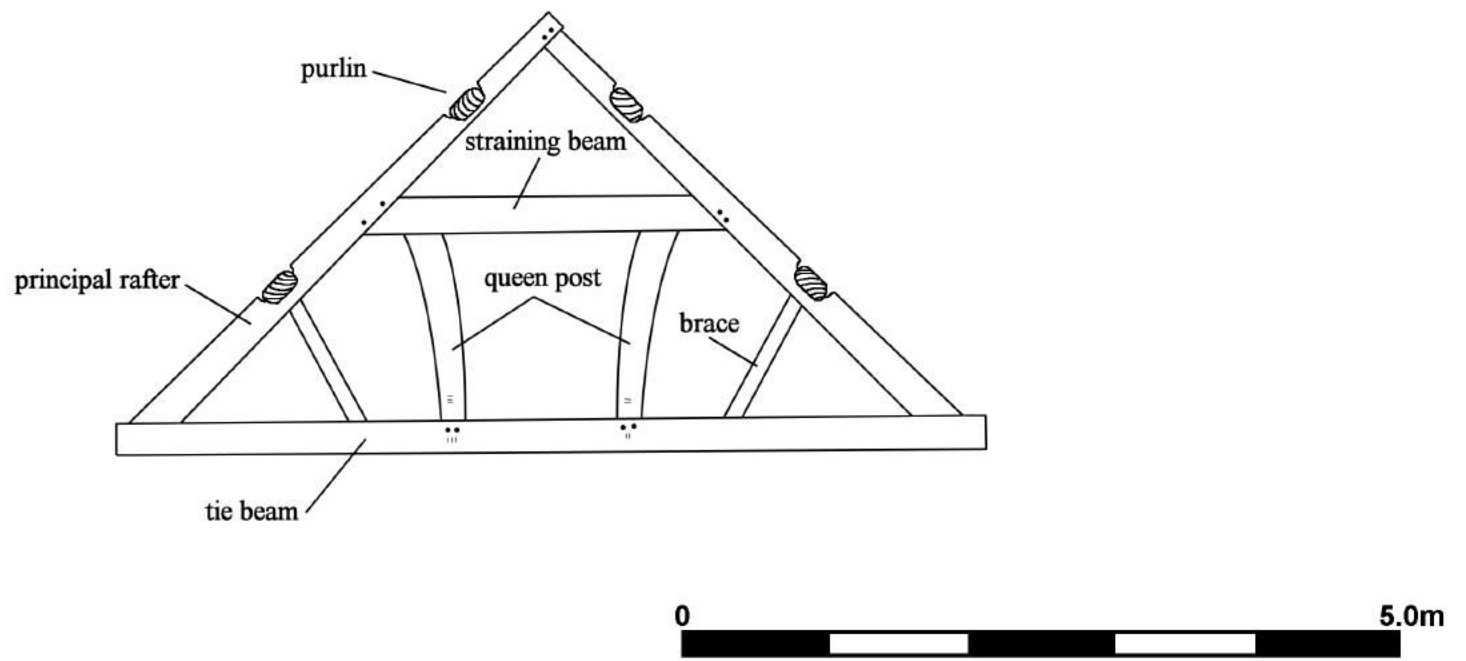
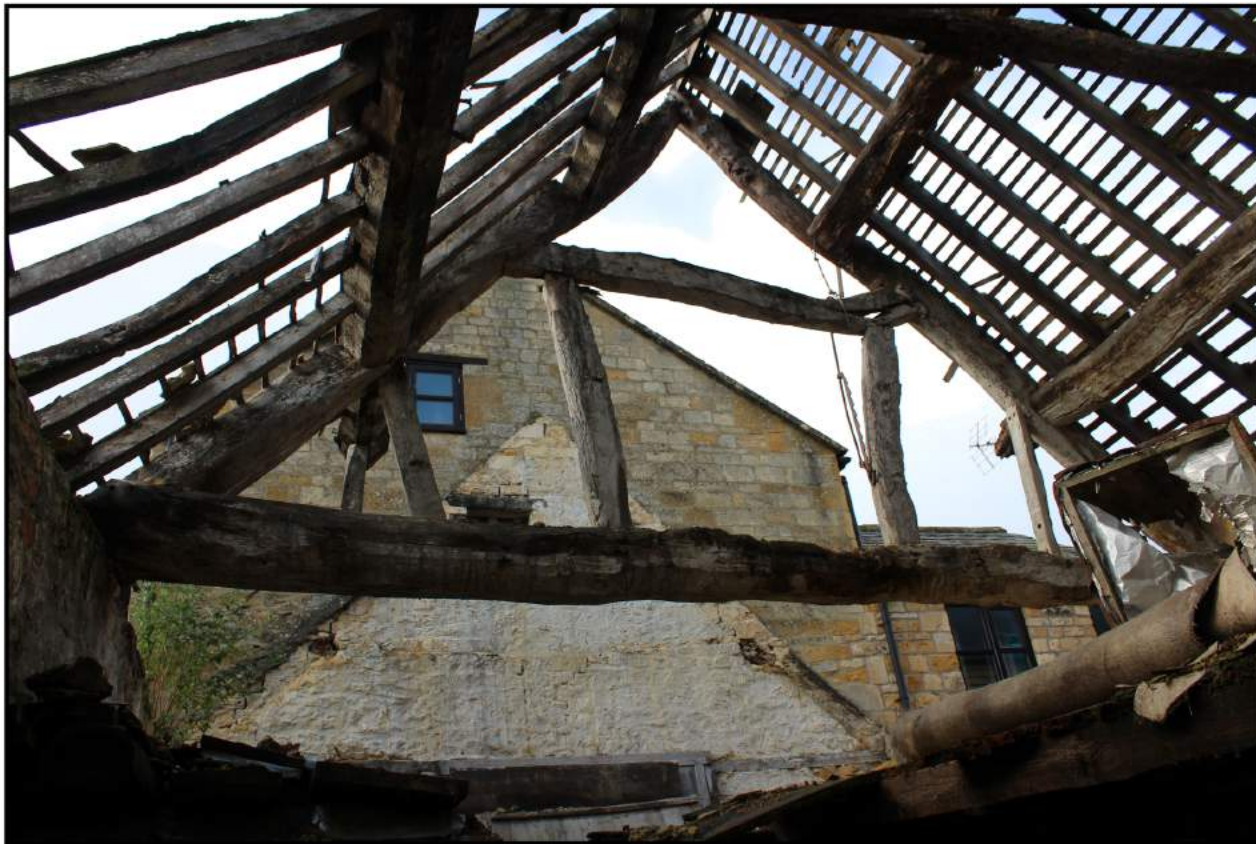
Fig 3.5 Roof truss showing principal components and carpenter's marks

There was a single roof truss in the centre of the long side of the building (Fig 3.6). This was of queen post design, the main members being pegged together, with two purlins each side, halved into the principal rafters. The lower purlin on each side was supported by a brace. The braces were not obviously pegged and they are probably later additions. The purlins were built into the gable end of the recorded building and the wall of the adjacent building. The purlins supported common rafters which in turn carried stone roof tiles. These decreased in size from the eaves to the ridge (Fig 8). Some were nailed and others were secured to the roof structure with wooden pegs.

Carpenter's assembly marks were identified on the lower ends of the queen posts and the side of the tie beam (Fig 3.6).

It is sometimes inconvenient to have the centre of the truss occupied by a member, especially where it is necessary to have apartments in the roof. In such a case recourse may be had to the queen-post truss. Two suspending posts, known as queen-posts, are used, and a fourth element is introduced, namely the straining beam, extending between the heads of the posts. The principle of trussing is the same. The rafters, struts and straining beam are compressed and the tie beam and queen-posts are in a state of tension. For larger spans, three or more suspending posts may be used.

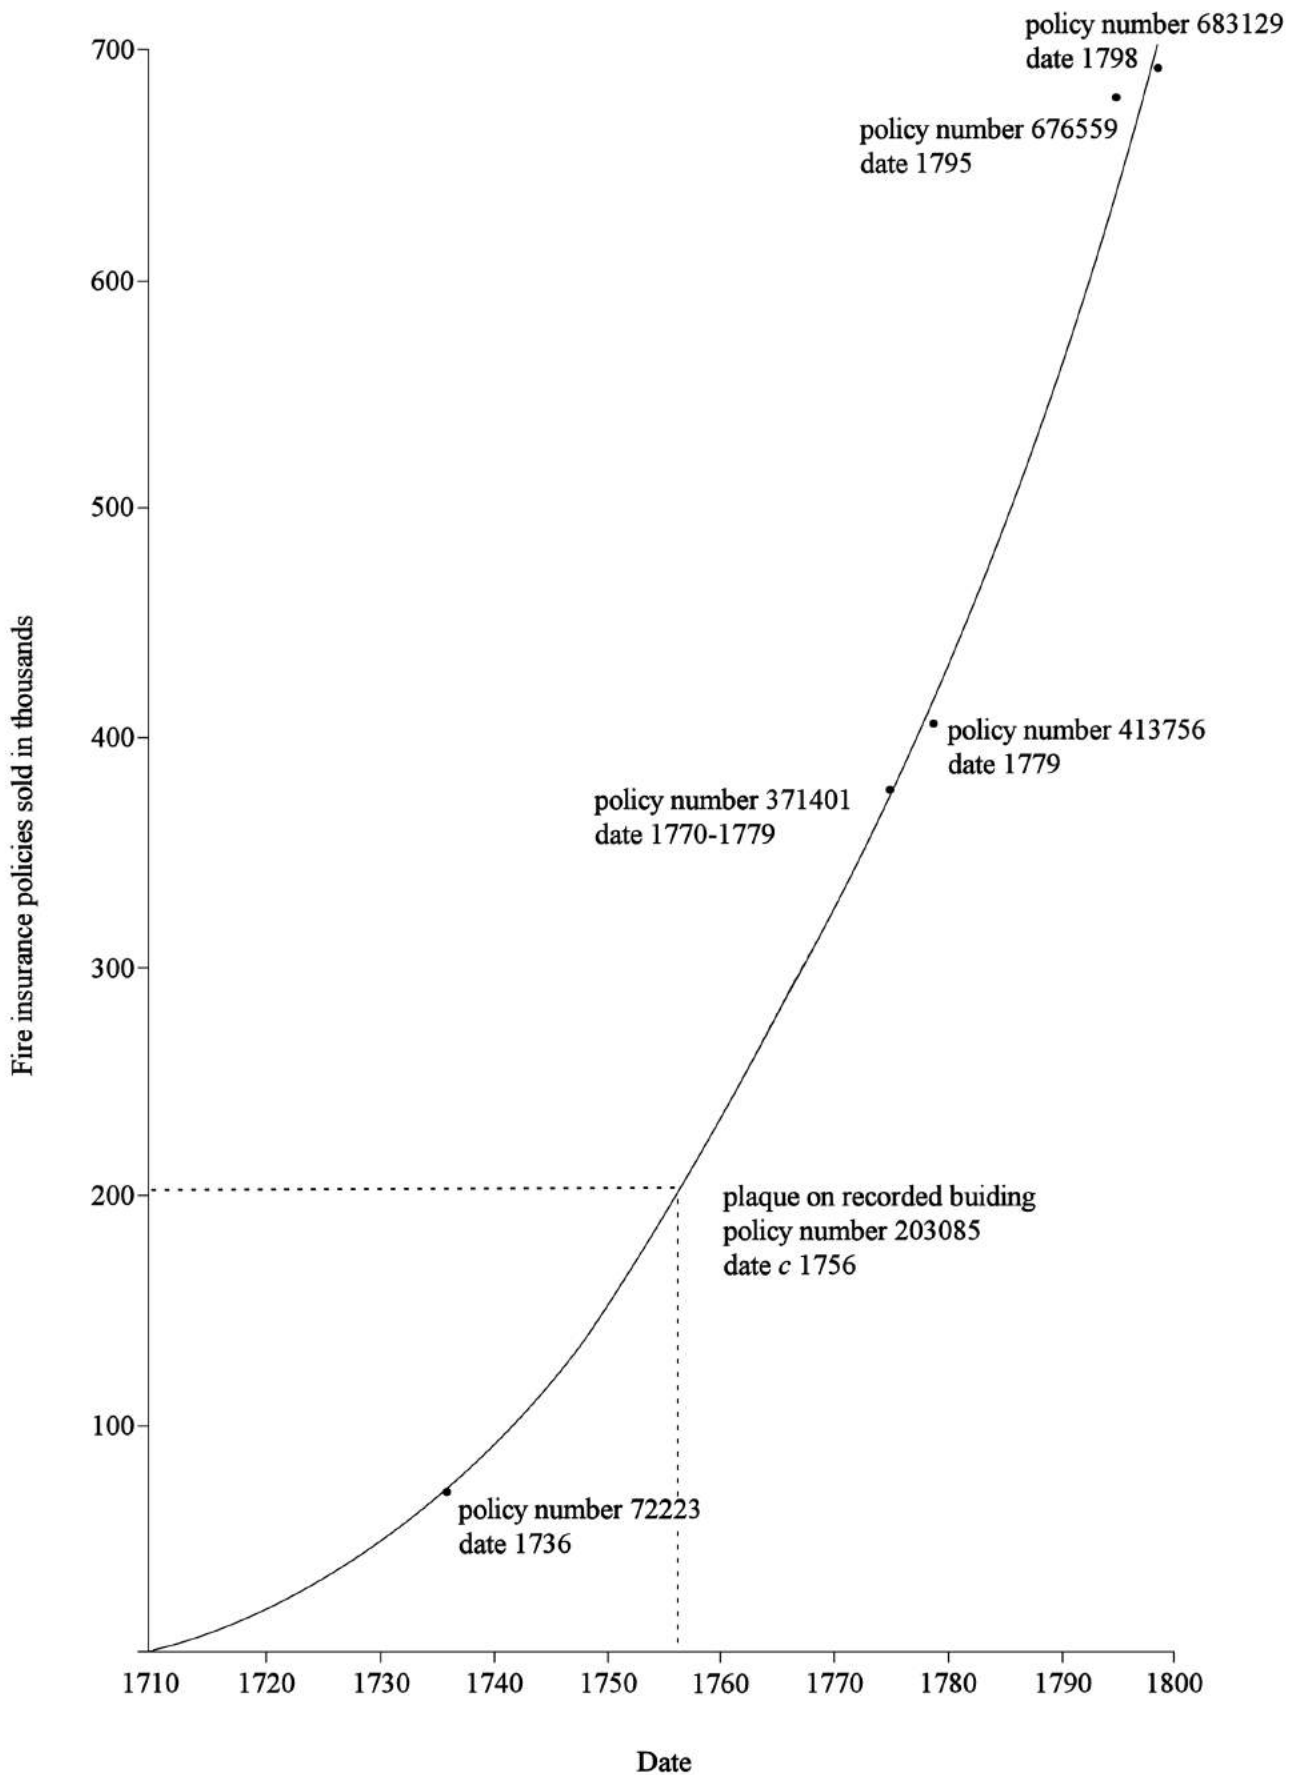
Fig 3.7: Numbers of fire insurance policies sold by Sun Fire Office from its founding in 1710

The map evidence only allows dating of this phase to before 1771. However, if the fire insurance plaque on the south-east elevation is actually associated with the recorded building, then a better date might be possible. Closely dated examples of these plaques are difficult to find without visiting the National Archives where many of these early insurance policies are held. However, a number of dated examples can be found online. An example in the Museum of English Rural Life, Reading, with an index number of 72223, is dated to 1736. A fire plaque formerly on a house in Headington, near Oxford has an index number of 371401 and is dated on their website to between 1770-1790. However, this can be more closely dated to between 1770 and 1779 due to work by the Walton and Weybridge Local History Society. This society has identified the dates of a number of Sun Fire Office fire plaques whose index numbers are 413756 – 1779 and 676559 – 1795. An example in the Museum of London, index number 683129, is dated to 1798. These have been plotted on a graph (Fig 3.7) and from this it is possible to deduce that the example on the recorded building was issued around 1756. This may be a better date for the construction of the recorded building.

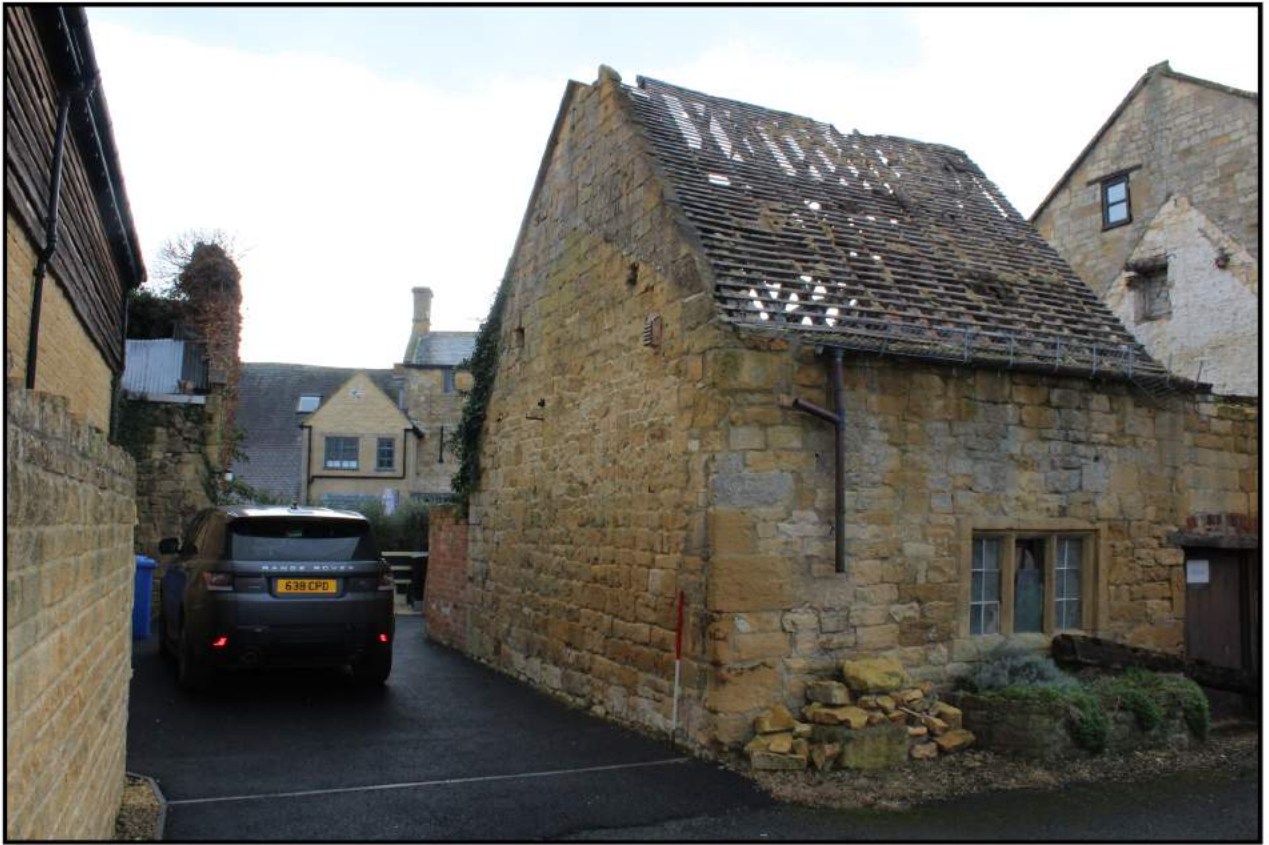
Fig 4: North-east and north-west elevations

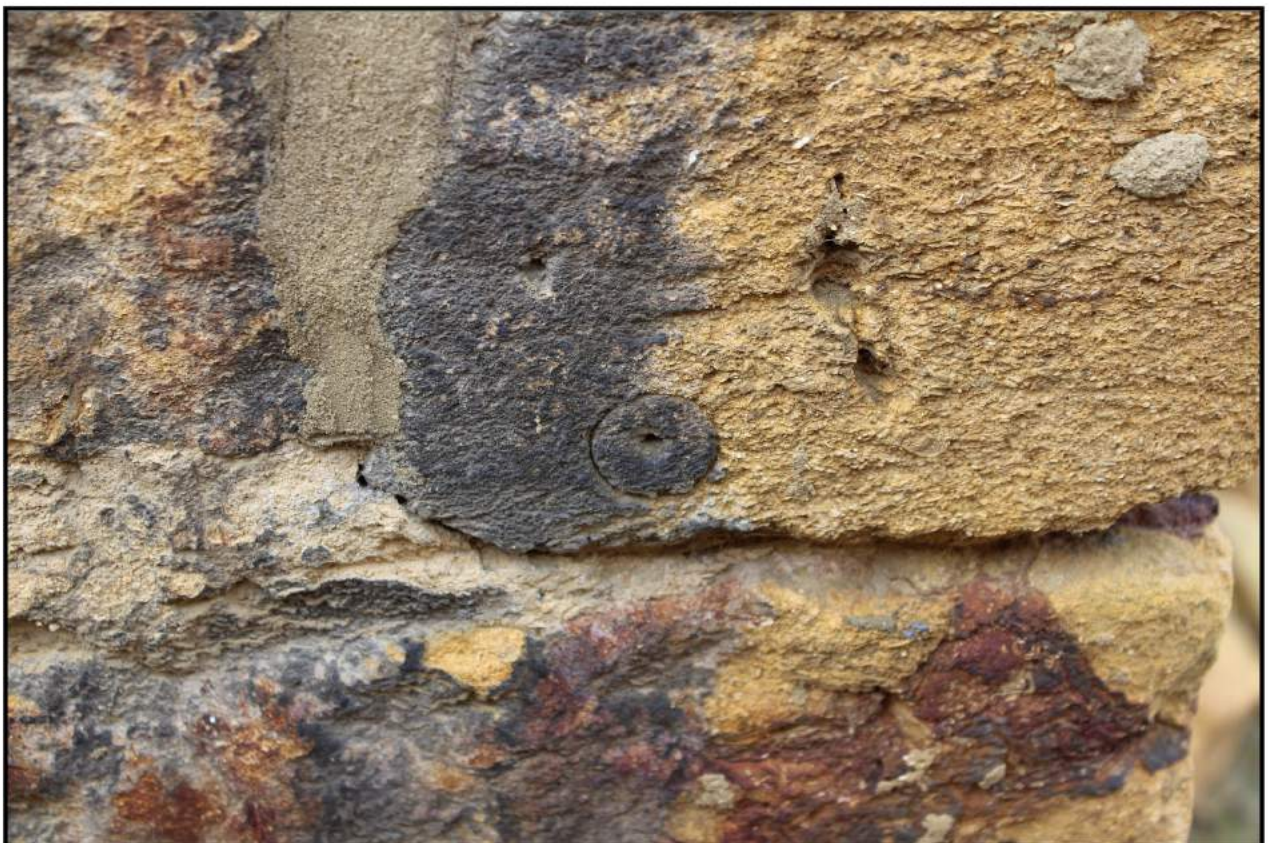
Fig 5: North-east elevation; showing scribed circular mark, c 2cm diameter

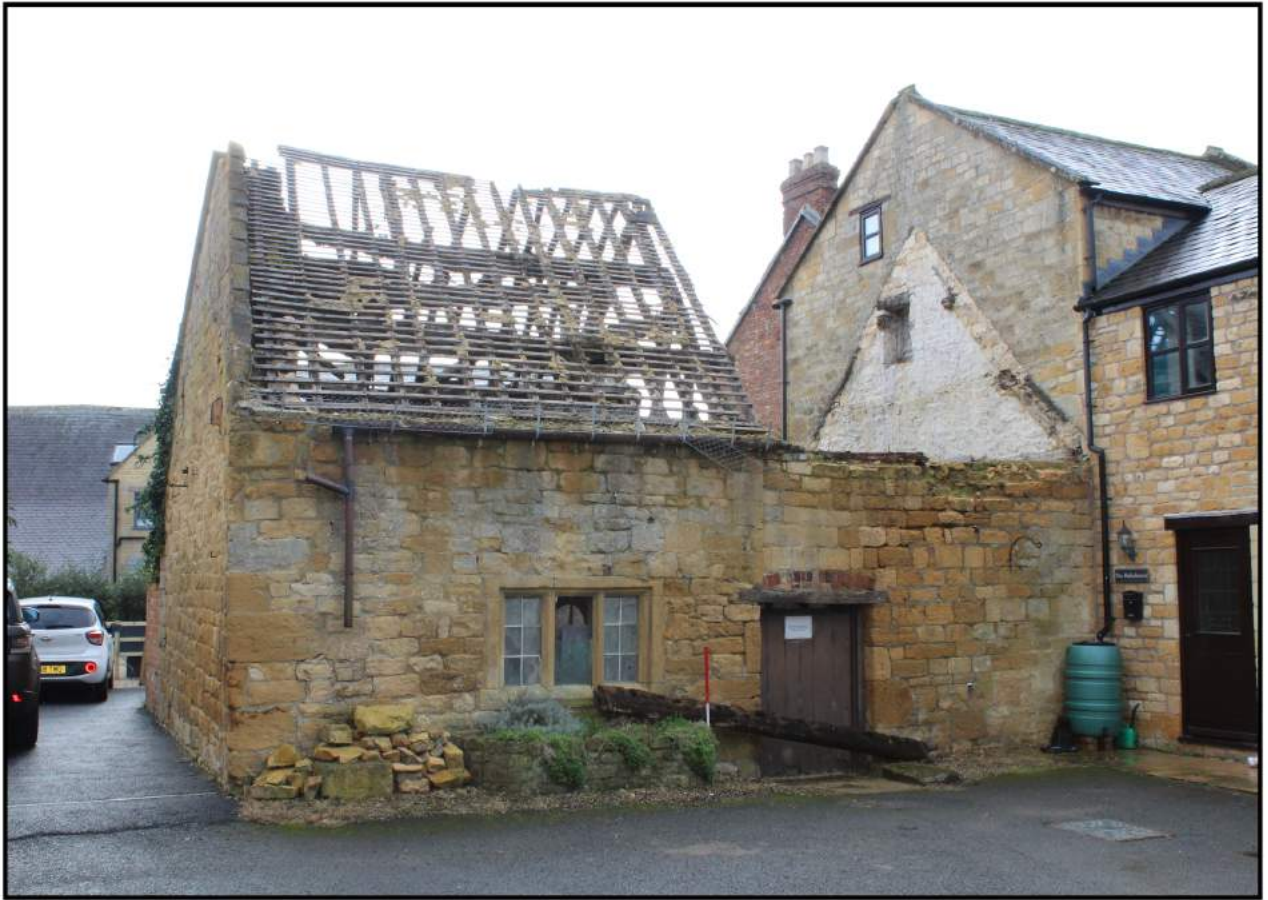
The north-west elevation was built of semi-squared stone blocks in courses (Figs 3.2, 6 and 7), with large quoin stones at the north-east corner and eastern jamb of the doorway. It has a stone, mullioned, three-light window with chamfered jamb and mullion profiles as shown on Fig 3.5. The south-east elevation was carefully built-in to the existing building to its west (Figs 3.3 and 9) utilizing mostly squared stone, mostly in courses. It has large quoin stones at its south-east corner and on both sides of its door jambs. The door lintel is a substantial stone but it has not been carefully squared on either its ends or its upper face. The elevation has a stone, mullioned, two-light window with chamfered jamb and mullion profiles as shown on Fig 3.5. The jamb and mullion profiles of the two windows are of different sizes.

The use of stone mullioned windows in the building (Figs 6 and 9) suggests that it was originally for some form of domestic occupation, perhaps contemporary with, and associated with, the building with similar windows (6 High Street; WSM 45019) on the High Street frontage. Unfortunately, chamfered mullion and jamb profiles were in use at many periods of architectural history and they do not provide useful dating evidence.

Fig 6: North-west elevation

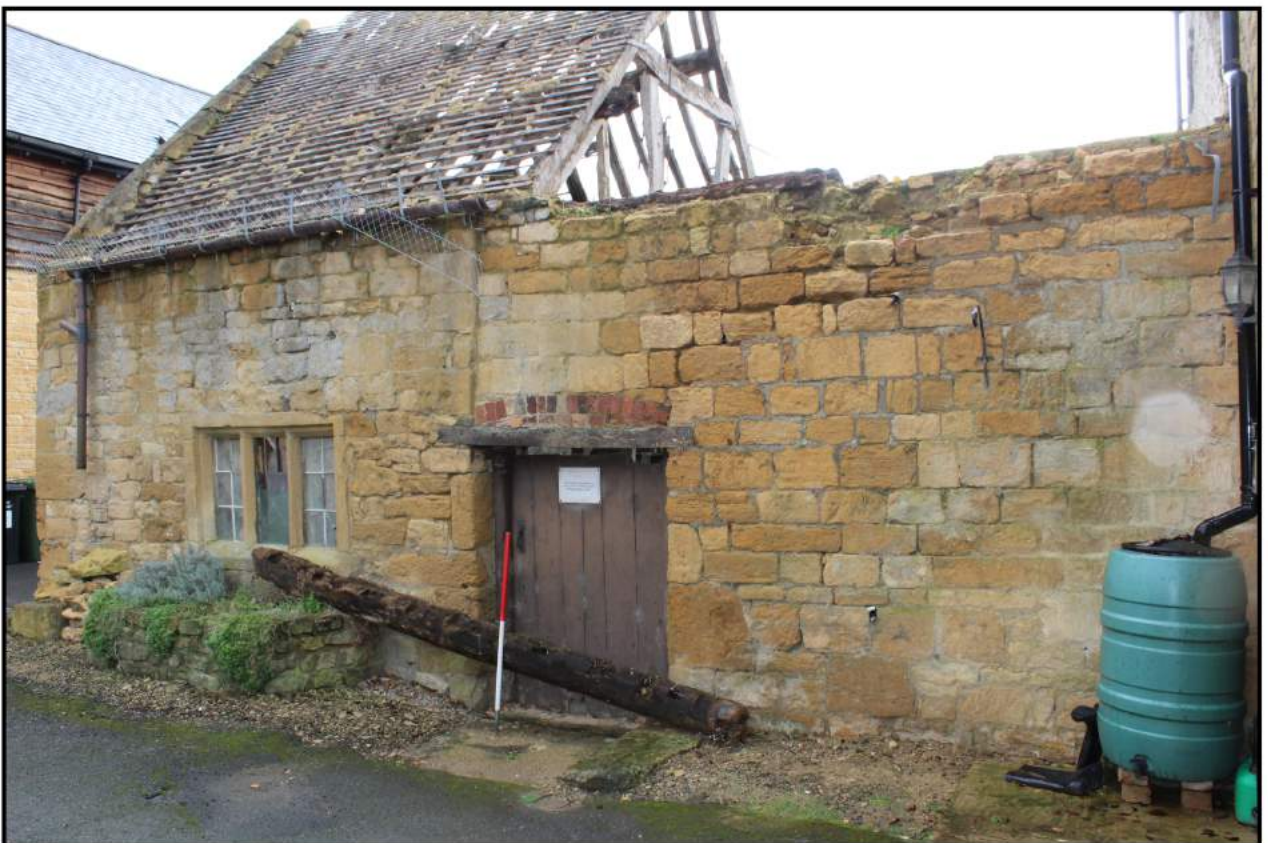
Fig 7: North-west elevation

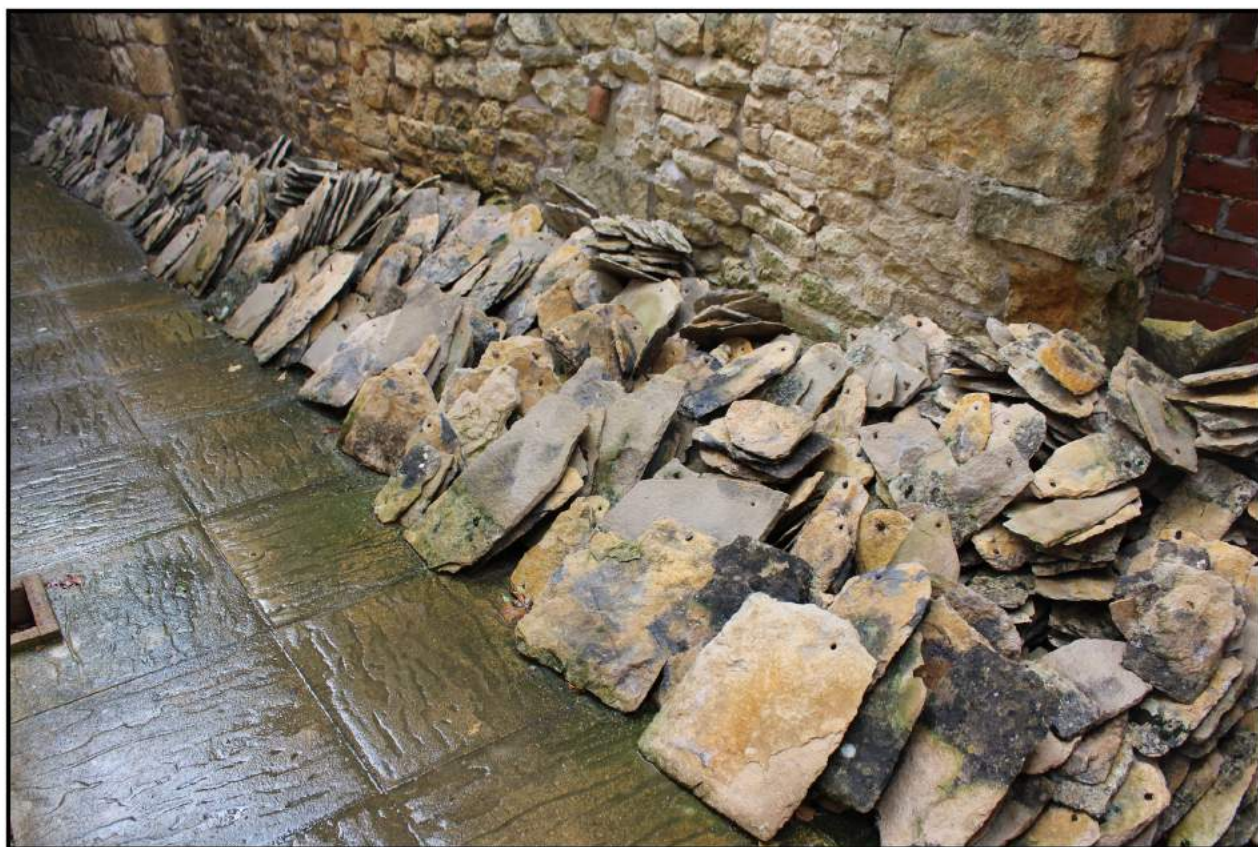
Fig 8: Stone tiles removed from collapsed roof

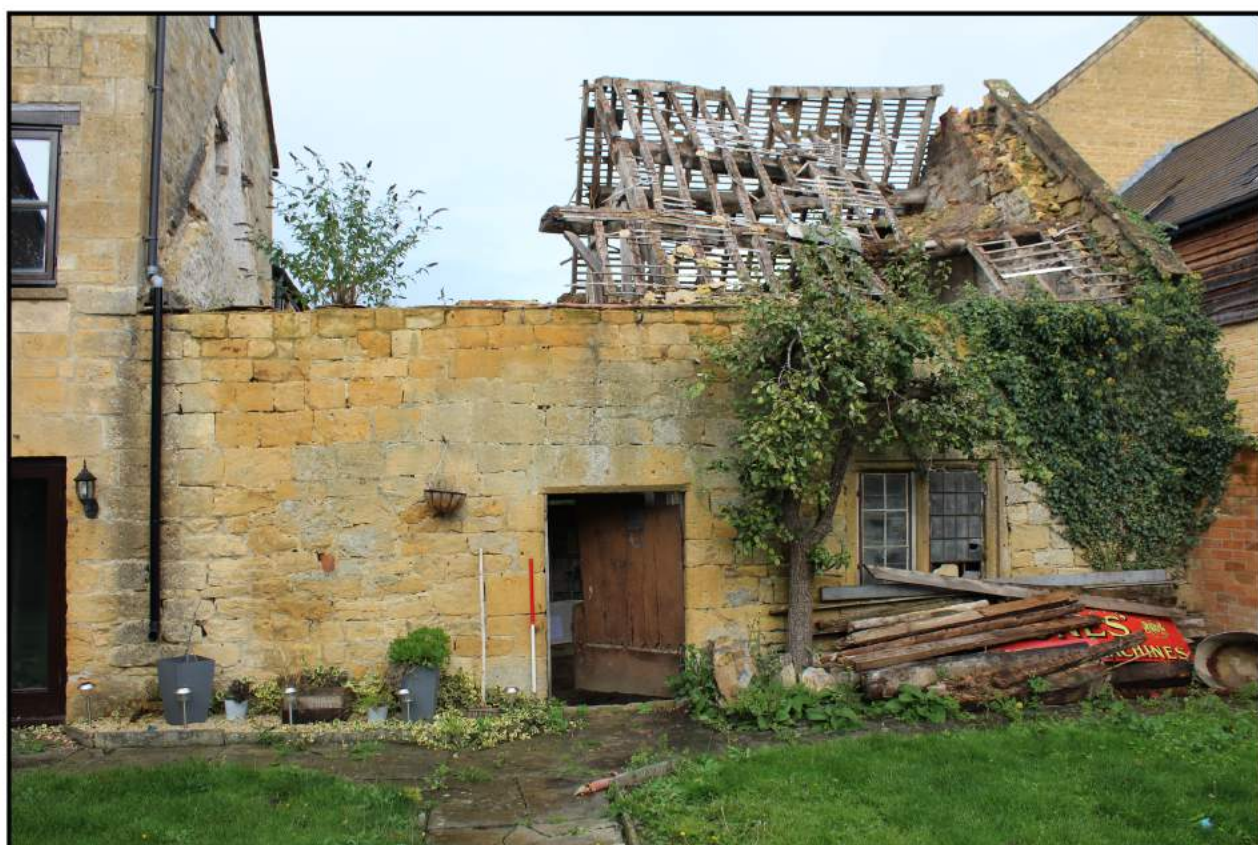
Fig 9: South-east elevation

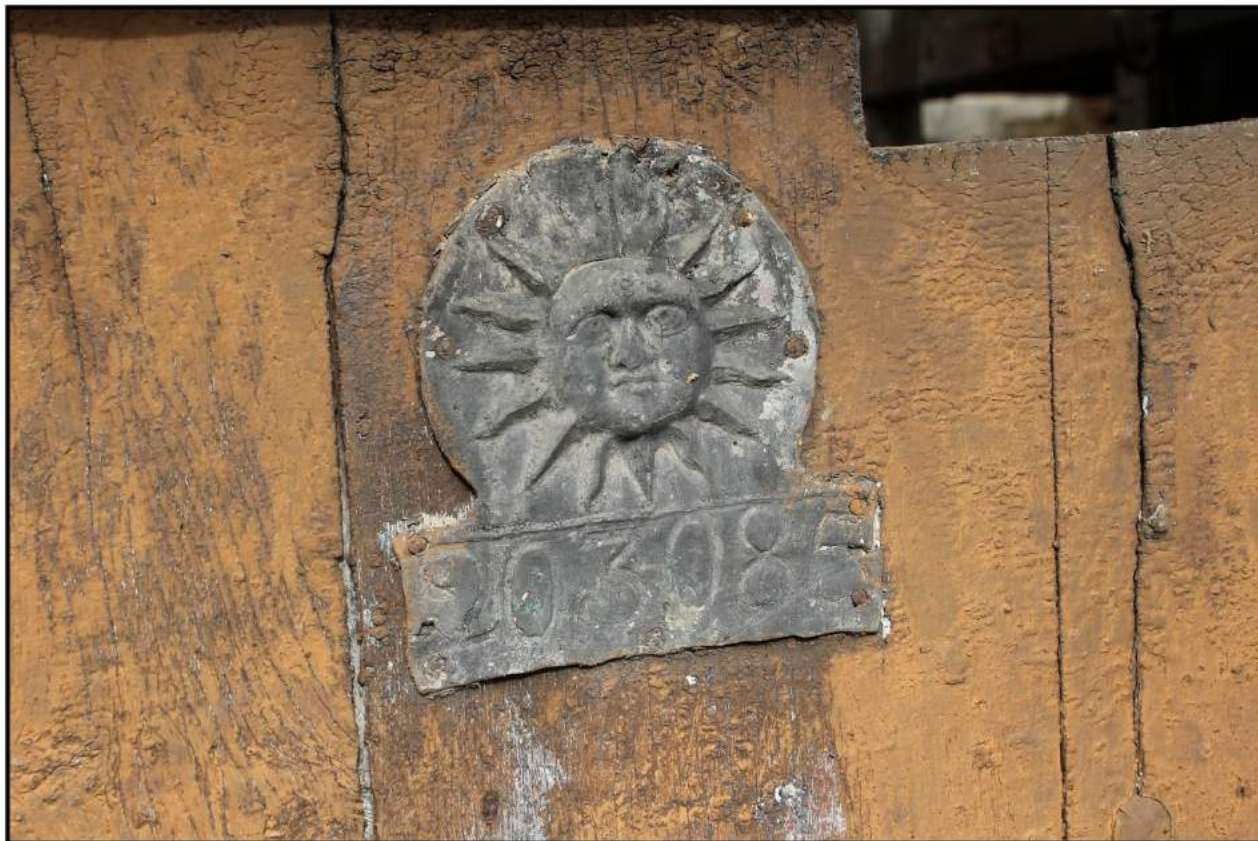
On the door of the south-east elevation is a fire insurance plaque of the Sun Fire Office (Fig 10). These are embossed metal signs, marked with the emblem of the insurance company, which were placed on the front of buildings indicating they were insured against fire and by whom. The private fire services, often operated by the insurance companies themselves, then knew which houses were insured by them and therefore which ones to save. The fire marks were provided by the insurance companies and appeared on buildings from 1710 onwards when the Sun Fire Office was founded. The example on the recorded building has an index number of 203085.

Fig 10: South-east elevation; showing Sun Fire Office plaque

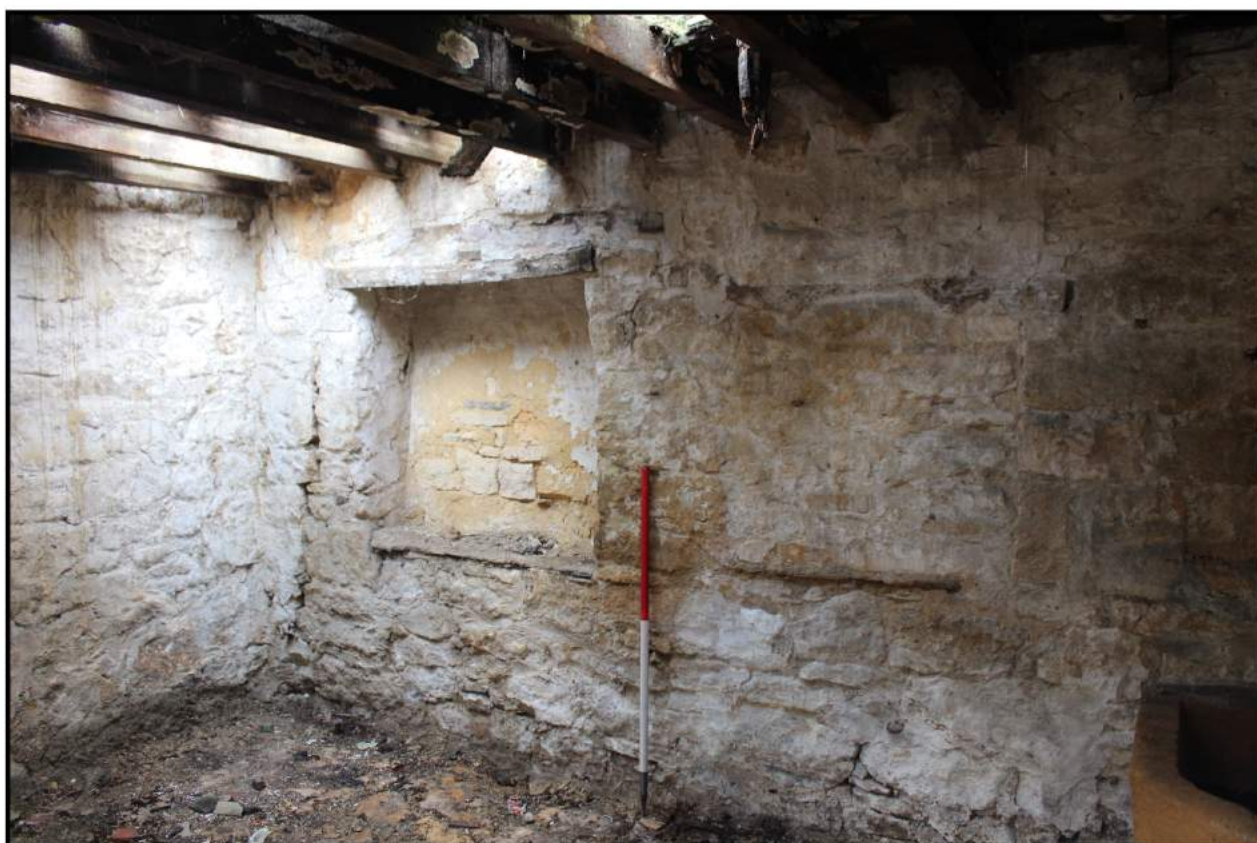
The recorded building was built onto an existing building to its west (Fig 3.1). The evidence for this is that the western boundary wall of the recorded building is unequivocally part of the existing building to its west (Fig 21) with the stone coursing being continuous across the roof scar. Additionally, there are three window openings (Figs 11 and 21) in this boundary wall that are unlikely to be contemporary with the recorded building.

Fig 11: Interior, south-west end; showing two blocked windows

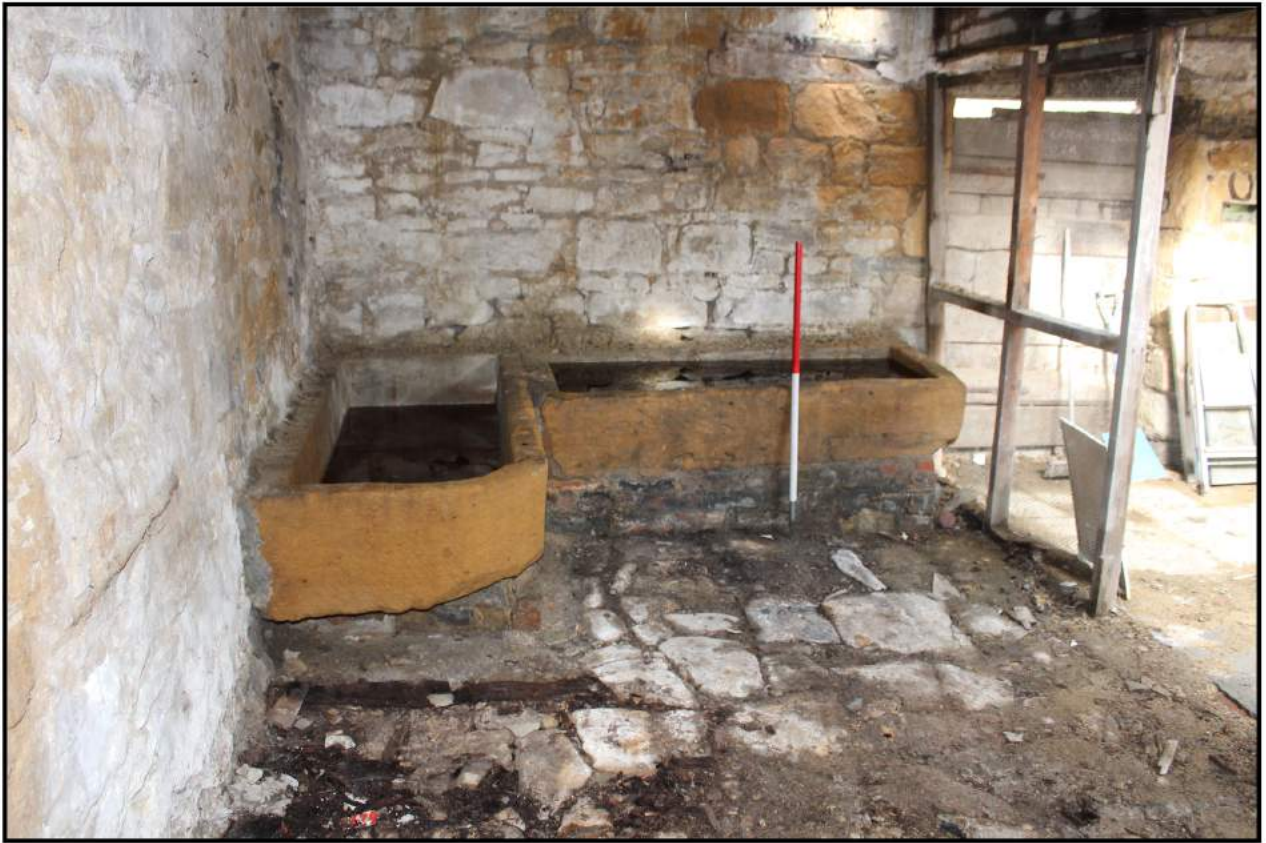
Butcher's hooks (Fig 18) and possibly the two large tanks (Fig 13) indicate that the building was in use for a period for slaughter, meat preparation and storage, probably associated with the shop on the High Street frontage.

Fig 13: Interior, south-west end showing tanks and stone floor

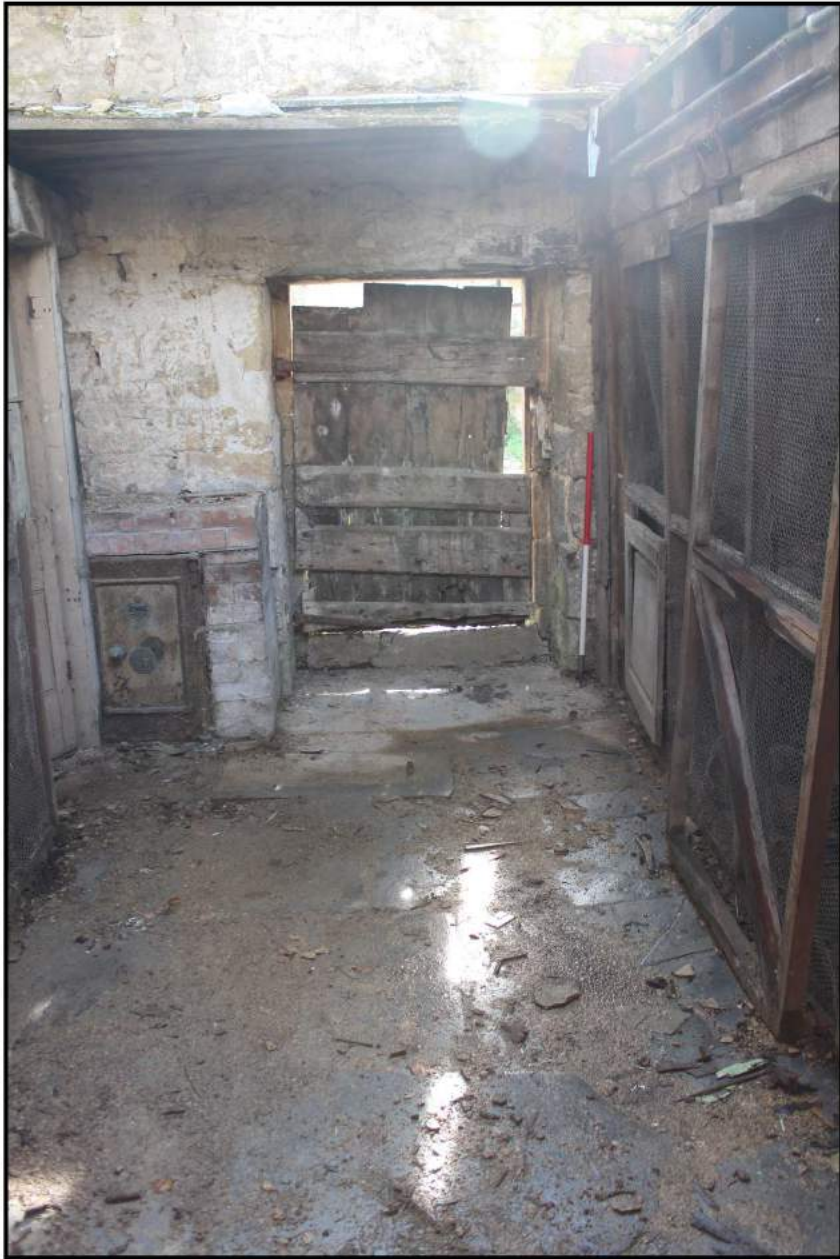
The enclosing of the ground floor, either side of the cross passage with chicken wire (Figs 15 and 16), suggests that keeping of birds, perhaps hens, was the final use of the ground floor of the building.

Fig 15: Interior; showing cross-passage, south end

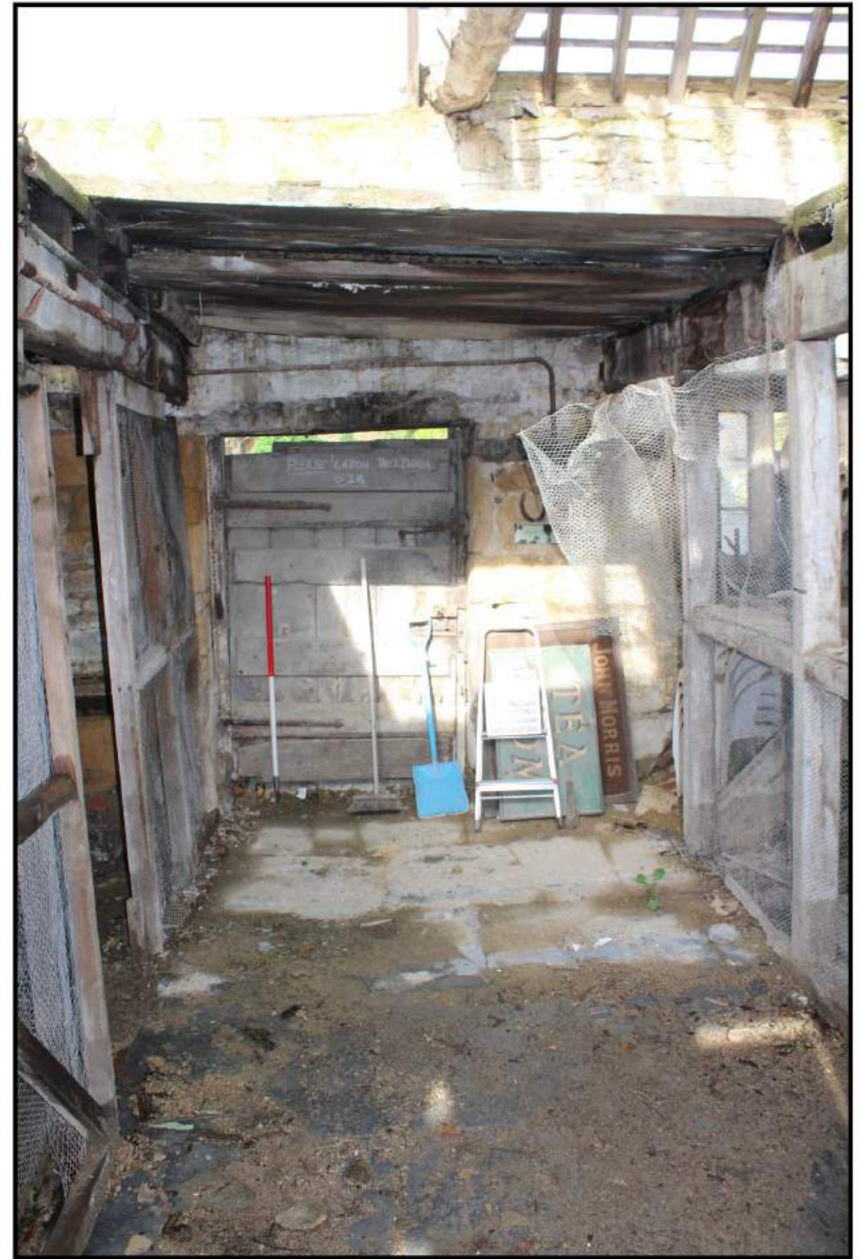
Fig 16: Interior; showing cross-passage, north end

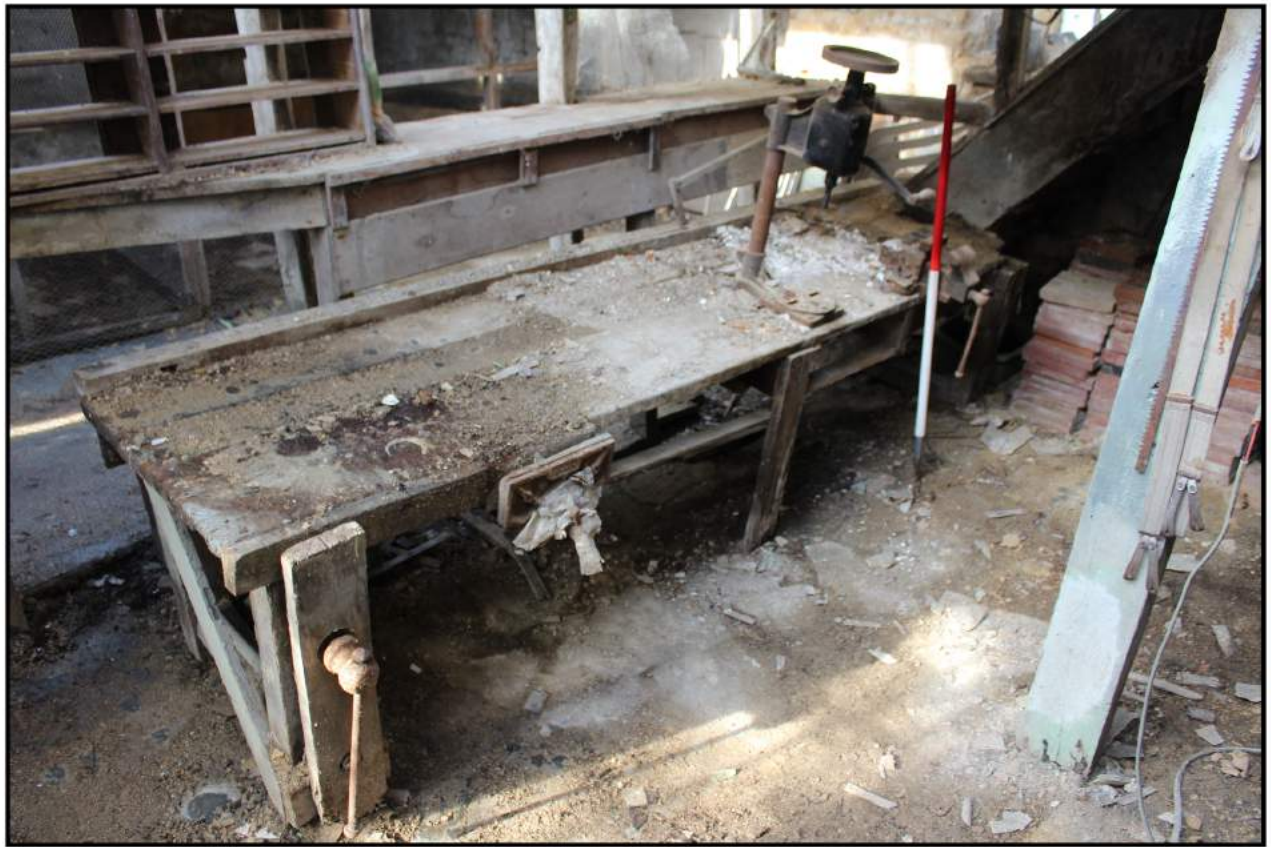
Various vices, a pillar drill (Fig 17) and a treadle grindstone (Fig 20) suggest that the ground floor was in use for engineering purposes or as a repair workshop of some kind.

Fig 17: Interior, north-east end; showing work bench and equipment

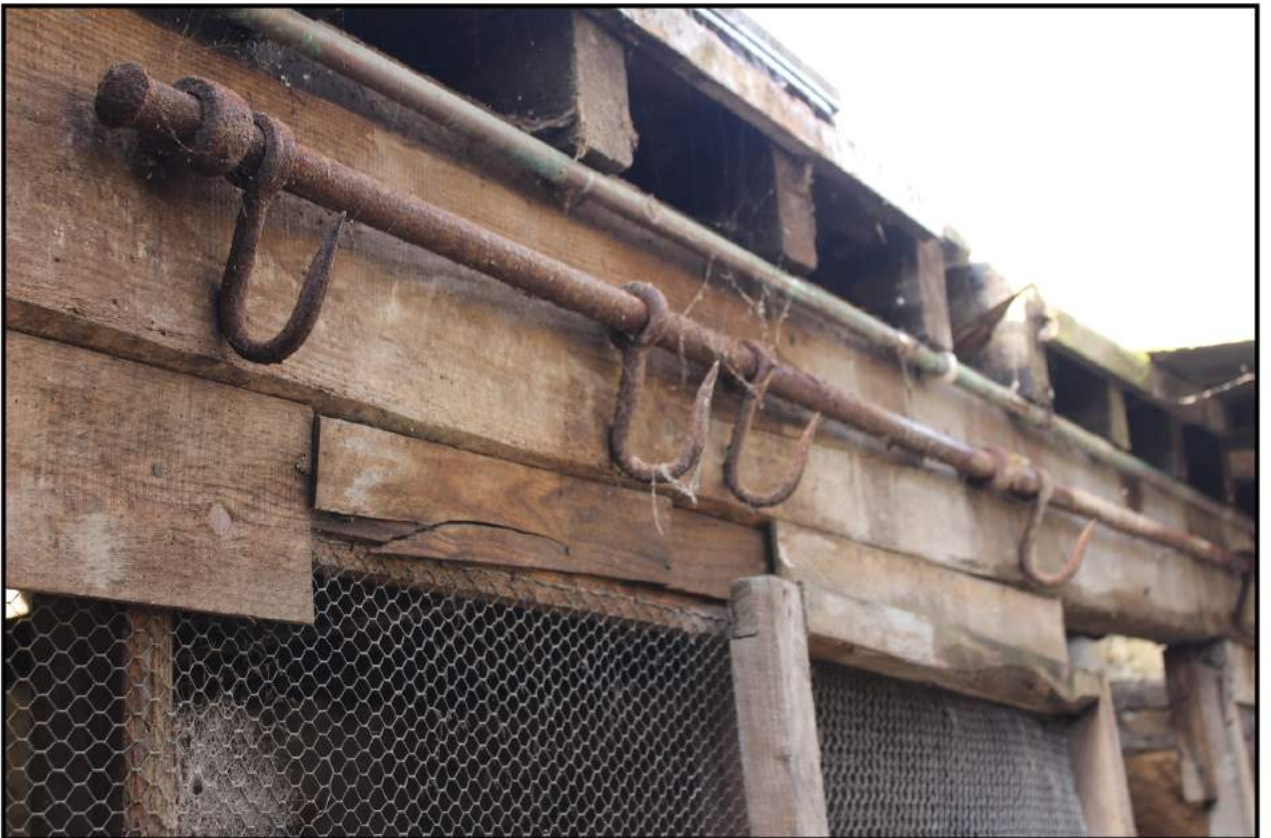
Fig 18: Interior, cross-passage; showing row of butcher's hooks

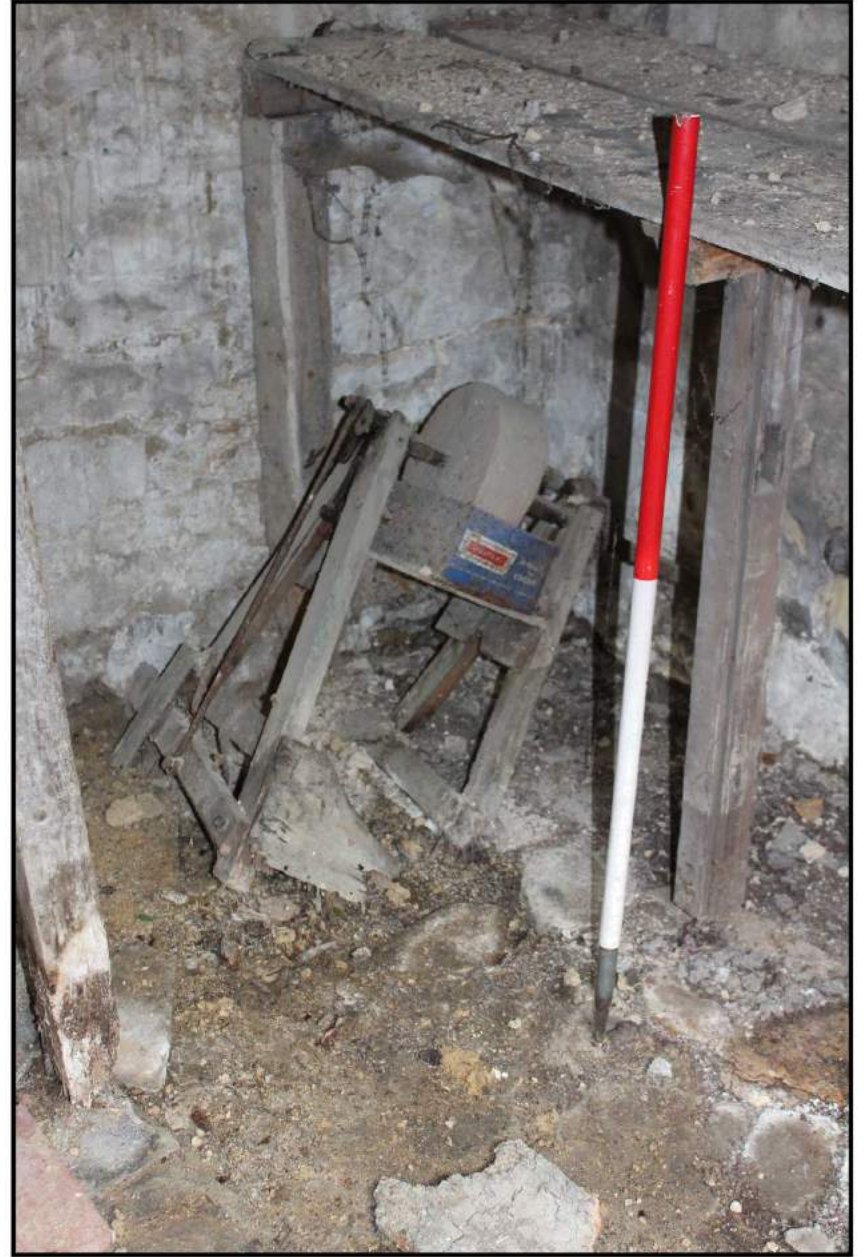
Fig 20: Interior, north-east end; showing pedal grindstone
