**Historic building recording
of an ancillary storage building
adjoining the Bakehouse,
Back Lane,
Broadway,
Worcestershire
WR12 7BP**

Martin Cook BA MCIfA

23rd November 2019

WSM 71720

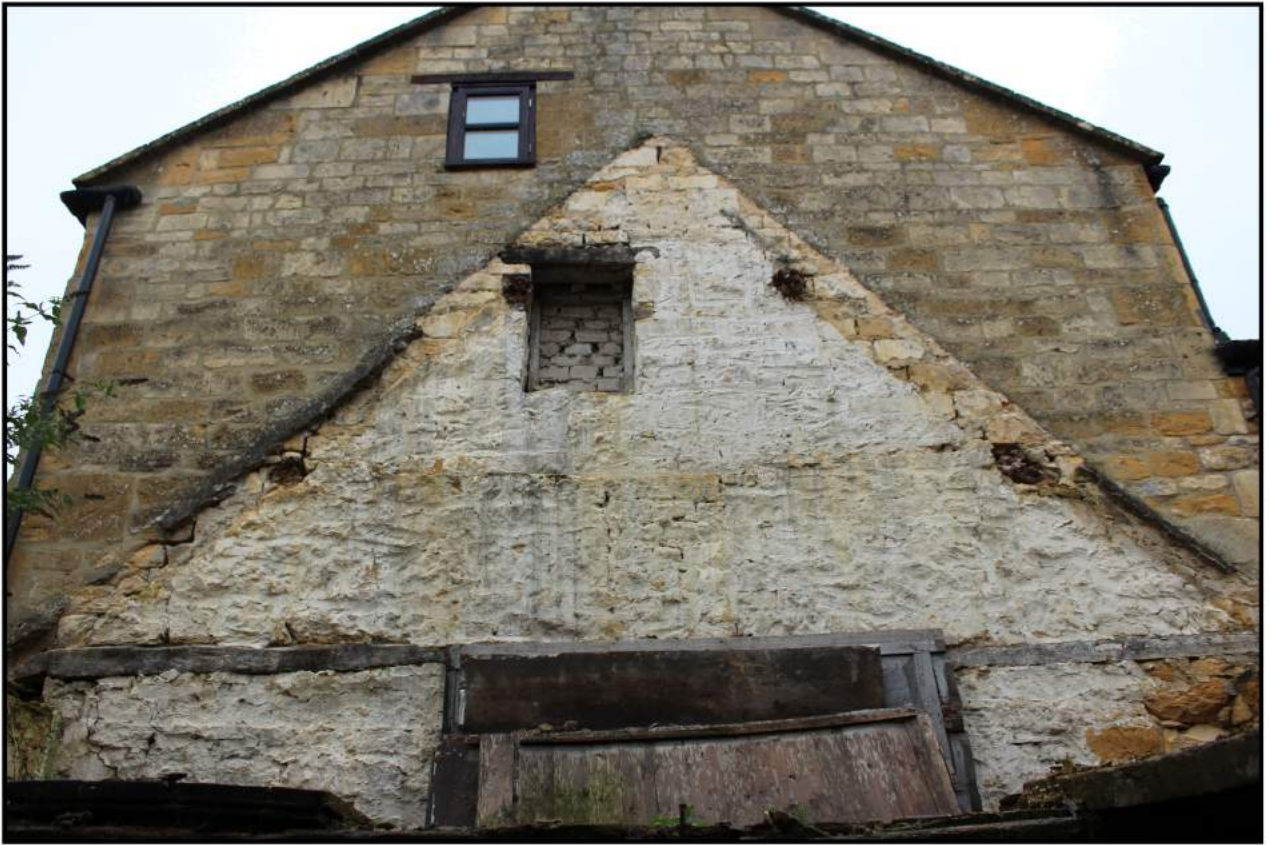
The recorded building was built onto an existing building to its west (Fig 3.1). The evidence for this is that the western boundary wall of the recorded building is unequivocally part of the existing building to its west (Fig 21) with the stone coursing being continuous across the roof scar. Additionally, there are three window openings (Figs 11 and 21) in this boundary wall that are unlikely to be contemporary with the recorded building.

Fig 21: Scar on wall of building to south-west, showing blocked window and sockets for purlins
