**Archaeological watching brief  
at the Rotunda  
Croome Court  
Worcestershire**

25th November 2019

An archaeological watching brief was carried out at the Rotunda, Croome Court, Worcestershire (SO 88866 44557; Fig 1) at the request of Mr John Goom of John C Goom Architects and Historic Building Consultants on behalf of the National Trust. This work was undertaken in order to investigate the deposits underlying a circular paved area and steps surrounding the Rotunda which were showing signs of structural failure and specifically to address the following questions:

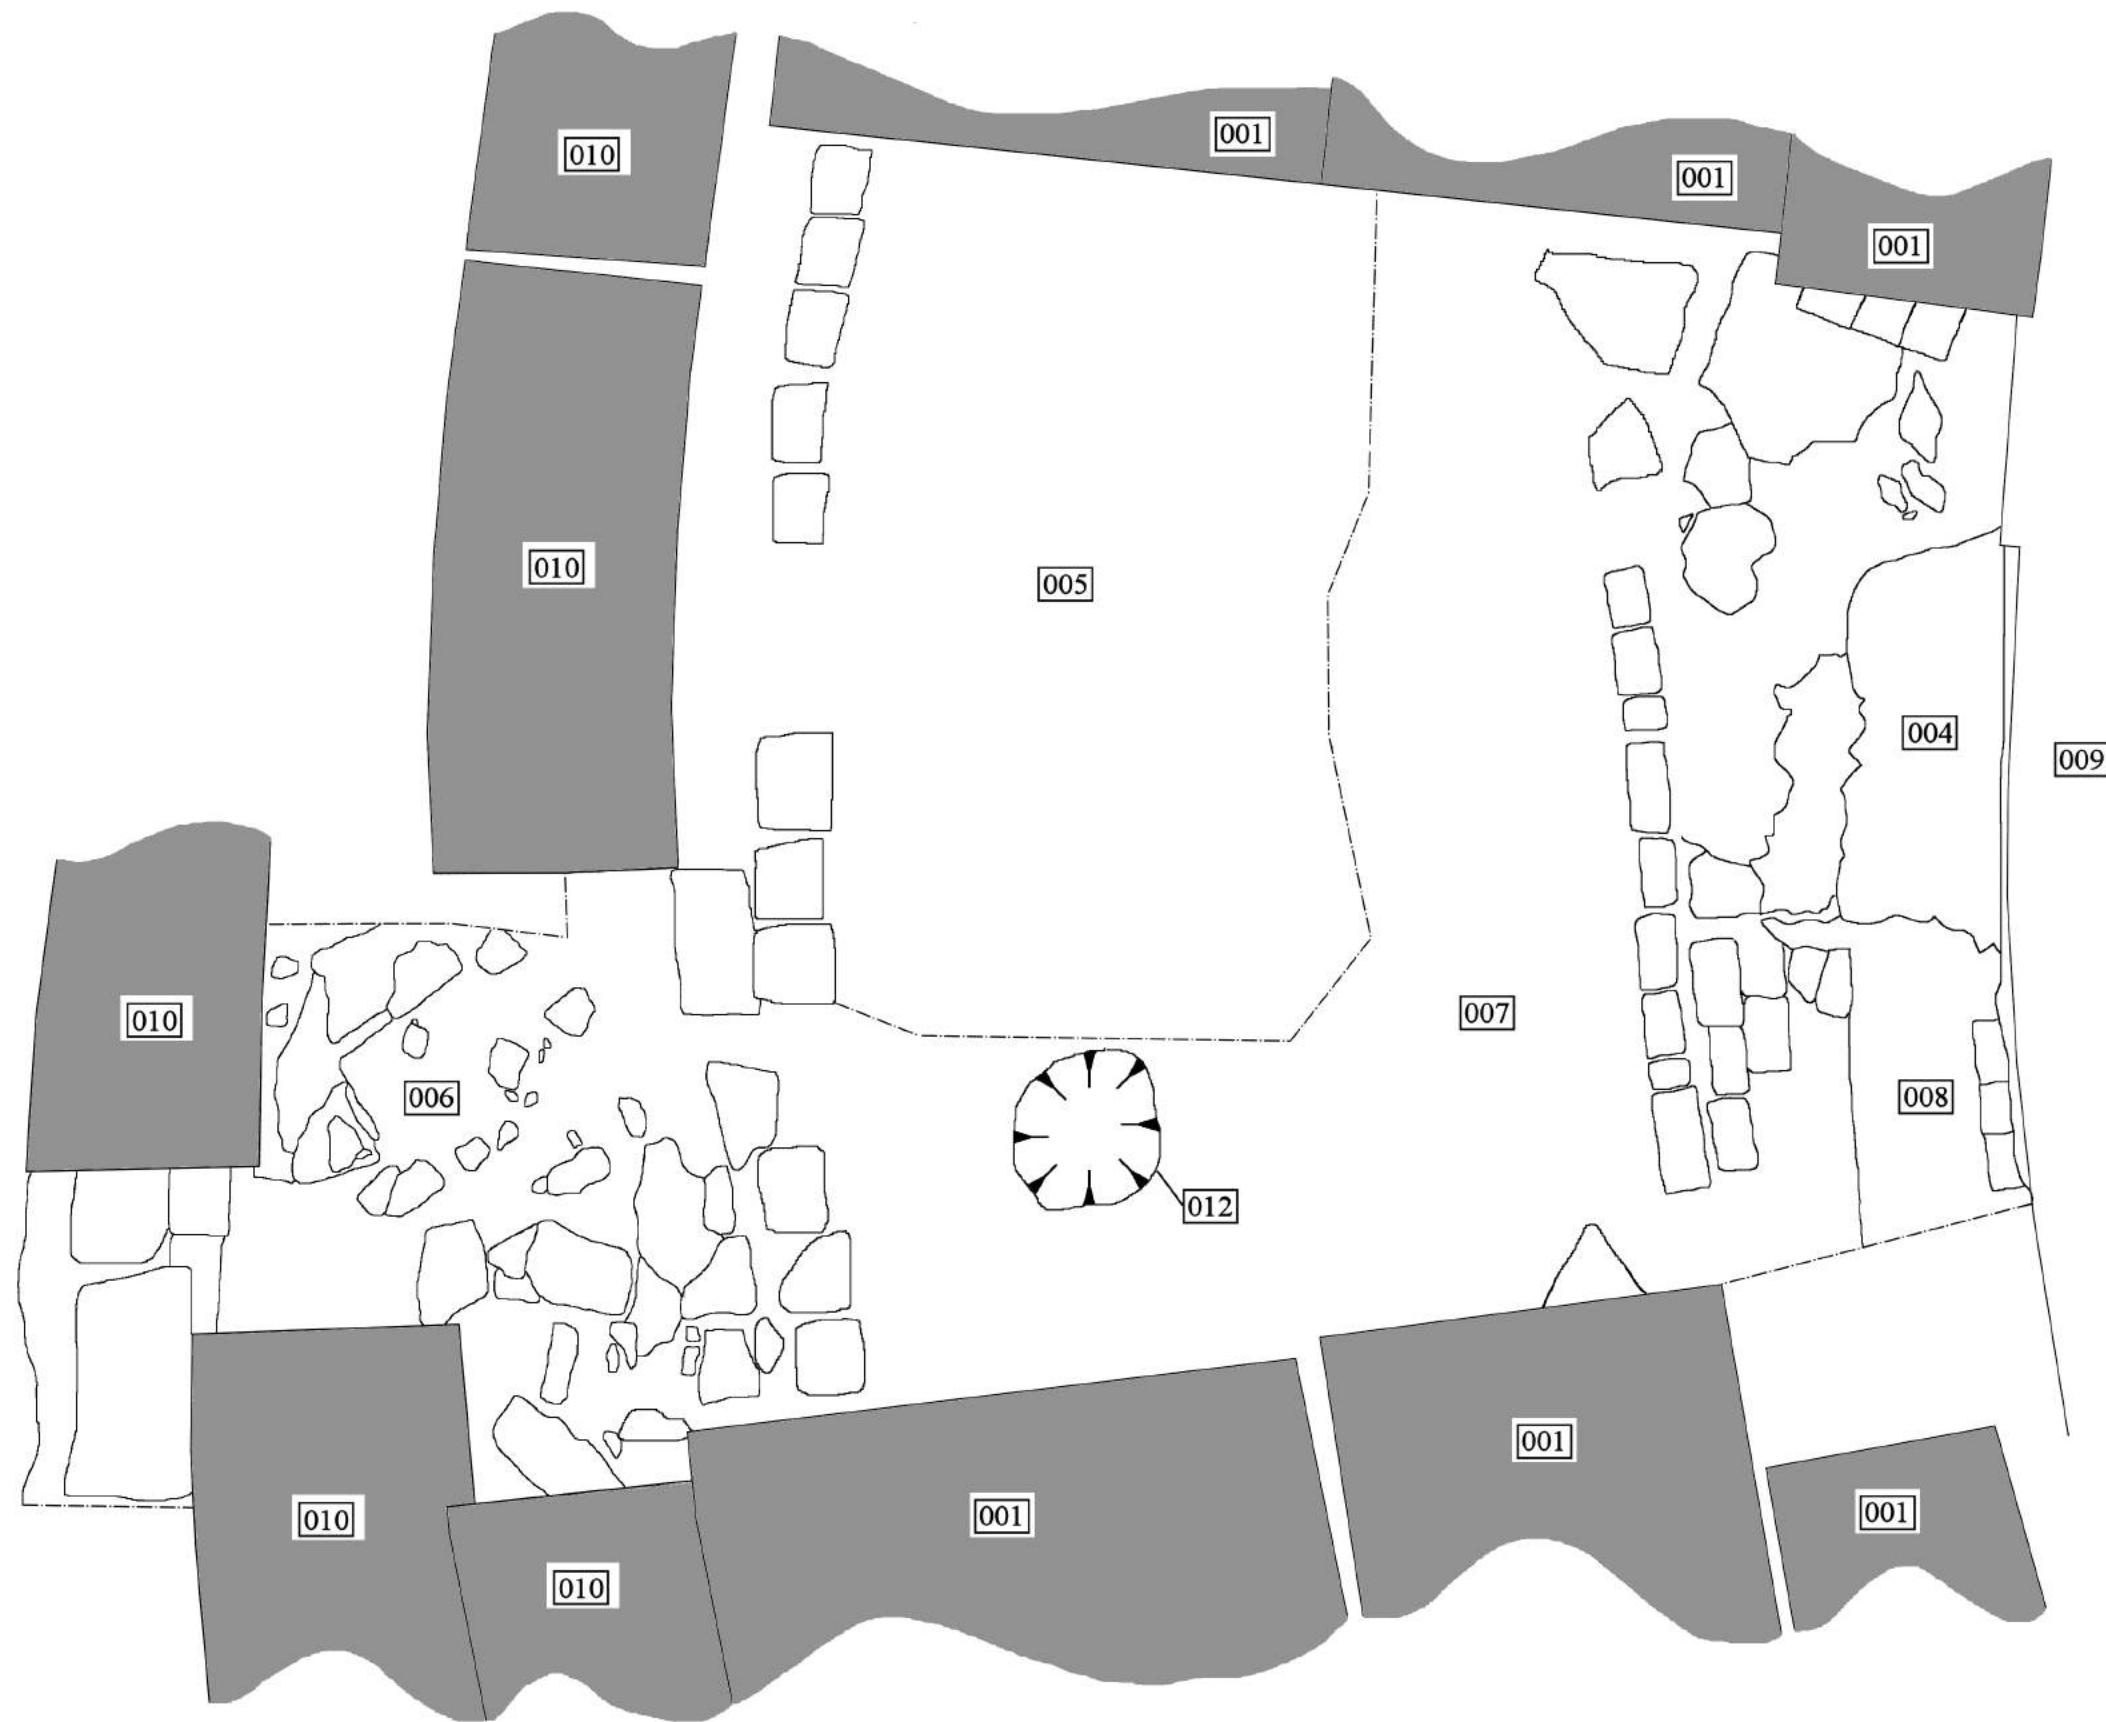
Fig 2: Plan showing deposits after lifting of the Rotunda paving (context 001), steps (context 010) and contexts 002 and 003

Construction of a brickwork 'dome' (context 007; Figs 2, 3 and 6) which abuts the stepped foundation of the Rotunda (context 008; Figs 2, 3 and 7).

Digging of a sub-rectangular hole through this dome (context 012; Figs 2 and 3). This was filled with a grey clay (context 013; Fig 3).

Levelling-up of the upper surface of the dome with rough brickwork and a very hard mortar (context 005; Figs 2, 3 and 4).

Building-up of the outer rim of the dome (context 006; Figs 2, 3, 8 and 9) in the same brickwork and mortar as Phase 3.1, in preparation for installation of the three rings of stone steps (context 010; Figs 2 and 3).

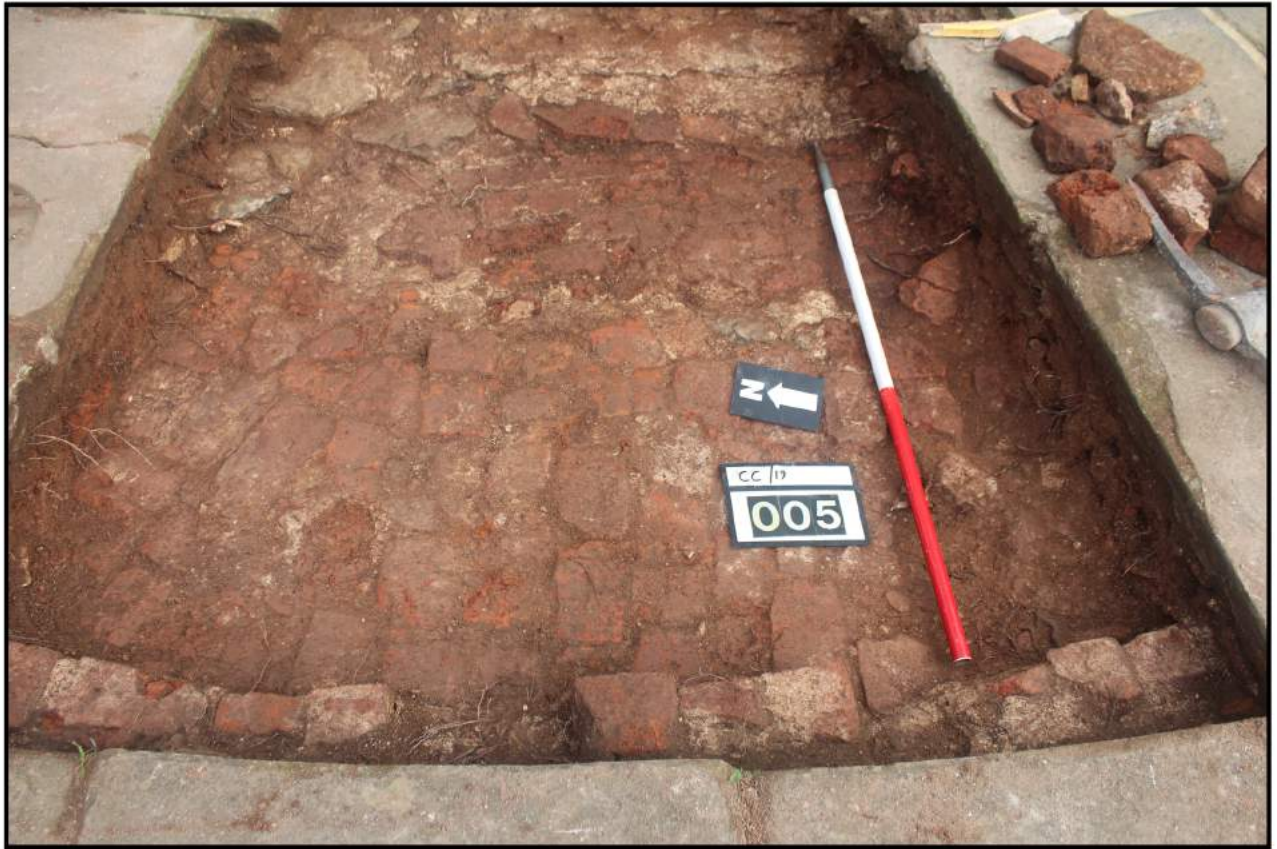
Fig 4: Levelling-up of the 'dome' with rough brickwork and very hard mortar (context 005)

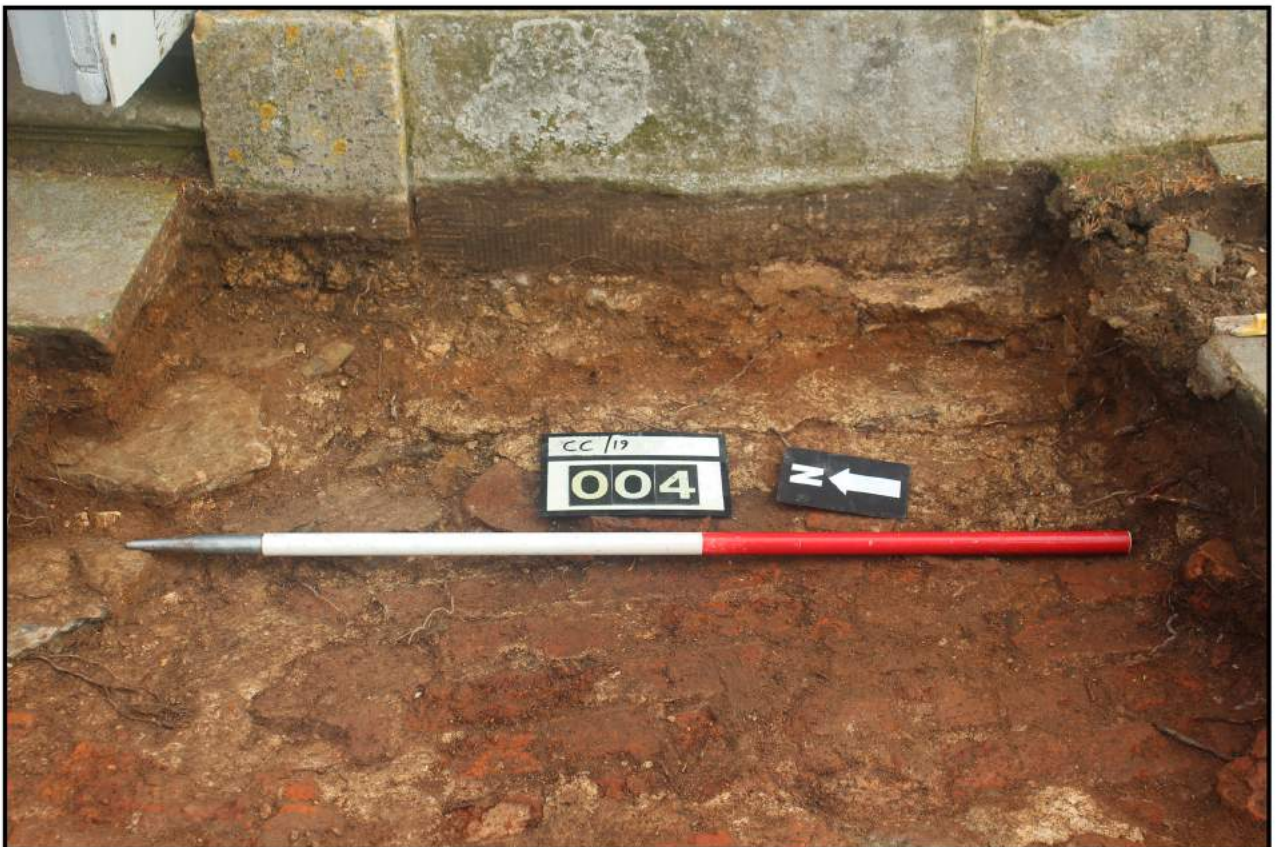
Fig 5: Triangular fillet of mortar (context 004) between the stone skin of the Rotunda (context 009) and the stepped foundation (context 008)

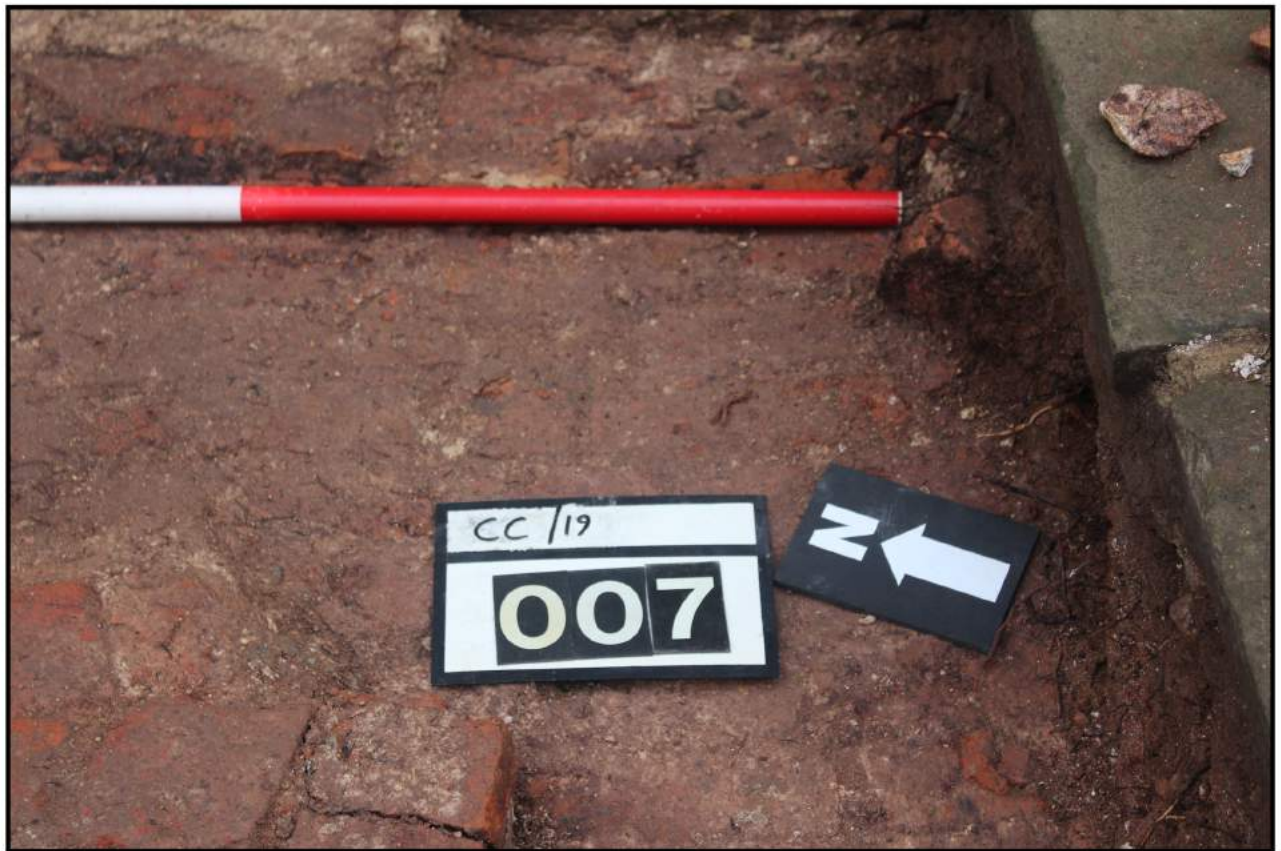
A well-built brickwork 'dome' (context 007) was identified, closely abutting the stepped foundation of the Rotunda (context 008). This appeared to be in sound condition and showed no evidence of movement or displacement. A sub-rectangular hole, approximately 0.2m across, was cut through this dome and subsequently a 'levelling-up' layer of comparatively indifferently laid brickwork (context 005) was installed. The existing steps (context 010) were installed by placing the individual stones in position and then pushing fragments of stone, brick and mortar beneath them (context 006). The hollow thus created within the circle of the steps was then filled, first with a mixture of rubble and sand (context 003) and then with a layer of sand (context 002) which was to be the bedding layer for the paving slabs (context 001).

Fig 6: Brick 'dome' (context 007)

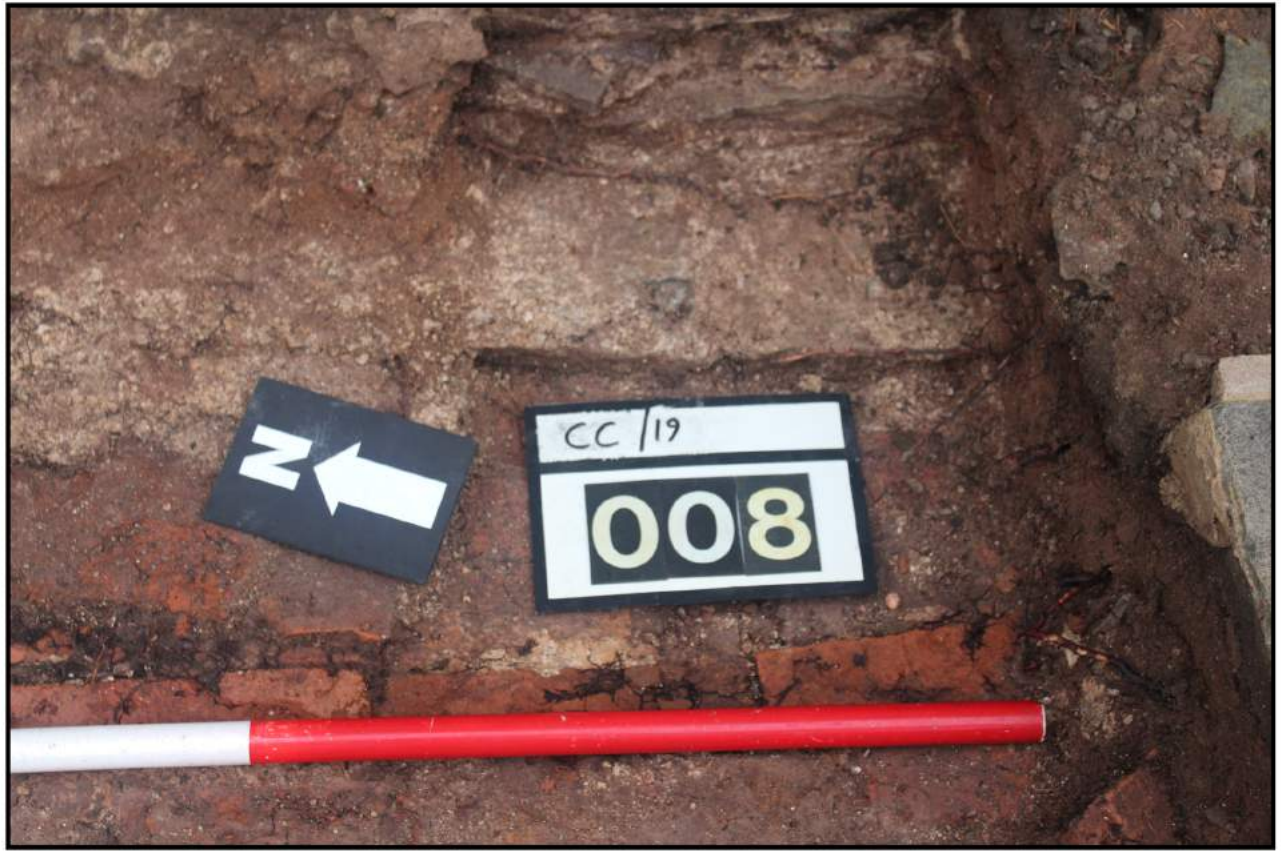
Fig 7: Stepped footing of Rotunda (context 008)

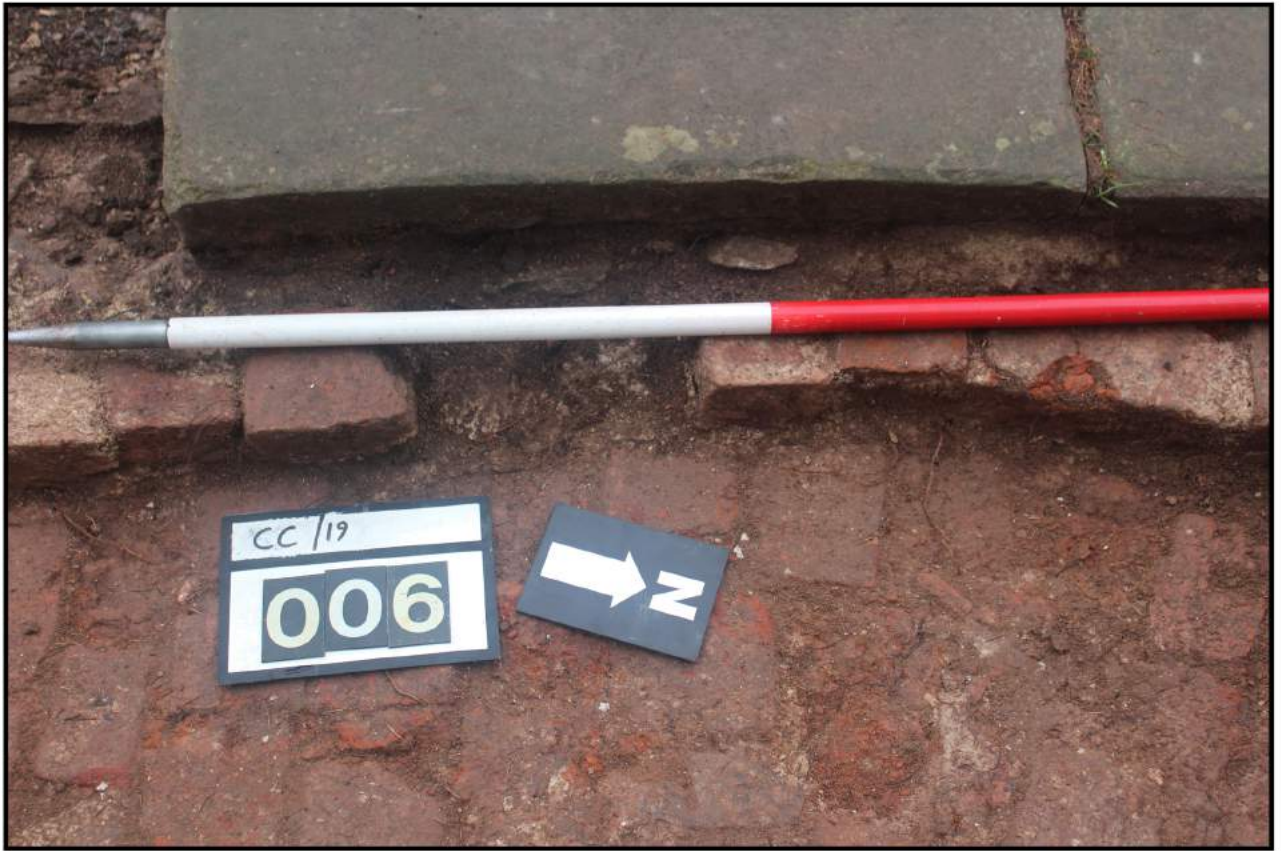
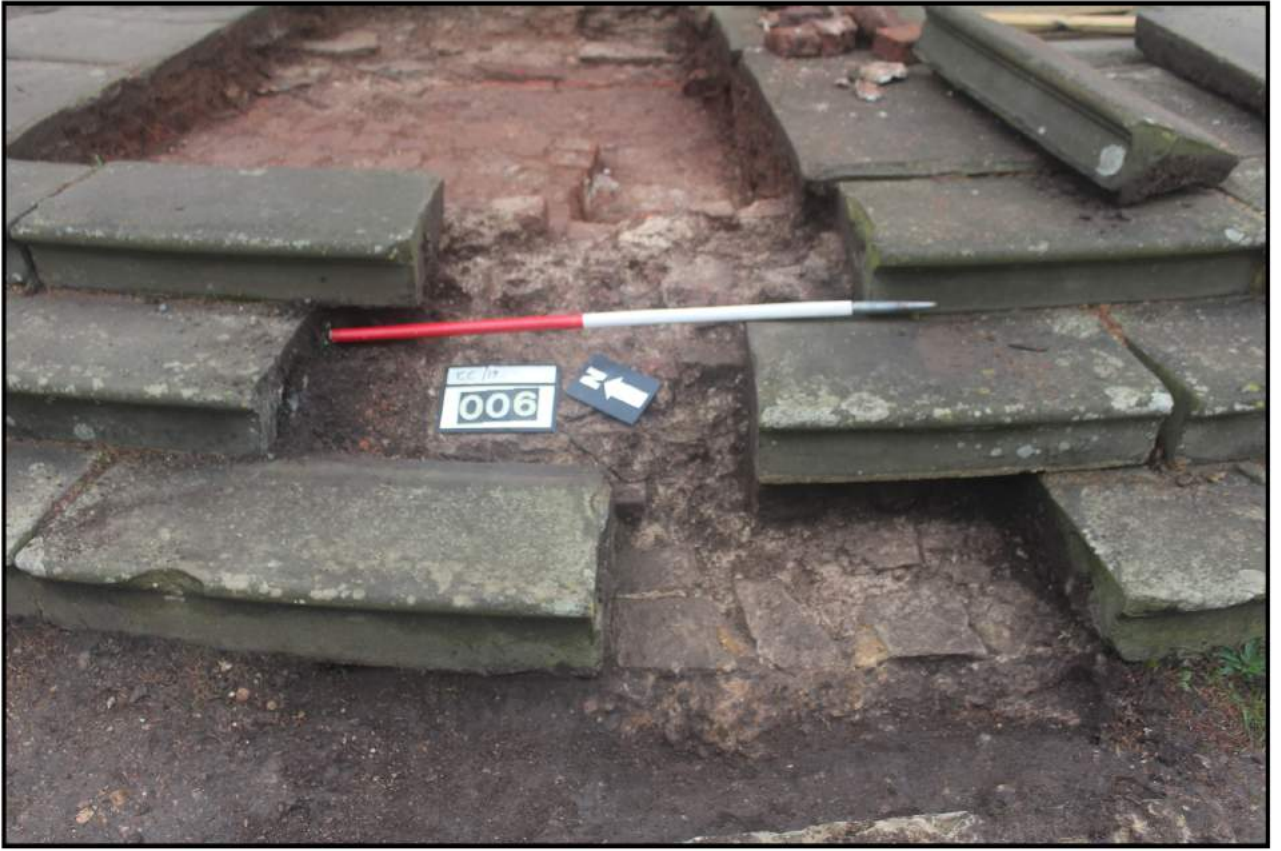
Fig 8: Material pushed under the steps to align and support them (context 006)

Fig 9: Material pushed under the steps to align and support them (context 006)

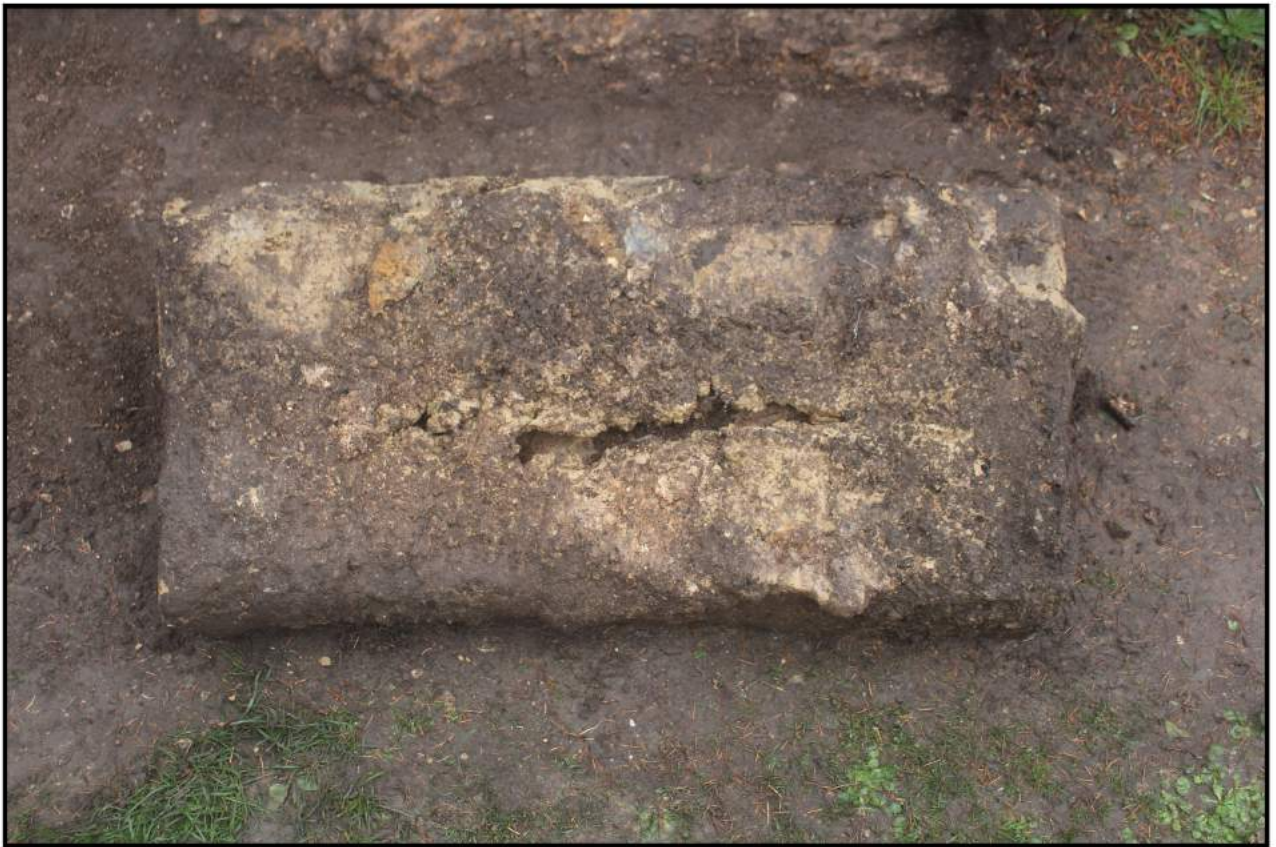
The steps (context 010; Figs 2 and 3) were installed, starting with the outer, by placing them approximately in position and then adjusting their position by pushing stone and brick fragments and mortar underneath them from their inside faces. This is suggested by the deposits left on the underside of the steps (Fig 10).

Fig 10: Underside of a step showing how mortar pushed underneath from the front and the back has left a gap near the middle

Since the brickwork 'dome', which underlies everything else, appears to be sound, the fault must lie elsewhere. The paving slabs (context 001) are bedded upon two layers: a mixed layer of rubble and sand (context 003) and a layer of sand (context 002). The second day of the excavation was quite wet and it was noted that water could pour straight off of the roof and onto the paving stones, pooling upon them for a while before soaking away through the underlying material. It cannot be proved but it is thought that this action, over an extended period of time, may have washed away finer elements of contexts 002 and 003, leaving multiple micro-voids. If these voids collapsed under the weight of the paving stones, some displacement of the stones would occur. Because of the manner in which the surrounding steps were laid, there is little or nothing to prevent them moving outwards. The impetus for this could have derived from the movement of the paving slabs above.
