**Archaeological watching brief
at The Walled Garden,
Blakeshall Lane,
Wolverley,
Worcestershire
DY11 5XJ**

5th May 2020
Revised 23rd June 2020

WSM 72046

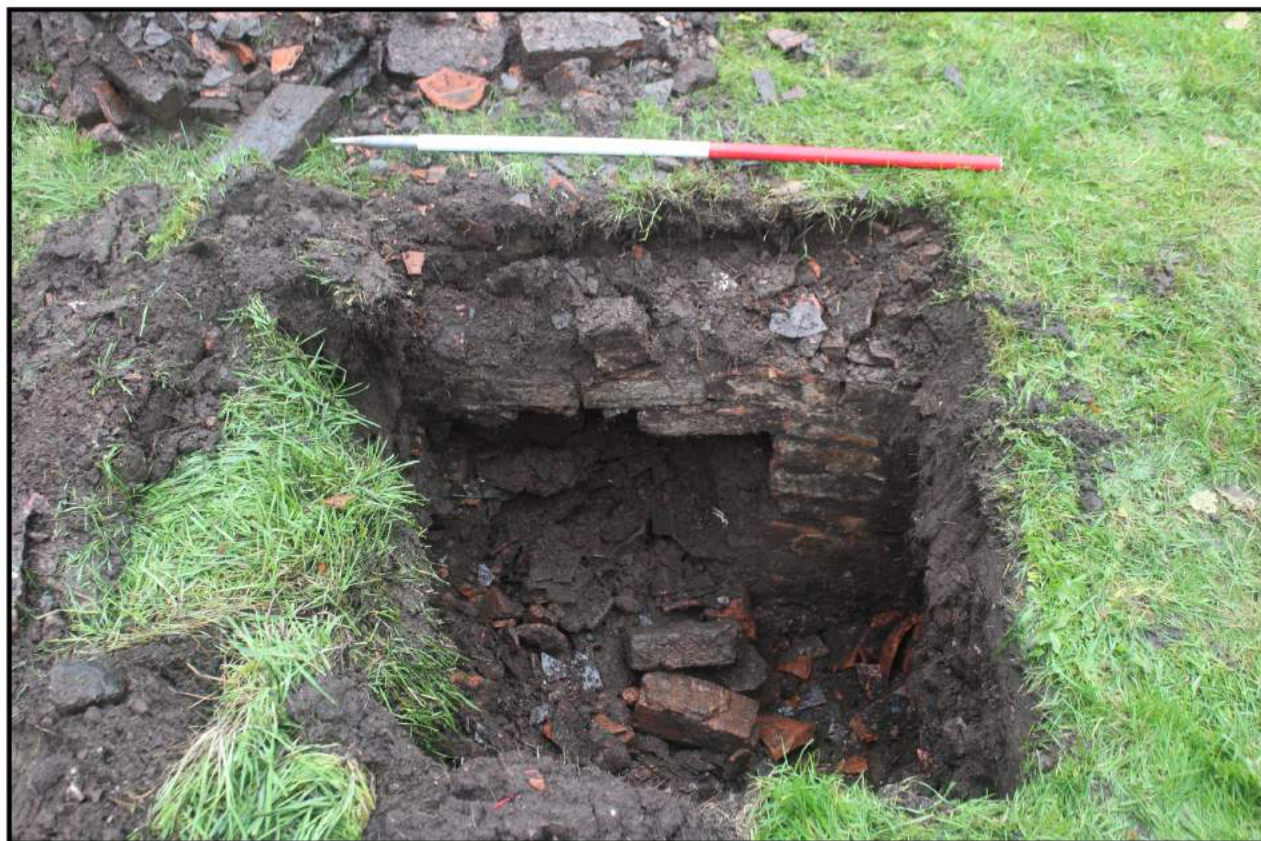
Trial hole 4 had a slightly curving brick wall, four bricks thick, across its northern face (Figs 3.1 and 4, contexts 006 and 007; Section 1), overlain by the topsoil (context 005). The bricks measured 212mm (long) x 98mm (wide) x 45mm (deep). In imperial measurements this equates to $8\frac{11}{32}$ inch x $3\frac{55}{64}$ inch x $1\frac{49}{64}$ inch.

There was some evidence for a corner on the southern side of the wall. The other significant deposit was a fill of small fragments of glass, flower pot and bricks (context 007).

Fig 4: Trial hole 4, contexts 006 and 007; see Fig 3.1, section 1

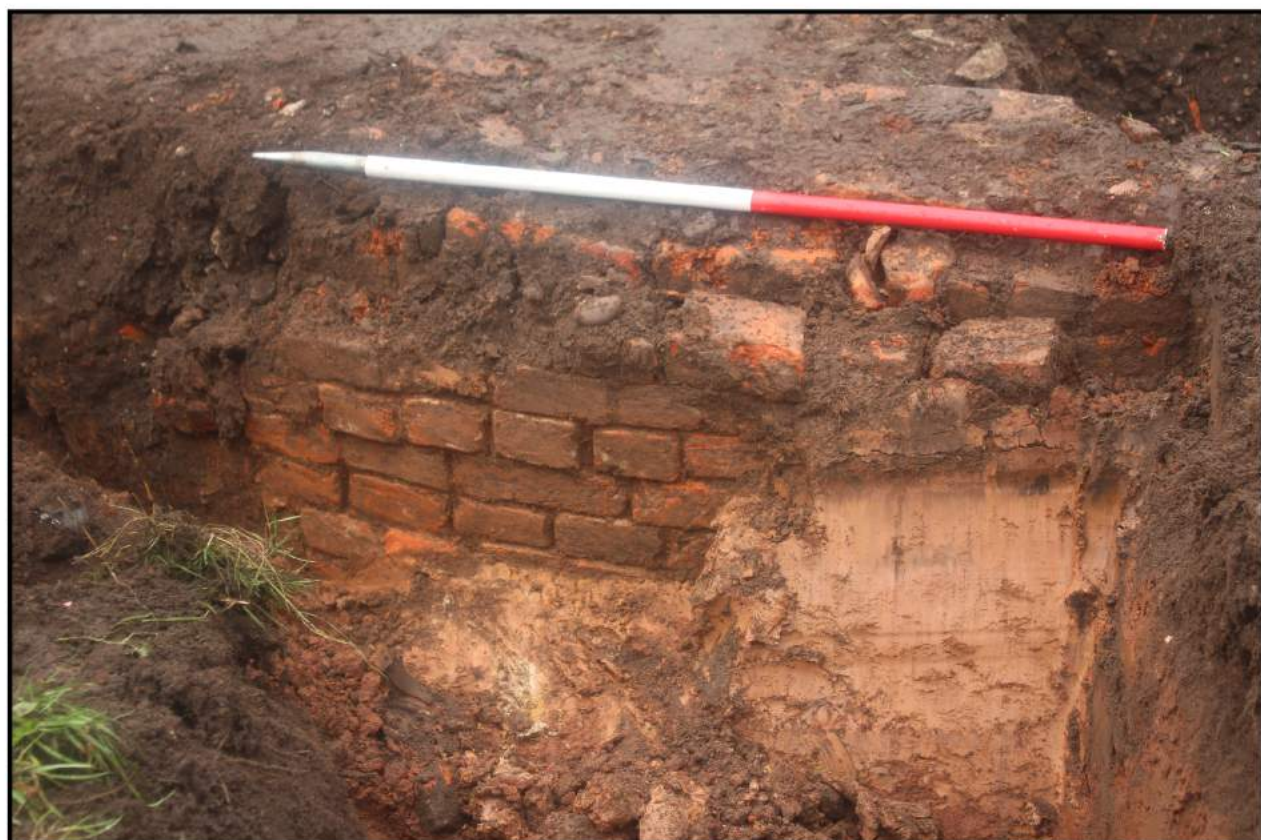
Fig 5: Exposure of outer face of context 008 adjacent to trial hole 1

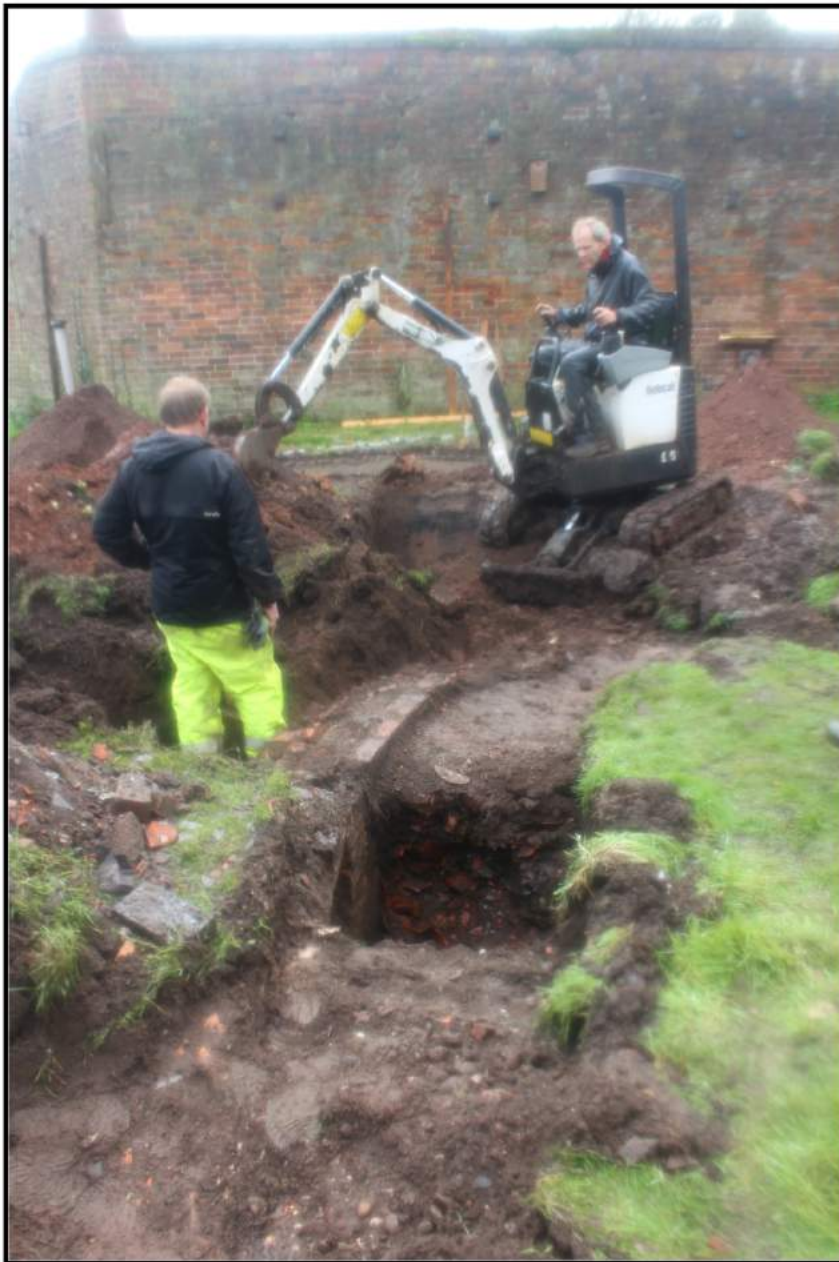
Fig 6: Excavation of the trial holes

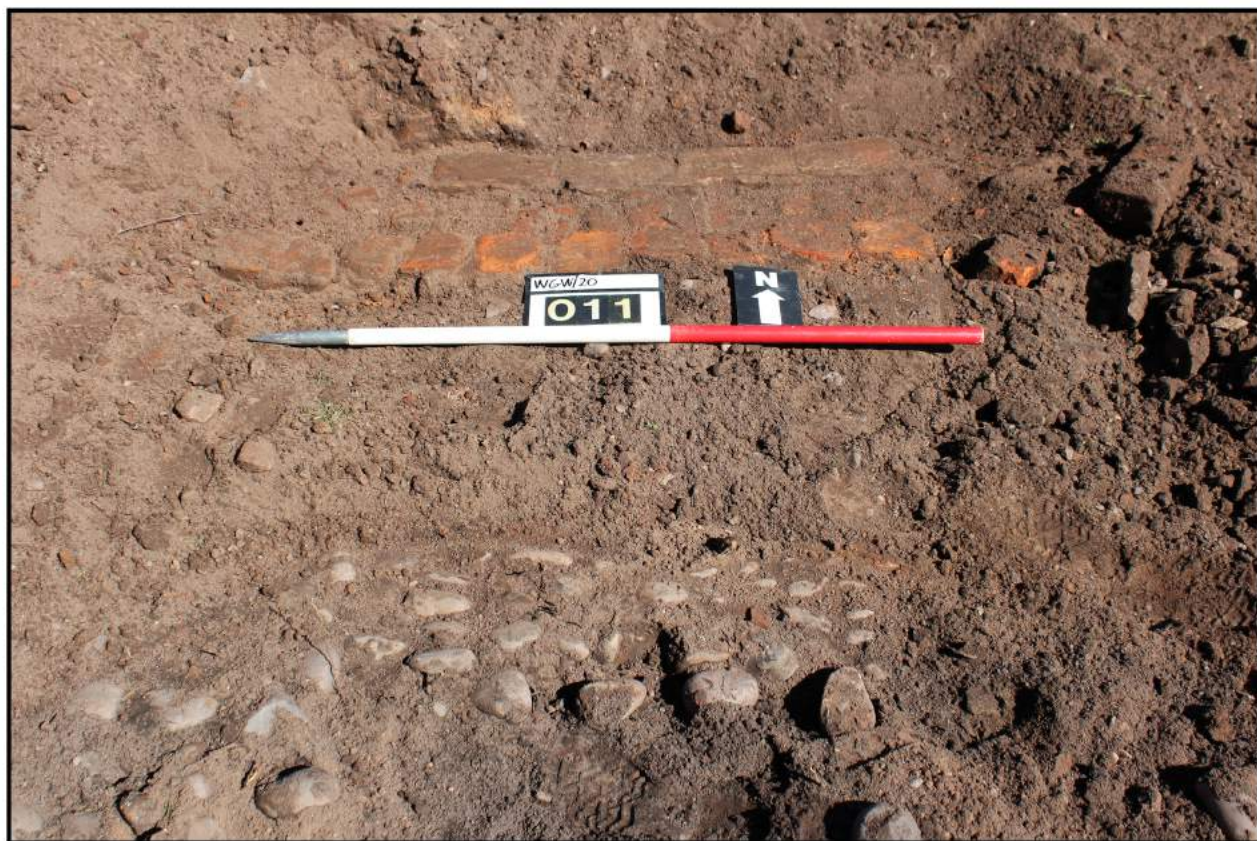
Fig 7: Context 011, curving brick wall, with context 012, cobbled surface in the foreground

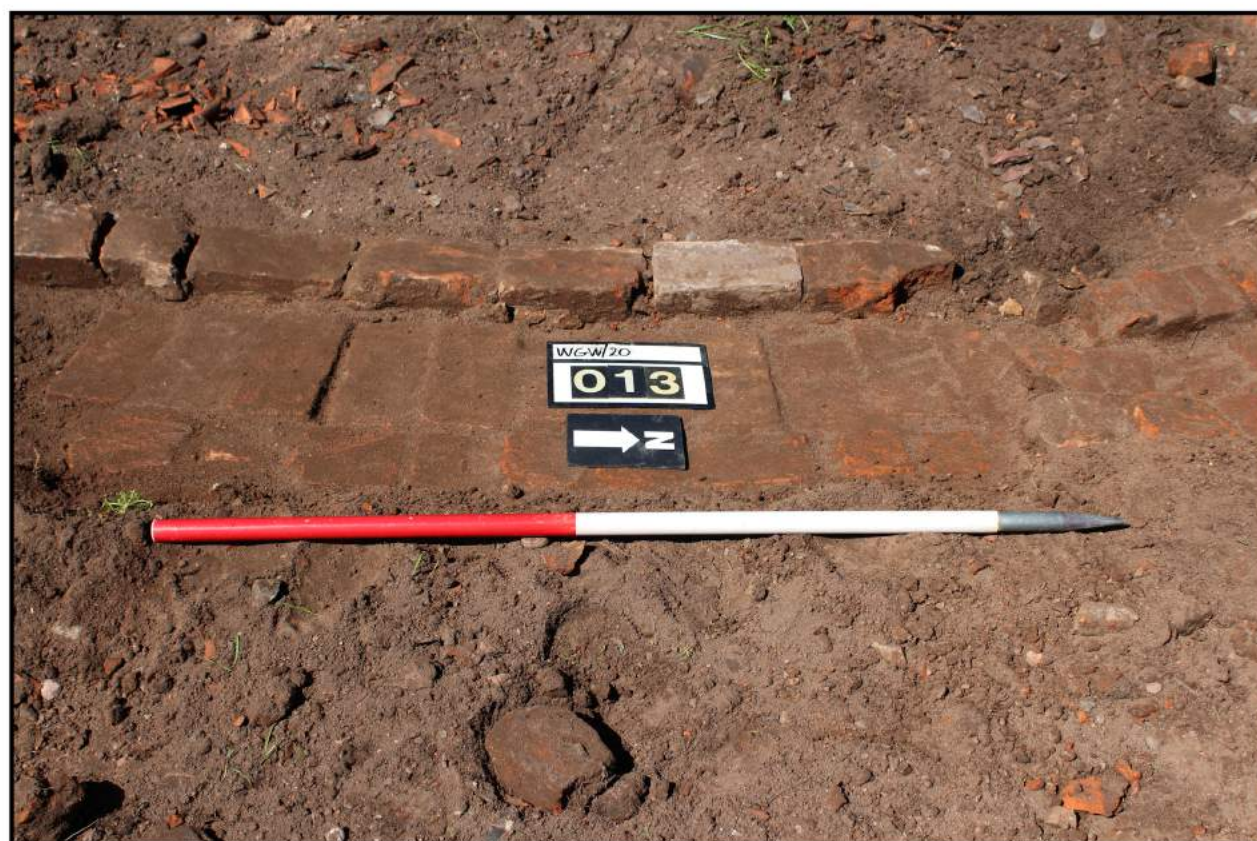
Fig 8: Context 013, curving brick wall

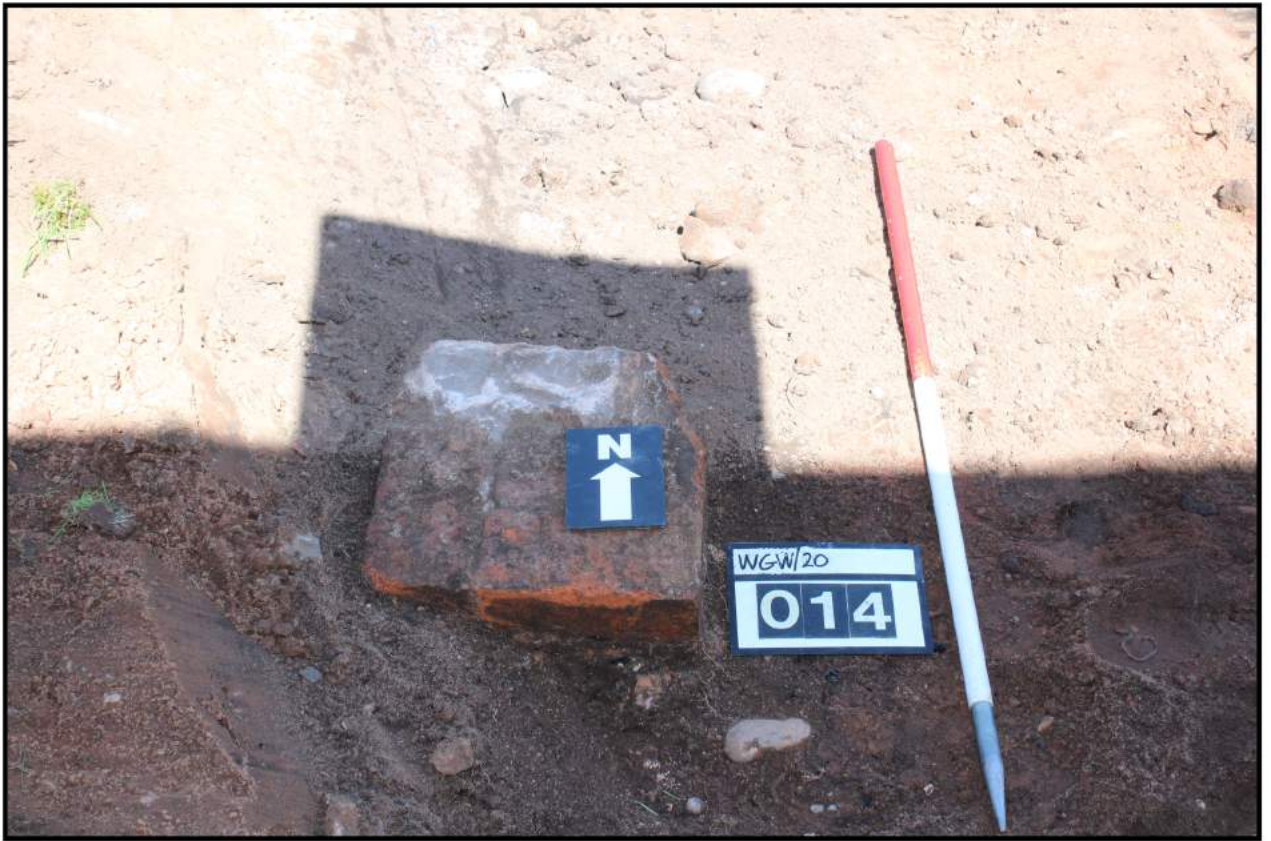
Fig 9: Context 014, brick pier

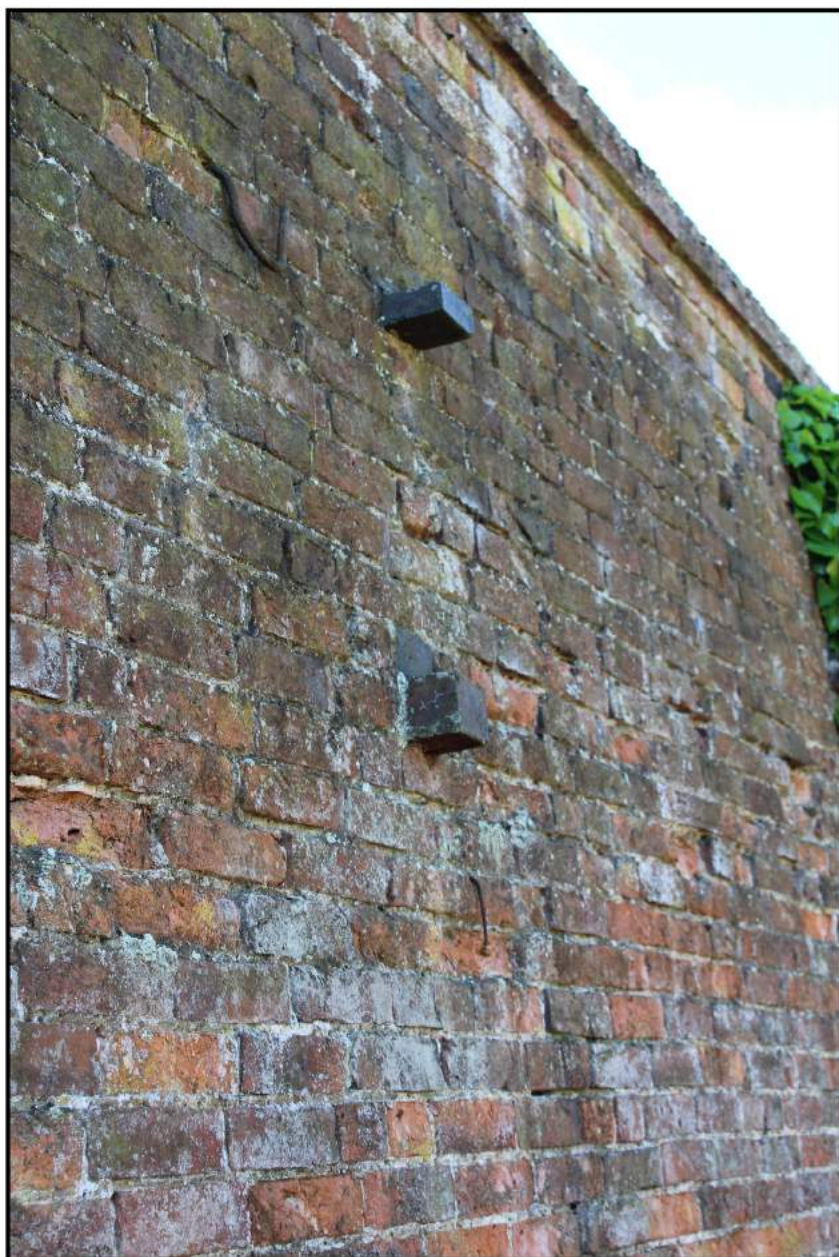
Finally, it was observed that a number of well-fired bricks (compared with those that formed the greater part of the wall of the Walled Garden) protruded from the face of the wall of the Walled Garden (Fig 3.2). This feature occurred on one face of the octagonal circuit only: that adjacent to the excavations for the proposed development. These bricks were in pairs (Fig 10) and a consistent number of brick courses apart. However, from east to west, each pair was one course lower than its neighbour to the east.

Fig 10: One pair of bricks protruding from the face of the wall of the Walled Garden

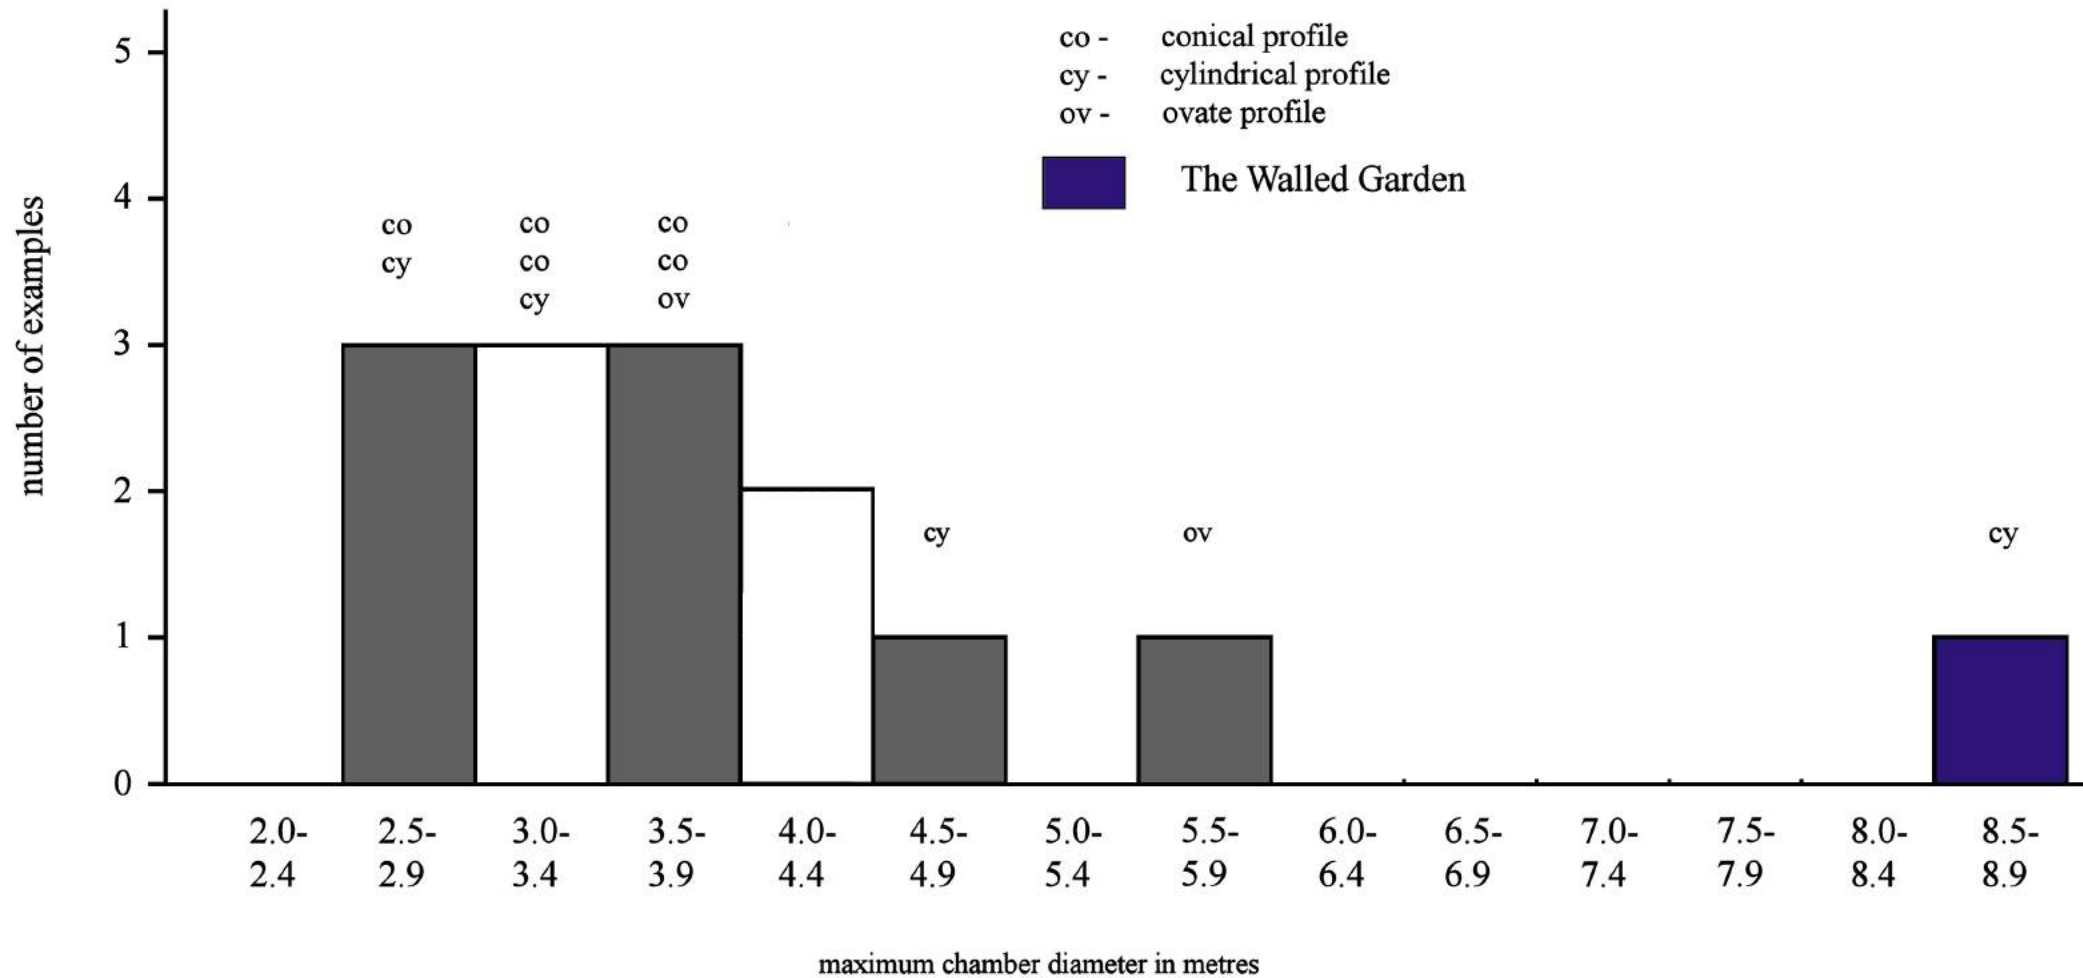
Fig 12: Histogram of maximum chamber diameter against frequency - chamber profile, where available, is indicated

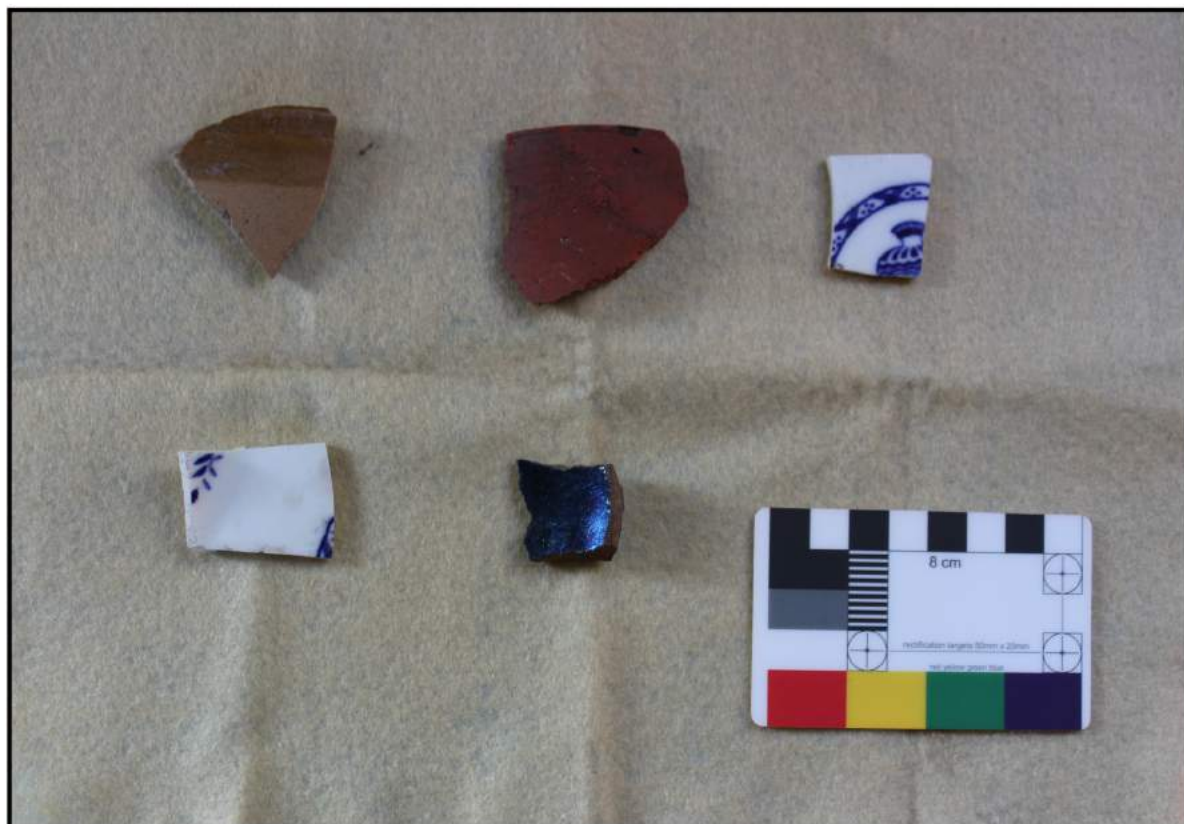
Two sherds of post-medieval red ware (fabric 78) were retrieved. The first was the small base fragment, likely from a jar, which was high-fired and decorated with a purplish black glaze characteristic of this ware type. The sherd could be dated late 17th-18th century (context 001).

Fig 17: Finds from context 001

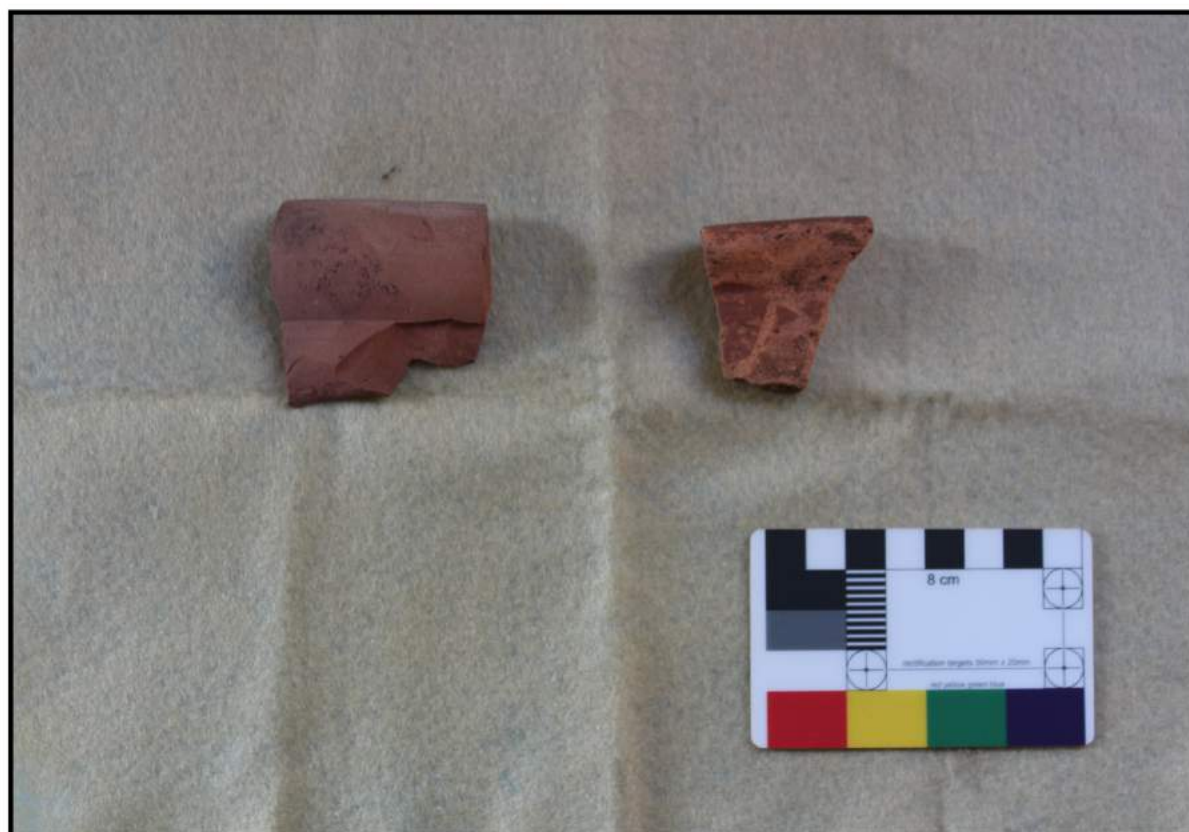
The other sherd (context 007) was from a fairly substantial open vessel (310mm diameter) with a thickened rim and had a dark red iron slip on both surfaces. The walls are near upright, indicating it to have been a straight-sided bowl or large jar form. It is possible, given the context in which it was found, that this vessel was a flowerpot. Evidence from Castle Bromwich Hall, amongst other sites, has indicated that flowerpots of 18th and early 19th century date closely resembled the local domestic vessels, being made of the same orange or buff earthenware and commonly having a dark red/maroon slip reminiscent of those seen on Midlands Blackwares (Currie 1993, 238).

The only stratified sherd of modern date was identified as the rim of an unglazed earthenware flowerpot (context 007; fabric 101). The rim was of collared form, which had faint traces of white slip painted around the top and measured 330mm in diameter. The collared form and presence of white slip indicate mid19th century date for this sherd (Currie 1993, 239).

Finds from context 007

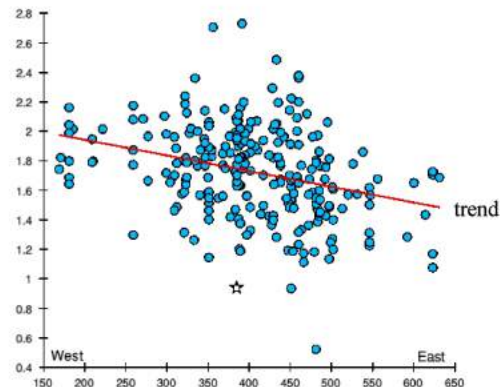
Fig 19: Analysis of brick size after Harrison (<http://jaharrison.me.uk/Brickwork/Sizes.html>)

As a preliminary analysis, he calculated the volume for each brick and used this as a comparative metric (Fig 19; Geographical distribution of sample, including volume). The example from the Walled Garden was 0.935 litres, which fell into the smallest of his categories. He concluded that larger bricks tended to be found further north. With one exception, the example from the Walled Garden is as far north as its category (0.8 litres to 1.2 litres) reached.

A more dramatic illustration was obtained by considering east to west and south to north variations separately (Fig 19; Brick volume against Ordnance Survey easting and northing). The variation is enormous but the trend line, shown red, indicates that the volume increases with distance north and west. In each case the example from the Walled Garden is an outlier on or near the extreme edge of the distribution.

Harrison considered that the thickness accounted for more of the size difference than either length or width. The thickness of the bricks that he measured ranged from 42mm to 90mm. (Fig 19; Geographical distribution against thickness). The example from the Walled Garden was 45mm, which fell into the smallest of his categories. He concluded that larger bricks tended to be found further north. Again, with one exception, the example from the Walled Garden is as far north as its category (40-50mm) reached.

Again, the most dramatic illustration was obtained by considering east to west and south to north variations separately (Fig 19; Brick thickness against Ordnance Survey easting and northing). The variation is even greater than that for volume but the trend line, shown red, indicates that the thickness increases with distance north and west. Again, the example from the Walled Garden is an outlier on or near the extreme edge of the distribution.

Across the sample, there was quite a strong correlation between width and length (Fig 19; Dimensional variation width-length), as would be expected since, when laid in a wall, two headers and a layer of mortar should take the same space as a stretcher, ie the width should be just under half the length. The dotted line on the graph shows a ratio of 2:1 and the example from the Walled Garden lies closer to it than many of Harrison's samples.

Across the sample there was more variation in thickness than in width, and very little correlation between them, as the graph (Fig 19; Dimensional variation thickness-width) shows. The example from the Walled Garden is an outlier on the extreme edge of the distribution.

Across the sample thickness and length varied by similar amounts, but the proportional variation in thickness is much greater (a factor of 2.1 between extremes) than in length (a factor of 1.5 between extremes) and there was very little evidence of correlation between the two (Fig 19; Dimensional variation thickness-length). The example from the Walled Garden is an outlier on the extreme edge of the distribution.

The bricks recorded at the Walled Garden frequently fell at the edge, often the extreme edge, of the distributions analysed by Harrison. Until the 16th or 17th centuries transporting bricks would have been very difficult, very time-consuming and very expensive (Reeder 1983). Even significantly later than this date, bricks were frequently made as close as possible to the site of the building for which they were intended and material available on or close to the site was commonly used.
