**Historic building recording
of a barn at
Foster's Green Farm,
Foster's Green,
Lower Bentley,
Worcestershire,
B60 4HY**

Martin Cook BA MCIfA

26th December 2020

WSM 73468

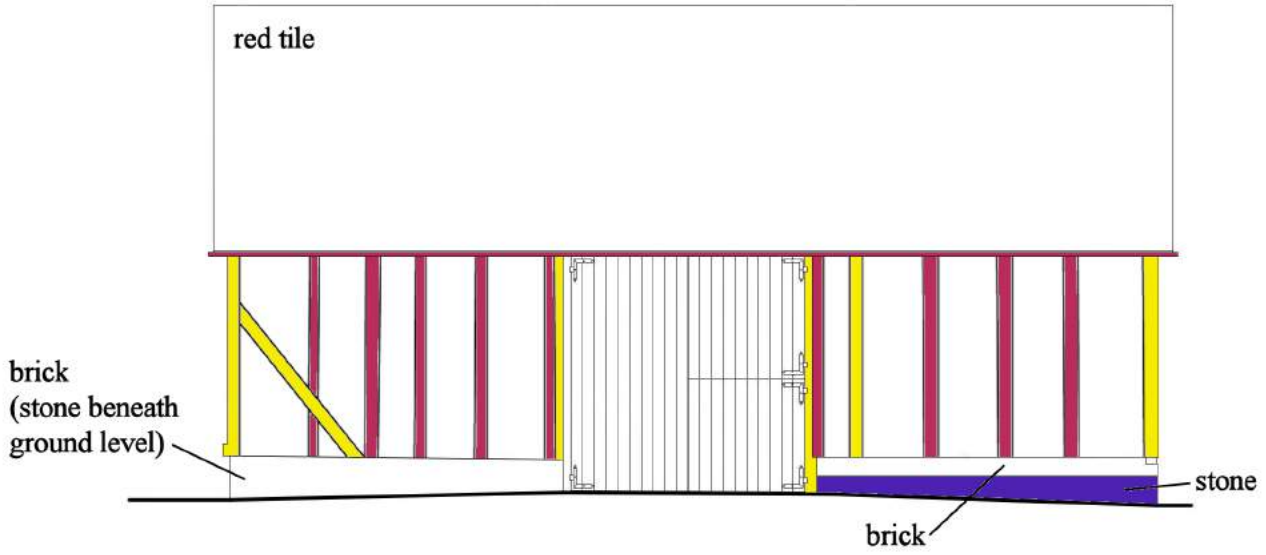
Fig 3.1: South-east and north-west elevations

South-east elevation - weather board omitted

North-west elevation - weather board omitted

- Phase 1: pre 1839
- Phase 2: pre 1884
- Phase 3: late 20th century

The phase 1 timber-framed barn was dismantled and the dwarf wall repaired and raised in brick (Figs 3.1, 3.2, 3.3, 4, 5, 6, 7, 9, 10, 12, 13, 15 and 16). The cill beams, the four trusses and the wall plates were then re-erected (Figs 3.1, 3.2, 3.3, 9, 10, 11, 12, 13, 17, 18, 19 and 20). On the doorpost of the north-west elevation are the remains of three transverse planks (Fig 22). On the doorposts of the same elevation are two steel fittings (Figs 23 and 24) and on the doorposts of the south-east elevation are two recesses (Figs 25 and 26).

A number of posts were replaced (Figs 3.1 and 3.3), as were the doors on either side of the threshing floor (Figs 27 and 28).

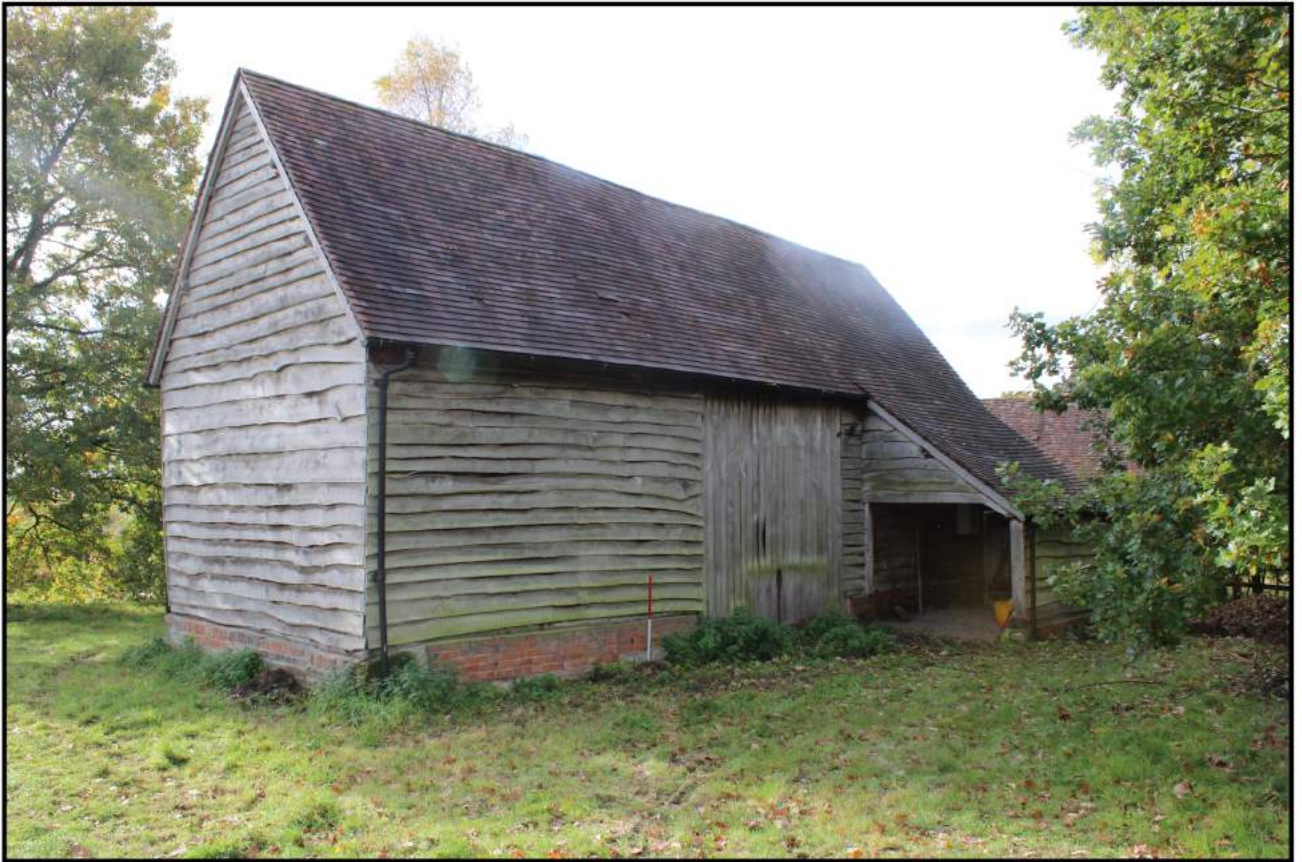
Fig 4: North-west elevation

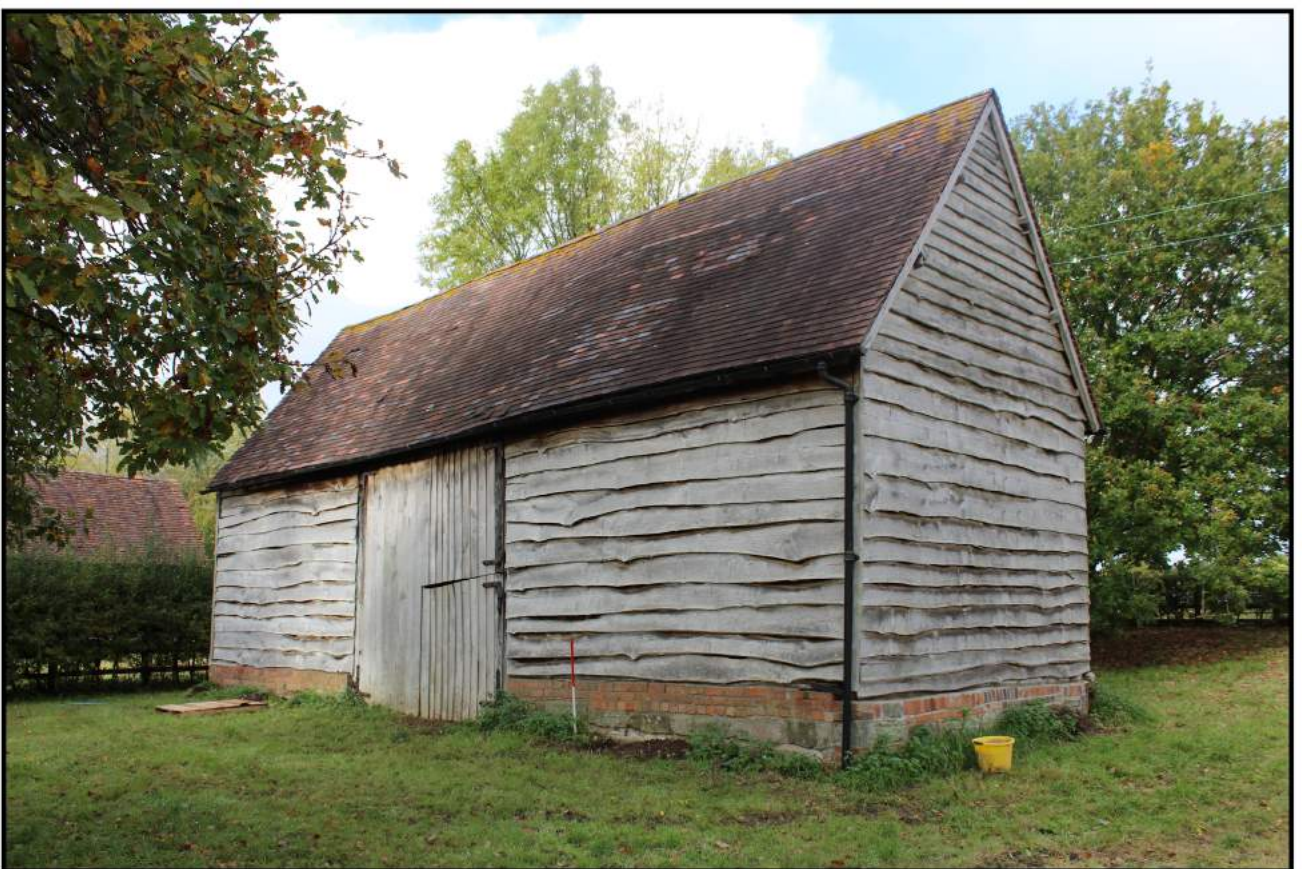
Fig 5: South-east elevation

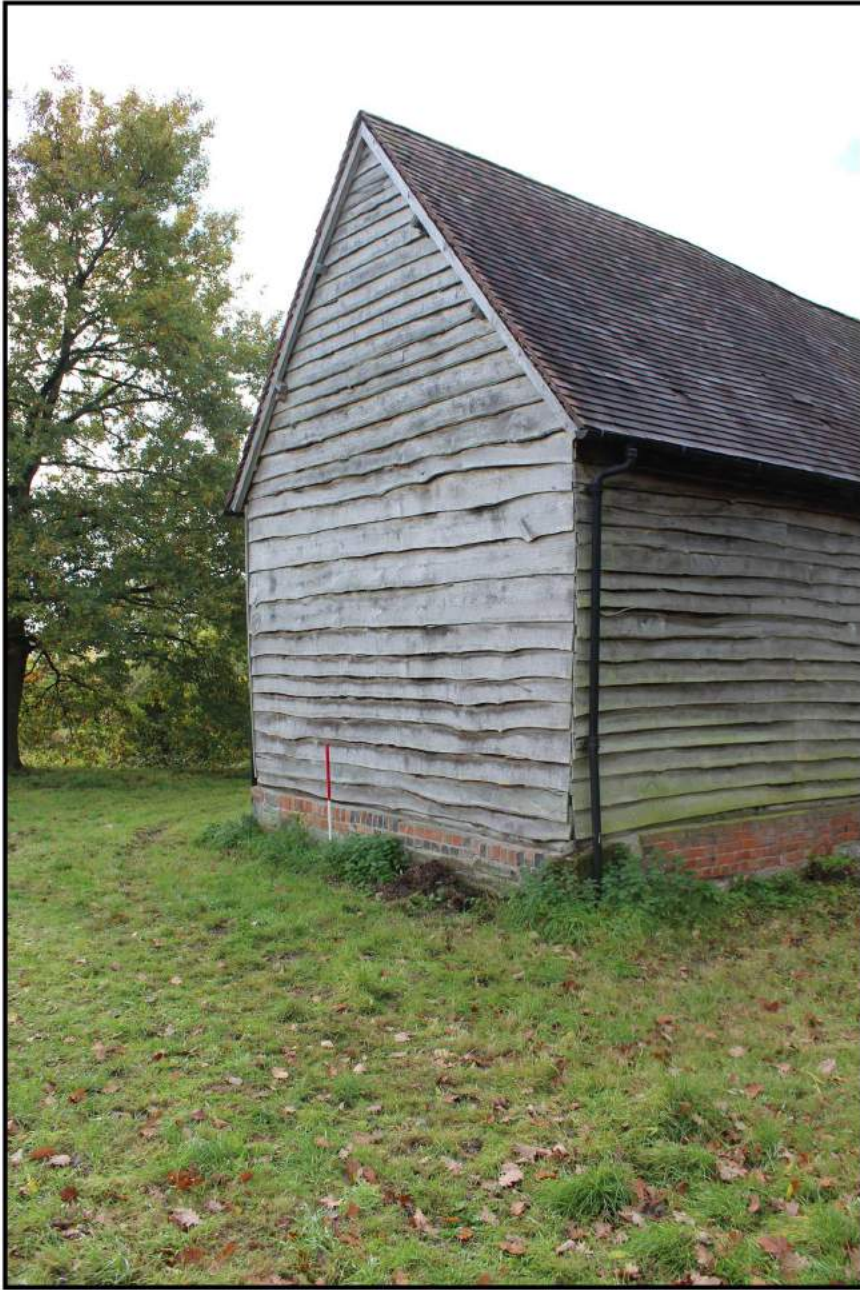
Fig 6: North-east elevation

A stone dwarf wall was constructed around the perimeter of the building and across the edges of the threshing floor. This survives around most of the perimeter and on the north-eastern side of the threshing floor (Figs 3.1, 3.2, 4, 5, 6, 7 and 12). This supported the timber-framed barn of this period.

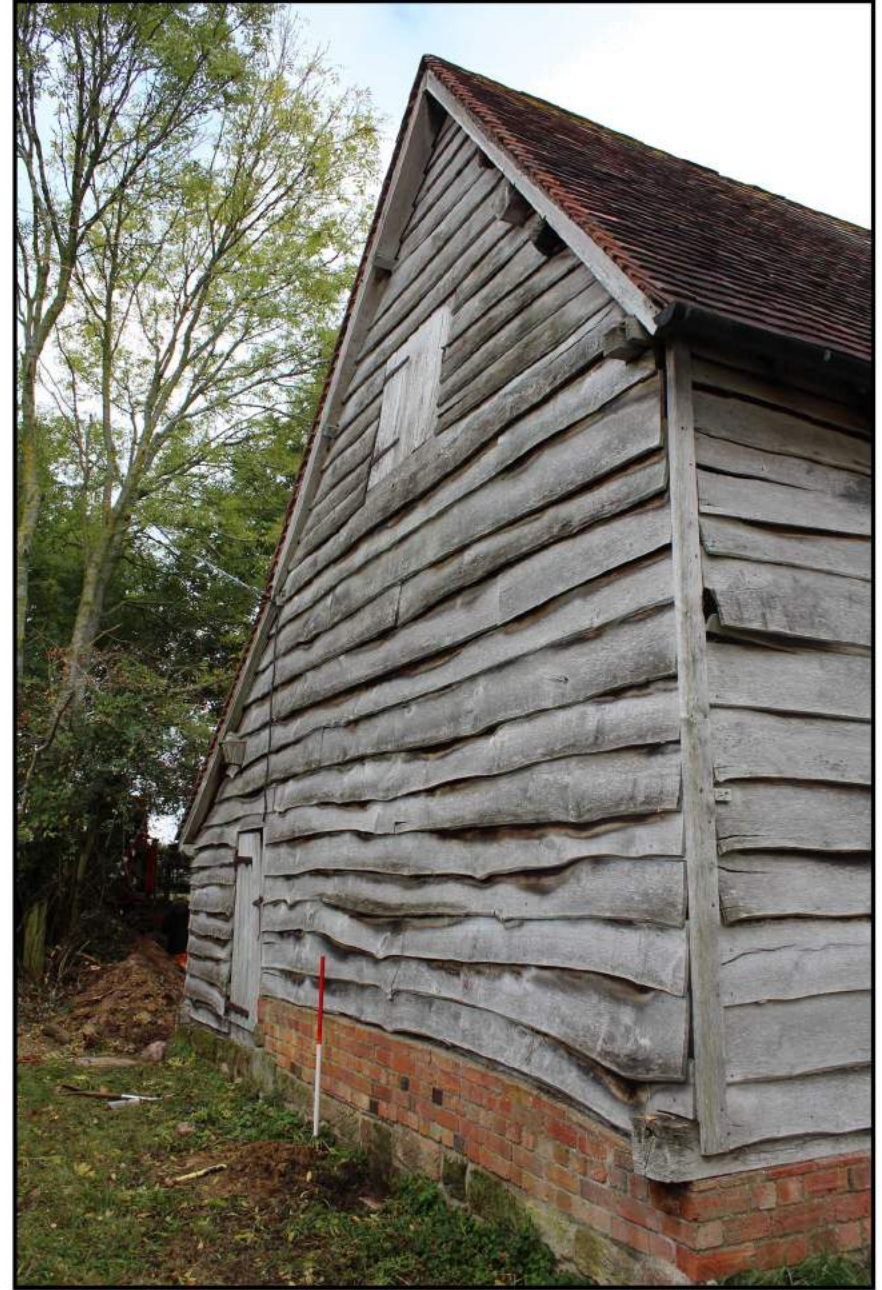
Fig 7: South-west elevation

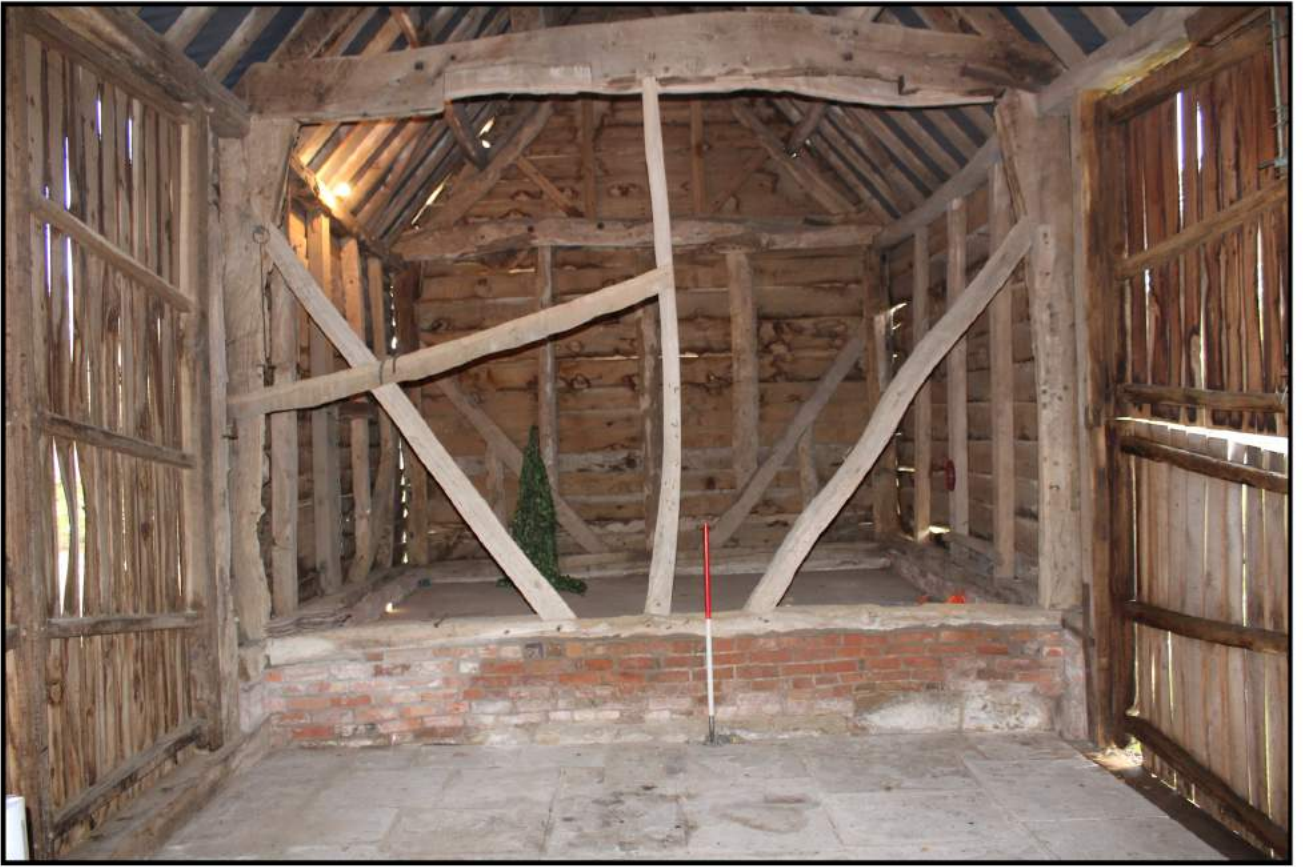
Fig 12: Truss 2

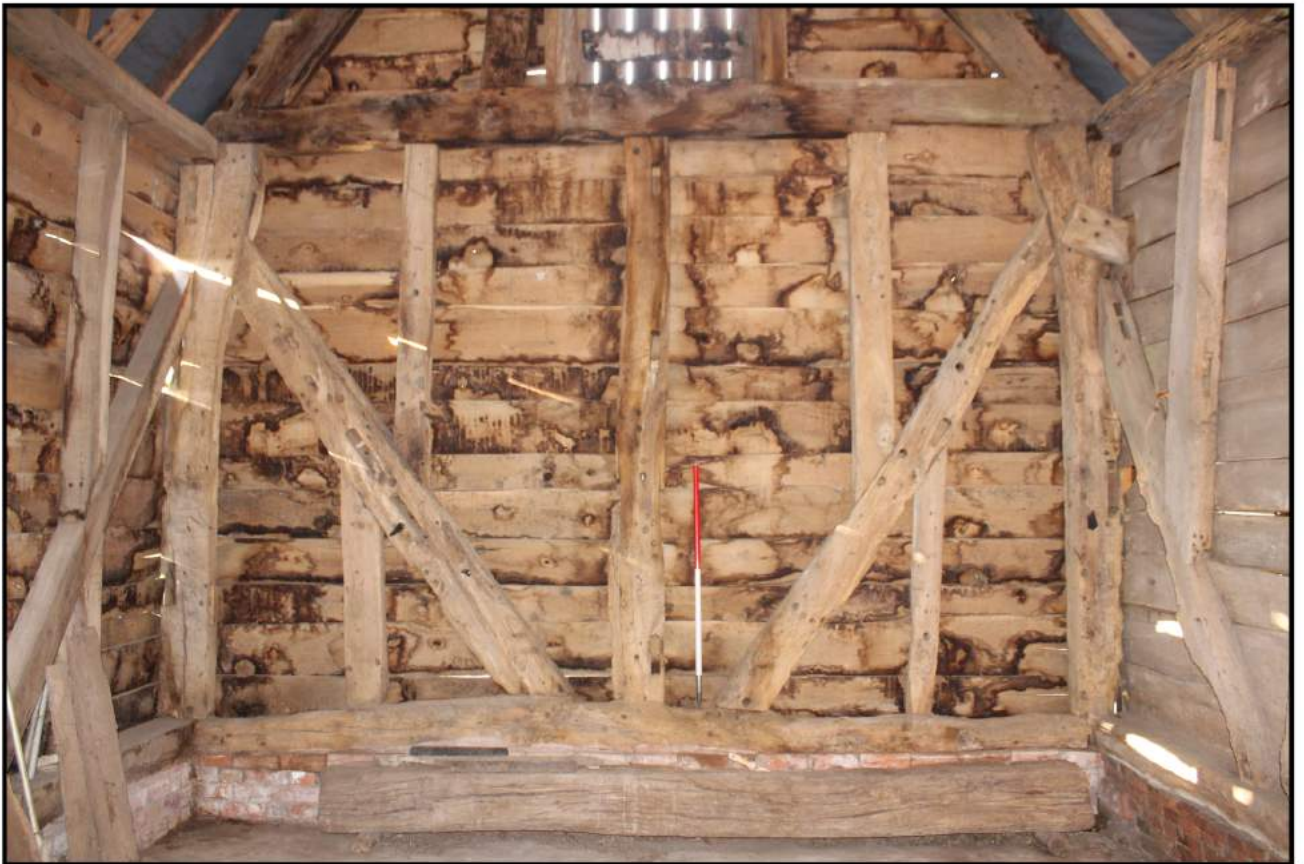
Fig 13: Truss 1

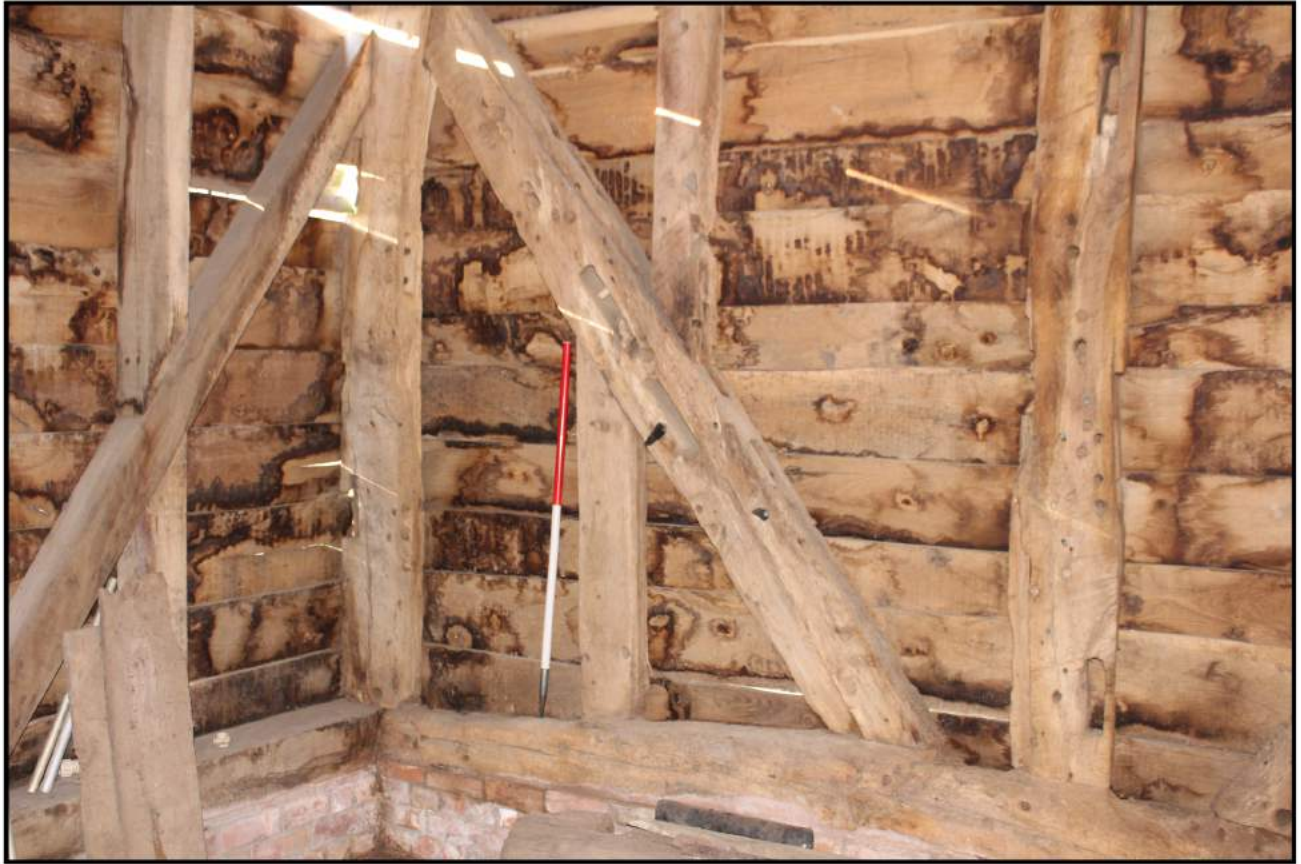
Fig 14: Detail of south corner of barn

The plan form of the building has remained constant although it is clear that it has been repaired and rebuilt a number of times. In particular, the trusses have not only been repaired with reused timber, multiple redundant mortices and peg holes in more than one plane suggest that they were probably constructed of reused timbers in the first place (Fig 14).

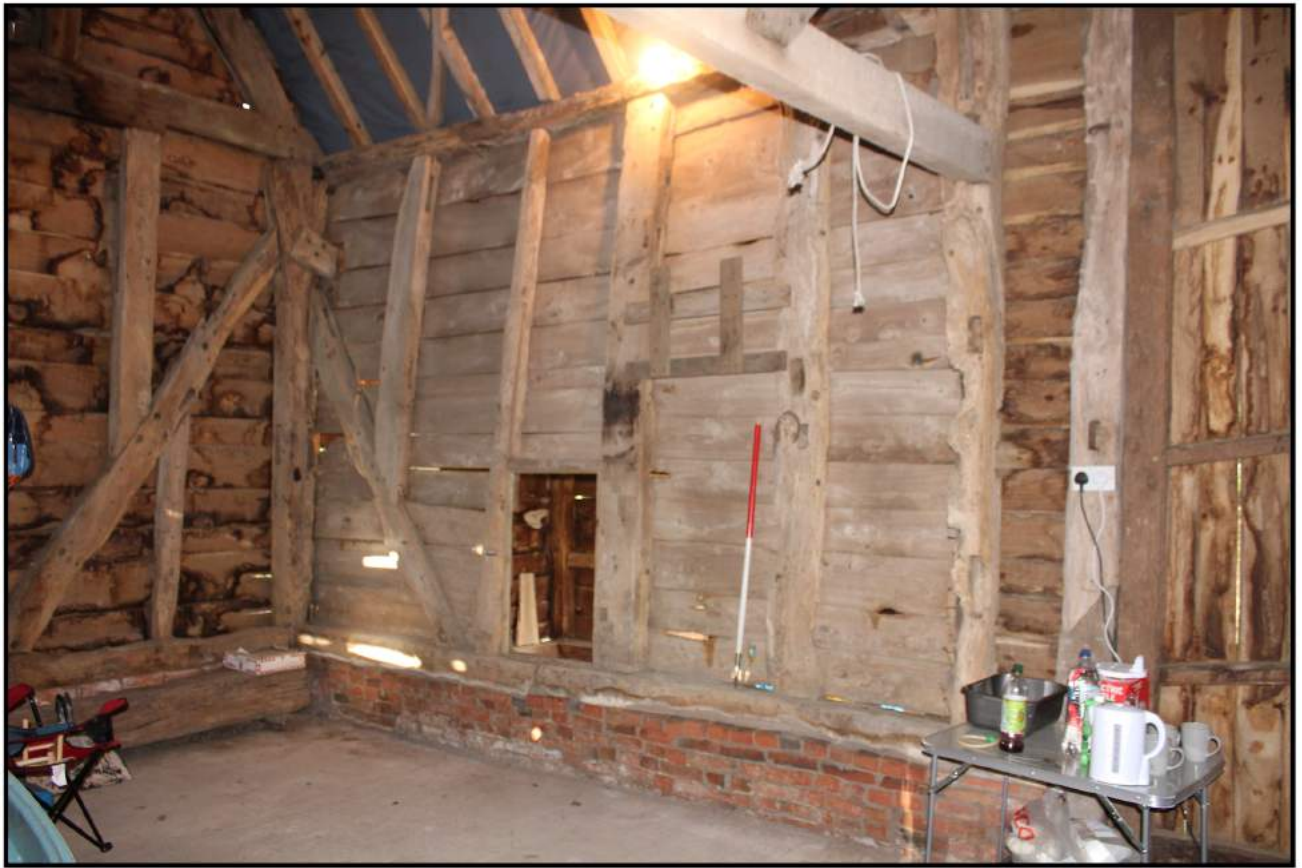
Fig 16: Interior of barn; north-west elevation, south-west end

If the whole barn were occupied by unthreshed corn, no room was left for threshed straw. Flail threshing was slow, spread out over the winter and sometimes even longer. Much of the straw could thus be consumed as threshed, any surplus being stored in lofts over the cowhouse, of which there is known to be an example at Foster's Green Farm (WSM 37611) and stable. Alternatively, if only one side of the barn were filled with corn, the straw could be housed in the other half and the threshing be done much faster. The use of machinery from the late 18th century was to make this the more usual practice. During the summer the bays could be used for other purposes. Hunt refers to using them for folding sheep at shearing time, a small door to the yard being provided to let them in, which also served for cleaning out the bays. Such an arrangement may have existed at Foster's Green Farm (Fig 16).

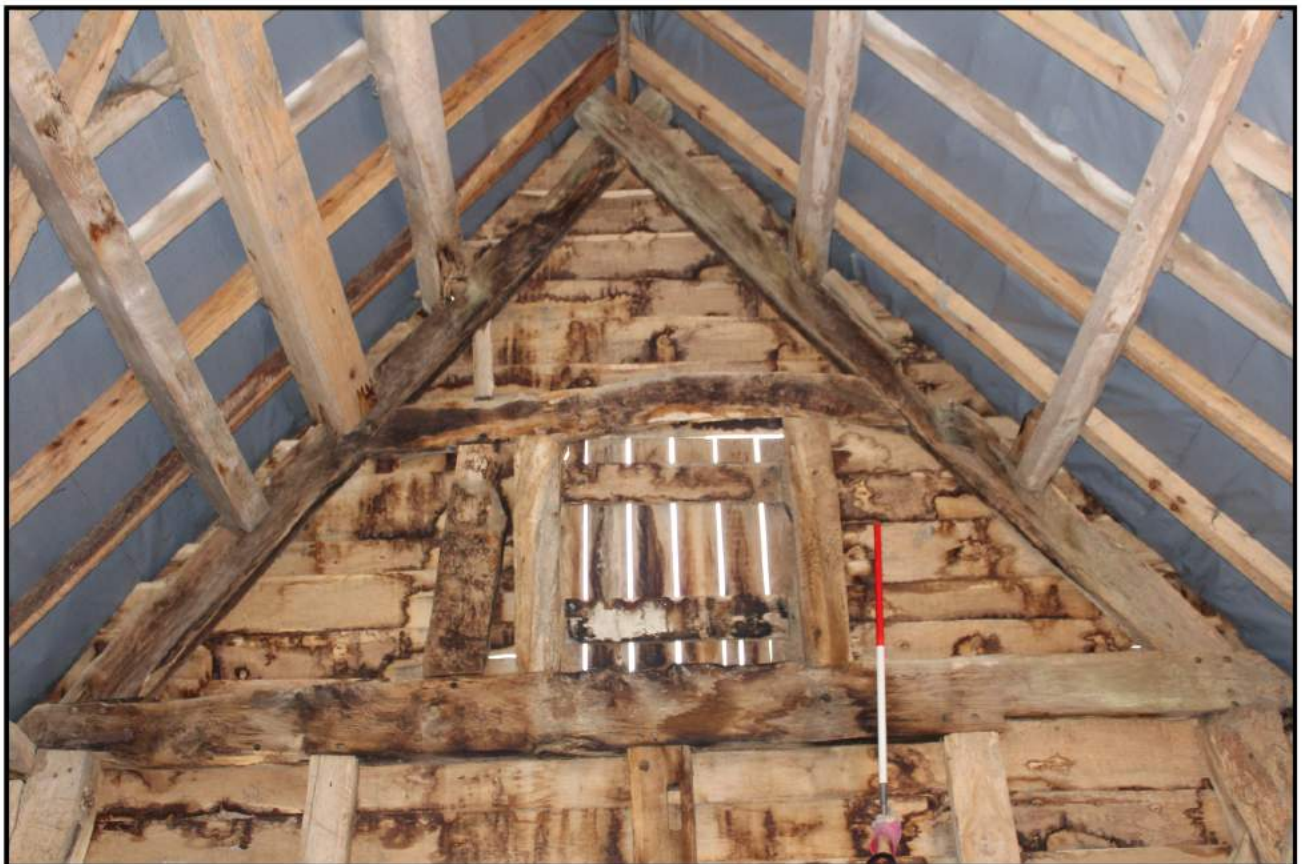
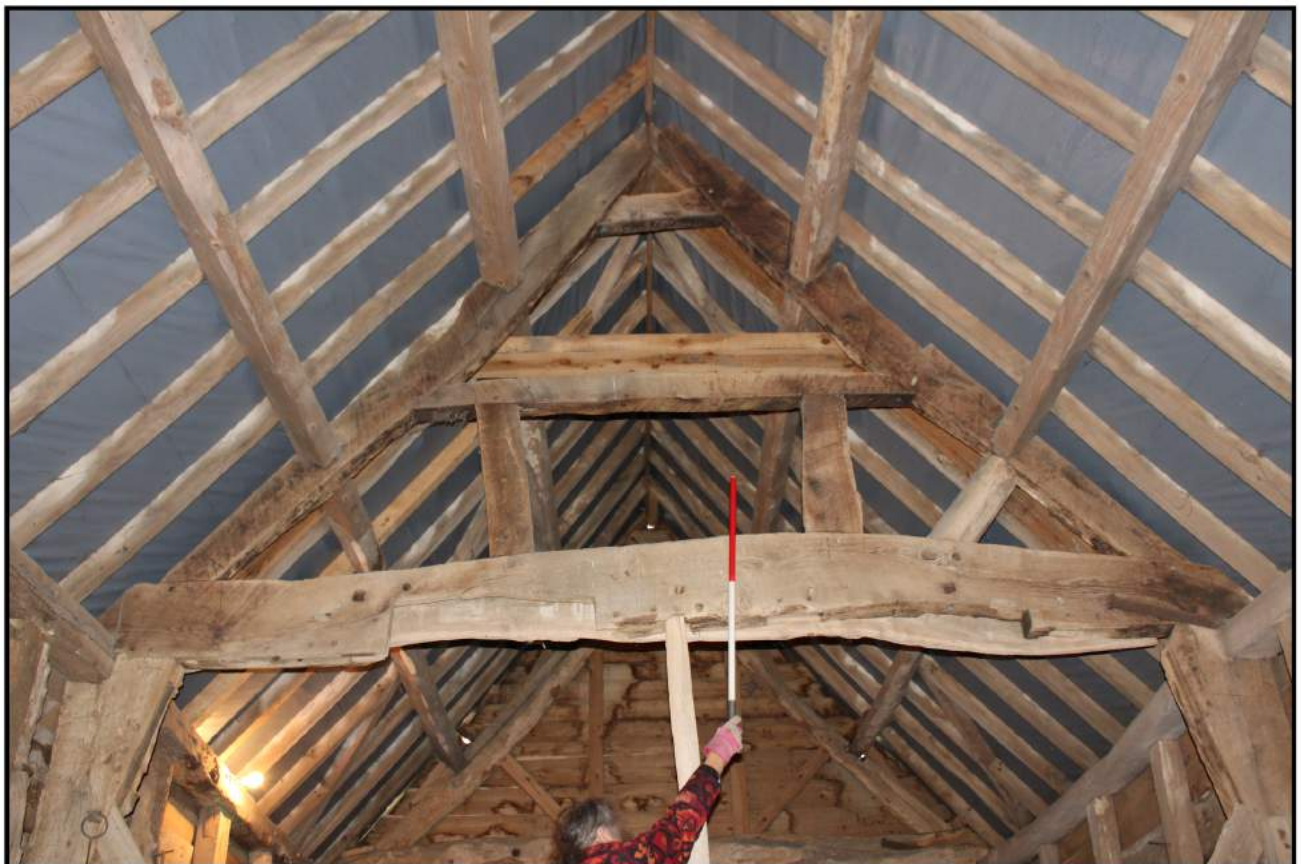
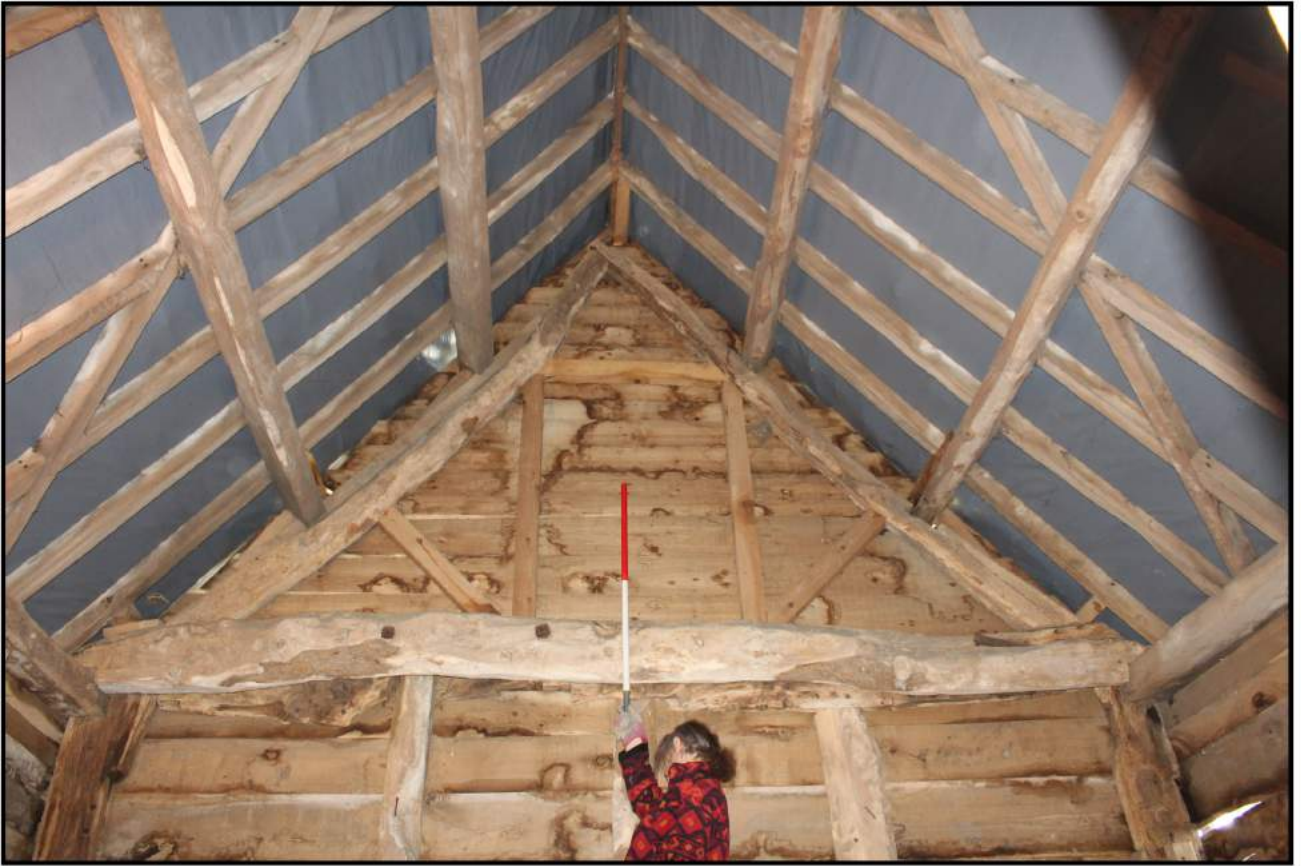
Fig 17: Upper part of truss 4

Fig 19: Upper part of truss 2

Fig 20: Upper part of truss 1

Only the roof trusses from this period survive. These are queen post trusses (Figs 3.2, 17, 18, 19 and 20) but no two are the same.

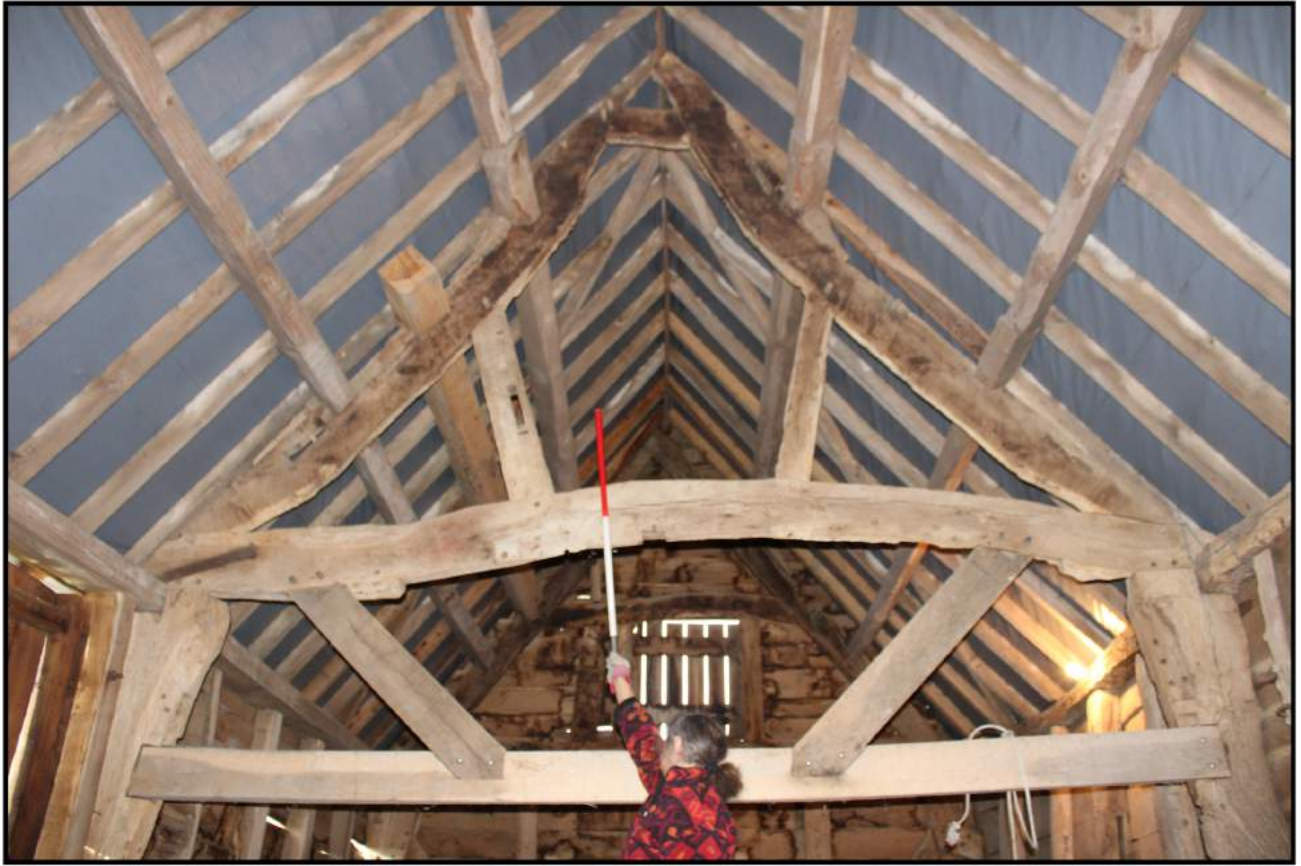
Fig 18: Upper part of truss 3

The purlins, common rafters and braces were replaced (eg Fig 21). A supplementary tie beam and struts were added to truss 3 (Fig 18).

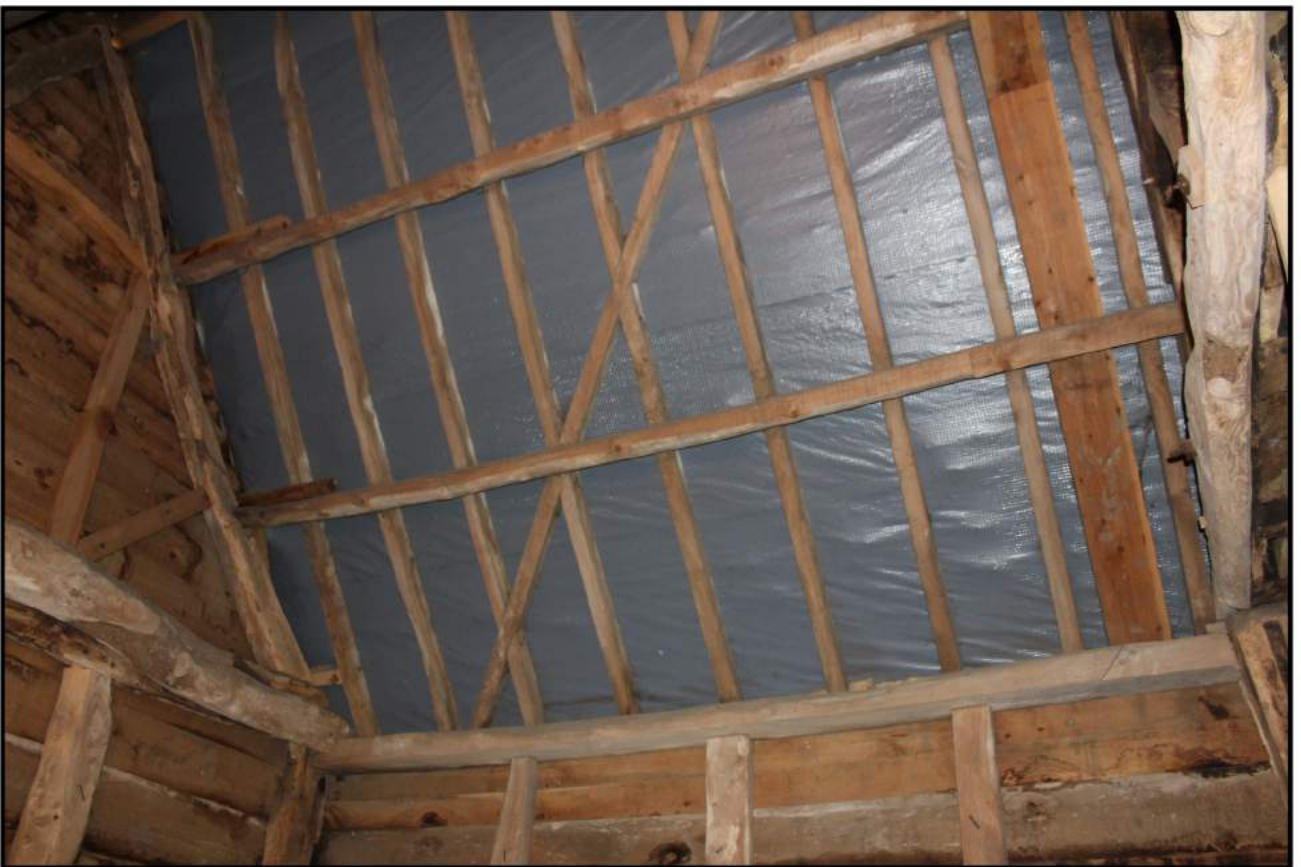
Fig 21: East corner of barn showing modern roof structure

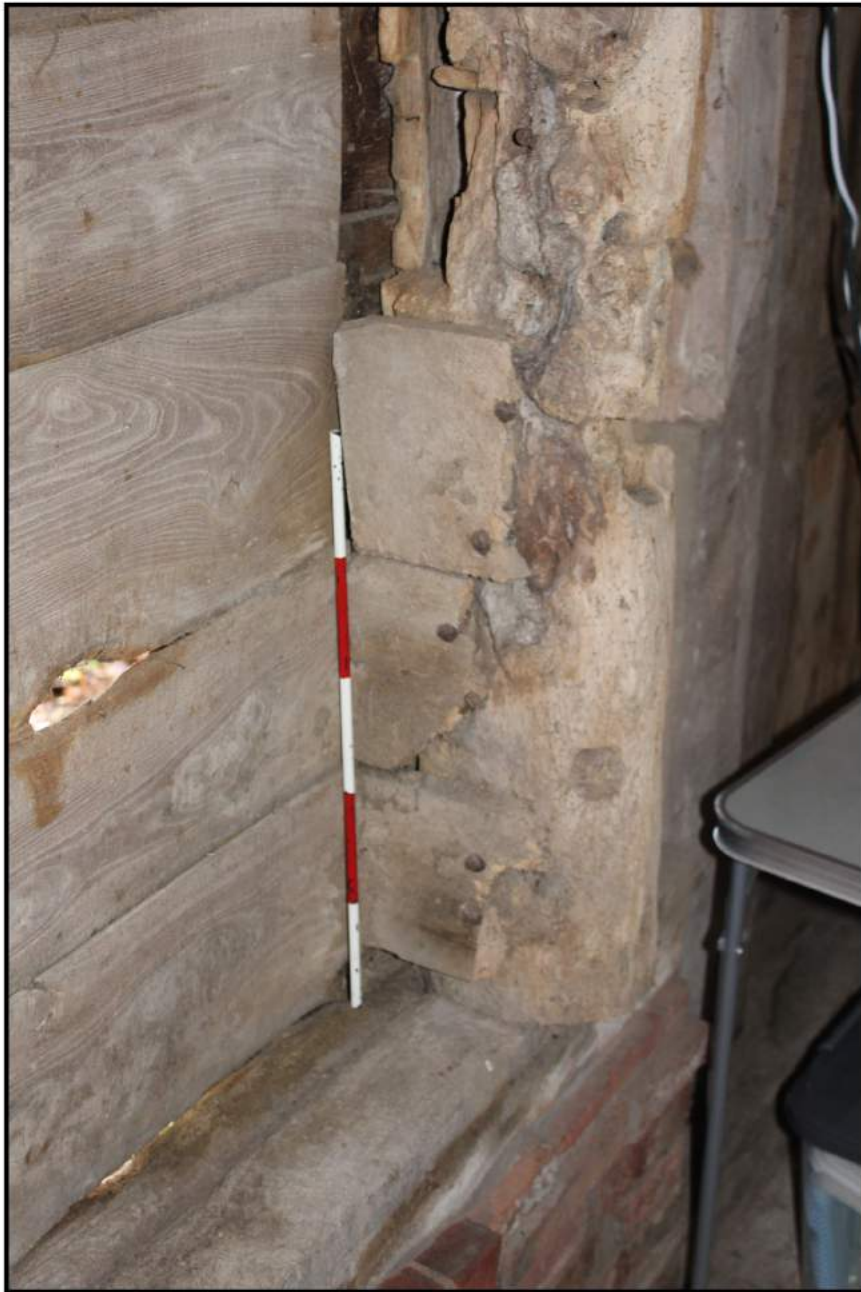
Fig 22: Barn interior; north-west elevation, south-west end, detail of possible cornhole

The threshing floor was usually in the middle of the barn, as at Foster's Green Farm, but its position could vary. The large doors opening onto it admitted laden carts and provided light for flail threshing and air for winnowing. It was often divided from the adjoining bays by low walls, built to prevent the loose straw falling back onto it. One of these (Fig 12) survives at Foster's Green Farm. Off it opened a cornhole, used to store the grain until it was to be winnowed. It is possible that the three transverse planks (Fig 22) are the remains of such an arrangement.

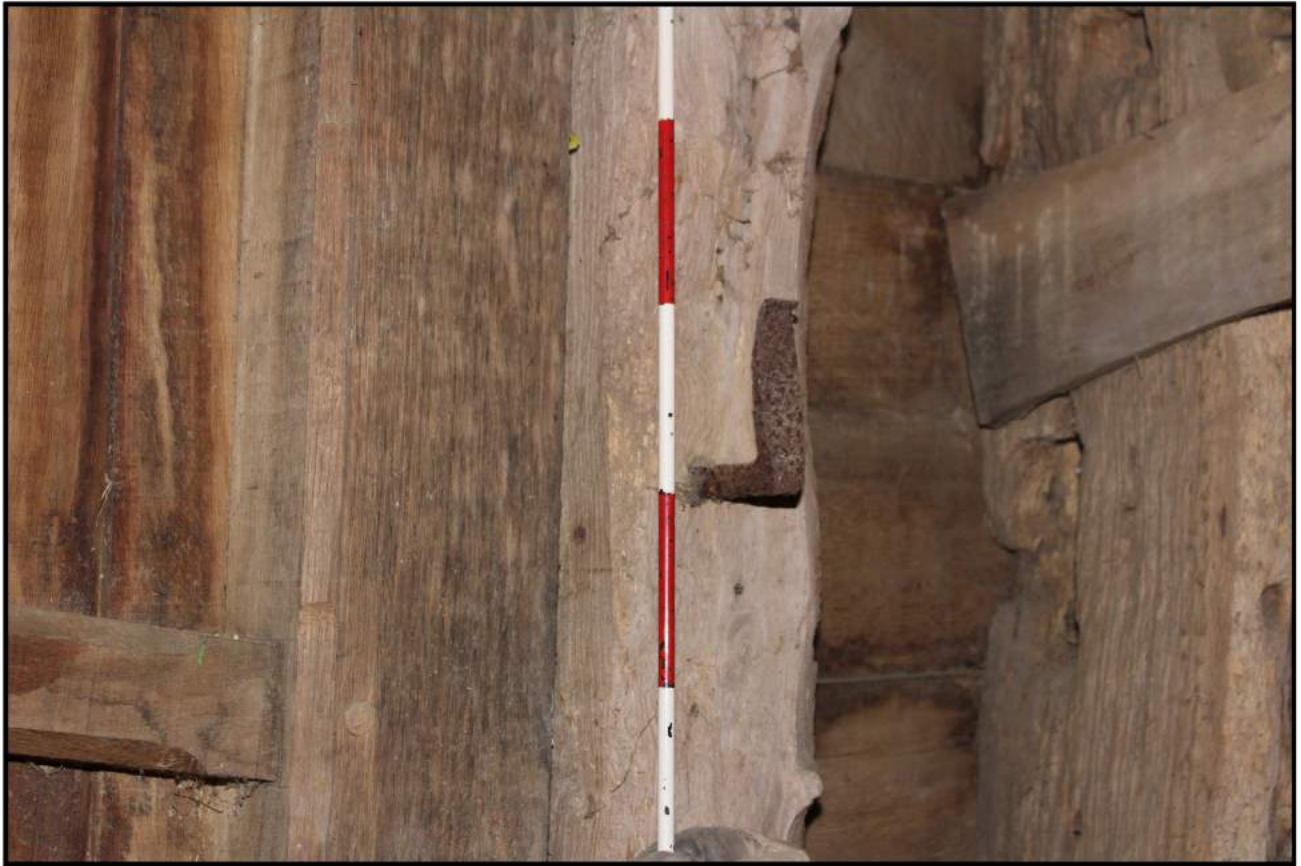
Fig 23: Barn interior; north-west elevation, adjacent to edge of threshing floor door, detail of metal fitting

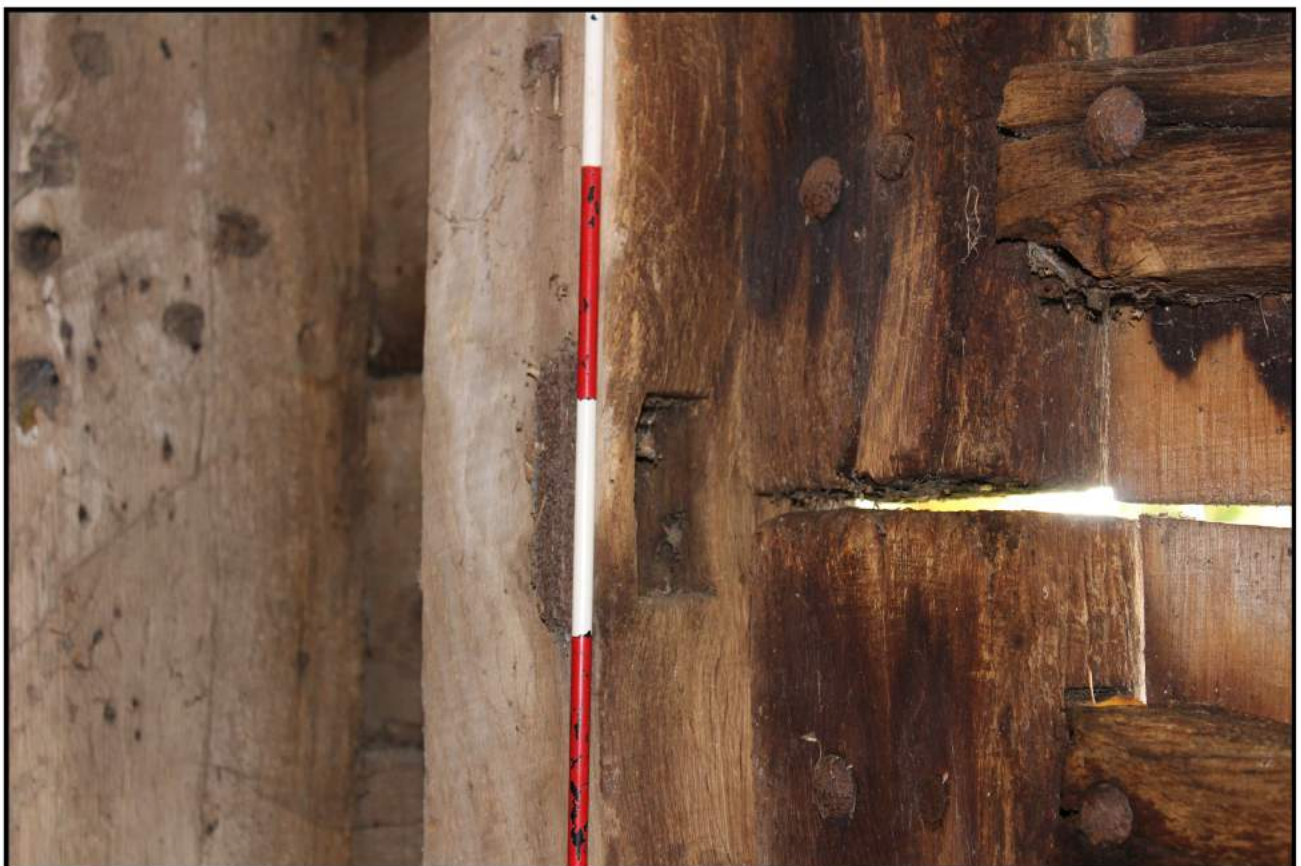
Fig 25: Barn interior; south-east elevation, adjacent to edge of threshing floor door, slot in post

Fig 26: Barn interior; south-east elevation, adjacent to edge of threshing floor door, slot in post

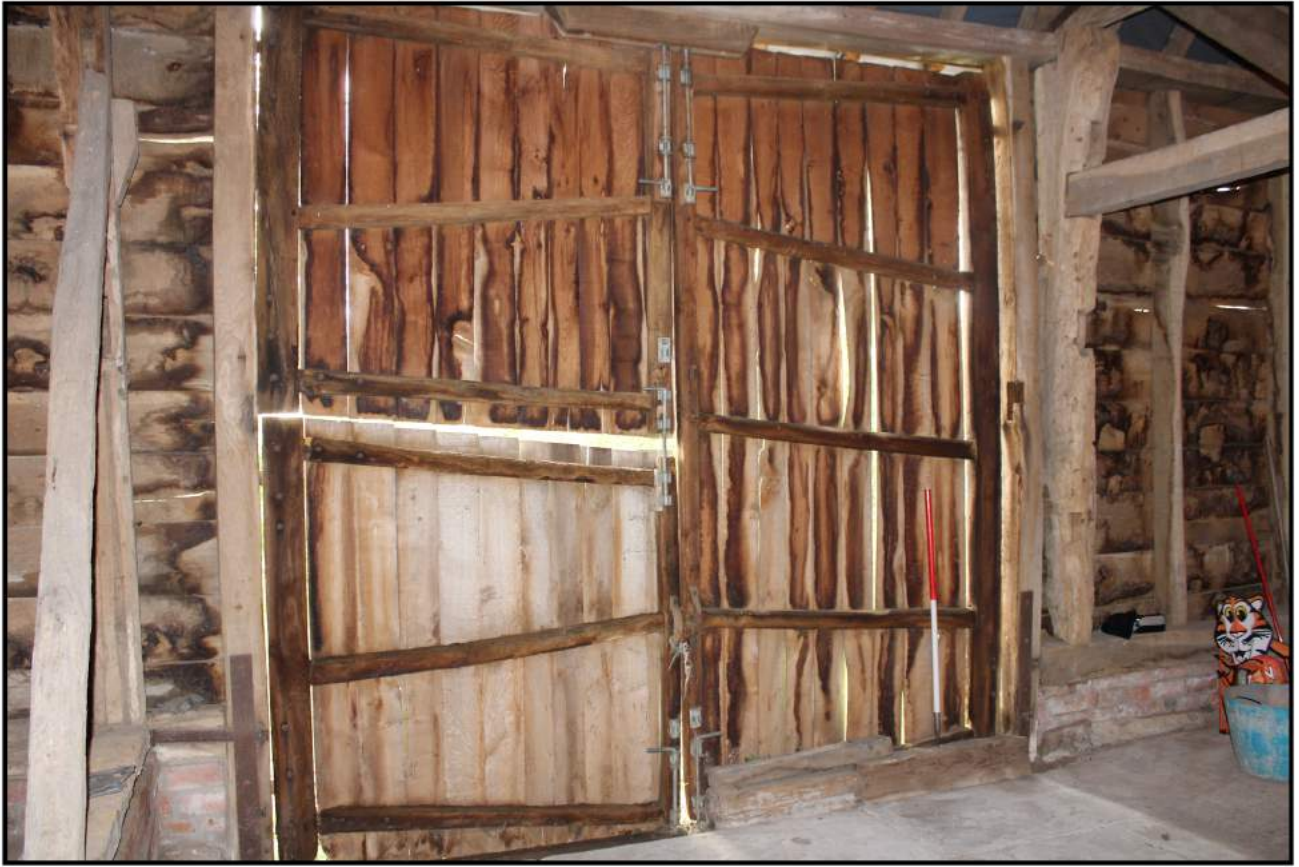
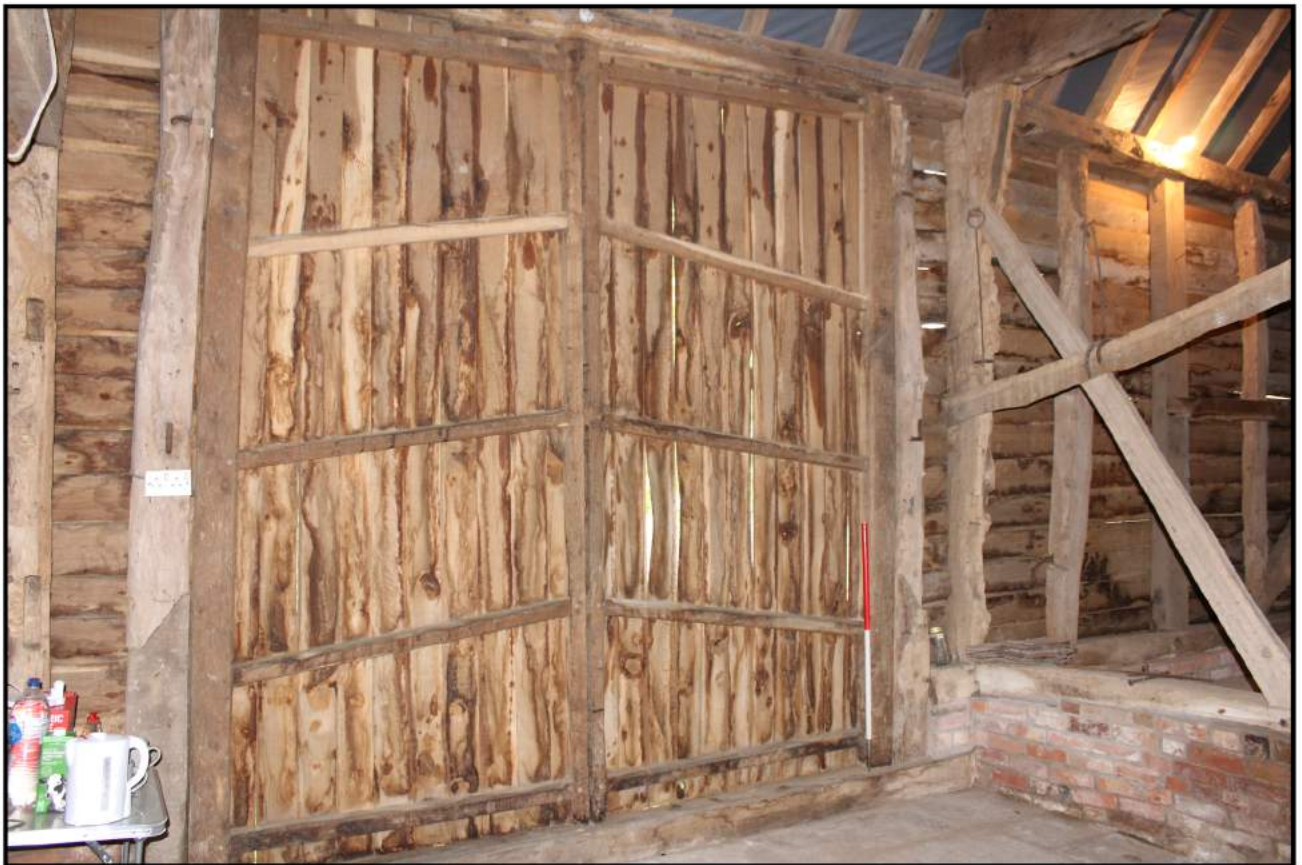
Fig 27: Barn interior; south-east elevation, detail of threshing floor doors

Fig 28: Barn interior; north-west elevation, detail of threshing floor doors

Barns with high doors on both sides of the threshing floor make up nearly three-quarters of the examples, varying in date from the 16th century to the end of the period. They owed their popularity to their fitness for purpose and their adaptability. Loudon noted that they not only permitted laden carts or waggons to enter from either side, but provided light for flail threshing and air for winnowing. In the more developed later examples the doors began about two feet up, with a 'lift' to fill the gap, comprising of a series of planks let into grooves in either doorpost. This enabled the doors to clear the manure in the yard and also kept out pigs when threshing was proceeding. There was no evidence of this arrangement at Foster's Green Farm. However, the doors and their arrangement are thought to be modern.
