**Historic building recording
of a barn at
Foster's Green Farm,
Foster's Green,
Lower Bentley,
Worcestershire,
B60 4HY**

Martin Cook BA MCIfA

26th December 2020

WSM 73468

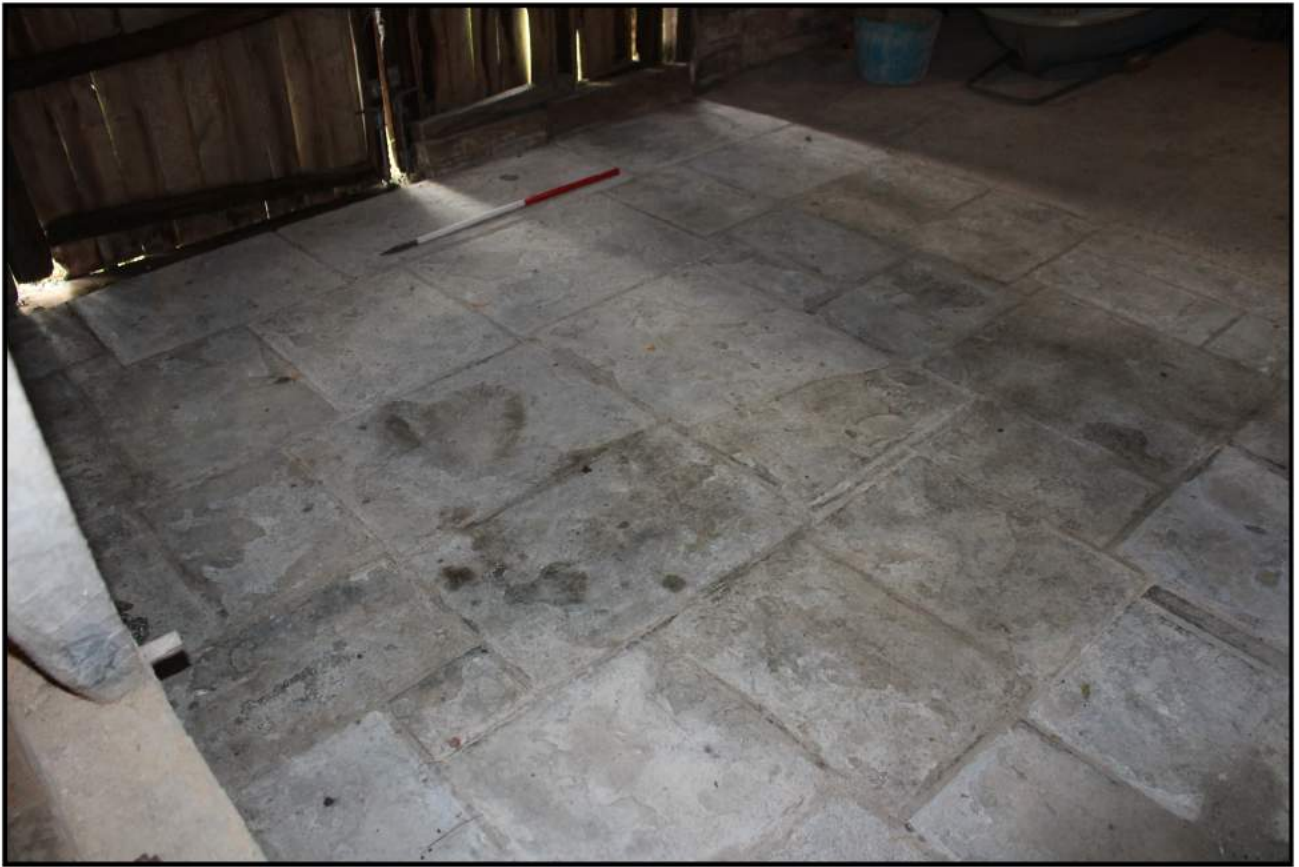
Fig 29: The threshing floor; relaid when the concrete floors were installed

Either side of the threshing floor are concrete slabs. The threshing floor itself is of stone but was probably re-laid when the concrete was installed.

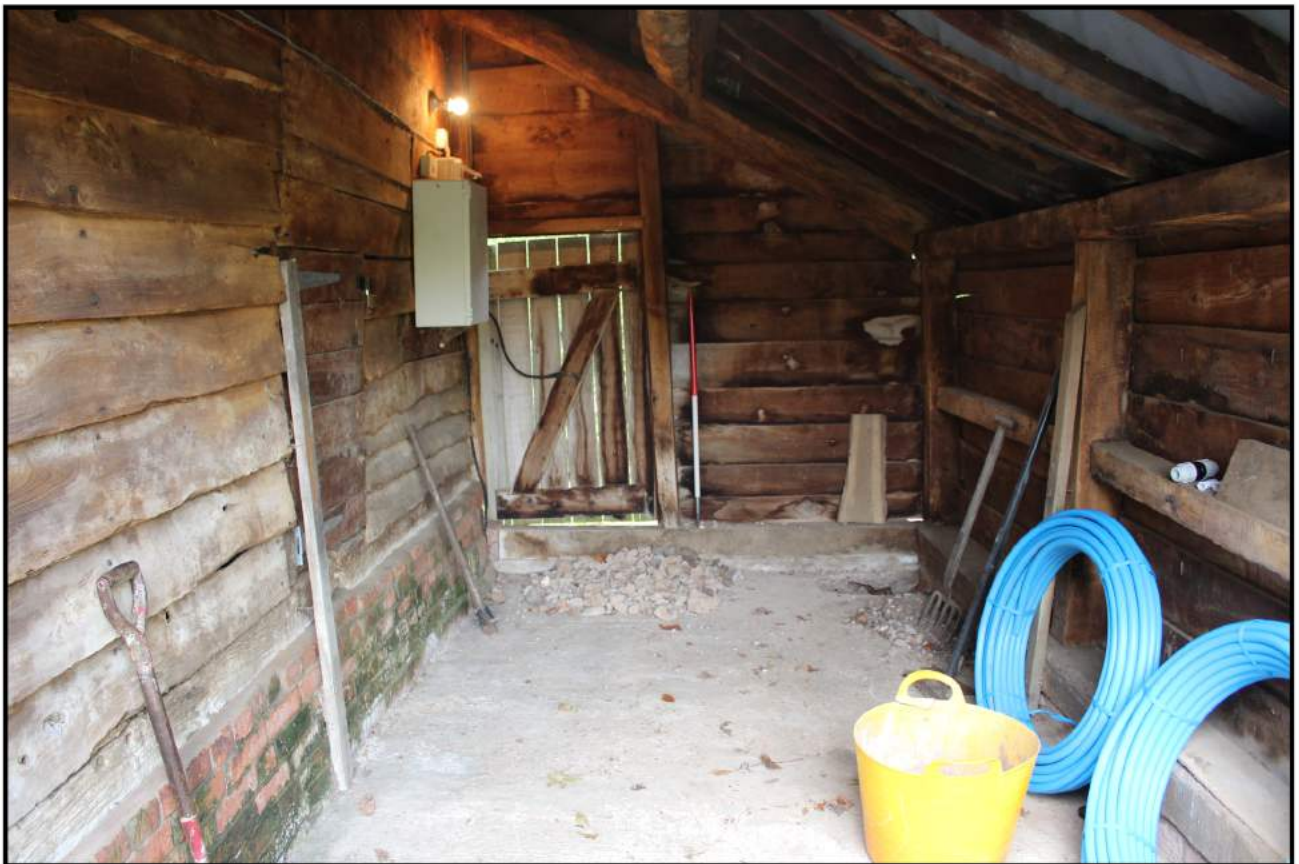
Fig 30: The outshut; modern construction on historic footprint
