**Historic building recording  
of a hop kiln at  
Hill Top Farm,  
Bromyard Road,  
Sutton,  
near Tenbury Wells,  
WR15 8RH**

12th January 2021

WSM 73755

The project was undertaken to level two standard, in advance of conversion and restoration of the property.

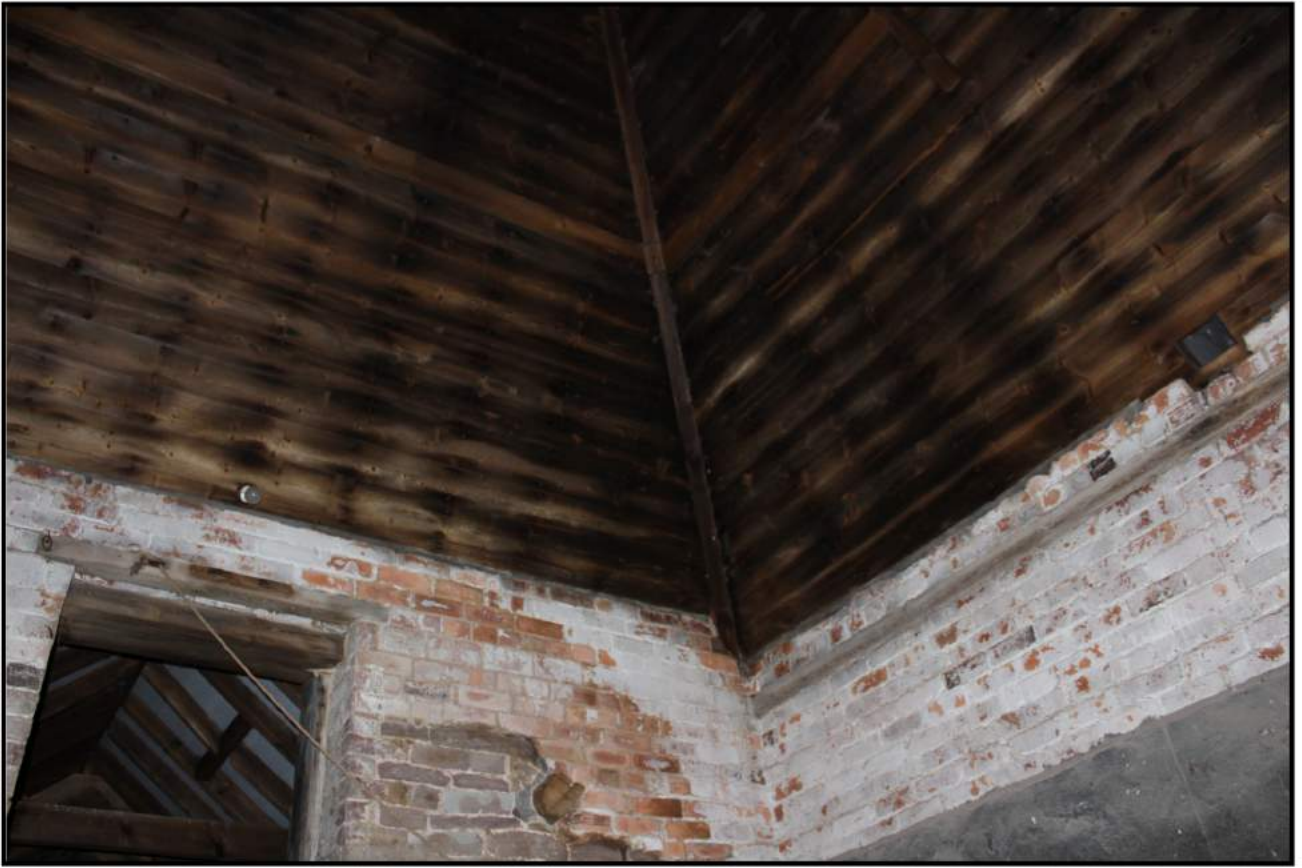
Fig 22: Interior of oast roof showing singed boards

A hop kiln was constructed on the south-eastern end of the phase 1 building (Fig 3.3). This was built of brick, approximately 5.1m square with a ground and an upper first floor level. Curiously, Flemish garden wall bond was employed on the north-east and south-west elevations with English garden wall bond being used on the south-east (Figs 3.1, 3.2, 8, 9 and 11). The hop kiln had three small, rectangular openings at ground level in the north-east, south-west and south-east elevations (Figs 3.1, 3.2, 7, 10 and 12). Two of these, the north-east and the south-east, had brick segmental arches and it is likely that the south west opening had one too. At first-floor level the south-west and south-east elevations had windows and the same elevations had windows at upper first floor level (immediately underneath the eaves; Figs 3.1, 3.2, 8 and 9). At upper first floor level the hop kiln drying floor had been removed but joist sockets remained to indicate its previous position (Figs 20 and 21). The roof structure was hidden behind close boarding which showed signs of singeing (Fig 22).

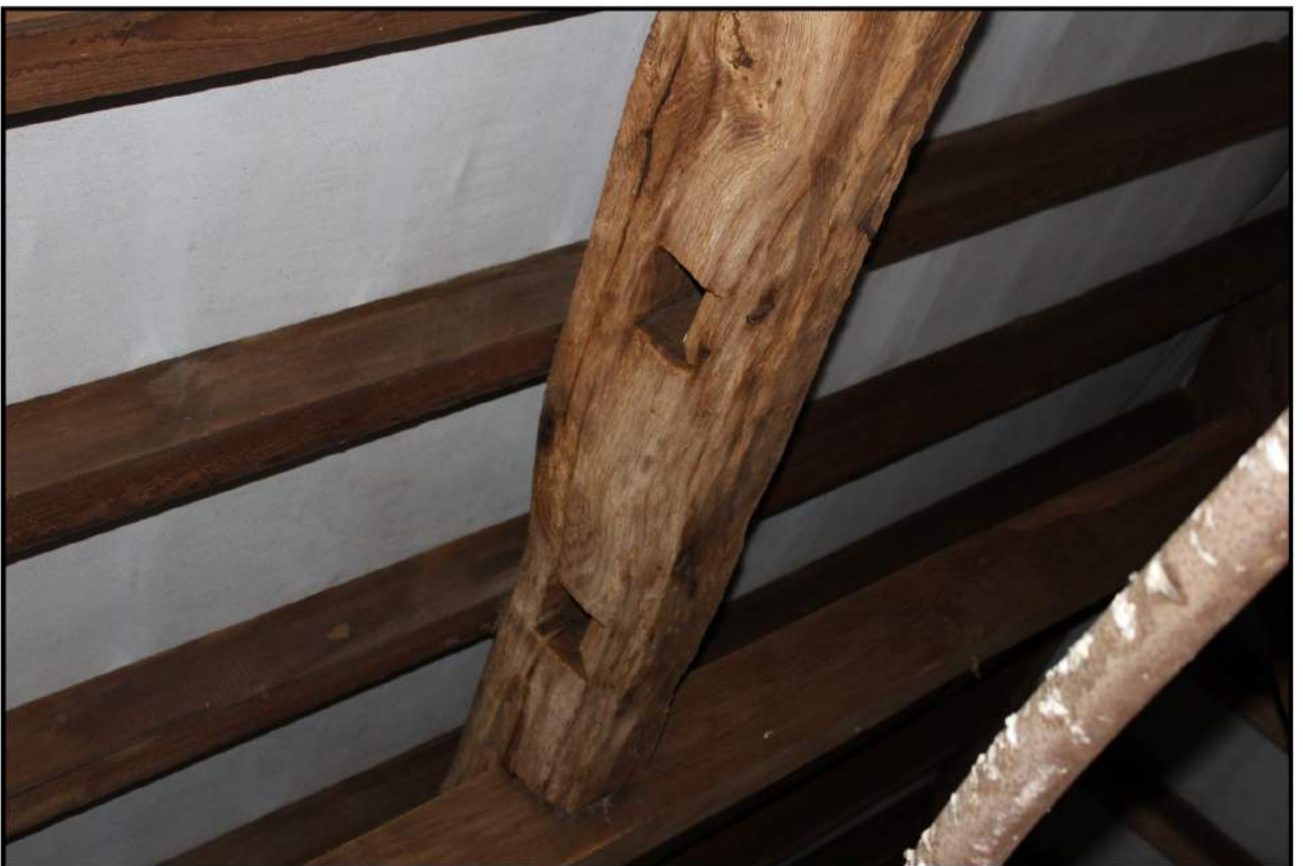
Fig 28: Detail of purlin; showing redundant mortices, indicative of former use as a floor beam

In the interior, the ground floor was of brick setts, a section of which survives (Fig 3.3). At ground floor level nothing else survives of the interior arrangement or fittings. The means of access to the first floor is uncertain but may have been a simple ladder, possibly secured directly to one of the walls. At first floor level nothing survives of the interior arrangement or fittings. The only elements of the roof structure that may belong to this period are the king-post roof trusses (Figs 25 and 27). The tie-beams of these are slightly curved to provide some additional headroom on the first floor and straight saw-cuts suggest that the timbers were pit-sawn (Fig 33). Some re-use of timber is indicated by the south-west purlin which has redundant mortices at regular intervals (Fig 28).

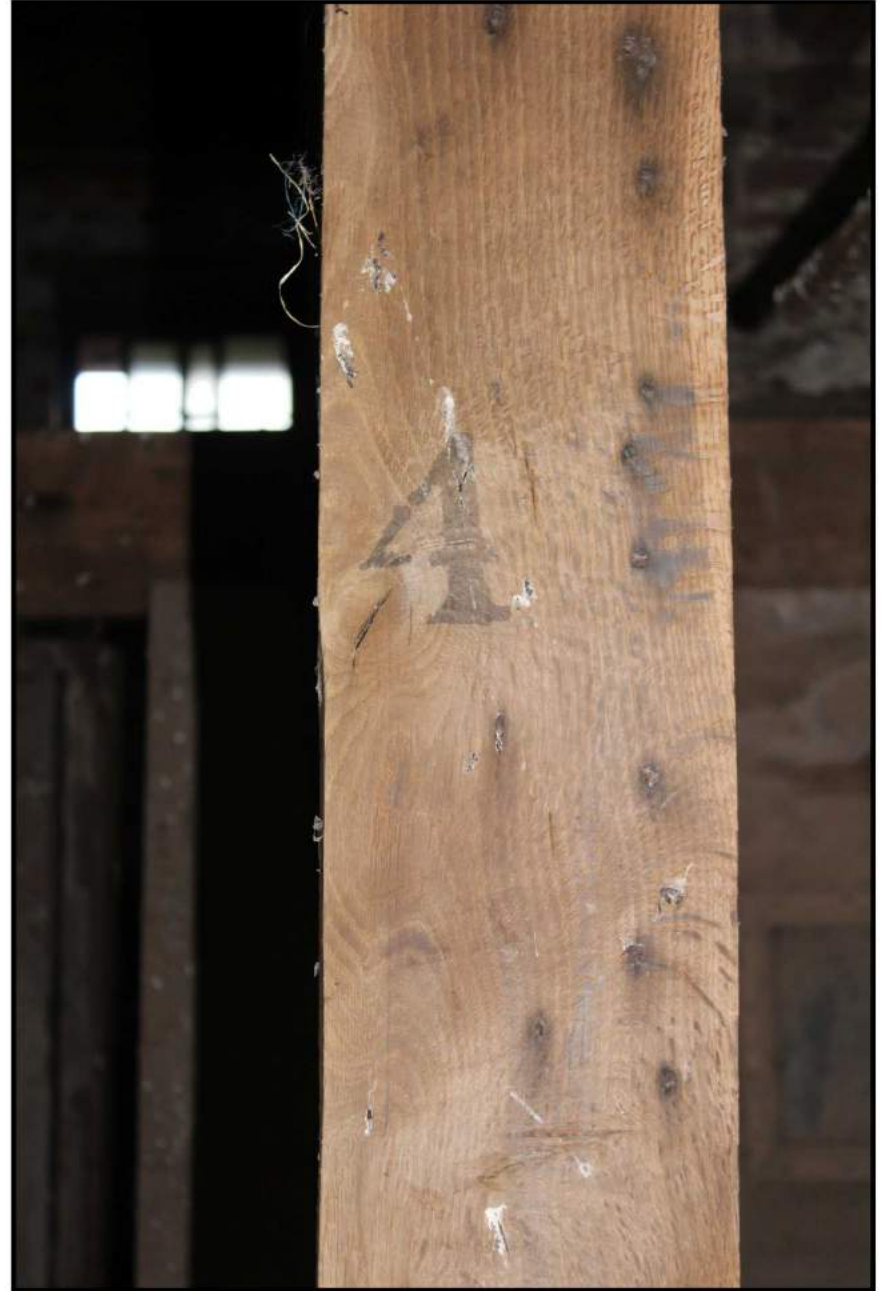
Fig 30: Stencilling on upper part of post

An isolated figure ‘4’ was stencilled on one of the posts adjacent to the record of hop pocket output (Fig 30). This may have been a practice attempt. The stencils for this activity were kept on a nail in the first floor window in the south-west elevation (Fig 32).

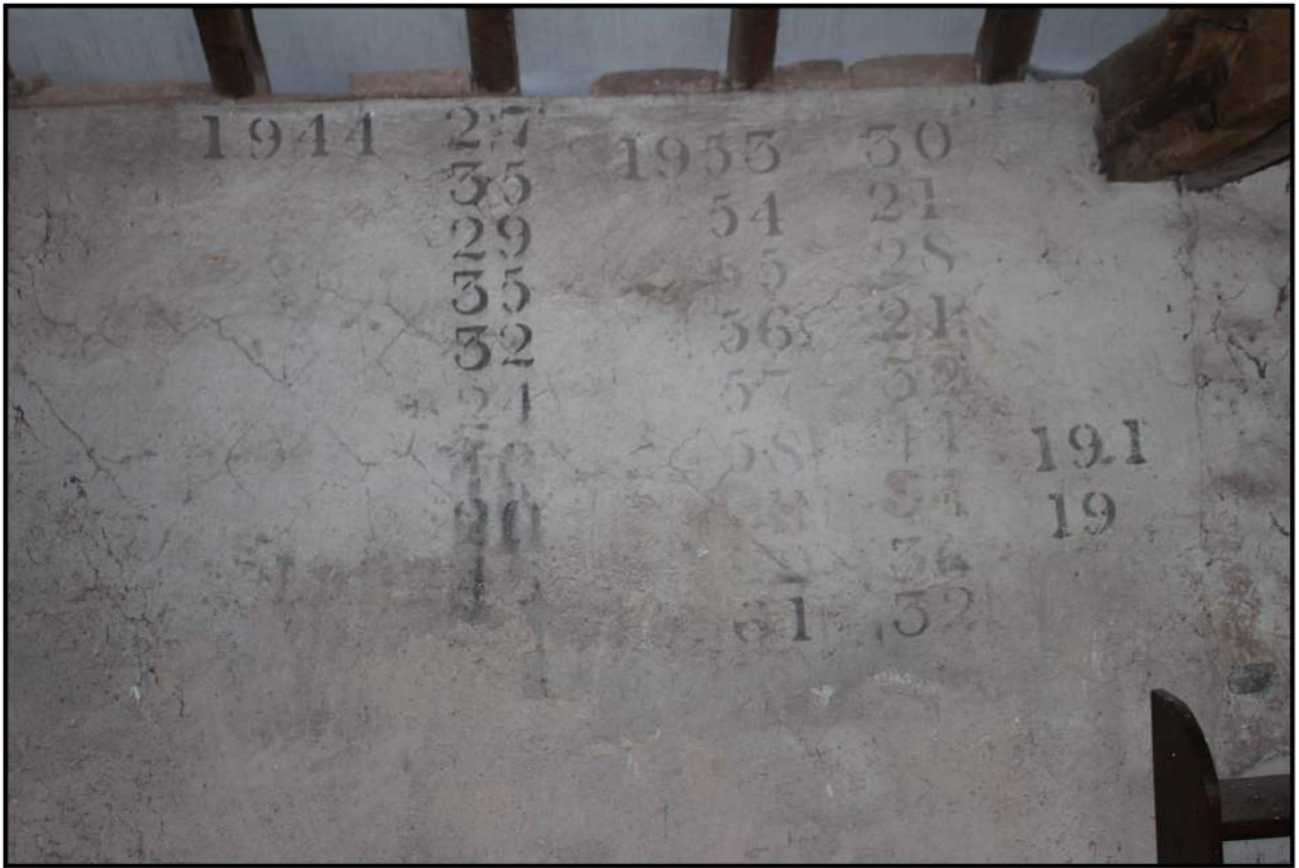
Fig 31: Stencilling on wall indicating yearly output of hops

Between 1944 and 1961 an informal record of the output of the hop kiln in terms of numbers of ‘hop pockets’ was kept by stencilling on the wall of the first floor (Fig 31). The format of the record changed in 1953 when the farm changed hands (pers comm Mr Jeffries’ father-in-law). It is uncertain to what the figures 19.1 and 19 refer.

1944	27	1953	30	
	35	54	21	
	29	55	28	
	35	56	21	
	32	57	32	
	24	58	41	19.1
	40	59	31	19
	20	60	36	
	45	61	32

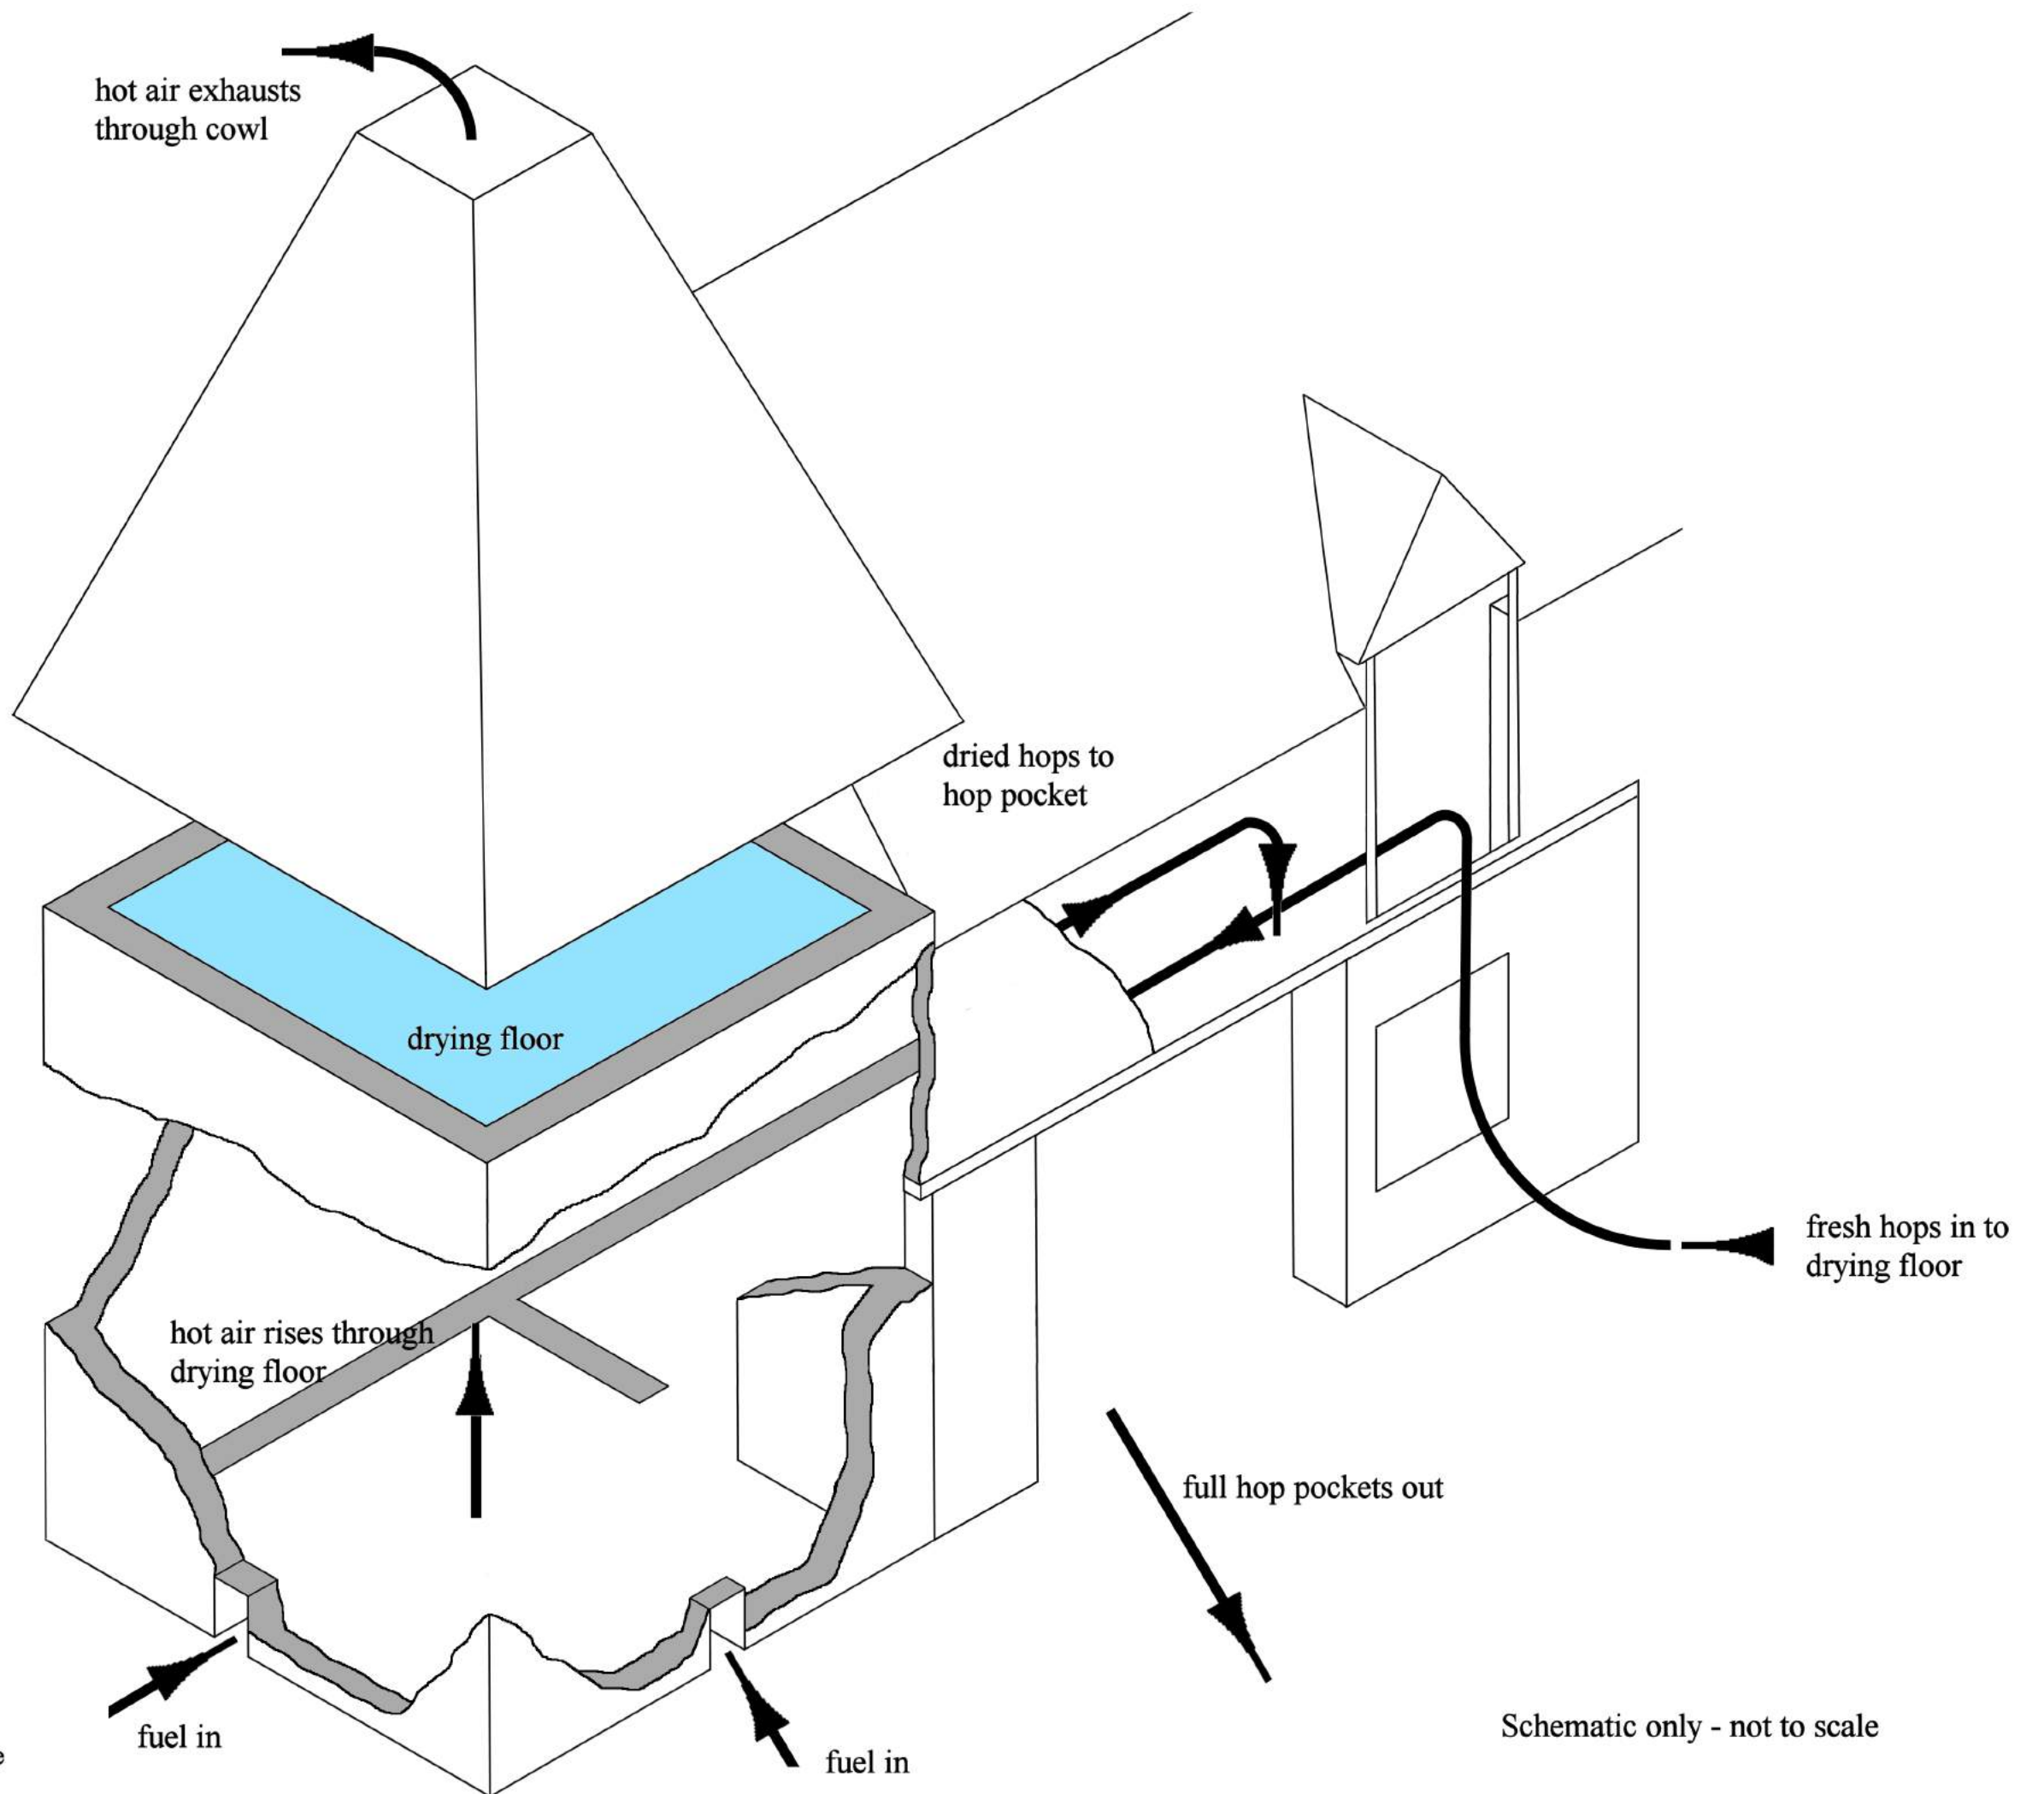
Fig 35: Process flow in the oast house

Most hop kilns are found in Kent and Sussex. The building type is also found in Herefordshire and Worcestershire, since the counties had, by 1880, come to supply a quarter of the hop harvest. There the structures are often combined, rather incongruously, with provision for cider making, the kiln being at the end of a building whose upper level stored green hops and whose lower level housed the cider mill. At Hill Top Farm the oast house was added to the end of a multi-purpose building. A schematic process flow diagram has been included as Fig 35.
