**Archaeological salvage recording  
at Tringford Pumping Station  
Little Tring,  
Wendover Arm, Grand Union Canal,  
Dacorum**

Martin Cook BA MCIfA

15th November 2020  
Revised 25th February 2021

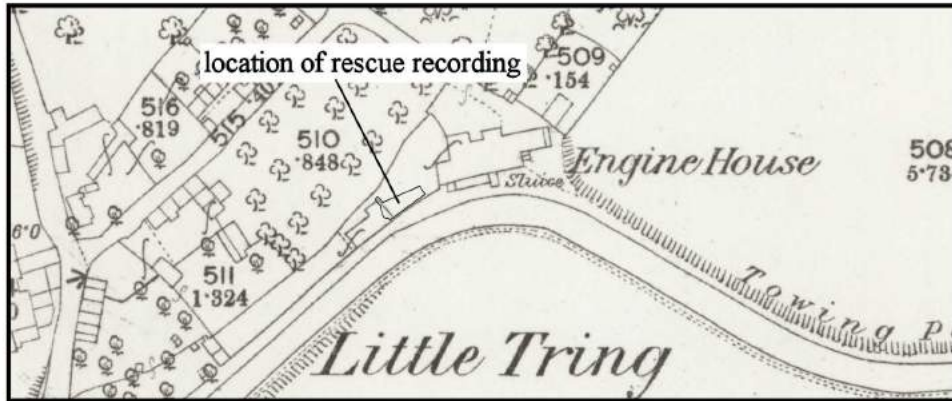
Fig 2.1: Historic mapping; the dates are of the original survey or revision

The earliest available map is the 1st edition Ordnance Survey map of 1877 (Fig 2.1). This shows the site occupied by an 'L' shaped building to the south-west and an open space to the north-east. There is a boundary linking the eastern-most corner of the building with the adjacent engine house or pumping station. The only difference between this map and the Ordnance Survey maps of 1897 and 1922 is a short 'L' shaped boundary extending from the northern-most corner of the building (Fig 2.1).

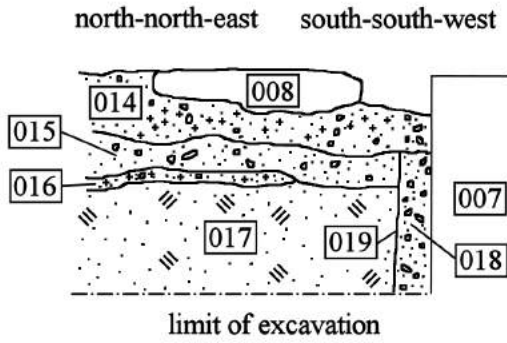
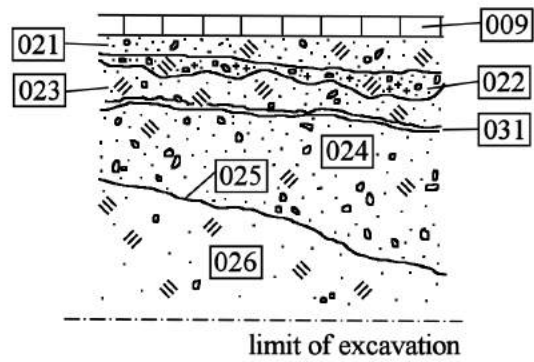
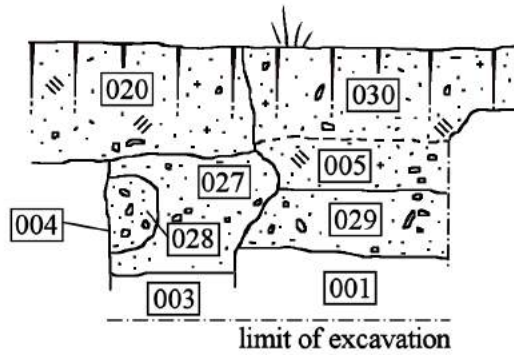
Fig 3.3: Sections

These comprised a very light grey cream sandy clay (contexts 017 and 026; Fig 3.3, sections 1 and 2). In addition, the upper surface of context 026 (context 025; Fig 3.3, section 2) sloped down to the north-north-west and was thought to represent the original natural ground level, predating canal construction activity on this part of the site.

The natural slope of the ground was levelled-up with a succession of layers of varying composition (contexts 022, 023, 031 and 024; Figs 3.3 and 11, section 2), culminating with a screed (context 021).

The area to the south-west of the now demolished wall, context 003, was raised a little in level by two rather uneven layers (contexts 015 and 016; Figs 3.3 and 9, section 1). These may be construction debris or other detritus. A foundation trench (context 019) was cut through these layers and into the natural subsoil. Within this trench a building and boundary wall (contexts 007 and 006; Figs 3.1, 9, 10, 12 and 13) were built, at right-angles to each other but at a slight angle to the original boundary wall (context 001). A brick floor (context 009; Figs 3.1, 3.3, 11 and 22, section 2) was laid inside the building, on top of the screed (context 021) and the void left between the edge of the foundation trench (context 019) and the wall (context 007) was backfilled (context 018). Other deposits associated with

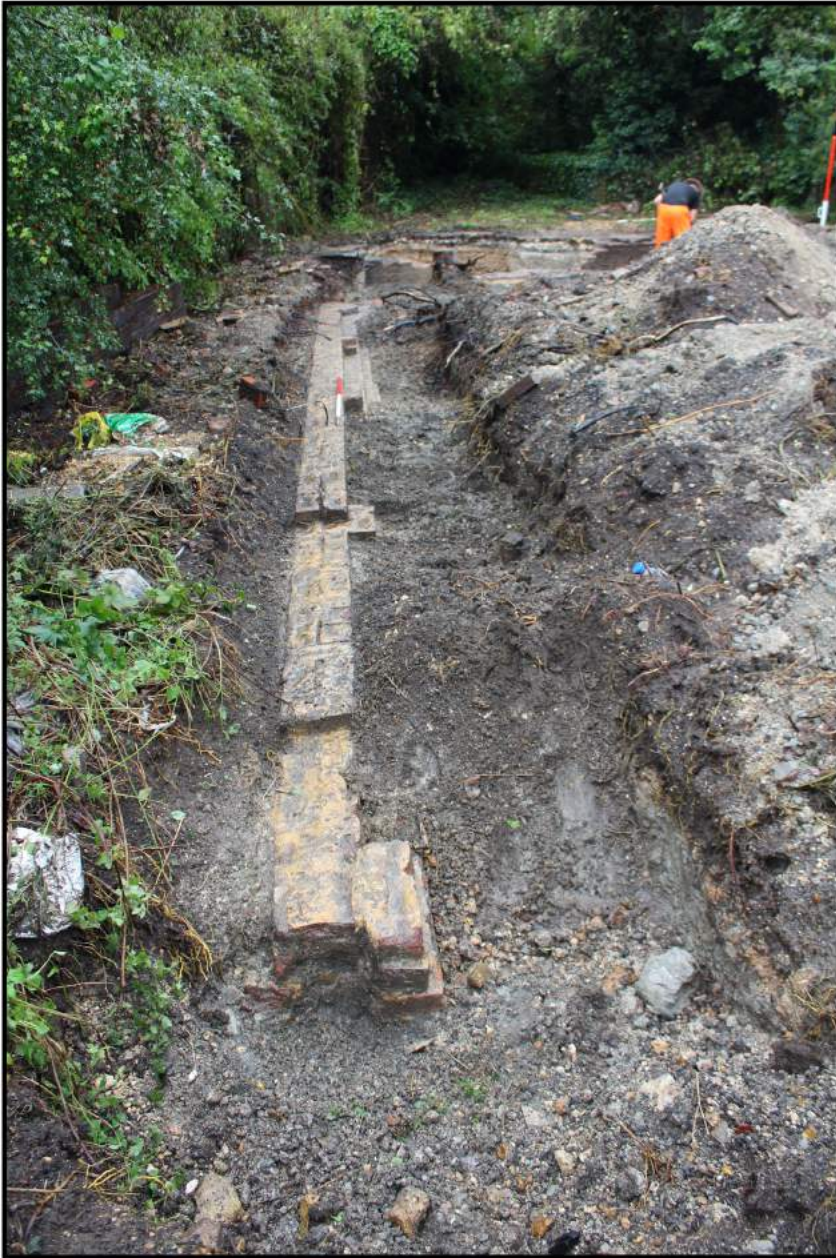
Fig 4: Boundary wall; showing buttresses, context 001, scale 1.0m

An 'L' shaped, brick boundary wall (context 001; Figs 3.1, 4 and 5) was built to the south-west of the Tringford engine house, and is, presumably, contemporary with it. The south-western end of this wall was replaced in Phase 3, its original line being preserved by a robber trench filled with contexts 005 and 029; Figs 3.1, 3.3 and 15, section 3 – see below). Context 005 is clearly at right-angles to context 001 and represents a wall that, as a minimum, must have been closely associated with it and is believed to have been constructionally identical.

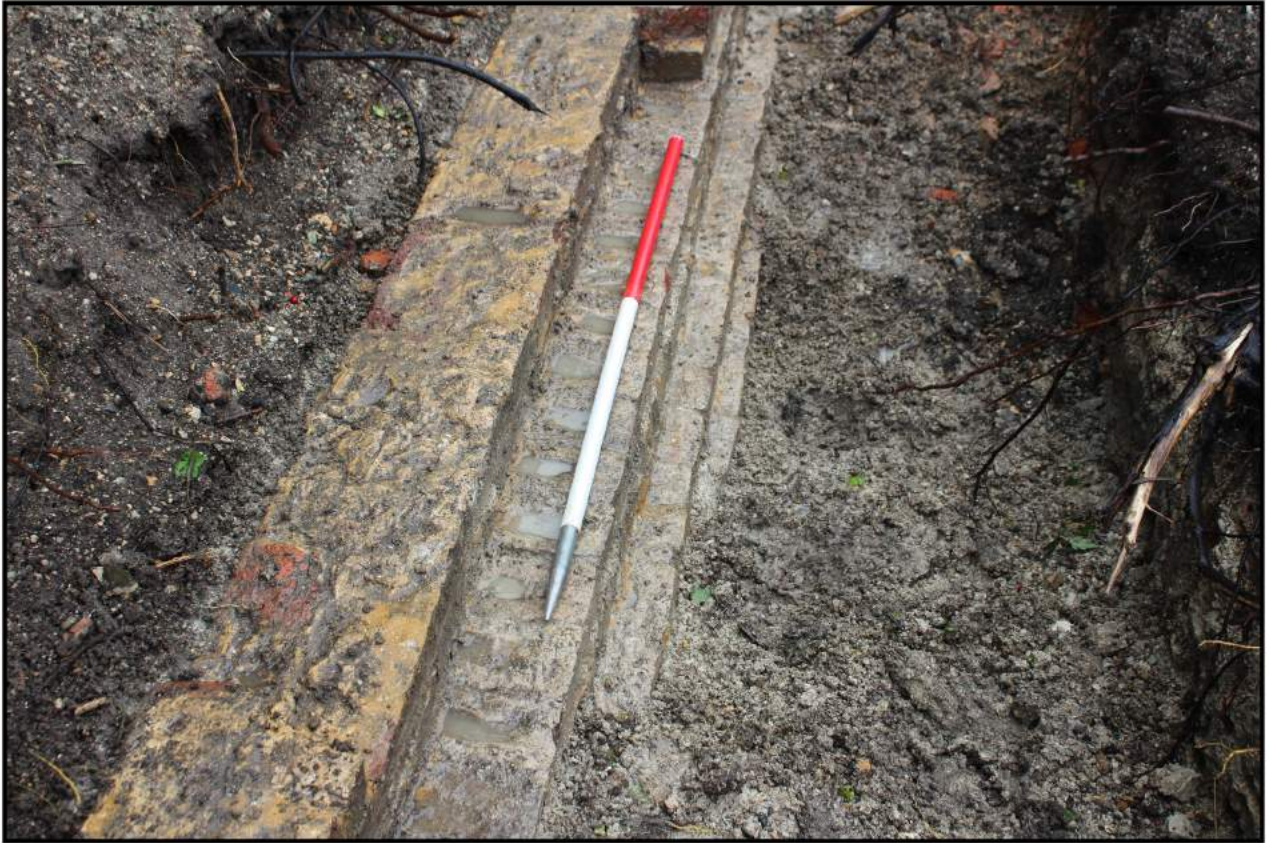
Fig 5: Boundary wall; context 001, showing stepped footing, scale 1.0m

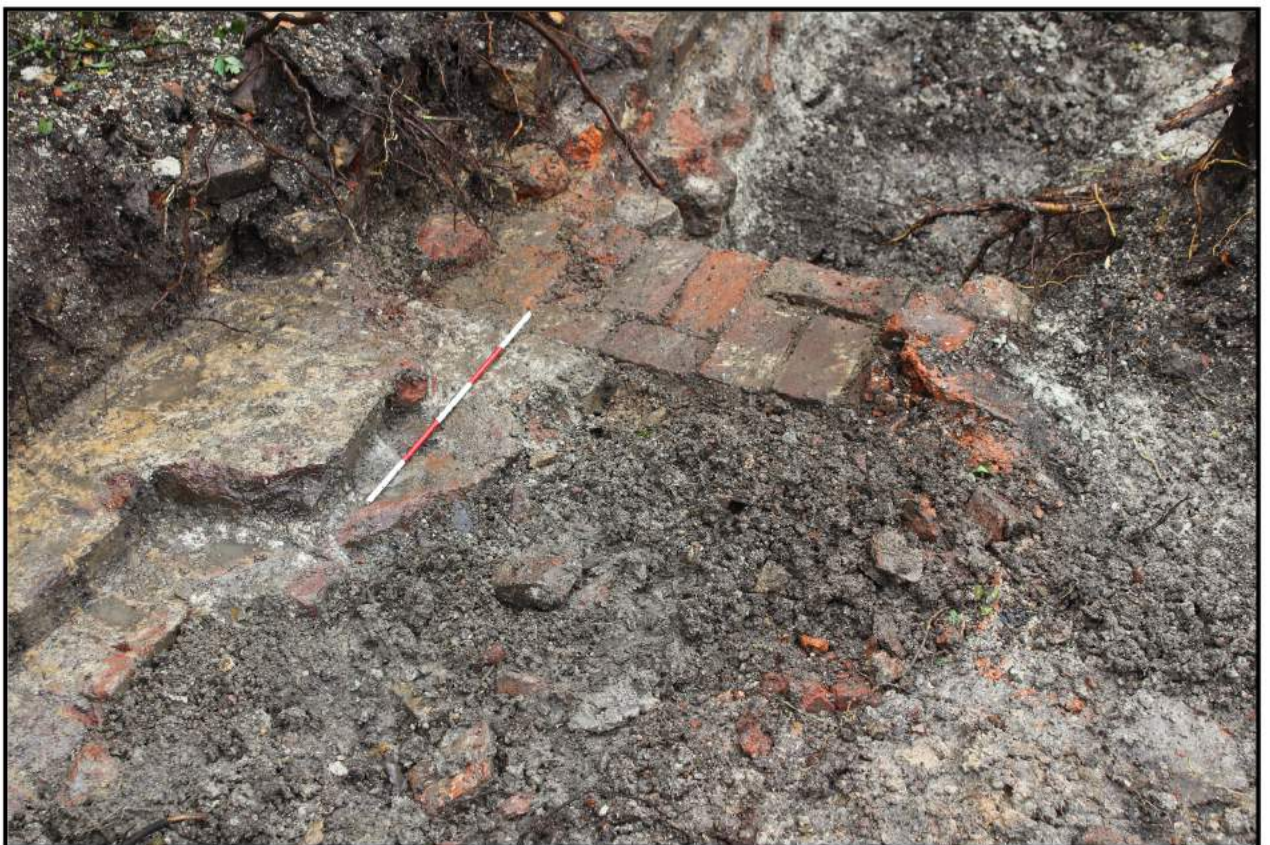
Fig 6: Junction of boundary wall, existing wall and robbed wall, contexts 001, 002 and 005, scale 0.5m

A new south-western return to the boundary wall (context 001), of slighter construction, was erected immediately adjacent to the earlier alignment (context 003; Figs 3.1, 3.3 and 14, section 3). Context 003 is clearly at right-angles to context 001 and must be associated with it. This wall appears to have had a doorway in the corner between contexts 001 and 003), providing access to the area to the south-west. This doorway was subsequently blocked-up by a brick in-filling of very slight construction (context 002; Figs 3.1, 6, 7 and 18).

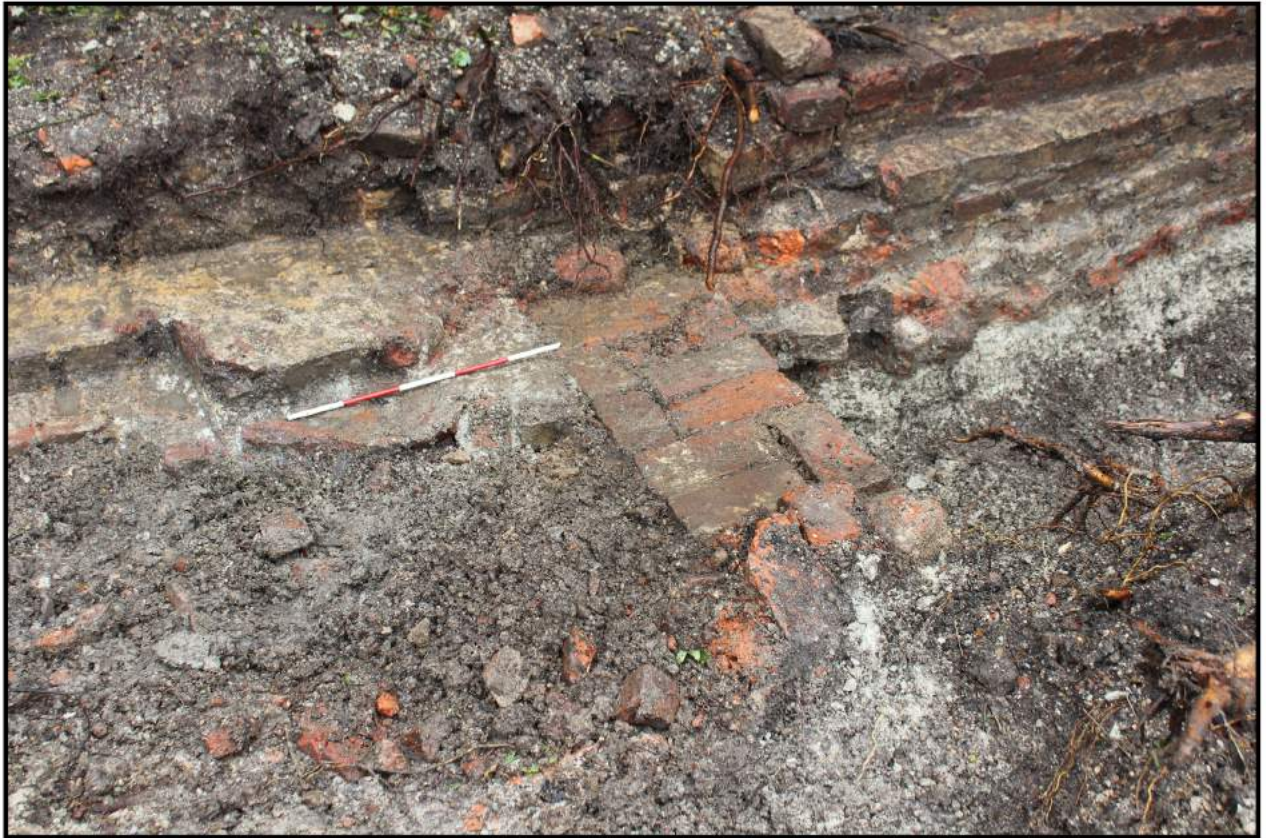
Fig 7: Junction of boundary wall, existing wall, robbed wall and other existing wall, contexts 001, 002, 005 and 006, scale 0.5m

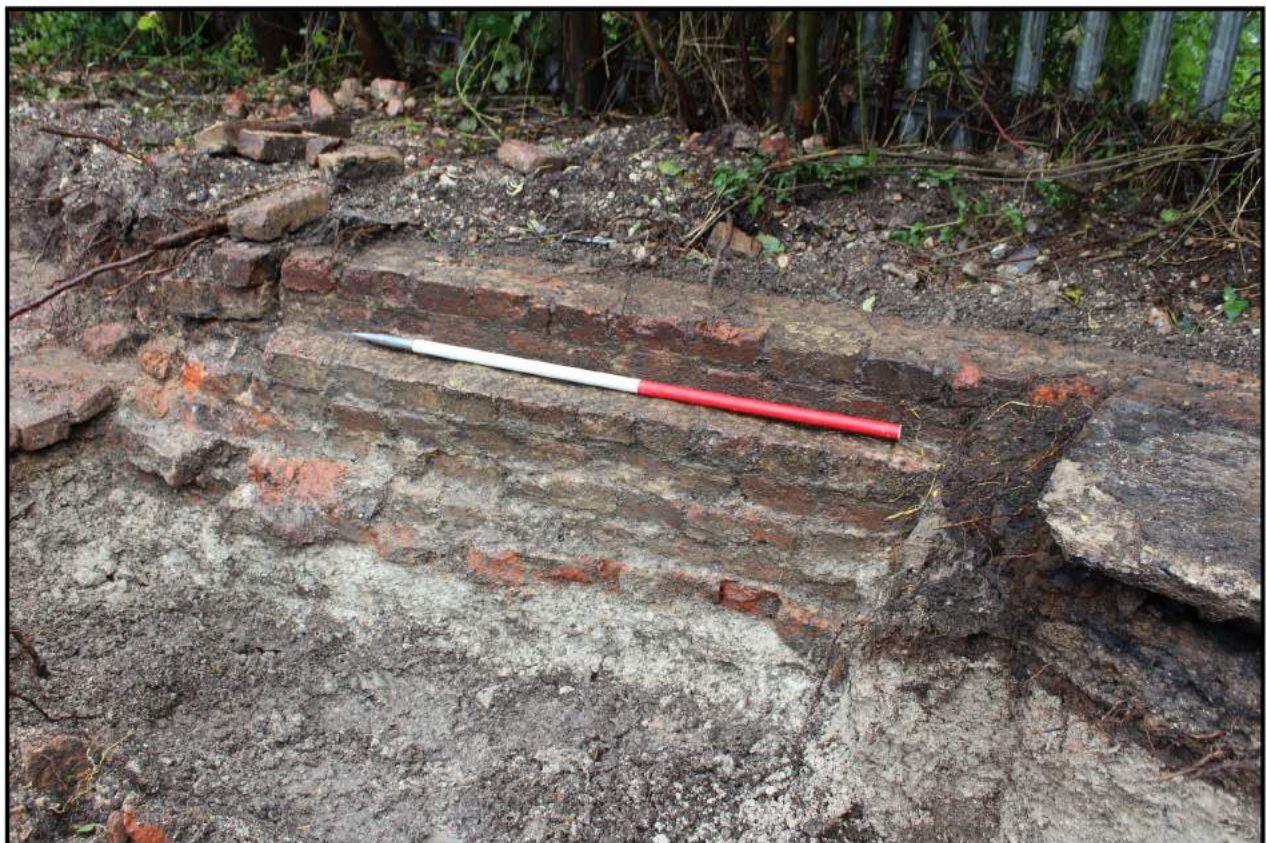
Fig 8: Existing wall; showing stepped footing, context 006, scale 1.0m

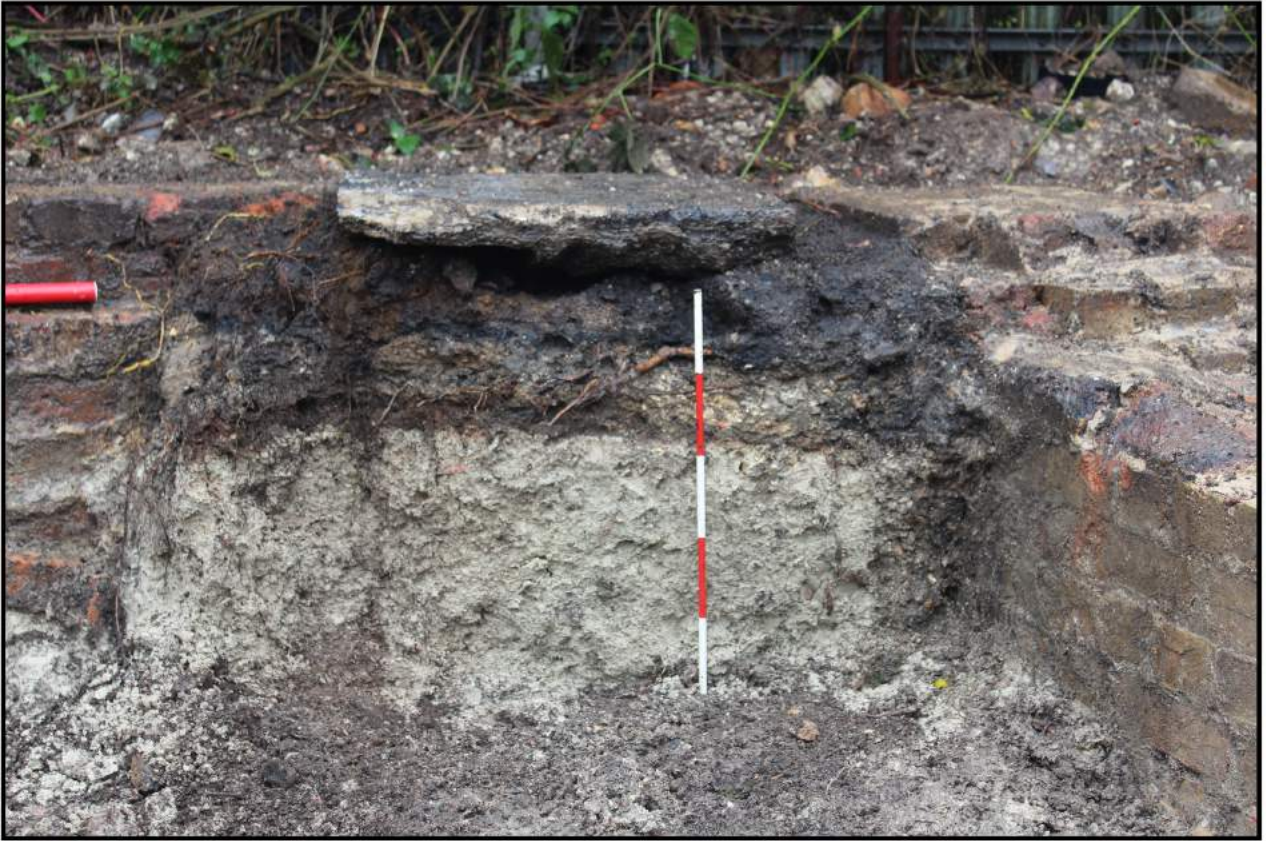
Fig 9: Section 1, scale 0.5m

Activity resulting in a large quantity of ashes and other burnt material (context 014; Figs 3.1, 3.3 and 9, section 1) was undertaken in the corner between contexts 006 and 007. This may have been a bonfire, burning inflammable construction debris. A rectangular stone slab, possibly one of many forming a paved surface, was subsequently laid on this deposit (context 008; Figs 3.1, 3.3, 9 and 20, section 1).

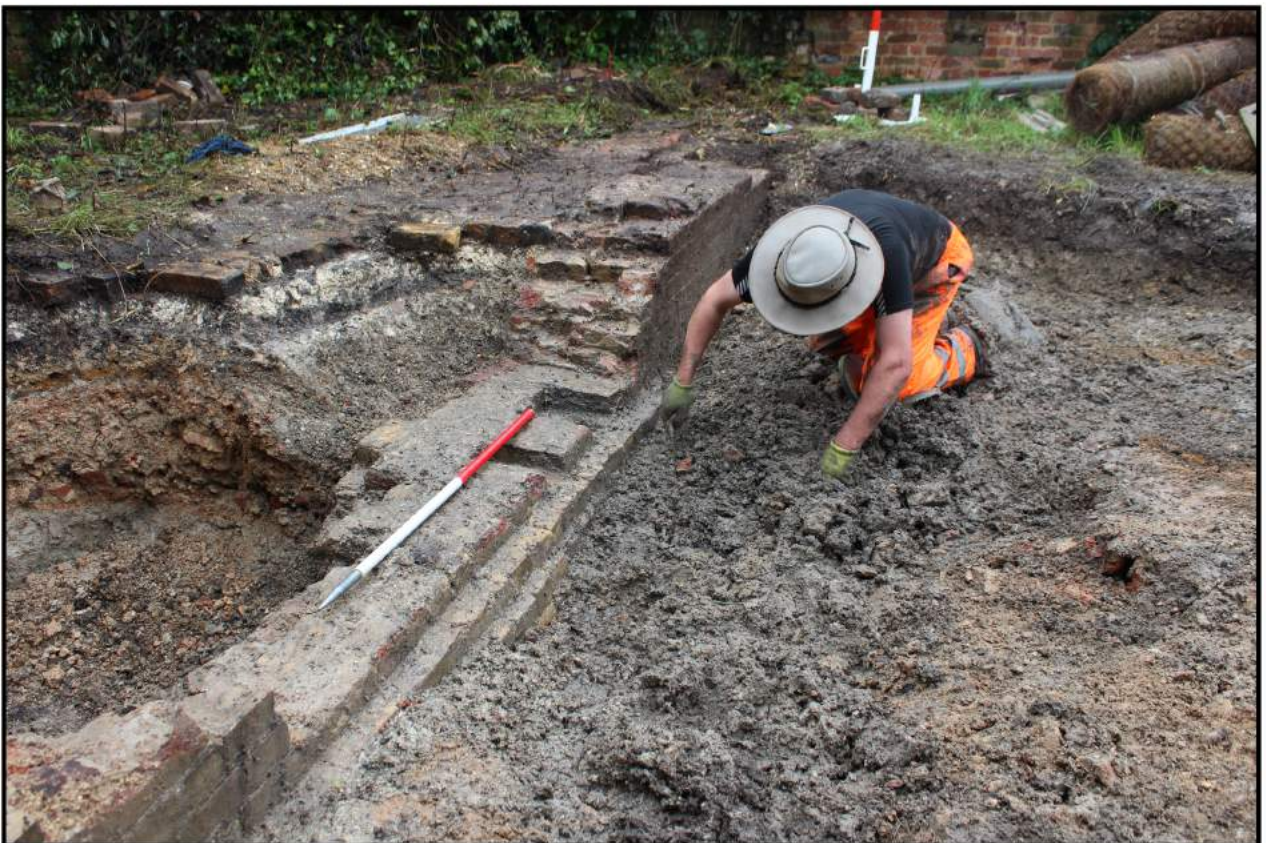
Fig 10: Existing wall, context 007 with stepped footing, context 010, probably same wall as shown on historic mapping, Figs 2.1 and 2.2, scale 1.0m

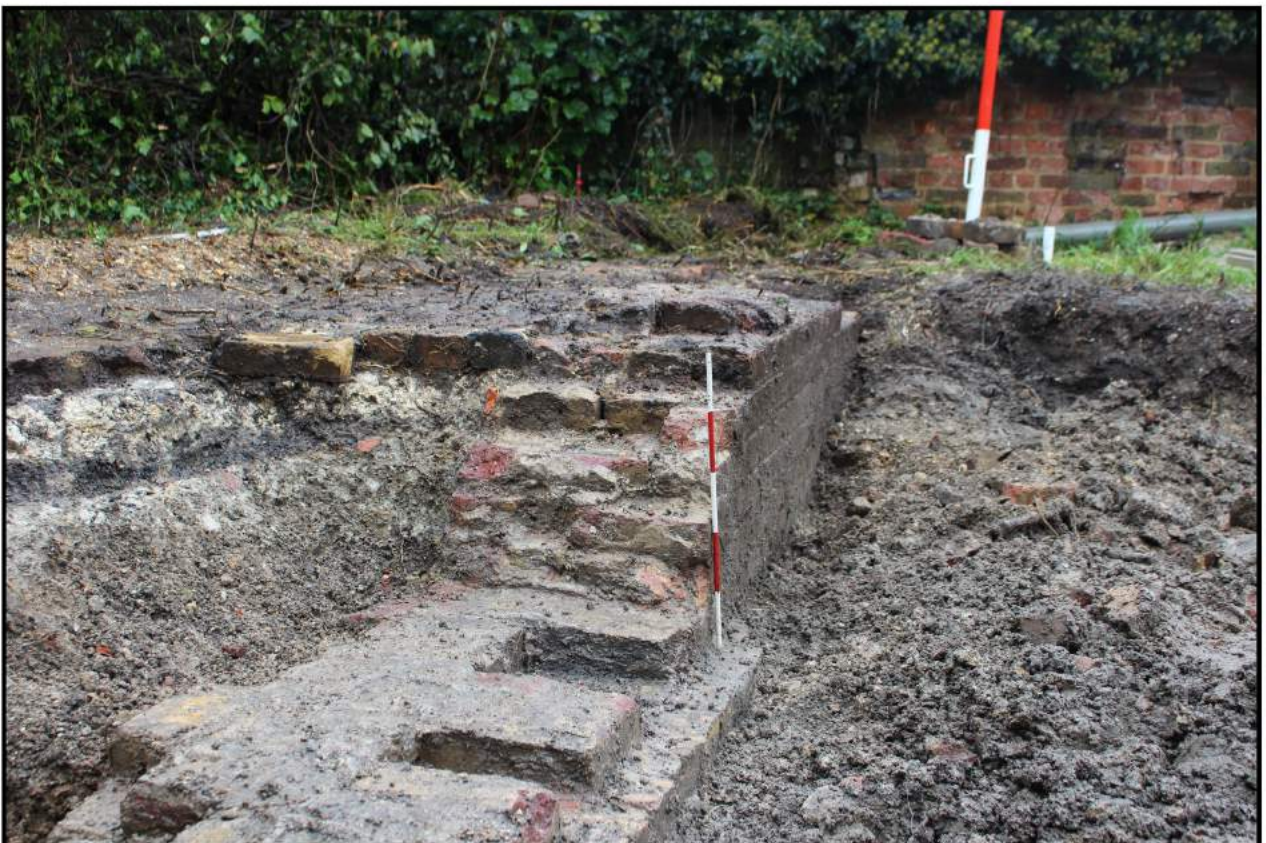
Fig 12: Existing wall; context 007, scale 0.5m

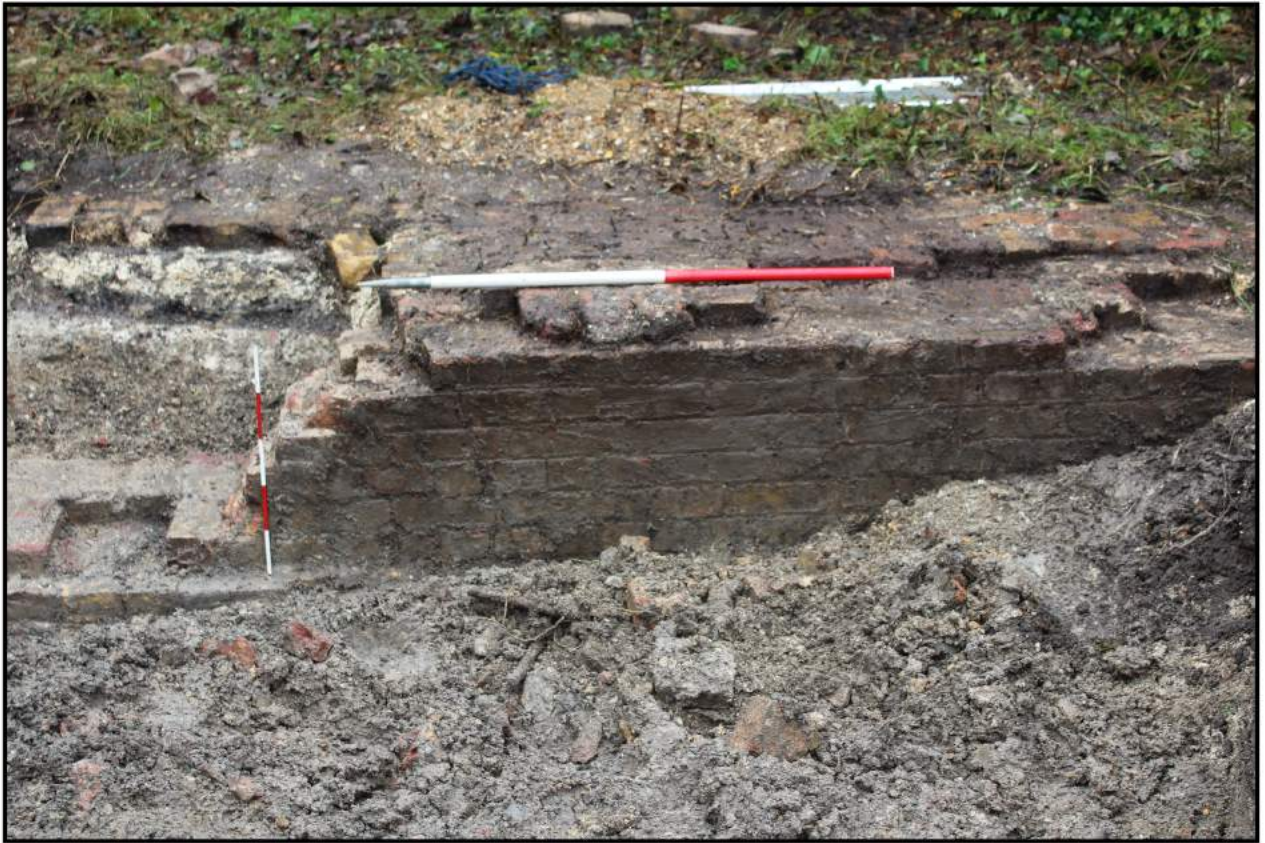
Fig 13: Existing wall; context 007, English bond, scales 0.5 and 1.0m

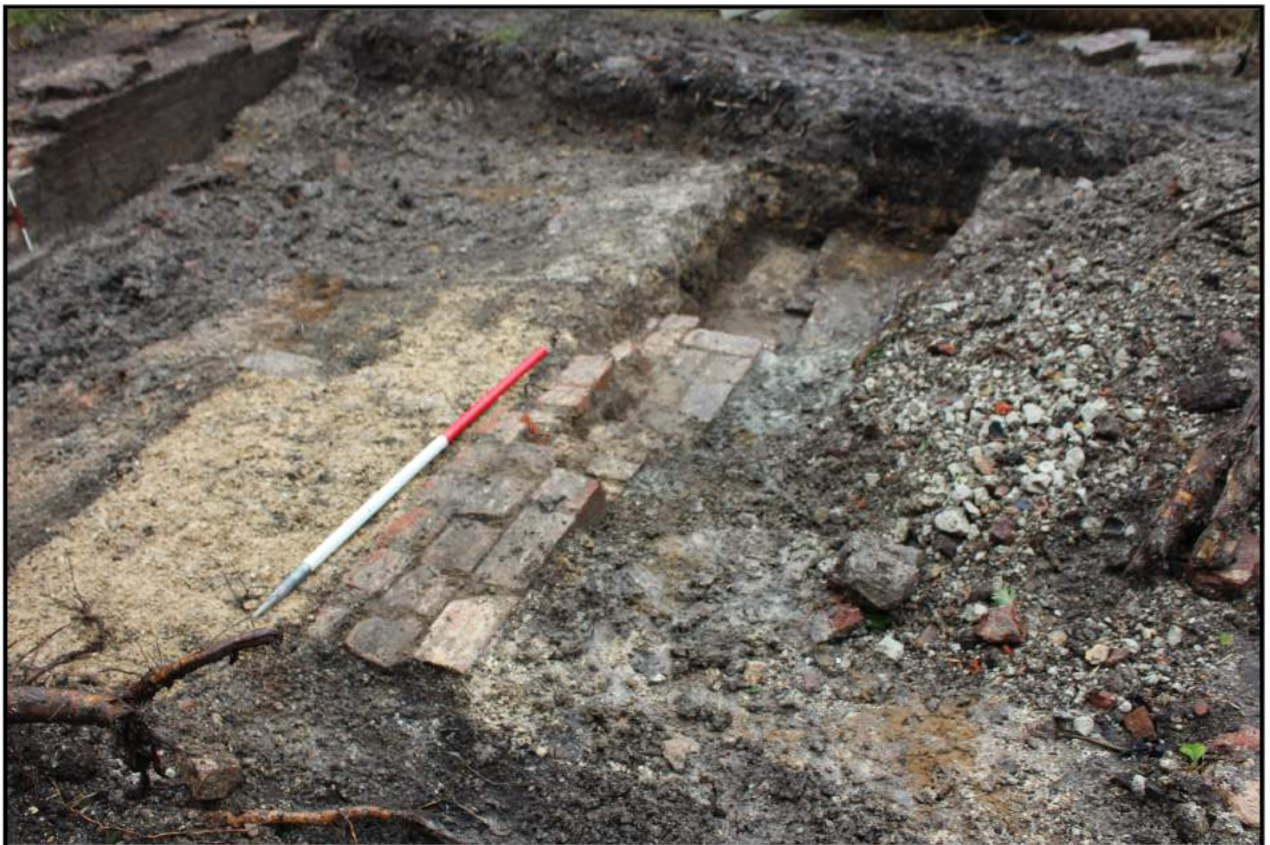
Fig 14: Existing wall, context 003 and robber trench, context 004, scale 1.0m

The replacement wall, context 003, was itself demolished and its bricks recovered by a robber trench (context 004), subsequently filled with contexts 027 and 028 (Figs 3.1 and 3.3, 14, 15 and 17, section 3). It is likely that this was in preparation for the construction activity of Phase 5.

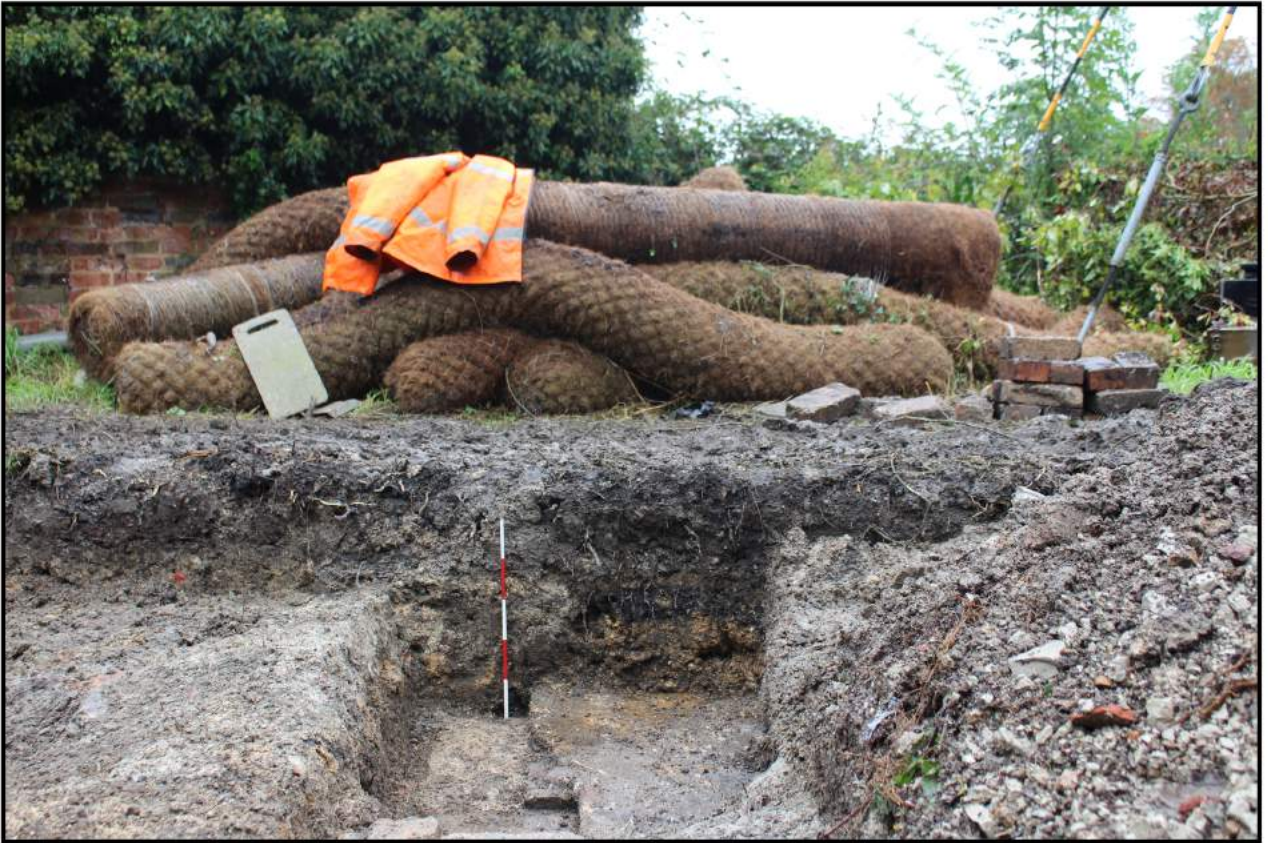
Fig 15: Section 3; scale 0.5m

A layer of topsoil formed or was laid across the site (contexts 020 and 030; Figs 3.3 and 15, section 3).

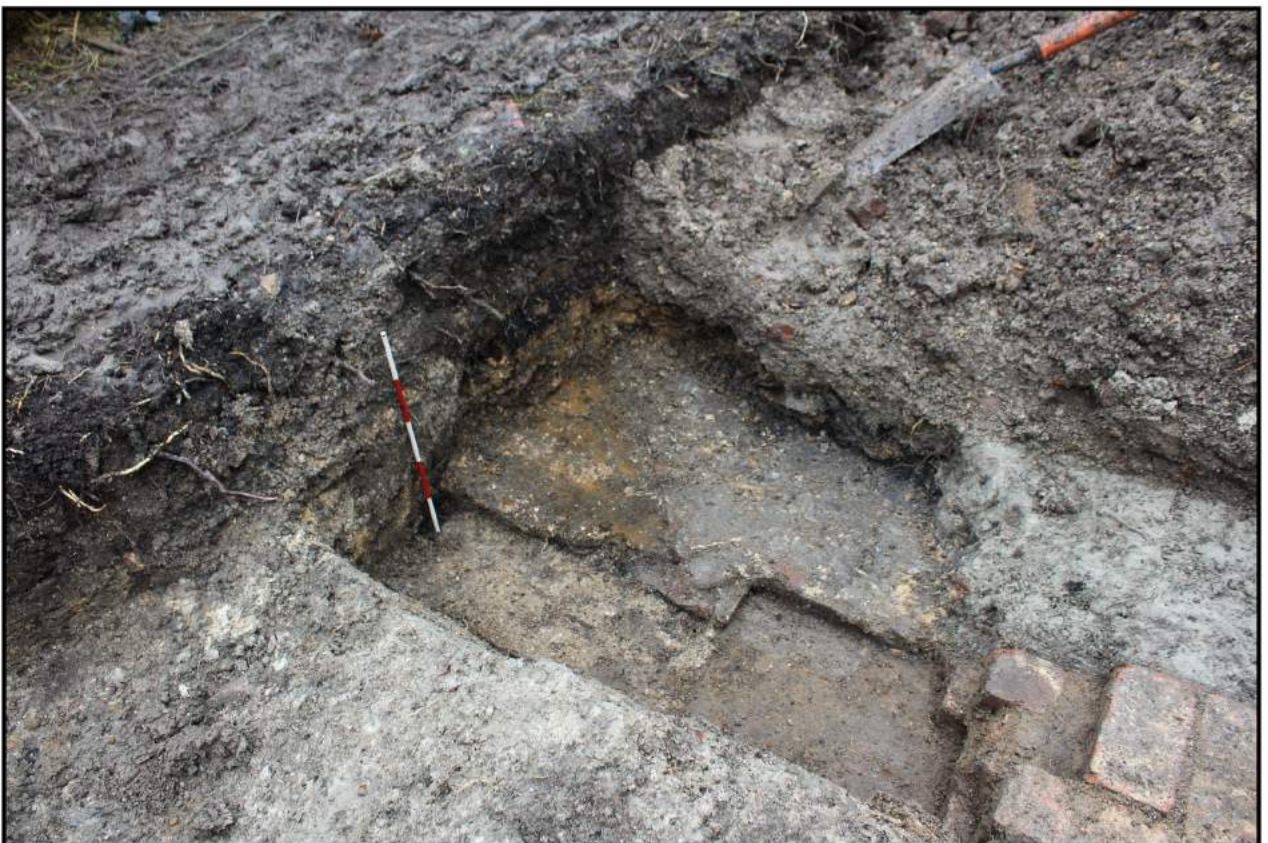
Fig 16: Existing wall, context 003, robbed wall, context 005 and robber trench, context 004; scale 0.5m

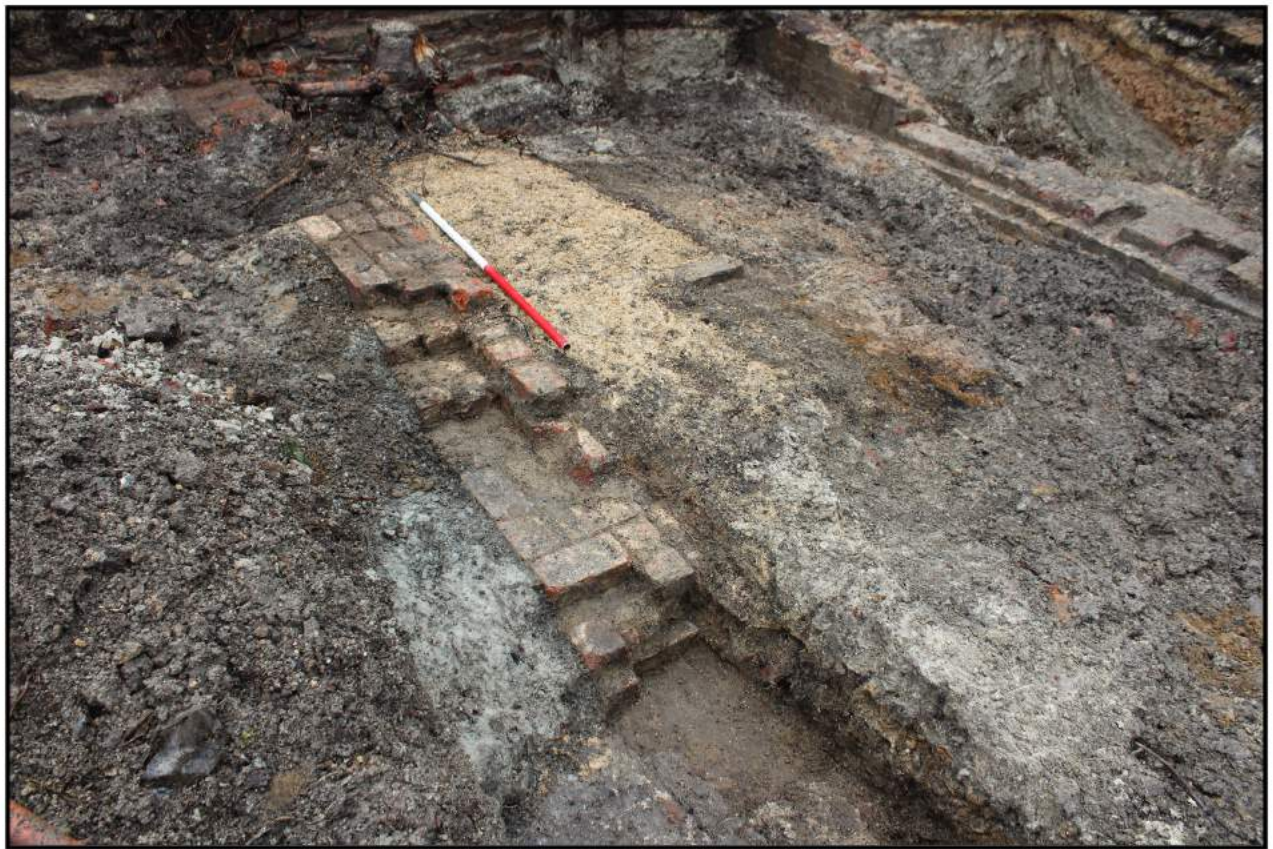
Fig 17: Existing wall, context 003, robbed wall, context 005 and robber trench, context 004; scale 1.0m

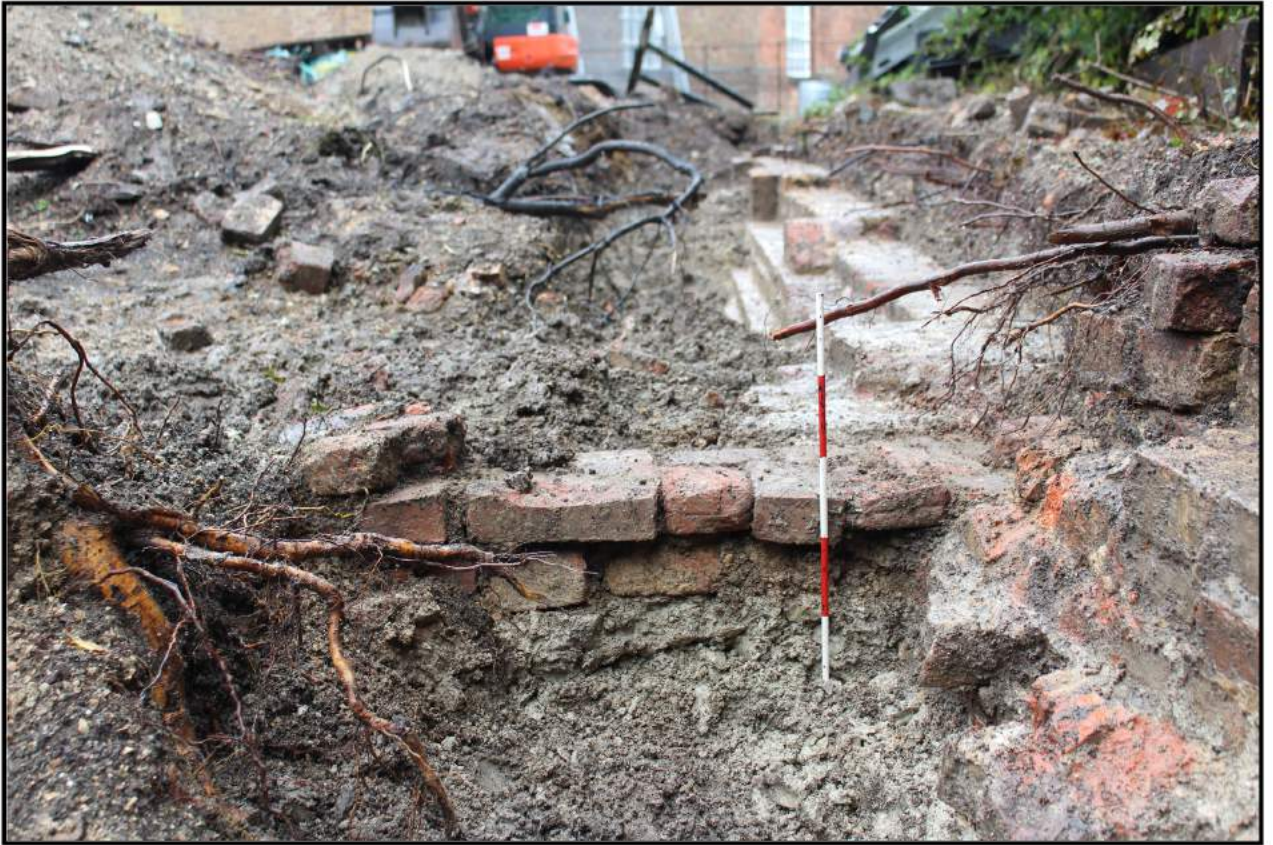
Fig 18: Existing wall, context 002; showing its slight construction

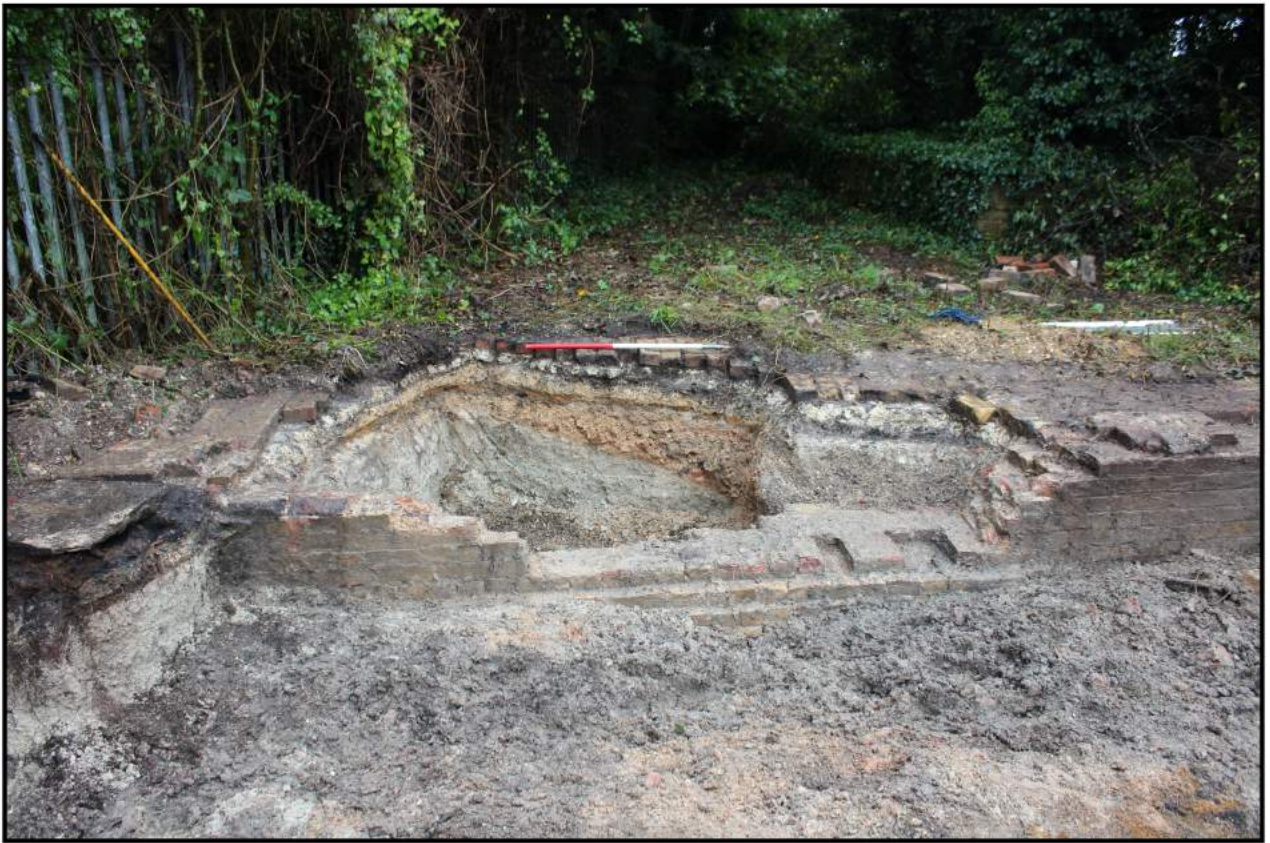
Fig 19: Existing wall, context 007 with brick surface, context 009 behind, scale 1.0m

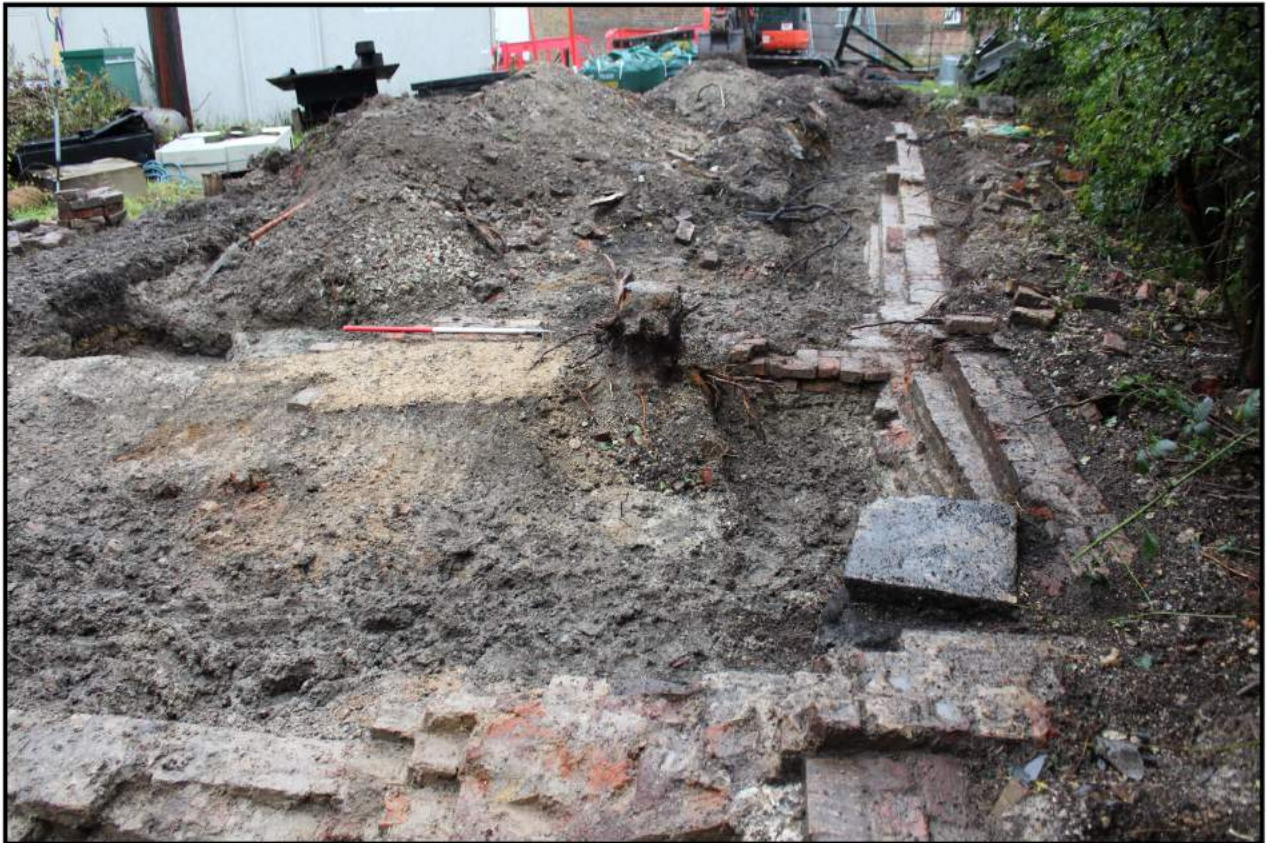
Fig 20: Existing walls, contexts 001 and 006, showing angle between them and stone slab, context 008, scale 1.0m

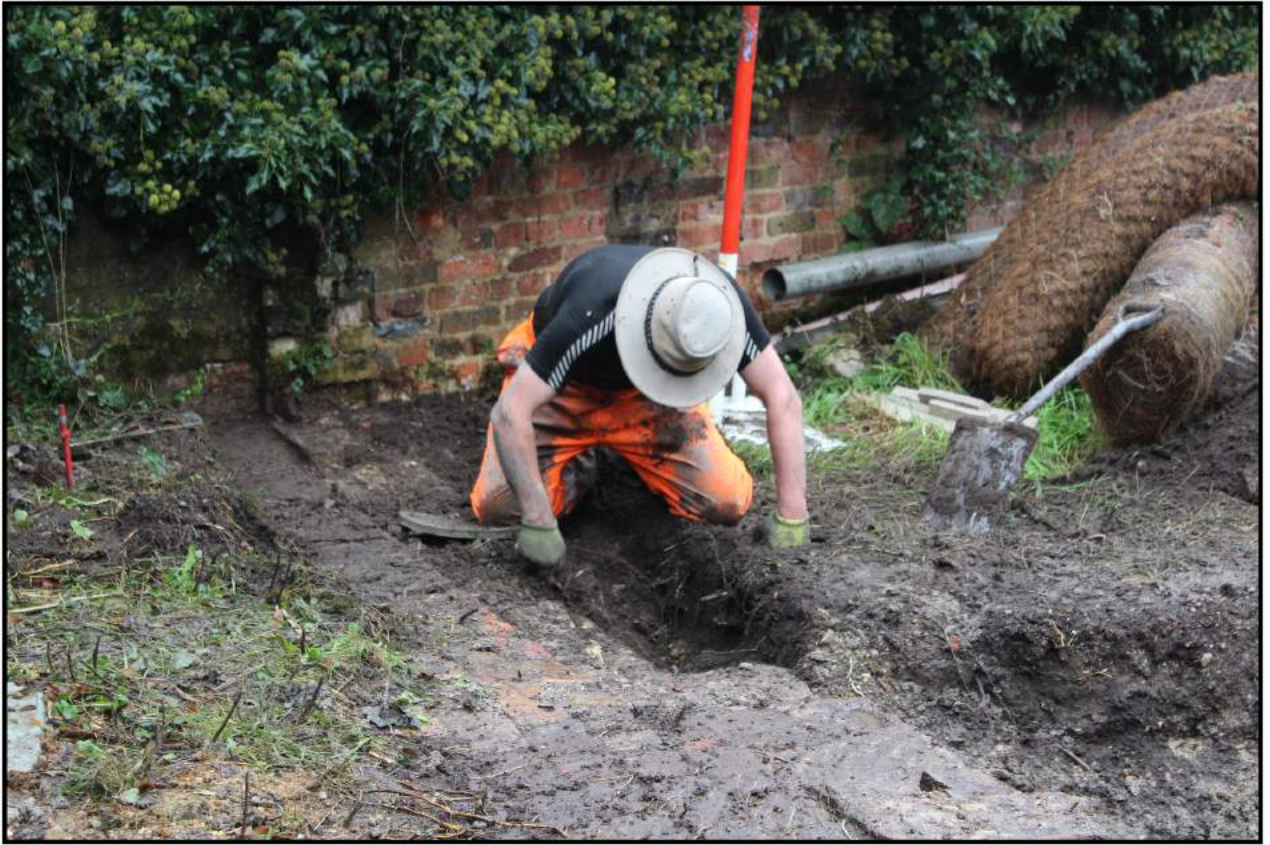
Fig 21: Existing wall, context 007 under excavation

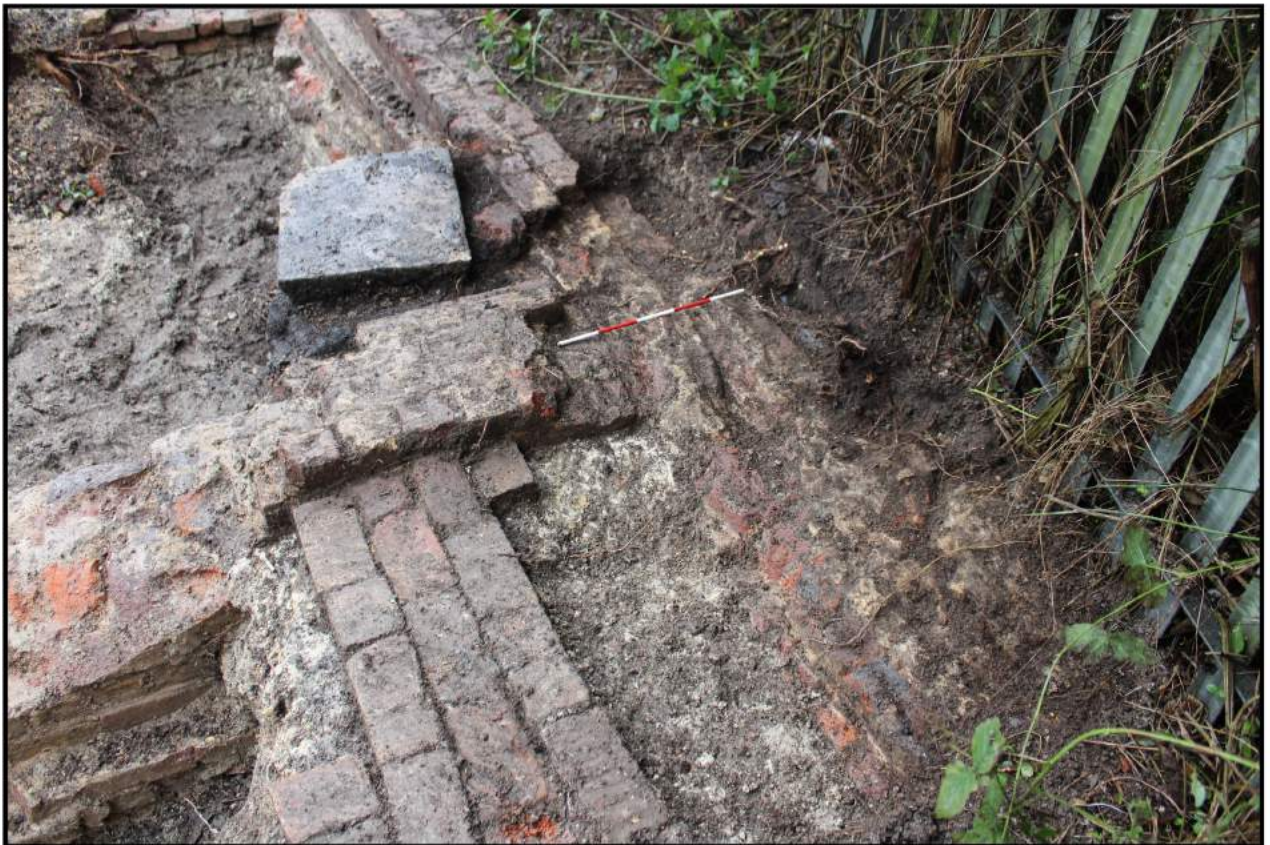
Fig 22: Junction of existing walls, contexts 006 and 007, showing stone slab, context 008 and brick surface, context 009

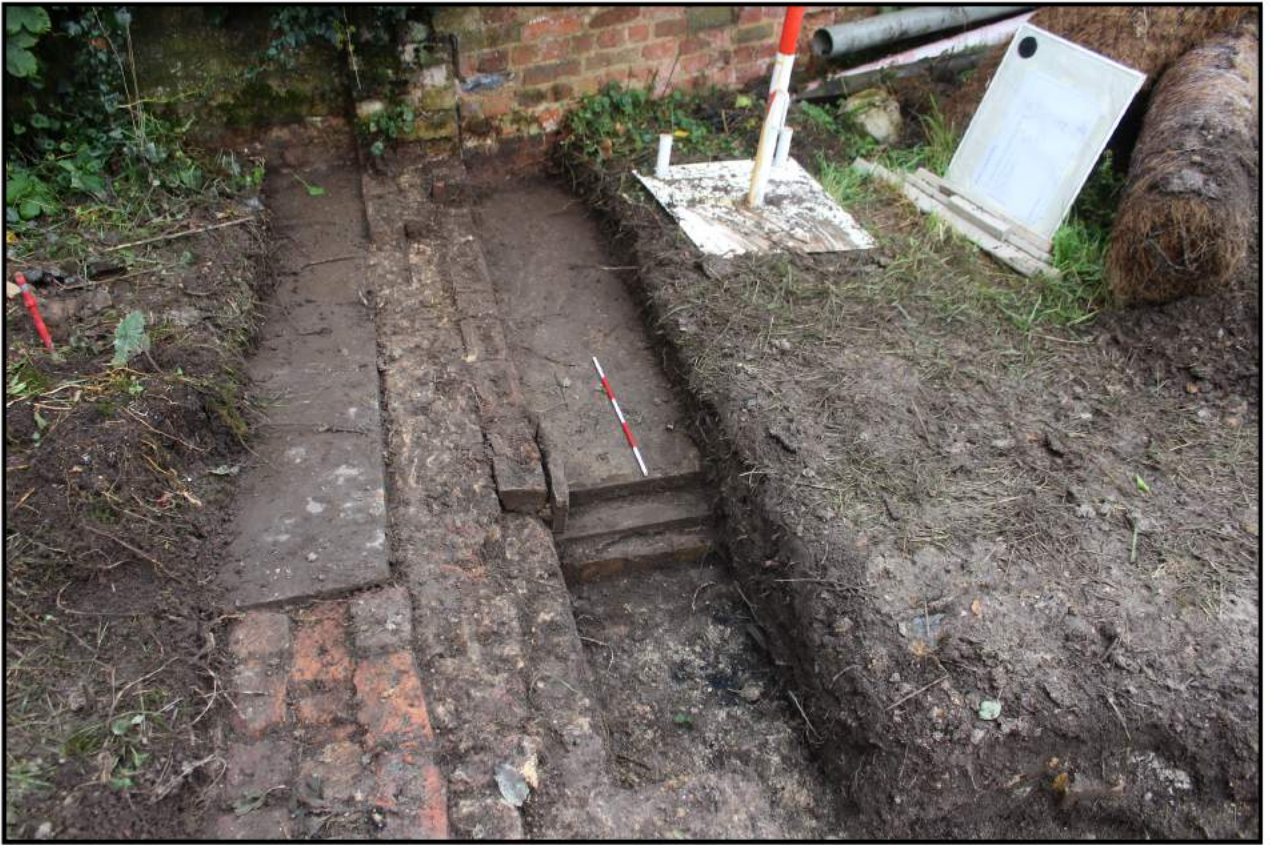
Fig 23: Existing wall, context 007, concrete surface, context 013, cast iron sheets, contexts 011 and 012 and brick surface, context 009, scale 0.5m

this phase are two cast iron plates (contexts 011 and 012; Figs 3.1 and 23) and a concrete surface (context 013; Figs 3.1 and 23).
