**Archaeological salvage recording  
at Tringford Pumping Station  
Little Tring,  
Wendover Arm, Grand Union Canal,  
Dacorum**

Martin Cook BA MCIfA

15th November 2020  
Revised 25th February 2021

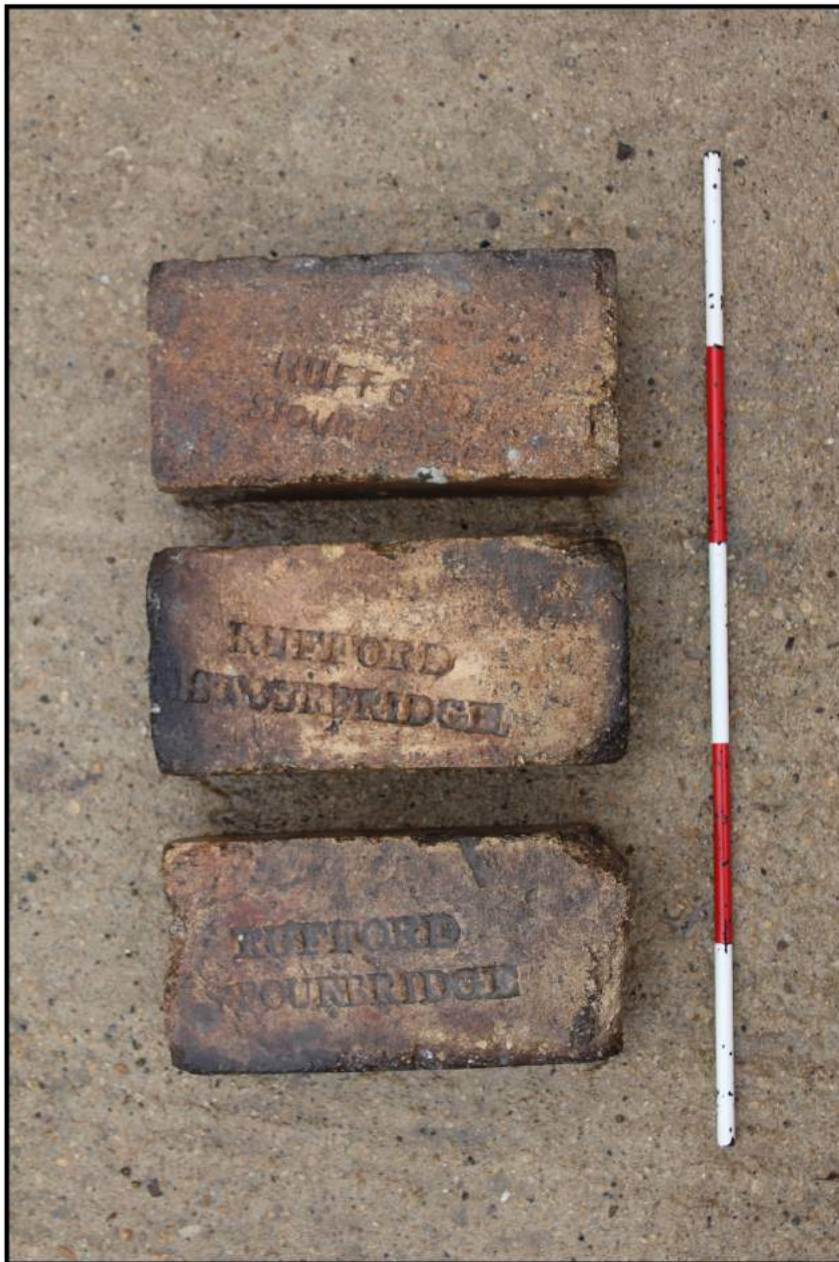
Three frogless bricks were recovered stamped RUFFORD STOURBRIDGE (Fig 24). These measured:

225 x 112 x 63mm  
230 x 110 x 66mm  
225 x 111 x 65mm

Fig 24: Samples of bricks from the site; made by Rufford of Stourbridge, scale 0.5m
