**Desk-based assessment, evaluation and
recording on the site of a bridge at the
rear of High Street,
Wednesfield
near Wolverhampton**

Desk-based assessment, evaluation and recording on the site of a bridge at the rear of High Street, Wednesfield near Wolverhampton

A desk-based assessment, evaluation and subsequent recording were undertaken of a demolished late 18th century canal bridge at Wednesfield on the Wyrley and Essington Canal. The work demonstrated that the bridge was of the traditional type associated with canals, being built of brick with the wing walls curving in both the horizontal and vertical planes. Excavation within the surviving abutment threw light on construction methods of this period and identified a buried soil pre-dating the construction of the canal.

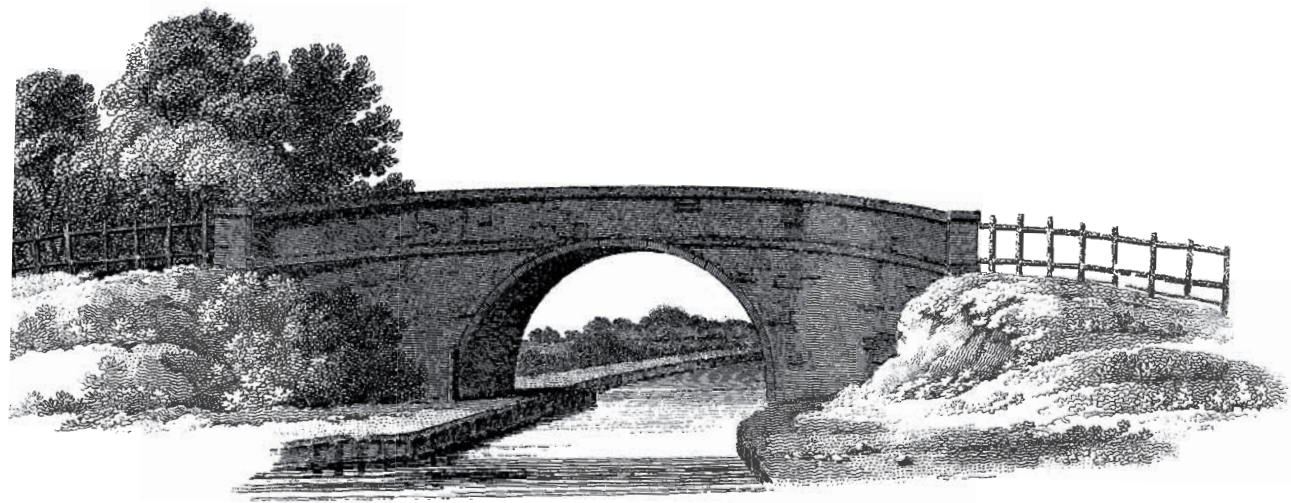
A particular form of small, brick bridge has become associated with canals and was employed on the Wyrley and Essington (Fig 4.1). It was employed when it was necessary to re-establish access to lands which had been severed by the construction of the canal and was known as an 'accommodation bridge'. Such a bridge was described and illustrated by Rees (1819-20; Fig 3):

A kind of brick bridge has long since come into almost general use on canals of which an example is given. The form of these bridges is well calculated for saving of materials and giving strength at the same time, the whole of the walls being more or less battering and the side walls are splaying outwards at their ends to make the entrance onto the bridge the more easy, by which the side walls are rendered curving inwards in every part. In the building of bridges the utmost care must be taken to sink the foundations down to sound stuff, or to drive piles on which to begin the work; it is a good practice to have wedge-like or arching bricks made, on purpose to use after a certain number of courses of key bricks, or those forming the soffits of the arch, and to introduce oblique courses of bricks for the more effectual tying of the work together (see below). Large bricks made of the best earth and well burnt should also be used, placed on edge upon the top of the walls of the bridges as a coping, unless very good stone is near at hand, the top corners of the stones or coping bricks should be carefully rounded off in the making in that the same should present as few angles as possible for the weather or the traffic to catch hold of.

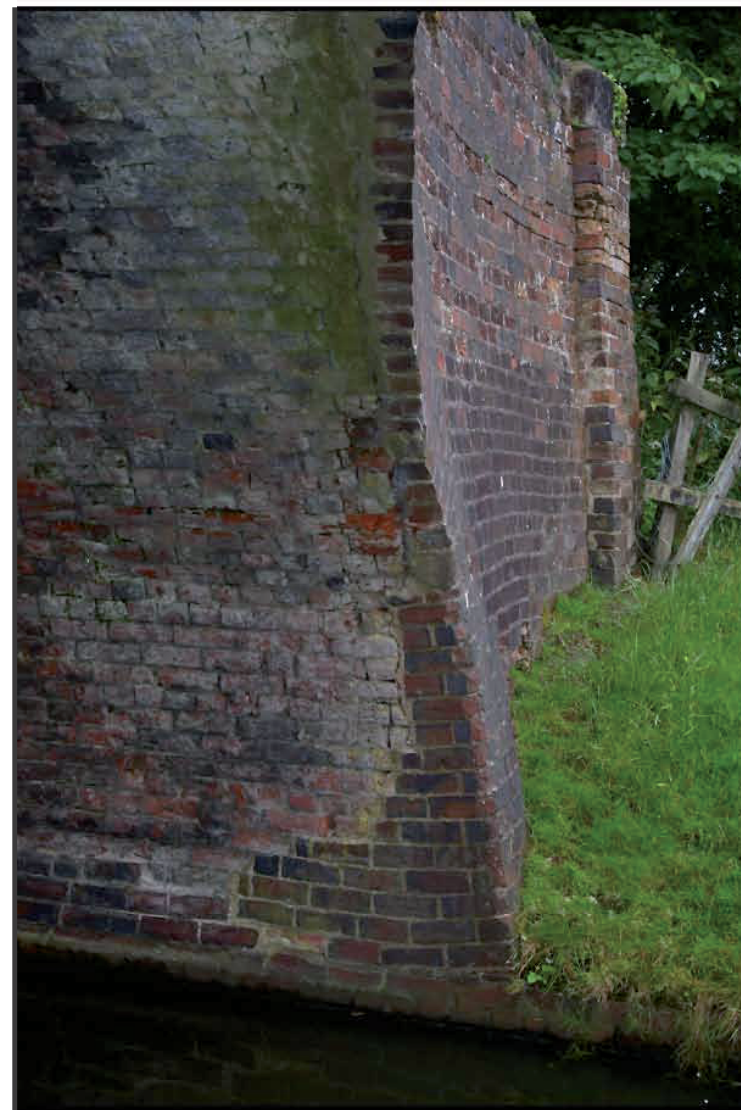
Fig 9: Bridge at Hockley Heath; North Stratford Canal

A useful over-simplification is that an arch is in equilibrium (ie it stands up) when each part of one abutment pushes against an equivalent part in the opposing abutment. This state of equilibrium is easily attained when the bridge is symmetrical and its abutments are at right angles to its longitudinal axis. Examples of such bridges are commonplace across the canal system. An example of such a bridge may be seen at Tardebigge (SO 989 891) on the Worcester and Birmingham Canal (Fig 8), as is the example given in Rees (1819-20; Fig 3). However, in the case of an oblique or skew bridge, the bridge's abutments are not at right angles to its longitudinal axis. The result of this is that the ends of the abutments on two of the opposing corners have nothing against which they can push. Effectively, in these positions, only half of the bridge has been built. The result is that the arch ring is forced away from the core of the arch on both sides of the bridge. This effect of this may be seen on a bridge at Hockley Heath (SO 146 729) on the North Stratford Canal (Fig 9).

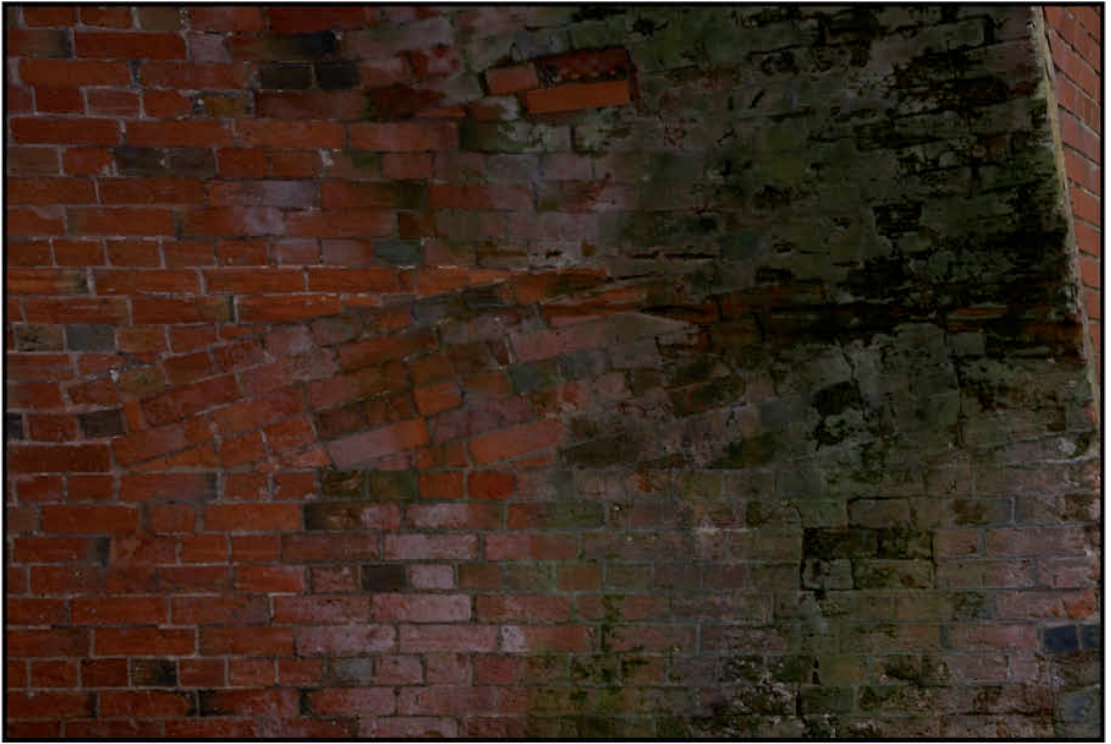
Fig 10: Bridge at Lower Bittell Reservoir; Worcester and Birmingham Canal

and an example of such construction may be seen on the Worcester and Birmingham Canal (Fig 10) at Lower Bittell Reservoir (SP 020 738).

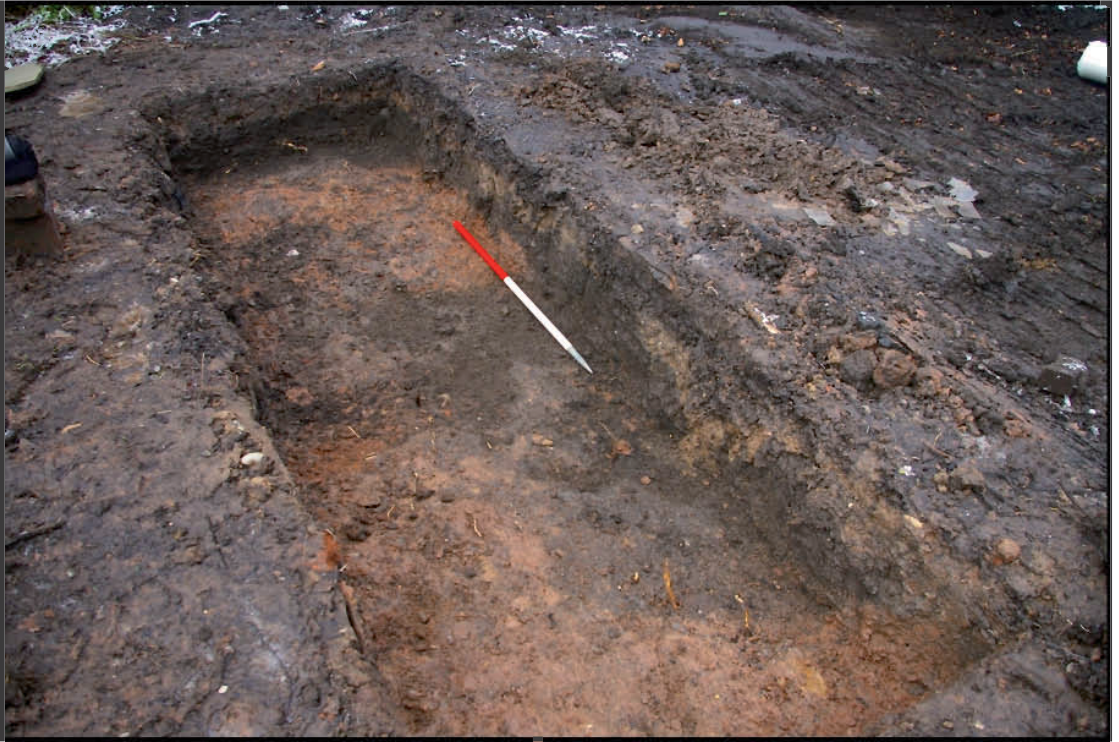
Fieldwork was undertaken on the 11th, 12th, 13th, and 17th February 2009. An 'L' shaped trench, approximately 3.5m long and 2m wide at its widest point, was excavated in a position to take in the projected position of the carriageway and the western wing wall (Figs 5 and 11).

Beneath the topsoil (context 001) were a number of deposits (Fig 6). The most recent of these was modern disturbance caused by tree-boles or burrowing animals (Fig 11; contexts 003 and 004). However, two deposits were relevant to the construction of the bridge. The first of these was a layer of tenacious clay (context 002). This was clearly not the natural subsoil but its significance was not realised at this time (see below). The second (context 006) was revealed when an overlying layer (context 005) was removed. Context 006 was a sloping surface, cut into benches, and is believed to be the western side of the ramped approach to the bridge (Figs 6 and 12).

Fig 11: General view of trench looking south-east

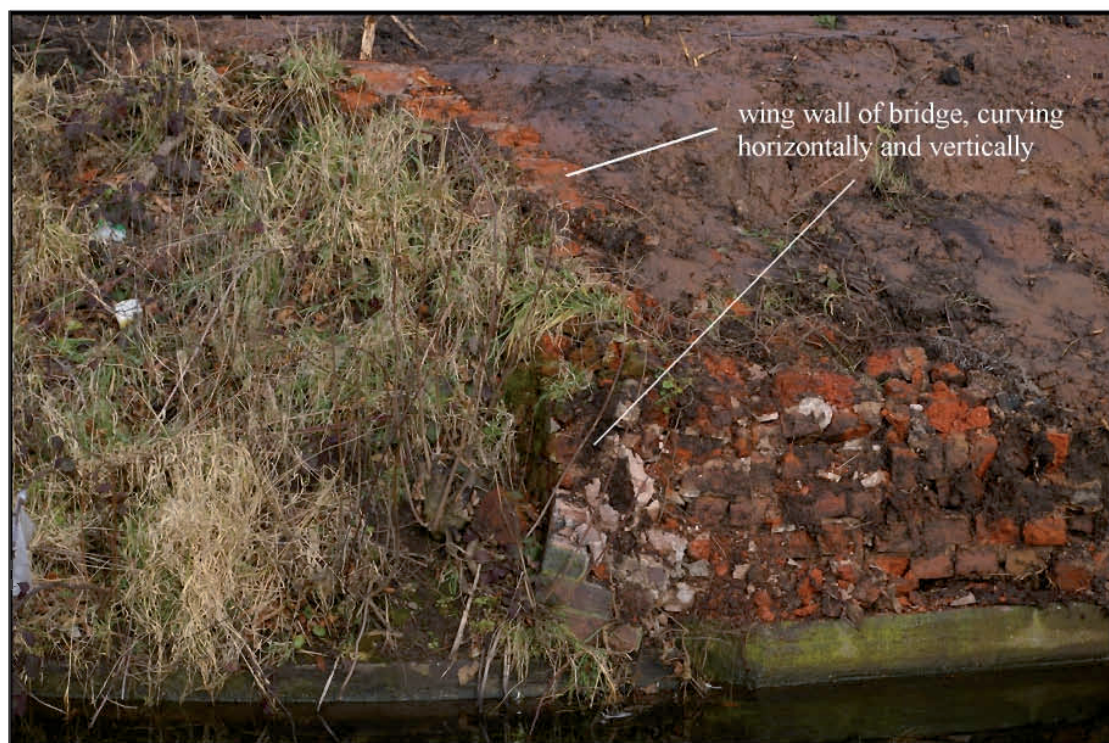
With the removal of the vegetation covering the site of the northern bridge abutment it was clear that the design of this bridge was that of the traditional canal bridge described above (Fig 13). It was possible to obtain measurements of the bricks used. These were unfrogged, measured 250x110x80mm and were laid in lime mortar.

Fig 13: View of northern bridge abutment showing curving wing wall
