SITE ADDRESS	Utility trench, Highcliffe Court, adj.110 Clifton, York				
CLIENT NAME	CE Electric UK				
YAT PROJECT#	5470 YAT REPORT # 2011/1				
MUSEUM ACCESSION #	n/a GRID REFERENCE SE 5942 5295				
PLANNING REFERENCE #	n/a AAI OPS NOTICE # 10032

INTRODUCTION

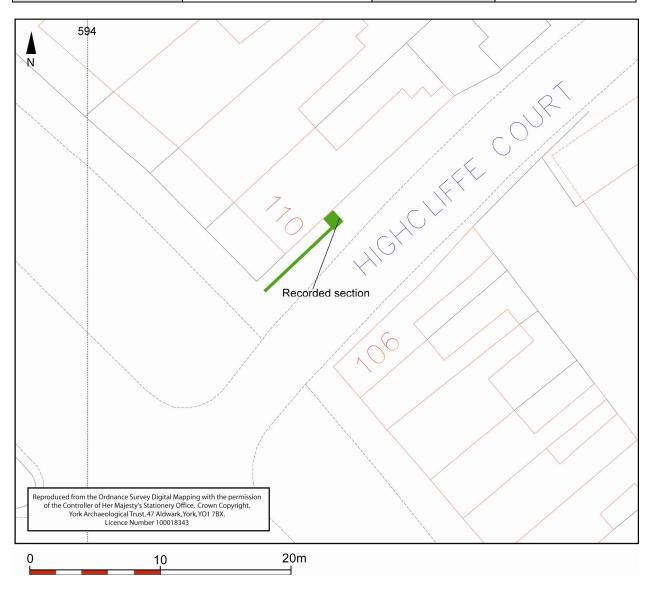
A single specimen section was recorded towards the north-east end of the trench. Here, between 0.35m below ground level (BGL) and at least the base of the trench at 0.6m BGL, there was a firm mid brown clay (1000). This was overlain by a 0.2m deep layer of mid brown silt with moderate pale brown mortar and brick / tile (1001). Sealing this was a 0.1m deep deposit of pale grey crushed limestone (1002) which formed the make-up for the existing pavement surface of tarmac (1003).

Figure 3 Location of trench and recorded section

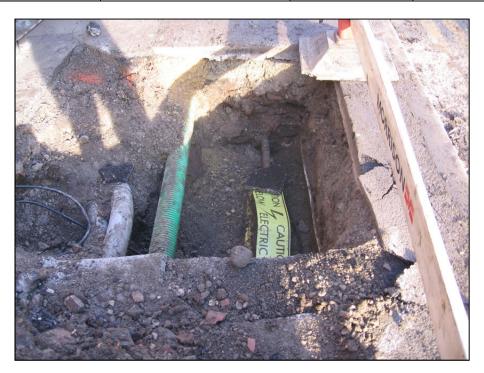
Although relatively close to the modern ground surface the firm, mid brown clay (1000) seen towards the base of the trench was probably natural. No features were seen to be cut through and none of the overying layers were deemed to be of any great age or archaeological significance and were probably or definitely modern.

Plate 1 North-east end of trench, looking north-east

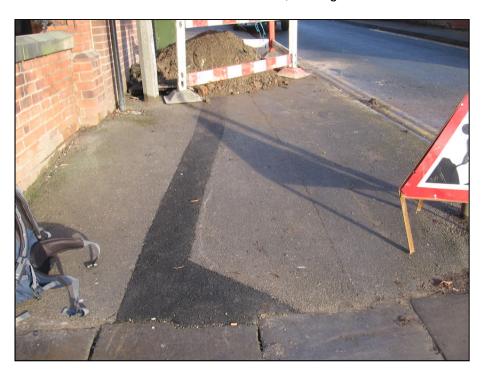
Plate 2 General view of works, looking north-east
