**HALL FARM, MIDDLEGATE LANE, BONBY
NORTH LINCOLNSHIRE**

DESK BASED ASSESSMENT

by D.T. Evans

REPORT NUMBER 2011/64

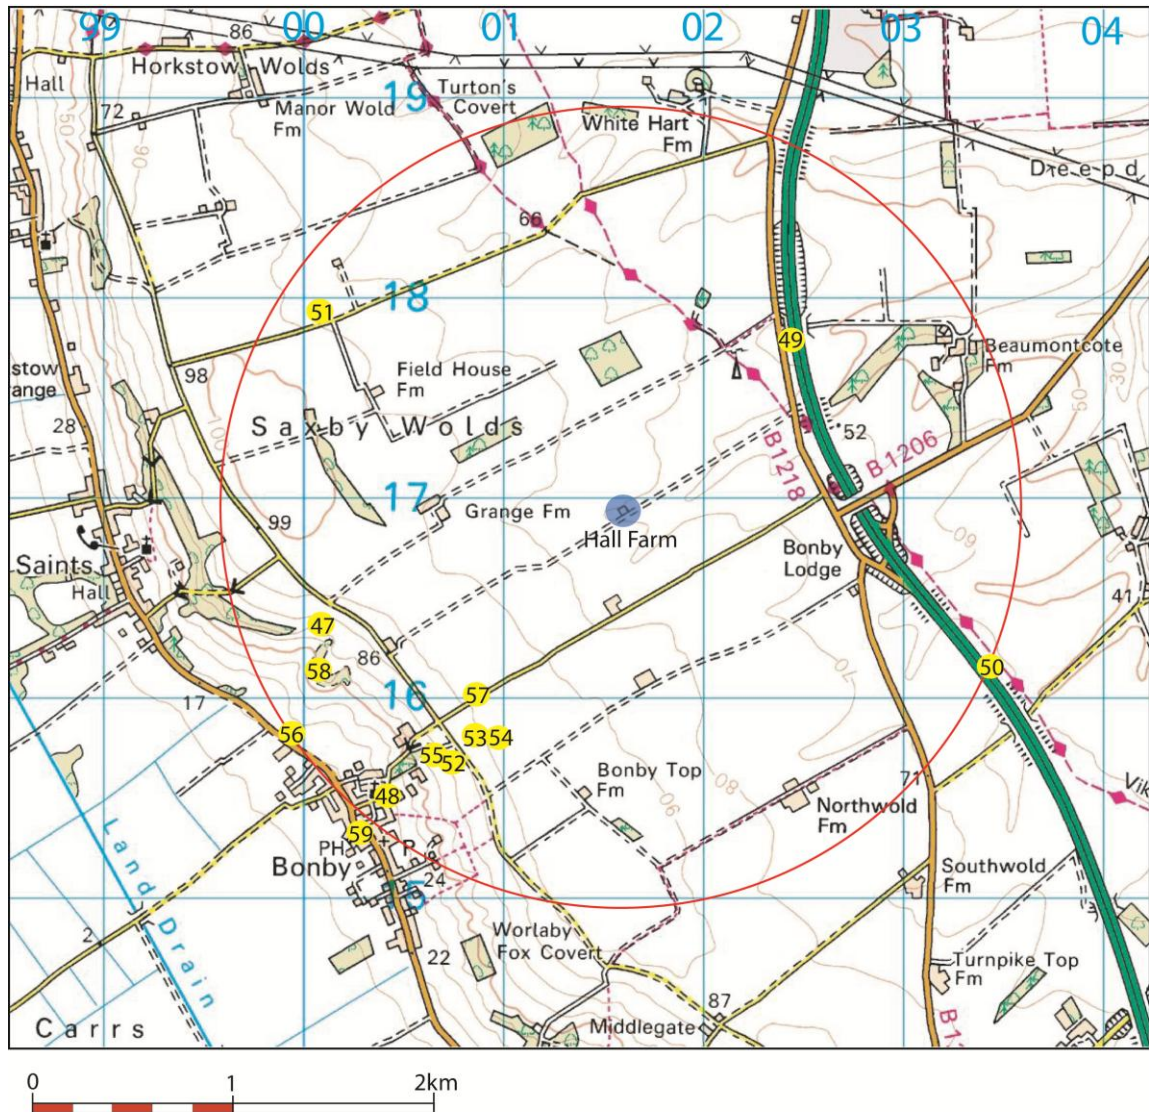
Figure 7 Medieval sites and finds in the study area

Pottery possibly of this period has been recovered from the site north-west of Bonby Hall, (47) (NMR UI 63647). St Andrew's Church, all that survives of Bonby Priory, dates originally to the 12th century, (48) (NMR UI 78808). The A15 fieldwalking has recovered Medieval pottery (49) (NLHER MLS440), (50) (NLHER MLS2254). Other Medieval finds from the study area include a coin of Edward I (51) (NLHER MLS1646) and pottery (52) (NLHER MLS19702) during fieldwalking on land to the west of Middlegate Lane, Bonby. A silver penny of Edward I (53) (NLHER MLS19703) has been recovered during fieldwalking on land to the east of Middlegate Lane and the general area has also produced small quantities of

pottery of this period (54) (NLHER MLS19705). Other fieldwalking has recovered c.75 sherds of pottery (55) (NLHER MLS19706) from an area east of Saxby Road and c.160 sherds of pottery (56) (NLHER MLS19710) have come from another area of fieldwalking east of Saxby Road. A small quantity, 10 sherds, of Medieval pottery (57) (NLHER MLS19956) came from fieldwalking in “Ring” Field and 3 sherds (58) (NLHER MLS19965) from “Plateau” Field. An evaluation excavation in advance of a small housing development at 2 Church Lane, Bonby in 2008 recorded Medieval pits and ditches (59) (NLHER MLS20666).

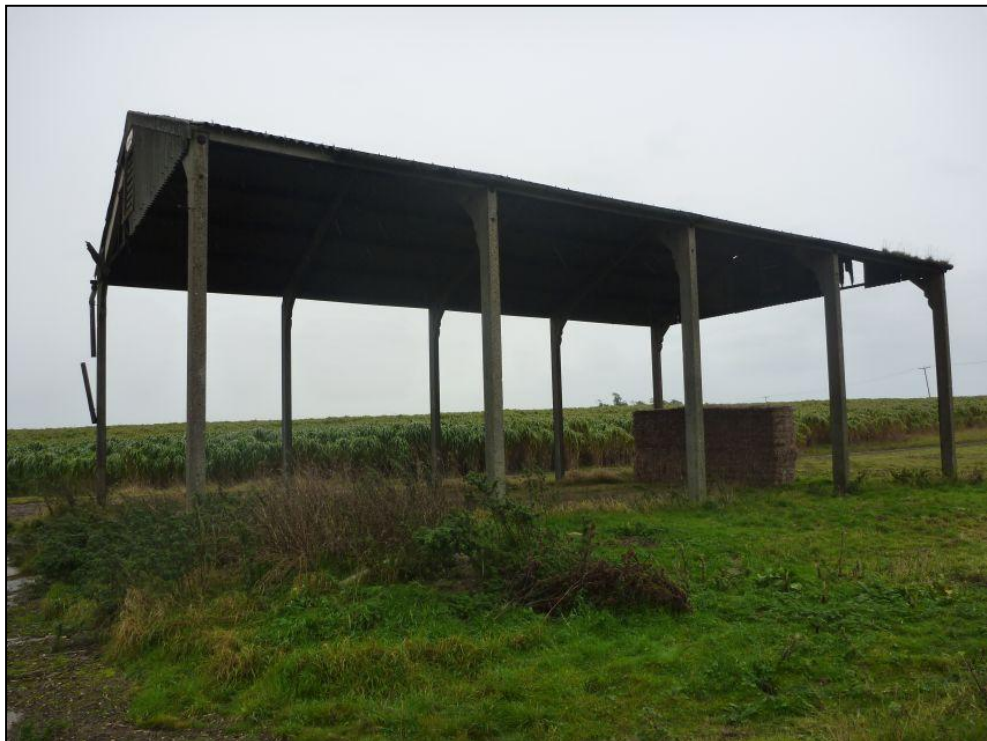
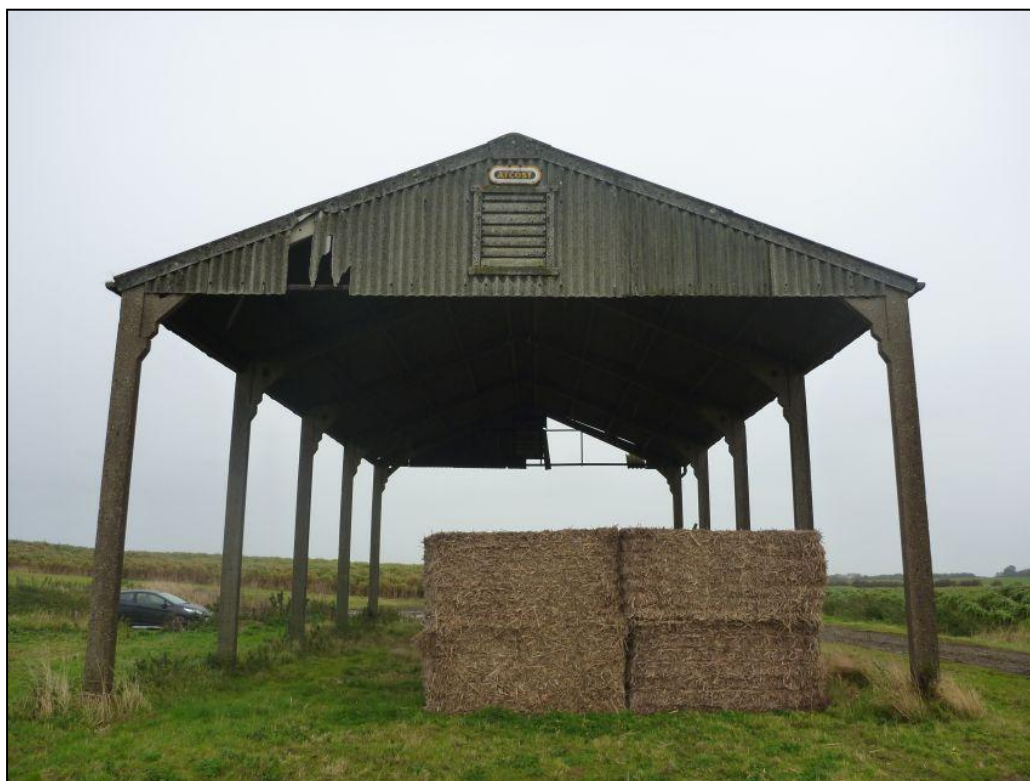
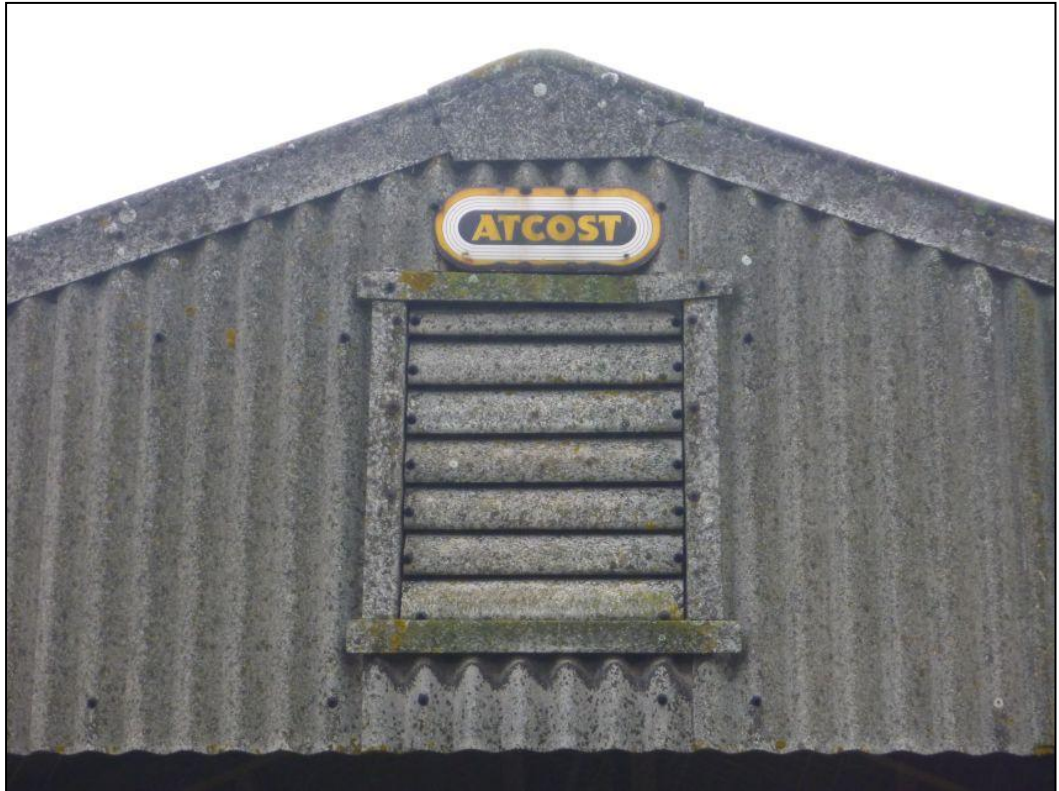
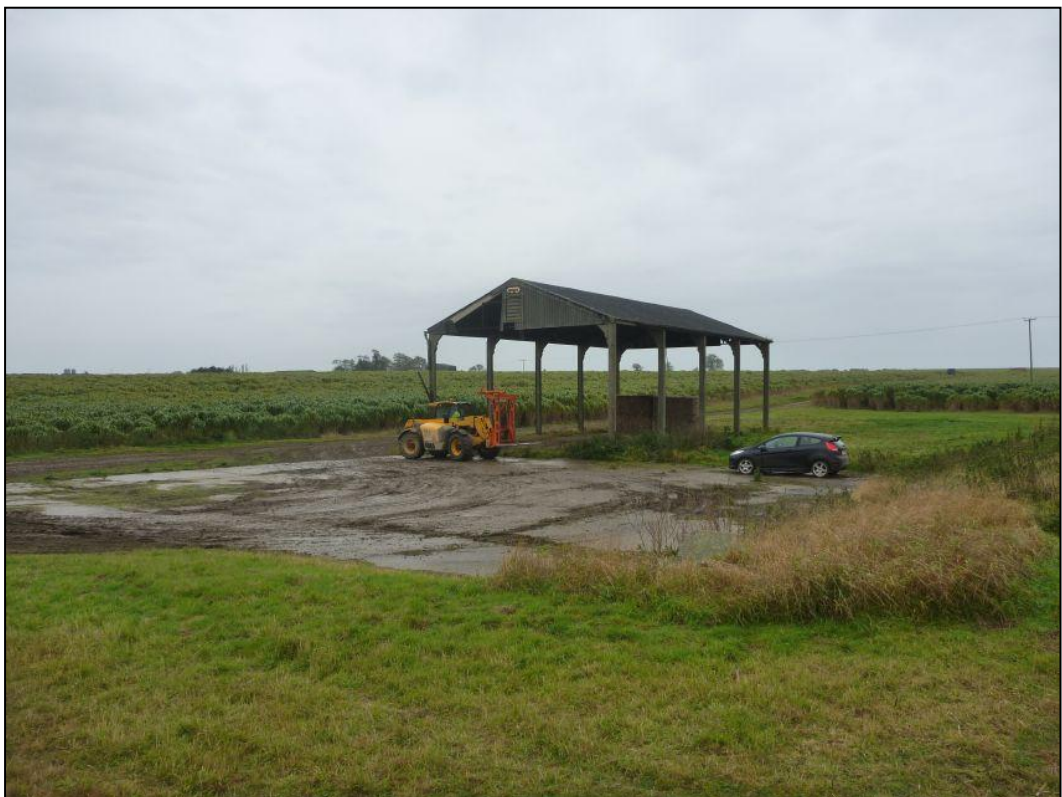
The Dutch barn (Plates 6-10) is open sided and of four bays. It measures some 18m long (south-west – north-east) by 10m wide (south-east – north-west) and has a height to the apex of the roof of around 8.5m (approximately 6.5m to the wall plate). The principal structural elements of the barn are all of pre-cast steel reinforced concrete. These elements are comprised of five sets of posts, set within concrete, and affixed to which are five pairs of principal rafters and a wall-plate that extends along either long side of the barn at eaves level. The five pairs of two piece principal rafters, which effectively form roof trusses, are jointed by simple bolted steel jointing plates. All other joints between the structural elements are secured with steel bolts. Four sets of equally spaced steel reinforced concrete purlins extend above the principal rafters to each side of the roof. The roof cover, which is of corrugated asbestos, is affixed to the purlins. Remnants of asbestos guttering remain affixed to the outside of the wall-plate whilst fragments of asbestos down-pipes also still remain. Both gable ends of the roof have a covering of corrugated asbestos with a centrally placed rectangular louvre. An enamelled manufacturers plate bearing the name 'ATCOST' is secured above each louvre. Narrow concrete lined channels extend at ground level between each of the posts to the long sides. Although the function of these is not known for certain, it may have been to permit the insertion of sectional walling were this to have been required. The ground surface within the barn is of earth and the barn itself is likely to have been constructed in the 1960's – 1970's by the Atcost company, which was founded in the 1950s.

Plate 6 General view of the barn, looking south

Plate 7 Detail view of underside of barn roof, looking south-west

Plate 8 View of south-west end of barn, looking north-east

Plate 9 Detail of louvre and manufacturer's plate, looking north-east

Plate 10 Barn, concrete and part of the roughly grassed area, looking south
