**YORK GAS WORKS,
HEWORTH GREEN, YORK**

WATCHING BRIEF REPORT

REPORT NUMBER 2012/03

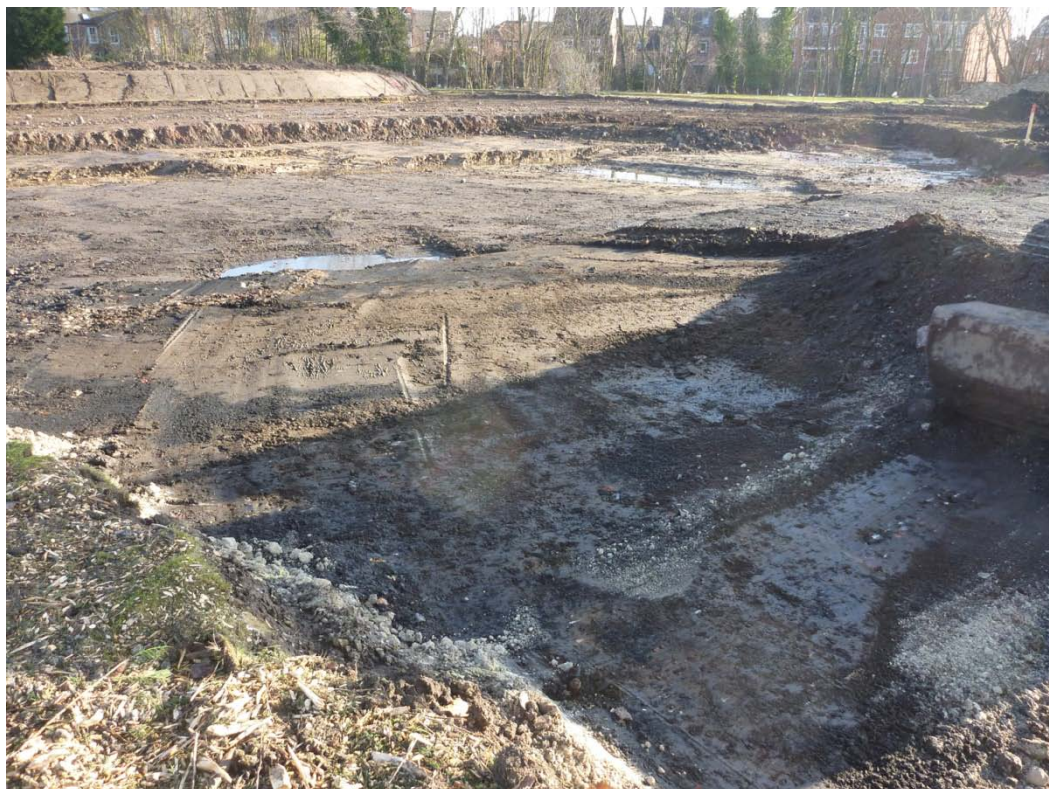
Plate 1 General view of Area S4, looking south-east

Area S4 (Figure 3, Plates 1-4) was cleared in three main sections, during which heavy rain and then snow reduced the opportunity to view successive areas together before the exposed surfaces became weathered, potentially reducing the likelihood of identifying site-wide features. Further small extensions to the north-east were later excavated under archaeological observation following further soil tests. In general, the excavation did not go deeper than approximately 0.70-0.80m BGL, which was the point at which a dark grey-black silty clay identified across the site and containing ash, coal, clinker and modern material gave way to underlying deposits. In many areas, these underlying deposits contained relatively modern material and were considered to represent levelling and dumping of rubbish (see below). Consequently, the opportunities to view natural strata and any potential Roman or medieval features cut into it were very limited.

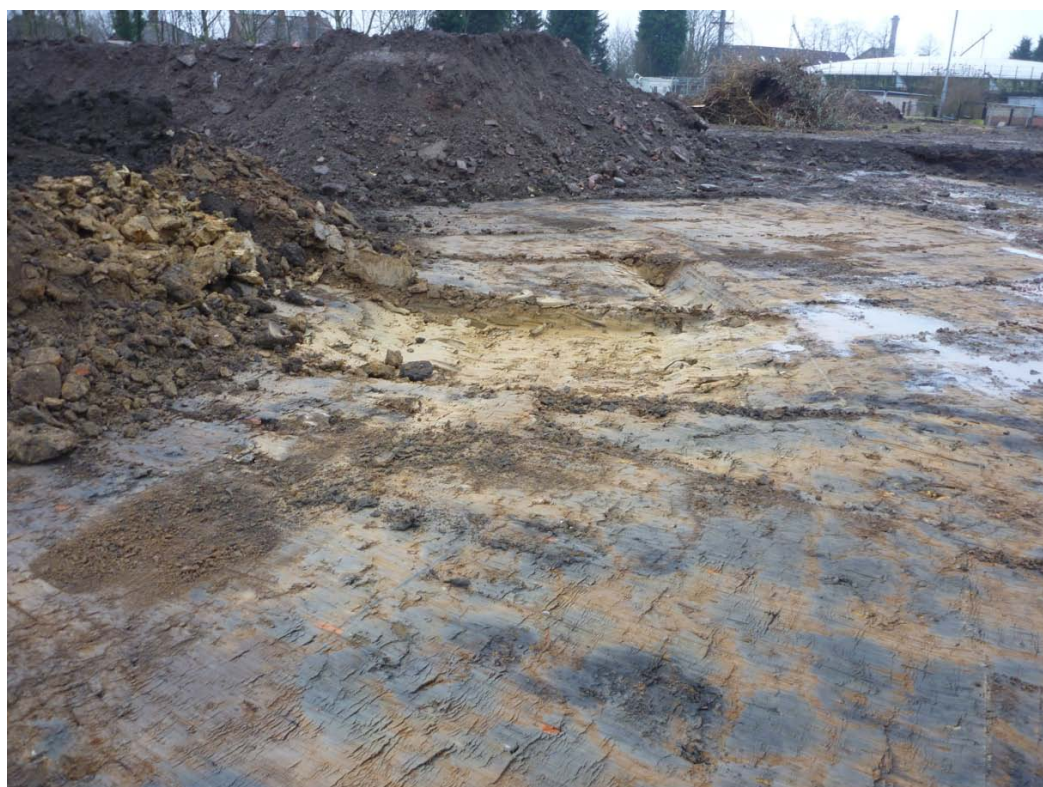
Plate 2 Eastern side of S4, showing Natural 10010 after hotspot removal

The earliest deposit identified in area S4 was an orange sandy clay, context 10010, which was interpreted as natural. This was only seen in the eastern part of S4 at a depth of between 0.80m – 1m BGL, where the backfills of the OAN evaluation trenches 4 and 5 were completely dug out, and in a few small areas where deeper ‘hotspots’ of contaminated material were removed (Plate 2). In general, the excavation did not reach this depth across the whole area, and so observation of natural was limited.

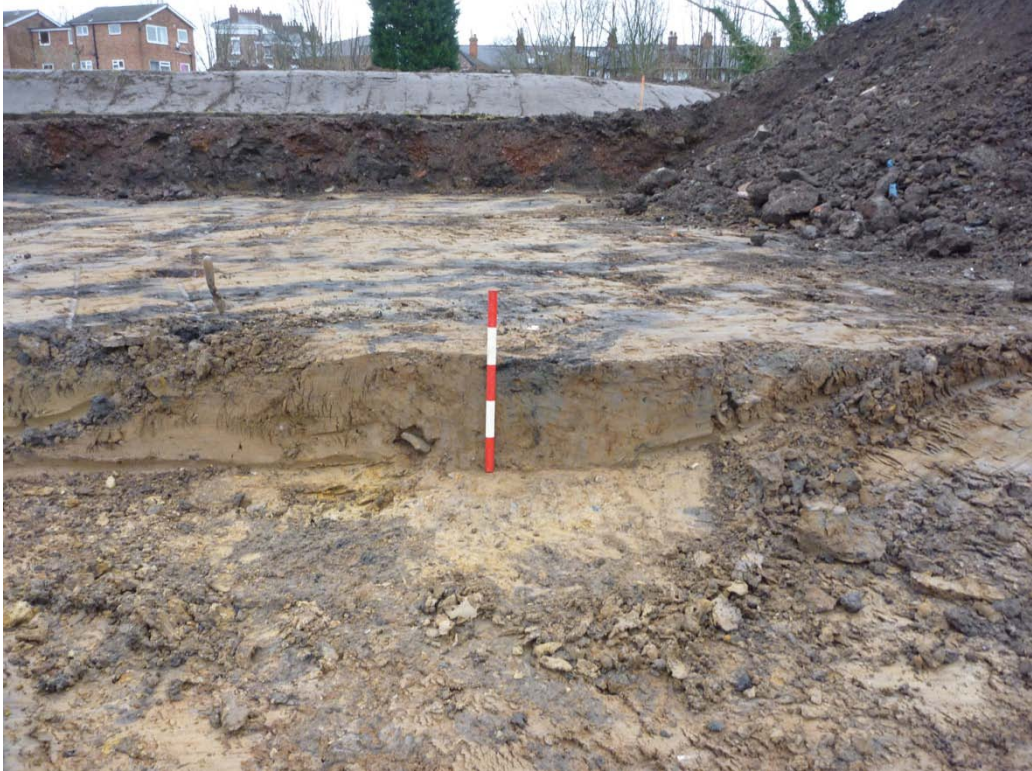
Plate 3 Agricultural soil 10006 in section overlying Natural 10010, looking east

Overlying natural clay in the eastern part of S4 was a layer of pale orange-brown slightly silty clay, context 10006, that was up to 0.35m thick and again observed mainly in the more deeply excavated areas (Plate 3). Although this deposit appeared to derive partially from natural material, it produced residual medieval roof tile and abraded sherds of 18th century pottery, suggesting that 10006 was an agricultural soil that was in use until the turn of the 18th and 19th centuries, and was truncated by later levelling. 10006 was partially exposed in plan at approximately 0.70m BGL across the eastern part of S4 but was considerably mixed with the overlying deposits at the interface between the two.

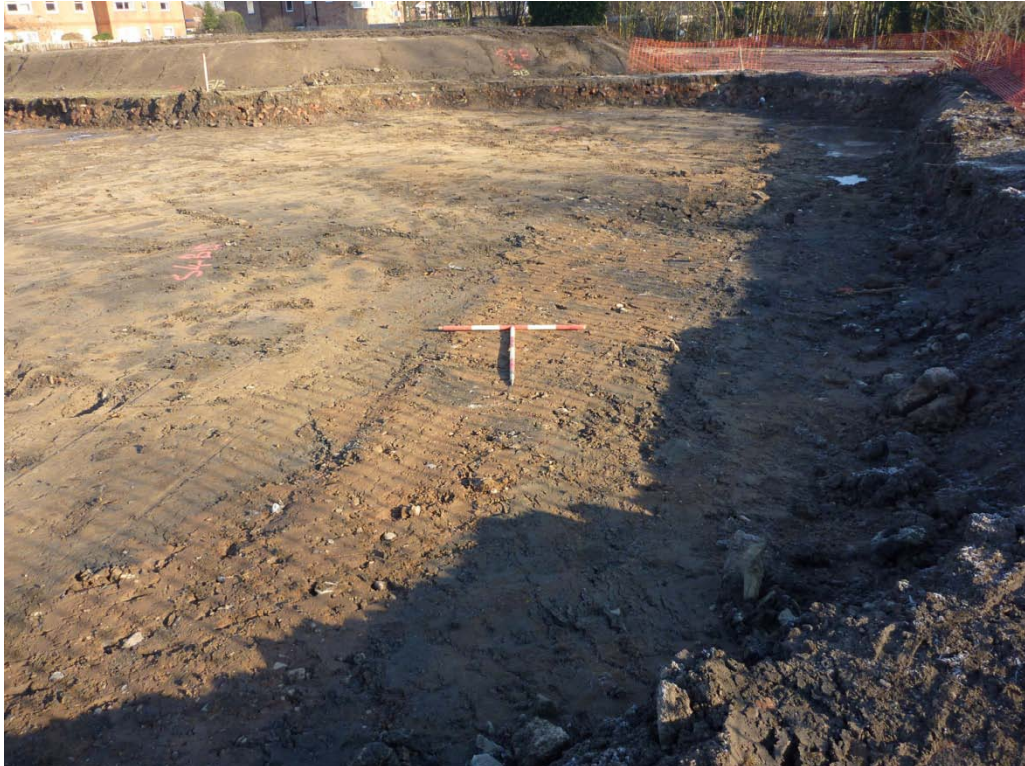
Plate 4 Clay deposit 10009 looking east in eastern side of S4

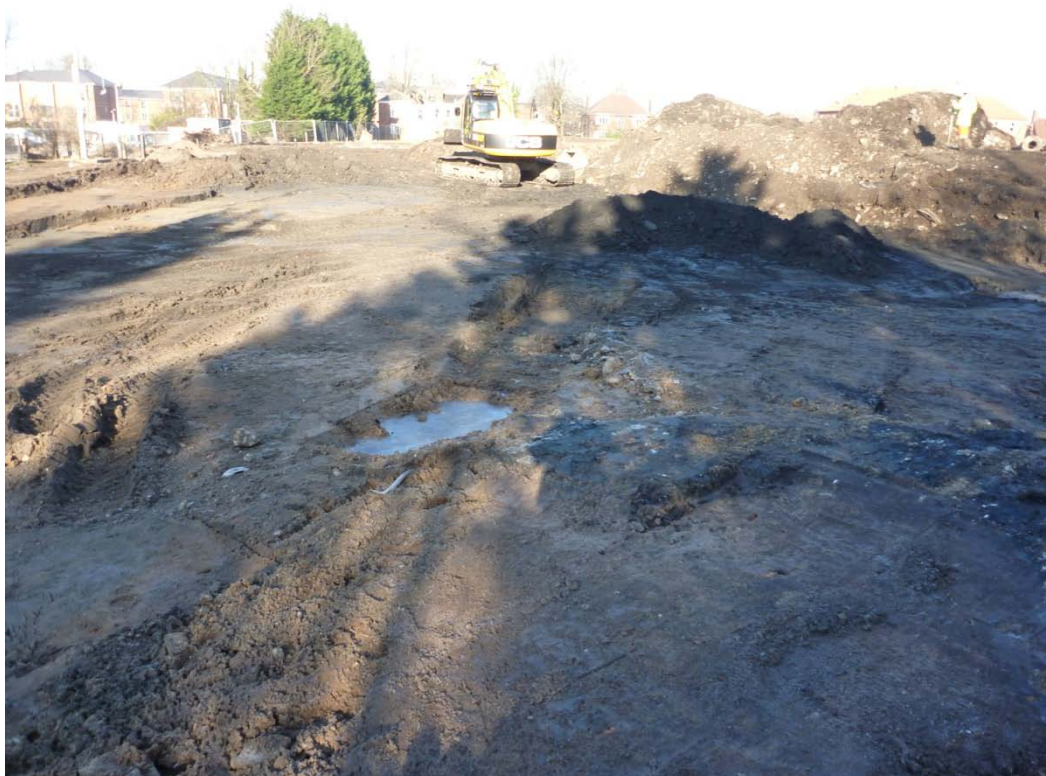
Plate 5 General view of Area S1, looking north

Contaminated deposits in area S1 were removed prior to archaeological observation, in accordance with the specification (Plates 5-7). In general, this entailed excavation to a depth of between 0.70m – 0.80m BGL, save in the south-eastern part, where a considerably greater quantity of contaminated material was observed. Here, deposits up to 1.4m deep were removed, and subsequent testing necessitated the extension of S1 to the north-east in an area measuring c.18m x 17m (Figure 3).

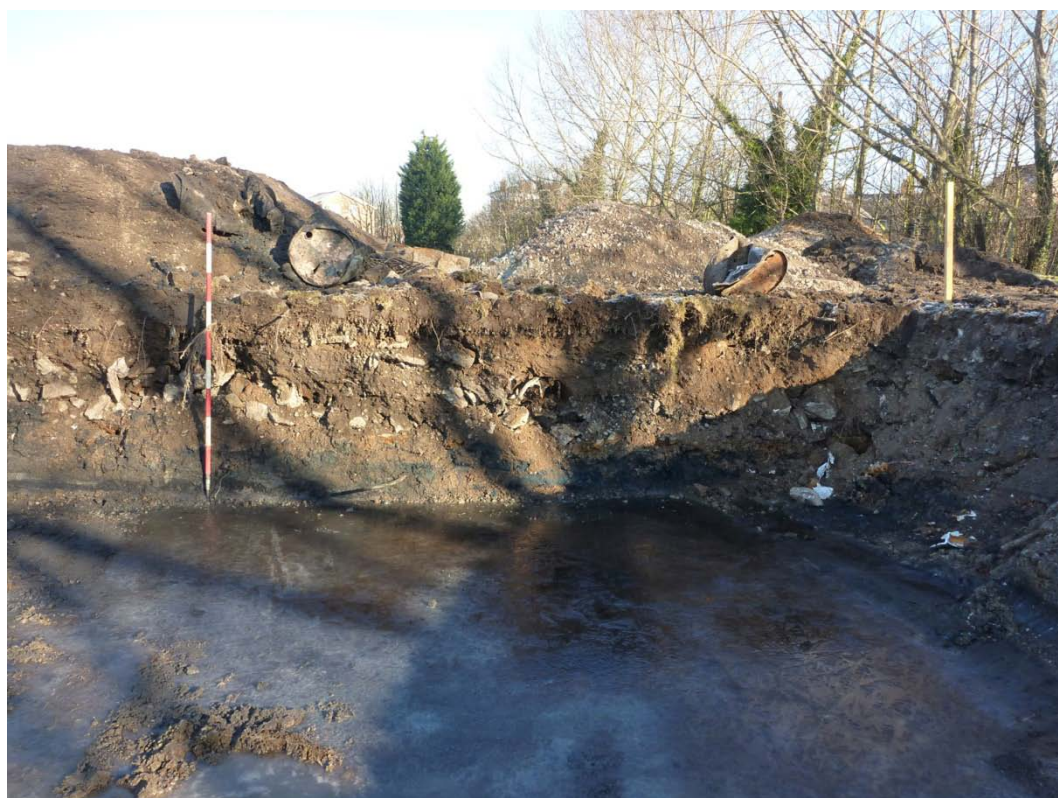
Plate 6 Blue soil 11003 at base of south-west facing section in southern part of S1

The waste levelling, 10002/11002, and later refuse pits represent the use of the site as open ground and possibly as a coal yard as the gasworks expanded its operations into the 20th century. The highly contaminated blue-coloured silts in S1 derive from town gas production and reflect this phase of the site's use. It seems likely, following the cessation of gas-production and conversion to gas storage in the mid 20th century, that the large tank or drain in S1 was inserted as part of the infrastructural redevelopment, and that the area was then levelled and raised with brick rubble to seal contaminated material prior to being grassed over.

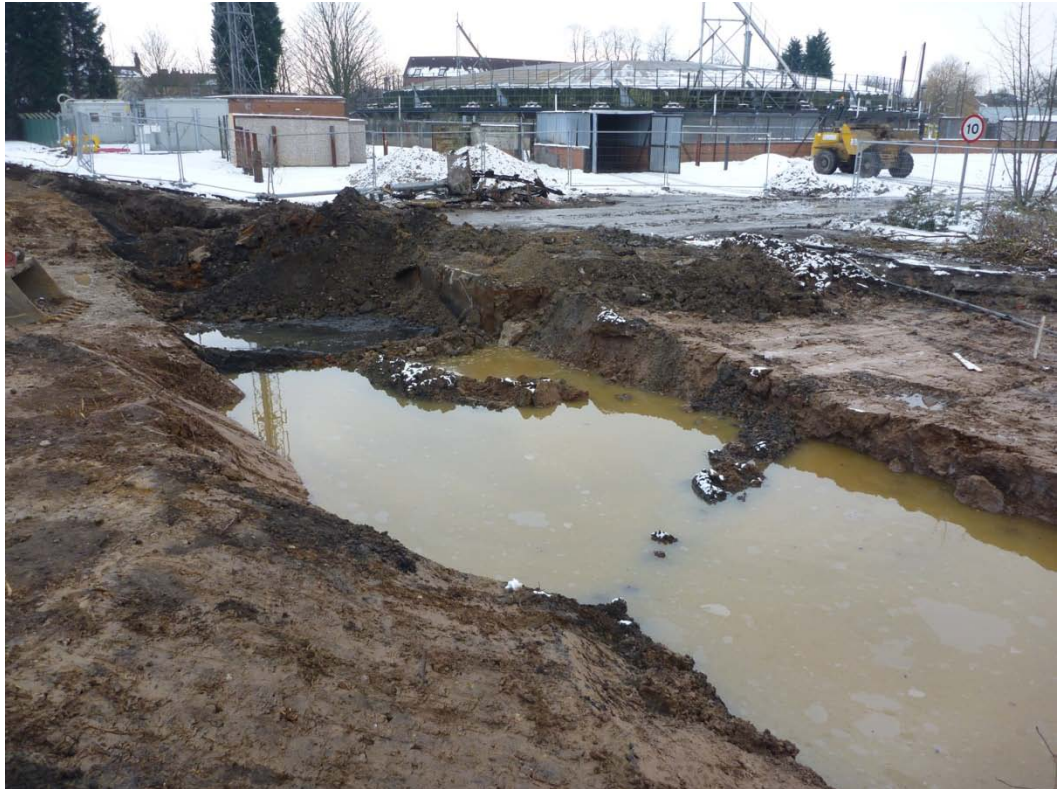
Plate 7 Excavated construction cut 11007 for tank 11006, looking south

Overlying these deposits, and covering the entire area of S1, was 11002, a 0.10-0.20m thick layer of charcoal and ash-rich dark grey sandy silt. This deposit represented the main contaminant to be removed by the contractor, and was considerably mixed with the underlying deposits in the interface as observed in area S4. Cut into this deposit, and therefore of 20th century date, was a very large concrete-lined drain or tank, 11006. This measured approximately 25m x 10m wide and was oriented NNW-SSE along the boundary of the grassed area and the car-park to the west of it. This feature was at least 3m deep, and when excavated was full of water and too deep to enter and record in detail (Plate 7). The base, when briefly exposed, was clearly cut deeply into the underlying natural deposits and no features were observed in the section of its construction cut, 11007.
