**LOTHERTON HALL, ABERFORD,
WEST YORKSHIRE**

**EARTHWORK SURVEY, STRIP AND RECORD AND
GEOTECHNICAL TEST PITTING REPORT**

REPORT NUMBER 2012/28

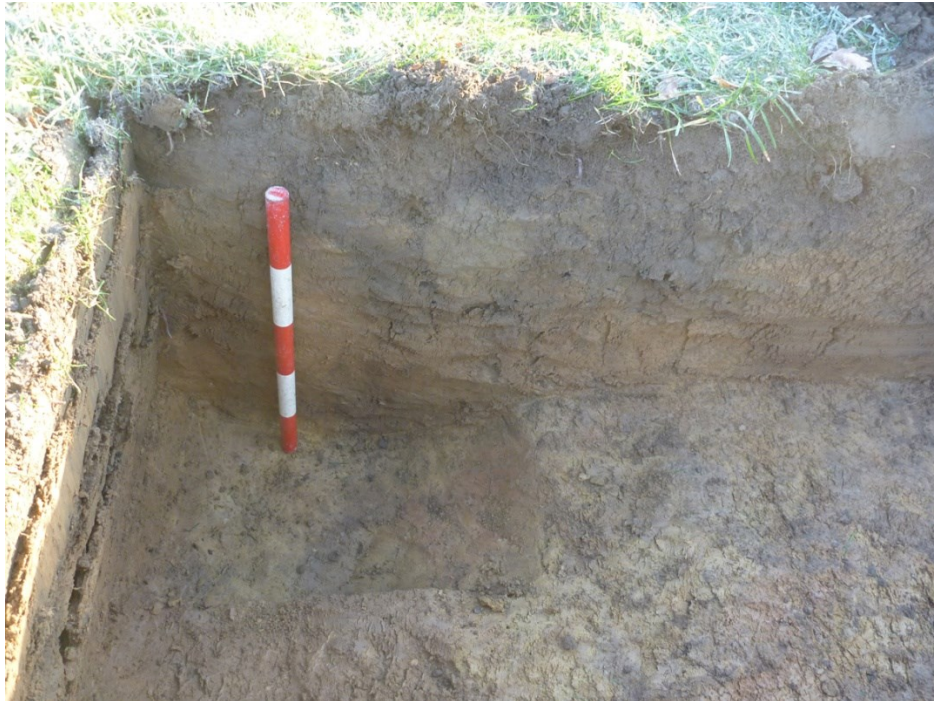
Plate 1 Gully 1004 in the west facing section of Test Pit 1

Test Pit 1 measured 0.70m x 3m long and was aligned north-south. The earliest recorded deposit was 1005, a firm yellow-white sandy clay with patches of stiff red-brown clay that was observed at 0.45m BGL and interpreted as natural. At the northern end of the trench natural was cut by a possible ditch or gully, 1004, which was aligned east-west and at least 0.40m wide and 0.25m deep, with its northern edge lying beyond the northern limit of excavation (Plate 1). This gully was shallow and probably truncated by later ploughing, with the base sloping up very slightly at the limit of excavation, suggesting a probable total width of c.0.60m. 1004 was filled with 1003, a firm slightly red-brown clayey sandy silt that was distinct from the overlying deposit 1002, a 0.38m deep firm light yellow-brown very sandy silt

with occasional pebbles and charcoal flecks. This deposit was interpreted as forming the bulk of an extant medieval plough ridge through which the test pit was been cut, and was overlain by the topsoil, a 0.12-0.18m thick soft, slightly orange mid-brown very sandy silt. The interface between this and the probable ploughsoil was disturbed by the roots from nearby trees.

The ridges were all well-preserved, with up to 0.35m of material surviving, although this was generally less well-preserved in the western area of the garden. The possible gully in TP1 was very ephemeral but did contain a distinct fill; it is possible that this represents a remnant of an earlier field system sealed below the medieval ploughing, but it is also possible that it is a natural undulation in the geological deposits. No other archaeological features were observed in this area.

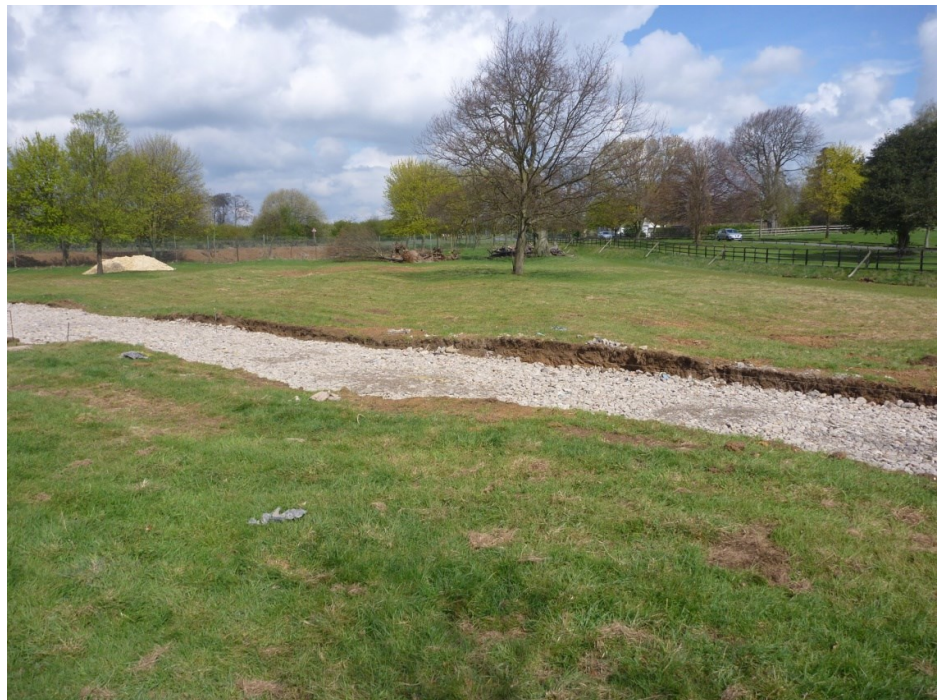
Plate 3 Ridge and furrow in the central part of the new access road, looking N

At the point where the road cut through the ridge and furrow some seven ridges and eight furrows were present. These represent the remains of a former arable field system. The spacing of the ridges and furrows is typically some 7m–8m apart. Such spacing is suggestive of a medieval date, a factor seemingly borne out by its forming part of what is a much more extensive system. From the base of the furrows to the top of the ridges heights of up to 400mm are common, particularly in the central area which is more pronounced. To the western extremity the ridge and furrow is less pronounced, this may be due to works associated with the adjacent public highway which is somewhat elevated in relation to the deer-park in this area. Tree planting activity in recent decades may also have served to lessen the upstanding character of the system in this area. The eastern side of the deer-park in this area is demarcated by a 'deer-proof' boundary that appears to have cut through the ridge and furrow system. This boundary follows the classic form of an internal ditch and a very low external bank surmounted by a pale or fence; albeit one created in the 1970s. The ditch itself is typically less than 1m deep though in many places in excess of 5m wide whilst the external bank is barely higher than the ridges of the adjacent field system. The pale is fabricated of steel tall steel fencing posts and wire mesh. The short stretch of new road between the deer fence and the existing road cuts through a grassed area. This ribbon-like grassed area appears fairly flat and no ridges or furrows can be seen within it. That this is so indicates that any such features have been removed, perhaps during a levelling process associated with the construction of the existing roadway.

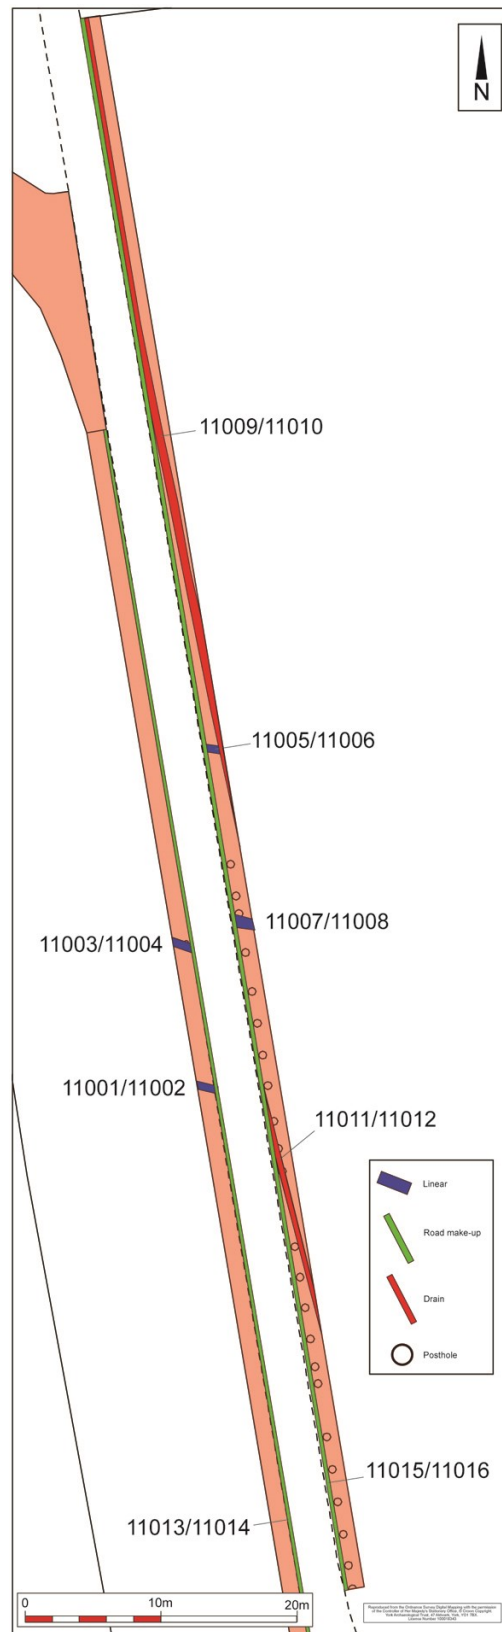
Figure 4 Detail of the northern road widening

The existing road is positioned on a slightly raised corridor of land, which consists of a modern make-up deposit of crushed limestone (Figures 3 and 4). The construction of the road had removed virtually all trace of the ridge-and furrow either side of it, leaving only the most ephemeral of traces.

Several features were identified (Figure 4, Plates 6-10), most of which probably cut through the topsoil, except for the earliest identified features, which were four linears aligned WNW-ESE (fill/cut 11001/11002, 11003/11004, 11005/11006, 11007/11008), one of which, 11007/11008 was very ephemeral. These consisted of shallow trenches up to 0.48m wide and 0.10m deep that were interpreted as possible truncated medieval furrows. 11001/2 and 11003/4 were identified in the western widening trench, about 10m apart. 11005/6 and 11007/8 were identified in the eastern side and were similarly spaced; 11007/8 may represent the plough-smeared continuation of 11003/4 on the western side. The fills of these features consisted of a compact-friable, red-brown gravelly sandy silt.

Visible along both trenches (but only illustrated in Figure 4 in the eastern trench) was a line of modern postholes at intervals of c.2.4 – 2.6m that were the remnants of a low fence flanking the existing roadway, grubbed up by the machine prior to excavation. These were not numbered.

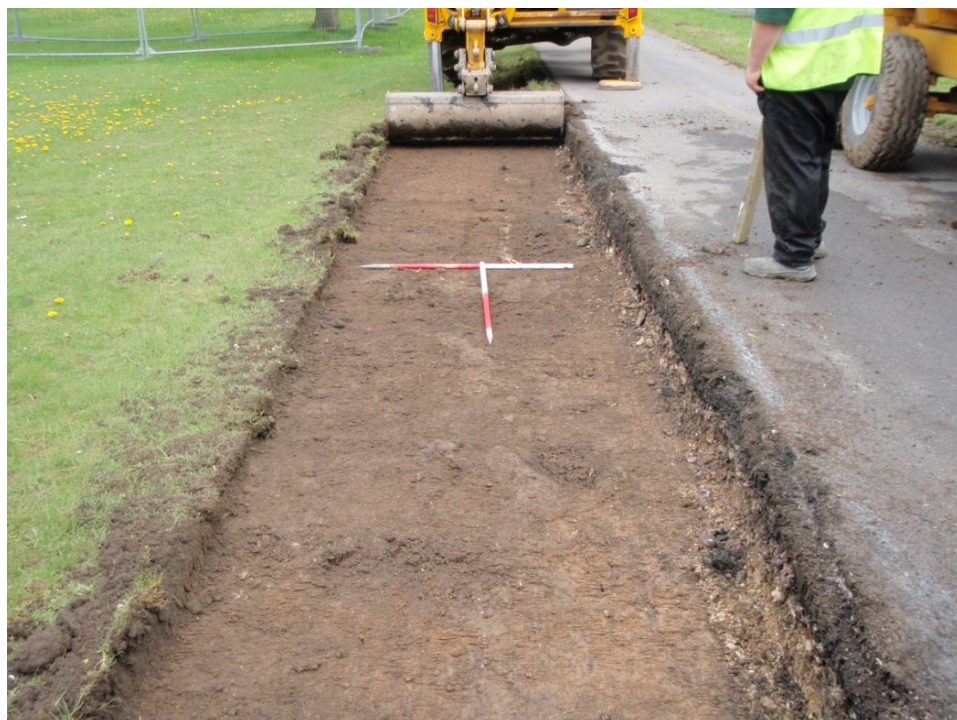
Plate 4 Sample view of northern road widening, west side, looking north

The shallow depth of the excavation, at only 0.25m below the surface of the road, meant that only the topsoil was removed to its interface with a sub-soil. Topsoil, context 11000, consisted of a soft, dark grey, slightly clayey sandy silt, and lay over a subsoil that was a firm, mid orange-brown, slightly clayey sand with occasional charcoal flecks (context 2017). This interface between these two deposits had been exploited by plant roots, especially by trees, which on occasion made the distinction between the two difficult to determine. In some places, topsoil remained *in situ* after the depth had been attained. This occurred in the southern 25m of the western trench and the northern 50m and southern 8m of the eastern trench. Between 27m and 33m from the northern end of the eastern trench, the depth of soil in the eastern section dropped from c. 0.10m to 0.05m, possible representing the remains of a medieval plough ridge.

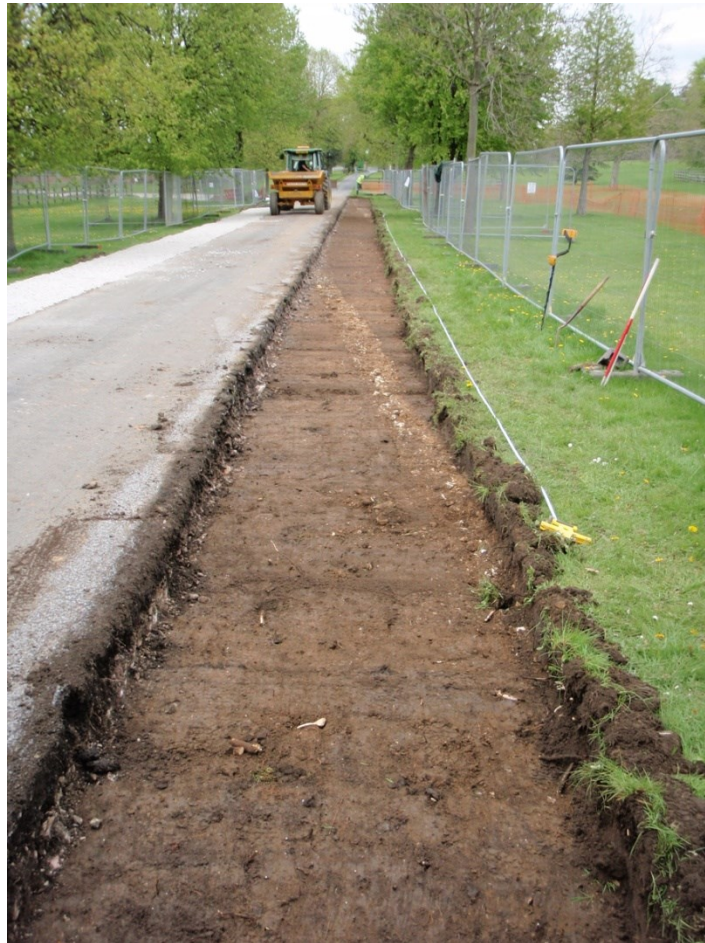
Plate 10 Drains 11009 and 11011, looking north

The eastern widening trench also contained two linears aligned NNW-SSE, 11009/11010 and 11011/11012. These were up to 0.40m wide, consisted of compacted crushed limestone fragments in vertically sided trenches and were interpreted as modern land drains. 11010

was cut through the furrow fill 11005, and on this basis the drains were grouped above the possible furrows.

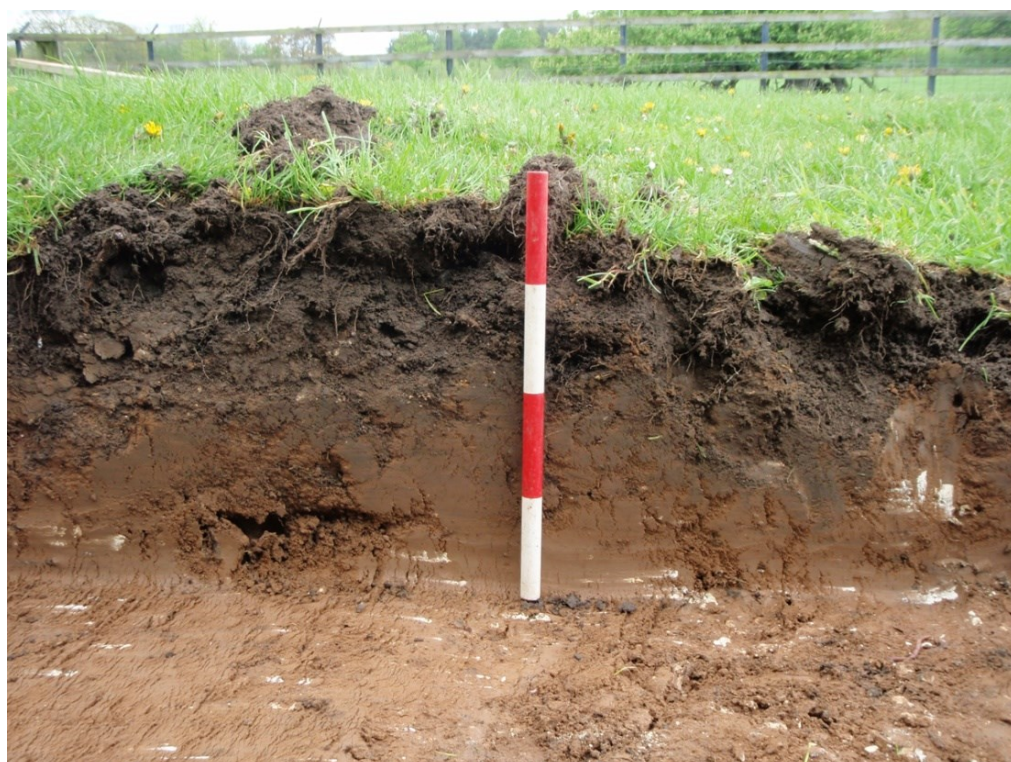
Plate 13 East facing section of southern turning circle

The depth of topsoil decreased as the excavation proceeded southwards, from c.0.25m at the entrance booth to 0.15m about 20m along, before increasing again to around 0.27m within the southernmost turning area. On the eastern side, south of the entrance booth, the verge beside the road formed a low rise above the level of the existing roadway, creating a 0.50m deep trench in which the possible interface between the sub-soil and natural clayey sand with frequent limestone fragments was exposed for c.4m between 15 and 19m south of the entrance booth.

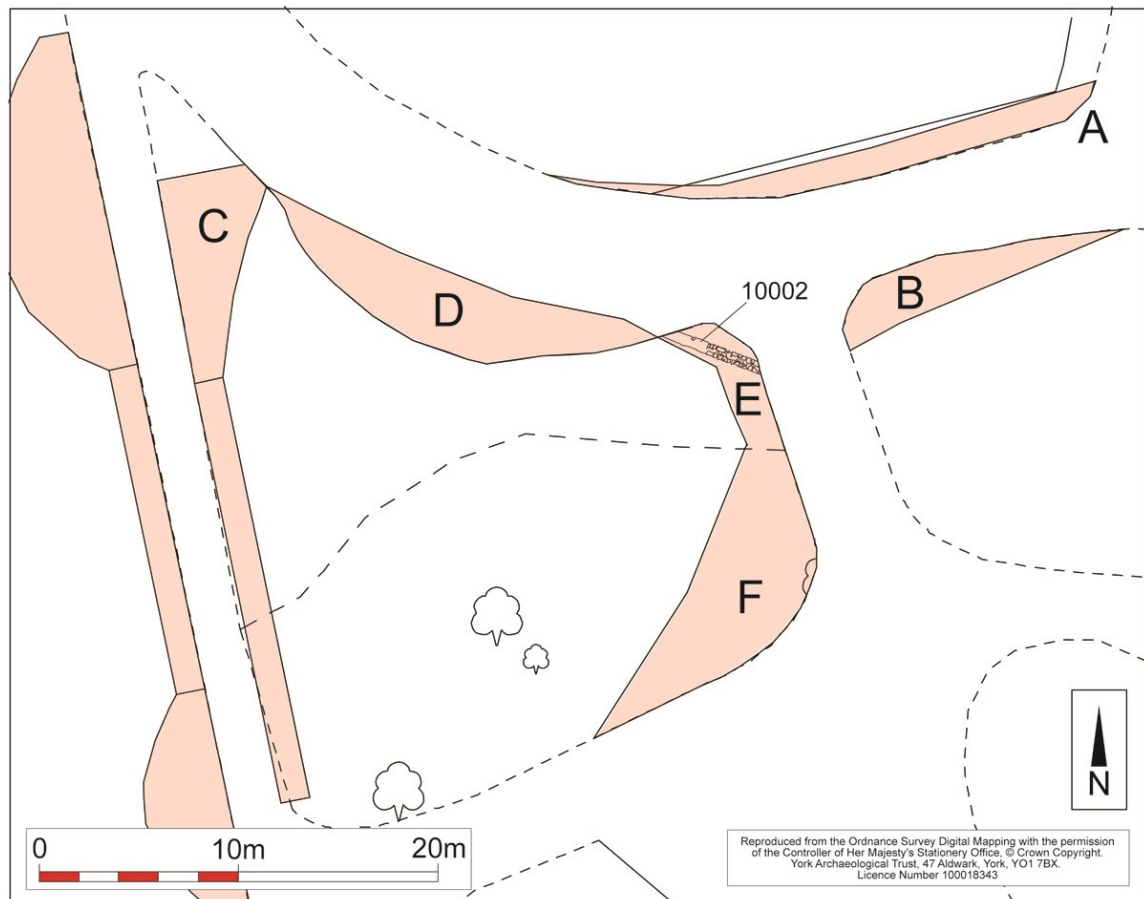
Figure 5 Detail of car park entrance area

The complex of grass islands created by the network of small lanes behind the entrance booth was also altered under observation (Figure 5). These were divided into 6 areas, lettered A to F, which effectively represent the widening of the lanes to create a quasi-roundabout (Plates 16-26).

Areas A and D exposed the crushed limestone road make-up at 0.05m BGL. In area B, the excavation ceased at 0.30m BGL, just at the interface between topsoil and subsoil. A 0.40m wide service cut ran through on a N-S alignment; this was not excavated below the depth limit. Area C, located behind the entrance booth, was only 0.25m deep and contained crushed hardcore overlying a firm orange-brown clayey sand subsoil that was riddled with tree roots. The southern end of area C extended into the eastern side of the roadway widening trench described above.

Areas E and F contained the only significant structural archaeological remains exposed during the northern half of the road widening operation. In area E, a large wall foundation was exposed and numbered 10002 (Figure 5, Plates 23 and 24). This was c.0.60m wide and

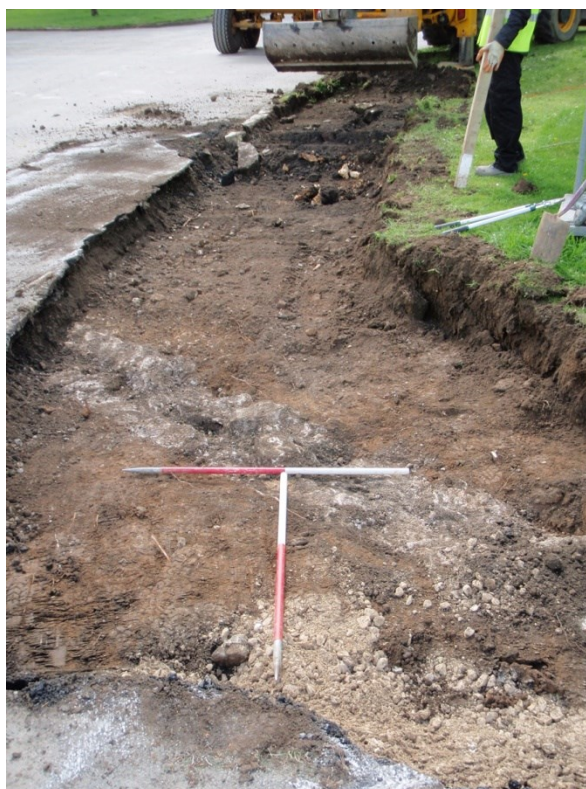
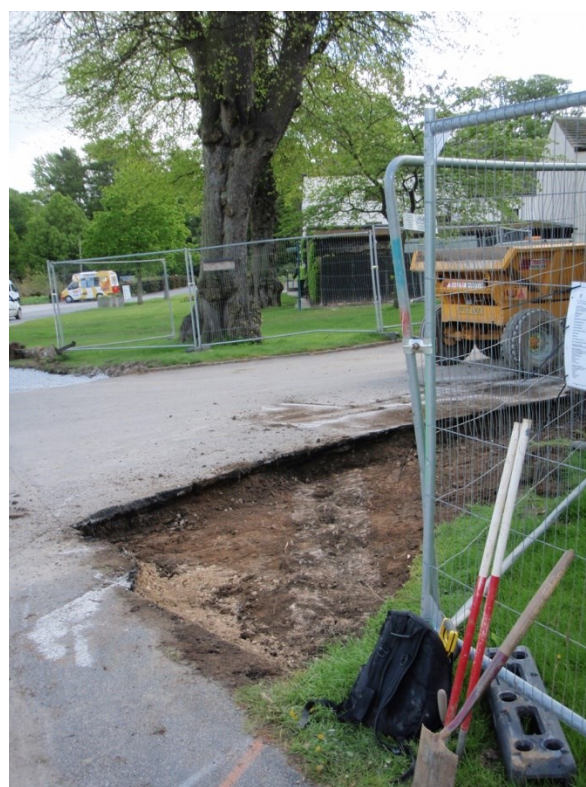
Plate 23 Area E, looking south, showing wall 10002

constructed of rough-hewn limestone facing blocks with a rubble core. The wall was revealed at 0.30m below the road way, and was aligned NW-SE, seeming to line up with the edge of the extant stables and coach house block some 35m to the SE. Immediately south of this wall, a disturbed loose topsoil produced a small quantity of late C19th / early C20th pottery and glass (see appendix 1); this deposit, 10001, probably represents a dump of waste material used as a levelling deposit during landscaping. This was further evidenced in area F by an apparent earlier surface of clinker that lay at 0.20 BGL beneath modern topsoil and subsoil, and sealed a further deposit of subsoil that was exposed to a depth of 0.08m in the base of the excavation.

This activity can probably be associated with the creation of the deer park during the 1970s, when the Lotherton estate was adapted for public access by the City of Leeds. The wall is large enough to have formed the front of a building, but with no evidence for a return or a parallel rear wall, it may be that it was a boundary springing NW from the stable buildings that survive today.

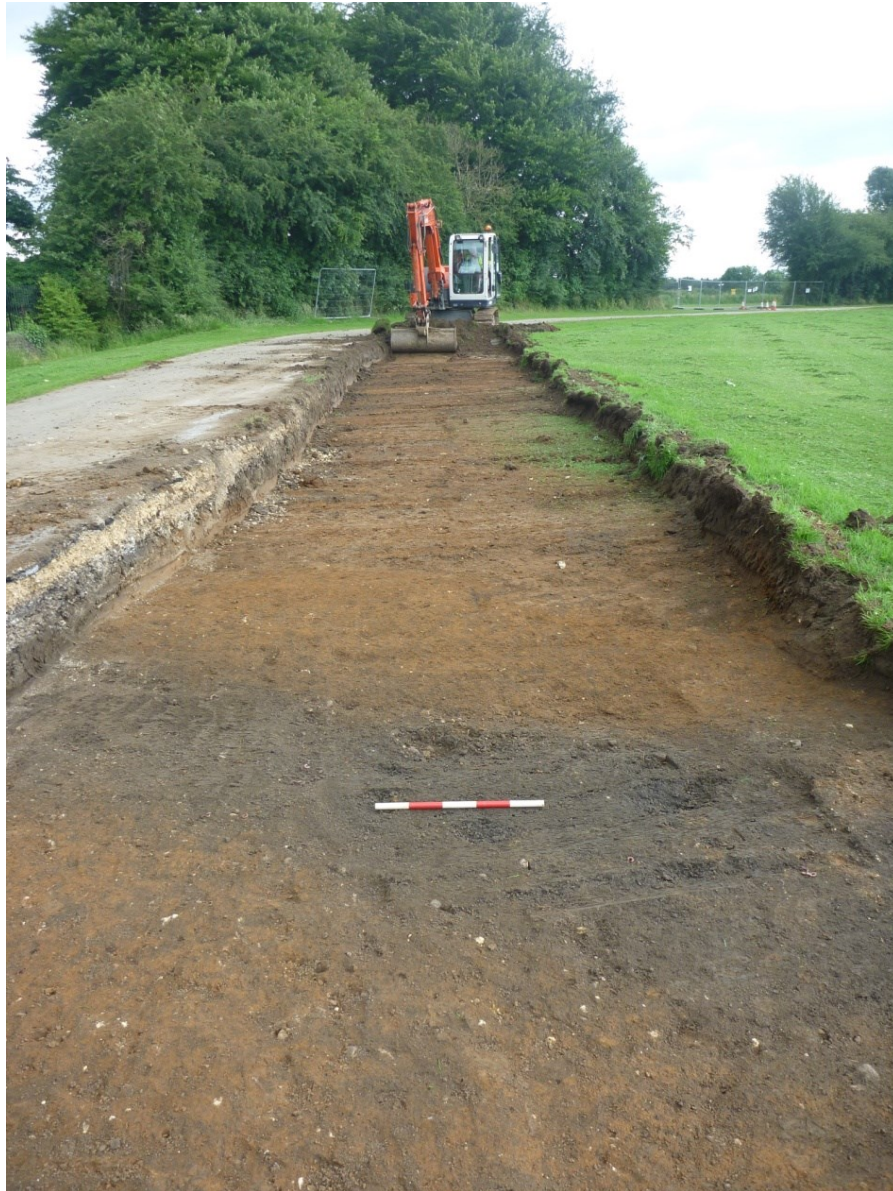
Plate 28 Ditch like furrow 12014, looking SSE

Ridge and furrow is again present to the sides of the existing road in much of this southern part of the site, though is somewhat less visible within a narrow strip immediately adjacent to the road. Away from the road the ridge and furrow, whilst largely traceable on the ground, is not at all prominent. A number of sections of the ridge and furrow were drawn and the positions of these are shown in Figure 6. Within these sections the cuts of the furrows were again seen to be generally very shallow and it was not possible to draw a meaningful distinction between the soil at the top of the ridges and that at the bases of the furrows. The fairly indistinct character of the ridge and furrow may in part relate to truncation or compaction caused by post-medieval land-use. Alternatively, it may be resultant upon its never developing substantial height and depth characteristics during the medieval period. The only exception to this was in the central part of this area where a particularly wide and deep furrow cut, context 12014, with a pale brownish grey silty fill, context 12015, is present (Plate 28). It is possible that this feature represents a division within an open ridge and furrow field that served to delineate the strips on one side from those on the other. As such this may have functioned as a ditch-like boundary.
