SITE ADDRESS	Park Gate, Blansby Park Lane, Pickering, North Yorkshire						
CLIENT NAME		Smiths Gore					
YAT PROJECT#	5632 YAT REPORT # 2012/34						
MUSEUM ACCESSION #	HUHFM:2012.41	GRID REFERENCE	SE 8079 8587				
PLANNING REFERENCE #	NYM/2012/0288/FL	NYM/2012/0288/FL AAI OPS NOTICE # NA

INTRODUCTION

A watching brief was undertaken by York Archaeological Trust, acting on behalf of Smiths Gore, on a site at Park Gate, Blansby Park Lane, Pickering, North Yorkshire (Figures 1-2, NGR 8079 8587). The watching brief was in advance of the construction of a new agricultural building at the northern end of the site, the excavation of a new septic tank pit with associated services trenches at the southern end of the site and the excavation of a soakaway pit on the eastern boundary of the site (Figure 3).

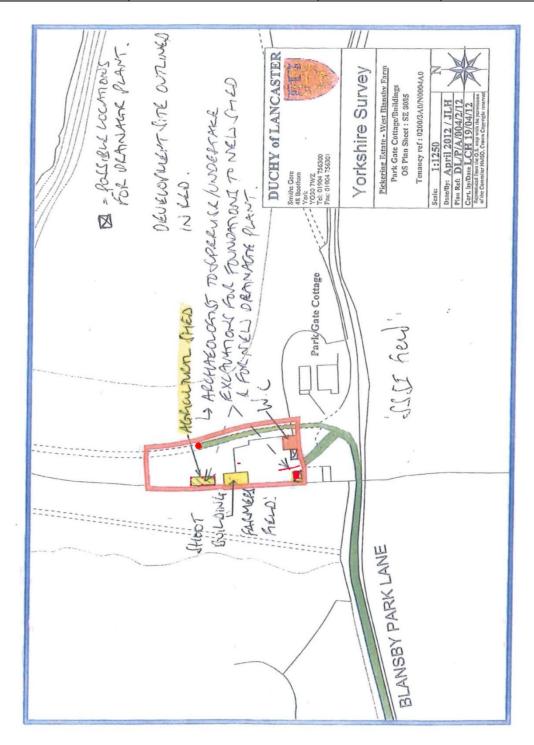
Figure 3 Developer supplied plan showing the location of the observed works in red.

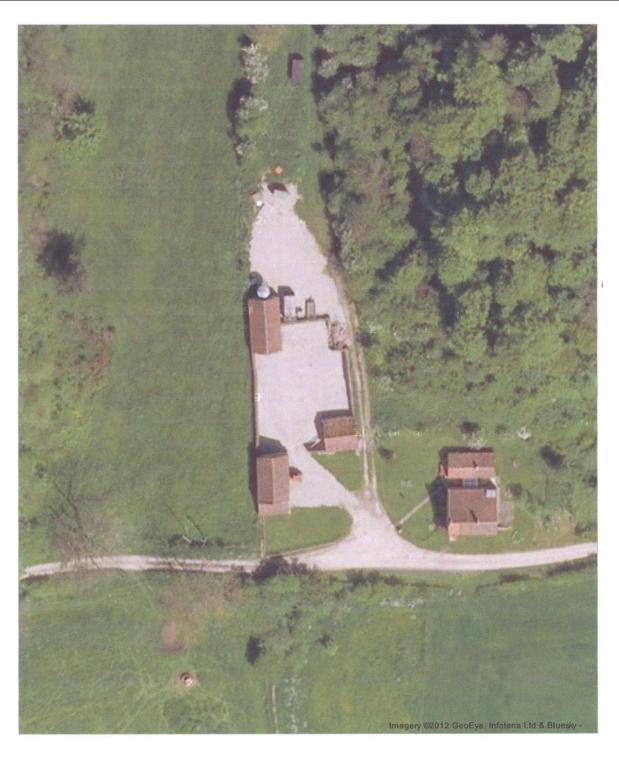
Figure 4 Aerial view of the site © Google Maps.

The site lies in a small valley, which is aligned north-south, and slopes down towards the south (Figure 4). The site comprises an almost rectangular shaped yard at the southern end of the site, with a small access lane to the east leading to a second yard directly to the north. There are three buildings within the development area; the first building is aligned with the long-axis north-south, and lies to the immediate south of the south-western corner of southernmost yard, The second building is aligned with the long axis east-west and is located within the south-eastern corner of southernmost yard, and the third building is aligned with the long axis north-south, the southern half of this building being in the north-western corner of the southernmost yard and the northern half of the building is in the south-western corner of the northernmost yard. The southernmost yard was bordered by walls on all sides except the southern side which was a gate between two buildings. The northernmost yard had a barbed wire fence on the western side and a wall and gate on the southern side, while the northern and eastern sides were unfenced. To the south-east of the site is a cottage, to the east and north the land is wooded, while to the west the site is a grassed field with woodland on the opposing valley slopes to the west. The western boundary of the development site is at the lowest point of the valley.

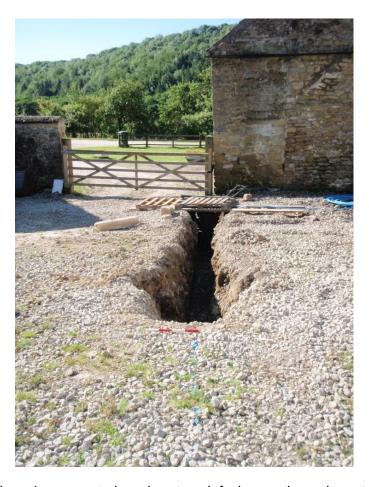
Prior to the commencement of the watching brief a services trench 10m long, 0.4m wide and a maximum of 0.9m deep had been excavated (Plates 1-2). The southern end of the trench was located close to the western gate post on the southern side of the southernmost yard, and the trench was aligned north-north-west (heading towards the south-eastern corner of the building in the north-western corner of the southernmost yard). The uppermost deposit observed was a layer of modern limestone chippings 0.25m thick (Context 1000), which incorporated very occasional fragments of pan tile and one fragment of wood from a modern fence or gate post, which lay horizontally within the limestone chippings. Beneath this was naturally occurring light yellow-brown sandy-clay with occasional fragments of angular limestone. Nothing of archaeological interest was observed within the trench.

Plate 1 View along the excavated services trench facing south-south-east, scale unit 0.1m.

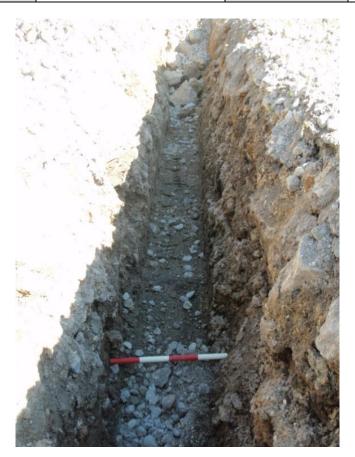
Plate 2 View along the excavated services trench facing north-north-west scale unit 0.1m.

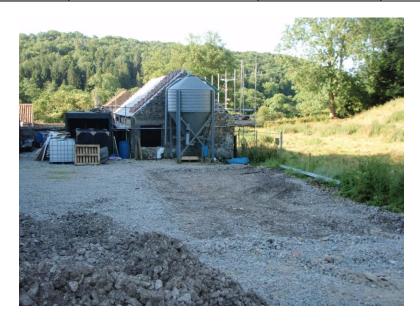
The main focus of the watching brief was observing the excavations associated with the construction of a new agricultural building, 10m x 5m in size, located on the western limits of the northernmost yard, 5m to the north of the building in the south-western corner of the yard. Prior to the commencement of the watching brief an area 13.8m x 5.5m had been cleared to a depth of 0.25m (Plate 3). The deposit which had been removed was a layer of modern limestone chippings (Context 2000), the chippings being up to 95mm x 65mm x 50mm in size, but typically being 40mm x 40mm x 35mm in size. The chippings were in a matrix of dark grey silt, which had clearly washed down between the stones from the surrounding landscape. The limestone chippings of both Context 1000 and 2000 were quarry waste from a nearby quarry which had been used recently to create even surfaces over the two yards.

Plate 3 The area of the new building prior to the watching brief, facing south, scale unit 0.1m.

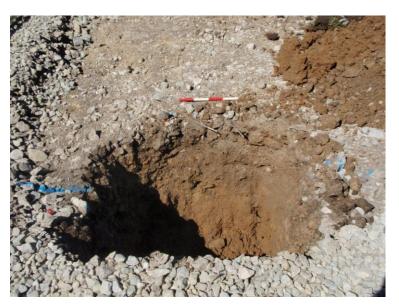
Pit 1 (Plate 4) – This was located at the south-eastern corner of the proposed building, was 1m² and 1m deep. The uppermost 0.3m was of limestone chippings in a matrix of dark grey silt (Context 2001), which was clearly of modern date. This was above a deposit 0.2m thick (Context 2002) which comprised featureless grey silt, which in turn sealed naturally occurring light yellow-brown natural sandy-clay (Context 2003).

Plate 4 Pit 1, facing west, scale unit 0.1m.

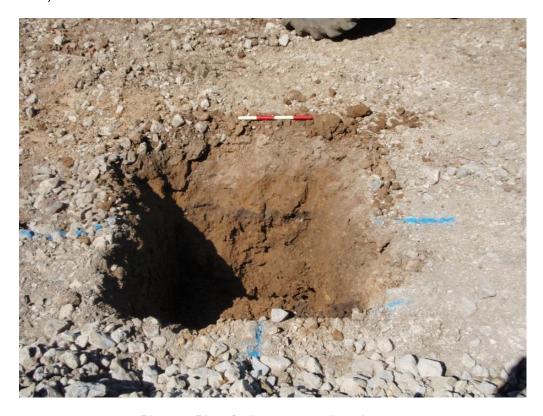
Pit 2 (Plate 5) – This was located midway along the eastern side of the proposed building, was 1m² and 1m deep. The uppermost 0.3m was of limestone chippings in a matrix of dark grey silt (Context 2004), which was clearly of modern date. This was above a deposit 0.3-0.4m thick (Context 2005) which comprised grey silt with frequent angular stone fragments. This sealed a 0.1m thick deposit of dark grey silt (Context 2006) which in turn sealed naturally occurring light yellow-brown sandy-clay (Context 2007).

Plate 5 Pit 2, facing west, scale unit 0.1m.

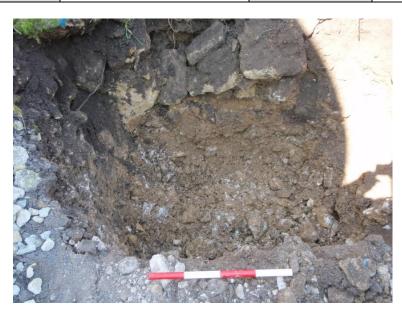
Pit 3 (Plate 6) – This was located on the south-western corner of the proposed building, was 1m² and 1m deep. It was located 1.2m east of the line of the barbed wire fence. The uppermost deposit comprised limestone chippings in a matrix of dark grey silt (Context 2008), which was clearly of modern date. This was 0.4m thick on the western side of the pit, but extended to a depth of 0.6m on the eastern half of the trench. Beneath this there was a deposit, largely concentrated in the western half of the pit, which comprised a band of large irregular stone blocks (Context 2009), the stones being up to 0.9m x 0.6m x 0.3m in size; given its location this deposit probably represented the remains of a boundary wall, but it had clearly been dismantled and robbed out at some stage, with the stones being dumped in an irregular manner. There was no sign of mortar associated with the stones, and no artefacts were present to enable the date of the robbing to be established. The stones were above naturally occurring light yellow-brown sandy-clay (Context 2010).

Plate 6 Pit 3, facing west, scale unit 0.1m.

No artefacts were recovered from any of the stanchion pits, and the only occupation derived deposit observed was Context 2009 in Pit 3, comprising a dump of stones suggestive of a robbed/dismantled wall. This was not observed in either of the pits to the north (Pits 4 and 5) though stray stones were present in these trenches which presumably originated from a similar source. It was determined that the trenches required for the sides of the proposed new building would only penetrate into the uppermost deposit of modern limestone chippings seen across the site, and the decision was therefore taken not to observe the excavation of these foundations, as no features of archaeological importance would be disturbed.

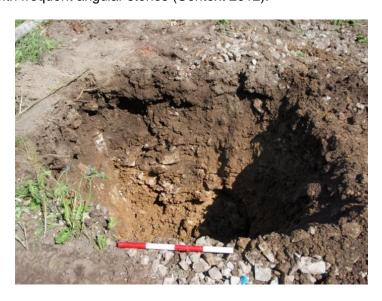
Pit 4 (Plate 7) – This was located midway along the western side of the proposed building, was 1m² and 1m deep. It was located 1.2m east of the line of the barbed wire fence. The uppermost deposit was 0.65m thick and comprised limestone chippings in a matrix of dark grey silt (Context 2011), which was clearly of modern date. Within Context 2011 there were occasional large irregular limestone fragments, similar to those of Context 2009, which had presumably also originated from the robbing/demolition of a boundary wall. Context 2011 sealed naturally occurring light yellowbrown sandy-clay with frequent angular stones (Context 2012).

Plate 7 Pit 4, facing north, scale unit 0.1m.

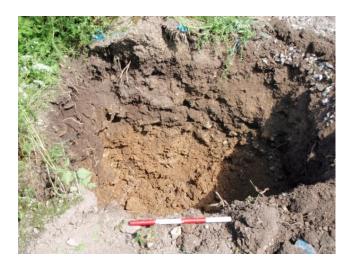
Pit 5 (Plate 8) – This was located at the north-western corner of the proposed building, was 1m² and 1.3m deep. It was located 1.2m east of the line of the barbed wire fence. The uppermost deposit was 0.7m thick and comprised dark grey silt with frequent limestone chippings (Context 2013), which incorporated irregular fragments of stone up to 0.46m x 0.30m x 0.20m in size. This sealed naturally occurring light yellow-brown sandy-clay with frequent angular stones (Context 2014).

Plate 8 Pit 5, facing north, scale unit 0.1m.

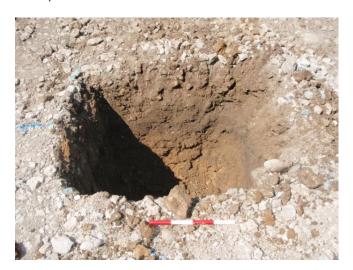
Pit 6 (Plate 9) – This was located at the north-eastern corner of the proposed building, and was 1m² and 1.2m deep. The uppermost deposit was 0.3m thick and comprised a mixture of limestone chippings and dark grey silt (Context 2015). This sealed a deposit of dark grey silt 0.3m thick (Context 2016) which was above naturally occurring light yellow-brown sandy-clay with frequent angular stones (Context 2017).

Plate 9 Pit 6, facing north, scale unit 0.1m.

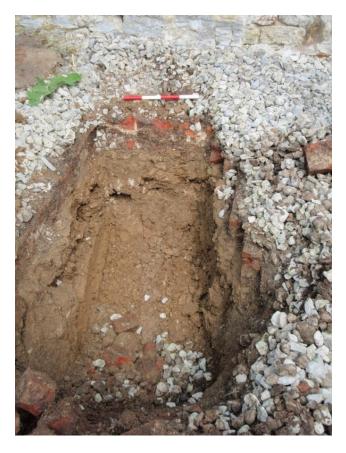
In addition to the excavation of the stanchion pits a small test pit (Plate 10) was excavated on the line of proposed services trench in the southernmost yard. This trench was located 0.6m south of the northern wall of the southernmost yard and 3.4m east of the building in the north-western corner of the southernmost yard. The test pit was 0.8m wide, 3m long, and 0.7m deep, and was aligned with the long axis north-south. The uppermost deposit was 0.15m thick and comprised modern limestone chippings (Context 3000). This was above a brick floor (Context 3001) made from slop moulded bricks 215mm x 111mm x 71mm in size; these bricks dated from the latter half of the 18th or early 19th century. The brick floor lay directly above naturally occurring light yellow brown clay with frequent small angular stones (Context 3002).

Plate 10 Service trench text pit, facing north, scale unit 0.1m.

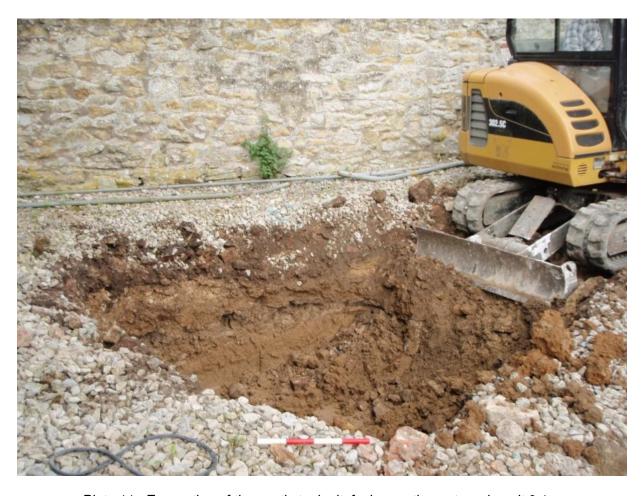
A trench was excavated for the insertion of the septic tank, this was 1.6m north of the extant building to the south-west of the southernmost yard, 1.1m to the east of the southernmost yard boundary wall, measured 2.8m x 2.5m in area and excavations were observed to a depth of 2.7m below ground level. The uppermost deposit (Context 4000) was a layer of limestone chippings 0.2m thick. The sealed a deposit of mixed limestone chippings and dark grey silt 0.25m thick (Context 4001) which was only visible in the westernmost section (Plate 11). In the west facing section there was a deposit 0.15m thick of mid-dark brown silty clay from which no artefacts or dating evidence was recovered (Context 4002). This deposit could not be examined in detail as the sides of the trench were too unstable to enable close access. Context 4002 sealed naturally occurring light yellow sandy clay which extended to a depth of 2.4m below ground level (Context 4003) at which point underlying limestone bedrock was encountered (Context 4004). The completed septic tank pit is illustrated on Plate 12.

Plate 11 Excavation of the septic tank pit, facing north-west, scale unit 0.1m.

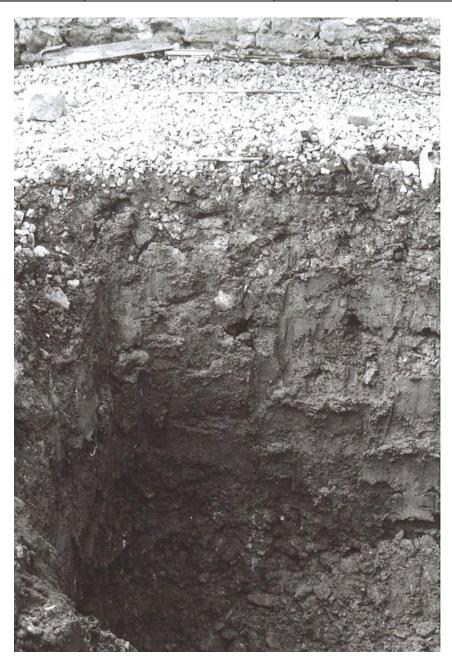
Plate 12 The septic tank pit on completion, facing south, scale unit 0.1m.

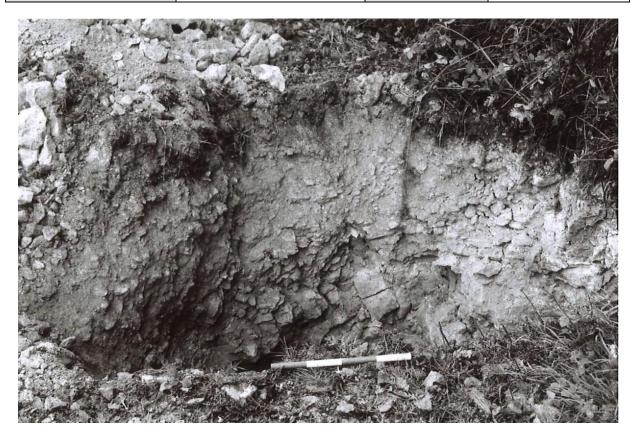
A soakaway pit (Plate 13) was excavated at the easternmost limits of the site, directly opposite the southernmost end of the proposed new building. The pit measured 2.4m² and was 1.9m deep. The uppermost 0.1m was of topsoil comprising a mid brown silty clay with frequent grass roots (Context 5000), which was directly above natural limestone bedrock (Context 5001).

Plate 13 The soakaway pit on completion, facing north-north-east, scale unit 0.1m.
