**GAS UTILITY TRENCH, THACKRAY LANE
& MICKLEGATE, PONTEFRACT,
WEST YORKSHIRE**

WATCHING BRIEF REPORT

REPORT NUMBER 2013/13

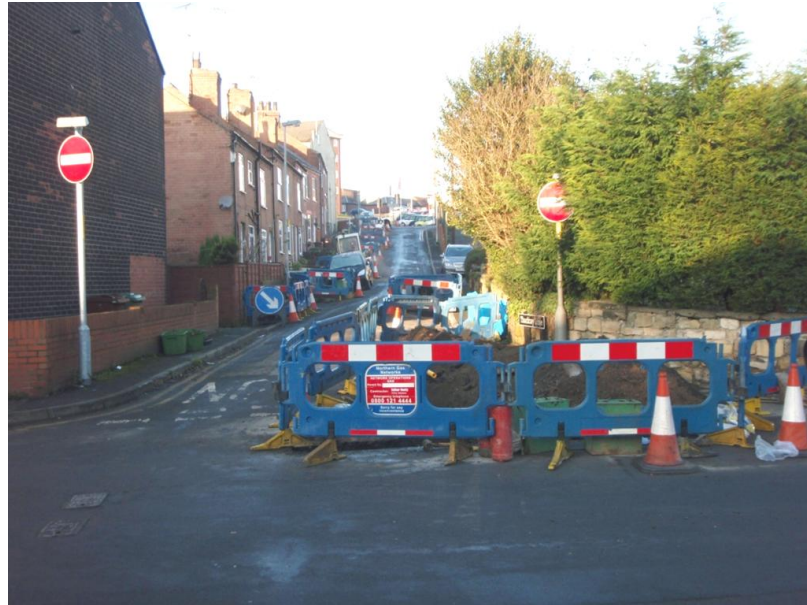
Plate 1 View of the works along Thackray Lane from the bottom of the lane, looking north-west

The Thackray Lane trenches (Plate 1), trench numbers 1–11, were opened prior to the commencement of the watching brief and recorded before the insertion of the new gas main. All trenches, save for 8 and 11, were excavated on the south-western side of the lane.

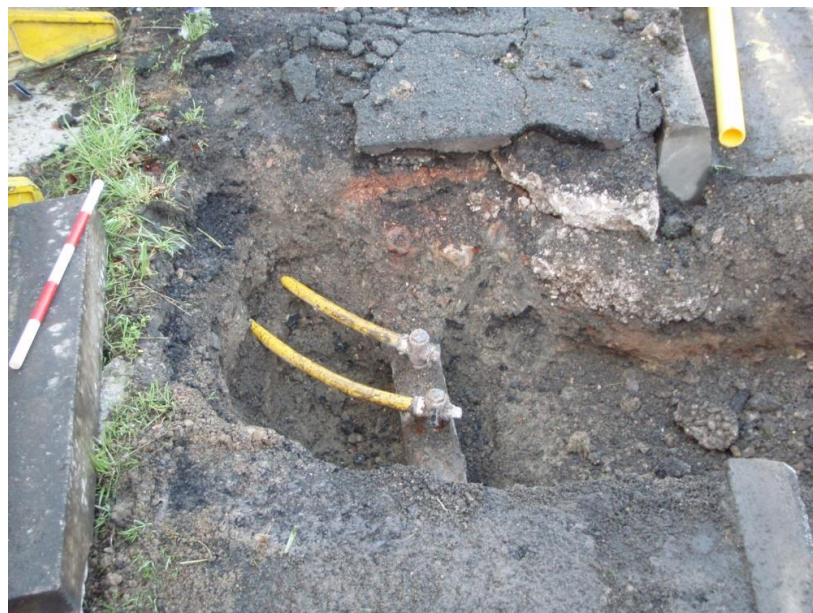
Plate 2 Trench 1 facing north-west, scale unit 0.1m.

Trench 1 (Plate 2) was located towards the north-western end of the south-west side of Thackray Lane and measured some 1.2m long by 0.70m wide and had a depth of up to 0.49m. The long axis of the trench was aligned south-west/north-east, fully occupied the footpath and extended beyond the kerb into the road at a slightly shallower depth. A discontinuous layer of orange-brown clayey-silt containing occasional small pebbles was observed towards the basal part of the north-east part of the trench. The origin of this deposit is uncertain. Within the confines of the footpath, all deposits below the tarmac surface related to mixed rubble backfilling of the old gas main. To the north-east of the main, deposits were comprised of the modern kerbing with concrete haunching and the tarmac road with stoney makeup deposits below.

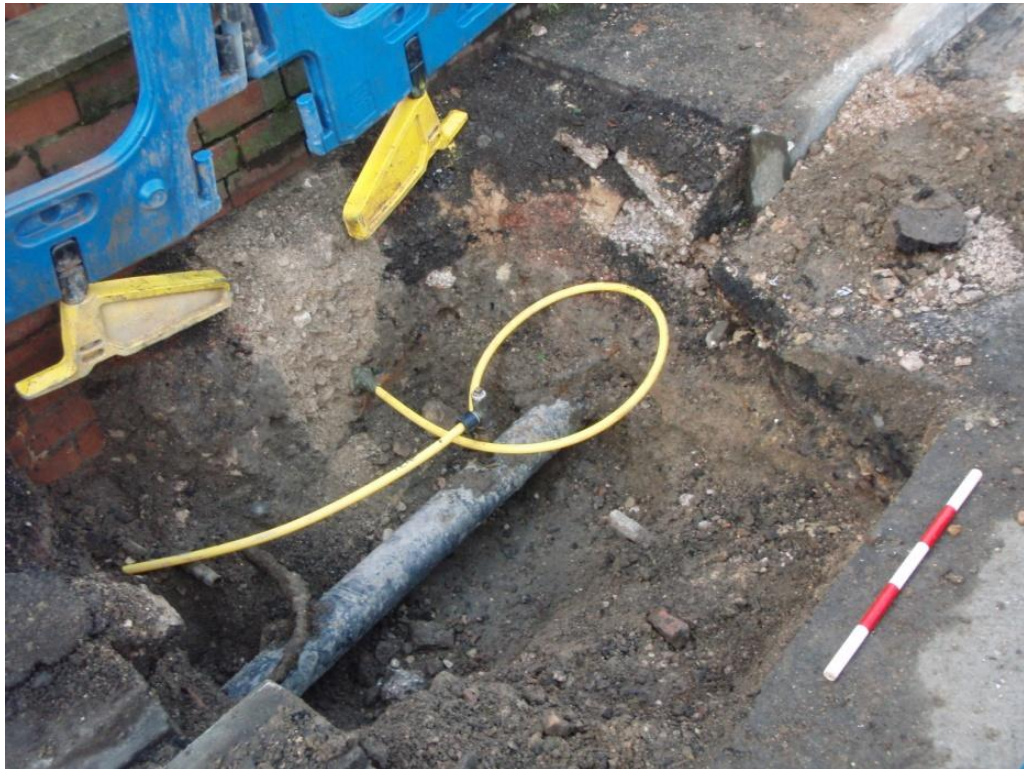
Plate 3 Trench 2 facing east, scale unit 0.1m.

Trench 2 (Plate 3) extended fully across the width of the pavement to the south-western side of the lane and extended into the roadway by around 0.50m. Measuring some 1.4m in length, with a width of 1.05m this trench was up to 0.60m deep though shelved up somewhat towards its north-eastern, road, side. All deposits encountered in Trench 2 related to modern activity. Below the existing tarmac footpath, kerb plus haunching, tarmac roadway and

makeup, this was comprised of backfills relating to the original gas main and to old services (thought to be water).

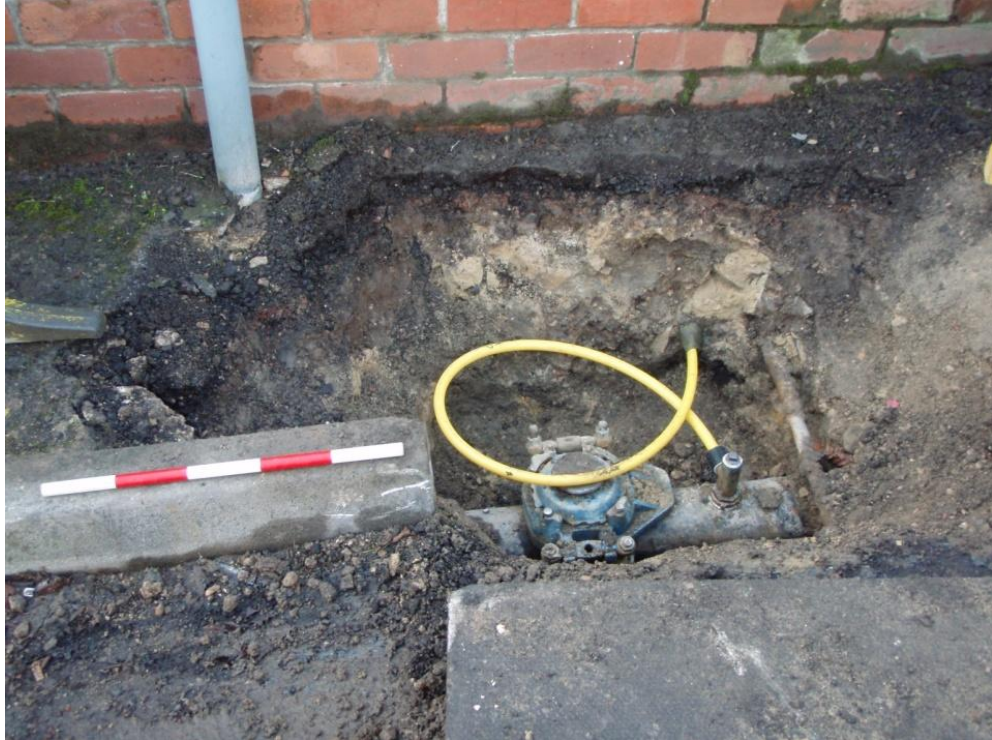
Plate 4 Trench 3 facing south-east, scale unit 0.1m. Note the stone in section below the modern wall.

Measuring just 0.75m long by 0.60m wide Trench 3 (Plate 4) was excavated to a depth of 0.58m. The entirety of this trench lay within the width of the narrow footpath and kerb. Beneath the modern surfaces of tarmac footpath, kerb and haunching, all excavated material related to the back-filling of the original gas main trench. However, the south-western side of the original trench had clipped the north-eastern side of rough stonework of yellow-white sandstone that lay below the 20th century garden wall of number 6 Thackray Lane. It cannot be stated whether this stonework represents merely footings or a wall in its own right, nor can a date be attributed to this feature.

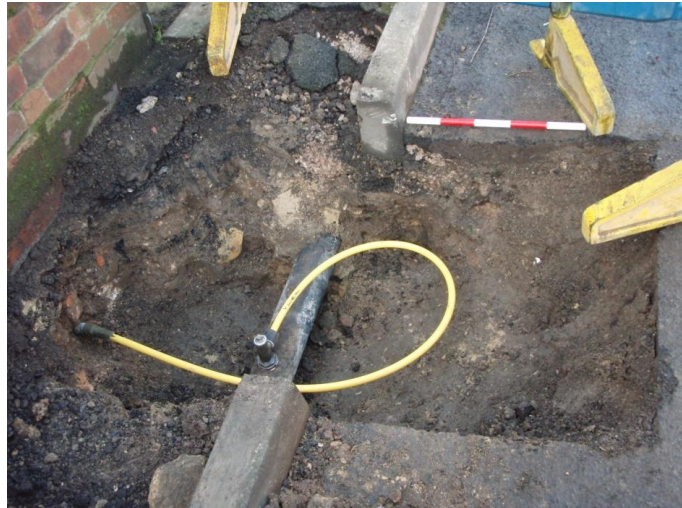
Plate 5 Trench 4 facing north-west, scale unit 0.1m.

Trench 4 (Plate 5) measured some 1.2m by 0.87m wide and was excavated to a depth of up to 0.51m. The long axis of the trench was aligned south-west/north-east, and whilst it straddled both the footpath and road the trench shelved upwards towards its north-eastern side. In the lower parts of the trench small areas of earlier deposits were seen to either side of the cut for the original gas main. These were mid-dark greyish brown, slightly clayey-sandy-silts containing occasional pebbles, small fragments of white sandstone up to 0.08m in size and a very small number of flecks of ceramic building material. No securely datable artefactual material was recovered from this deposit. Above this the trench exposed only modern deposits relating to the footpath, kerb, road, road makeup and backfill of the original gas main.

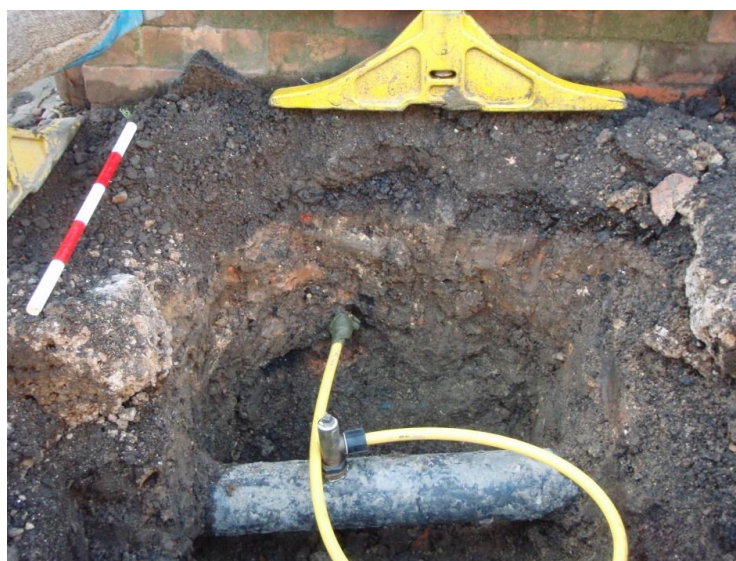
Plate 6 Trench 5 facing south-west, scale unit 0.1m.

This small trench (Plate 6) measured 1m long by 0.60m wide and was excavated to a depth of 0.49m. It was fully located within the width of the pavement. The majority of the deposits removed from the trench related to the tarmac footpath and backfill material from within the original trench for the gas main. A slither of earlier deposits was present to the south-western side of the trench. The lowest material within these was a mid-dark brownish grey slightly clayey-sandy-silt containing occasional pebbles, the precise origins and date of which are uncertain. The uppermost of the deposits was comprised of thin, multi-coloured mix of clayey-silt containing frequent flecks of ceramic building material, pebbles and the odd small cobble, that lay directly below the tarmac. This may represent fairly recent levelling-up material for the pavement works.

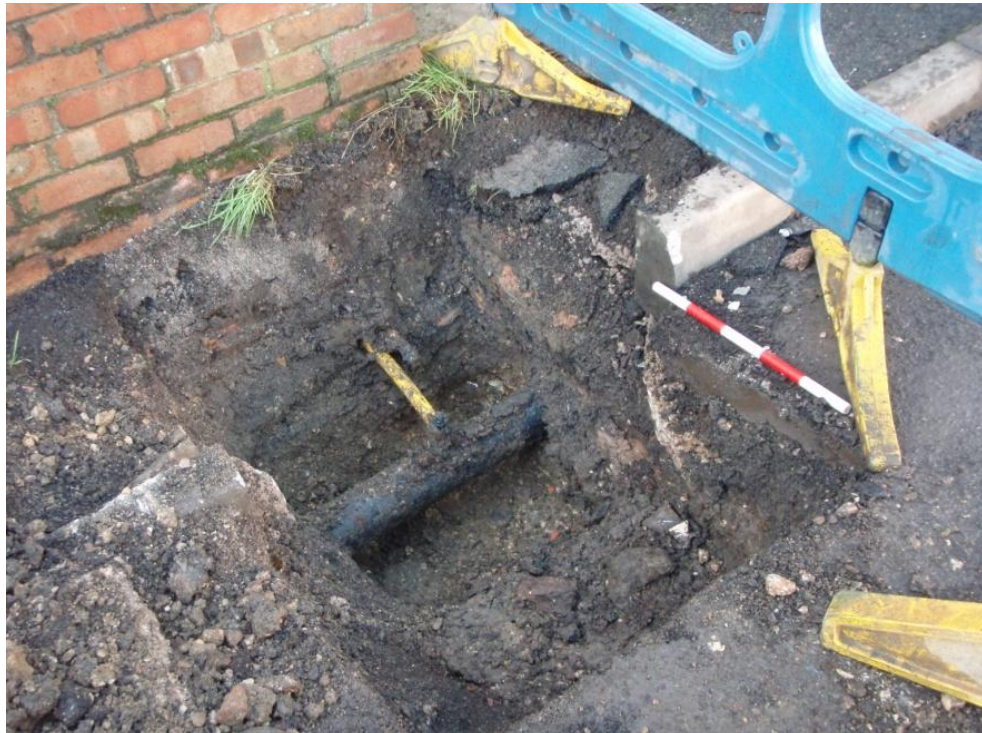
Plate 7 Trench 6 facing west, scale unit 0.1m.

Trench 6 (Plate 7) measured some 1.2m long by 0.75m wide, was up to 0.60m deep and straddled both footpath and the edge of the road. The north-eastern (road) side of the trench was somewhat shallower than the south-western (footpath) side. All materials in this trench were either modern, namely the surfaces and makeup to footpath, kerb and road or related to backfill deposits within the cut of the original gas main trench.

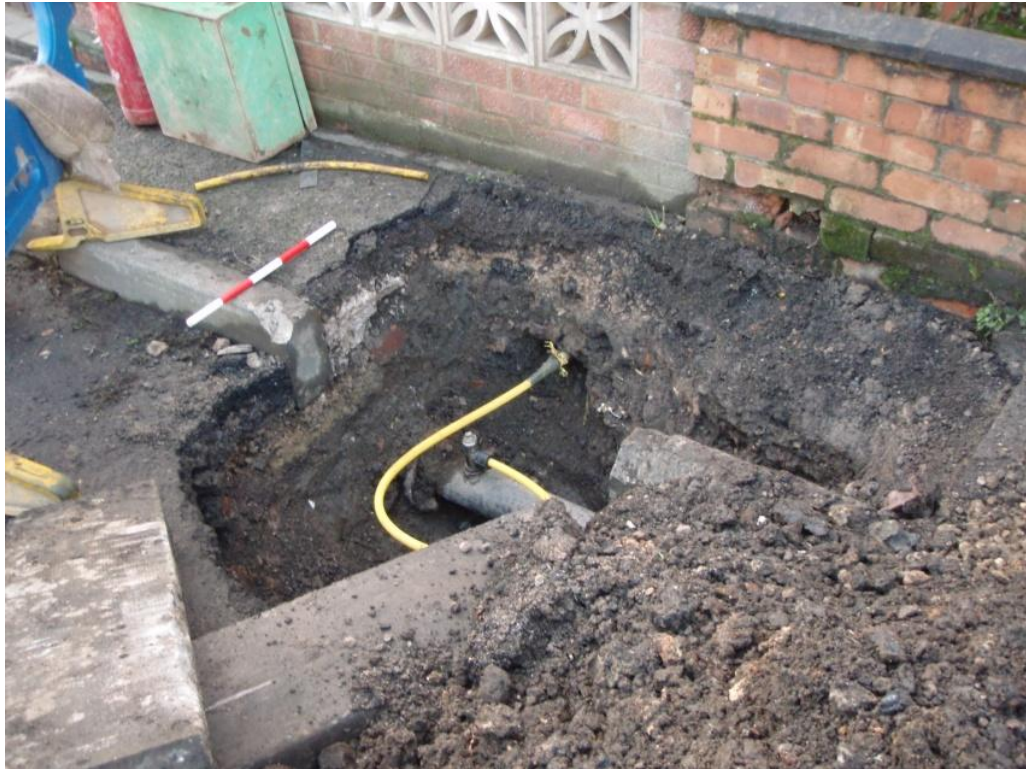
Plate 8 Trench 7 facing south-south-west, scale unit 0.1m.

Trench 7 (Plate 8) was of a rough 'L' shape in plan, occupied the full width of the pavement and extended nearly 0.50m into the roadway at its south-eastern end. Measuring some 1.2m long by up to 0.95m wide, this trench was up to 0.61m deep. All materials in this trench were either modern surfaces and makeup to the footpath, kerb and road, or related to mixed backfill deposits within the cut of the original gas main trench.

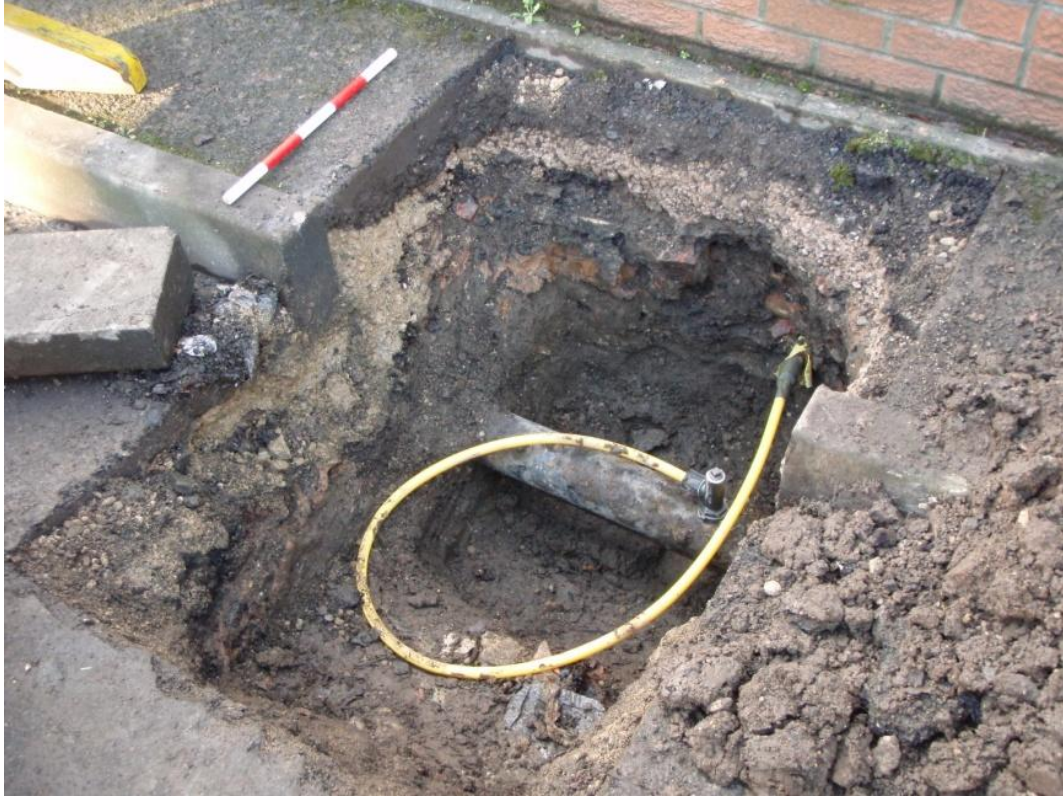
Plate 9 Trench 8 facing south-south-west, scale unit 0.1m

Spanning the footpath and roadway Trench 8 (Plate 9) measured 1.15m long by 0.75m wide and was up to 0.64m in depth. Underneath the modern materials, and to the south-west side of the original trench cut, older deposits were evident and these largely mirrored those within trench 5. Beneath the pavement a fairly thin multi-coloured clayey-silt containing small fragments of brick, pebbles and one or two small cobbles, was seen. This may represent recent levelling-up material for the pavement works. This overlay mid-dark brownish grey slightly clayey-sandy-silt containing occasional pebbles. No dating evidence was recovered from this lower deposit and its origins and function are uncertain. Modern deposits were comprised of the tarmac footpath and road and associated stoney makeup, the kerb and its haunching, and the backfill of the original gas main trench.

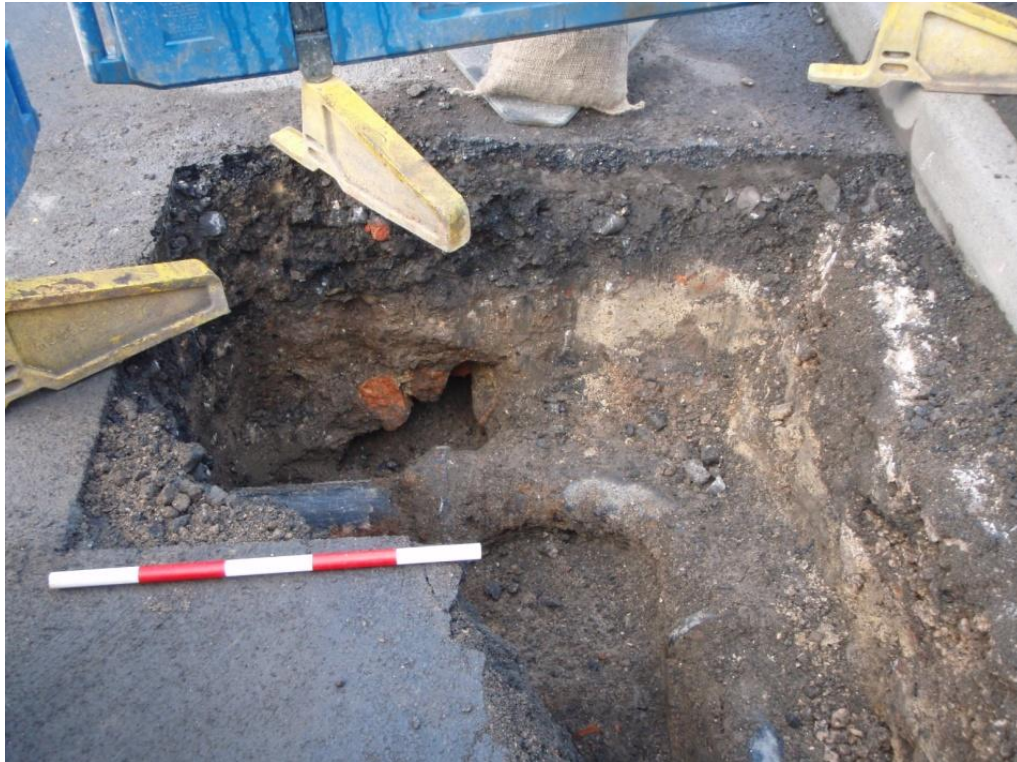
Plate 10 Trench 9 facing north-west, scale unit 0.1m

The 'L' shaped Trench 9 (Plate 10) was located to the north-eastern side of, and fully within, the roadway of Thackray Lane. Measuring up to 1.5m by 1.5m, the south-western side of the trench was excavated to a depth of 0.64m, while the north-eastern side was fractionally under 0.5m deep. The bulk of this trench was again occupied by deposits that were predominantly of recent and modern date, namely the kerb and haunching, road surface and underlying stoney makeup deposits and the backfill of the original gas main trench. However, at the south-western side of the trench a brick-built culvert, aligned with the length of the road and with arched top was present. The culvert was no longer in use and had largely silted up. The brickwork of this feature, which may be of earlier 19th century date, was bonded with a soft lime mortar.

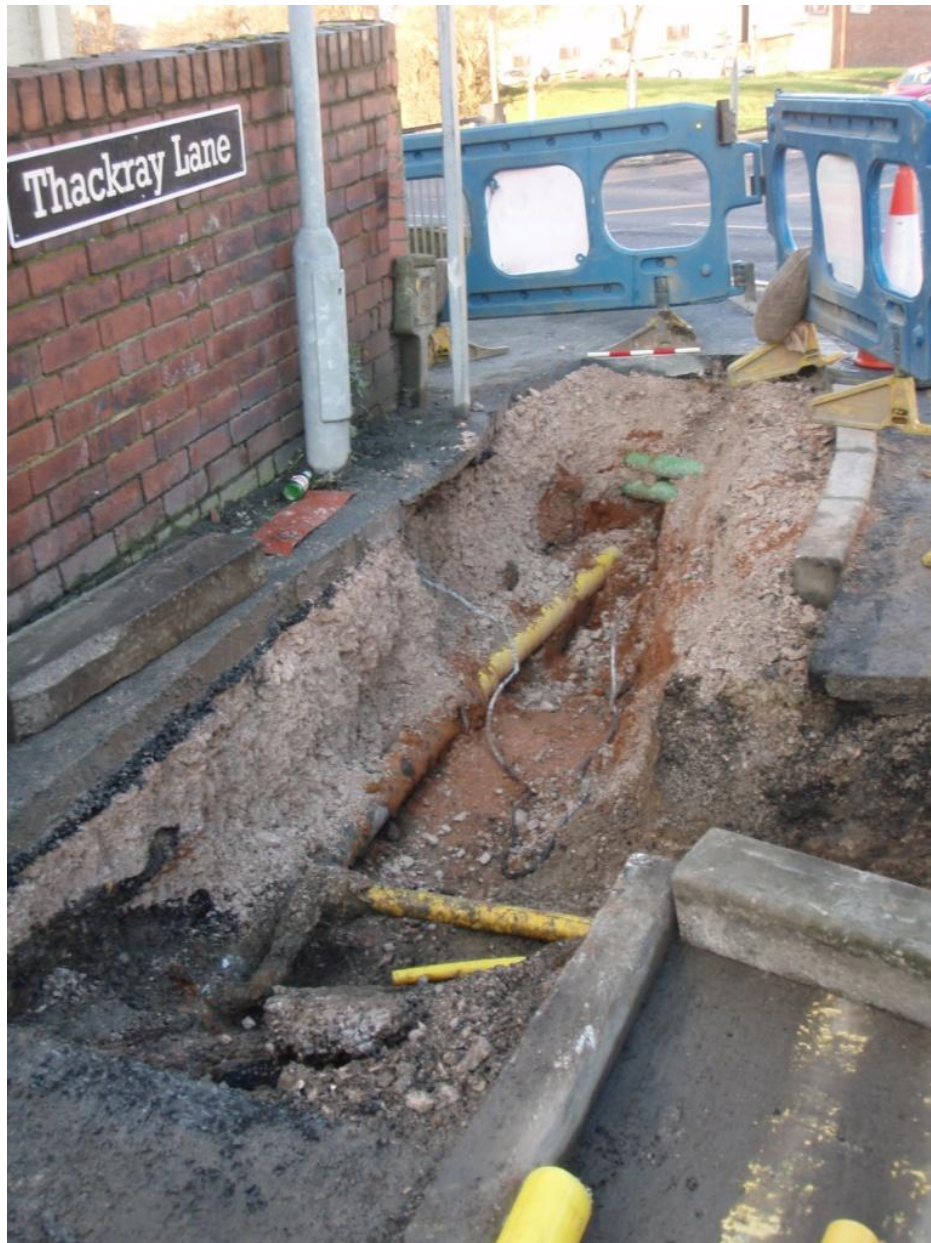
Plate 11 Trench 10 facing west, scale unit 0.1m

Trench 10 (Plate 11) was located at the extreme south-west corner of Thackray Lane, entirely within the pavement excepting for a small extension into the roadway. Measuring 3.9m long up to 1.1m wide (plus a 0.60m projection into the roadway) the maximum depth of this trench was 0.75m. Beneath the modern surfaces the entirety of the contents from within the trench related to a series of backfills. At the south-eastern end of the trench this was the rubbly fill of the original gas main trench. For the remainder of the trench these backfills related primarily to works associated with the partial replacement of the old metal mains pipe by a newer plastic mains pipe. These more recent backfills were comprised of orange coloured sand and limestone chippings ballast.

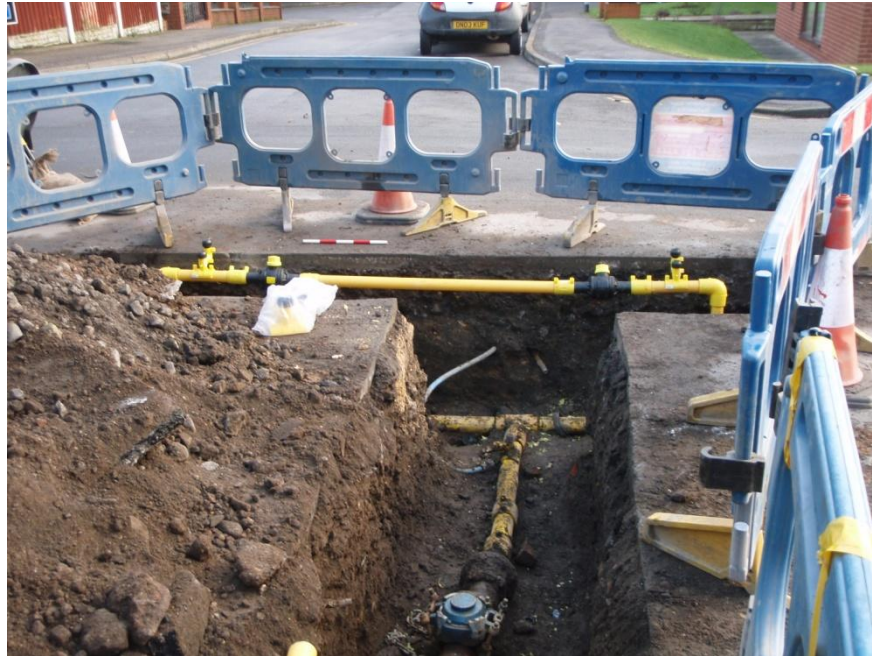
Plate 12 Trench 11 facing east-south-east, scale unit 0.1m

Trench 11 (Plate 12) was a 'T' shaped trench located at the lower, south-eastern, end of Thackray Lane, fully within the roadway and towards its northern side. The head of the 'T' was some 4m long by 0.60m wide, the arm, 3m long by 0.95m wide, and both had a depth of up to 0.70m. Beneath the modern tarmac road surface and its stoney makeup, the mixed and jumbled characteristics of the deposits indicated that were related to the backfilling of both the original gas main and to that of later works which had seen some of the metal mains replaced by plastic. A number of other utility services were also seen to be present within this trench.

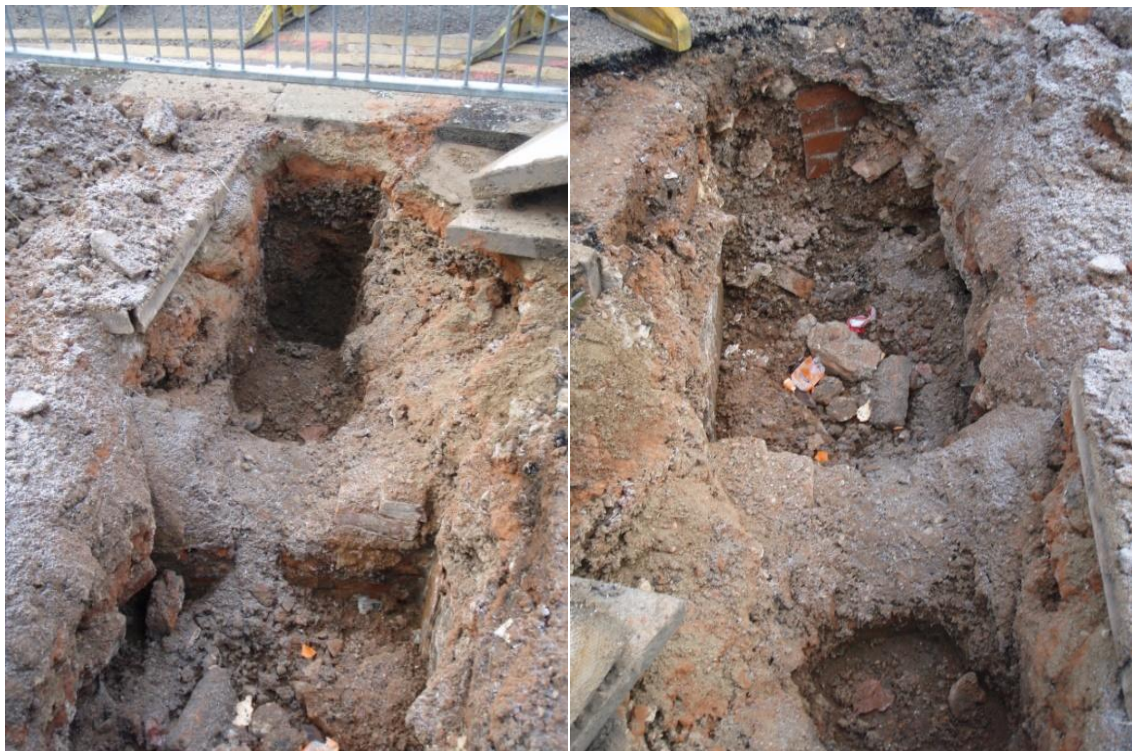
Plate 14 Trench 13 facing south-west and north-east.

Trench 13 (Plate 14) was located at the northern end of Broad Lane. This trench had to be observed from behind the safety barriers and it was not possible therefore to accurately measure the depth of the features seen.

The trench was rectangular and measured 2.5m x 0.84m in size and 0.84m deep, and was aligned with the long axis parallel to Micklegate. This earliest feature seen in this trench was a north-west to south-east aligned wall. The bricks within the wall were 0.70m thick suggesting a late-18th century or later date. The earliest deposit in the area to the west of the wall was a dark grey brown silty-sandy-clay with brick fragments which represented modern backfilling. At the easternmost end of the trench, visible in the section only there was a second brick wall, constructed from machine made bricks, which therefore dated to the mid-19th century at the earliest. The area between the two walls comprised a modern brick rubble backfill deposit. The uppermost deposit to the west of the wall comprised paving slabs 0.6 x 0.6 x 0.06m in size, resting on a levelling deposit of orange sand up to 0.55m thick, while to the east of the wall there was tarmac up to 0.07m thick above a bedding of orange sand up to 0.55m thick.

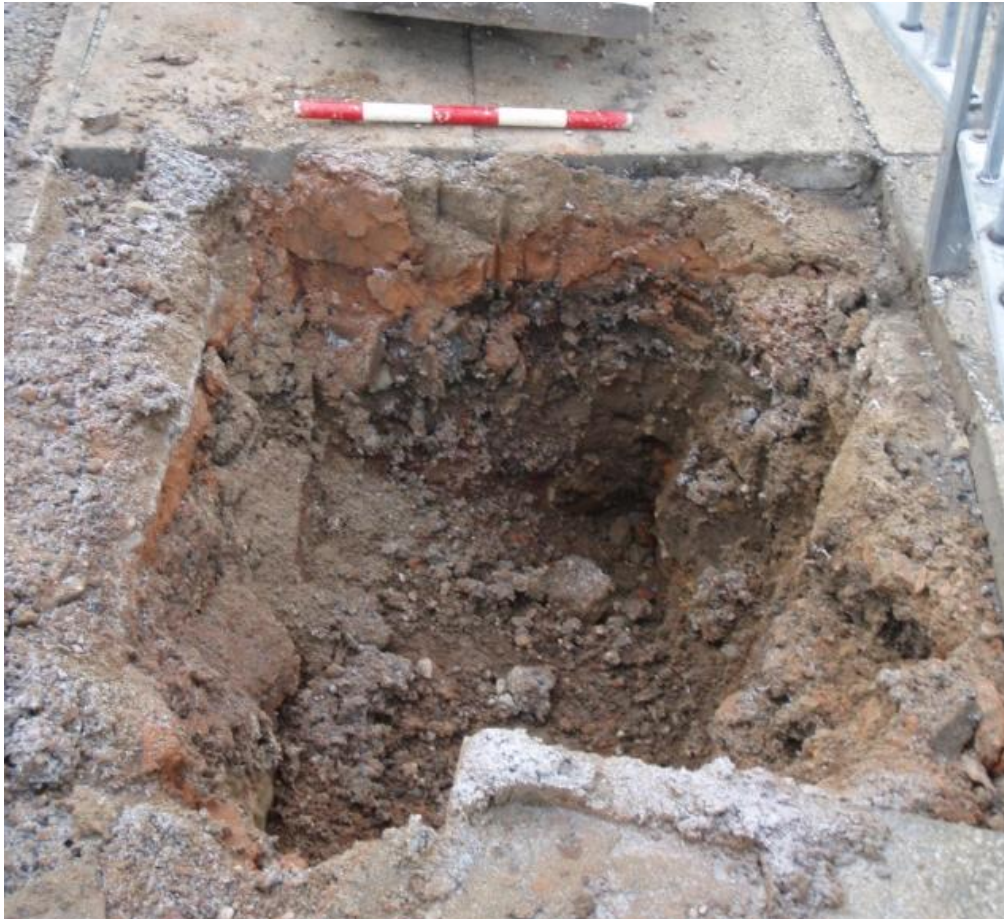
Plate 15 Trench 14 facing south-west, scale unit 0.1m.

Trench 14 (Plates 15-16) was located at the junction of Broad Lane and Micklegate, and was 1.4m x 1m in size and 0.9m deep, the long axis of the trench being parallel to Micklegate.

The earliest deposit seen was a mid brown sandy-clay with frequent small stones which represented the backfill of the earlier gas mains trench. Running along the south-easternmost side of the trench at between 0.25-0.55m below ground level there were an irregular sandstone block and two bricks, but these were not bonded together, in addition they were intermittent and one of the bricks was at an angle. The stone and bricks seem therefore to represent dumped items dumped within gas pipe backfill rather than representing an *in situ* wall of any kind. The uppermost deposits seen were orange sand levelling up to 0.2m thick beneath paving slabs 0.49m x 0.60m in size and 0.06m thick.

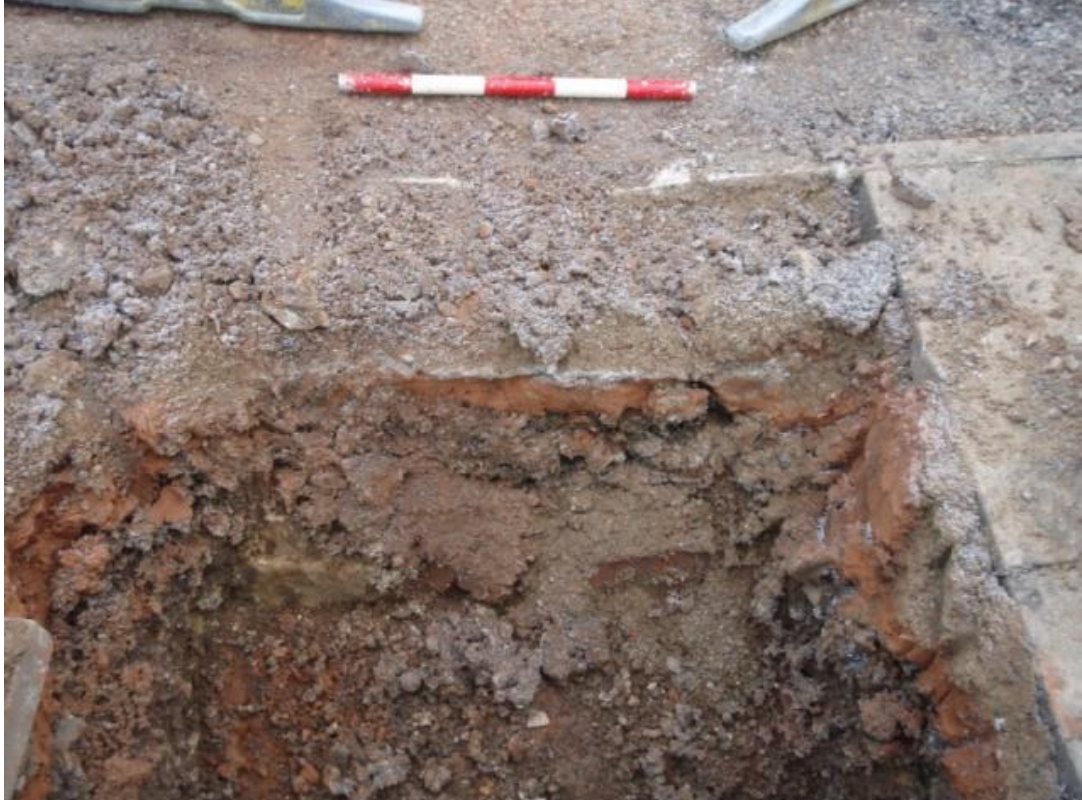
Plate 16 Trench 14 facing south-east, scale unit 0.1m. The sandstone block and two bricks occur centrally within the photograph

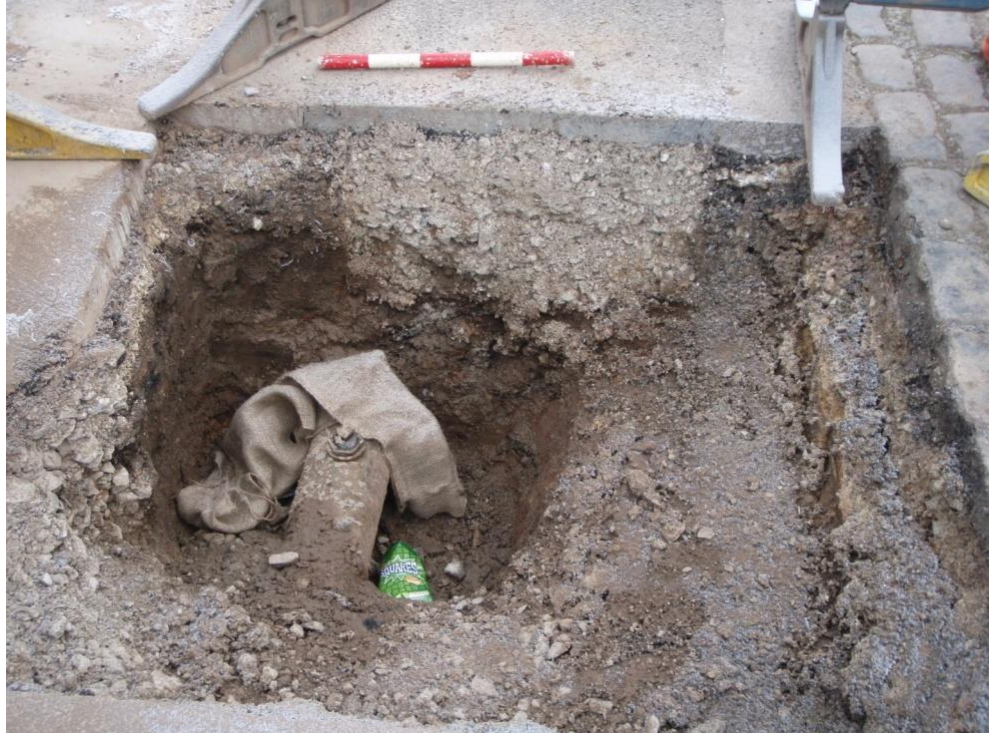
Plate 17 Trench 15 facing south-west, scale unit 0.1m.

Trench 15 (Plate 17) was 1.83m x 1.23m in size and a maximum of 0.69m deep on the south-eastern side, but 0.36m deep on the north-western side, with the long axis of the trench at right angles to Micklegate. The earliest feature was the cast iron gas main and its associated trench backfill which was a dark brown sandy-clay with occasional stones. This was beneath a levelling deposit of limestone rubble which was in turn truncated by a vertically sided modern linear cut, 0.36m deep which was backfilled with limestone hardcore. This modern trench was in turn beneath the tarmac of the present pavement which was 0.07m thick. To the immediate north-west of the trench the upper surface was of stone setts, but these were undisturbed by the excavation of the trench.

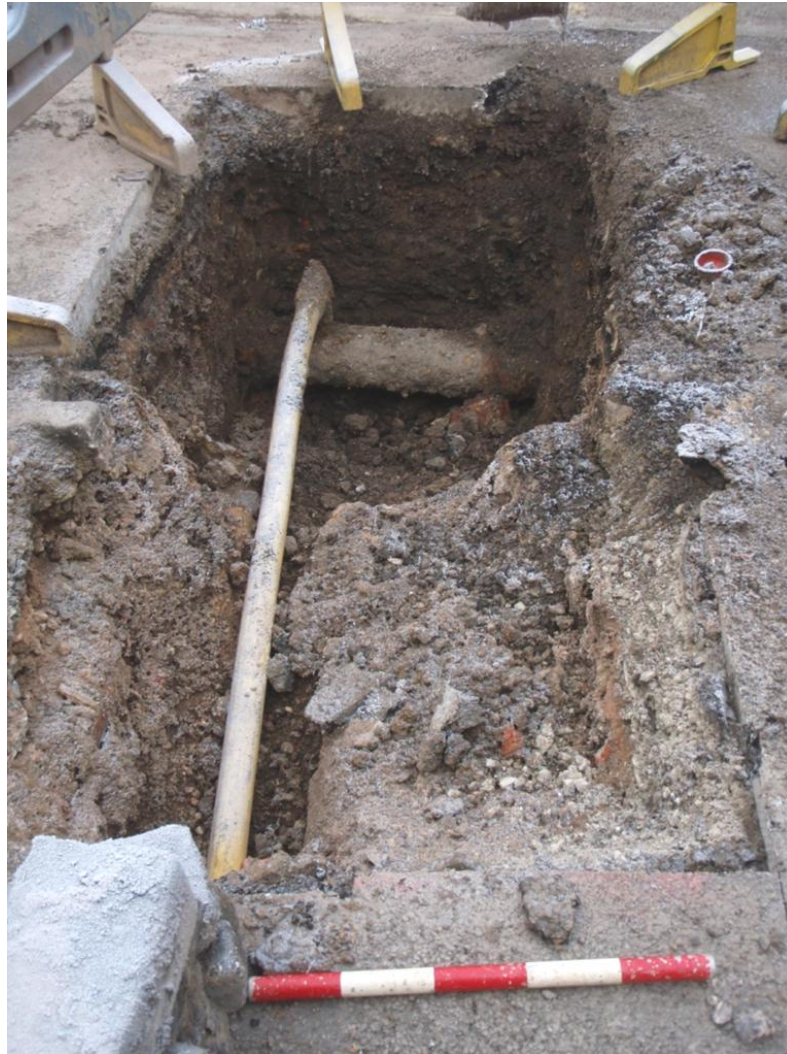
Plate 18 Trench 16 facing north-west, scale unit 0.1m.

To the north-west of this block was the cast iron gas main, which ran parallel to Micklegate at the north-western side of the trench. The top of the pipe was at 0.67m below ground level, and the associated pipe trench backfill was dark brown silty-sandy-clay with occasional stones. Connecting to the upperside of the pipe was a new plastic gas pipe, aligned north-west to south-east; this truncated the sandstone block. The deposits above this smaller pipe were more mixed comprising very mixed brick fragments, and sandstone fragments which was clearly modern dumping of demolition debris. These deposits were sealed by a levelling deposit of limestone chippings 0.06m thick and the associated tarmac surface of the pavement which was 0.07m thick.

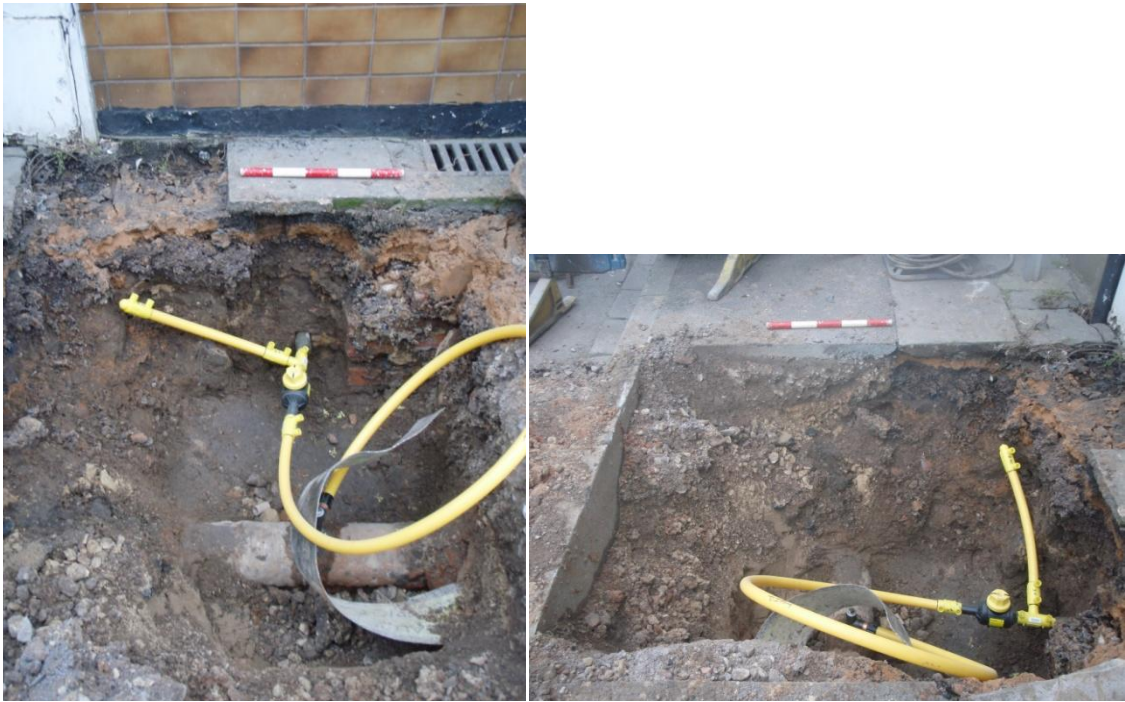
Plate 19 Trench 17 facing south-east and north-east, scale unit 0.1m.

Trench 17 (Plate 19) was rectangular and was 1.49m x 1.40m in size and a maximum of 0.8m deep, though the base of the trench was shallower on the north-western side. The long axis of the trench was at right angles to Micklegate. The earliest feature seen was the cast iron gas main which was aligned parallel to Micklegate. Smaller yellow plastic pipes had been connected to the main pipe. All the deposits above the cast iron gas main were mid brown sandy-clay which represented the backfill of the original gas mains trench. On the south-eastern side, the trench was adjacent to a modern brick wall which formed the tank beneath a pavement grid which was clearly of modern date. Over the south-eastern half of the trench the uppermost deposits comprised a levelling deposit of ash and clinker up to 0.25m thick, beneath a second levelling deposit of orange sand up to 0.07m thick, beneath paving stones up to 0.9m x 0.64m x 0.07m in size. The north-western side of the trench the

uppermost deposits were a layer of limestone chippings up to 0.2m thick beneath tarmac 0.07m thick.

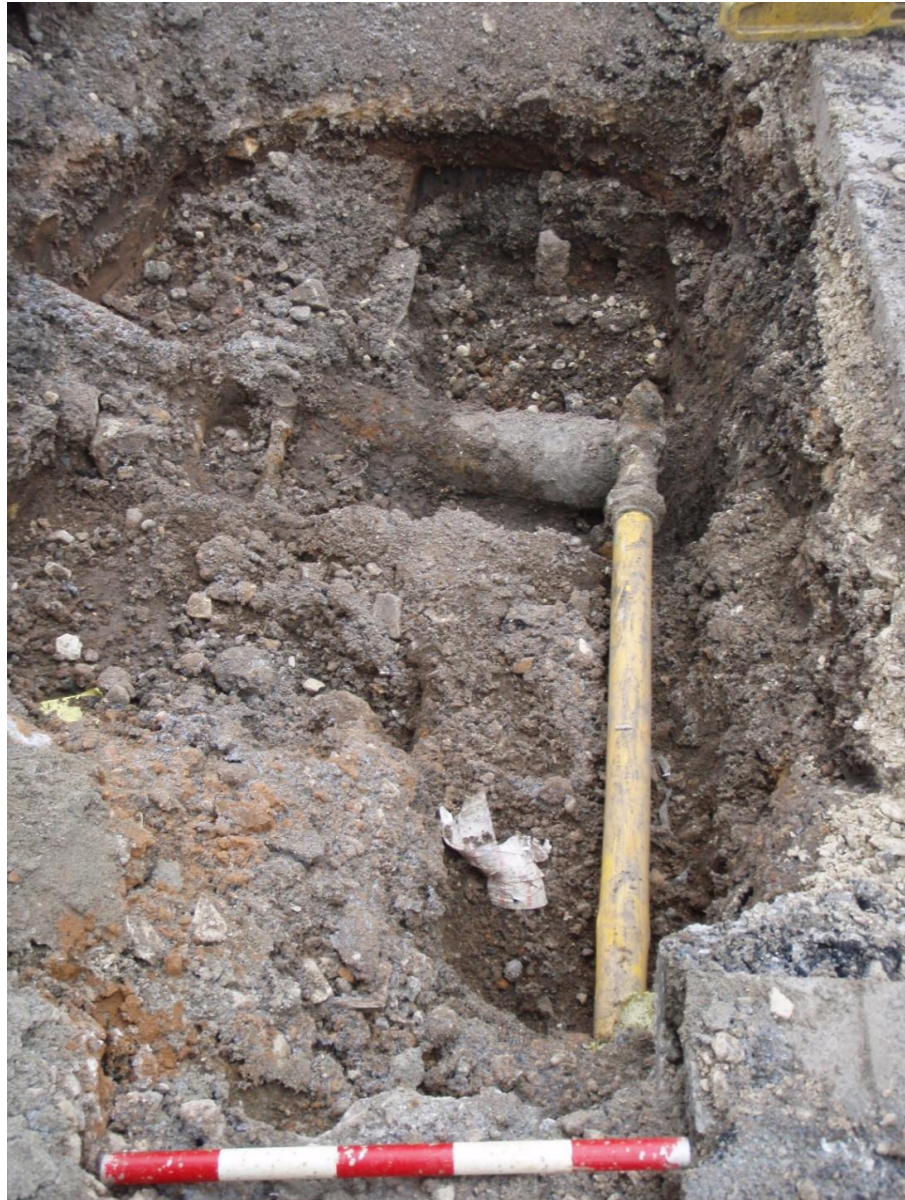
Plate 20 Trench 18 facing north-west, scale unit 0.1m.

Trench 18 (Plate 20) was located at the junction of Micklegate and a small lane aligned north-west to south-east which gives access to a group of almshouses. The trench measures 19m x 1.2m in area, and was of variable depth, being a maximum of 0.9m deep adjacent to the gas main but 0.6m deep elsewhere. The long axis of the trench was at right angles to Micklegate. The earliest context observed was a deposit of clean brown clay which was only seen in the lowest part of the north-westernmost corner of the trench. No artefacts were present in this deposit and its date is therefore unknown. This had been truncated by the gas mains trench, and the cast iron gas main ran parallel to Micklegate. A smaller iron pipe was directly above the south-western end of the gas mains pipe, and this smaller pipe was at right angles to Micklegate. A new yellow plastic pipe had been connected to the north-eastern end of the gas mains pipe, and this pipe also ran at right angles to Micklegate. All the deposits above the pipes represented modern backfill comprising mid brown gritty sandy-clay with occasional stone fragments. The trench was sealed by a deposit of limestone chippings up to 0.1m thick which was beneath the tarmac of the present pavement which was 0.08m thick.

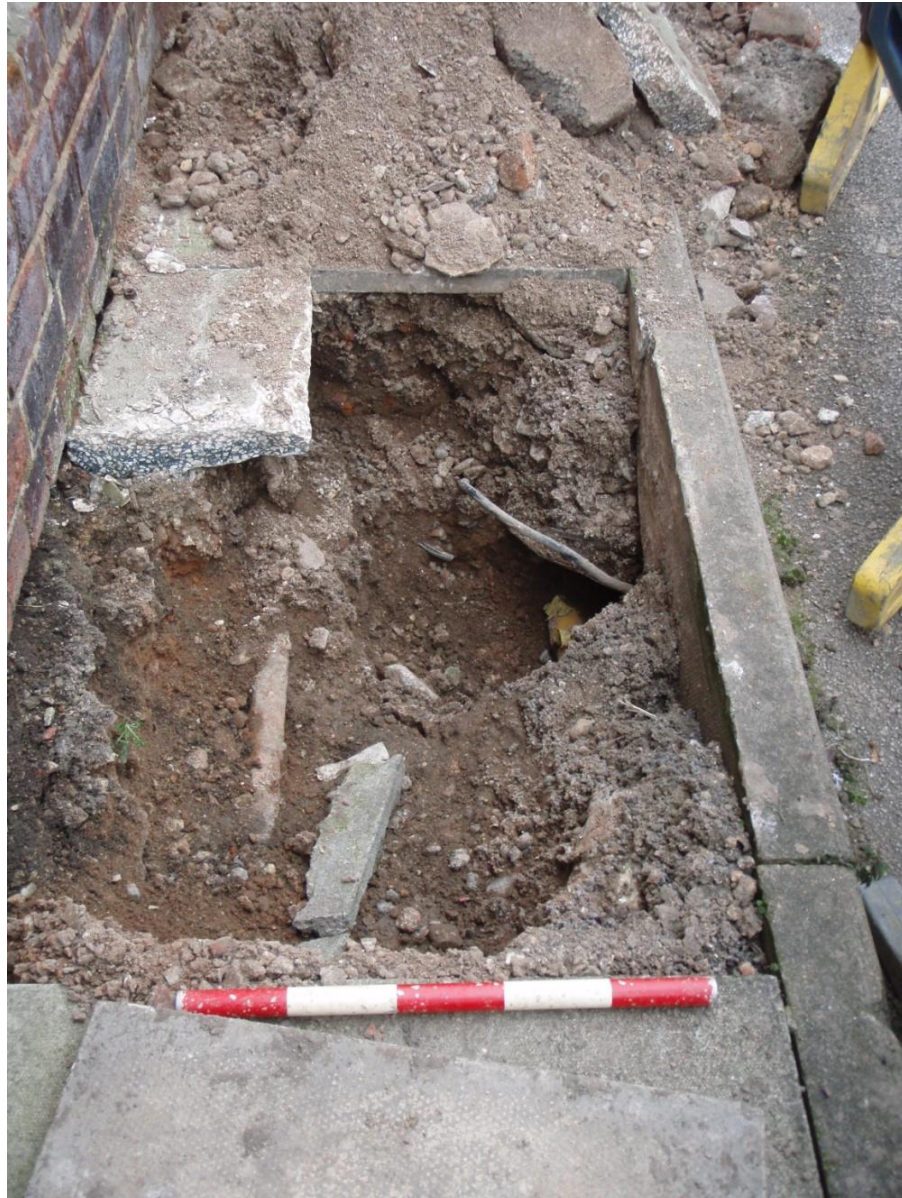
Plate 21 Trench 19 facing north-west, scale unit 0.1m.

Trench 19 (Plate 21) was located to the south-east of Trench 18, on a small lane giving access to a group of almshouses. The trench was 1.05m x 1.08m in area with the long axis at north-west to south-east, and the trench was up to 0.6m deep. There were three modern services within the trench, a yellow plastic gas pipe at right angles to Micklegate, 0.6m below ground level, a cable running diagonally across the northern corner of the trench at 0.5m below ground level and a cast iron pipe 0.4m below ground level in the south-western half of the trench which again ran at right angles to Micklegate. Above these services was modern fill comprising mid brown sandy-clay with frequent stone and brick fragments. This was beneath tarmac 0.07m thick.

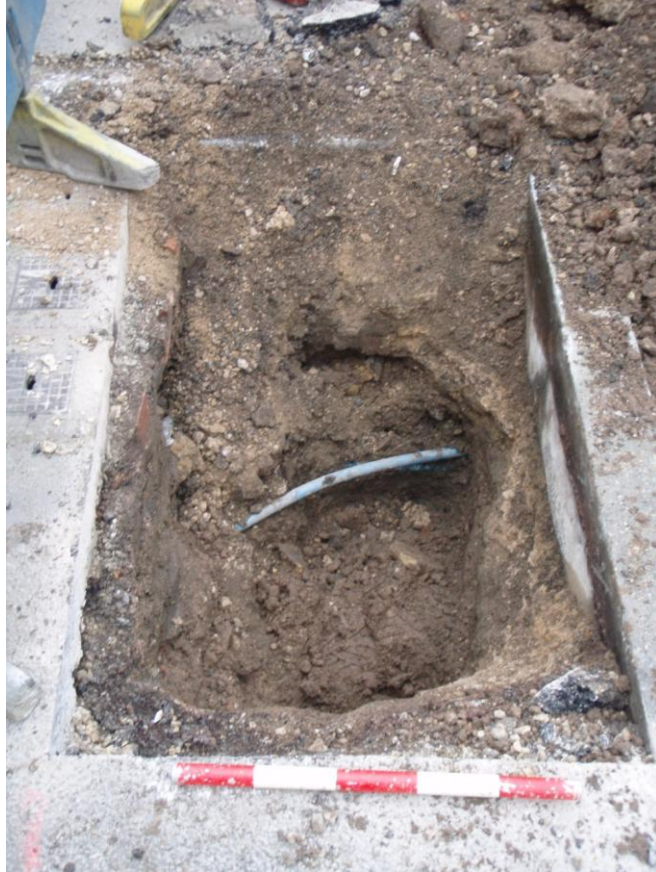
Plate 22 Trench 20 facing south-west, scale unit 0.1m.

Trench 20 (Plate 22) was 1.25m x 0.87m in area and up to 0.6m deep. The long axis of the trench was parallel to Micklegate. The earliest features visible were two superimposed blue plastic pipes of modern date beneath a backfill of gritty sandy-clay with occasional stones. This was beneath a 0.17m thick levelling deposit of ash and clinker with some modern brick fragments which was clearly designed to level up the ground beneath the present paving. Along the north-eastern side of the trench this ash deposit was truncated by a construction cut for the present kerb stones which was 0.28m deep and was backfilled with a deposit of limestone hardcore. The uppermost deposit was tarmac 0.07m thick.

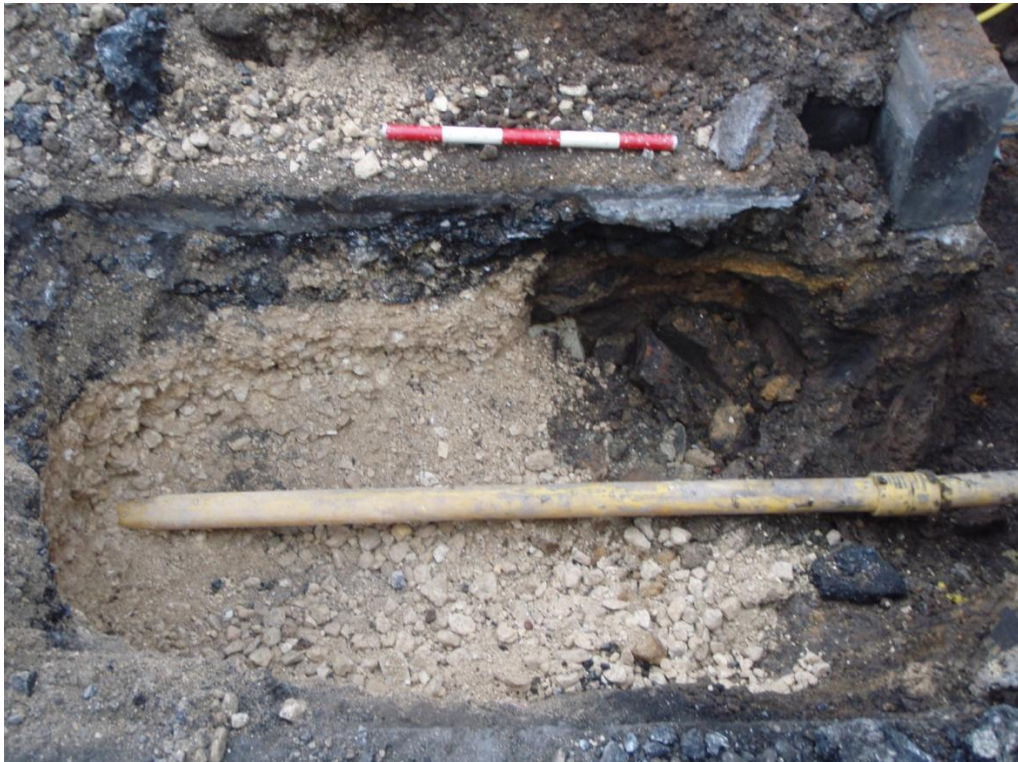
Plate 23 Trench 21 facing north-east showing the banded deposits to the immediate north-west of the present kerb stones, scale unit 0.1m.

stones to the immediate north-west forming a gutter. The kerb and gutter were set in a linear trench infilled with limestone chippings.

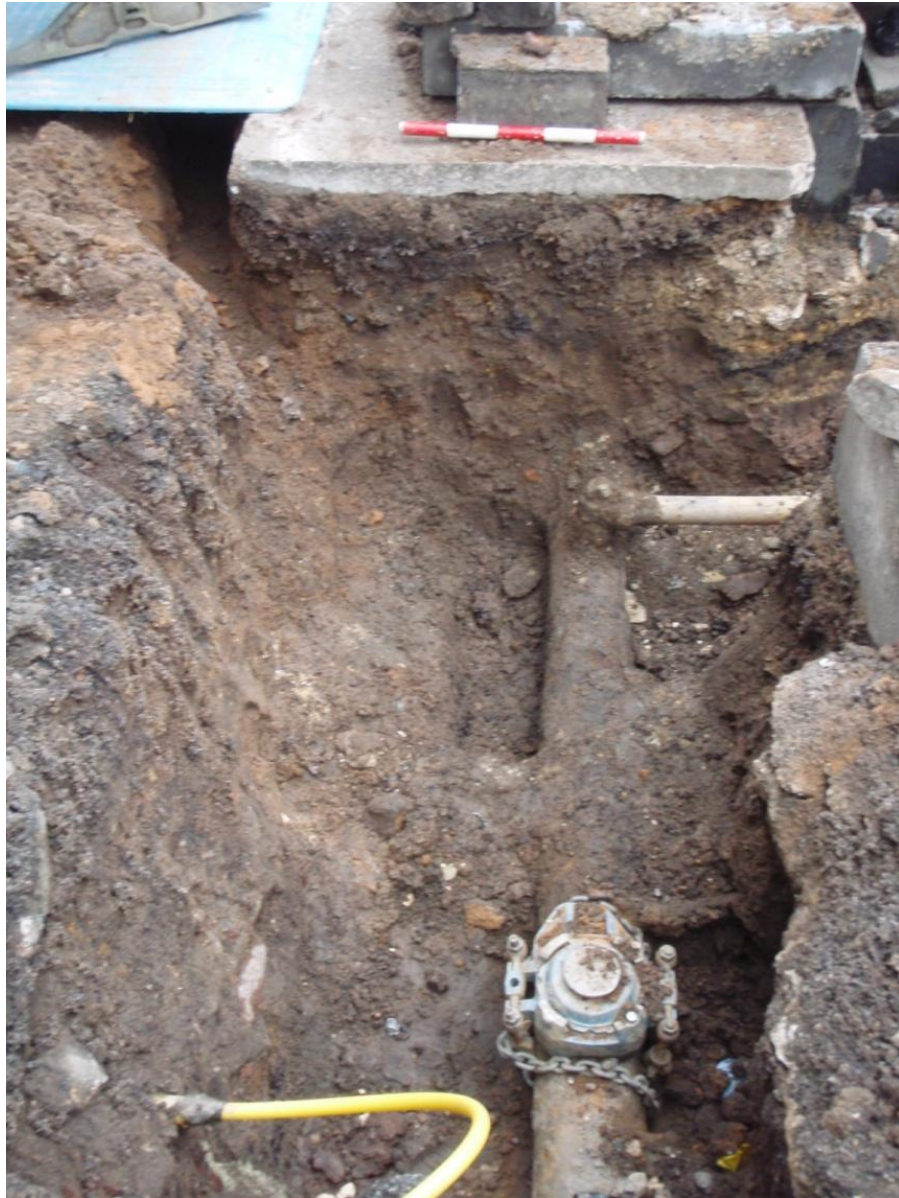
Plate 24 Trench 21 facing north-west, scale unit 0.1m.

The second zone of the trench (Plate 24) comprised the whole of the north-east to south-west aligned portion of the trench. This area comprised the trench for the cast iron gas main which truncated the south-eastern side of the banded deposits described above. The backfill of the gas mains trench was dark brown gritty sandy-clay with occasional stones. Two new yellow plastic gas pipes and been attached to the gas mains at the north-eastern and south-western ends. The backfill of the gas mains pipe was beneath a levelling deposit of ash and clinker which incorporated one fragment of a paving slab at the north-eastern end of the trench. This levelling was beneath the tarmac of the present path which was 0.07m thick.
