**GAS UTILITY TRENCH, THACKRAY LANE
& MICKLEGATE, PONTEFRACT,
WEST YORKSHIRE**

WATCHING BRIEF REPORT

REPORT NUMBER 2013/13

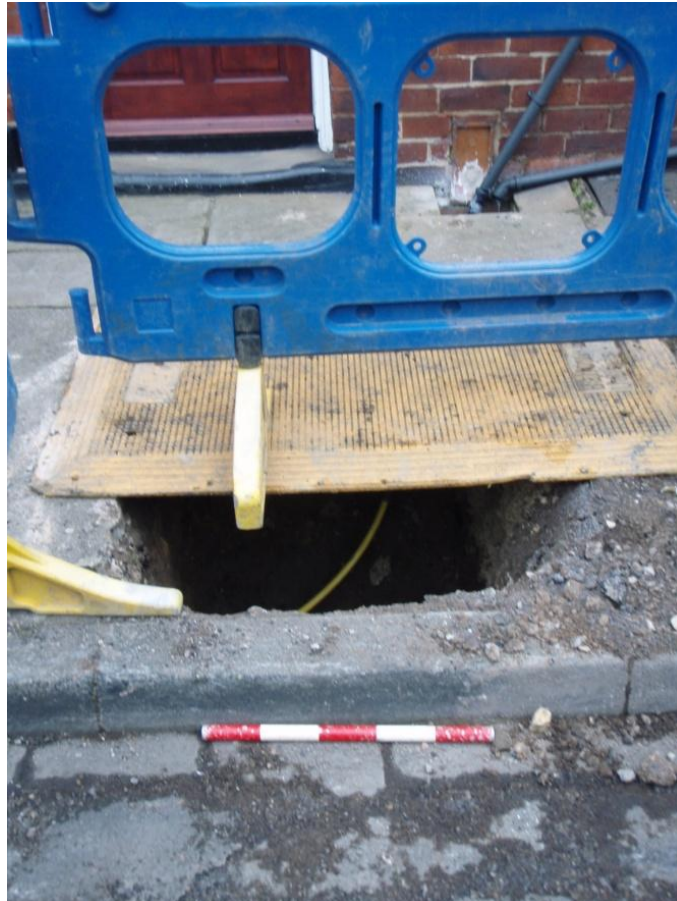
Plate 25 Trench 22 facing south-east, scale unit 0.1m.

Trench 22 (Plate 25) was obscured by a heavy metal plate providing access across the pavement to houses. A small area of the trench was visible, and as far as could be determined the cast iron gas main ran parallel to Micklegate and a new yellow plastic pipe had been connected into the top of the mains. In the south-western section a modern black corrugated plastic drain pipe was visible, this was set vertically in a trench backfilled with limestone hardcore. The trench was sealed by tarmac up to 0.07m thick.

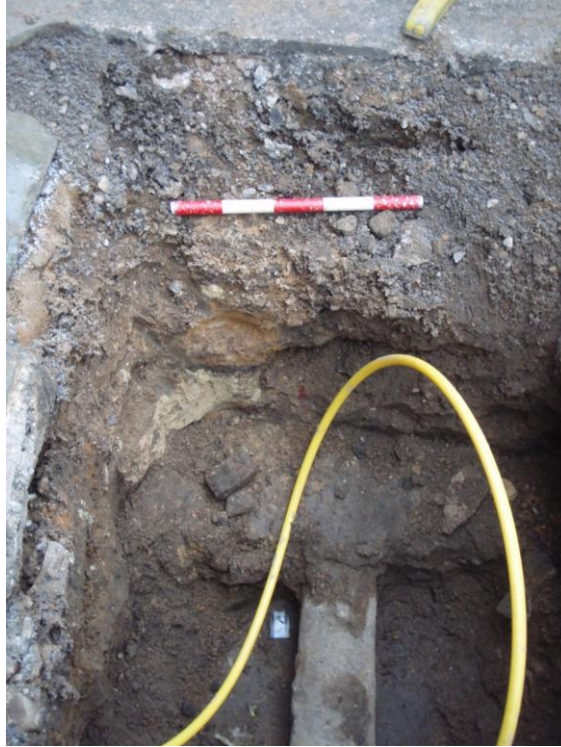
Plate 26 Trench 23 facing south-west, showing the sandstone block in the south-western corner, scale unit 0.1m.

Trench 23 was a rectangular trench measuring 1.03m x 0.90m in area and 0.9m deep, with the long axis parallel to Micklegate. The earliest context seen was the cast iron gas main running parallel to Micklegate. This was beneath a backfill of dark brown gritty sandy-clay with occasional stones. In the south-western corner of the trench there was a single irregular lump of sandstone (Plate 26). There was no sign of any other associated stones, so it was impossible to determine if this was a wall which had just been clipped by the trench or not. Directly above the sandstone block was a vertically sided cut containing a backfill of clean orange sand; although no dating evidence was present in the sand it was probably of modern date representing the backfill of a services trench of some kind; again, this had just been clipped by the trench. The uppermost deposits in the trench comprised a layer of ashy/clinker levelling 0.16m thick, which was in turn beneath a very levelling layer of orange sand which was just 0.02m thick, and this was in turn beneath the tarmac of the present pavement, which was 0.07m thick. On the north-western side the trench butted up against vertically set kerb stones (Plate 27).

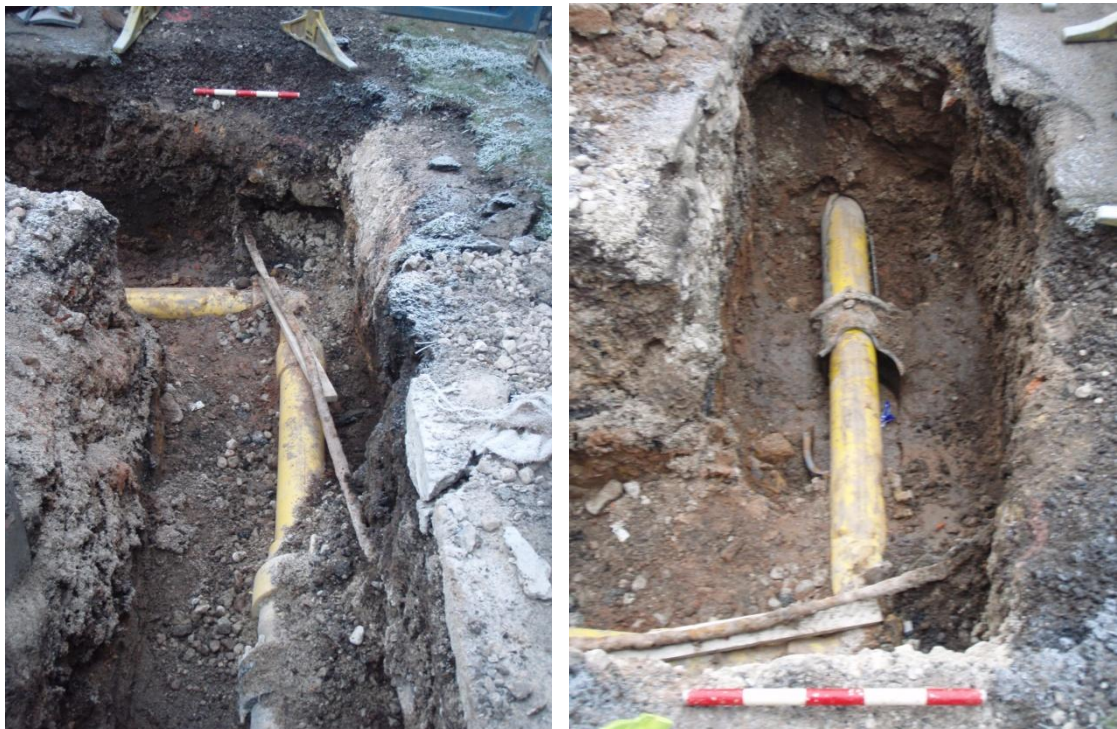
Plate 28 Trench 24 facing north-east and north-west, scale unit 0.1m.

The earliest deposit seen was mid brown clean clay the date of which is unclear. This was truncated by numerous modern services trenches. The cast iron gas main was originally L shaped and located in the base of the trench, but the north-easternmost portion of this had been replaced with a yellow plastic pipe. Above the gas main there was an iron pipe running obliquely from the north-eastern to south-eastern sections of the trench, and a second sawn off cast iron pipe was visible in the south-eastern section. The backfill above these pipes was dark brown sandy-clay with frequent stone including three larger lumps of un-worked sandstone which were clearly dumped within the backfill. Two further vertically-sided modern services cuts were visible at the northern end of the north-eastern facing section of the trench, which were aligned at right angles to Micklegate. These were 0.5m wide and 0.6m deep and 0.6m wide and 0.5m deep respectively and are visible in the left hand side of Plate 29. Beneath the present road there was a deposit of hardcore and tarmac which acted as levelling for the road surface. The uppermost surface in the path comprised a deposit of concrete up to 0.07m thick at the southern end and a deposit of tarmac which was up to 0.4m thick at the northern end with thin grass growing through it

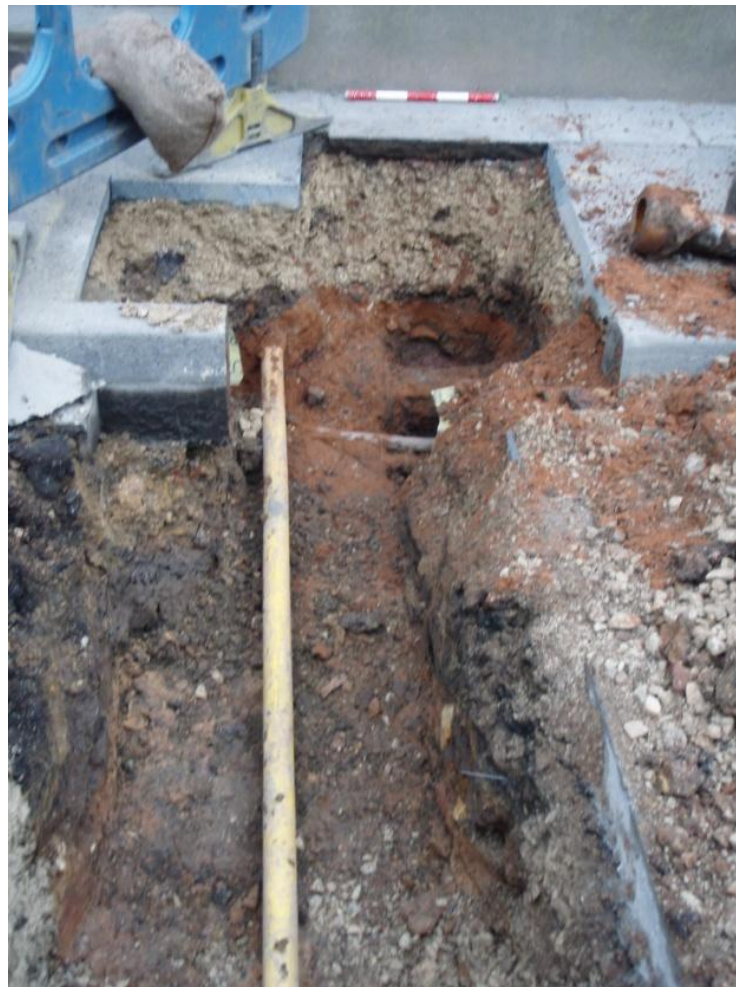
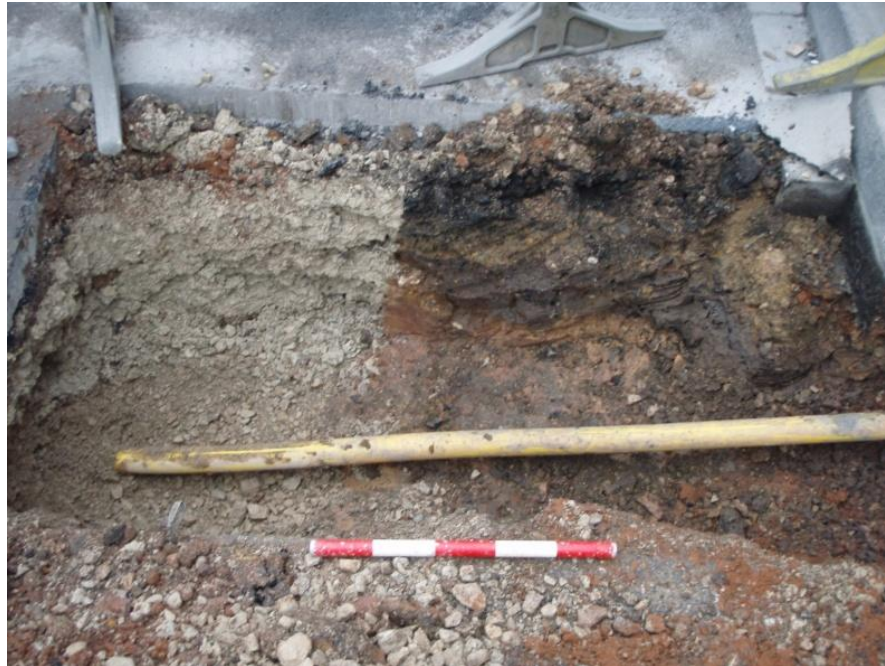
Plate 29 Trench 25 facing north-west, scale unit 0.1m.

Plate 30 Trench 25 facing north-east, scale unit 0.1m.

Trench 25 (Plate 29-30) was sub-rectangular plan, being a maximum of 2.9m x 1.9m in area and up to 0.76m deep. The gas main ran parallel to Micklegate at the south-eastern side of the trench, with a second new yellow plastic gas pipe aligned north-west-south-east directly above and this had deposit of sand acting as both bedding and capping at the south-eastern end. To the immediate north-west of the cast iron gas main there were three other services visible, a cable, a small broken cast iron pipe and a broken ceramic pipe. Distinct cuts could not be determined for each of these pipes, they were all beneath a deposit of was dark grey brown sandy-clay with occasional stones, which was clearly backfilling above services. The area beneath the kerb had a deposit of limestone levelling up to 0.4m thick beneath tarmac 0.07m thick, which was bordered on the north-western side by a vertically set kerb stone and stone gutter. The area beneath the present road surface comprised limestone chippings set in a vertically sided trench which extended the full depth of the trench. The present tarmac road surface was 0.07m thick.

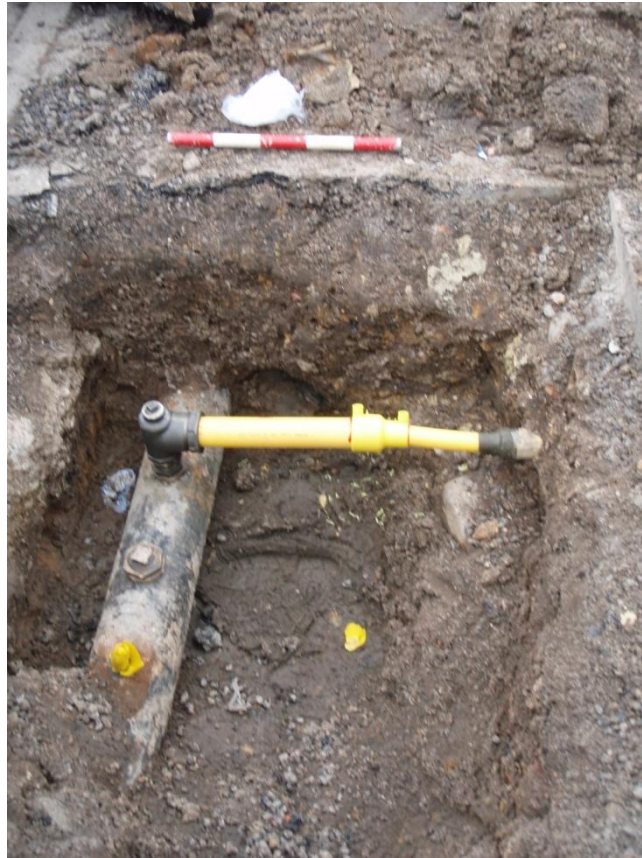
Plate 31 Trench 26 facing west, scale unit 0.1m.

Trench 26 (Plate 31) was 1.2m x 1.3m in area, with the long axis parallel to Micklegate. The trench was up to 0.7m deep, though the base was irregular, being only 0.4m deep on the northern side, and being somewhat uneven to either side of the existing gas main. The cast iron gas main ran along the southern side of the trench at approximately 0.5m below ground level, and a new yellow plastic pipe aligned north-south connected into the top of the cast iron gas main at the western end of the trench. The deposit to either side of the gas main at the base of the trench was dark brown sandy-clay with few inclusions, while the deposits above the pipe, though still dark brown sandy-clay had frequent inclusions of stone and rubble and clearly represented modern backfilling. A single stone was visible at a depth of 0.4m below ground level on the northern side of the trench (visible in Plate 31 directly below the yellow gas pipe), but this was an isolated stone and did not form part of a wall or structure, and it was presumably dumped within the modern backfill. Along the southern side of the trench the uppermost 0.3m of deposits comprised the present kerb stone and an associated construction cut backfill of compacted limestone hardcore. The uppermost 0.09m of deposits comprised the present tarmac surface.

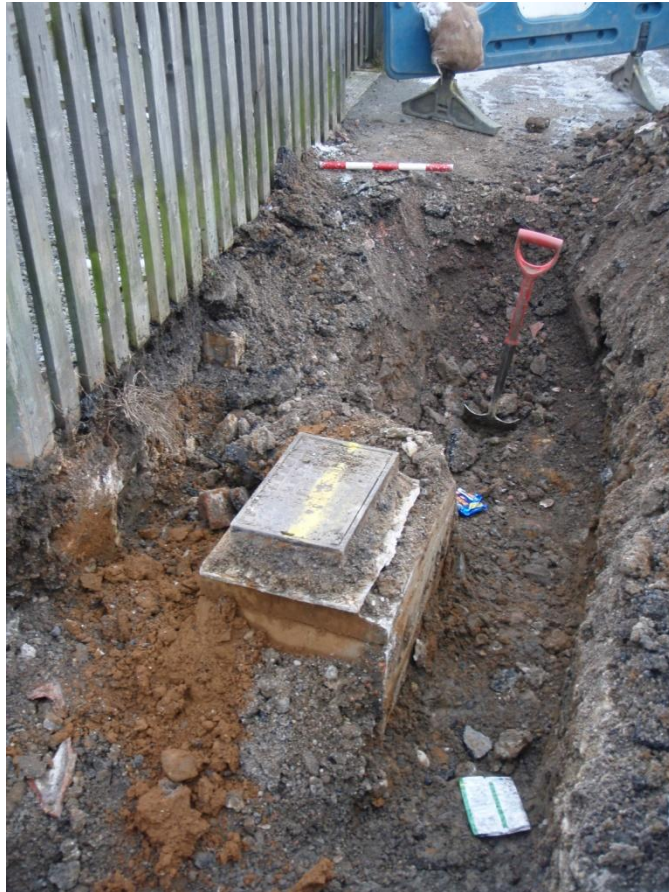
Plate 32 Trench 27 facing east, showing the modern man hole, scale unit 0.1m.

The east-west aligned portion of the trench (Plate 32) varied in width due to the presence of a modern metal services plate and associated brick man-hole. To the immediate north of this man-hole there was a trench backfill of pure sand which seemed to represent the infilling of a trench for the adjacent garden fence. Elsewhere in this portion of the trench the deposits comprised dark brown sandy-clay with occasional stone and brick fragments, the bricks being of late-18th century or later date; this deposit represented modern backfill. The uppermost 0.12m of deposits comprised tarmac.

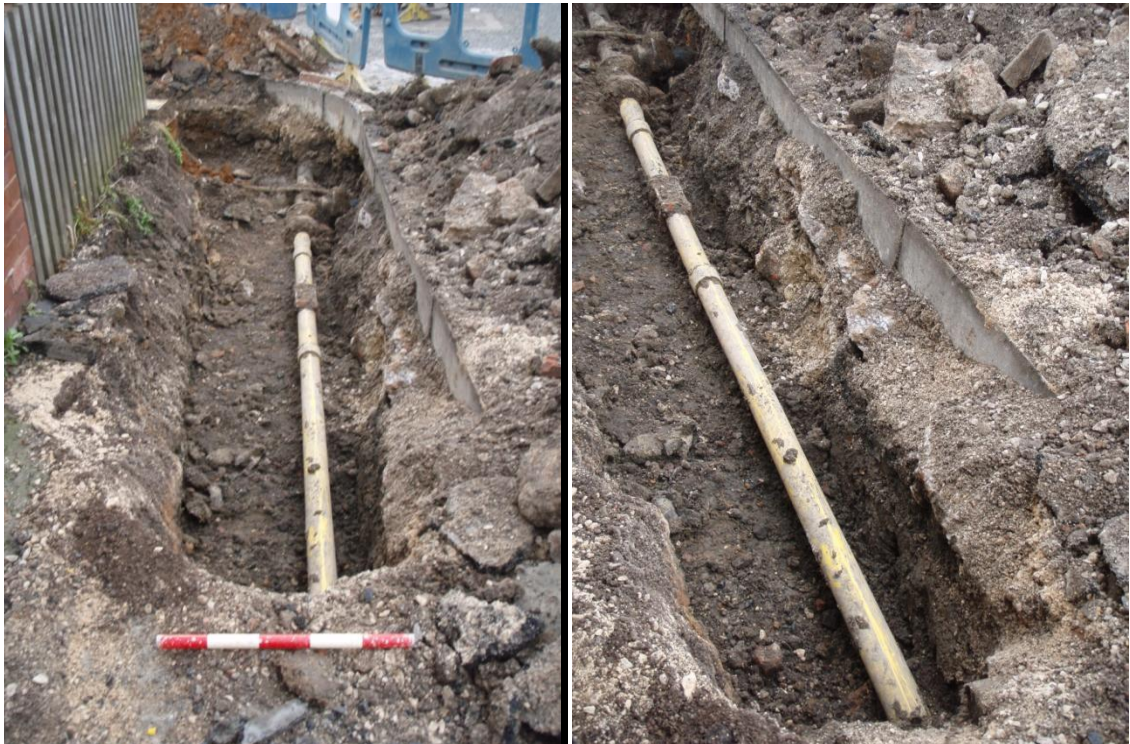
Plate 33 Trench 27 facing south and south-west, scale unit 0.1m.

The western side of the north-south aligned portion of the trench butted against the kerb stones of the pavement (Plate 33 right hand image), while the eastern side butted against the garden fence and part of the property wall of 15 Micklegate (Plate 33 left hand image). The earliest deposit seen was dark brown sandy-clay with occasional stones and brick fragments. There was a small iron pipe running across the trench in an east-west direction at the southern end, and this was either capped a ceramic cover or was within a ceramic pipe, it was not possible to determine which. The new yellow plastic gas main ran north-south along the western side of the trench at 0.6m below ground level, joining into the original cast iron gas main at the southern end, and this cast iron portion had a junction with a mains pipe on the western side. In the north-easternmost corner of the trench there was a deposit of pale yellow crushed stone levelling 0.1m thick, which was beneath a 0.19m thick levelling deposit of dark grey gritty-ash. These were both clearly of modern date, and were cut on the southern side by a modern trench backfilled with limestone hard core, (visible in the centre of the right hand image in Plate 34), which ran obliquely across the northern end of the trench, being visible in both the western and eastern facing sections. The uppermost 0.3m of deposits visible in the east facing section were the kerb stones of the pavement and an

associated haunching of concrete. Elsewhere the upper most deposits were the tarmac of the present path which was up to 0.12m thick.

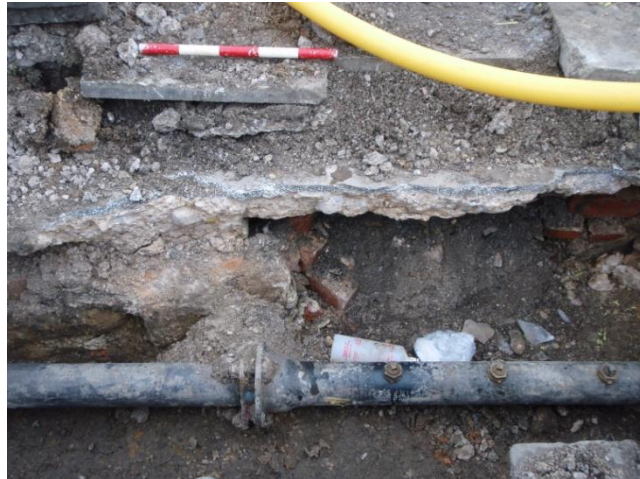
Plate 34 Eastern end of Trench 28 facing north, showing the sandstone truncated by a modern brick feature, scale unit 0.1m.

Trench 28 measured 4.10m x 0.7m in area and up to 0.7m deep, with the long axis parallel to Micklegate. The earliest deposit seen was pale yellow sandstone which was visible in the base of the south-facing section; this was up to 0.3m thick (visible in the centre left hand portion of Plate 34). This was largely obscured by the gas mains pipe and it was impossible to determine if it represented a structural wall or part of a footing/foundation. This had clearly been cut away on both the eastern and southern sides by modern features. All the remaining features in the trench were of clearly modern date (Plate 35). To the south of the sandstone there was a deposit of dark brown sandy-clay with occasional stones, which clearly represented the backfilling of not just the gas mains trench but other services trenches. Near the eastern end of the trench the sandstone was truncated by a modern brick feature, backfilled with loose rubble, only the corner of this feature had been clipped by the present trench, causing a small area of collapse within the section (right hand side of Plate 34). A sawn off metal pipe was visible in the central portion of the north-facing section. A ceramic pipe was visible in the east-facing section there was a modern ceramic pipe at 0.3m below ground level. In the extreme north-western corner of the trench there was a modern brick

wall bedded on a deposit of concrete up to 0.08m thick, the top of the wall being 0.3m below ground level. This wall lay beyond the limits of the trench. Butting up against the eastern side of this wall was a deposit of modern limestone hardcore up to 0.2m thick which was only visible in the south-facing section. This was beneath a layer of tarmac 0.1m thick. In the north-facing section of the trench there was a brick man-hole capped by a metal plate. The uppermost deposits across the trench were limestone hardcore levelling 0.08, thick which was below paving stones 0.07m thick.

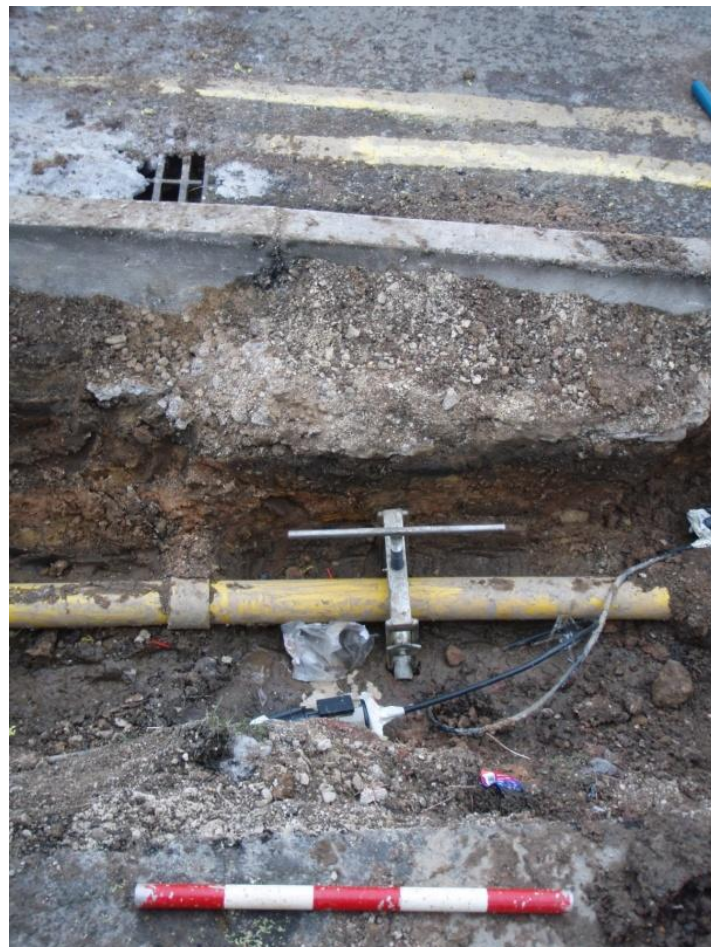
Plate 36 The central portion of the east facing section of Trench 29 facing west, showing the sandstone visible at the base of the section, scale unit 0.1m.

Trench 29 was 3.5m x 1.1m in area and 0.63m deep, with the long axis at right angles to Micklegate. The earliest deposit seen was of sandstone which was visible in the northernmost and central portion of the east-facing section (directly behind the metal bar in Plate 36), though the central portion was somewhat obscured by loose material. The sandstone was also visible in the central portion of the west facing section. This stonework had been so heavily truncated that it was unclear if it represented a wall or footing. In the case of the east facing section the sandstone had been truncated on an oblique angle by a modern cable trench, while in the tough facing and west facing sections the sandstone had been truncated by the trench for the cast iron gas mains.

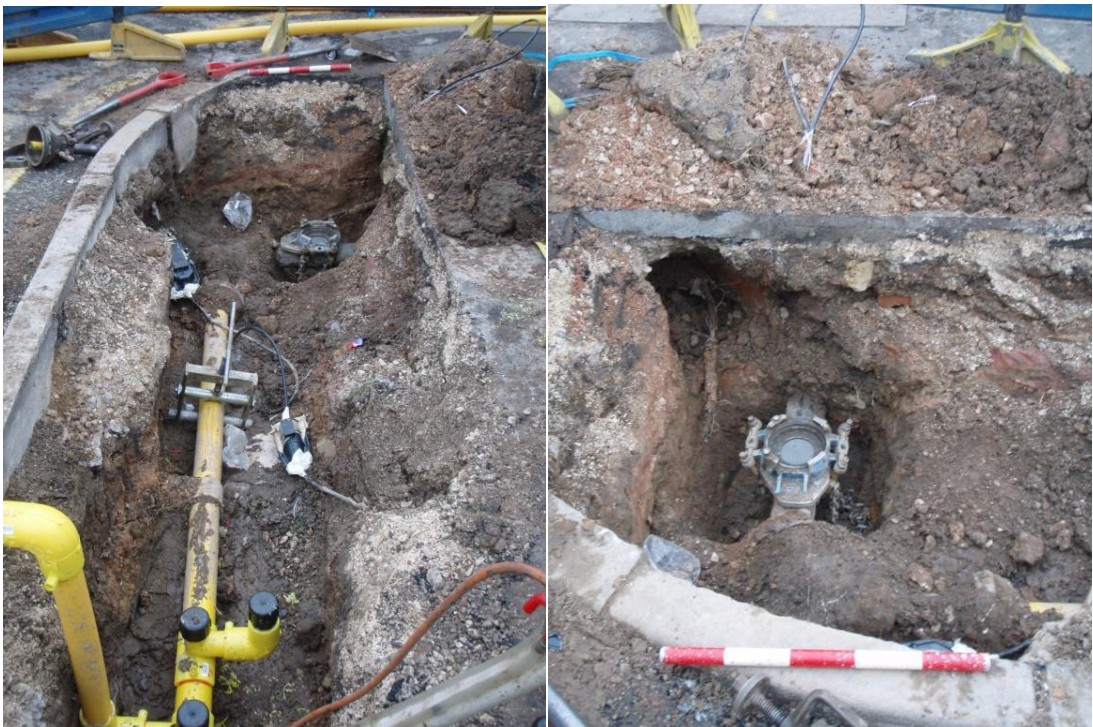
Plate 37 Trench 29 facing south, and the south-western corner of the trench facing east showing the void in the corner of the trench, scale unit 0.1m.

All the material observed above the sandstone was the fill of modern services cuts. The main portion of the gas mains ran parallel to Micklegate, with a smaller connecting pipe aligned north-south. The connecting pipe was a new yellow plastic pipe. There was also a cable

trench in the extreme south-western corner of the trench, the fill of which had collapsed creating a slight void (see right hand image Plate 37); this cable was clearly no longer live. The third service comprised a modern cable and junction box running diagonally across the trench from north-west to south-east. The backfills of these services were indistinguishable, representing earth that has been repeatedly disturbed, which comprised dark brown sandy-clay with occasional stones and occasional brick fragments. Further modern disturbance had been caused by a construction cut for the present kerb stones which was 0.3m deep and up to 0.25m wide and ran around the eastern and southern sides of the trench. This trench was infilled with compacted limestone hardcore. The uppermost surface seen was tarmac 0.07m thick.

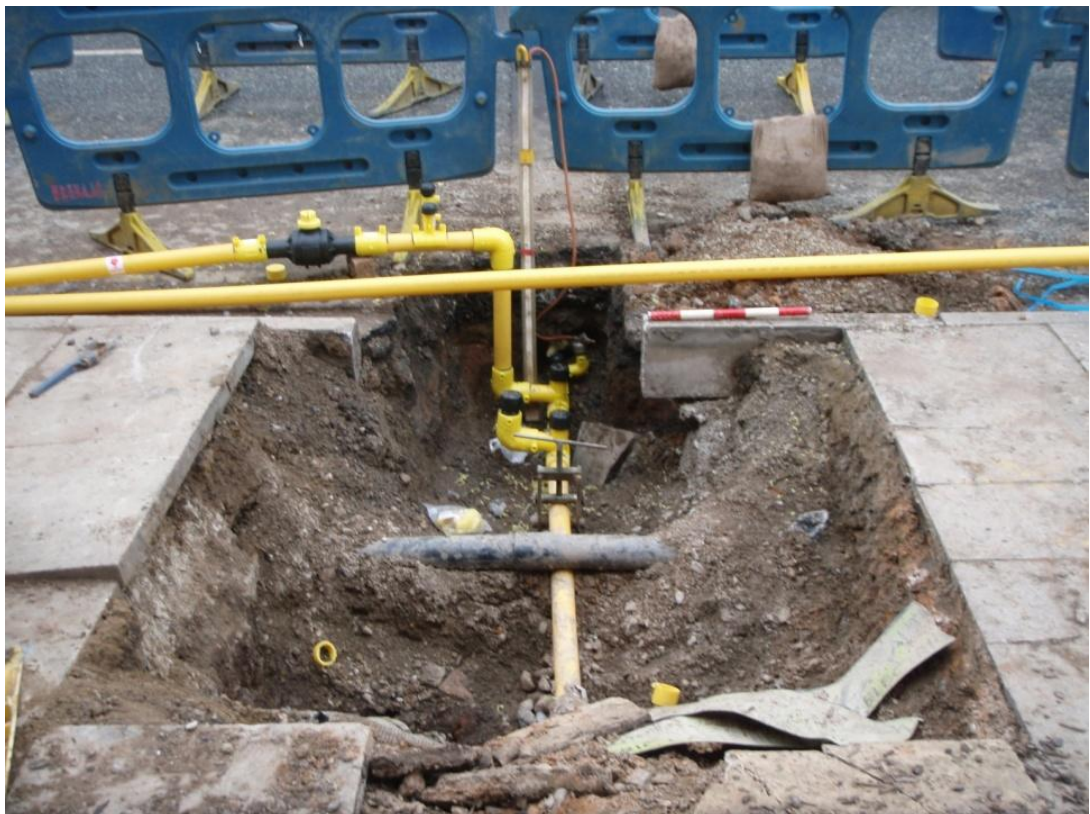
Plate 38 Trench 30 facing south, scale unit 0.1m.

The main portion of Trench 30 (Plate 38) was 1.75m x 1.78m in size and up to 0.9m deep, though it was only 0.34m deep for the northernmost 0.6m in width of the trench, and this was located beneath the pavement. Midway along the southern side there was a small additional extension measuring 0.9m east-west and 0.6m north-south which extended beneath the present road surface.

The entire area had been heavily disturbed by modern services including the cast iron gas main running west-east, which was 0.7m below ground level. There was a smaller connecting north-south aligned yellow plastic pipe on the southern side. To either side of the gas main there were two further pipes on an east-west alignment, the northernmost of which was of corrugated plastic. All of the material above the pipes represented soil which had been repeatedly disturbed, and comprised dark brown sandy-clay with occasional stones. In the north-westernmost corner there was a modern vertically sided cut 1m wide and 0.43m deep, which had a lump of concrete in the base and was backfilled with limestone hardcore (top left hand corner of Plate 39). The construction cut for the kerb stones was 0.3m deep and 0.2m wide, and also backfilled with limestone hardcore. The uppermost surface was paving stones up to 0.9 x 0.6 x 0.07m in size, while the road had tarmac and associated levelling up to 0.23m thick.

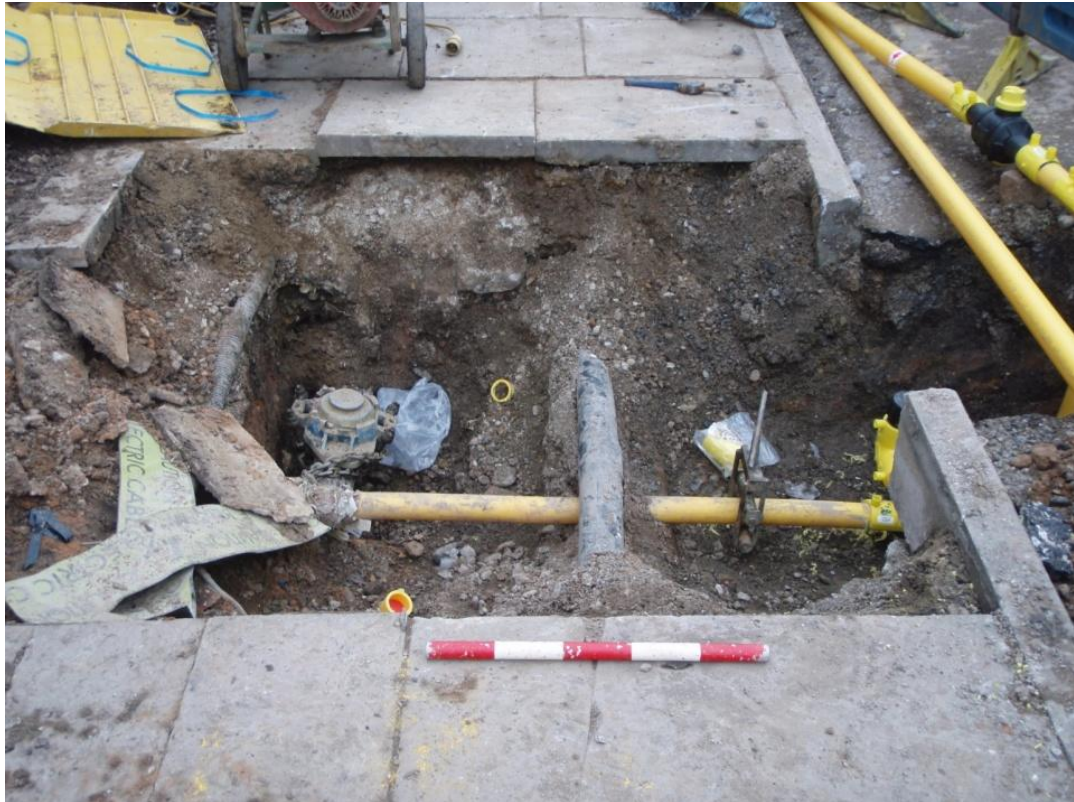
Plate 39 Trench 30 facing east, showing the modern hardcore filled trench cut and modern services, scale unit 0.1m.

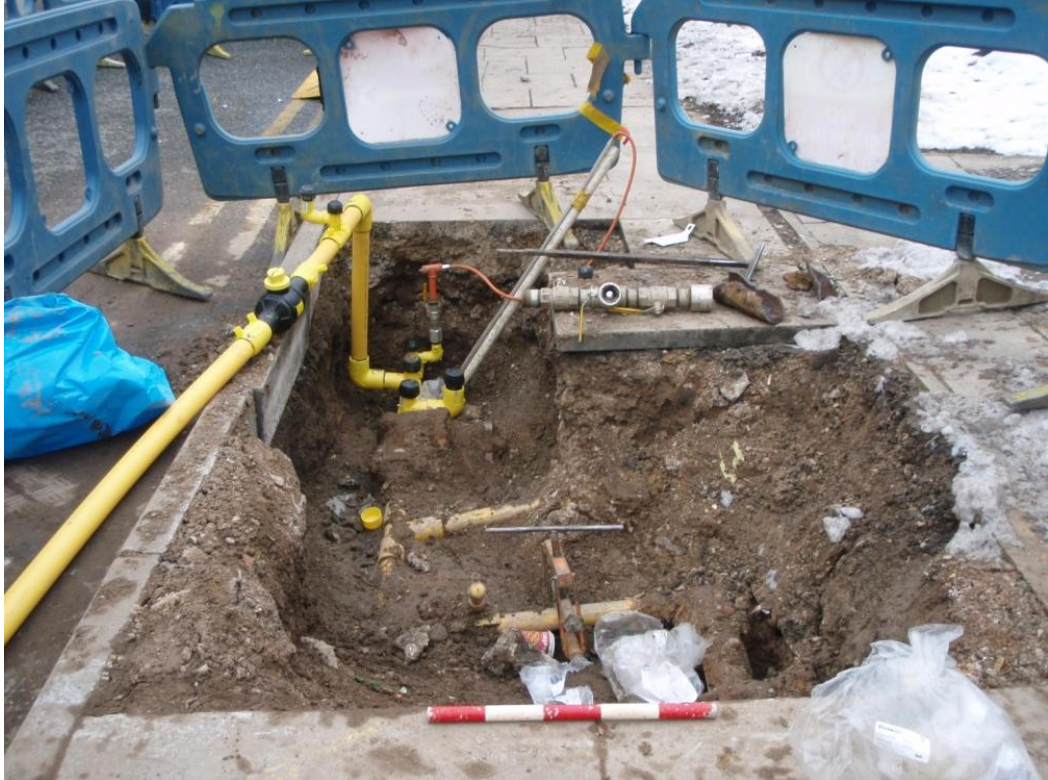
Plate 40 Trench 31 facing west, scale unit 0.1m.

The main portion of Trench 31 was 1.5m north-south and 1.73m east-west, with a small extension measuring 1.07m east-west and 0.7m north-south on the south-western corner. The trench was up to 0.65m deep, but only 0.5m deep on the northernmost side and in the south-eastern corner, where loose material had fallen into the trench. The trench contained a gas main running east-west with a dog-leg in the central portion of the trench (Plate 40). The portion of the gas main to the west of the dog-leg had been replaced by yellow plastic pipes. There were two further modern services visible: the first was an electricity cable running east-west to the immediate north of the gas main which was covered with orange sand; while the second was a curving cable running around the northern and eastern sides of the trench (Plate 41). The deposits visible in the section seemed to be modern backfill comprising dark brown sandy-clay with occasional stones and fragments of concrete. The construction cut for the present kerb stones up to 0.3m deep and 0.2m wide and was infilled with compacted hardcore. The uppermost deposit was paving stones up to 0.9m x 0.6m x 0.07m in size.

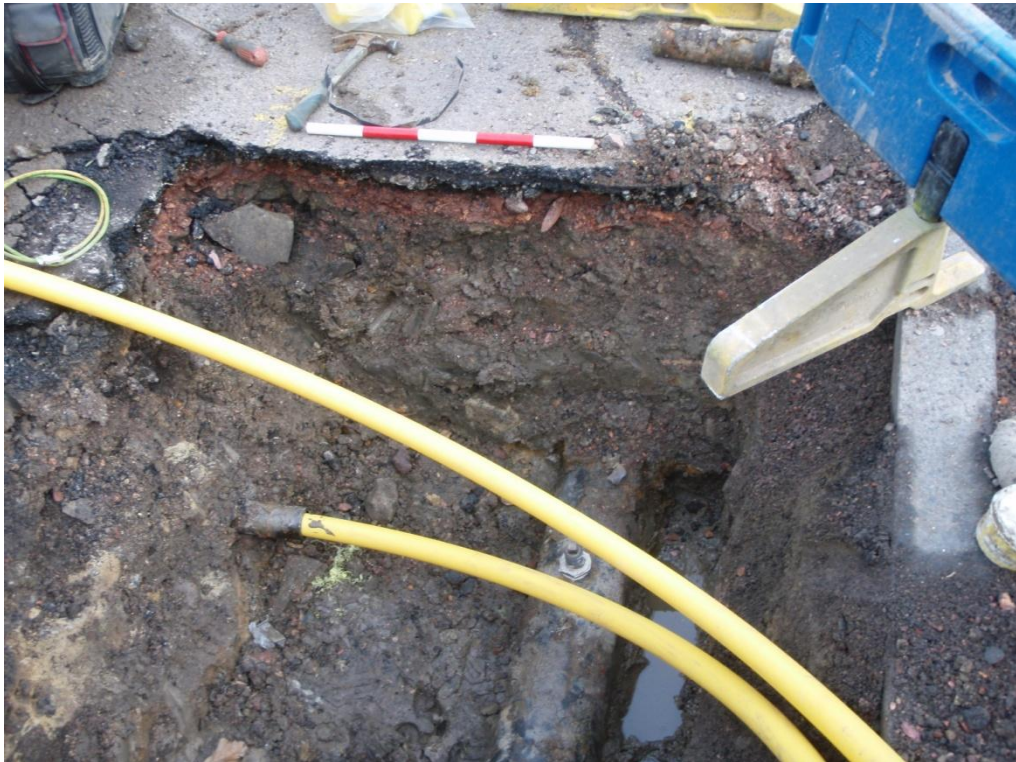
Plate 42 Trench 32, facing east, scale unit 0.1m. The in-situ stoney deposit can be seen to the left.

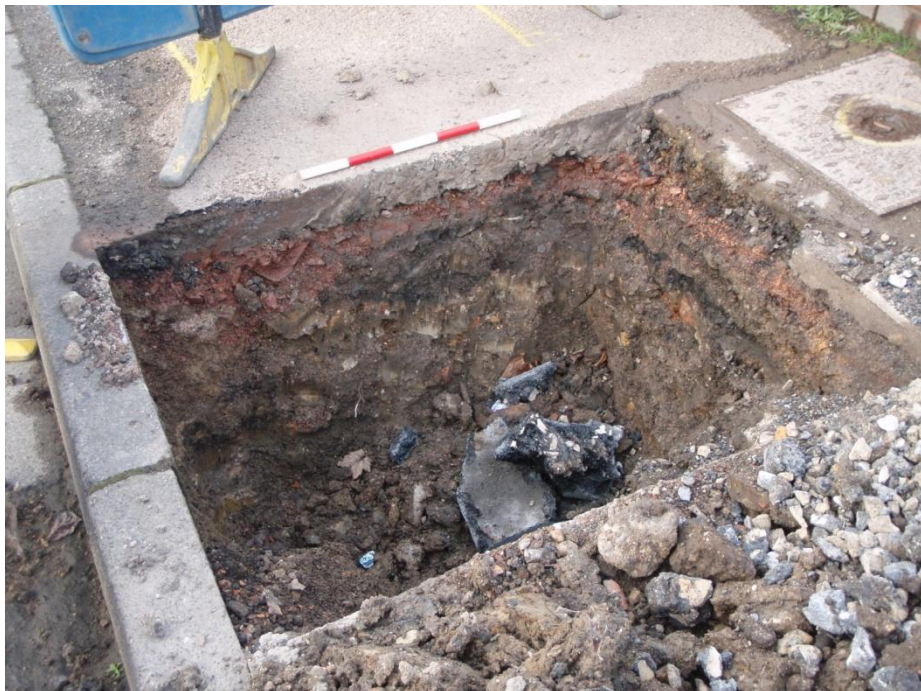
Plate 43 Trench 33, facing north-west, scale unit 0.1m. The intact deposits lie to the right.

Located fully within the footpath directly in front of the car-park wall of the church Trench 33 measured some 1m square and had a depth of up to 0.63m (Plate 43). Around 90% of the trench was occupied by the cut and its backfills of the gas main. However, to the north side of the trench a sequence of intact deposits could be observed. The lower of these was a pale

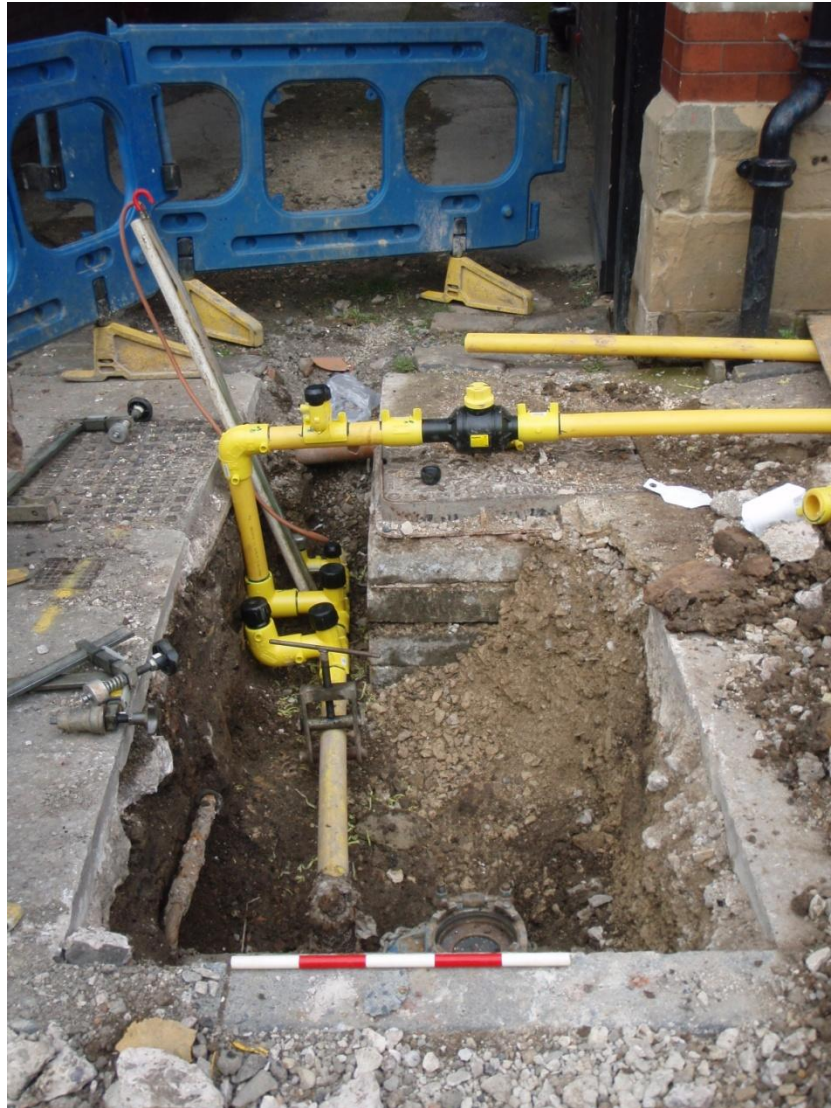
Plate 44 Trench 34, facing north-west, scale unit 0.1m.

Trench 34 was located immediately in front of the archway of the 'Old Castle', a former hostelry and now residential accommodation (Plate 44). This large trench measured some 2.2m (north-west/south-east) by 1m (south-west/north-east) – minus an area of some 0.7m x 0.7m to the northern corner which was occupied by a chamber relating to a water meter. The entirety of this trench was occupied by modern materials. Much of this was the cut, backfills and pipes of the gas network, but also included a number of other utility services. These utilities were sealed by modern surfaces, primarily concrete that forms the footpath surface in this area.

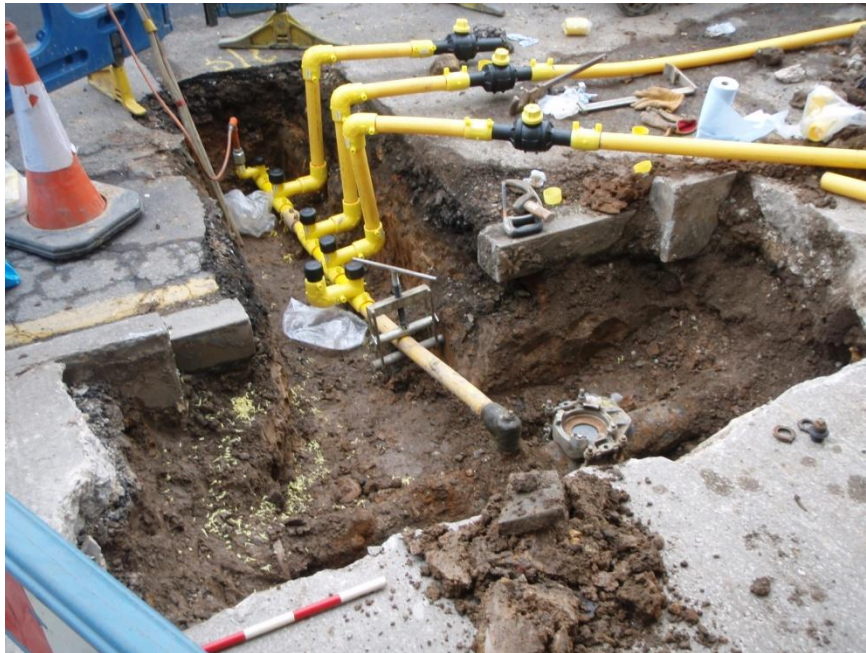
Plate 45 Trench 35, facing north-west, scale unit 0.1m.

Trench 35 was also located in front of the 'Old Castle', a few metres to the south-east of Trench 34. The 'bar' of this 'T' shaped trench was located in the footpath and measured some 2.8m (south-west/north-east) x 1m (north-west/south-east). The remaining part of the trench was comprised of a narrow extension some 1.6m long by 0.55m wide extending into the roadway. The depth of both parts of the trench was a fairly constant 0.60m. Modern backfills and materials occupied the entirety of the larger, footpath part, of the trench, early deposits being present only within that part in the roadway. Here, in the basal parts of the trench a dull orange – buff coloured layer of silty clay containing occasional flecks of charcoal and fragments of stone up to 60mm, was seen, the origin of which is uncertain. This material was sealed by a layer of stone bedding material for the existing tarmac road

surface. Sealing deposits over the remainder of the trench were comprised of kerb-stones set in concrete haunching and a concrete pavement surface.
