**ROUNDHAY PRIMARY CAMPUS,
ELMETE LANE, LEEDS,
WEST YORKSHIRE**

WATCHING BRIEF REPORT

REPORT NUMBER 2012/35

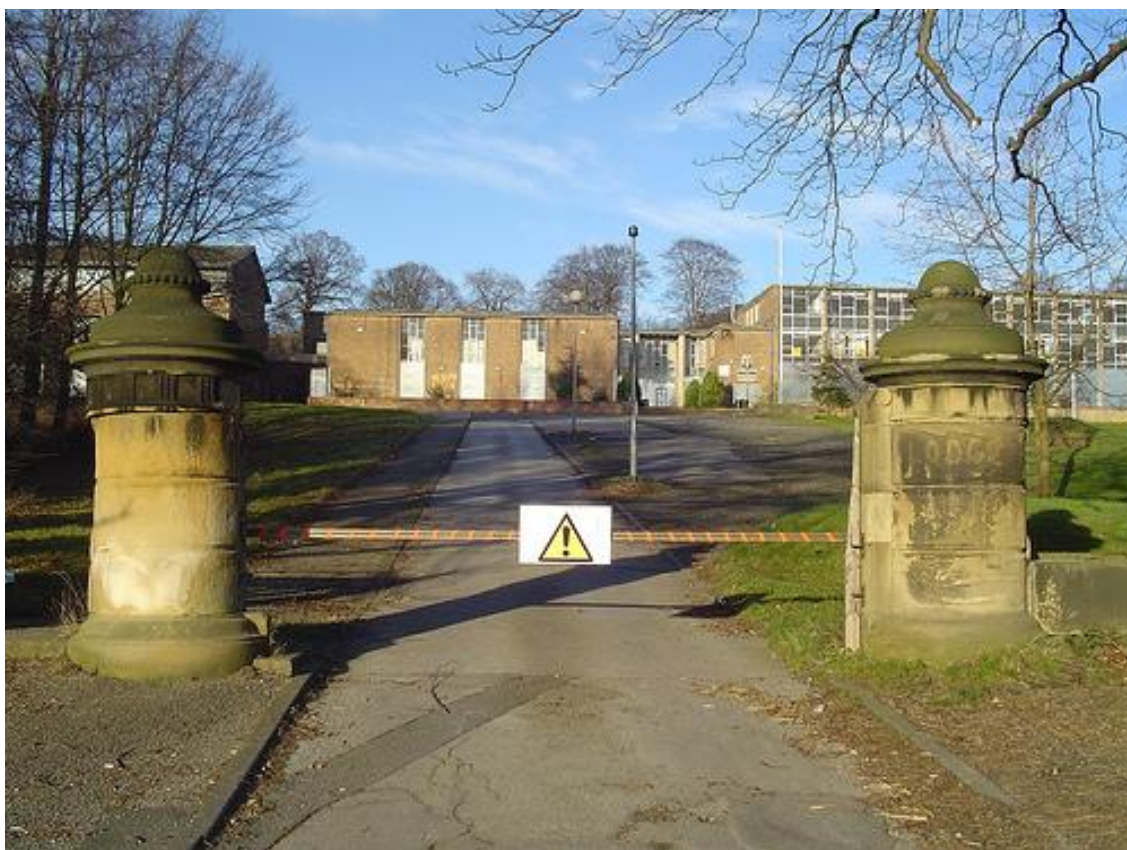
*Plate 1 View of Braim Wood School in 2007 before demolition.
The gateposts still survive and the roadway removal was monitored*

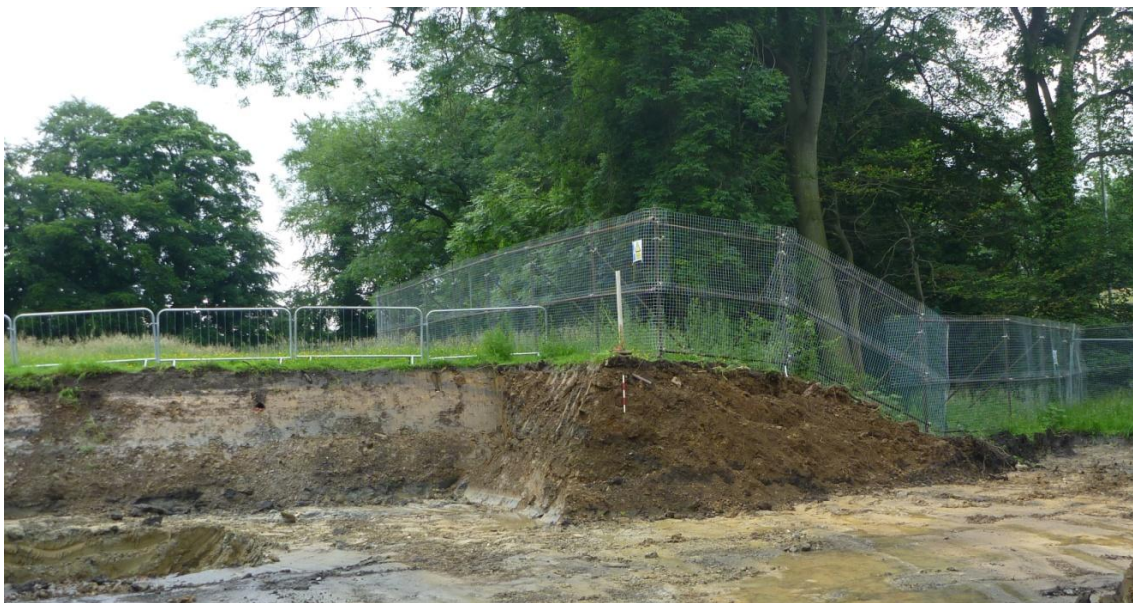
The programme of further stripping at the site to the formation level of the car park revealed the presence of a thin band of mid greyish brown clayey silt, typically just under 200mm in depth and containing quantities of pebbles and numerous rootlets, context 103. This material was seen to have a distinct north down to south slope along its length. Context 103 clearly represents the soil of a former, and lower, ground level. The paleness of this deposit would suggest that this represents either the basal part of a former topsoil or else a sub-soil. Although it is possible that the material may be a leached former topsoil any such topsoil is likely to have been removed during the works of 1953. Beneath the soil 103 natural bedrock, in the form of sandstones with some clay, context 105, was reached, (Plate 6). The very upper part of this material for a depth of 100-200mm, context 104, was considerably less stony than the material below and presumably represents the heavily weathered top of natural geological deposits. The character of bedrock 105 was seen to be subject to some differential banding in the horizontal plane, particularly within the cut for the attenuation tank located in the car park area. This was seen to range from angular fragments of sandstone within a clayey matrix to slab-like layers of sandstone.

Plate 4 SE corner area of new car park as machined to formation level. A relict soil, 103, can be seen within the section and one or two tip-lines in the re-deposited material, 102, above this. Looking ESE. 0.10m scale divisions.

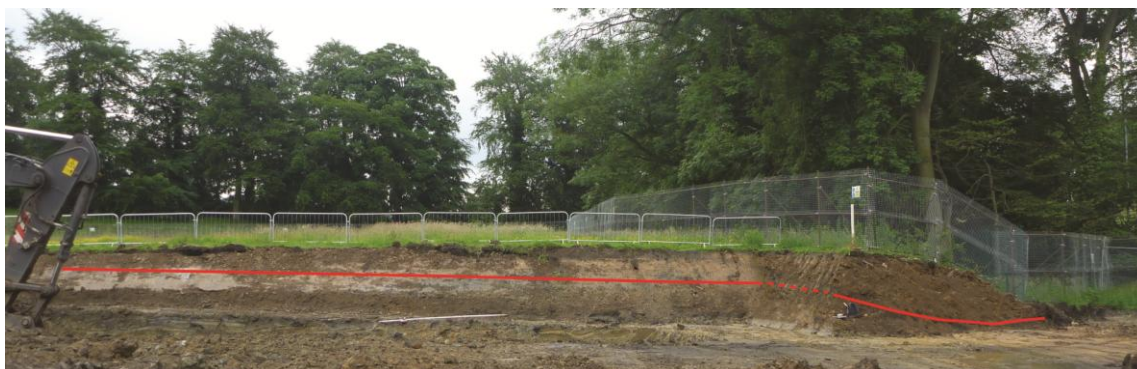
Plate 5 Wider view of same section forming the eastern limit of the car park area with the buried soil line indicated in red. Looking ESE

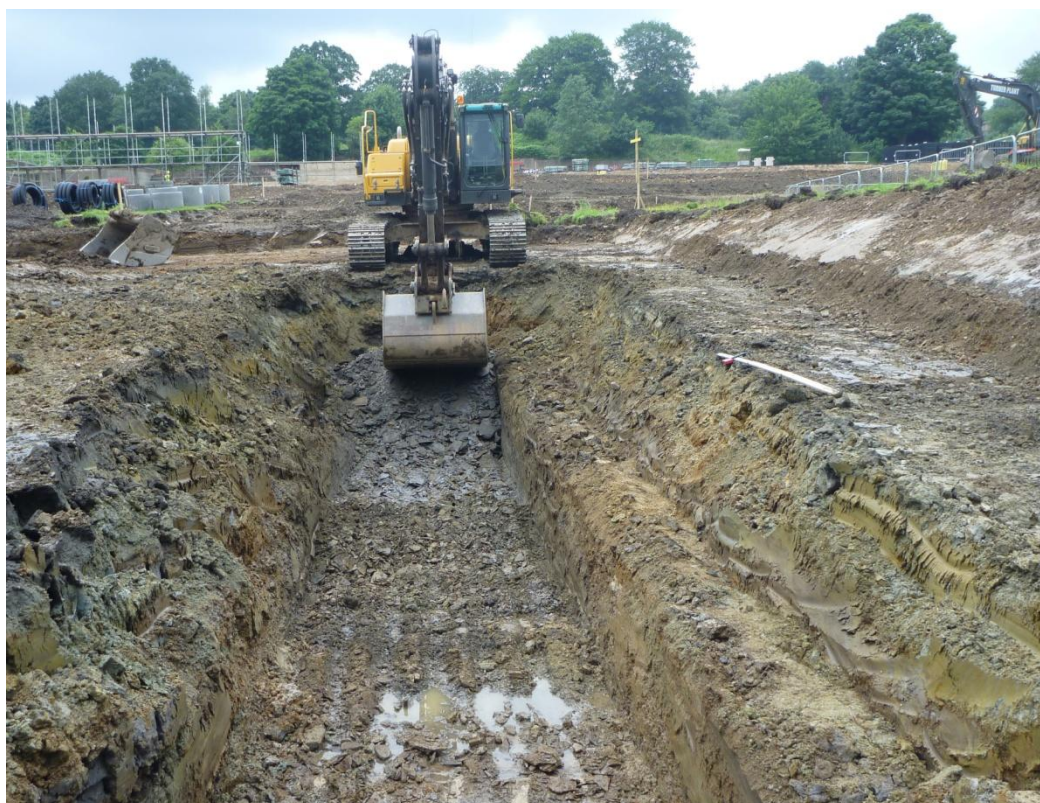
Plate 6 Excavation for the attenuation tank below the car park, looking N.

Note the variation within bedrock strata

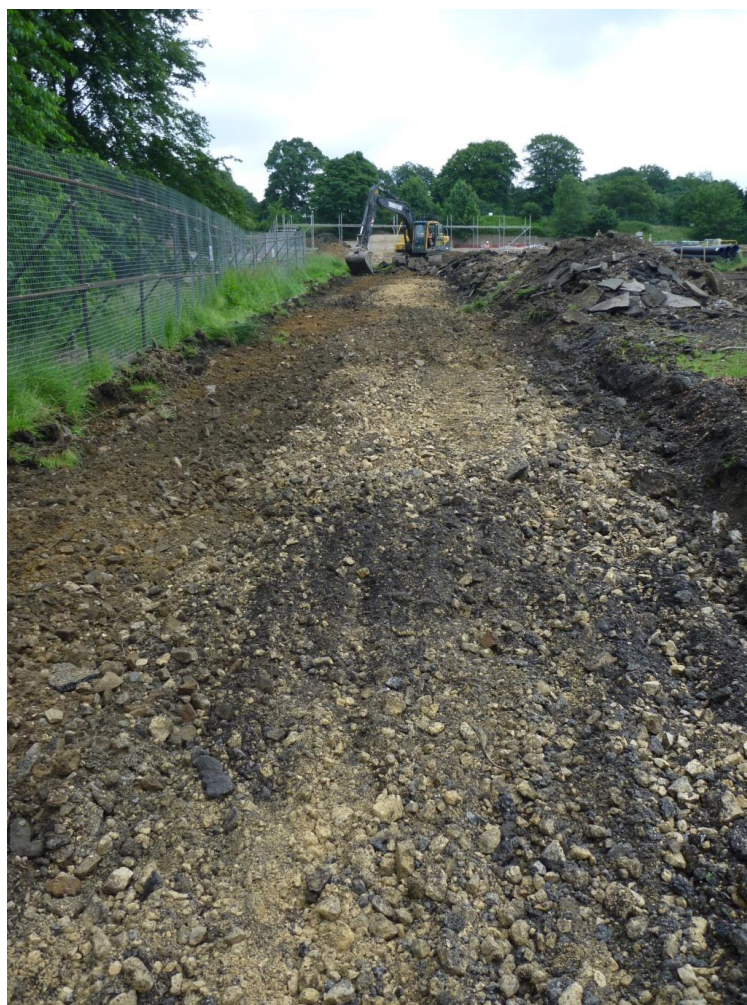
Observations were also made during the stripping of parts of the old roadway immediately to the east of the new car park area. Stripping in this area was solely of the tarmac surface and the uppermost parts of the limestone chipping make-up beneath this, i.e. above the level at which any archaeological remains may potentially survive (Plate 7).

Plate 7 Stripping of the existing road adjacent to the new car park area, looking N
