21 CLIFTON GREEN
YORK

Archaeological
Watching Brief
Report

June 2006

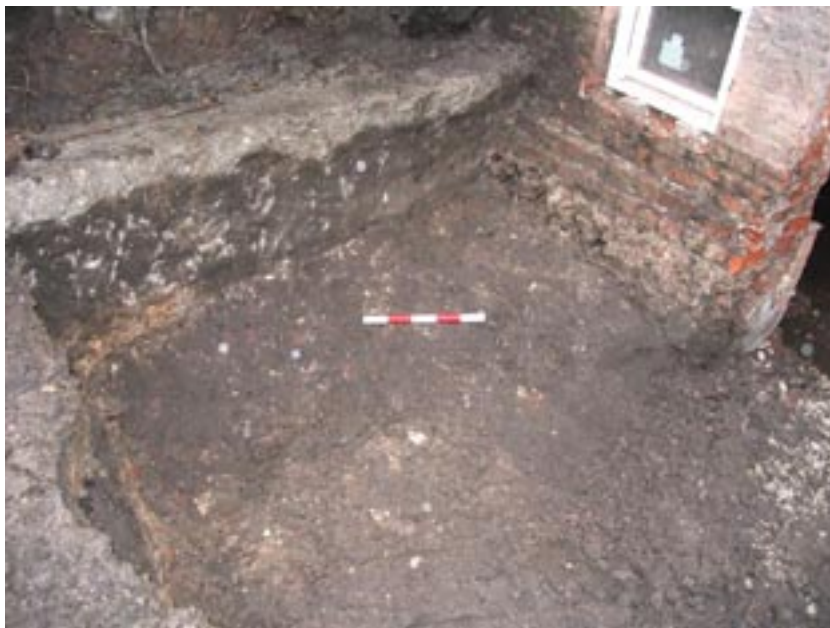
Plate 1 Deposit 1010 (centre) extending beneath foundations 1019 and brick foundations 1018 of Wall 1017. South-east lightwell (south-west end) looks west

Several deposits were observed overlying natural in the south-east part of the site. Towards the south-east side of the building was friable dark grey sandy silt loam with frequent charcoal flecks, moderate small-medium brick/tile fragments and occasional pebbles-cobbles (1002). In the east corner of the building was friable mid grey/brown silty clay with occasional pebbles (1023). On the south-west side of the south-east light-well was dark brown clay loam, some 0.15m thick (1010; Plate 1). Beneath the middle of the south-east exterior wall of the house

was a more mixed deposit of light orange/brown sandy clay and mid grey silty clay loam (1020); this deposit appears to have extended southwards, overlying Deposit 1010. The top of these layers was around 9.6m AOD and they were an average of 0.2m thick; a 14th century date is suggested by pottery and brick/tile found in Deposits 1002 and 1010. The absence of any underlying subsoil

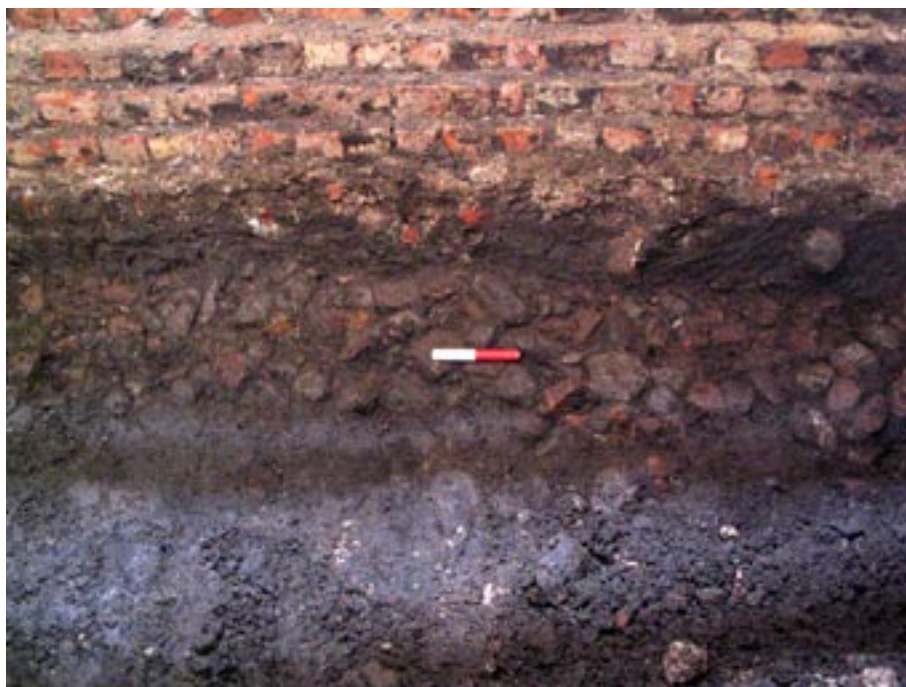
Plate 2 Rubble feature 1001 beneath the south-east wall of the house. looks south-east.

Cutting Deposit 1002 and lying beneath the south-east wall of the house was a linear cut with a concave profile (1003). It was aligned slightly more west-east than the house, so that it was inside the house on the south-west side (Plate 2), whereas further north-east it was seen extending beyond the external face of the house wall. It was not observed at the north-east end of the light-well, which suggests that it terminated or returned to the north-west. Overall, this feature was at least 5m long by 0.7m wide and 0.25m deep. It contained 90% cobbles set in mid brown silty clay loam, with occasional mortar flecks and small brick/tile fragments (1001=1015). The function of this feature is uncertain, although it could have been a wall foundation. Pottery and brick/tile suggest an 18th century date.
