**GAS MAINS REPLACEMENT, ALDBOROUGH,
NORTH YORKSHIRE**

WATCHING BRIEF REPORT

REPORT NUMBER 2013/08

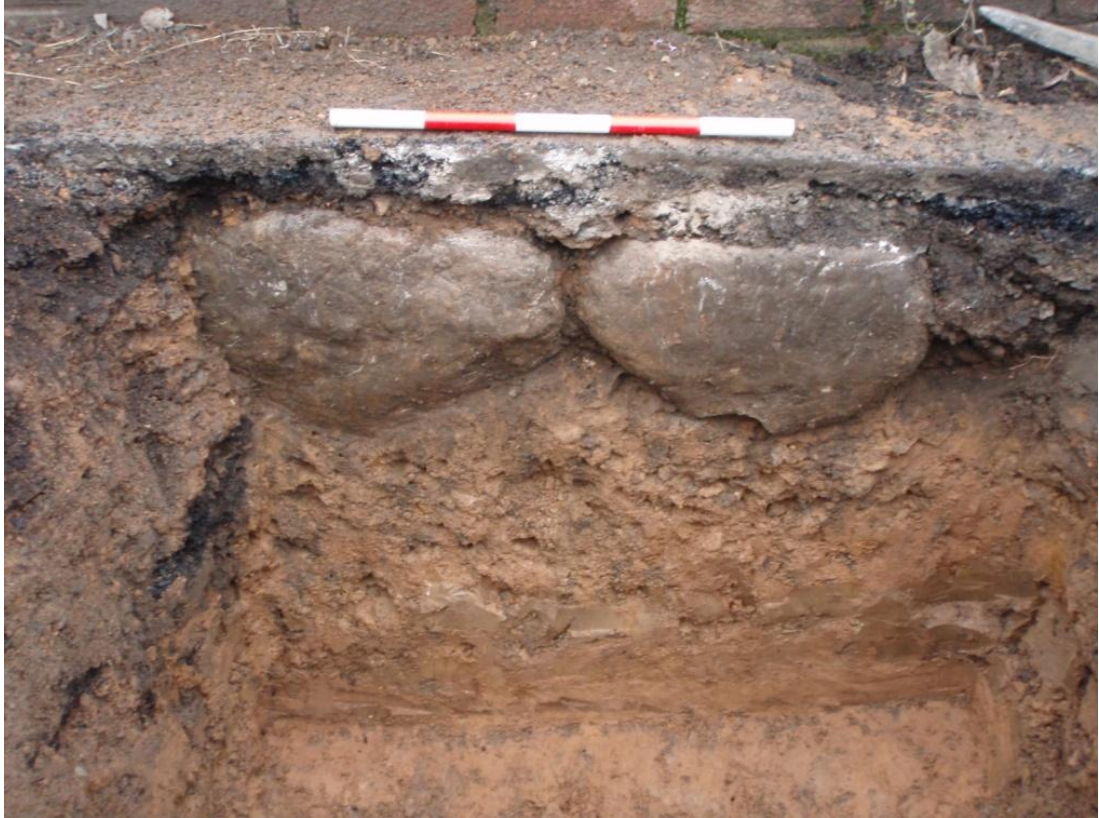
Plate 1 Former kerbing formed of large water-worn cobbles in Trench 9. Looking W

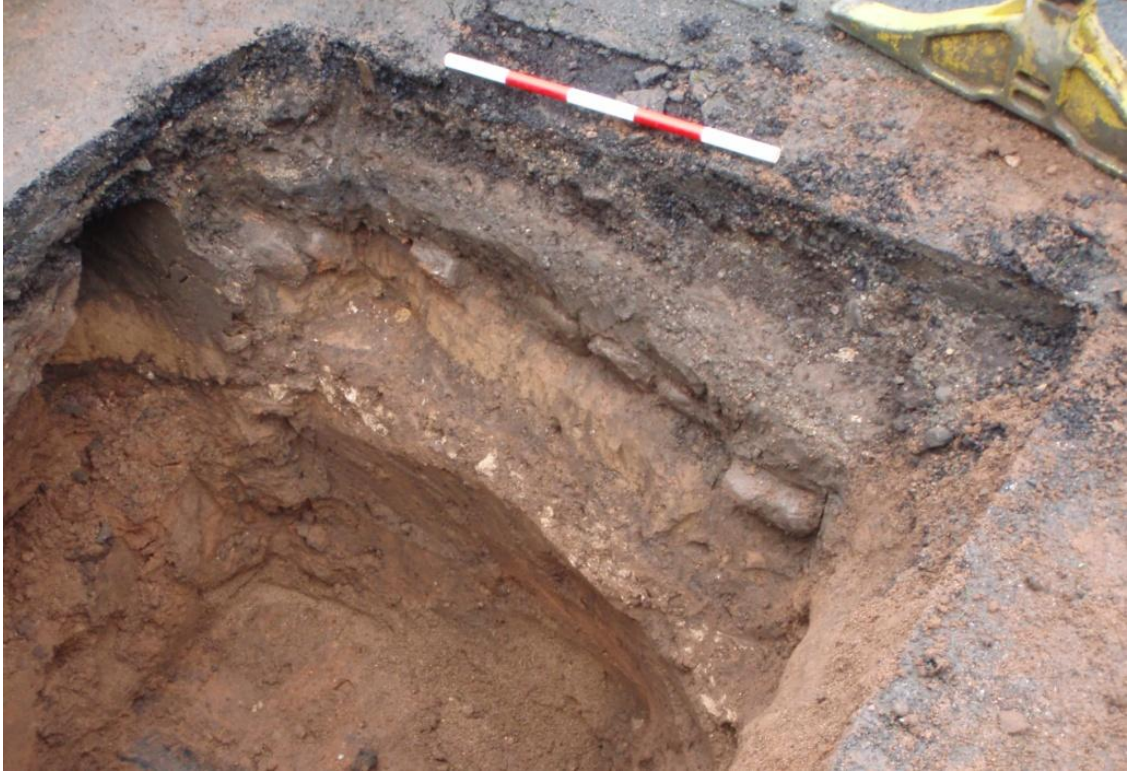
In the case of Trench 25 (Plate 2) this kerbing was directly associated with a metallised surface formed of a layer of cobbles set within a sandy bedding. This metallising appears to be a precursor of the modern road surface of Back Street. A thin silty deposit above the metallising appears to represent an accumulation over this surface. An earlier metallised surface of small pieces of stone within a silty matrix was evident below this, itself sealed by what is probably an accumulation deposit. The dating of this earlier surface is not clear cut and it could conceivably relate to the medieval period. Additional areas of cobbles, which were not seen to be directly related to kerbing were seen in Trenches 27, 28 and 66. The former two trenches were located on the eastern side of the grassed Square and suggest that the northern part of Back Street was wider than it is now whilst the same argument applies to Front Street in the area of Trench 66.

Plate 2 Metalled surface of cobbles set on a bedding of sand in Trench 25. The position of the kerbing (removed) can be seen in the void to the upper left. The stoney layer below this represents an earlier surface, with accumulation above. Looking NE

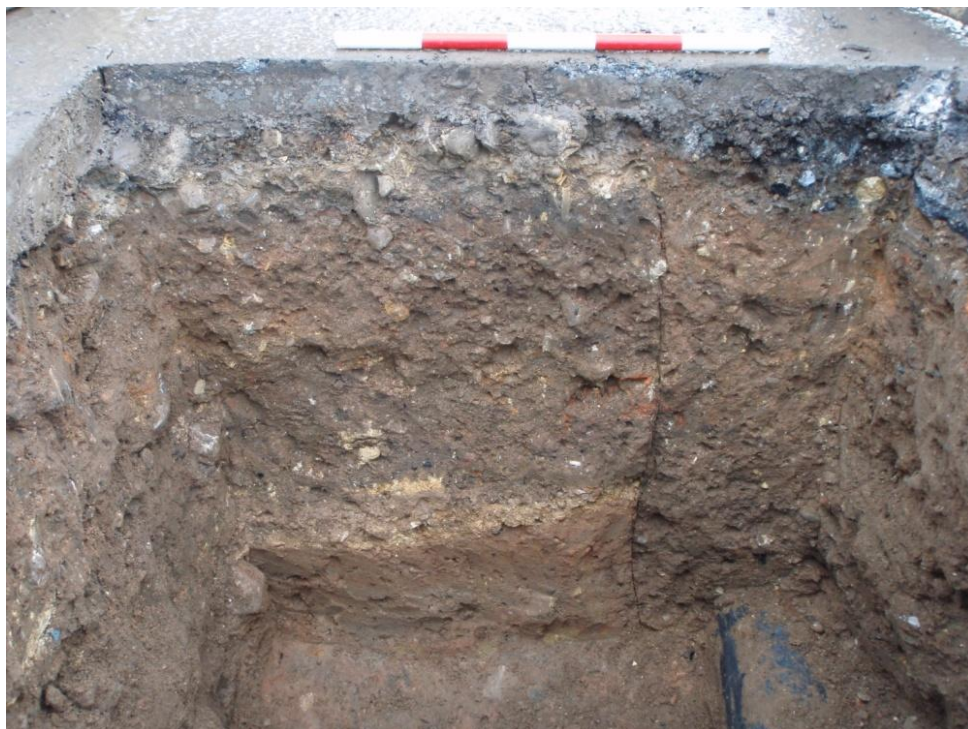
Plate 3 Stoney layer beneath modern road materials in Trench 48. This probably relates to a post-medieval metallated surface or its bedding. Looking E

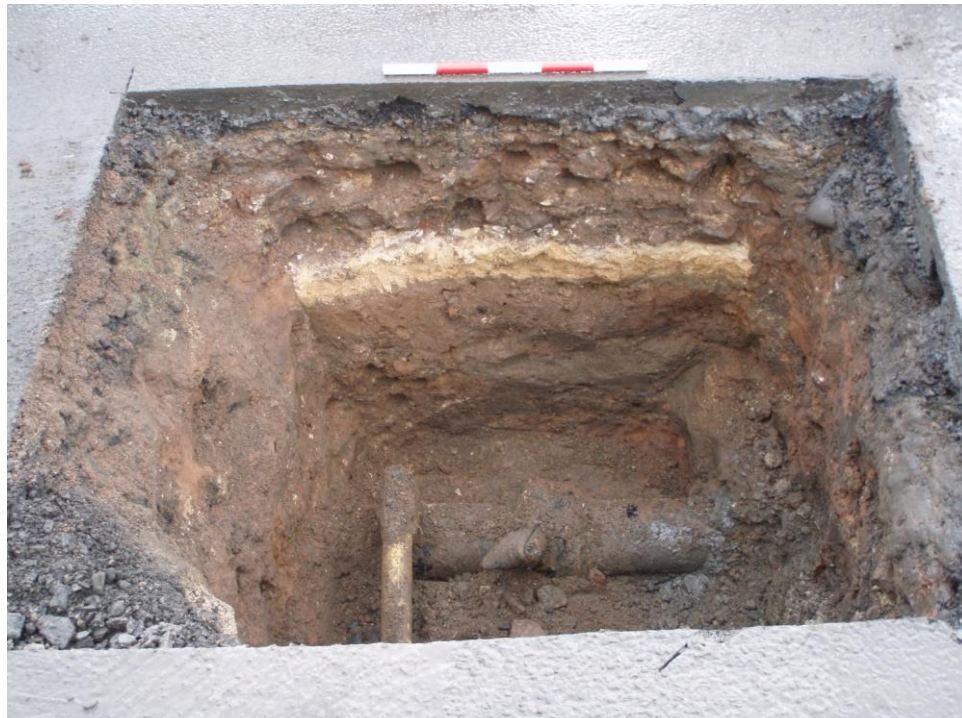
Plate 4 Metallated surface, predominantly of cobbles, below modern road materials in Trench 50. The pale coloured layer of crushed stone immediately below may relate to a bedding/makeup. Looking S

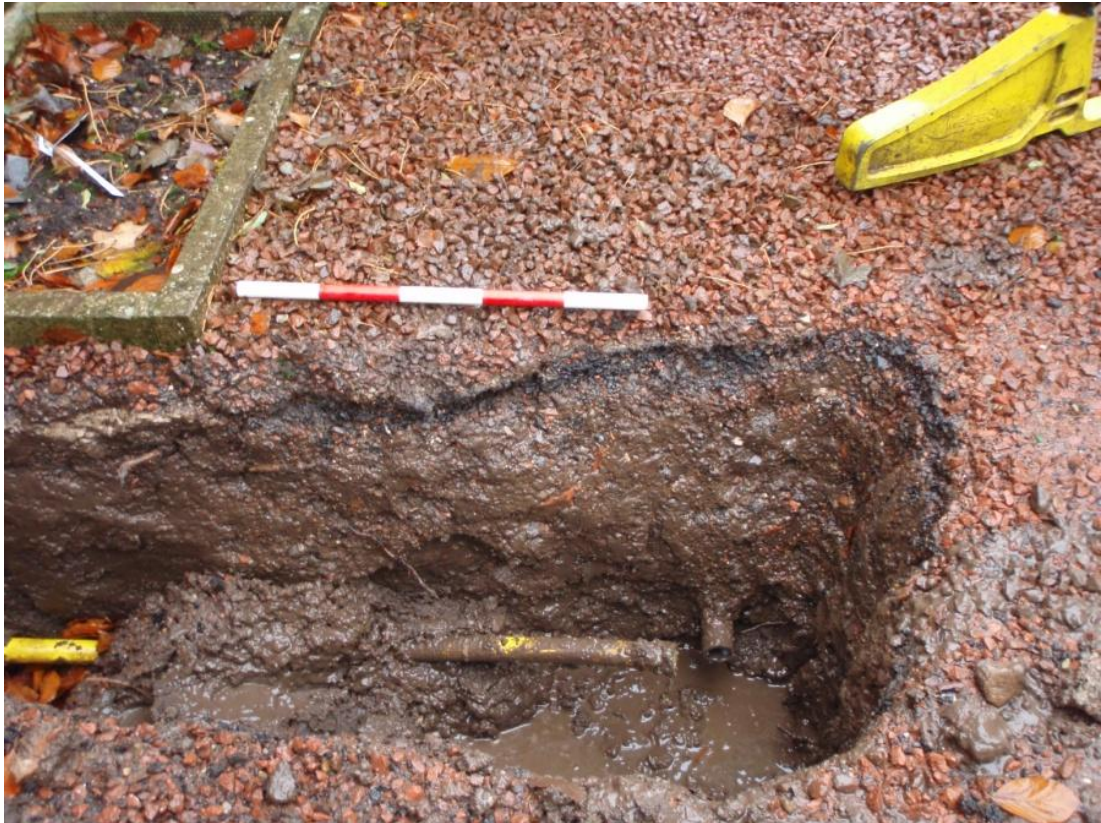
Worked garden soils containing later post-medieval materials were present in Trenches 44, 45, 46 and 47, all located below modern surfaces in areas immediately adjacent to Aldborough Hall (Plate 5). These soils were all dark coloured sandy silts. Similar soils in Trenches 32 and 33 may be of medieval or post-medieval date. Soils containing post-medieval material were also occasionally observed above what is demolition or robbing material of former Roman structures, the clearest examples being Trenches 38 and 55 (Plates 21, 22).

Plate 5 Former garden soil beneath modern surfacing in Trench 47, looking S

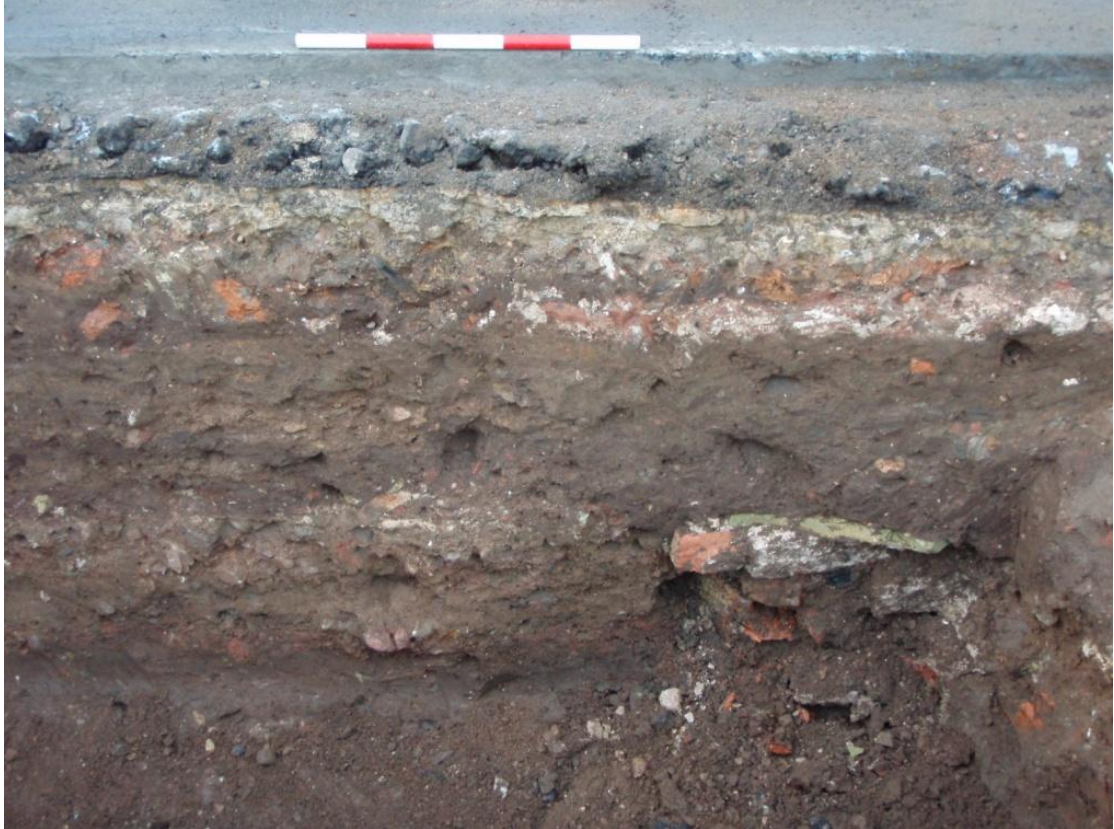
The remains of a Culvert extending across Boroughbridge Road were encountered in the north-western side of Trench 87 (Plate 6). Aligned south-south-west / north-north-east this feature occupied a construction trench that had been cut from a high level and was somewhat wider than the culvert itself. Backfilled with comparatively stone-free soils this cut had then been capped-off with aggregate to reinstate the roadway. The culvert was constructed of lime mortar bonded bricks capped off with thin slabs of pale yellow sandstone. The characteristics of the brick suggest that this culvert is of 18th or earlier 19th century date. Its alignment suggests it extends from an area somewhat to the west of Aldborough Manor down towards the lower ground to the north.

Plate 6 Remains of culvert in Trench 87, looking SW.

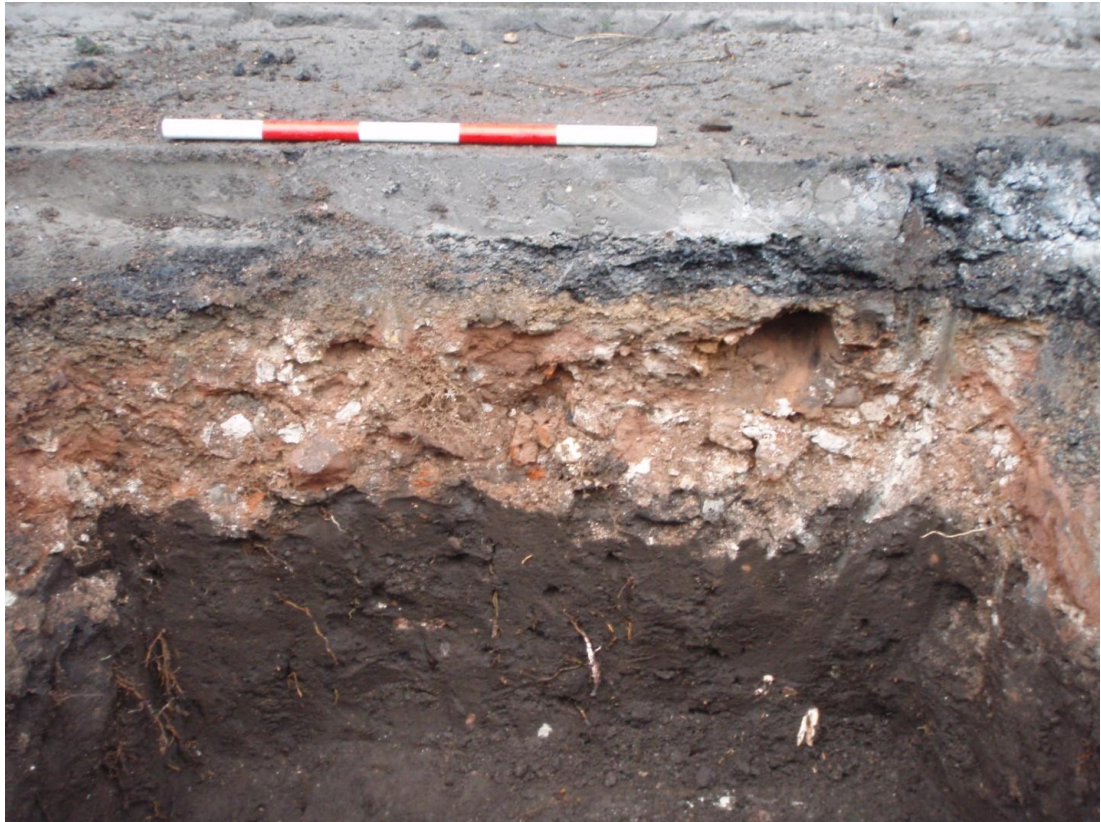
A series of post-medieval deposits were observed in Trenches 32, 33 and 34 in pavement areas immediately adjacent to the boundary wall of Aldborough Hall (Plate 7). In each of these trenches up to 0.30m of rubble, primarily comprised of fragments of ceramic building material, pebbles and fragments and flecks of lime mortar with a small amount of sand, was seen to be located under the existing footpath. The brickwork of the adjacent boundary wall suggests an 18th century, or slightly later date, for this feature. It is probable that this rubbly material relates to the levelling up and bedding for a pavement, though it is not clear whether it was for a pavement contemporary with the construction of the boundary wall, or later.

Plate 7 Post-medieval deposits sandwiched between existing footpath and soils in Trench 33, looking N.

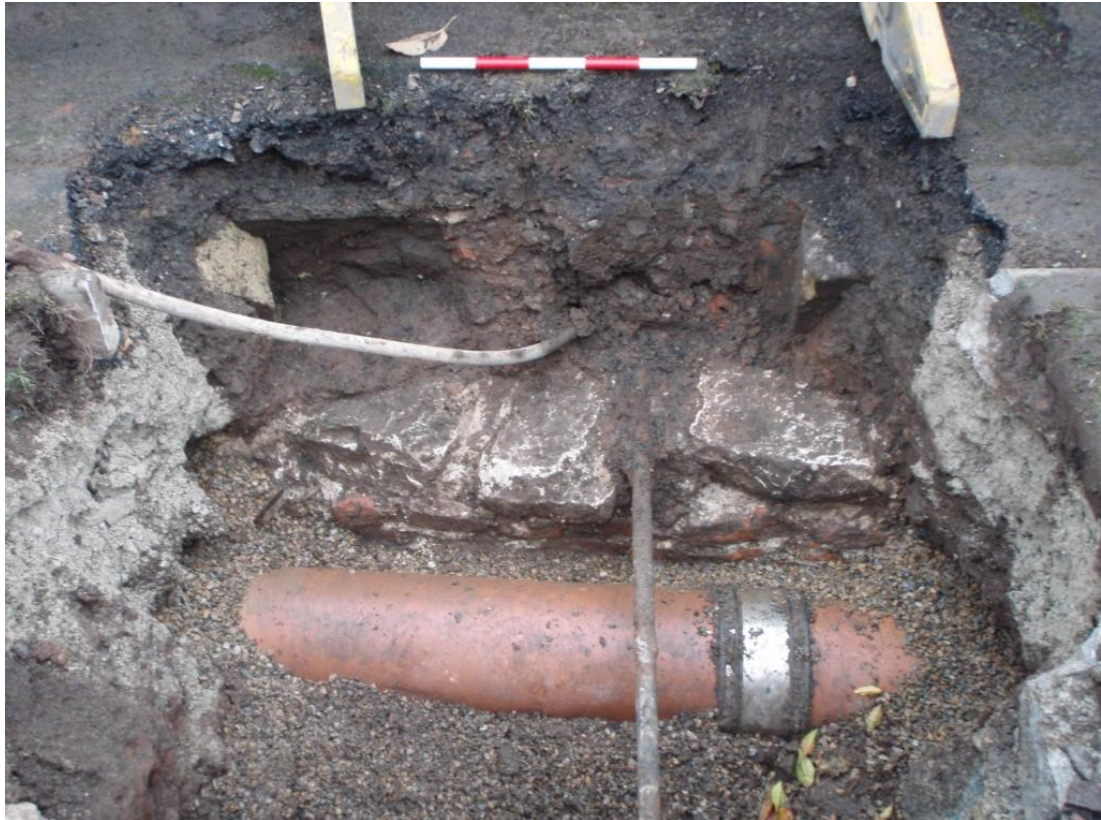
The only structural remains likely to be of post-medieval date relate to an arrangement within Trench 37, which also contained remains of later post-medieval kerbing (Plate 8). Although the remains were partly obscured by a variety of services a wall-like feature, aligned south-west / north-east i.e. parallel to the existing street alignment survived towards the south-eastern side of the trench, the uppermost parts being some 0.55m below existing pavement level. The lowest parts of this feature were two courses of thin bricks bonded with lime mortar. The bricks, which measured some 285mm in length by 60mm thick, appeared to extend to greater depth though it was not possible to excavate these further owing to the presence of adjacent services. The brickwork was surmounted by a single course of rough blocks of a creamy coloured limestone, again bonded with lime mortar, some of which measured in excess of 0.30m across by 0.20m thick. The overall width of the walling could not be determined due to its extending beyond the south-western limits of excavation. Whilst this feature appears to represent a wall quite what its specific function was is less certain, though its alignment does respect that of the adjacent roadway. It may be part of a boundary wall, alternatively, it could even form the sill wall for a timber-framed building. The lack of secure dating evidence for this feature does allow the possibility that it could relate to the latter part of the medieval period.

Plate 8 Stone and brick structural remains in Trench 37, looking SW. Note that the stubs of later kerbing slabs can be seen towards the upper parts of the sections to the side of the trench (removed between these points).

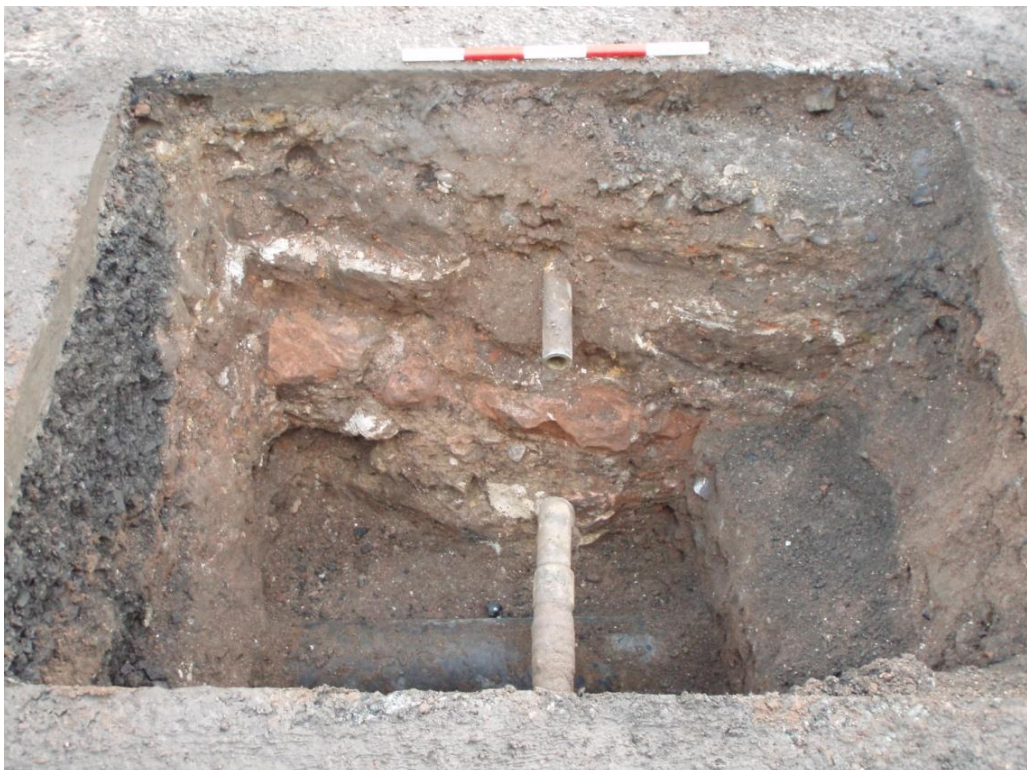
The walling within Trench 58, 586, was visible to its southern side and was comprised of a single course of rough blocks of red sandstone up to 0.32m across and 0.16m thick that were bonded with lime mortar (Plate 9). Although clearly at least partially truncated by the old gas main as well as by old narrow gas spurs, the alignment of the wall appears to be east-south-east / west-north-west. The stone blocks sat directly over a foundation comprised of approximately 60% lime mortar and 40% fragments of sandstone, 587, (largely the local red sandstone though a few pieces of creamy white sandstone were also present). This foundation material extended beyond the basal limits of the trench and was in excess of 0.30m thick. A thin silty deposit that probably accumulated immediately above the remnant stone blocks appears likely to relate to a post-Roman period.

Plate 9 Mortared red sandstone blocks above a thick deposit of lime mortar and rubble in Trench 58, looking S. The sandy silt and mortary deposits directly above are likely to post-date the Roman period.

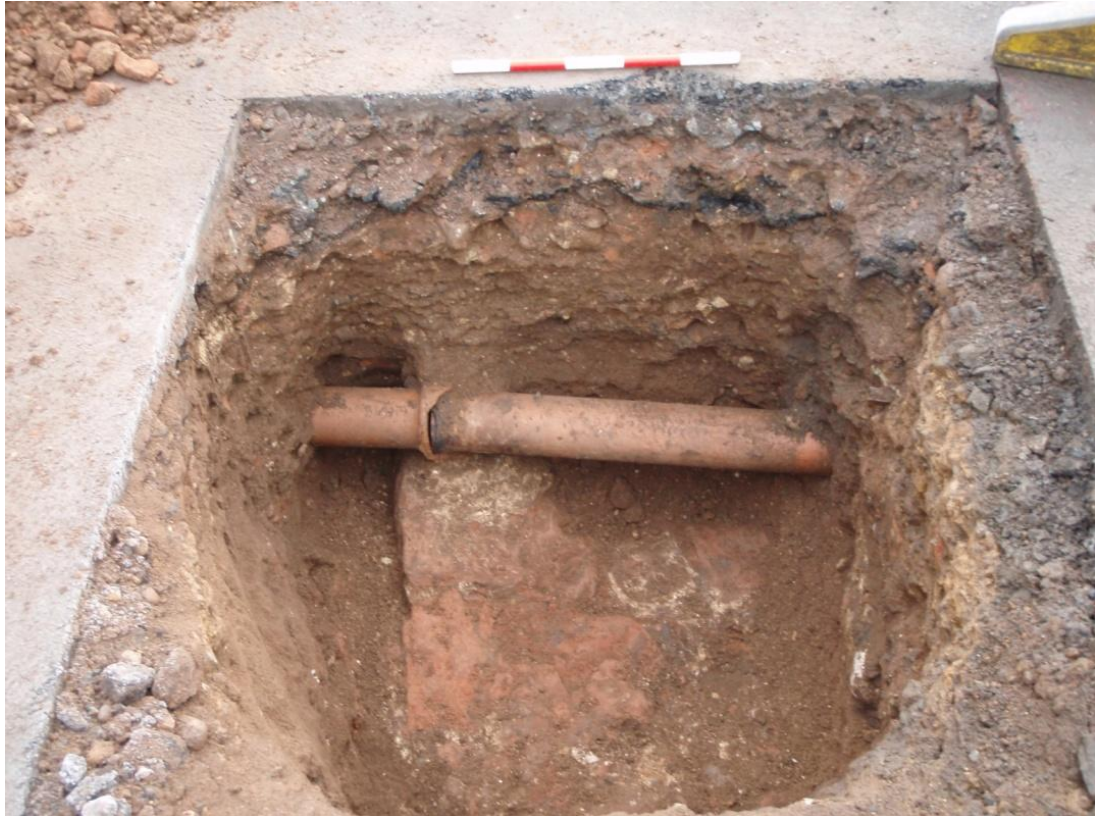
Within Trench 79 a single course of walling, 797, aligned west-north-west / east-south-east, was observed at the base of the trench at a depth of some 0.90m BGL (Plate 10). This was constructed of roughly squared blocks of red sandstone, up to 0.38m in size, bonded with lime mortar and extended beyond the basal limits of the trench. Clearly in excess of 0.73m wide, the northern face of the wall was fully exposed though its southern face lay beyond the base of the trench. The surviving upper surface of the wall undulated somewhat and this may

be the result of later robbing for stone. The deposit directly overlying the wall, 796 was comprised of angular fragments of sandstone and flecks of mortar with a slightly lesser proportion of greyish brown sandy silt up to 0.30m deep. The stoney characteristics of this deposit suggest it may derive from the robbing of wall 797. As such it is possible that this deposit may relate to a post-Roman, rather than Roman, period.

Plate 10 Wall of mortared red sandstone within Trench 79, looking E

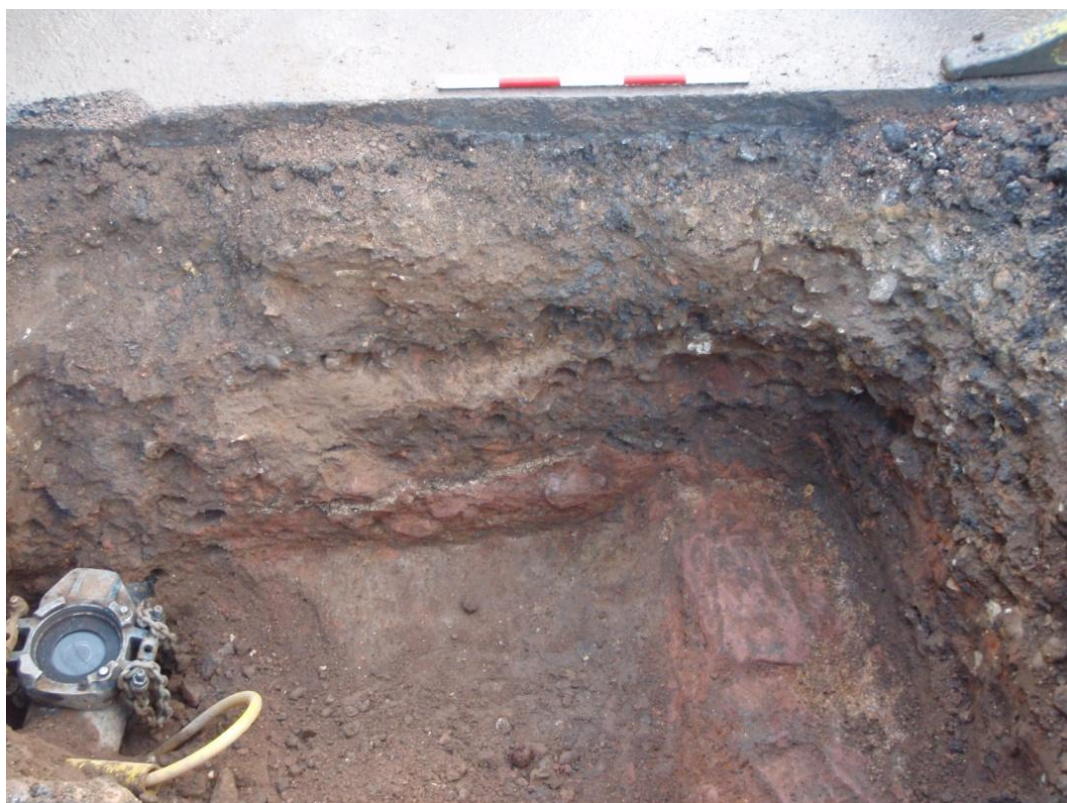
The northern part only of a single course of walling, 8191, aligned west-north-west / east-south-east, was found in Trench 81, the remainder extending beyond both the basal limits and southern baulk (Plate 11). The upper surviving parts this wall, which occurred at around 0.78m BGL, was again constructed of roughly squared blocks of red sandstone, up to 0.32m in size, and bonded with lime mortar. Trench 81 is located only around 15m to the north-west of Trench 79 and although the walling within both is similarly aligned the spatial relationship of the trenches suggests that they may form separate, rather than the same, walls. To the northern side of wall 8191 a deposit comprised overwhelmingly of fragments of red sandstone, 819, was present whilst sealing this was a thin stripe of mortar and plaster, 818. These deposits may relate to the collapse or demolition of this walling as may the deposit overlying the mortar, 817, a spread comprised predominantly of stone rubble.

Plate 11 Wall of mortared red sandstone, 8191, within Trench 81, looking E. Note the stone rubble, 819, sealed by a thin stripe of mortar and plaster, 818, to the north of the wall which may relate to collapse or demolition. The deposit above the mortar stripe, 817, may also relate to this process.

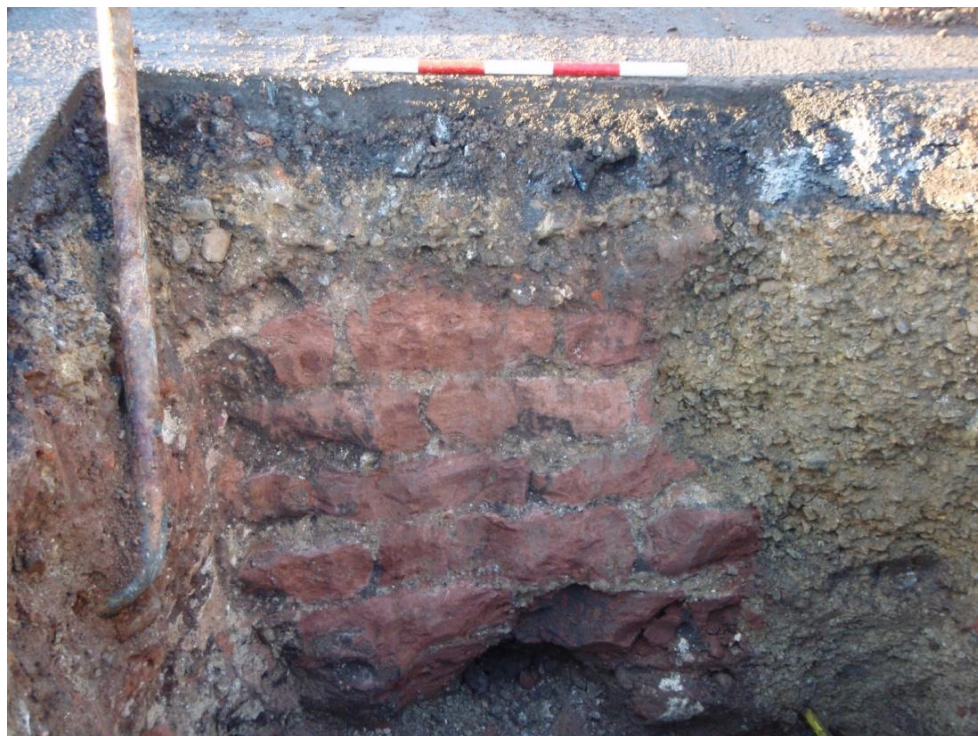
The adjacent trenches 85 and 86 both revealed stretches of walling, several courses tall, aligned north-north-east / west-south-west and at remarkably high levels. The uppermost course of that within Trench 85, 855, occurred within 0.30m of the existing road surface and continued for six courses to the base of the trench, beyond which it extended (Plate 12). The uppermost course within Trench 86, 865, was at a depth of some 0.54m of the present surface and continued for a depth of three courses with suggestions of a fourth extending beyond the basal limits of the trench (Plate 13). The stonework to each wall was of roughly squared blocks of red sandstone, fairly well coursed and bonded with lime mortar. The blocks to wall 855 were up to 0.34m long and 0.14m thick, those to wall 865 being up to 0.32m long by up to 0.15m thick. No surviving face to either wall was visible in the trenches as both walls had been truncated in the past by a combination of gas, water and unidentified services. The closeness of proximity of these similarly aligned walls (the trenches being approximately 1m apart) argues for some sort of relatedness between the two.

Plate 12 Wall of mortared red sandstone, 855, in Trench 85, looking W. Truncated to three sides by modern services the orientation of the blocks indicates the alignment of the wall.

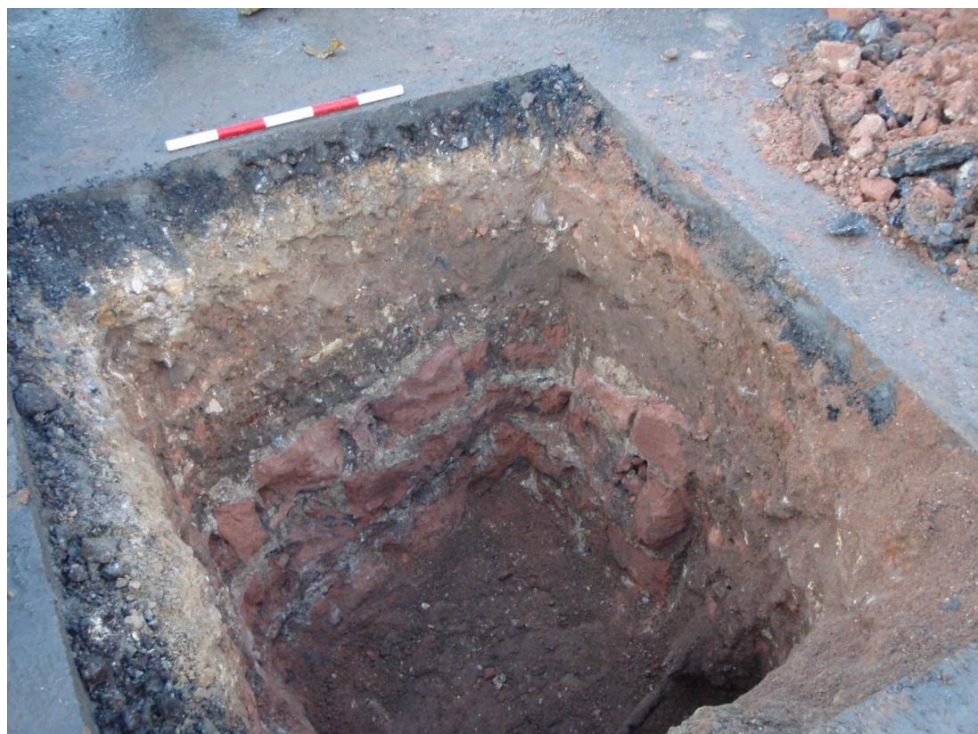
Plate 13 Wall of mortared red sandstone, 865, in Trench 86, looking WNW. Although again heavily truncated the orientation of the blocks indicates the alignment of the wall.

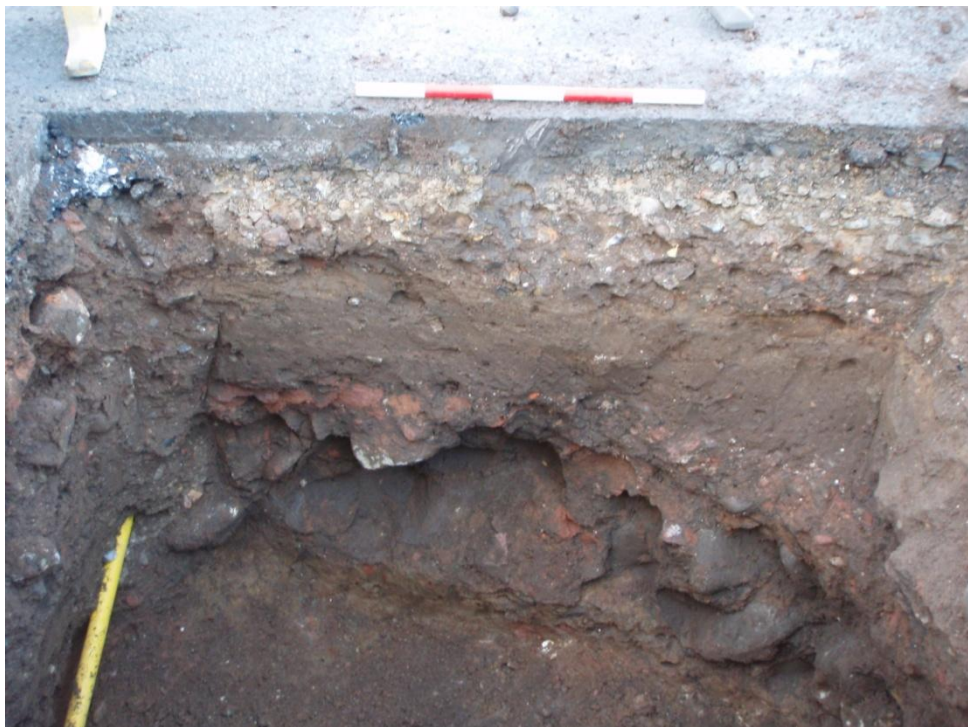
Within Trench 57 a dense mass, some 0.38m thick, of large rounded cobbles of a size up to 0.29m across, 579, was observed (Plate 14). This overlay a deposit of pale greenish yellow slightly clayey sand containing occasional flecks of charcoal and the odd fragment of red sandstone. Deposits 578 and 577, essentially fairly thin and very stoney layers containing varying quantities of greyish brown silt overlay the cobbles. These two layers may relate to robbing debris or levelling deposits.

The mass of cobbles 579 are likely to have formed foundation material, possibly for walling, or even for some sort of surface.

Plate 14 Trench 57, looking S. Thick cobble layer can be clearly seen (though many of the cobbles at the section edge have fallen away) as can the stoney layers immediately above. The relatively stone free soil deposit above these produced some residual Roman material

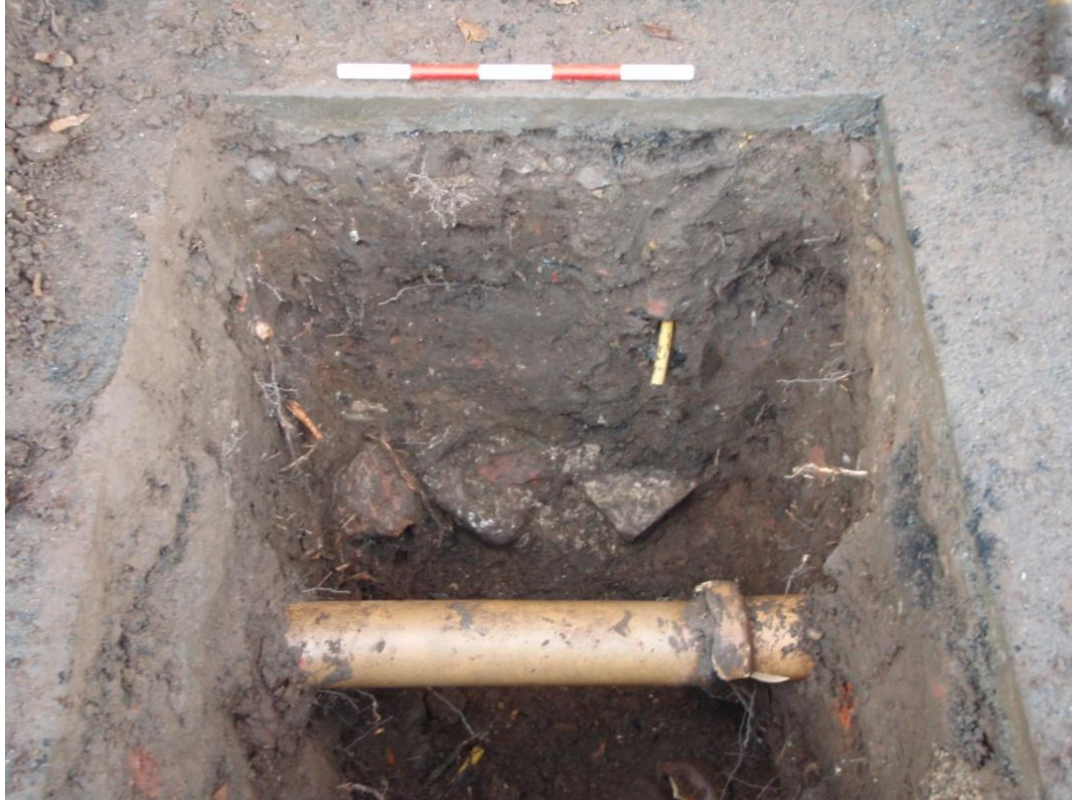
Trench 77 also contained a thick layer of large cobbles together with large fragments of red and white coloured sandstone, 777, close to its base (Plate 15). Lime mortar was also evident between some of these large stones. Interpretation of this deposit is not clear cut. The layer may represent a wall footing or even unwanted left over debris from the robbing of a wall. A pale coloured silty sand deposit, 776, immediately above 777 contained quantities of mortar and flecks of plaster and could conceivably relate to a wall robbing event.

Plate 15 Layer of cobbles in Trench 77, looking S.

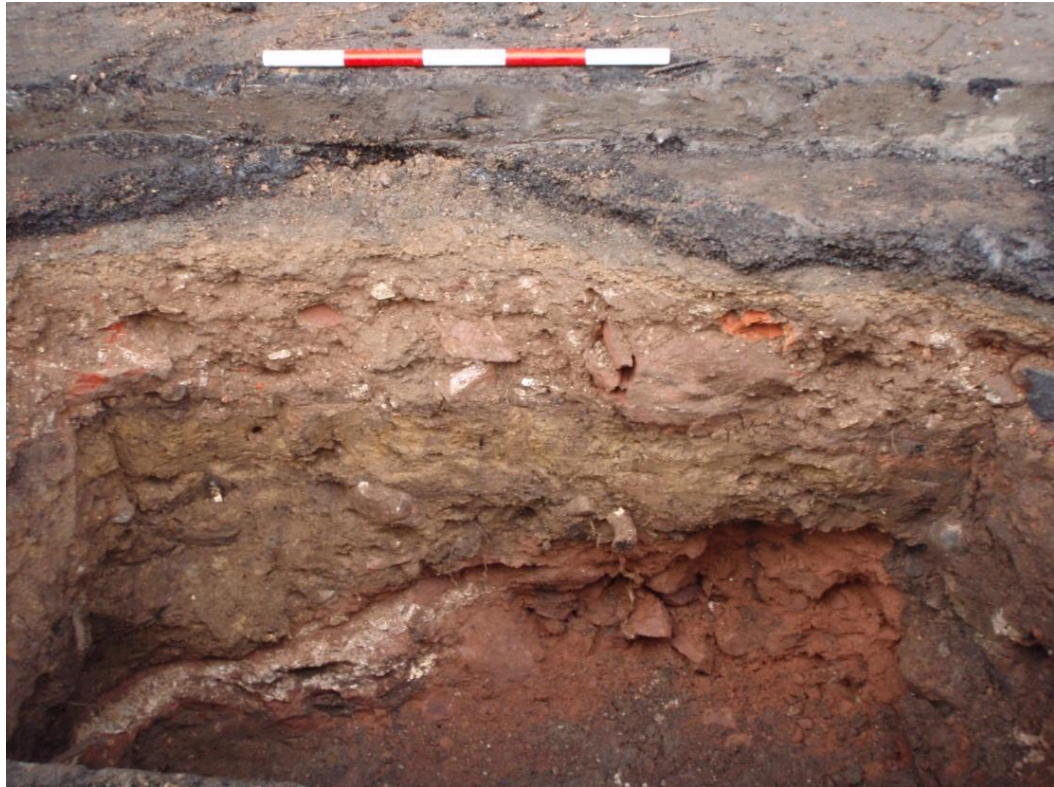
Within Trench 34 a dense mass of fragments of red sandstone, 348, were evident to the western part of the south facing elevation (Plate 16). Stratigraphically above this in the eastern part of the section successive deposits of mixed silts, 349, a layer of crushed mortar, 346 and further layers of pale coloured, stoney, silts, 346 and 345 were present. The stone deposit 348 is very likely to be derived from a wall. The particular interest in this instance is that the course of the eastern side of the town wall is said to be located at a point immediately to the east of Trench 34. It is tentatively suggested that 348 may represent the western tail end of deposits associated with either the collapse or robbing of this wall. It is possible that the layer of crushed mortar, 347, may be related to this episode whilst deposits 346 and 345 may post-date this.

Plate 16 Trench 34, looking N. Dense deposit of stone fragments may relate to the demise of part of the eastern side of the town wall, as may the mortar deposit to the lower left. Deposits immediately above this would seem likely to relate to a post-Roman period.

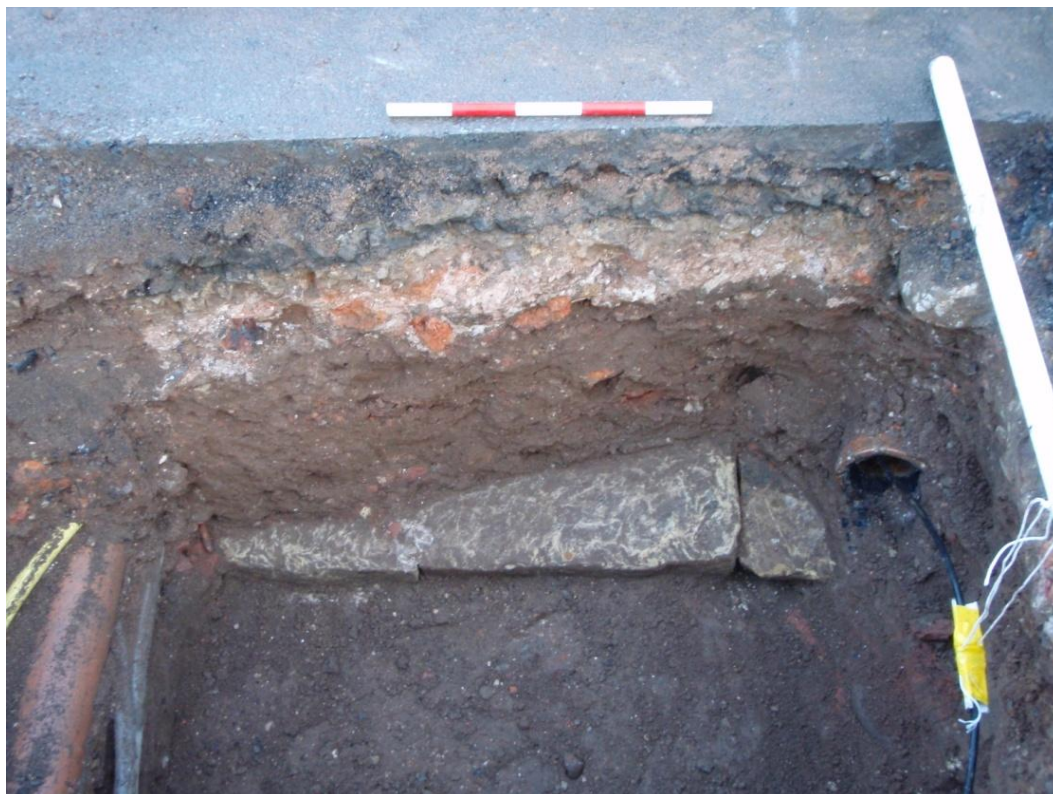
Toward the very basal parts of Trench 83, and at a depth of some 0.86m BGL what may be the remains of a drain aligned approximately north-west / south-east were revealed (Plates 17, 18). Only the southern part of this feature lay within the trench and these remains were comprised of three slab-like blocks of pale yellowish coloured fine grained sandstone. The pieces had all been roughly squared and the largest was some 0.66m in length. Each piece was bonded with lime mortar to the adjacent piece. A modern electric duct had cut into the top of this feature at the eastern side of the trench. Judicious exploratory probing indicated that the large central slab was only some 0.12m thick and no further stonework could be detected beneath. Such slab-like pieces of stone are perhaps unlikely to have formed part of a wall, particularly as no traces of mortar were present of the upper surfaces of the blocks. These observations may suggest that the slab like elements are actually capping stones sealing a stone-lined channel whose width is somewhat narrower than that of the capping stones themselves. Several drains of such form and of varying sizes are known from Roman contexts in York. Although the absence of dating evidence prevents the attribution of a conclusively Roman date for this feature, such must be considered a distinct likelihood.

Plate 17 Possible drain in Trench 83, looking N.

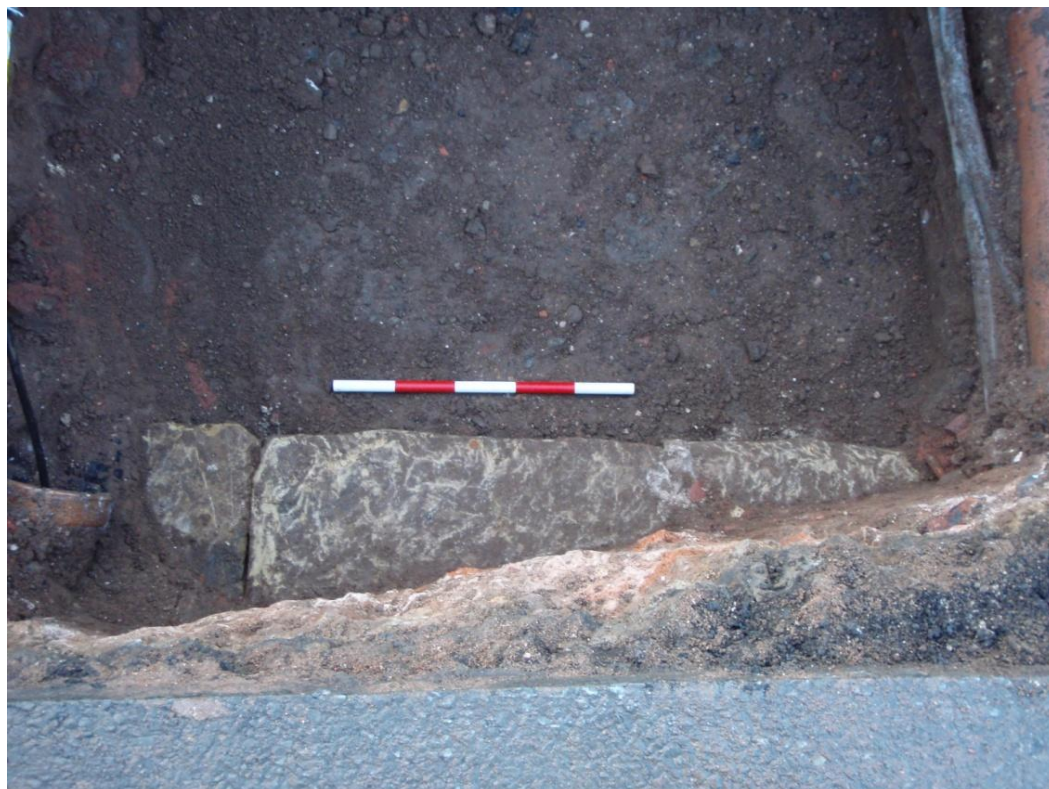
Plate 18 Looking down onto the possible drain in Trench 83.

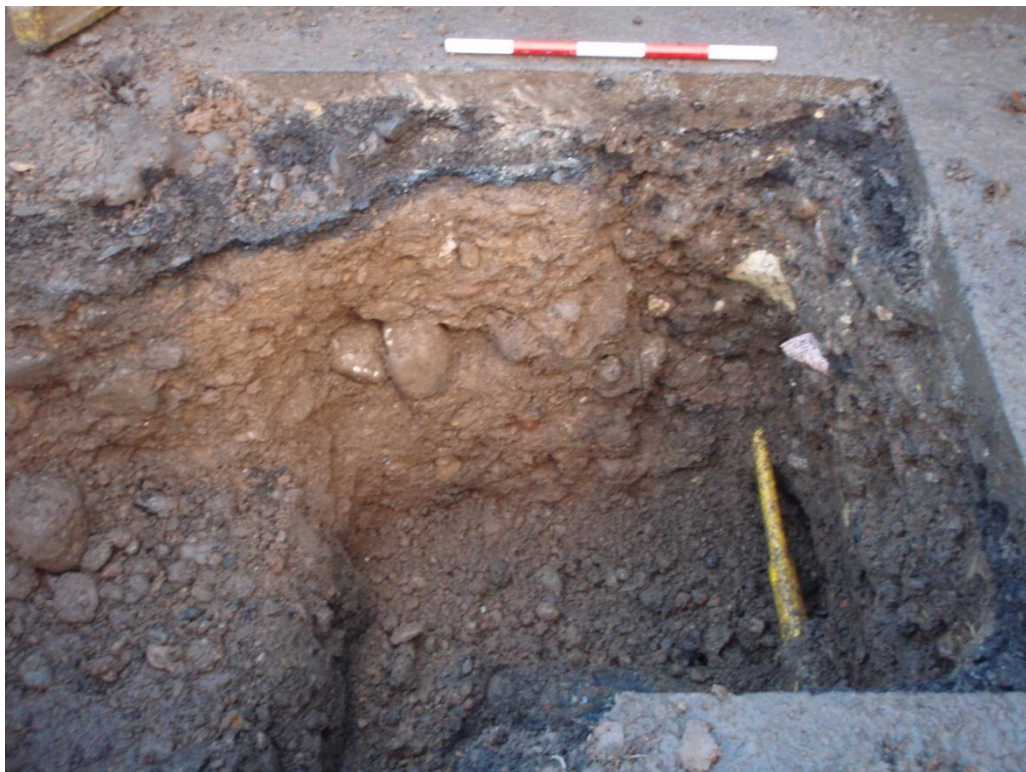
A very thick deposit of compacted clean gravel and cobbles was exposed in Trench 52, 524, (Plate 19). This material, which was cut at its eastern side by the trench of an old gas spur, extended from immediately below the tarmac of the footpath to beyond the basal limits of the trench. Suggestions of horizontal laminations were hinted at by lines of aggregate of common size. No finds or other dating material was recovered from this trench. Deposit 524 has the superficial appearance of a thick deposit of road makeup such as is occasionally found in Roman period deposits. Against this, it must be highlighted that the deposit was remarkably clean and, perhaps significantly, extended fully to the underside of the footpath tarmac. Whilst it is conceivable that this deposit may be of Roman date, one is minded to err on the side of caution and accept the possibility that it could be of modern date, perhaps relating to the backfill of a very large modern feature.

Plate 19 Thick deposit of compacted gravel and cobbles in Trench 52, Looking N.

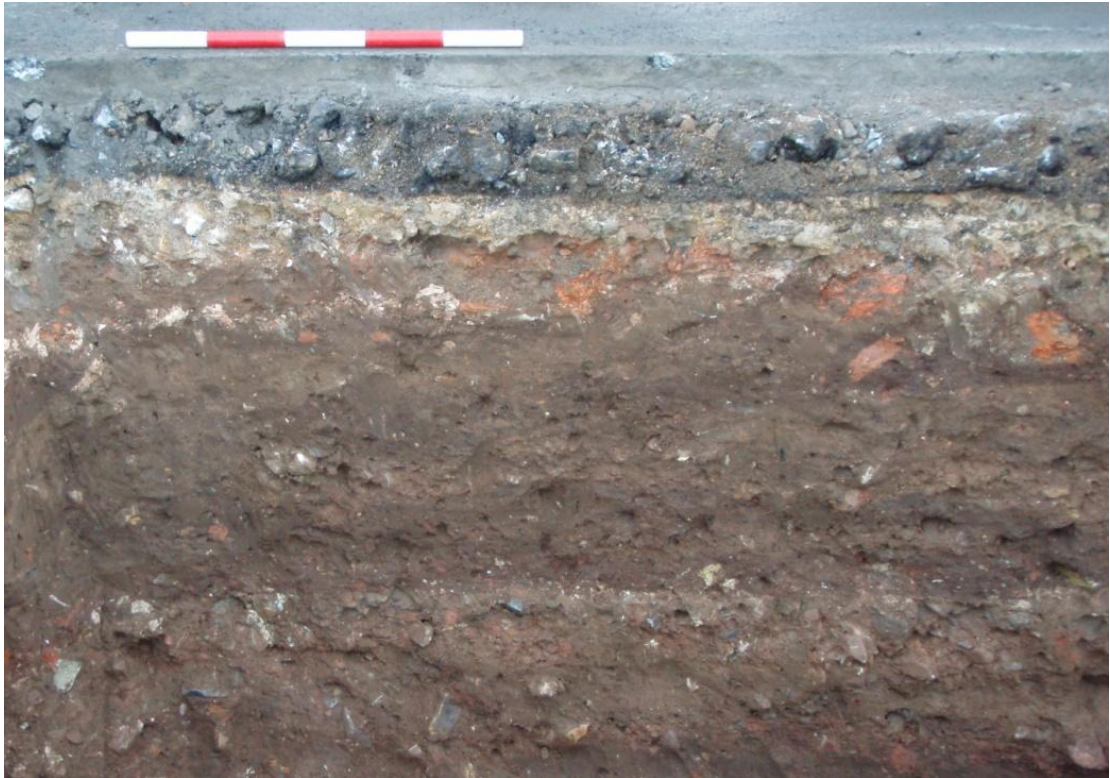
What may be road or surface metalling of the Roman period was present in Trenches 87 and 88 on the Boroughbridge Road. That in Trench 87 was comprised of a series of two horizontally lain stone rich layers, generally in the region of 0.10m thick and extending from a height of 0.79m BGL to the base of the trench at 1.05m BGL, 877, 879 (Plate 20). Interleaved between the two stoney bands was a deposit of yellowish brown sandy silt, 878. No dating evidence was recovered from these deposits.

Plate 20 Two bands of probable metalling in the lower 0.25m of Trench 87, looking SW

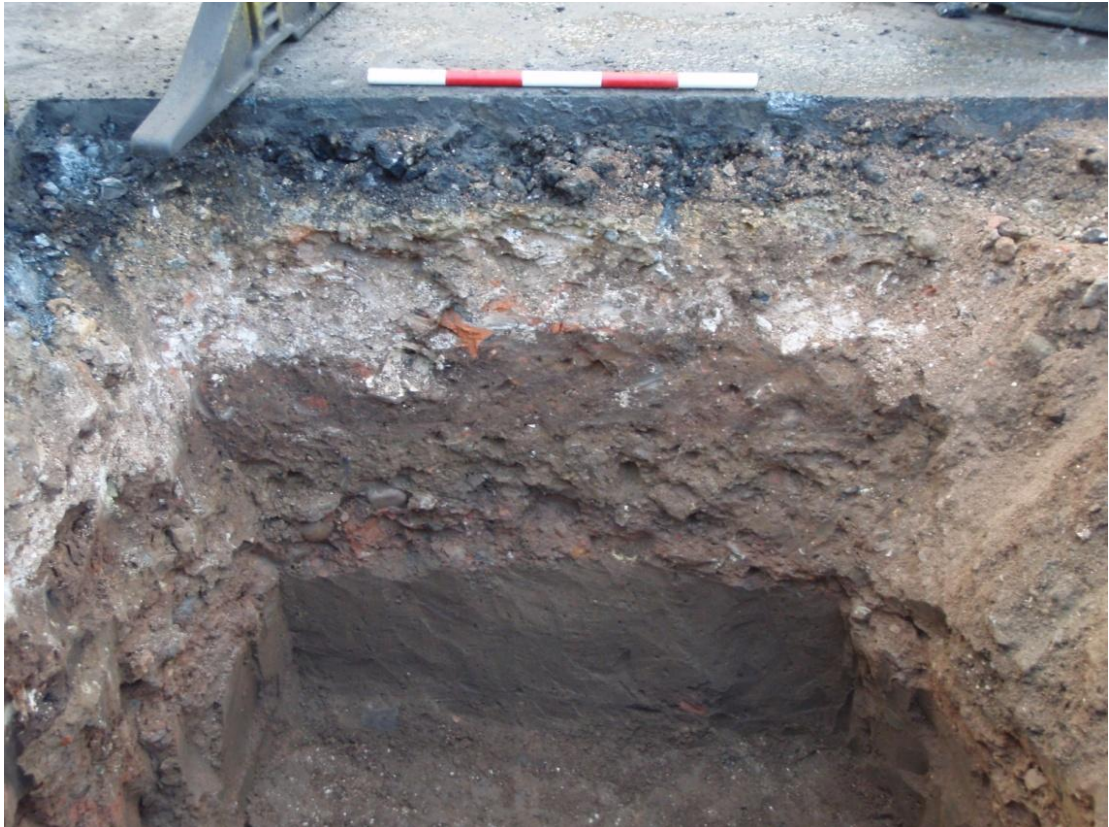
Within Trench 88, which lays immediately to the west of the defences of the western side of the Roman town, a somewhat denser layer of probable metalling, 884, was seen (Plate 21). The lower half of this was comprised of coarse gravel and fragments of red sandstone whilst the upper half was of gravel and occasional small cobbles. Interestingly, 884 directly overlay a clean, virtually stone free, soil of brown sandy silt of entirely 'non-urban' character, 885 (see 5.3.5 below). The characteristics of layer 884 suggest the likelihood that it formed metalling for a roadway or surface of some sort.

Plate 21 Probable road metalling in Trench 88 immediately above clean soil, Looking SW.
