**GAS MAINS REPLACEMENT, ALDBOROUGH,
NORTH YORKSHIRE**

WATCHING BRIEF REPORT

REPORT NUMBER 2013/08

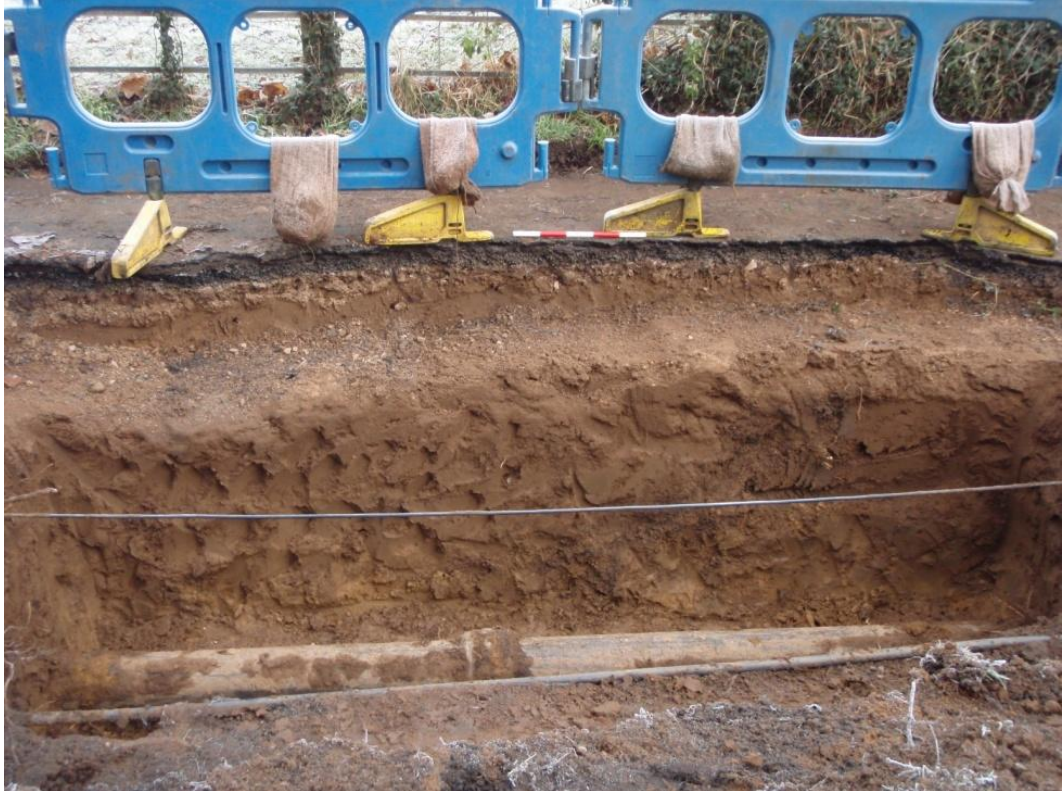
Clean soils of 'rural', rather than 'urban' appearance and character were observed in trenches 88, 89, 90, 91 and 92 (Plates 22, 23). All these soils were relatively stone free brown sandy silts virtually devoid of human derived material. The distribution of these trenches is quite striking, all occurring outside of the area of the walled town. These have the appearance of soils that were ultimately derived from processes of natural formation, though may well have subject to human working – perhaps predominantly though agriculture. Such may explain the banding within some of the soils best evidenced by that apparent in Trench 91 (see Plate 23). All these soils were fairly compact, a factor perhaps owed to their location beneath a roadway. Where clean relatively stone free soils were observed within the area of the walled town these were darker, occurred at a higher level in the stratigraphic sequence and are likely to be of medieval or later date. These have been considered in Sections 5.2.4 and 5.2.5 above.

Plate 22 Soils in Trench 90, Looking NNE.

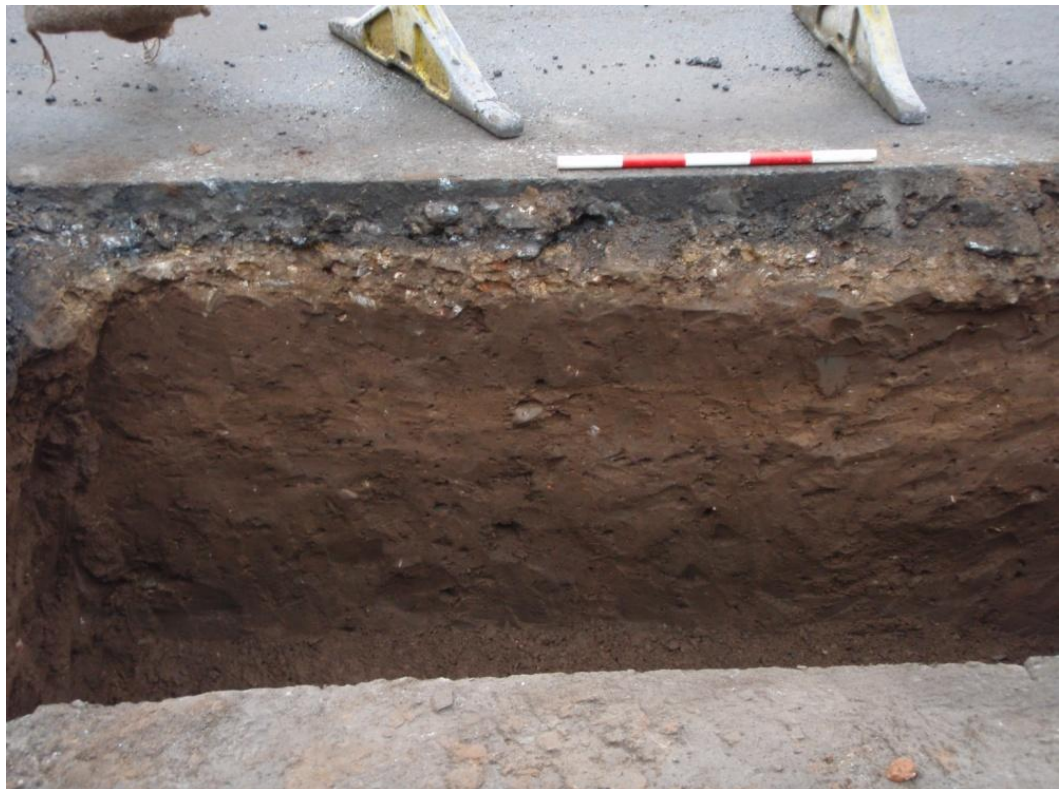
Plate 23 Soils in Trench 91, Looking SSW.

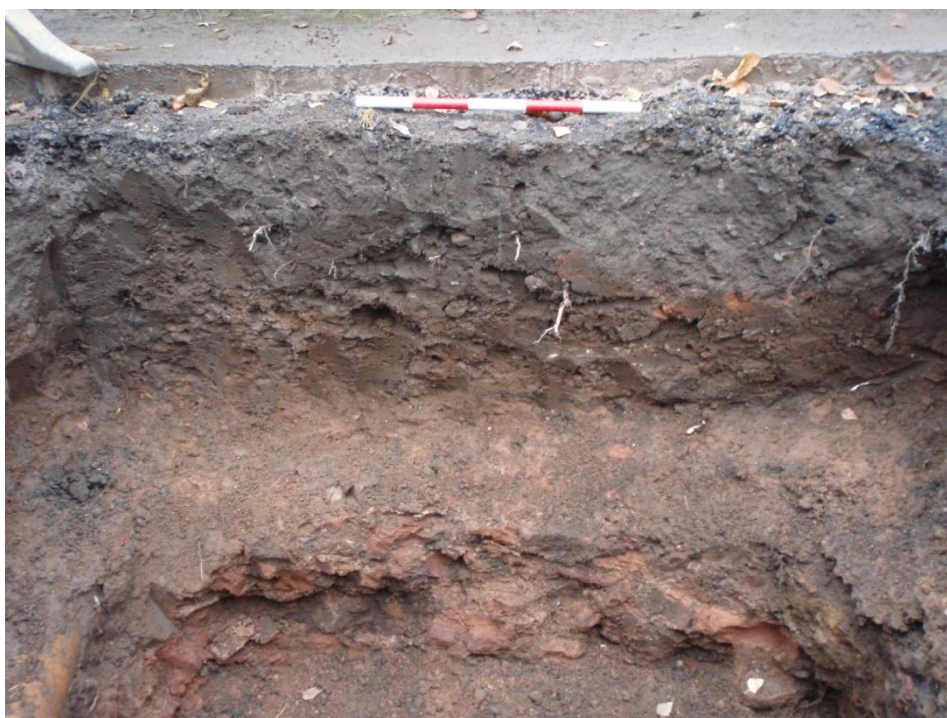
*Plate 24 Rubbly deposits of red sandstone in Trench 38, Looking SE.
The silty deposit above contained post-medieval material.*

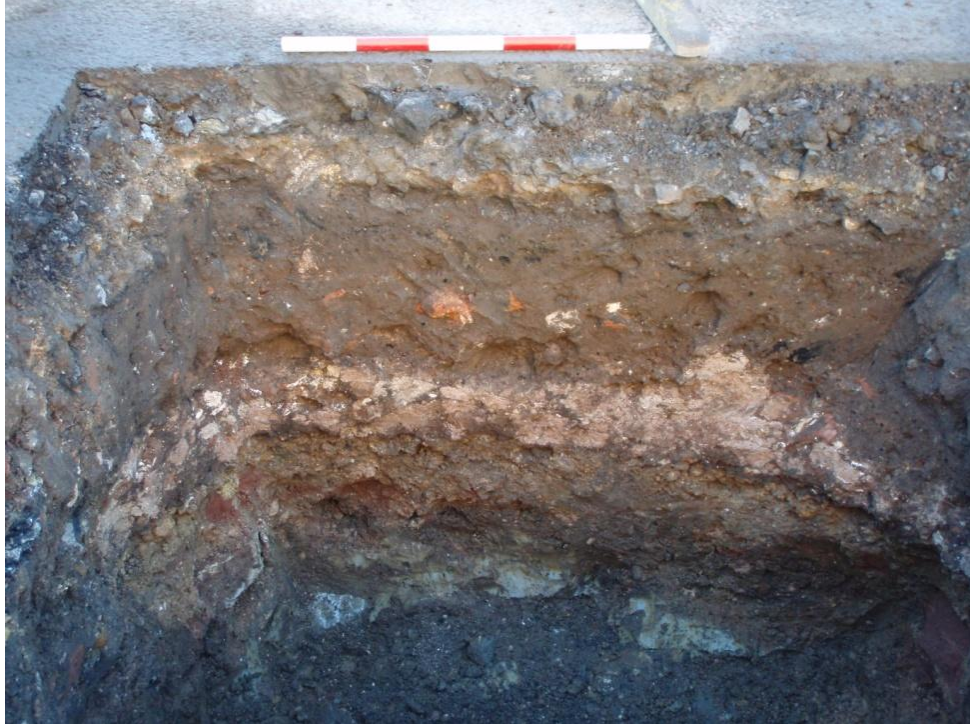
Plate 25 Mixed rubble deposits in Trench 55, Looking S. Note the creamy white band around 1/3 rd up the section which is comprised predominantly of wall plaster. The thick soily deposit above contained post-medieval finds.

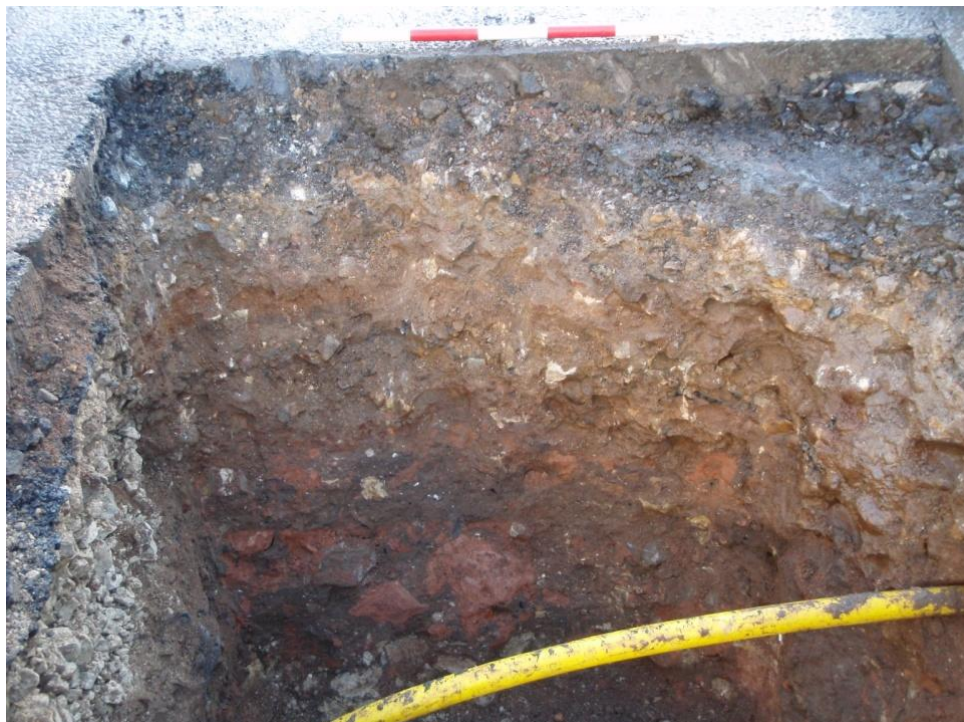
Plate 26 Rubble deposits comprised largely of red sandstone in the lower part of Trench 80, Looking SSW. The date of the paler coloured stoney deposits above is uncertain.

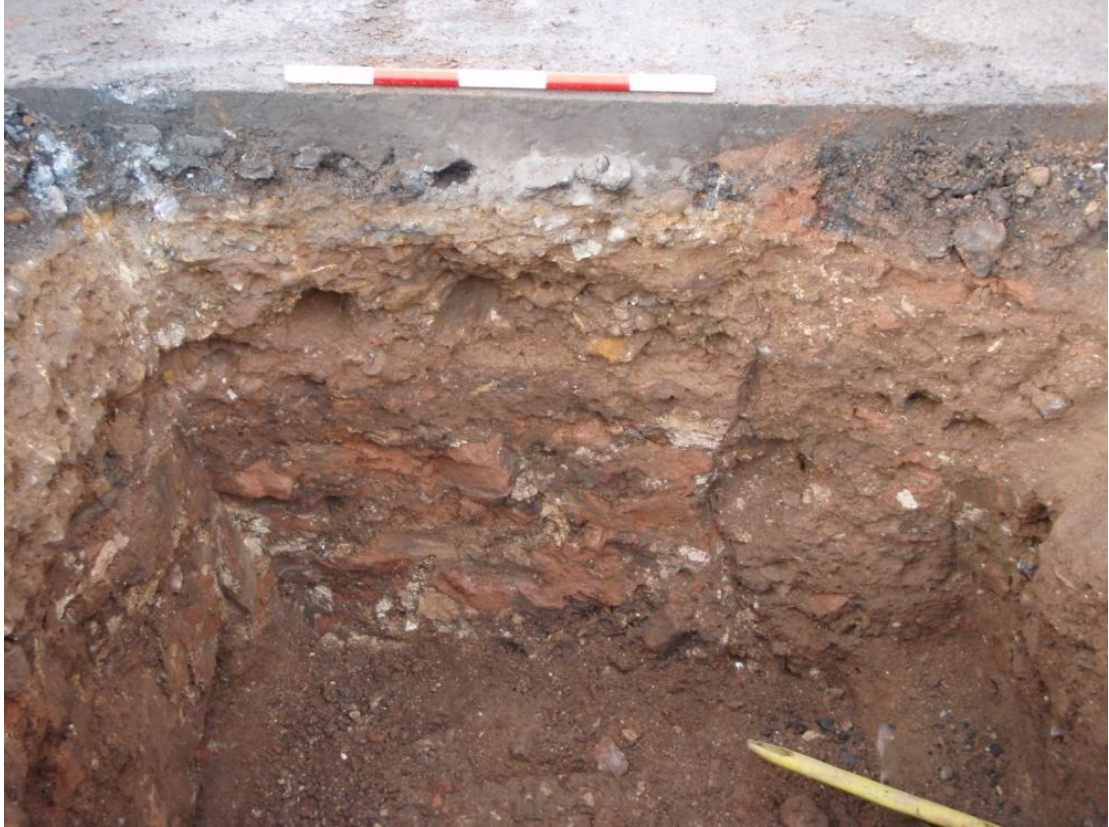
Plate 27 Mixed rubble deposits comprised largely of red sandstone, mortar and plaster in the lower part of Trench 93, Looking WNW.

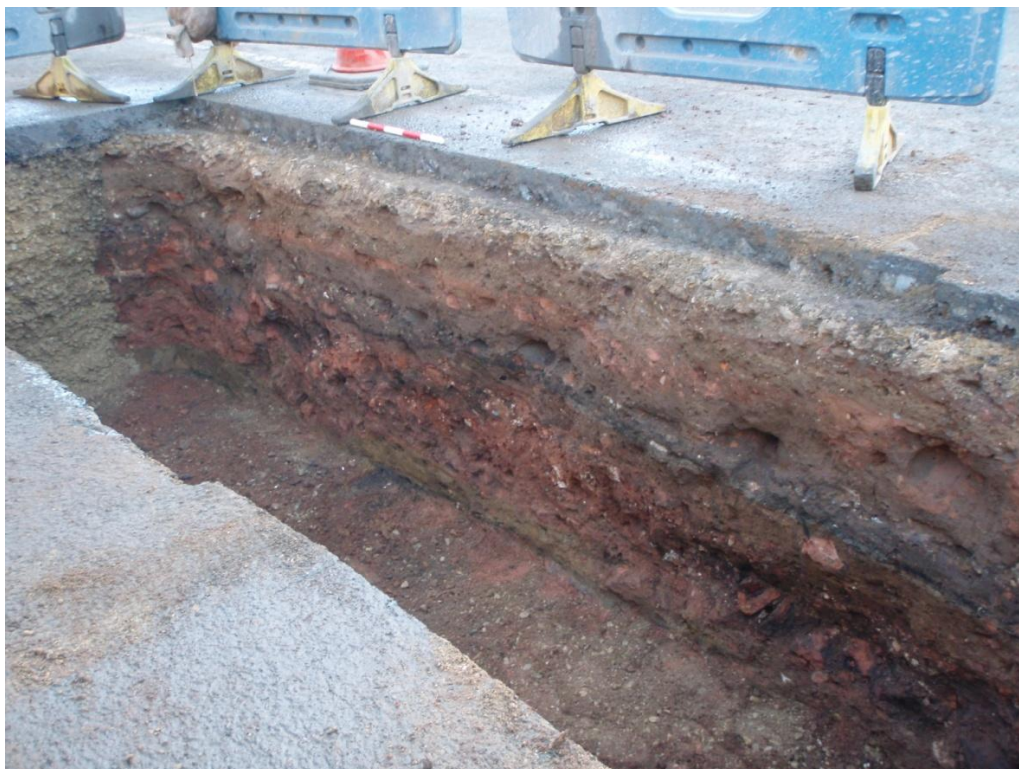
What may be characterised as ‘softer’ deposits, of a type more likely to relate to accumulations, deposition and dumping rather than to structures in the form of collapse, demolition or robbing, were identified in Trenches 50, 54, 56, 76 and 78. (Plates 28, 29, 30). In all cases these extended beyond the basal limits of the trenches and although the precise upper limits of the Roman material in these sequences could not readily be determined they are clearly of some depth. In all these instances rubble material of stone, mortar and plaster was present, but this was often interleaved with other materials and was at much lesser densities than those trenches with sequences predominantly of rubble. The ‘softer’ materials were principally comprised of layers of silts and sandy silts, occasional clayey layers - or layers with a clay content and charcoal rich layers. Often the colour range of these was quite considerable. The thickness of the soft deposits varied considerably from thin layers of charcoal rich materials only a few mm thick to thicker bands in excess of 0.20m. For the most part these deposits lay fairly horizontally though in the western part of trench 56 and the north-western end of Trench 78 they were inclined, or dipped (see Plates 26, 27). In the case of Trench 78, and possibly so in Trench 56, this appears to be related to the presence of a pit, that to 78 being particularly clear.

Plate 28 Mixture of rubble and soft deposits in the eastern part of Trench 56, Looking SE

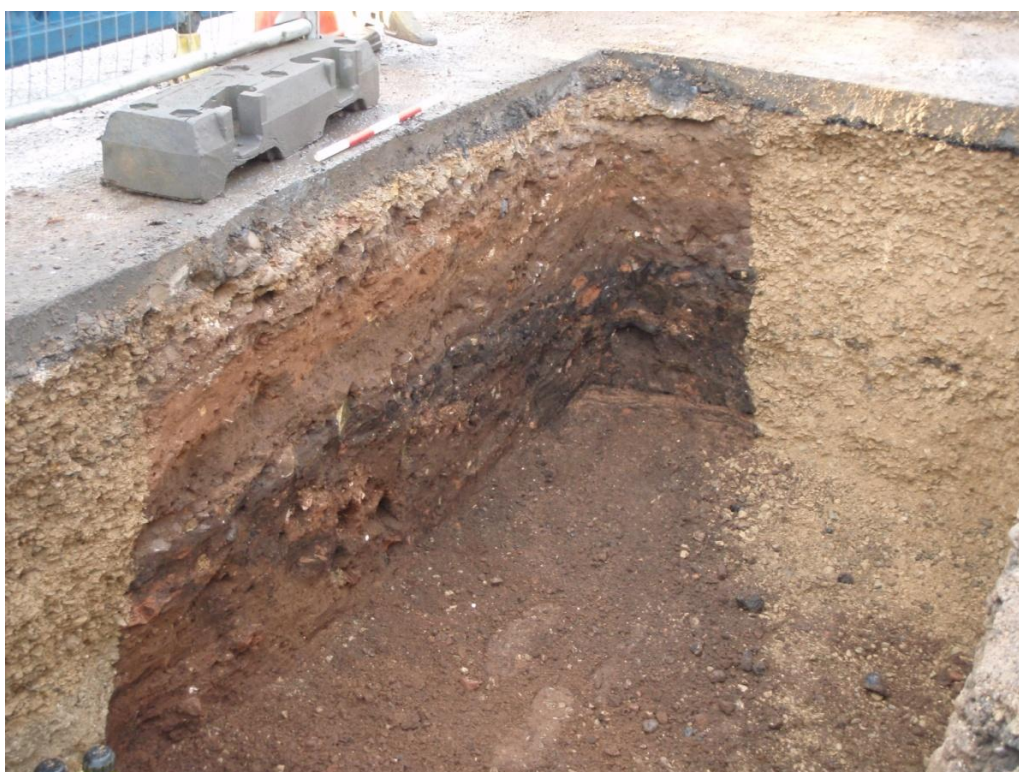
Plate 29 Predominantly soft deposits surviving between service cuts in the western part of Trench 56, Looking SW. Note that deposits towards the corner area are dipping down.

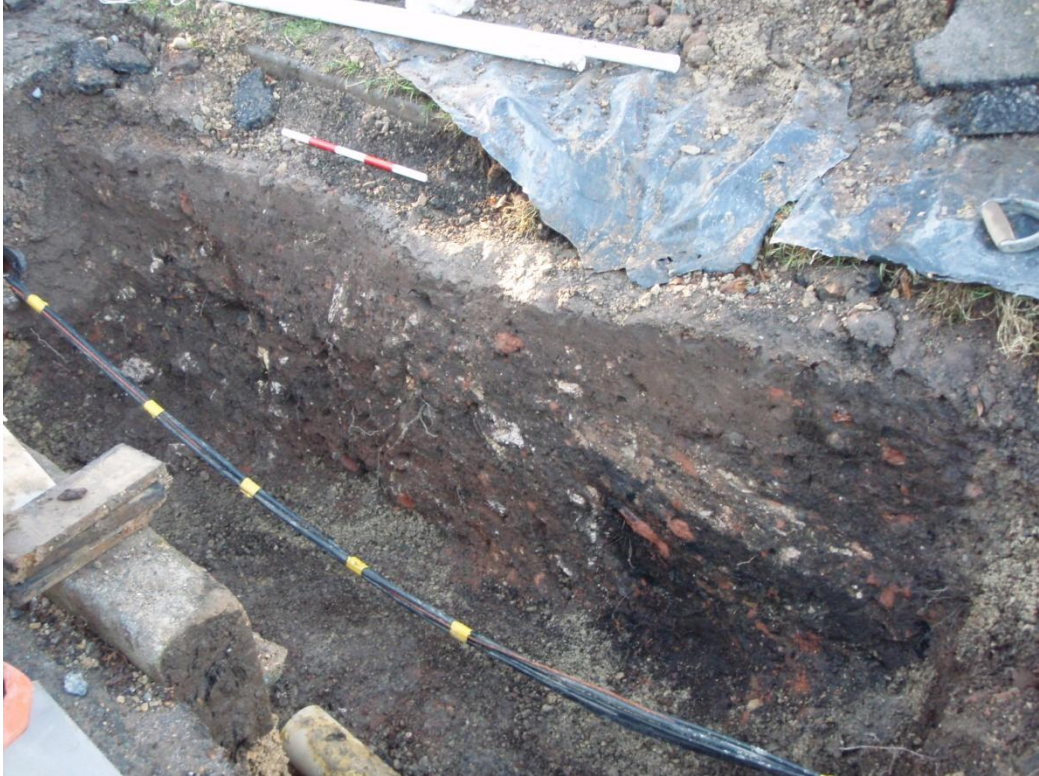
Plate 30 Predominantly soft deposits within Trench 78, Looking S. Note the presence of what may be a pit-like feature to the right.
