**OSGOODBY HALL, OSGOODBY,
THIRSK, NORTH YORKSHIRE**

WATCHING BRIEF & BUILDING RECORDING REPORT

REPORT NUMBER 2012/55

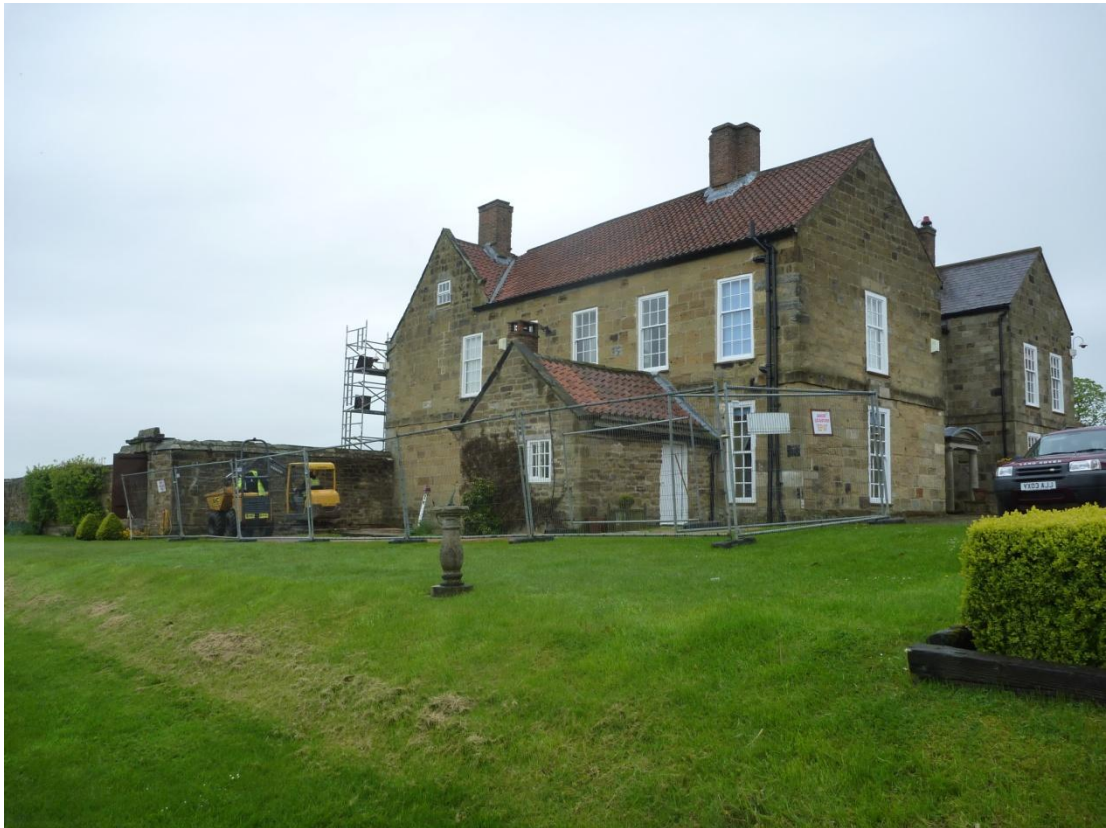
Plate 1 View of house and works for library extension. Note terracing in foreground. Looking NW.

The lowest deposits encountered, context 103, extending from around 0.65m BGL to 0.08m BGL, were a series of light coloured mixed soils and buff coloured clays containing occasional large cobbles, all thoroughly intermingled. Finds material recovered from this mixed deposit were comprised of four sherds of 19th – earlier 20th century pottery, several fragments of bottle glass and a fragment of window glass. Deposit 103 clearly represents disturbed, made ground. It was noted that the ground within the garden area immediately adjacent to the south, which forms one side of a small steep-sided valley, has been partially

terraced and it is possible that the disturbed ground of 103 relates to such landscaping activity. Above 103 lay a thin layer of sand, typically around 30mm deep, context 102, that forms a bedding for the existing surface across the area which is comprised of stone flags, context 101.

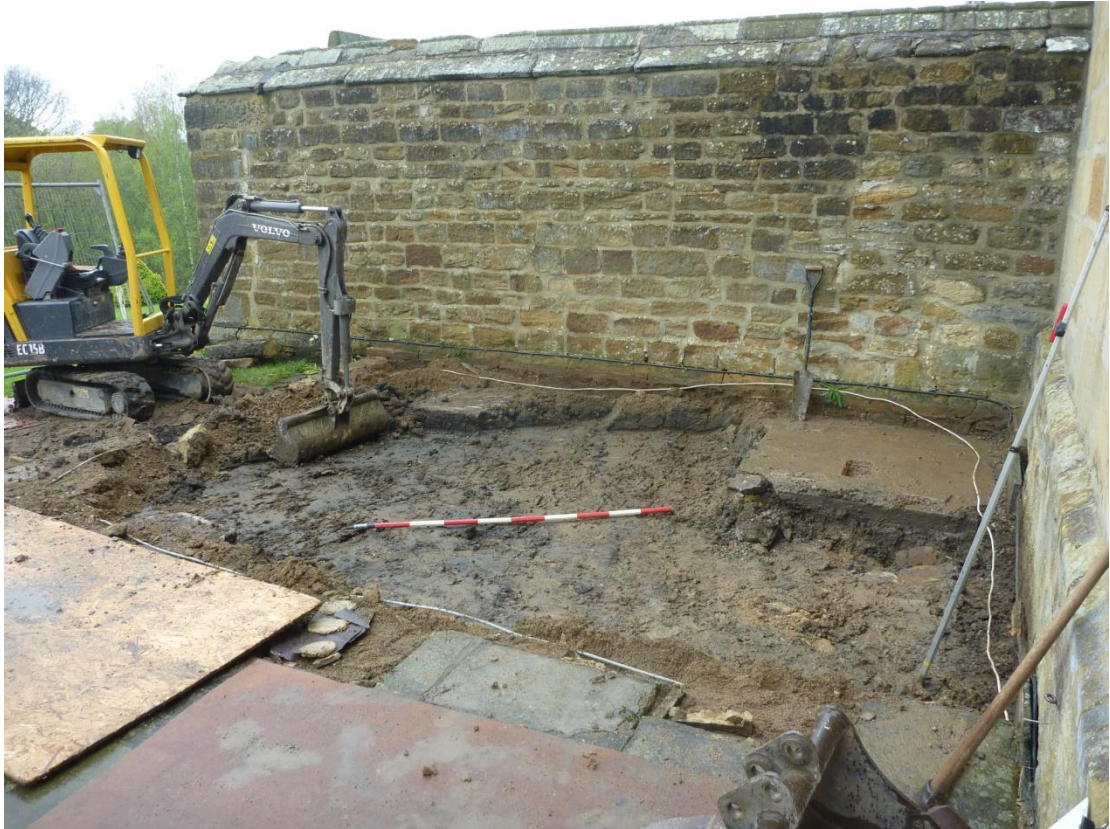
Plate 2 View of works for library extension. Note concrete setting to NW corner and two concrete settings for posts (on line with mini-digger bucket). Looking SW.

The only other deposits encountered were a series of concrete settings of later 19th – 20th century date. The largest of these was a slab around 1.5m square and 0.13m thick located in the north-west corner area, in the angle between the house and wall of the walled garden, context 104. A ceramic drain set within this suggests that this slab may have served as the foundation for a small outbuilding, perhaps a wash-house or privy. No scarring on the adjacent walling of the house or garden wall, to which it is assumed any such building must have abutted, is evident. It is possible that 104 may not have had walling or roofing of its own but have been covered by a structure represented by contexts 105, 106. The concrete settings, contexts 105, 106, each related to sub-square slabs between 0.10-0.17m thick, located at the west and east sides of the trench and around 4m to the south of the walling of the house. Both of these settings contained a sub-square post setting around 0.16m across, each of which still contained remnants of decayed timber. It is assumed that posts within

these settings created a lean-to arrangement against the south wall of the house, indeed an iron fitting, and a void for a further example to the wall (at a height of around 2.7m above paving slab level), may well have been integral to this arrangement. The use of concrete to contexts 104, and 105, 106, suggests the likelihood that these elements were contemporary and 105, 106, may even have supported the cover for 104.

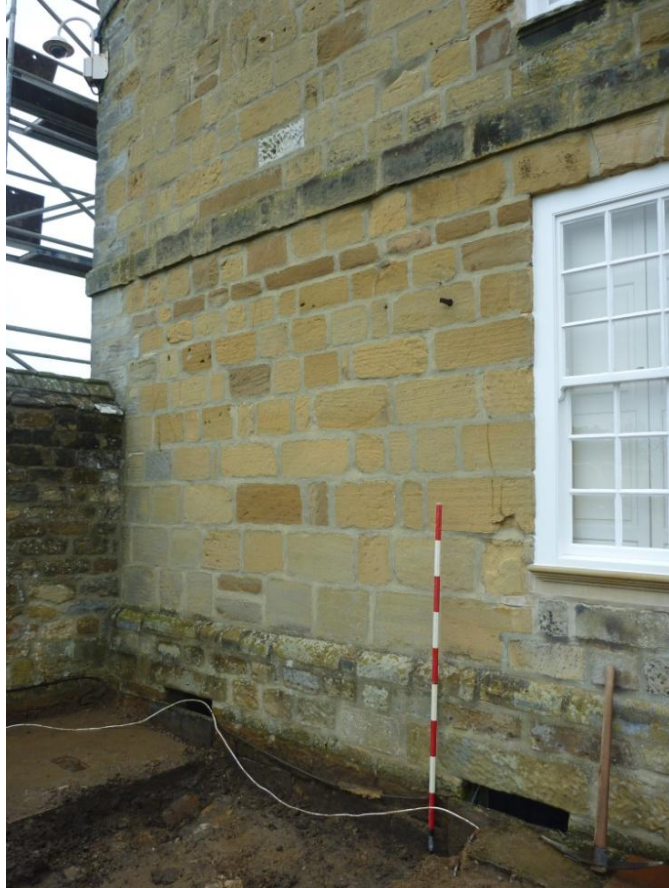
Plate 3 View of area of drawn walling, note the two basement windows.

The cutting through of the new doorway between the house and the new library was observed, see Plate 3. The walling was seen to be up to 0.67m in width, two courses wide with the coursed and dressed stone exterior not being matched by the stonework to the inner face of the wall. Instead this was generally of smaller stone that was often irregularly shaped and of somewhat rough appearance, seemingly so as to provide keying for the internal wall plaster. The stonework, particularly in the interior parts of the wall, was bonded with copious amounts of a creamy white coloured lime mortar.

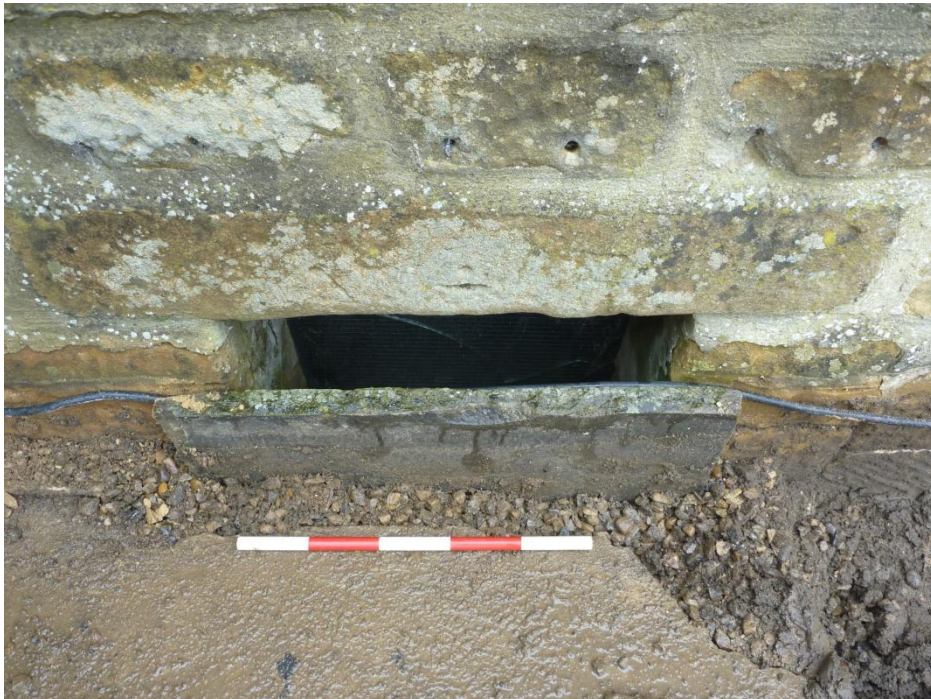
Plate 4 View of west basement window (to be blocked-up).

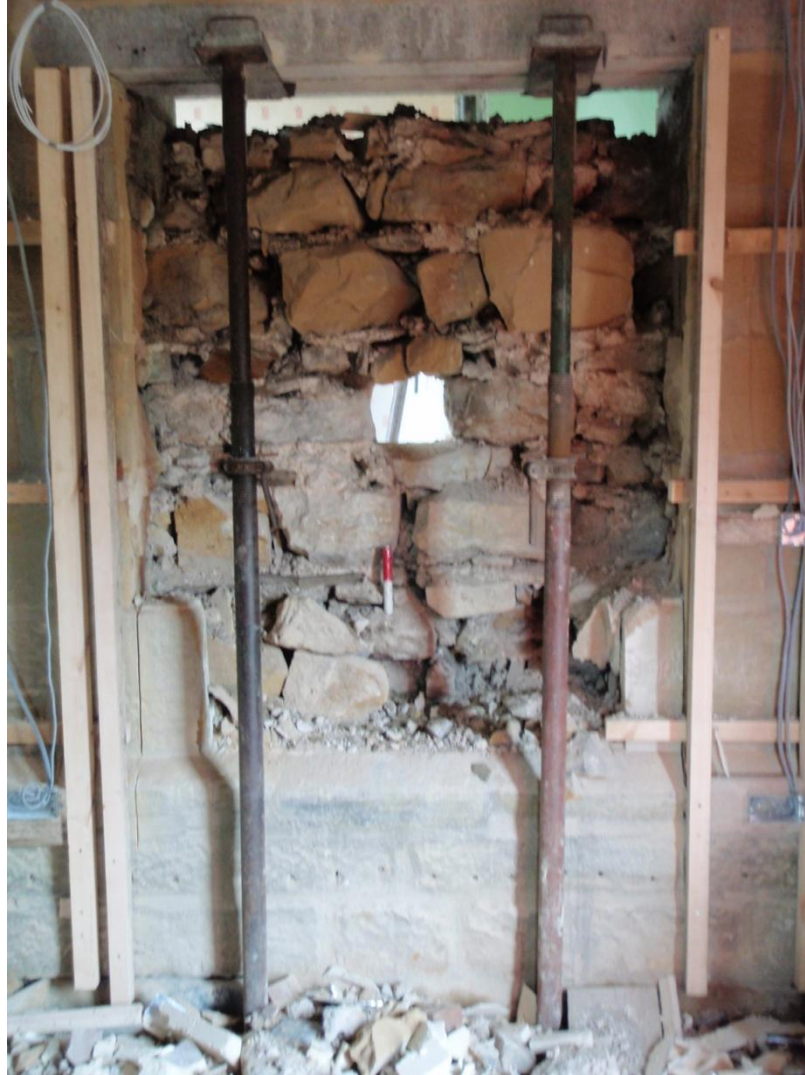
Plate 5 View of internal part of wall in area of new doorway to the library. Looking N.

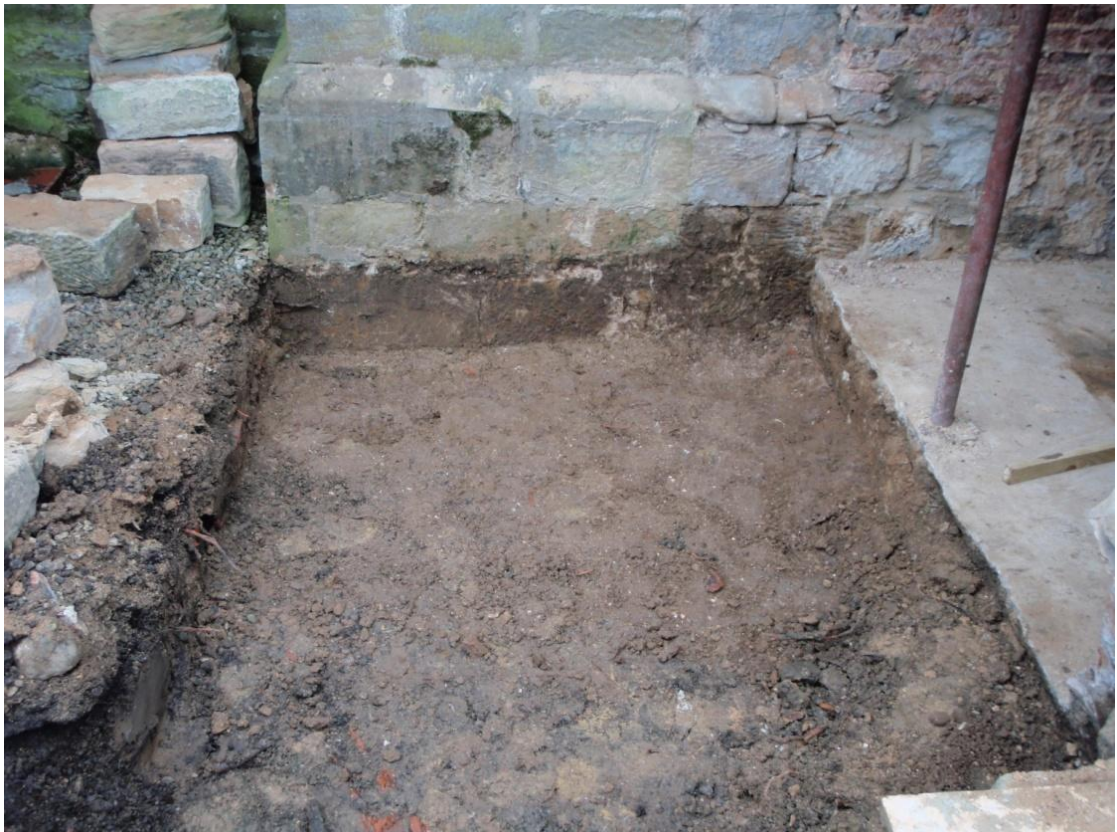
Plate 6 View of reduced area of ?natural ground in the area of extension to the store, Looking S. Note the dirtier appearance of that part in the foreground which is owed to the presence of tree roots, land drain and other disturbance.

The lowest deposit encountered in the stripped area was context 201, a stiff, orange brown, silty clay that extended across the entirety of the reduced area and seems likely to represent natural deposits of the glacial till. The northern part of this material was of patchier and occasionally darker appearance, this being the result of the action of recent tree roots and

related garden activity, including a ceramic land drain. In the north-west corner of the reduced area a small patch of mid greyish brown sandy silt clay containing occasional flecks of charcoal, context 202, was encountered. This contained a single sherd of pottery and seems likely to represent a former ground surface. The pottery was a rim sherd of a reduced sandy fabric with a greenish brown glaze. It appears to be part of a jug in the Humber Ware tradition, probably of 15th century date – though pottery of this tradition was in production between the late 14th – 16th centuries. At the southern end of the trench the lower courses of walling, 203, of what is believed to be the 16th century part of the Hall, cut through the natural deposits. Levelling deposits of re-deposited natural and a mid brown clayey sand, contexts 204, 205, overlay 201 and 202, and were in turn sealed by garden soils, context 205, and areas of gravel, context 206. The foundations of the existing store, which are of brick of a probable later 19th century origin, cut into the garden soil 205. This brickwork appears to provide a fairly secure general date for this late addition. The walling of the store itself was seen to formed of coursed stonework, two stones deep, bonded with a creamy white lime mortar.

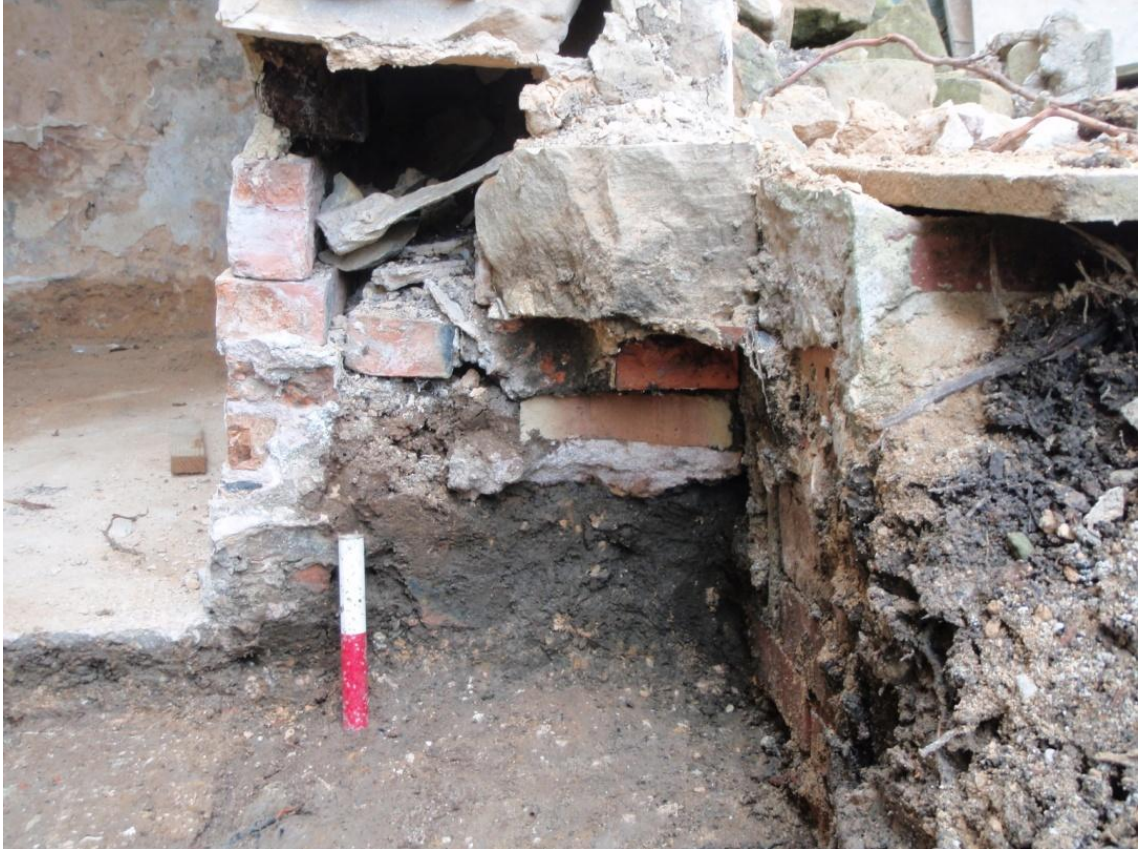
Plate 7 NW corner of the excavated area, looking W. The scale is stood on deposit 202 and deposit 205 lies immediately to the left. Garden soil 205 is visible immediately below the brick foundations of the existing store.

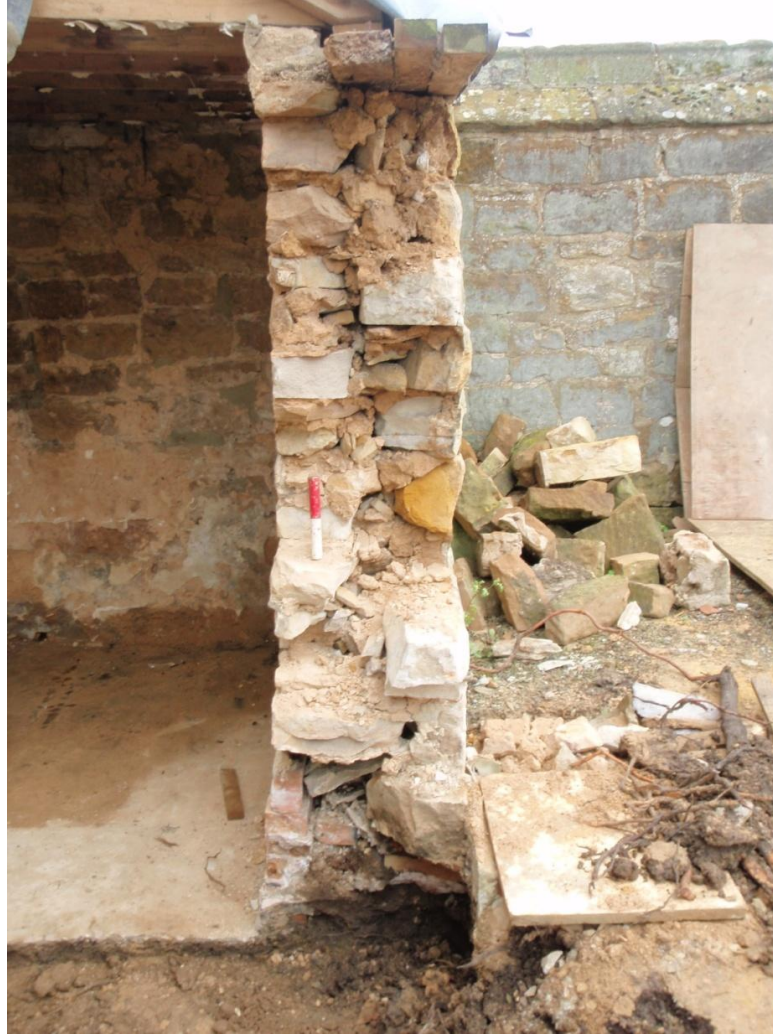
Plate 8 Cross section of store walling after removal of the east wall. Looking W.
