YORK ARCHAEOLOGICAL TRUST REPORT

SITE ADDRESS	Care Home, Nuffield Hospital, Haxby Road, York		
CLIENT NAME	Primary Care Investments		
YAT PROJECT #	5481	YAT REPORT #	2011/23
MUSEUM ACCESSION #	n/a	GRID REFERENCE	SE 6079 5344
PLANNING REFERENCE #	10/01677/FULM	AAI OPS NOTICE #	n/a

Between 7th February and 16th March 2011 York Archaeological Trust maintained a periodic watching brief on ground-works associated with the building of a new care home in the grounds of the Nuffield Hospital, Haxby Road, York (Figures 1 and 2). The archaeological monitoring was commissioned by Primary Care Investments and followed a City of York Council Archaeological Scheme of Investigation (2005).

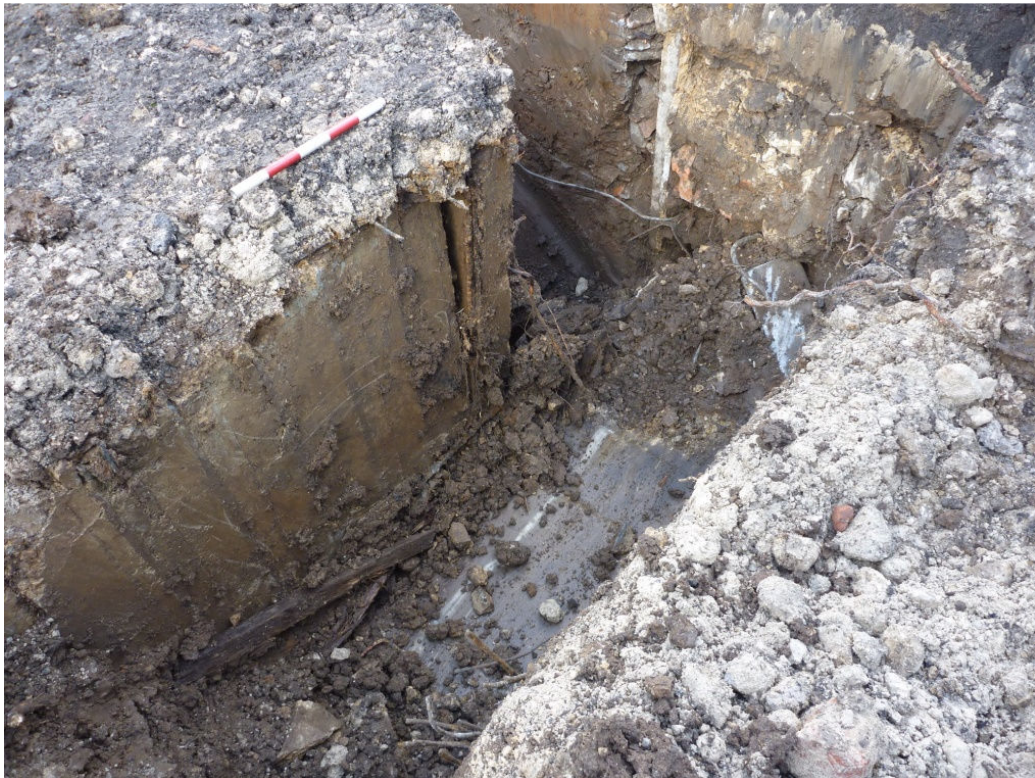
The basal part of the shelters were formed of pre-cast sectional slabs, typically fractionally over 100mm thick and around 1.52m in width (these dimensions appear likely to equate with imperial measurements of 4 inches thick and 5 feet wide, respectively). The sides of the shelters were formed of overlapping sections of pre-cast, steel reinforced concrete. Most commonly these were 0.27m wide by 0.11m thick and had a simple lap joint to either side. The length of these side panels could not be accurately ascertained owing to their top ends being smashed in at the time of demolition, however, this was clearly in excess of 1.55m. These side walls were fitted snugly against

the sides of the basal slab floors rather than being seated on their upper surface. The roof was made of similar panels, of the same width and thickness, though these had an arched profile to them and spanned from side wall to side wall. None of the roof panels, nor indeed the tops of the side panels, survived intact as these had been broken in at the time of demolition. Entrances/exits to the shelters was via concrete staircases at one end of the shelter and were aligned at 90 degrees to the long axis. Each of these steps was a pre-cast single unit and was embedded within the side walls of the entrance. The side walls of the entrances were, in all observed cases, built of brick with some steel reinforcing bars within. The theory behind such angling of entrances was that such would reduce the effects of blast within the shelter.

*Plate 1 Walls and base of Shelter 1, looking NW.
Foundation trench in top centre has cut through part of shelter wall*

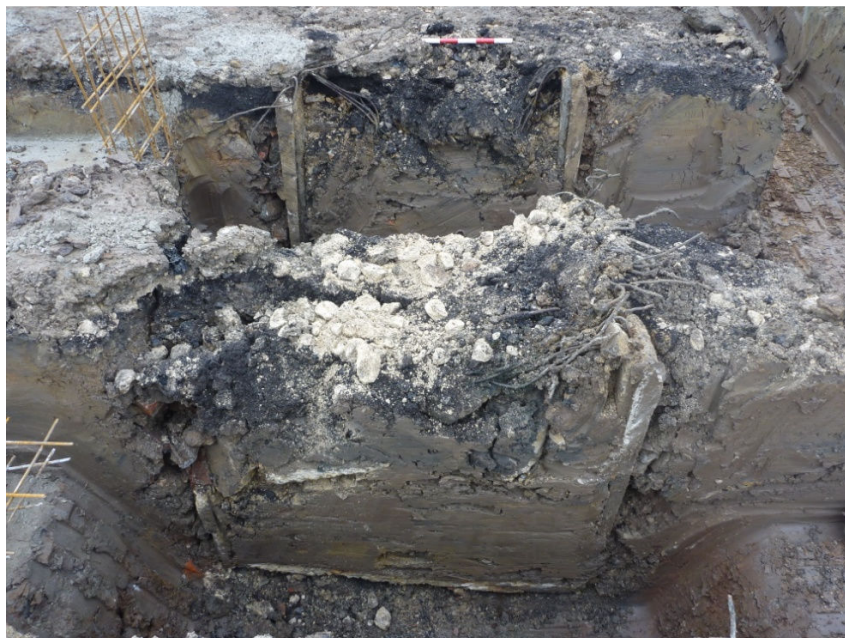
Plate 2 Walls and base of Shelter 2 cut through by two foundation trenches, looking S.

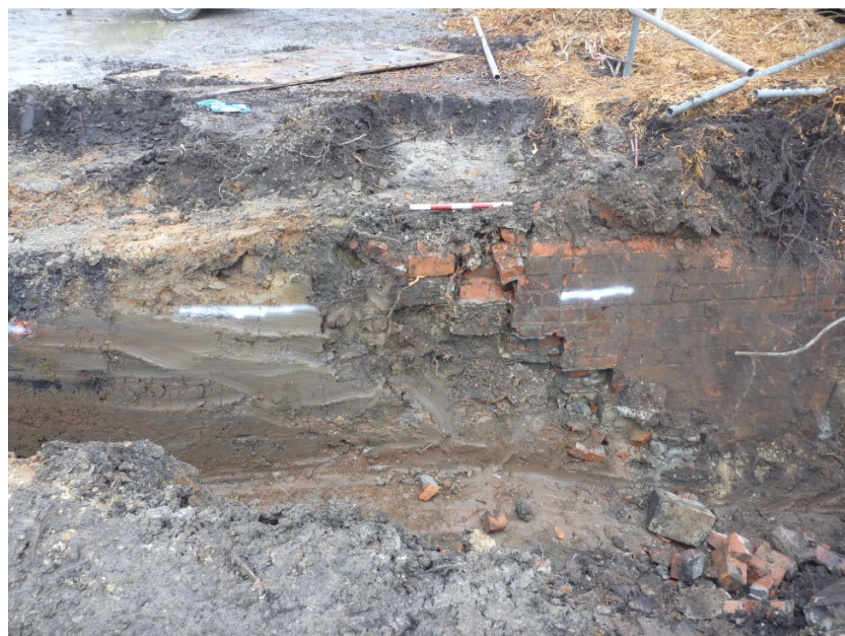
*Plate 3 Northern brick entrance walls to Shelter 2.
Note slots for concrete steps in wall, looking N.*

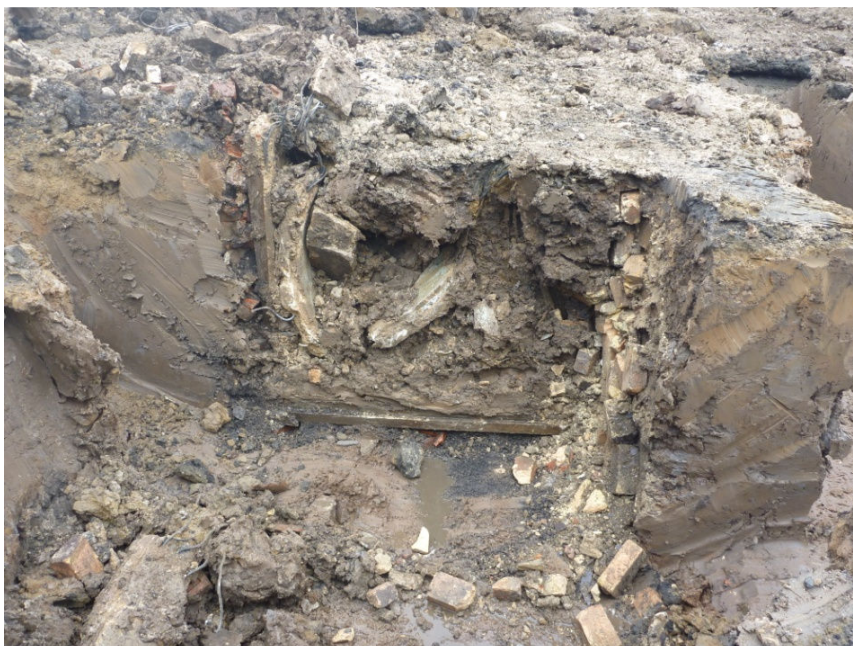
It is assumed that demolition of the air raid shelters took place soon after the war ended. Demolition was achieved by the crushing and breaking up of the roof, presumably with machines. Within the shelter tunnels there were also large quantities of re-deposited natural clays, often inter-mixed with darker, siltier, topsoil-like materials. No 'finds' or other materials were recovered from the shelters save for a number of pieces of partially decayed wood. It would seem likely that the shelters were kept reasonably clear and clean, this certainly appears to have been the case at the time of demolition.

Plate 4 Walls and base of Shelter 6. Note rubble fill in narrow gap between trench cut and wall, also curved roof panels within backfill, looking N.

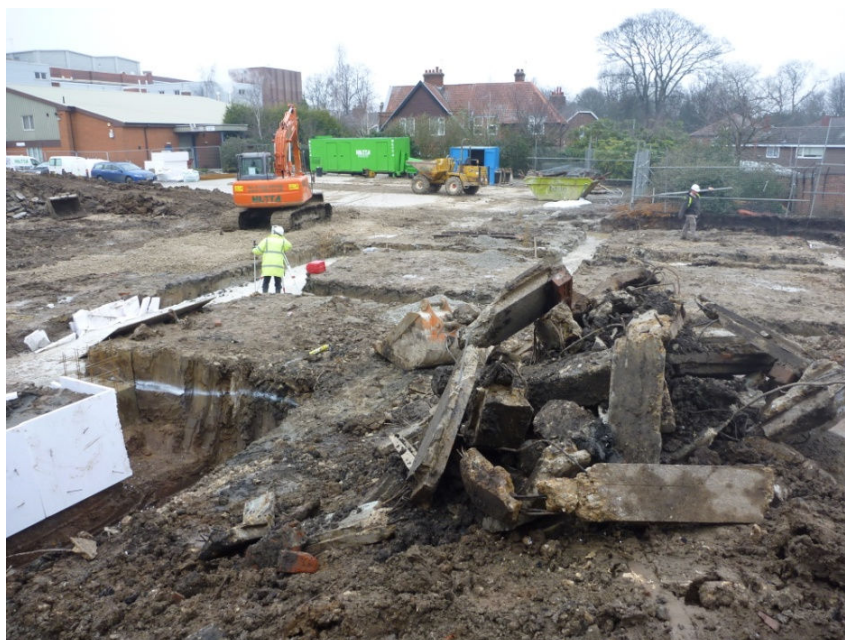
Plate 5 Typical air raid shelter materials as machined out during cutting of foundation trenches, looking NNW.

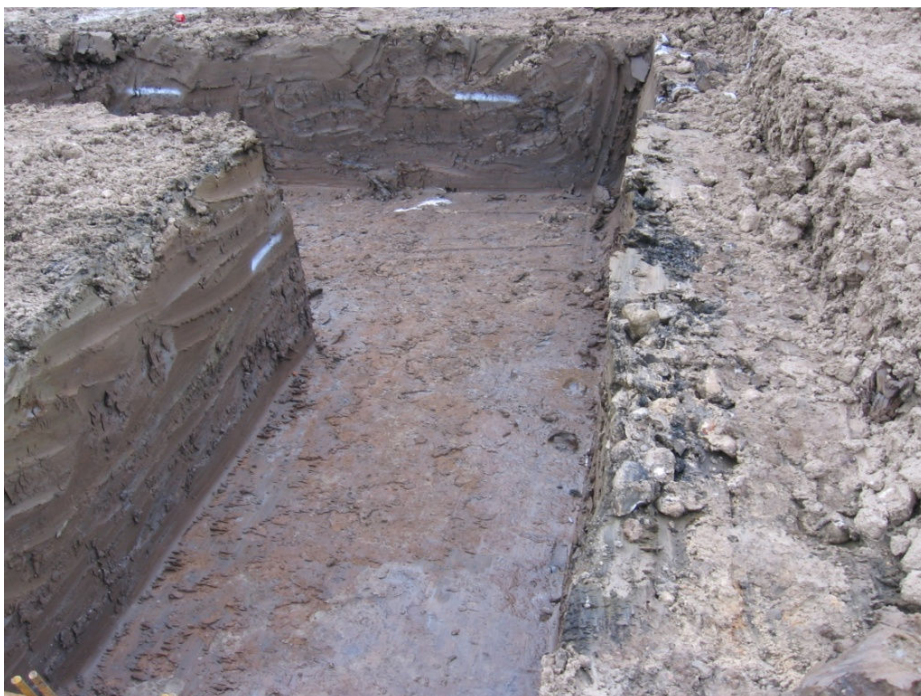
No archaeological finds or features, other than those of World War II were encountered during the watching brief. 20th century materials were seen to lie directly over 'natural materials'. It is clear that

there has been truncation at the site though it cannot be stated whether or not such truncation has removed any archaeological remains.

Plate 6 Foundation trenches in northern part of site showing modern materials directly over natural deposits, looking N.

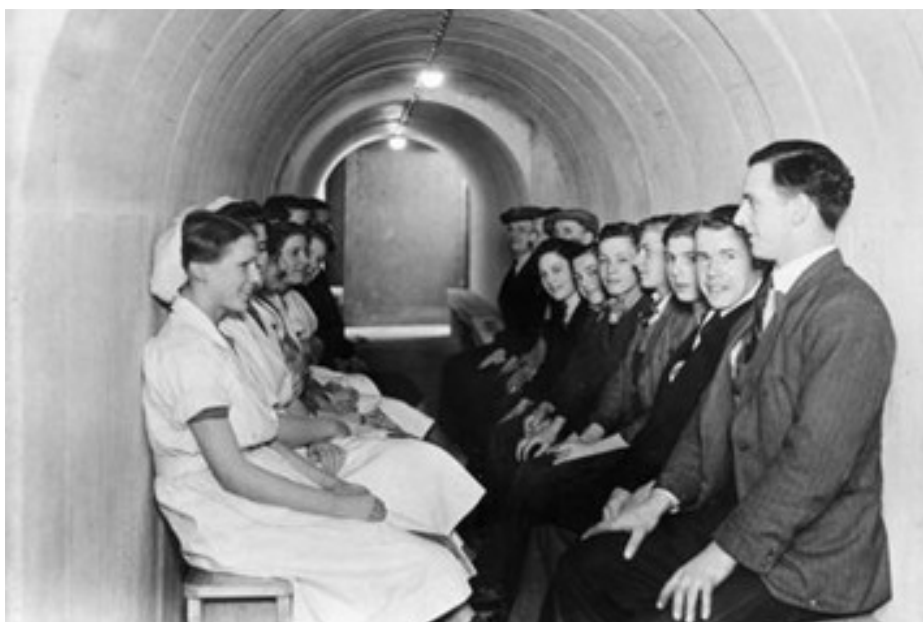
All the shelters appeared to have their long axes aligned north – south, with the short entrances to them being aligned east – west. It is assumed that this regularity of alignment is owed to a need to accommodate as many shelters as possible within a restricted area. The shelters were constructed initially by the digging of long vertically sided trenches to a level just below that of the underside of the basal slabs and fractionally wider than the side to side width of the slab walls. Small amounts of fill, principally brick rubble and soil occupied the gap between the outer sides of the side panels and the edge of the trench cut. This thin gap was seldom wider than 0.15m. Given the assumed heights of the side panels and contemporary ground level, it is likely that the upper parts of the side panels were roughly at ground level. Assuming such, then the arched roof would have risen slightly above the then existing ground level. Upcast from excavating the shelter trenches seems certain to have been laid up over the top of the shelter roofs producing the effect of a series of linear mounds. There are a handful of photographs of air-raid shelters at Rowntree's, though the location of the particular shelters depicted is not known. However, at least one of these photographs (Plate 7) depicts a trench shelter of broadly similar pattern to those observed during the watching brief. This photograph shows people seated on benches to either side of the shelter. No evidence for seating accommodation was encountered during the monitoring works and it is probable that such bench arrangements were utilised here. The same photograph also shows electric lighting.

Plate 7 Historic photograph entitled: Rowntree staff in an air raid shelter, York, 1939

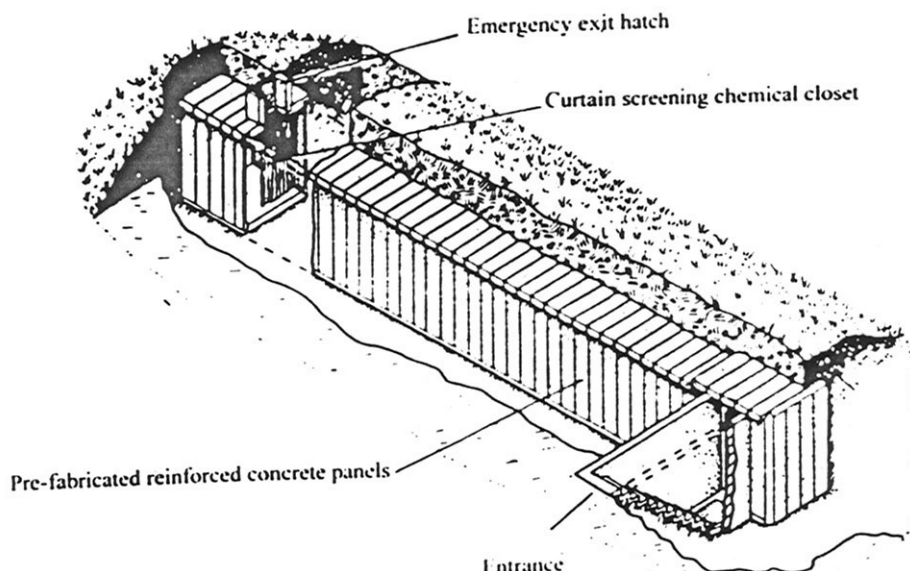
It is known that in some air-raid shelters of 'trench shelter' type that emergency exist hatches were provided at the ends opposite to the entrances (Figure 4). It is not known if such were a fixture of the Haxby Road shelters. Chemical toilets were also sometimes provided in these shelters, screened simply by a curtain, but again the presence of such arrangements here is unknown. Lighting in trench shelters could be by candle or by electric lighting. No cabling was observed within the backfilled shelters, though any such cabling could have been salvaged prior to demolition.

Figure 4 Covered trench shelter of broadly similar type to those revealed at the site
