**JUNCTION OF MOOR LANE AND A1237,
YORK, NORTH YORKSHIRE**

EVALUATION AND WATCHING BRIEF REPORT

REPORT NUMBER 2007/38

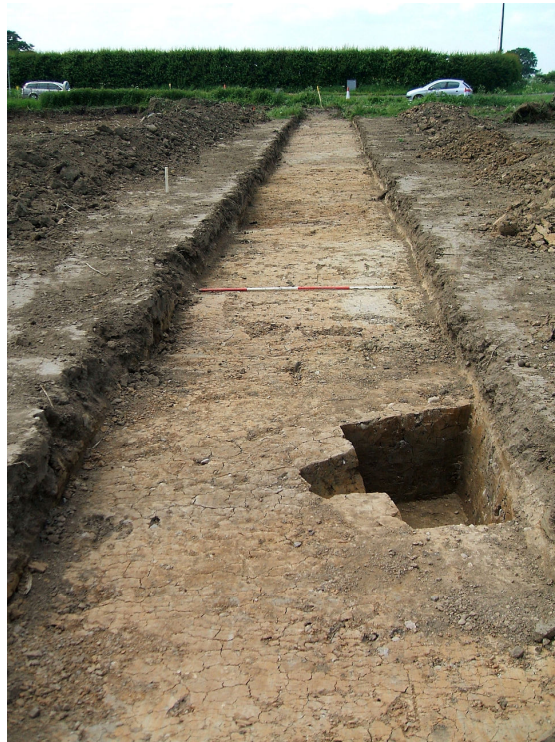
Trench 1 was aligned approximately east – west, across the proposed position of a new pond, and represents the southern-most of the excavated trenches. Natural deposits, 1002, were revealed at the base of the trench at a depth generally around 0.25m BGL. Essentially a compact, yellowish orange silty clay, some slight variation was noted in this material. A single linear feature, 1004, cut into the natural deposits. This feature was aligned NW – SE, some 0.52m wide, 0.45m deep and displayed steep sides with a flattish base. The single fill of 1004, context 1003, was a firm, mid grey, slightly silty clay with some yellowish orange colour variation. No finds were recovered from this fill. It is probable that 1004 represents a form of primitive land drain in which trenches are dug and the stratigraphy effectively inverted i.e. turf and topsoil is placed at the bottom of the trench and any natural clays above this. This feature was sealed by the extant friable, mid greyish brown, clayey silt top/ploughsoil, 1001.

Plate 1 *Trench 1 overall shot looking W*

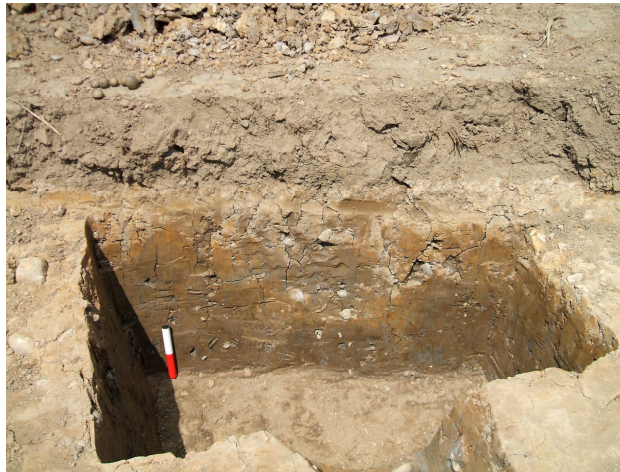
Plate 2 *Primitive land drain looking N*

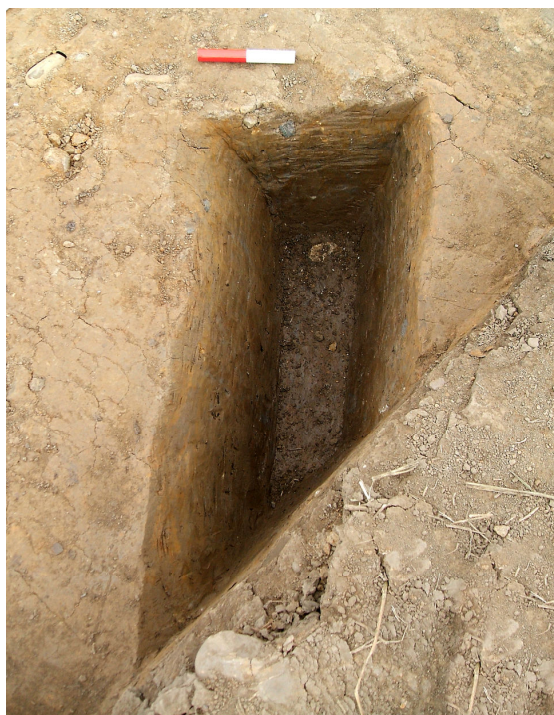
Natural deposits were reached in Trench 2, 2002, at a depth of 0.20m-0.25m BGL. The majority of these deposits were comprised of firm, yellowish brown silty clays (some colour variation), with areas of increased stone and sand content. Two features were observed and excavated. The northerly of these was a linear cut aligned approximately E-W, cut 2006. This feature measured some 0.44m wide by around 0.90m deep and proved to have very steep sides and a flattish base. No finds material was recovered from the single compact, mid greyish brown, silty clay fill of this feature. In the southern part of the trench the NE end of a SW-NE aligned feature, 2004, was examined. With a width of around 0.91m and a depth of just 0.16m, 2004 was steep sided and had a flattish-slightly concave base. A fill of pale-mid grey, sandy clay containing large amounts of dark grey slightly fibrous decayed woody material, 2003, was present within this cut. It is possible that the pale grey colouration evident in this fill may have been derived from some ash like material. No finds or dating evidence was recovered from 2003. The function and origin of this feature are uncertain. It may be that 2004 forms the NE portion of a rectangular pit, or possibly even of a longer linear feature.

Plate 3 *Trench 2 land drain looking SE*

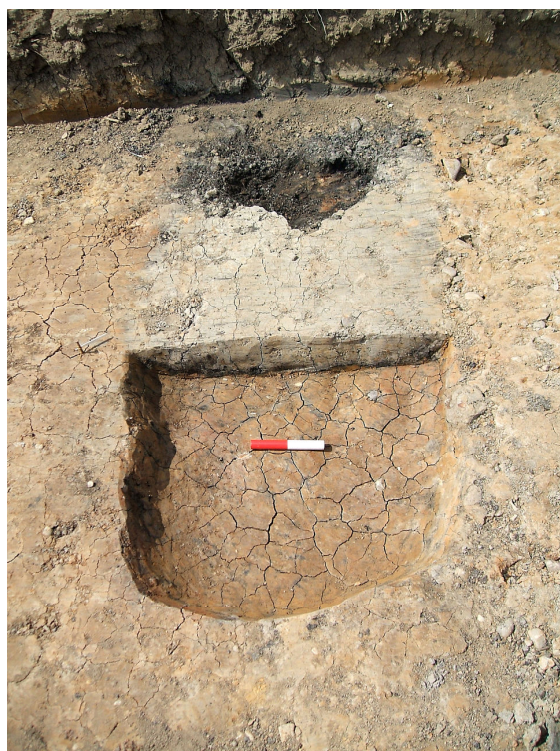
Plate 4 *Trench 2 shallow unidentified feature looking ESE*

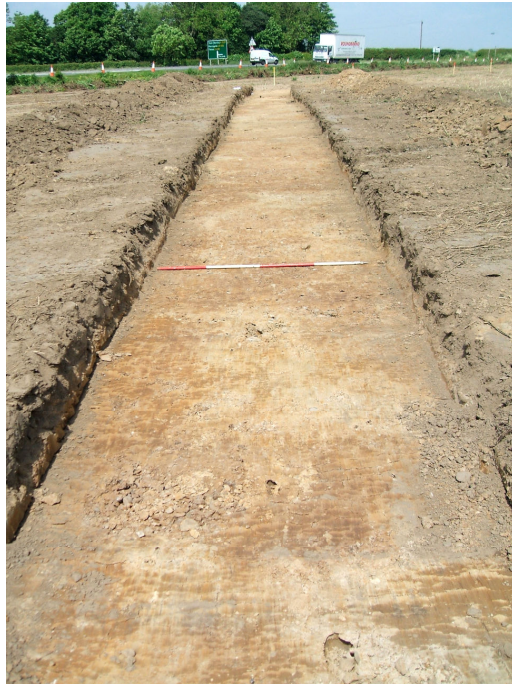
Natural deposits, 3002, in Trench 3 were reached at a depth generally in the region of 0.25m BGL. Exhibiting some colour and textural variation, the bulk of 3002 was a compact, pale orangey brown silty clay though patches of sandier clay together with an area of gritty, sandy clay at the extreme NE end of the trench were noted. No archaeological features or finds were observed in this trench. The top/ploughsoil, 3001, was a uniform mid-dark greyish brown clayey silt.

Plate 5 *Trench 3 overall shot looking NW*

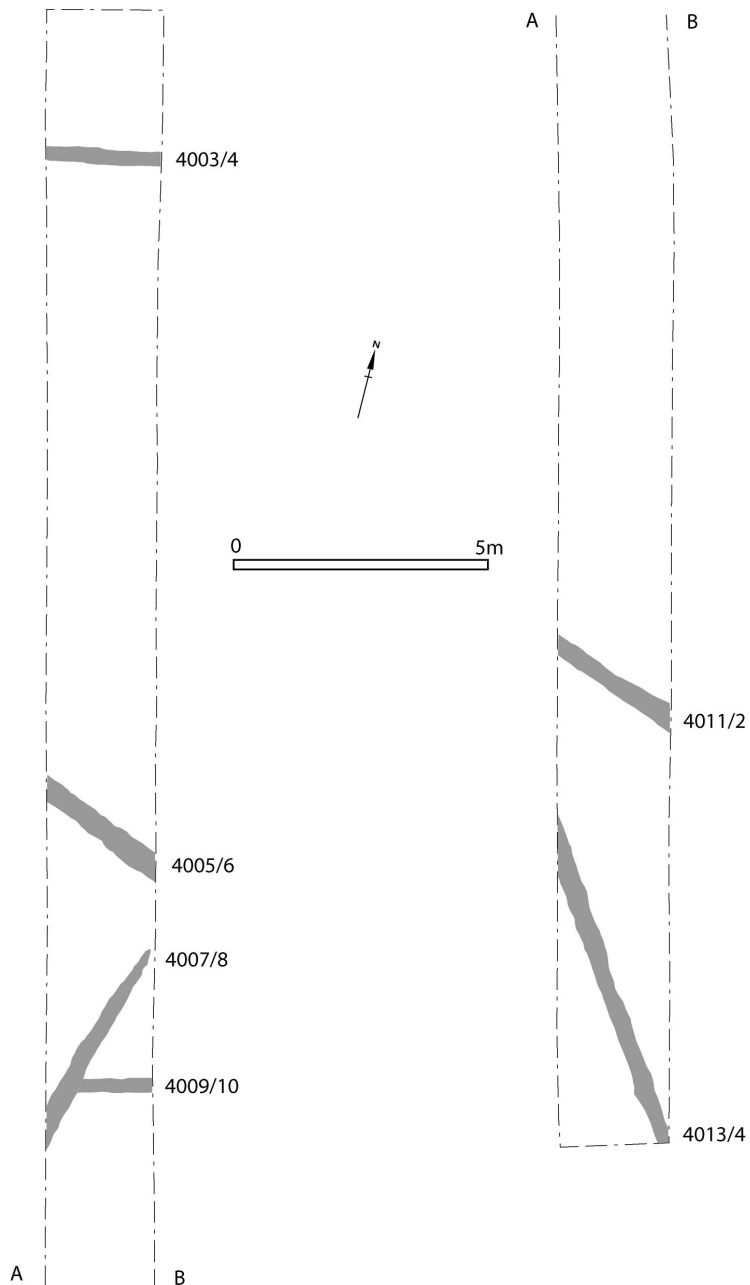
Figure 3 Trench 4 plan

In this, the most northerly of the trenches, natural deposits were revealed at depths of between 0.25m-0.30m BGL. This material, 4002, consisted of firm, light yellowish brown (with some variation) slightly silty clays. A total of six linear features were seen to cut through the natural deposits. Four of these, contexts 4006, 4008, 4012, 4014 were modern land drains, typically between 0.28m-0.40m wide. The fills of these drains, 4005, 4007, 4011, 4013, contained large amounts of small rounded gravel together with re-deposited natural clays. Of the other two features in Trench 4, context 4004 was an E-W aligned cut towards the northern end of the trench. This feature had a width of 0.32m, a depth of 0.95m and displayed very steep sides with a slightly rounded base. The fill, 4003, was composed of a mix of re-deposited topsoil and natural clays. A piece of cinder and a sherd of 18th-19th century pottery indicate a post-medieval date for this feature which seems certain to have

served as a primitive form of land drain. The remaining feature, 4010, was also an E-W aligned linear cut. This feature, which had been partially truncated by one of the modern land drains, had a width of 0.26m, a depth of 0.50m and displayed near vertical sides with a flattish base. The fill of 4010, context 4011, was comprised of material that appeared to represent a mixture of re-deposited topsoil and natural. No finds were recovered from this feature which is though likely to have operated as a primitive land drain. The topsoil in Trench 4 was a dark greyish brown clayey silt.

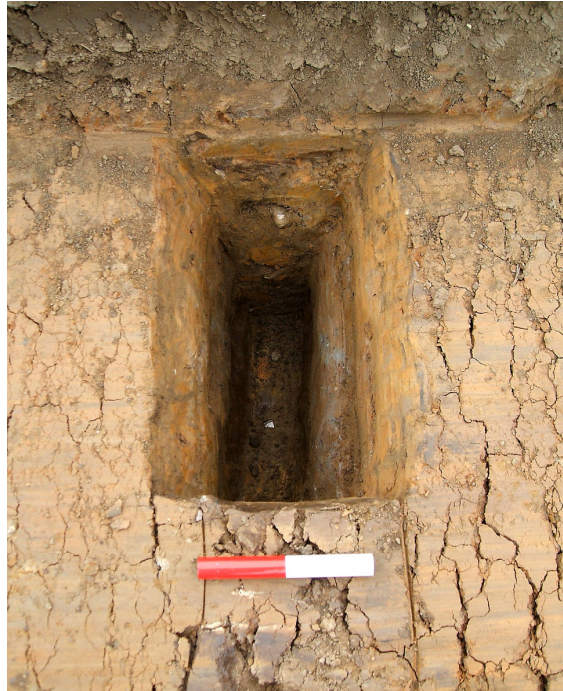
Plate 6 *Trench 4 land drain looking E*

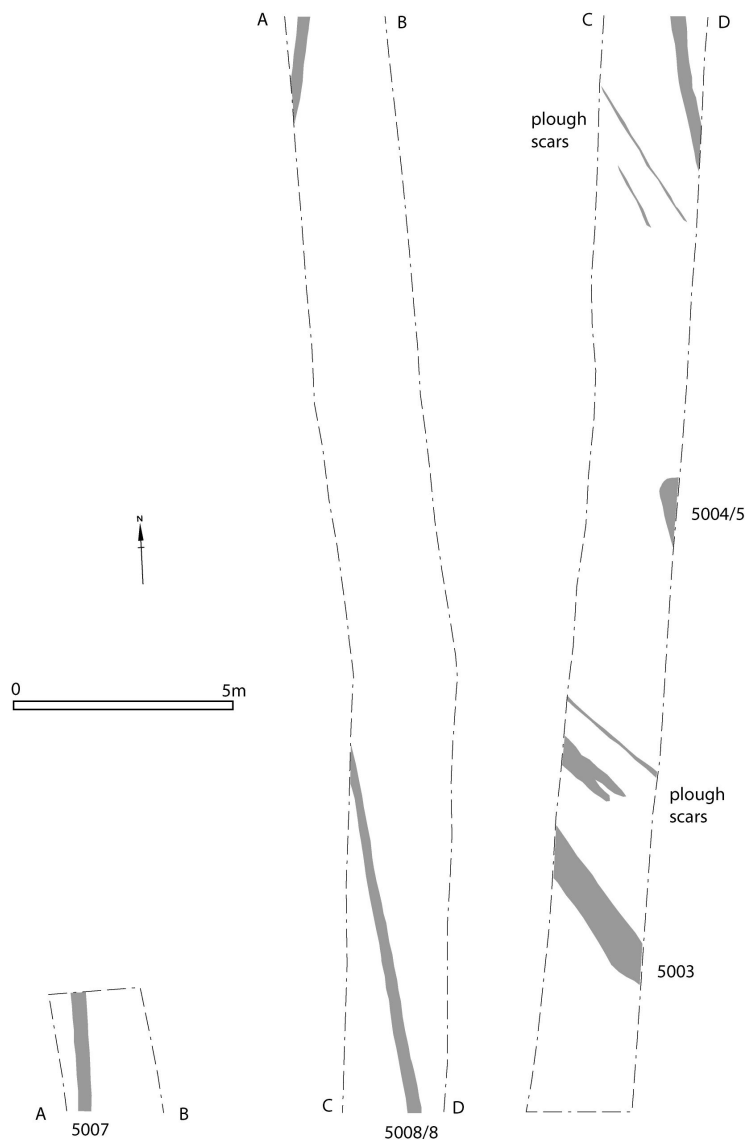
Figure 4 Trench 5 plan

Natural drift was reached in Trench 5 at a depth typically around 0.25m-0.30m and again consisted of pale orangey brown, silty clays with some variation. Several features, all apparently of post-medieval - modern origin were revealed. At the southern end of the trench a NW – SE aligned linear cut 0.85m wide and backfilled entirely with clean gravel, 5003, represents a modern land drain. A further gravel filled land drain aligned approximately N-S and of somewhat smaller size, 5007, was evident at the northern end of the trench. Around 6m north of drain 5003 parts of a straight sided vertically edged cut, 5005, was examined. The fill of this feature, 5004, was a mixture of brown clay and greyish brown clayey silt which at a depth of some 0.35m produced pieces of only partially decayed grass and straw. Although seen to be sealed by topsoil of the latest ploughing event the origin of this feature seems certain to relate to Test-Pit 1 of the geotechnical investigation of early January 2007 (YAT 2007). In the central part of the trench a N-S aligned linear cut, 5008, was examined. Having a width of 0.25m, a depth in excess of 0.40m with near vertical edges, the fill of this feature, 5006, was composed of re-deposited natural and topsoil together with a number of small cobbles and pebbles. 5008 is likely to have originated as a primitive land drain. The only other features in the trench were a series of plough scars. These seem likely to be of modern origin, though a single sherd of later medieval pottery was recovered from one of these.

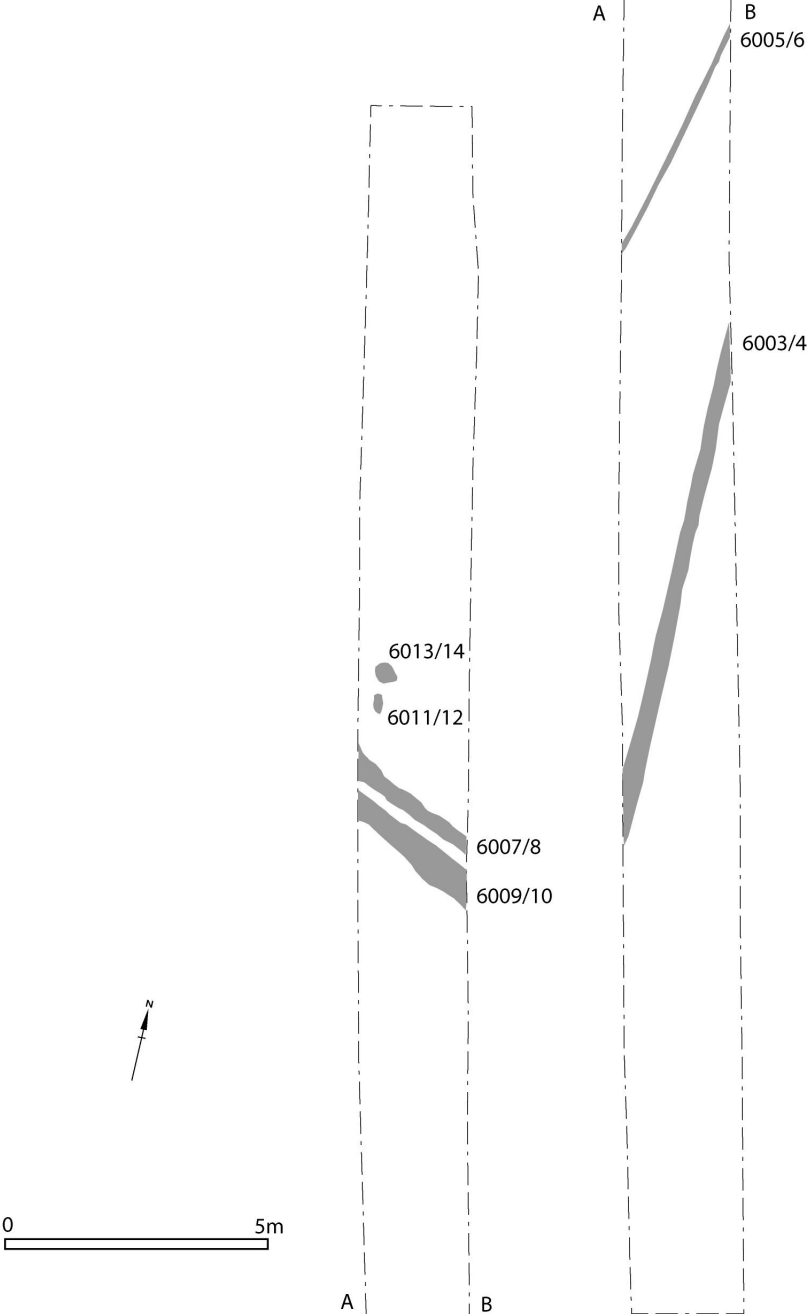
Figure 5 Trench 6 plan

Natural deposits were reached in Trench 6 at depths of around 0.30m BGL and were again seen to consist predominantly of firm, light orangish brown silty clays, 6002. Several features cut through the natural deposits. Two of these, 6004, 6006, were N-S aligned land drains of a width 0.30m-0.45m. Their fills, 6003, 6005 respectively, were mixtures of re-deposited natural clays, gravel and a small amount of topsoil. A number of linear stripes were apparent running across the trench. Two of these, 6007/6008, 6009/6010, were examined. These proved to be plough scars, quite probably of modern origin. The remaining features in trench 6 consisted of two small sub-oval depressions, 6012, 6014, up to 0.36m across and generally around 0.10m-0.15m deep. The fills were dark grey clayey silts, 6011, 6013, and

did not produce any finds. Given the proximity of these features to a number of plough scars it is entirely possible that they represent areas from which cobbles have been ripped from the ground by ploughing rather than, for example, postholes. The topsoil in trench 4, 6001, was a dark greyish brown, clayey silt.

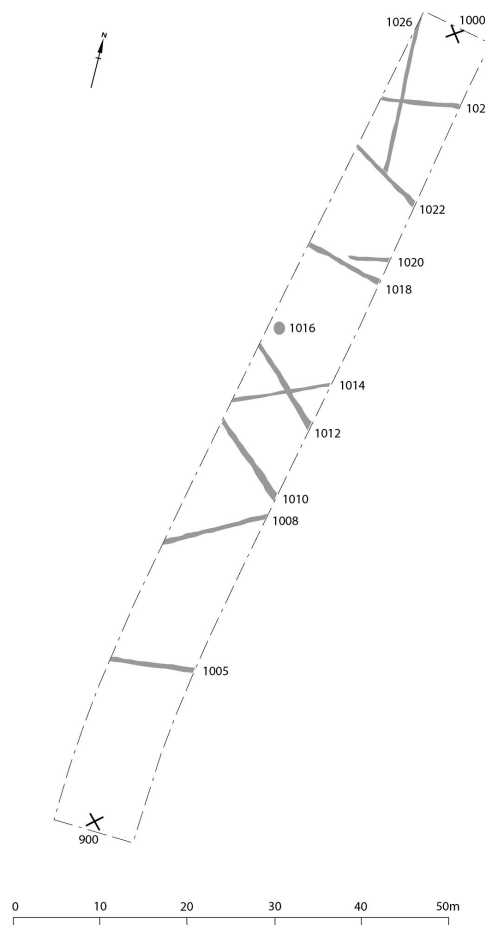
Figure 6 First stage watching brief plan

The first stage of the watching brief involved the stripping of all overburden, down to a horizon at which archaeological features were visible, over part of the realigned course of Moor Lane. This area measured approximately 102m by 9.5m wide. Eleven features were observed within this area, nearly all of which proved to be land-drains and their fills, contexts 103/104/105, 105/107/108, 109/110, 111/112, 113/114, 117/118, 119/120, 121/122, 123/124, 125/126. Measuring between 0.22m and 0.49m wide, all were linear in plan, followed a variety of alignments and were steep sided. Just over half of the drains featured gravel as their predominant fill whilst two contained plastic drainage pipes at their bases. Four of the features contained neither gravel or drainage pipes though their fills (mixtures of re-deposited clays and topsoils) suggests they may have been primitive land drains of a form in which drainage is aided by turf and topsoil at the bases of the trenches. The only other feature in this area of watching brief was a solitary sub-circular cut, 1016, measuring some 0.48m across, 0.30m deep and displaying steep sides and a flattish base. The fill, 1015, was of 19th century brick fragments within a sandy clay matrix. This feature may represent a modern posthole, the wider function of which is unknown.

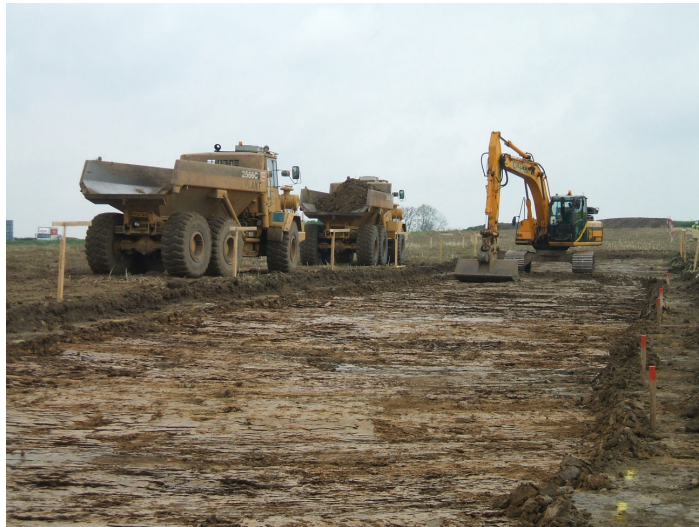
Plate 7 1stage watching brief, stripping, looking N

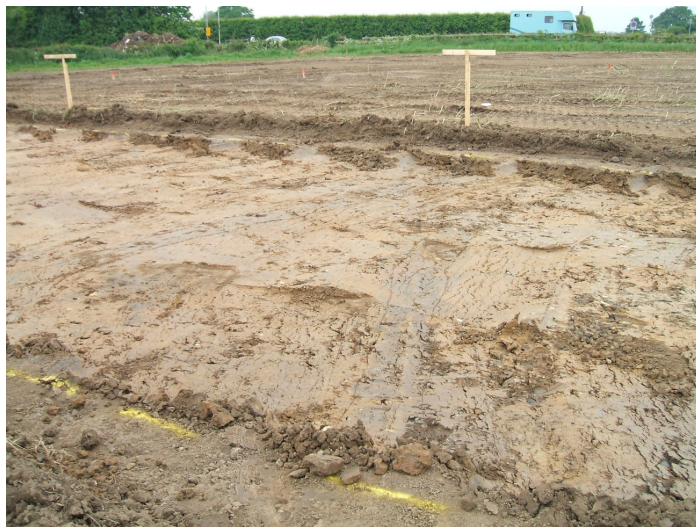
Plate 8 First stage watching brief, some of features revealed, looking W

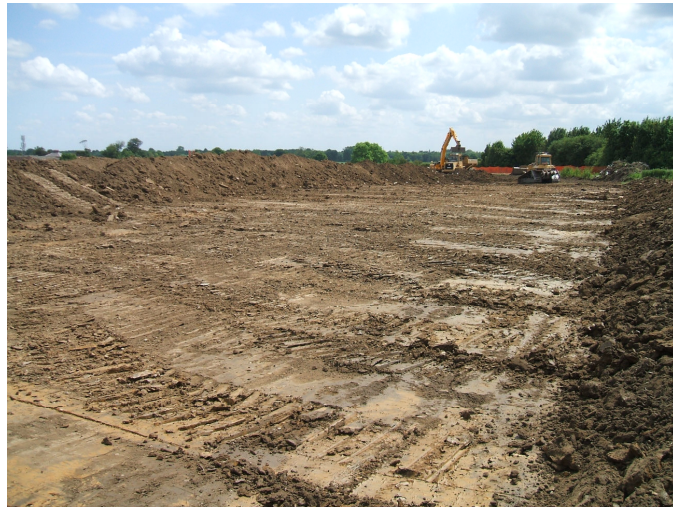
The second stage of watching brief involved monitoring of the stripping of topsoil in the field to the eastern side of the ring-road, i.e. the area of Trenches 1-4 subsequent to their excavation. This proved to be archaeologically unproductive owing to the manner of stripping. The exercise was carried out by a bulldozer pushing topsoil into linear heaps, atop which sat a 360° excavator that loaded the topsoil into dumper trucks. By necessity the bulldozer was required to continually track back and forth across the area being stripped,

each time blading off more of the topsoil. This inevitably led to a patchy skin of compacted dirty track trample, this serving to obscure any archaeological features.

Plate 9 *Second stage watching brief, process, looking S*

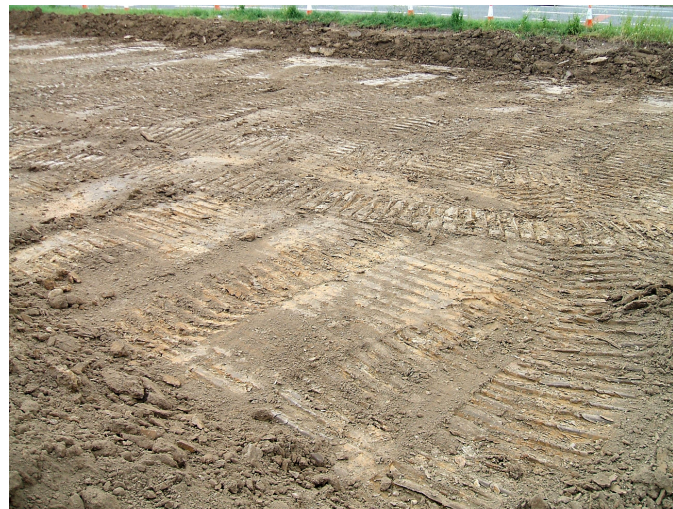
Plate 10 *Second stage watching brief, results, looking S*
