**YORK ARCHAEOLOGICAL TRUST**

**LAND OFF MITFORD STREET, FILEY,  
NORTH YORKSHIRE**

**BUILDINGS 6 & 9 RECORDING REPORT**

**REPORT NUMBER 2011/43**

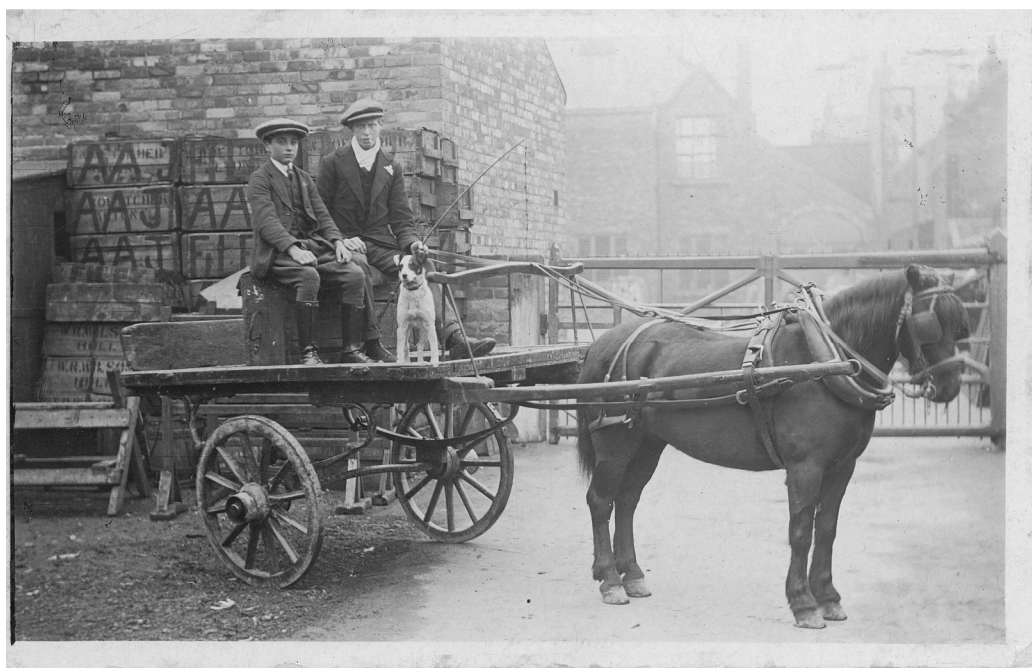
Plate 1 Photograph of the later 19<sup>th</sup> – early 20<sup>th</sup> centuries with part of Building 6 to the left

A set of photographs from the early 20<sup>th</sup> century are of interest as they show the rear of the Filey Town Council building and one in particular (Plate 1) shows part of Building 6 in the left background. This photograph depicts a horse and cart with two boys, and a dog, on the cart. Behind them are a large pile of what appear to be fish boxes. Behind the boxes is the east/west wing of Building 6 with a gate attached to the south-east end of the structure which marks the boundary of the council yard. Whilst these photos are not dated it must post date the 1890s as Building 6 and the Filey Town Council buildings do not appear on the 1893 OS map. By the time of the 1911 O.S. map Buildings 6 can be clearly identified and the present configuration of buildings and boundaries was established. Building 9 also appears on the 1911 O.S. map and appears to do so on that of 1893 also.

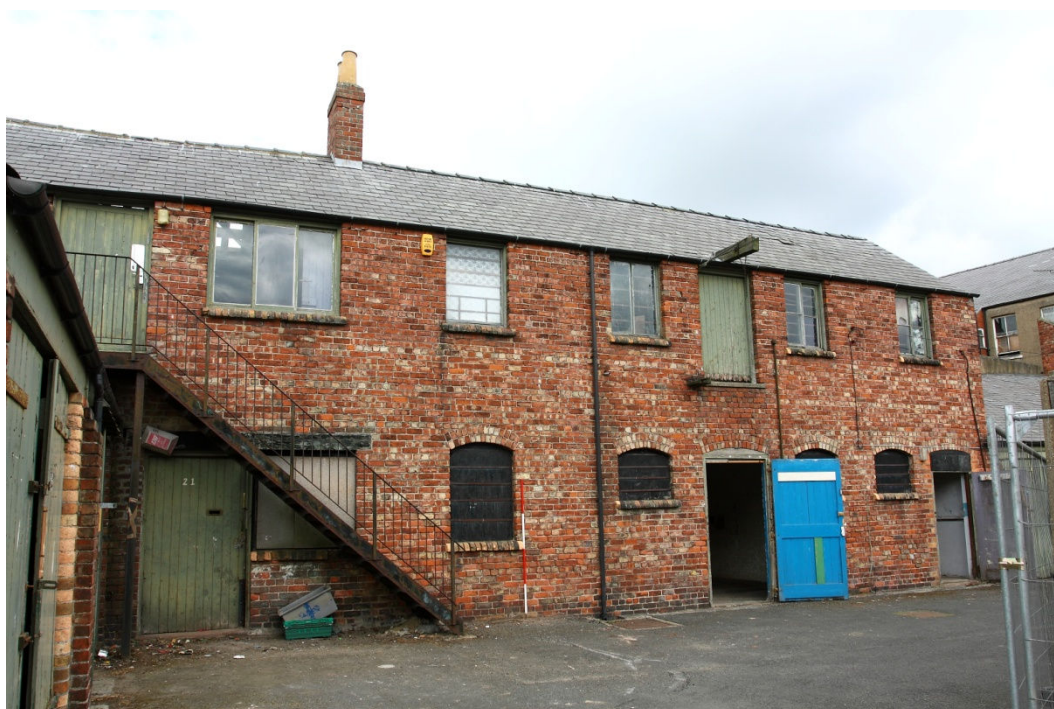
*Plate 2 E elevation of two-storey part of Building 6, looking W*

Building 6 is formed of an 'L' shaped block. The short east-west aligned arm at its southern end is single storied and has a mono-pitch roof. The northern end of the main north-south part is also single storied with a mono-pitch roof. The remainder of the building is of two stories and has a pitched roof. For the purposes of this report each room space within the building has been allocated a unique letter, the distribution of these spaces is depicted in Figure 5. The brickwork of Building 6 is of machine made orange/red common bricks of late 19<sup>th</sup> – early 20<sup>th</sup> century form and has roofs of slate with grey ceramic ridge tiles. All windows and doors are to the east elevation, the west elevation is completely of plain brickwork. The windows, all of which occur within the two storey part of the building, are of wood, some of horizontal sliding sash type, others non-opening 20<sup>th</sup> century replacements. Many of these windows are now boarded over. Sills to the windows are nearly all of moulded brick. The majority of ground floor windows have segmental arches of bricks to their heads whilst those to the first floor have horizontal lintels of timber. All the Building 6 doors are of wood, with those to the single storey parts all being of large double door type with timber lintels over. To the ground floor of the two storey part, two of the doors have segmental arches of brick to their heads, the remaining door, that towards the south end, has a horizontal lintel of timber. To the first floor both doors have timber lintels. The doors to spaces E and F are

replacements, the remaining doors may be original. A hoist, in the form of a projecting timber beam, is present above the northern of the first floor doors. The principal means of access to the first floor is via an external staircase towards the southern end of the east side of the building. The present staircase is of steel and later 20<sup>th</sup> century in date. The O.S. map of 1911 indicates there to have been a staircase in the same position at this time also. Guttering and down-pipes are of modern materials.

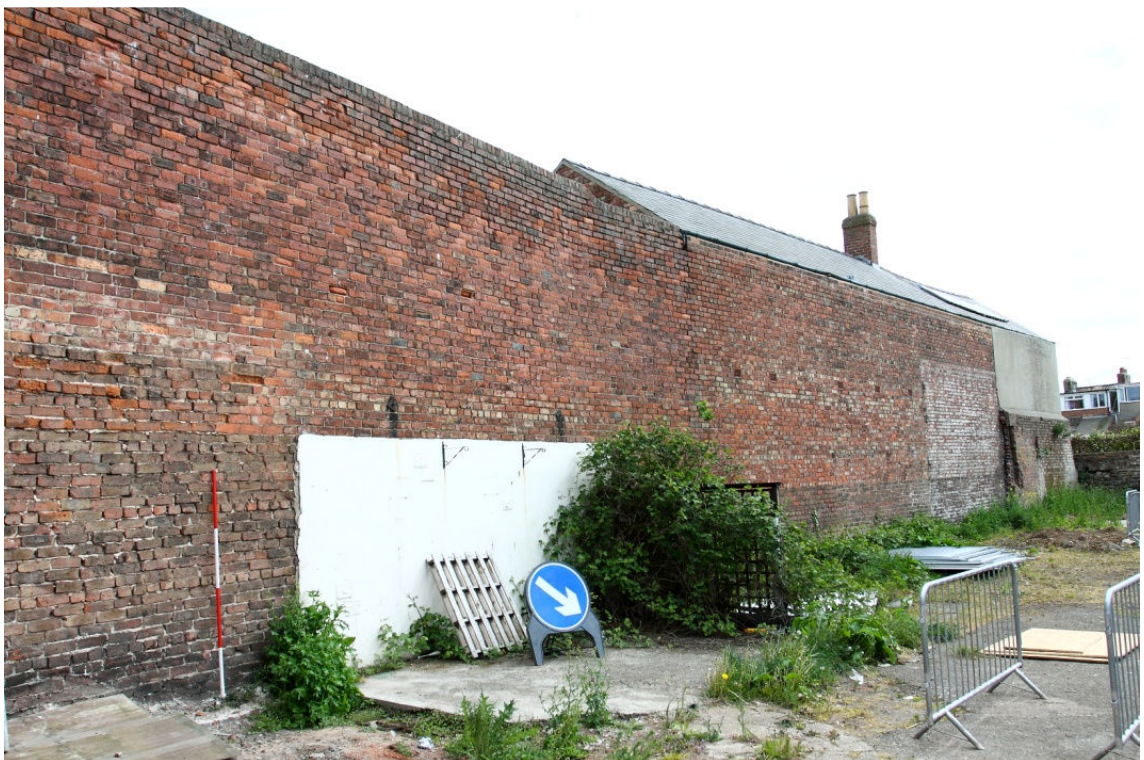
Plate 4 Rear of Building 6, looking S

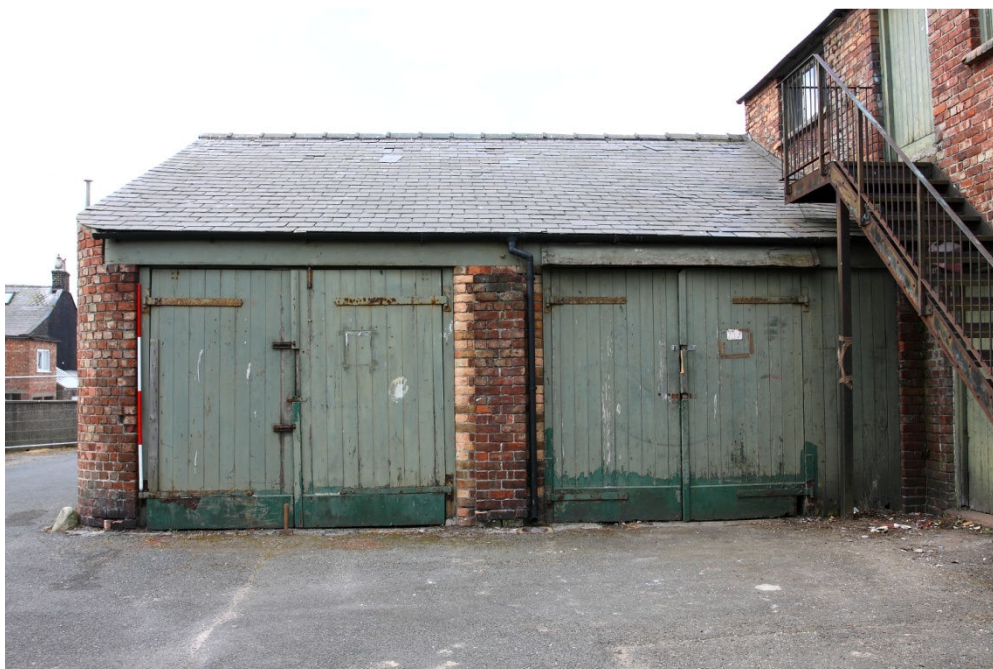
*Plate 5 Exterior of Spaces A and B, Building 6, looking SW*

The north-east corner of the single storied east-west part of Building 6, which incorporates spaces A and B, has a rounded corner and a guard stone at its lower part to protect it from damage by vehicle wheels. The south and east elevations of this part of Building 6 are entirely of plain brickwork with cement rendering to the lower part of the south side, whilst to the north elevation there are two large double doors separated by an elongated column of brickwork. These double doors form the only means of access to spaces A and B.

**Space A** has a floor of concrete, a ceiling of timber planks supported on east-west aligned joists, and a timber partition separating it from Space B. The floor surface, timber ceiling and partition all appear to be later additions.

**Space B** has a floor of concrete is fully open to the roof and separated from Space A by a timber partition. Space B is also separated from Space C of the two storey part of the building by a further partition, this of timber with a glazed upper part.

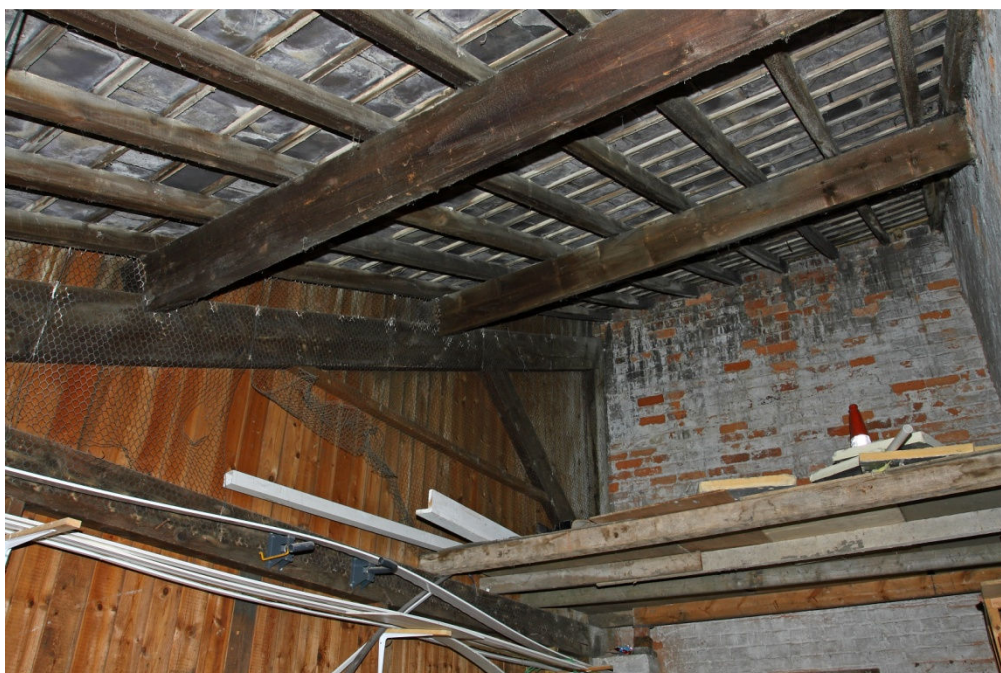
*Plate 6 Roof truss of Space B, Building 6, looking SSE*

A single north – south roof truss spans this single storey part of the building. This is comprised of a principal rafter extending from the higher southern wall down to the lower northern wall where it is seated within the brickwork of the elongated brick column. Support to the underside of the southern end of the rafter is provided by a wall mounted vertical timber which rests on a corbel of brick. Additional support to the rafter is afforded by a brace which extends from the lower part of the wall mounted timber to the underside of the rafter. A horizontal tie-beam extends along the base of the truss. Two trenched purlins, secured in the walls to east and west, are supported between spaces A and B by the rafter. Common rafters sit atop the purlins and are supported at their ends by the north and south walls. Battens secured to the upper sides of the rafters support the roof covering of slates.

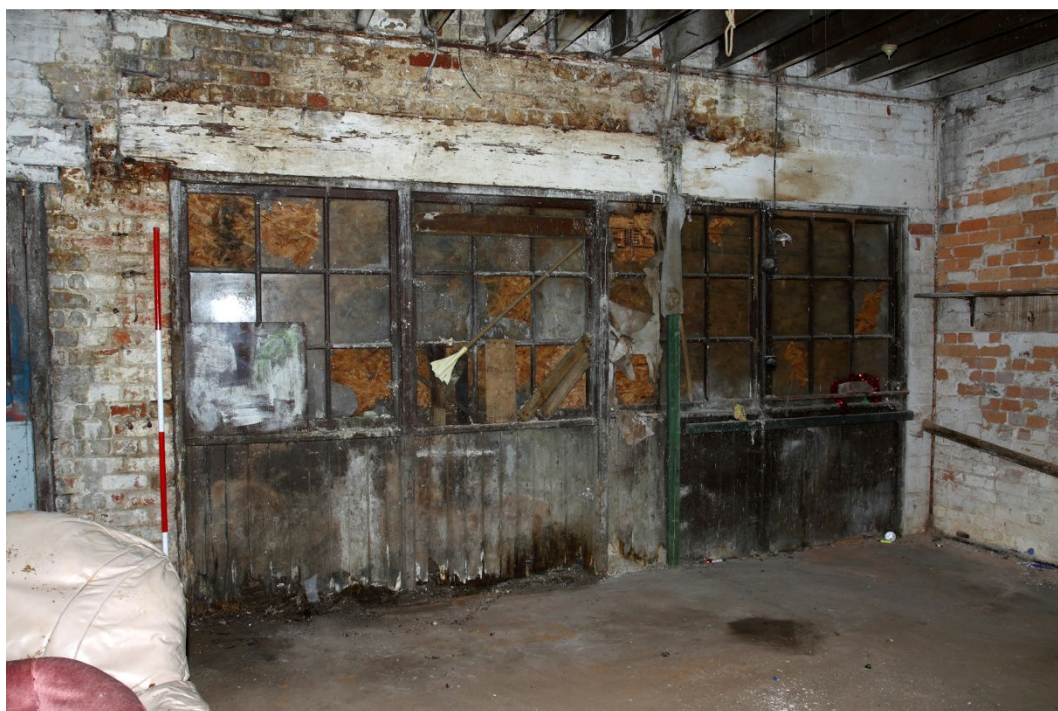
*Plate 7 Partition between Spaces C and B, looking SE. Note gas lamp towards right*

**Space C** has a floor of concrete and walls to the south and west sides that are of whitewashed plain brickwork. The east wall is also plain save for a doorway at its east side that provides access to Space D. The room is lit by a two piece sliding sash window to the east wall which abuts the north side of the doorway providing access to the room from the exterior. To the south part of the east wall, i.e. that part adjacent to Space C, there is a timber partition with glazed upper part that serves to separate Spaces C and D. An old gas lamp fitting is affixed to the upper part of this partition. A floor mounted gas fire, probably of mid 20<sup>th</sup> century date, is located against the south wall. There are numerous suspension nails to all internal walls. Joists supporting the first floor are exposed in this room and there have diagonal bridging pieces (strutting) between. Two parallel metal suspension fittings are secured to the underside of the joists in the north-west part of the room.

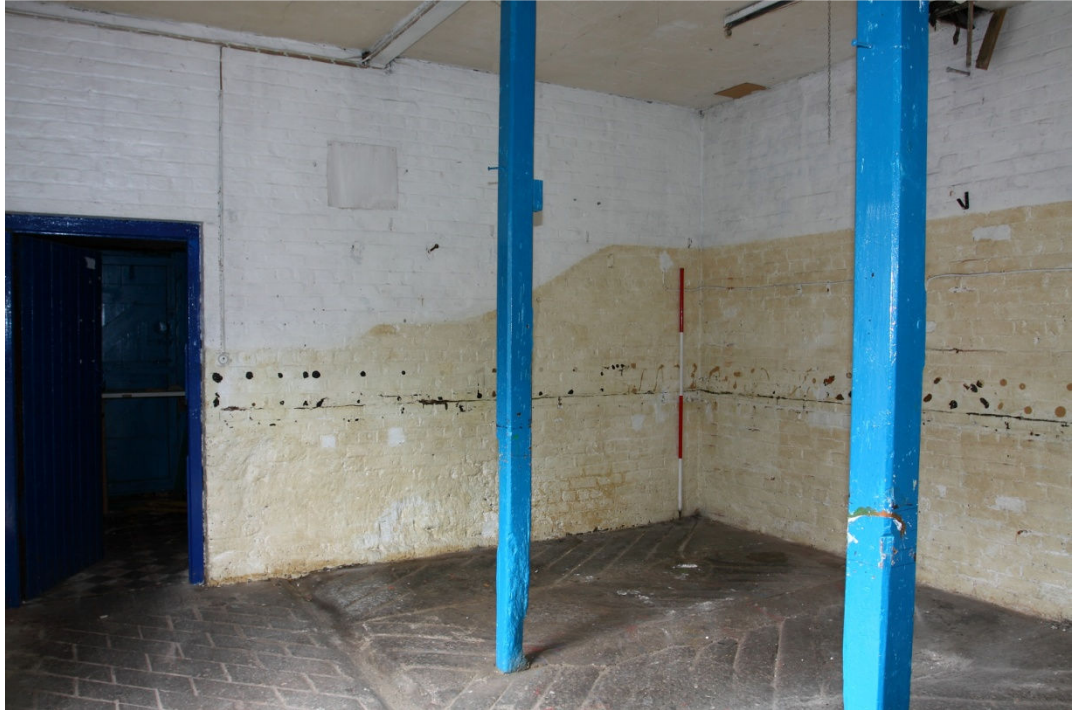
*Plate 8 Space E – former stables, looking WSW*

**Space E** is accessed from the exterior by a wide doorway to the centre of the east wall. Earlier pintels to the frame of this door indicate that it originally housed a two-piece, stable-type, door. This door is flanked by windows to both north and south. To the east side of the south wall a door provides internal access to Space D. The west and north walls are of painted brickwork whilst the ceiling is of plaster. Two full height square section timber posts, equidistantly spaced between the north and south walls, are present in the eastern part of the space. These correspond with paint scars to the west wall and to changes in level of the concrete floor. The ridged concrete floor itself has a north – south aligned drain immediately to the east of the line of the timber posts. This evidence, combined with variations to the paint scheme, indicates that the western 2/3rds of Space E was formerly divided into three parts.

Space E clearly functioned as a stable. Two spaces appear to relate directly this stable. The adjacent and directly accessed, Space D may have served as a harness room/tack room whilst Space I above served as a hayloft.

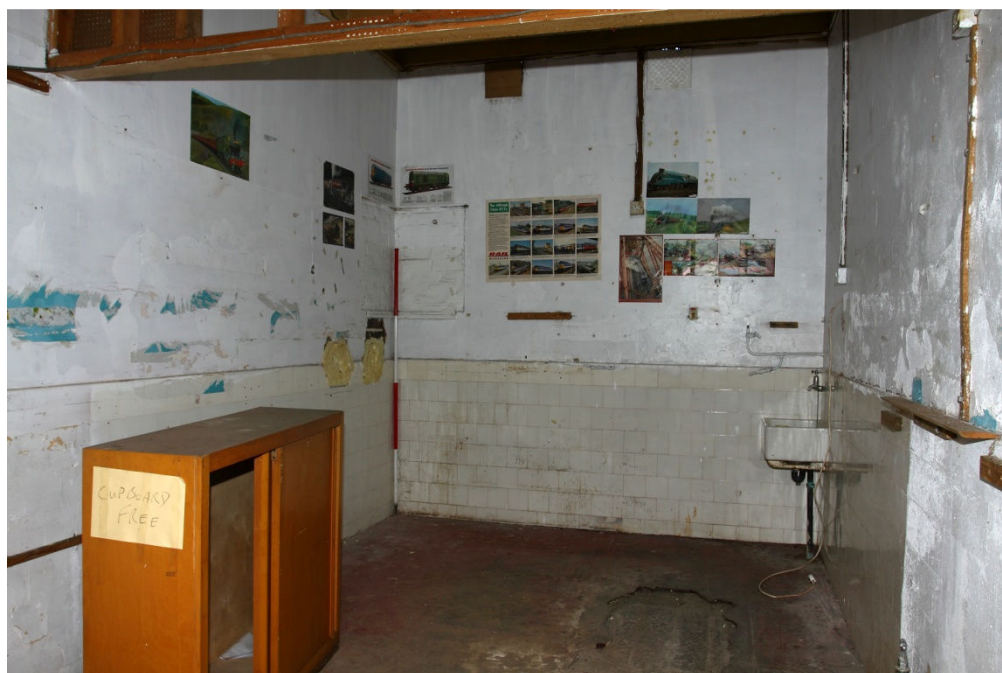
Plate 9 Space F, looking W

**Space F** has a floor of concrete and is accessed from the exterior by a door located towards the north end of the east wall. A single window is present to the south of the doorway. The walls to the south, west and north contain no windows or other openings. The lower part of the walls, up to a height of around 1.2m, are covered in plain white tiles, whilst above this level the wall finish is of white paint. Two small high level vents, now blocked, are present to the west wall. The only internal fitting is a small square, white ceramic sink mounted in the north-west corner of the room.

The original function of this room is uncertain though apparently it served as a mortuary in the mid and late 20<sup>th</sup> century.

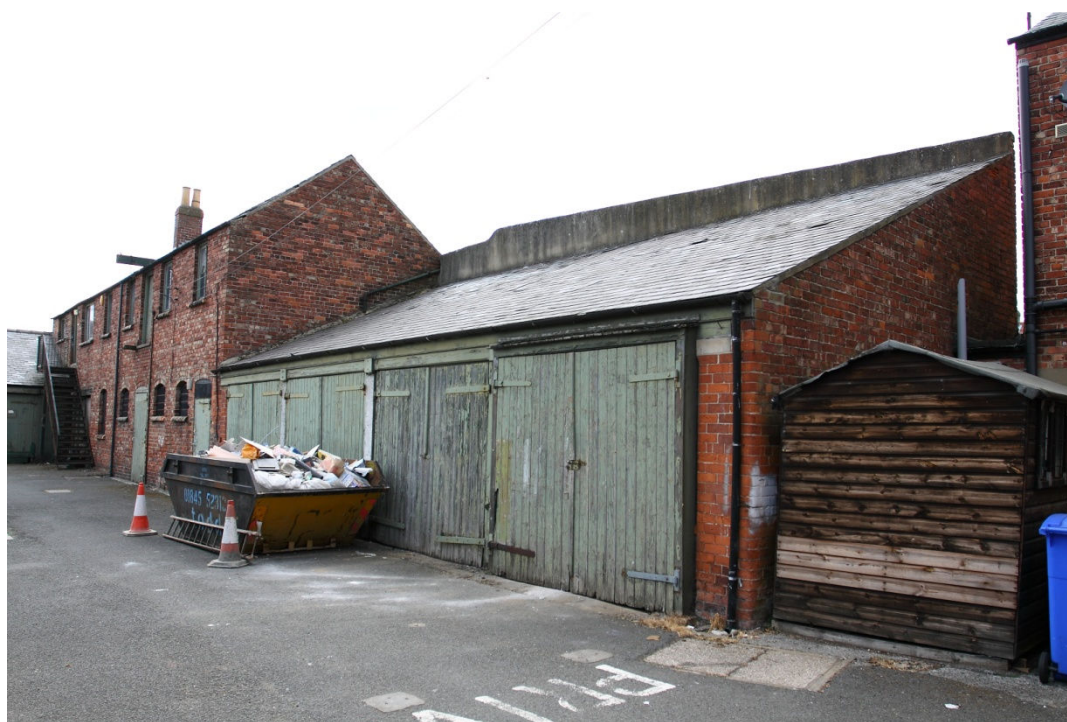
*Plate 10 Façade of Spaces X,Y,Z, looking SW*

**Spaces X, Y and Z** form a single storey range immediately to the north of the two-storey block. The western, rear, wall of these spaces is formed of a continuation of the west wall of the two-storey block. As this wall splays out slightly to the north, these spaces are of slightly irregular size and shape. The south wall of the range is formed of the gable end of the two-storey block whilst the northern end is of plain brickwork. The east side of this single storey range is of open construction, this being formed of small brick returns to the south and north ends and of three roughly equidistantly spaced cast iron columns (mostly obscured by wood) between. Timber lintels extend between the columns. The brick return to the south end of the east side of this range is keyed into that of the two-storey block though the brick is of slightly different type, the effect being to suggest that this single storey range is an addition to that of the two-storey block.

The three spaces all have concrete floors and are open to the roof structure. All access to the spaces is via four large sets of double doors of similar form to those fronting Spaces A and B. The doors and door frame to Space Z projects slightly further to the east than those of the other spaces. The iron columns and doors create four bays, though as there are just two internal partitions, between Spaces X and Y, and Y and Z, there are just three differentiated spaces. Space X is effectively a double bay space and Spaces Y and Z are single bay spaces. The partition between Spaces X and Y is of corrugated asbestos and extends only to the height of the roof tie-beam. The partition between Spaces Y and Z is of timber and is of full, roof, height.

The roof of this single storey range is mono-pitch and slopes from the west down to the east. The roof structure has three timber trusses, the tie-beams of which are retained in a metal housing atop the iron columns at the east side and sit on top of brick pilaster-like settings at the west side. Directly above the tie-beams to the west side there are wall mounted vertical baulks of timber. Extending from the tops of these baulks are principal rafters which at their east ends are secured towards the ends of the tie-beams. These are each supported by a raking strut that extends from the lower part of the vertical baulk to the underside of the tie-beam. Two sets of trenched purlins extend across the principal rafters and at their north and south ends are secured within the brick walls. Common rafters extend over the purlins and are secured into the lintels at their east ends and into the brick walling at their west ends. Battens are affixed to the rafters and these support the roof covering of slate. Guttering and a downpipe, at the north end, are of plastic.

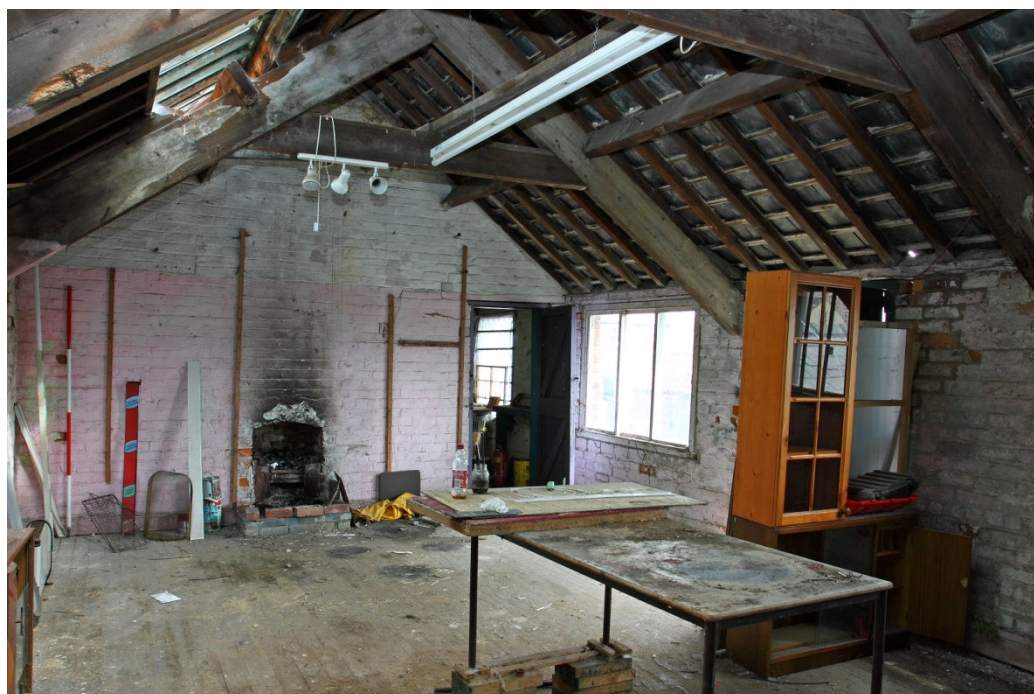
*Plate 11 Space G, looking SW*

**Space G** is the largest of the first floor rooms and is accessed via the modern external steel staircase mid way along its eastern side. Also to the eastern wall are two sliding sash windows, one towards the southern end of the wall, the other towards the northern end. The

north and west walls are of plain whitewashed brickwork whilst to the south wall there is a small centrally placed fireplace and a door leading to Space H at the eastern end. The floor of Space G is of very narrow (115mm) pine boards.

Within this room the roof structure contains two trusses the east and west ends of which are embedded within the walls. These trusses are of very simple design, consisting simply of principal rafters connected at a high level by a collar. A single purlin runs down each side of the roof and supports the common rafters. The lower ends of the common rafters are housed within a thin wall-plate whilst their upper ends are connected to a ridge plank. Battens atop the rafters support the roof covering of slate. To the west side of the roof there is a long, thin glazed section clearly intended to supply the room with as much light as possible.

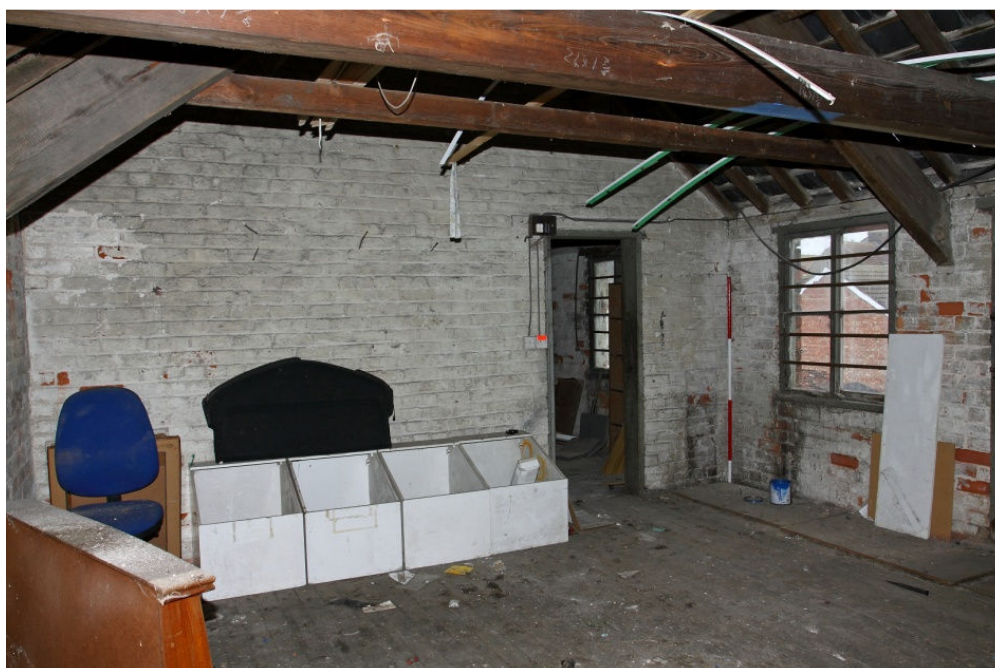
*Plate 12 Space I, looking NE. Note nearest beam forms part of hoist*

**Space I** is accessed via a doorway central to its southern wall. The west wall is of plain whitewashed brickwork whilst the north wall has a doorway towards its eastern end that leads into Space J. To the east wall there is a doorway extending fully from the floor to the eaves whilst to both north and south of this there are windows. That window to the north is of sliding sash type, that to the south non-opening. The flooring to this room is of narrow pine boards. There are two roof trusses to Space I. These, and all other roof elements, are identical to those of Space G. Additionally however, a large beam extends fully across the room in an east – west direction, this being supported by the door lintel to the east and by the wall-plate to the west. This beam, which also projects out slightly from the eastern façade of the building, clearly functioned as a hoist.

The presence of this hoist, combined with the location of the former stable below, argues strongly for Space I originally functioning as a hay-loft.

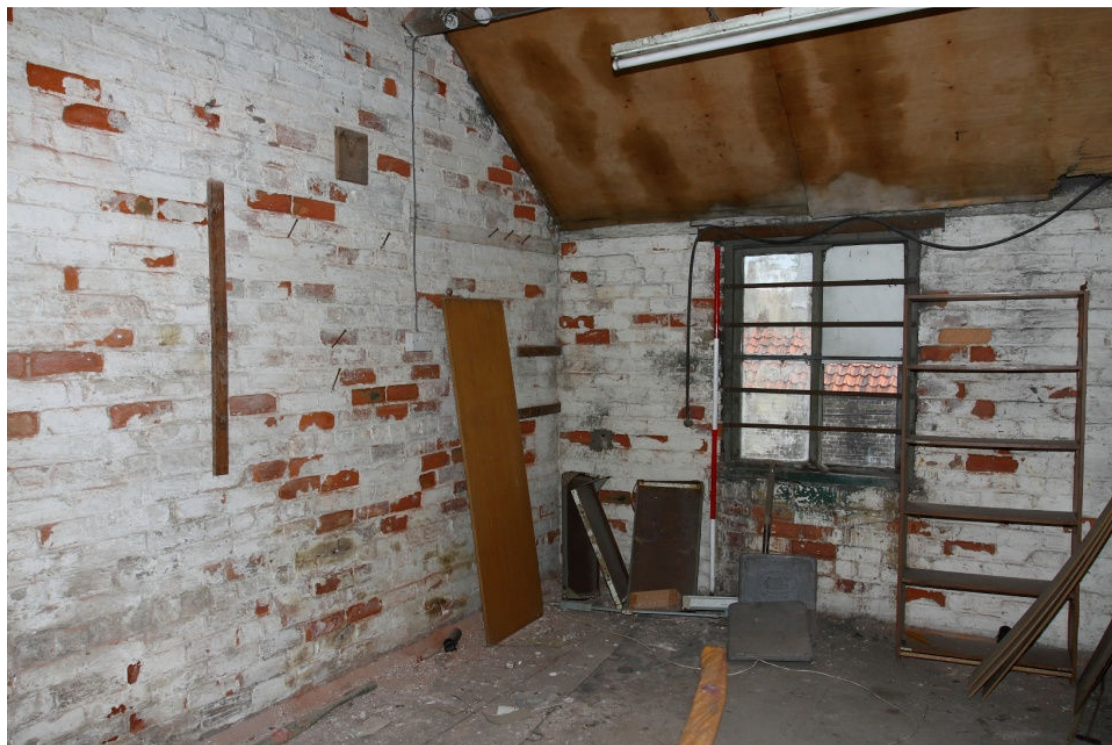
*Plate 13 Space J, looking E*

**Space J** forms the northernmost of the first floor rooms and is accessed from Space I by a doorway towards the eastern end of the south wall. The west and north walls of this small room are of plain whitewashed brickwork whilst to the east wall there is a single sliding sash window. The flooring to this room is of chipboard and clearly represents a modern replacement. There are no roof trusses in Space J and no elements of the roof structure are visible, these being boarded over by large sheets of plywood.

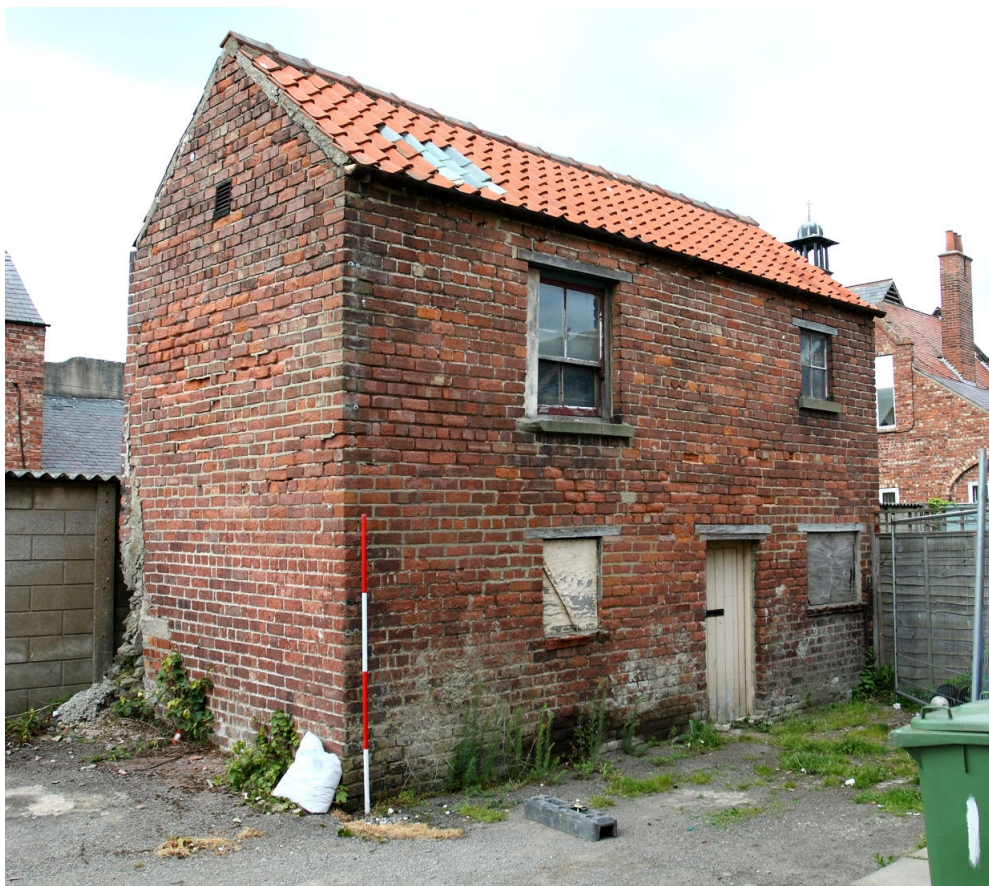
Plate 14 Building 9, looking NW

Building 9 is a small, narrow building of two storeys located to the east of building 9. It is built of machine made red brick of late 19<sup>th</sup> century type bonded with lime mortar. The south, north and east walls are all 220mm thick, i.e.: one brick length. This building incorporates parts of an older stone boundary wall, up to 480mm wide, to its western side, this being visible up to a height of around 1.7m within the ground floor. This stone walling is of coursed cobbles, together with the occasional fragmentary stone, bonded with copious amounts of lime mortar.

The exterior of the building is nearly completely plain to the south, west and north sides, save for high level iron vents to both the north and south elevations. To the east elevation there is a low doorway flanked by two boarded-up windows at ground floor level whilst to the first floor there are two further windows, that to the south of vertical sash type – the other non-opening, set over those to the ground floor. Each of these openings has a timber lintel. The two ground floor windows have sills of moulded brick, those to the first floor have sills of concrete. Curiously, each of the windows is of a different size in terms of both width and height.

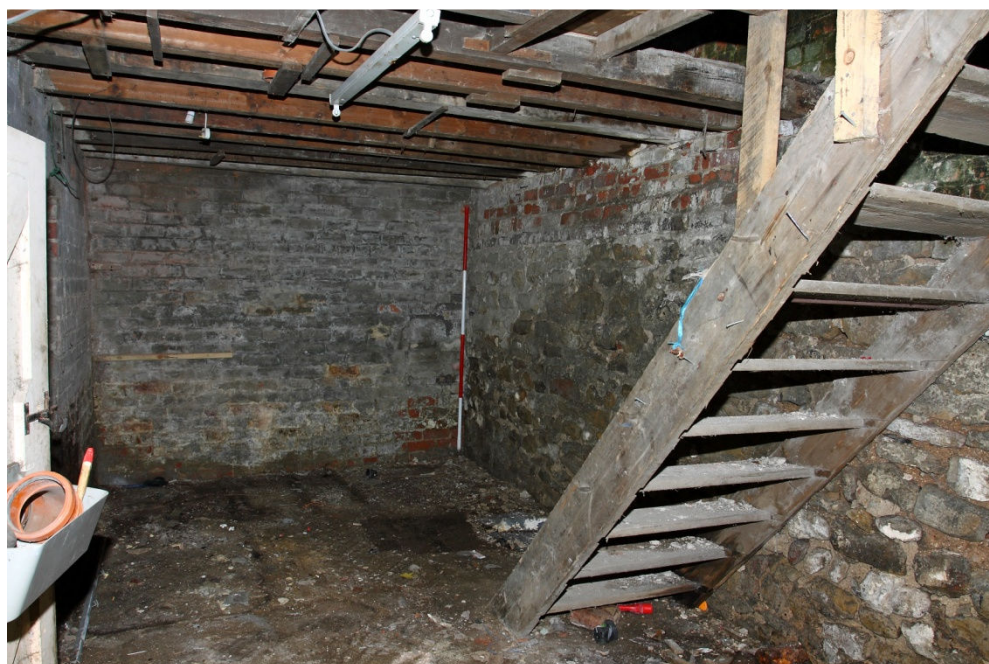
Plate 15 Building 9, ground floor, looking SW

Internally, the ground floor is formed of a single room with no internal divisions. It has a floor of concrete and walls that are plain save for traces of a whitewash finish applied to the brick and stonework. Excepting the door and windows to the east side, a few suspension nails within the ceiling joists and a simple staircase there are no internal features, fixings or fixtures to the ground floor. The staircase is built of machine sawn softwood, with no surface finish, against the western wall. This is a straight flight of ten treads, with no risers and with no newels or handrail, nor guard-rail at its head. The ceiling is formed of machine sawn, softwood, east – west aligned joists with pine floor boards over. At their east side the joists are lodged within the body of the brick walling whilst at their west sides they sit atop five courses of brickwork that surmount the stone wall. The majority of the joists were of a size of 130mm x 90mm whilst the remainder were of different proportions though did not show obvious signs of re-use.

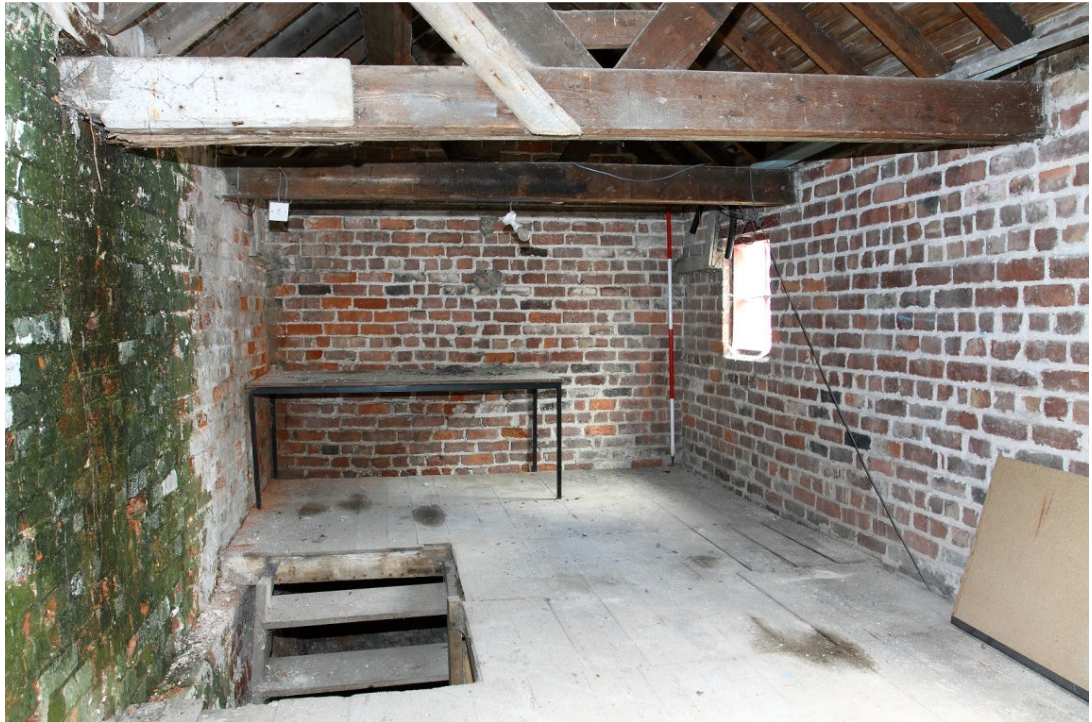
Plate 16 Building 9, first floor, looking NE

The first floor is again formed of a single open space with no internal divisions and, save for the two windows to the east wall and blocked-up high level vents to the north and south gable walls, is completely devoid of internal fittings and features. The flooring is of pine boards.

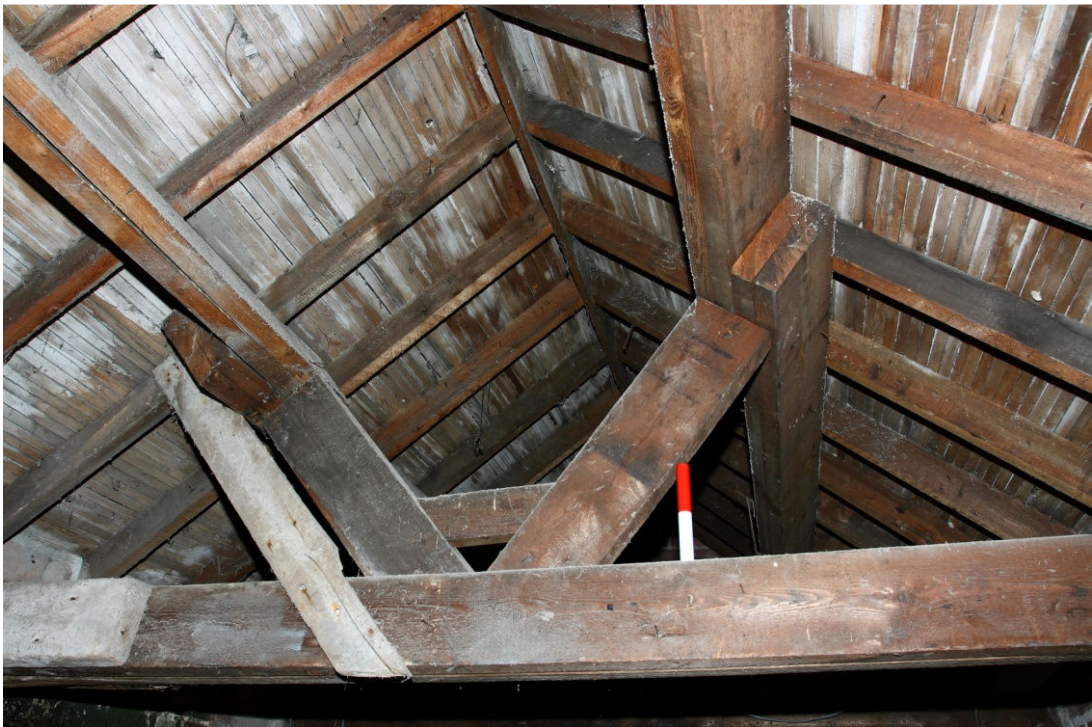
Plate 17 Building 9, detail of roof structure, looking N

The roof structure is formed of three equally spaced trusses of unusual form. Each contains a tie-beam, the east and west ends of which are embedded within the upper part of the brick walling below the level of the wall-plate. Two raking struts extend from the centre of the tie-beam to the underside of the purlins. In two of the trusses support is provided to the struts by a collar. The purlins themselves, of which there is one to each side of the roof, are simply fashioned from two planks, doubled up so as to provide the necessary thickness. Each purlin is fabricated in two lengths and staggered at their point of junction with the central truss, whilst to the north and south ends of the building they are secured within the gable walling. The trusses do not contain principal rafters. Instead a series of common rafters extend from the wall-plate, over the purlins, to connect with a ridge plank at the apex of the

roof. The rafters are in turn covered by edge to edge lath, on top of which is secured the roof covering of pan-tiles. There is guttering to the west, east and north sides of cast iron.
