**FORMER OSBORN MUSHET WORKS,
100 PENISTONE ROAD, SHEFFIELD,
SOUTH YORKSHIRE**

BUILDING RECORDING REPORT

REPORT NUMBER 2010/5

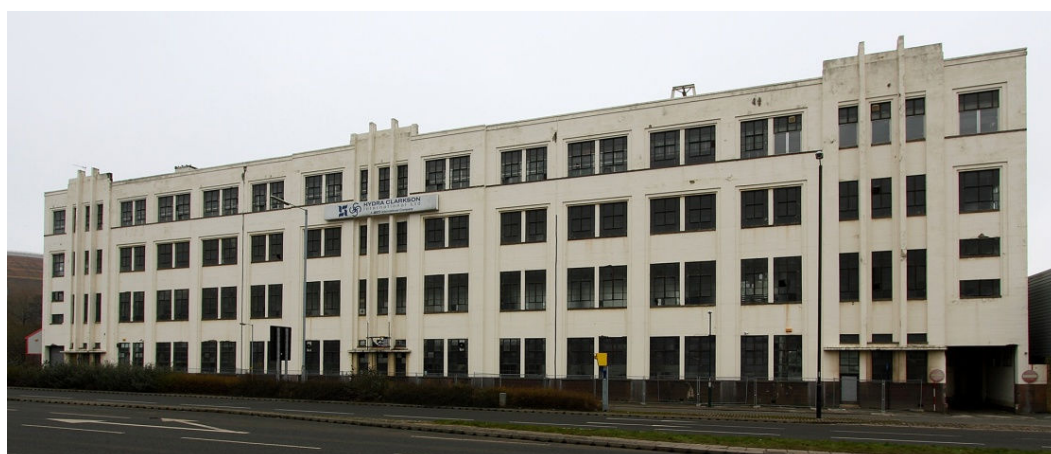
Plate 2 *Front elevation of building*

The front façade, which permits public view of the building, is entirely symmetrical and slightly more ornate than the elevations to the rear and sides. Two simple part-glazed doors (upper halves of three rows of two panes) which originally provided access into the building are present towards either end of the building. These are located beneath a simple flat canopy in the lower portion of slightly projecting elements of the façade and are accessed via two simple steps. A centrally placed projection, with the same fenestration details as those towards the ends does not, and never has, contained a doorway despite the presence of a flat canopy. The single bays between the projecting elements and the ends of the building contain squared openings that provide pedestrian and vehicular access from front to back fully through the building.

The two sets of five bays between the façade projections have identical fenestration. The windows, which are all of steel frame, are slightly taller to the ground and first floor than those of the second and third floors. Those to the lower two floors are each of six rows of four panes (with the central parts opening inwards) whilst those of the upper floor are of five rows of four panes, again with inward opening elements. The three projecting elements contain three windows to each floor of identical detail to those of the two sets of five bays though are of half width. The windows of the single bays forming the ends of the building are identical to those of the five bays at second and third floor level though at first floor level are comprised of two shallow sets of windows the upper of which is at a slightly higher level than the other windows of this floor. This irregularity is owed to the presence of mezzanine floors at either end of the first floor. All windows, as throughout the building, have plain concrete sills.

The three projections provide the effect of verticality. This is achieved by the narrowness of their window openings and by their projecting above the roof parapet. This is enhanced by two projecting full height ribs to each element which form the highest parts of the building.

Whilst lacking elaborate detail its plainness is enhanced by the use of a few simple but bold elements. The two vertical ribs to each projection form the most evident of these. More subtle are the window surrounds to the second and third floors. Unlike their totally plain counterparts to the lower floors, and elsewhere in the building, these openings have surrounds of two plain squared orders. Further elaboration is provided by the simple moulding to the roof parapet. There is no rainwater or other exterior pipe-work to this elevation. The narrow joints between the three structural elements are visible in the front elevation.

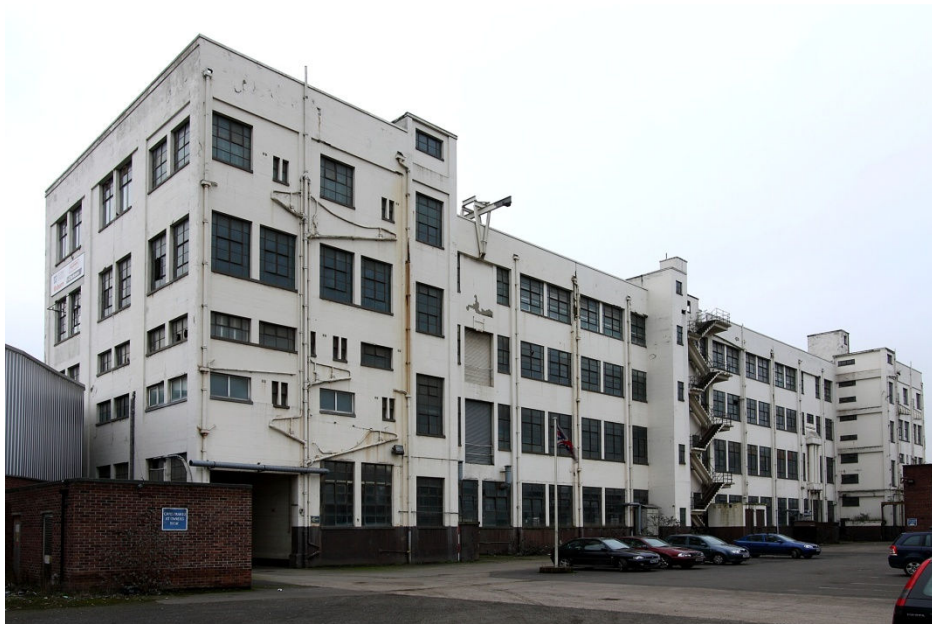
Plate 3 *Rear elevation of building*

The rear elevation lacks the near perfect symmetry and un-cluttered appearance of the front façade and allows some of the workings of the building to be seen. This is due to both the original design of, and subsequent alterations to, the fabric. The result is a composition of less obvious appeal but one of considerable practicality and still possessing grandeur of scale not at all out of place given its inwards aspect towards the heart of the industrial complex.

The ends of the building project backwards to form two short wings in which some of the internal space is occupied by toilets, some by factory floor whilst stairwells are located to the sides of these. The stairwells extend for the full height of the building. The somewhat cluttered appearance of these wings is owed partly to the tall, narrow windows of the toilets and their accompanying waste pipes that exit the building to down-pipes at a variety of angles. The larger windows of the ground and second floors, which functioned as workshop areas, match those of much of the main body of the building, whilst the mezzanine arrangement in the wings of the first floor has resulted in use of two bands shallow windows. That the windows of the stairwell, to both rear and side elevations, appear staggered in relation to the general lines of fenestration is owed to the practicalities of lighting between floors and the half-landings of the staircases.

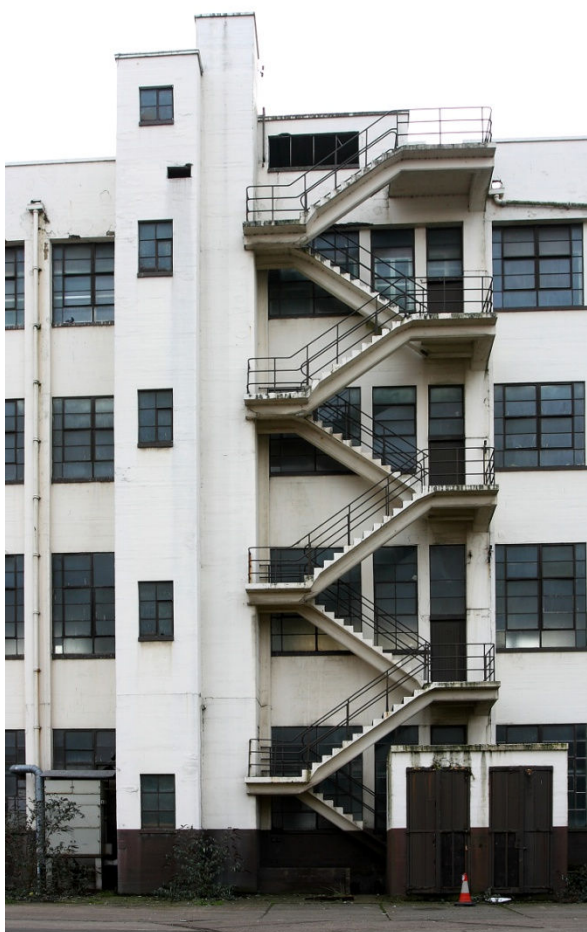
Plate 4 *Fire escape to rear elevation of building*

The central part of the elevation houses the central lift shaft, and to its north-west side the fire escape. Both of these elements project from the rear of the building whilst the former

also extends beyond the height of the roof parapet. The lift shaft is lit by five windows, each of three rows of two panes. The presence of windows in the shaft suggests that originally the lift itself (not accessible) may have had caged rather than solid sides. The fire escape extends from ground level to the roof and is comprised of eight sets of thirteen steps constructed of cast concrete with metal handrails. At the level of each floor a landing gives access, via a wooden door, to the interior spaces. The landings of the fire escape are secured, alternately, to the main wall of the building and to the side of the lift shaft. This arrangement has resulted in an irregularity of window widths in this area. Although entirely functional an arrangement the regularity of its angles and neatness of form gives the fire escape some visual appeal. Situated at roof level between the lift shaft and fire escape is a flat roofed concrete structure, housing water tanks, that was integral to the original build. This is lit to the rear elevation by a wide but shallow, window. At ground level and partially in front of the fire-escape is a free-standing structure, effectively a cube of concrete, without windows but accessed by two sets of steel double doors. This structure was originally the transformer room (caretaker, pers comm) and is believed to be original to the building.

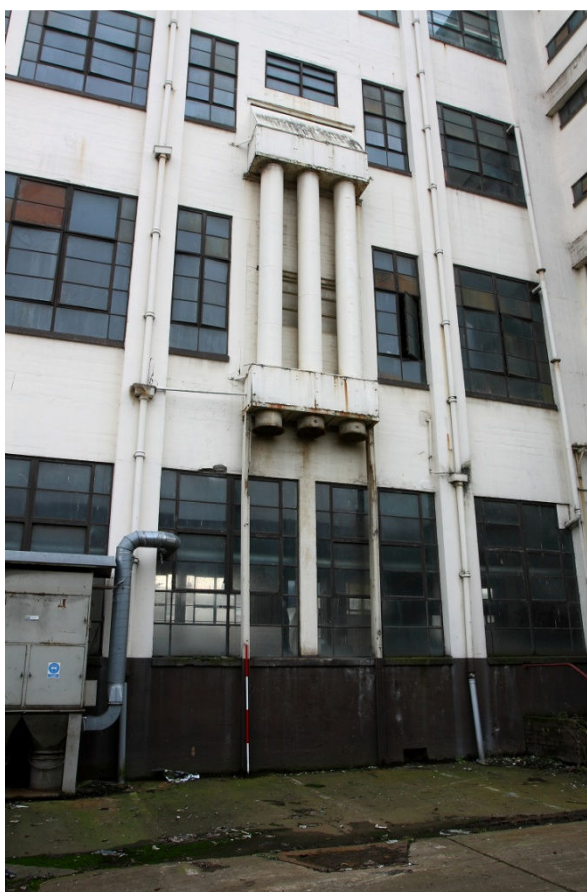
Plate 5 *Waste chutes to rear elevation of building*

The central parts of the rear elevation to either side of the lift and fire escape were originally identical to one another and contained large openings at first, second and third floor levels to both sides. Those to the north-west have been blocked over, as has that to the third floor at the south-east side. On the south-east side these are associated with a roof-top beam crane which permitted the movement of large and heavy loads in and out of the building. Although no remains of a crane are visible on the roof to the north-west side it is probable that there was one originally. The north-west openings were firstly partially blocked up and fitted with shallow steel framed windows of similar pattern to those elsewhere in the building. Subsequently, some of the windows were painted over and a series of three round vertically set chutes inserted between the first and second floors (Plate 5). These chutes were used for the rapid disposal of waste materials, the detritus being collected in bins/skips set at ground level below the chutes (caretaker, pers comm).

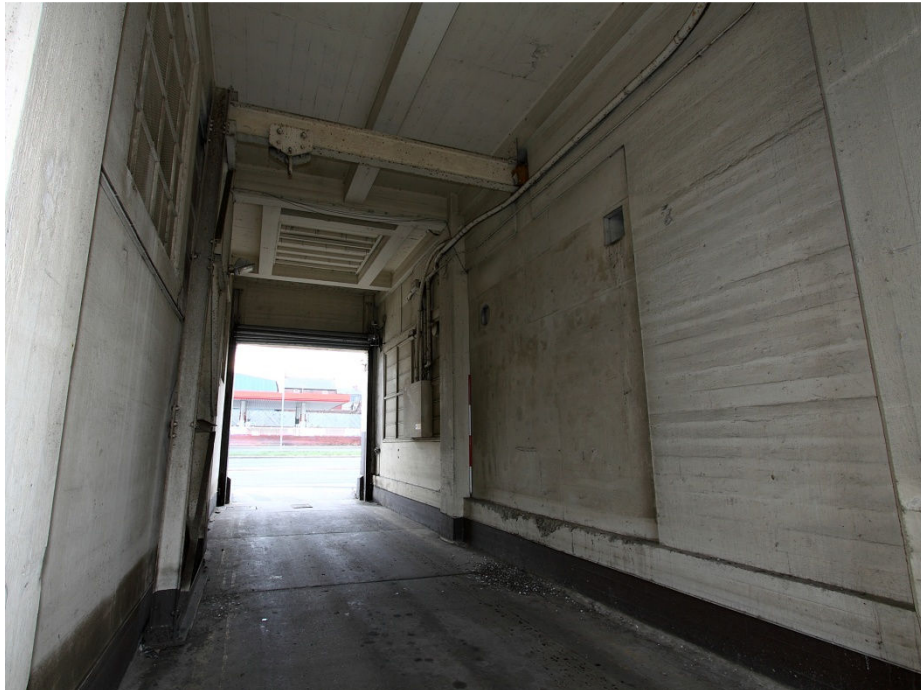
Plate 6 *Passage-way to SE side of building, looking SW*

The fenestration of the south-east elevation largely mirrors the arrangements of the rear of the south-east wing with a double arrangement of shallow windows to the first floor mezzanine though without the narrow windows of the toilets. The lowest set of windows, those at ground floor level, are again shallow and intended solely to provide light to the tunnel-like pedestrian and vehicular access that extends through the south-east wing from front to back. Within this passageway a large blocked opening, that formerly led into the factory, is present. The basal part of this former opening is flush with the factory ground floor and around 0.7m above the surface level of the passageway. A similar opening is extant at the north-west end of the building, though this is much closer to the exterior ground level. This discrepancy of height is owed to a gradual fall of the exterior ground surface in a north-west – south-east direction. Associated with the south-east opening is a hoist (beam crane) arrangement set immediately below the roof of the passageway which consists of a girder on which runs a ringed slider. This apparatus was formerly used to lift heavy material in and out of the ground floor of the factory. Within the passageway and immediately towards the frontage of the former opening are a set of windows, now painted over, that lit an office area in the southern corner area of the ground floor.

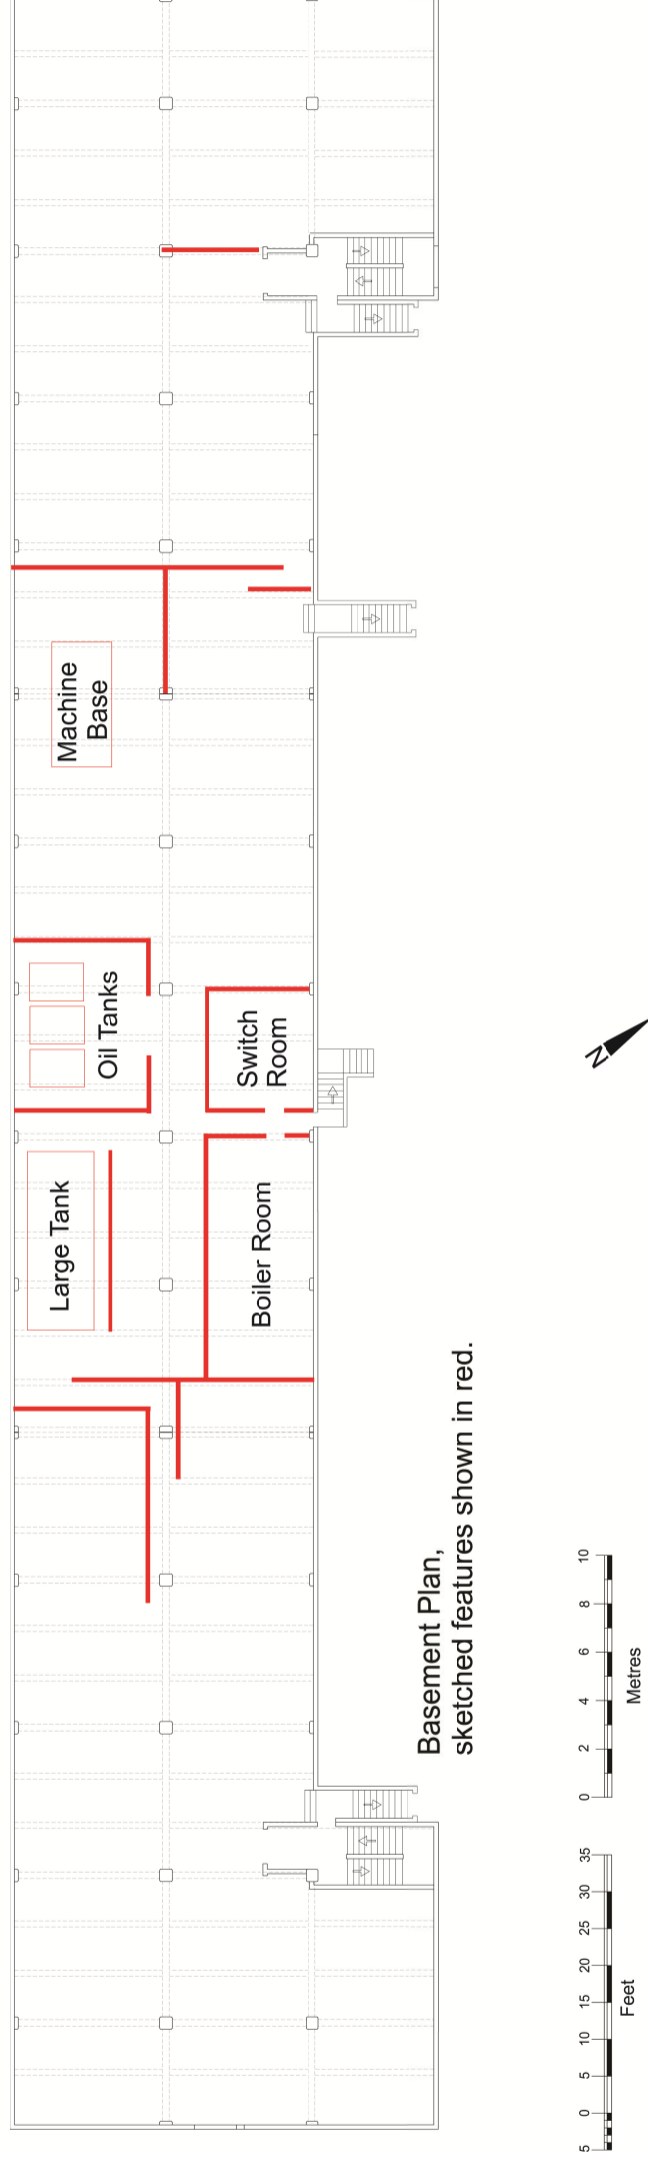
Figure 4 Basement plan

The basement is accessible via the stairwells at either end of the building and by four entrances at ground level to the rear of the building. The entrances at the rear have been described in 5.1 *North-east (rear) elevation* above and are also considered in 6 *Discussion* at the end of the text. The number, form and arrangement of entrances leave little doubt that the original primary intended function of the basement was to serve as an air raid shelter for the works (Plate 7). The two outer external entrances also have access to the base of the north-west and south-east main stairwells. At the time of recording the basement was partially flooded with oily water and on health and safety grounds was only superficially inspected from various points of access. The external walls, floor and ceiling are of cast concrete. To the ceiling a longitudinal beam of concrete extends between the central row of columns for length of the building whilst a series of lateral beams extend across the width of the building. The height of the basement is considerably less than that of the floors above. The row of central columns of the floors above mirrors that in the basement, as does the pattern of ceiling beams. The basement area is divided into a number of spaces by concrete walls, some extending between the columns and the external walls of the basement and others not. There are also a number of brick wall and breeze block wall divisions and these relate to the requirements of later usage. A number of the spaces are fitted with steel doors. Some equipment remains in the basement and this allows the function of some of the spaces to be identified. These include a boiler room (Plate 8) to the south-east of the open rear stair access point and a switch room (door signed as such) to the north-west of the same entrance. Given the proximity of the switch room to the external transformer room it is probable that this was the original function of this space. Opposite these two rooms two further spaces are occupied by oil storage tanks. A probable machine base is located to the north-west of the storage tanks.

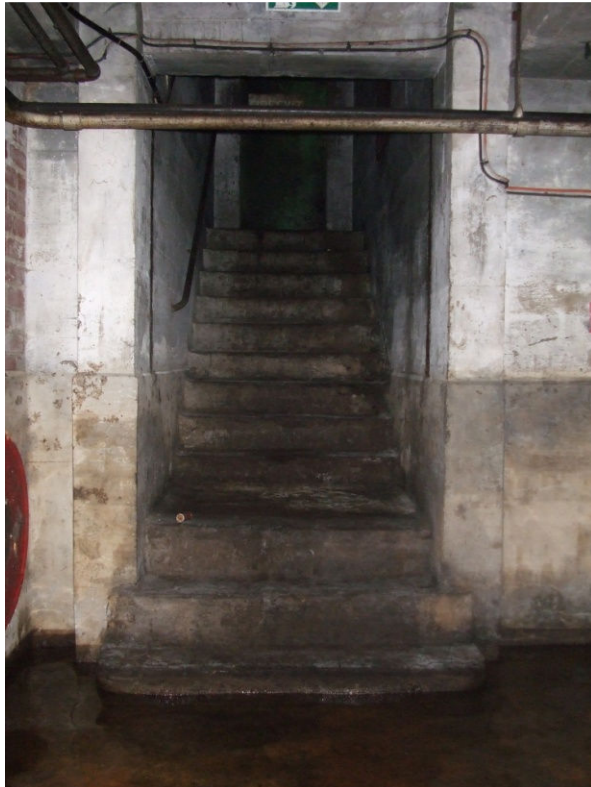
Plate 7 Access to basement via one of 'air raid' entrances

The basement was accessed via four routes, those two to the north-west and that to the south-east being of identical form. These projecting entrances, like the rest of the building, were constructed of cast concrete, contained a flight of stairs and angled down sharply

towards the basement. The covering to the entrances was by doors fabricated from 10mm thick steel. These three entrances and their blast doors have the physical attributes of air-raid shelter entrances. The fourth opening, again an original feature, was a dog-leg stair arrangement with a wall to the side and was located towards the centre of the rear elevation. The wall and dog leg arrangement of this design again accord well with an entrance to an air-raid shelter.

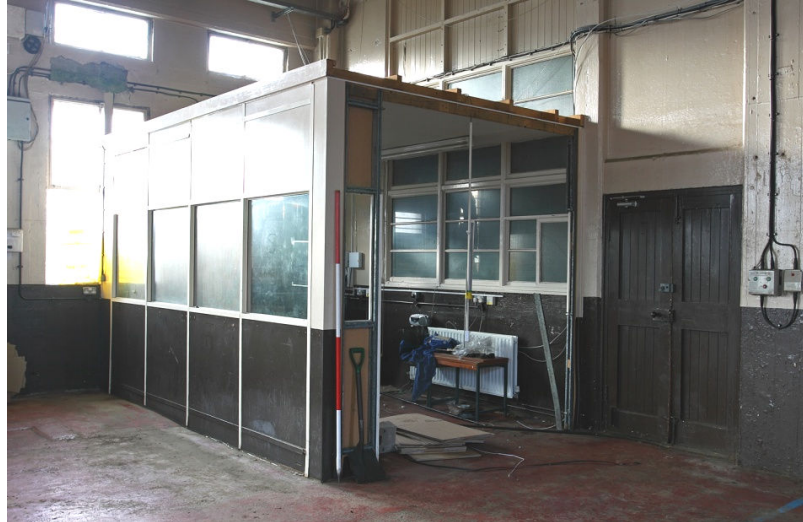
Plate 10 Office to W corner of NW end of ground floor, looking W

There are office areas to either end of the building. That to the western corner of the north-west end is a small arrangement of timber stud and glass and extends to only half the height of the ground floor. This office covers part of a window of the front elevation and is clearly an addition to the original building (Plate 10). It is possible that there was earlier office space at this end of the building, though no obvious indicators in the fabric can confirm this.

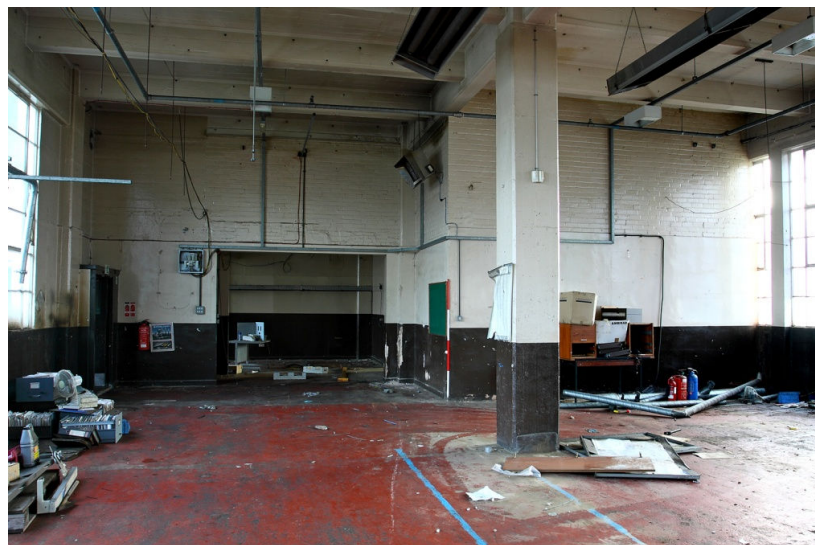
Plate 11 Later walling at SE end of ground floor, looking SE

The office arrangement at the southern end of the floor is comprised of three rooms and a hallway giving access to the front door via two steps. These offices are of brick-work, possibly with some concrete. The larger southern office is lit by windows to the front and formerly to the side that lines the passage and may form a part of the original design. The smaller two offices to the other side of the hallway are separated by timber stud and glass though their walling to the north-west is of brick. The brickwork, and the two offices, are additions to the original plan. This is evident both by the use of materials and that by where the wall butts up to the front of the building it partly obscures a window (Plate 11). Although the external wall of the offices extends to the full height of the ground floor the office ceilings are suspended and of a hardboard-like material.

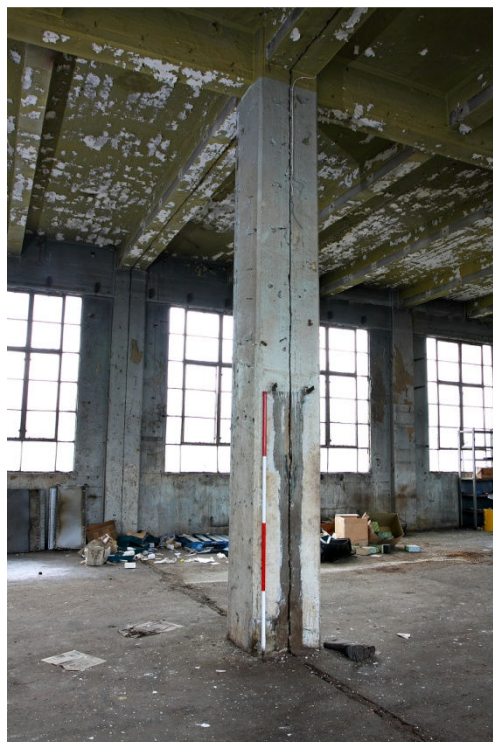
Plate 13 Structural division within building, first floor looking WSW

The walls, floor and ceiling and structural divisions into three elements were of identical structural characteristics and form to those already described for the ground floor (Plate 13). The central line of fourteen internal columns was also the same though there were an additional number owing to the floor extending over the ground floor side passages to either end. The window arrangements mirrored those of the ground floor save for that at the north-west and south-east ends where mezzanine floors, as part of the original building were present.

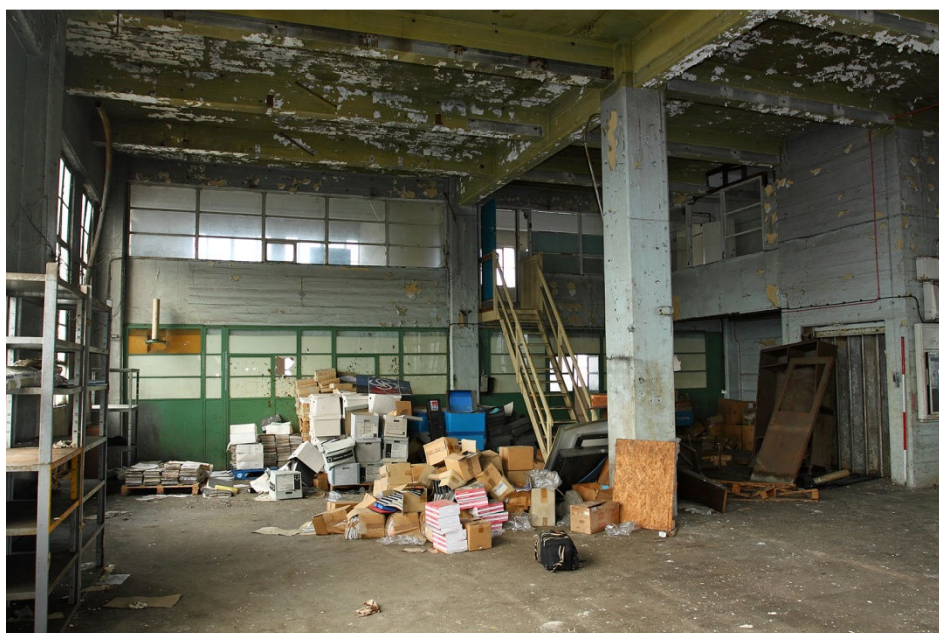
Plate 14 *First floor mezzanine at NW end of building, looking NW*

The mezzanine at the north-west end extended fully across the width of the building and was of shuttered concrete like the rest of the building (Plate 14). The mezzanine was accessed via a wooden door at the top of a single flight of wooden steps with small landing that was aligned to the long axis of the building. There was also access to the mezzanine via a corridor leading to the stairwell. The south-western part of the mezzanine was divided into two large office spaces separated by full height timber stud partitions whilst a third smaller space also led off from the north-eastern of the offices. The two larger offices were lit by steel framed windows to the north-west and south-west sides whilst the sides facing into the factory floor were also fitted with steel framed windows. That part of the mezzanine within the north-east wing of the building contained a corridor providing access to the stairwell. Leading

off the corridor were three small rooms, two containing two WC's within cubicles, the third with three cubicle WC's. Although no door labelling was present such division of toilet arrangements would argue that facilities were being provided for both sexes and were presumably intended primarily for use by office workers on this end of the floor rather than by those on the factory floor. Floor surfacing within the mezzanine area was of a linoleum-type material in contrast to the plain concrete of the factory floor and their associated toilets. The area immediately below the mezzanine offices was also enclosed into a single long, narrow area and was lit by steel framed windows to the north-west and south-west sides which mirrored those of the mezzanine above. This lower room appears likely, latterly at least, to have or store-like functions as a modern tool rack was affixed to the north-west wall. This space was separated from the factory floor by a green painted steel and glass partition with three door openings. Although it cannot be determined with certainty, this partition may be an arrangement that post-dates the earliest use of the building.

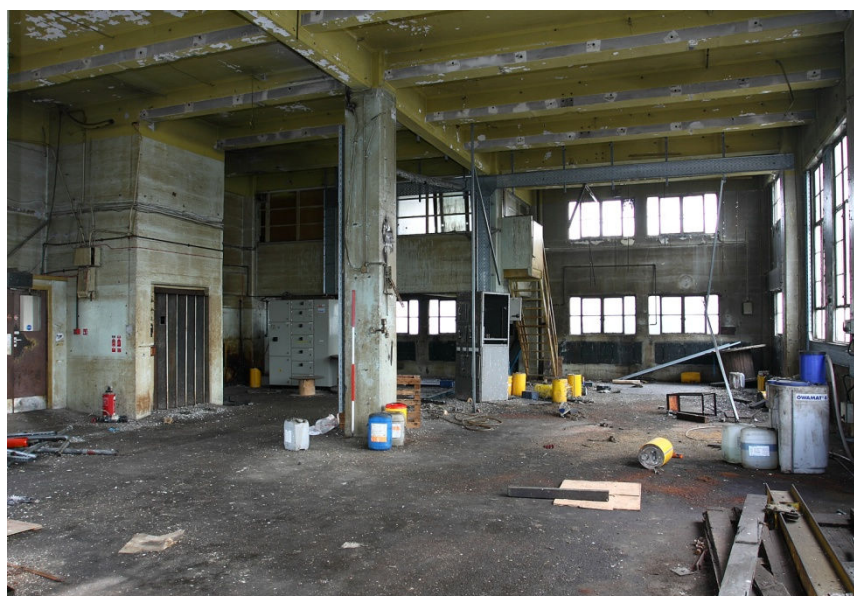
Plate 15 *First floor mezzanine at SE end of building, looking ESE*

The mezzanine at the south-east end again extended from the wing of the building as far as the central part of the factory floor and was of shuttered concrete like the rest of the building (Plate 15). Access to the mezzanine was via a single flight of wooden stairs, and from the stairwell via a corridor. This space was composed of three interconnected offices separated from one another by timber stud partitions, which may be a later insertion. Some recent secondary glazing was evident in the north-eastern of the offices. Below the mezzanine the space was open factory floor. In recent years a transformer, mounted on a base of concrete breeze blocks, had been set up. At the mezzanine level, and fully within the body of the wing

of the building, a corridor led from the offices to the stairwell. Leading from this corridor was a large toilet comprised of three WC cubicles and a wash-basins. These toilets are likely to have been for the use of the workers within the mezzanine offices. Floor surfacing in the south-east mezzanine was of a linoleum-type material.

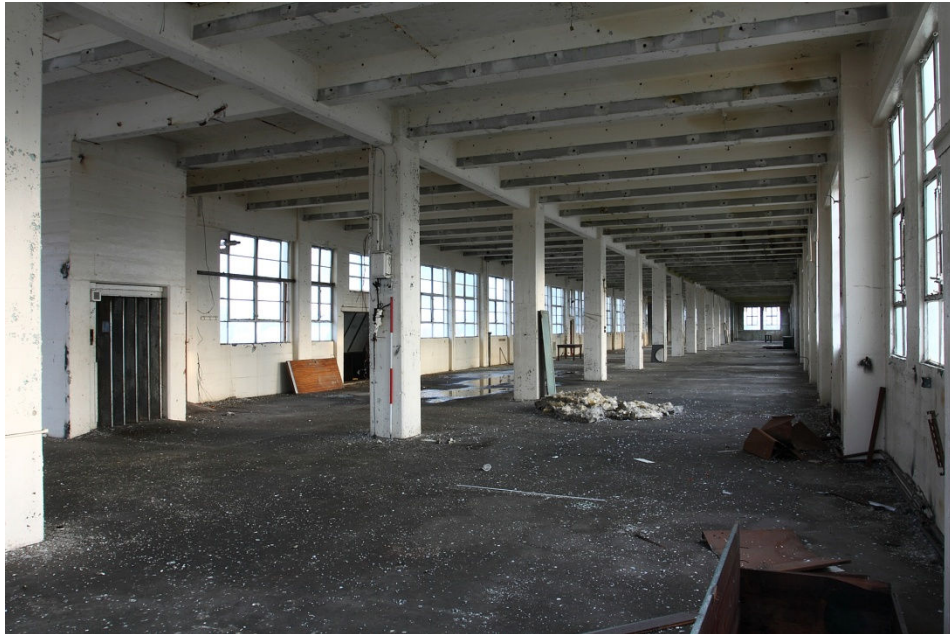
Plate 16 *Second floor, looking ESE*

The second floor is accessible via the stairwells to either end, by the three lifts, whilst a centrally placed fire escape door to the rear wall also provides access to the fire escape. This was the most open of all the floors of the Osborn Mushet building. There were no offices, toilets or mezzanine arrangements, the entire space forming a vast open factory workspace (Plate 16). The walls, floor and ceiling and structural divisions into three elements were of identical structural characteristics and form to those already described for previous floors. The central line of fourteen internal columns mirrored the structural arrangements both above and below. The steel framed window layout of the large central workspace were the same as those to the floors above and below, though these to the second (and third) floor are of slightly lesser height than the two lower floors. The windows to the north-west and south-east ends were of identical form and size as those of the central workspace.

There is a large opening in the rear wall to the north-west of the south wing. This is presently fitted with a modern steel roller shutter. Like the example on the first floor this opening will have permitted the craning in and out, by the roof mounted beam crane, of materials. Again,

no ceiling mounted fittings related to this opening were present. An identical opening towards the north-west end of the floor had formerly been present. This had been blocked up with brickwork and a small high level steel framed six pane window inserted. A three tubed vertical chute waste disposal system capped with lids at floor level, which additionally served the first floor, had also been inserted into the former opening.

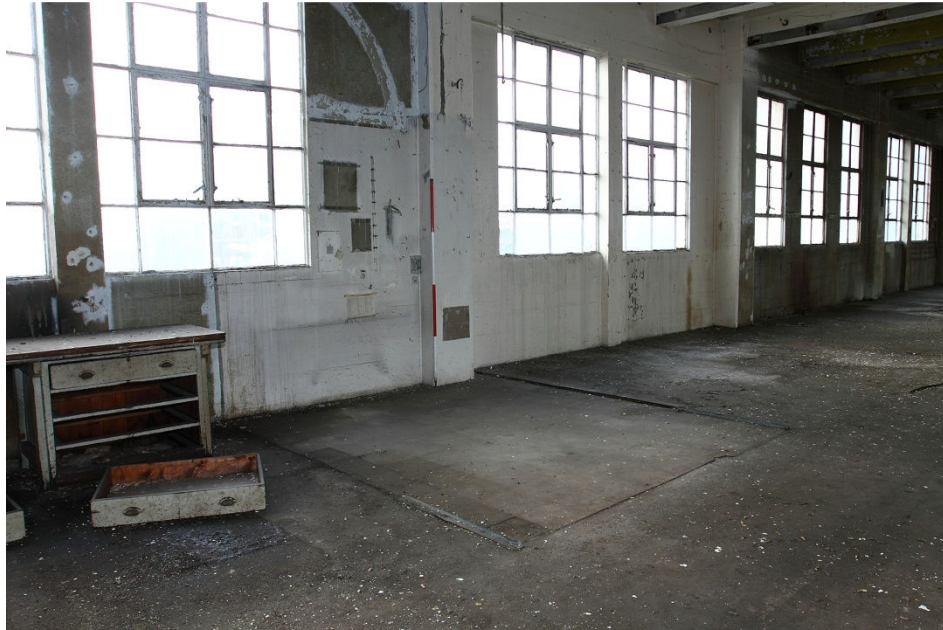
Plate 17 Second floor evidence for small enclosed space, looking W

Some evidence was found to suggest the former presence of a small, around 3m square, enclosed workspace in the central part of the south-western side of the floor. The evidence for this consisted of vinyl floor tiles with surrounding metal trim (probably the base mounts for partition walling), a telephone point and paint marks on the wall. The latter suggests that the enclosed space extended to a height only half that of the factory floor (Plate 17).

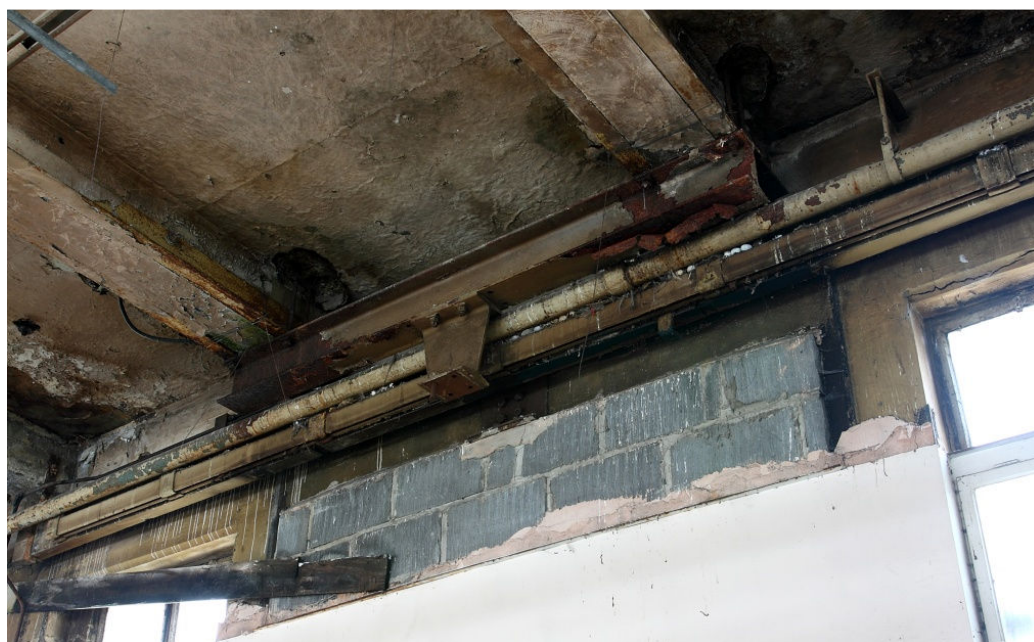
Plate 18 *Third floor blocked opening with mounting for beam crane, looking N*

There were originally large openings in the rear wall to the north-west and south-east of the floor matching those of the first and second floors that permitted the craning in and out of materials. Both of these openings had been blocked up, that to the south-east with breeze blocks and skimmed with plaster. This suggests that this opening was in use until the conversion and refurbishment of the third floor and that prior to this date the floor had functioned as a factory floor in the manner of the three other floors. Ceiling mounted fittings, presumably for a hoist-type arrangement and relating to this opening, were present (Plate 18).

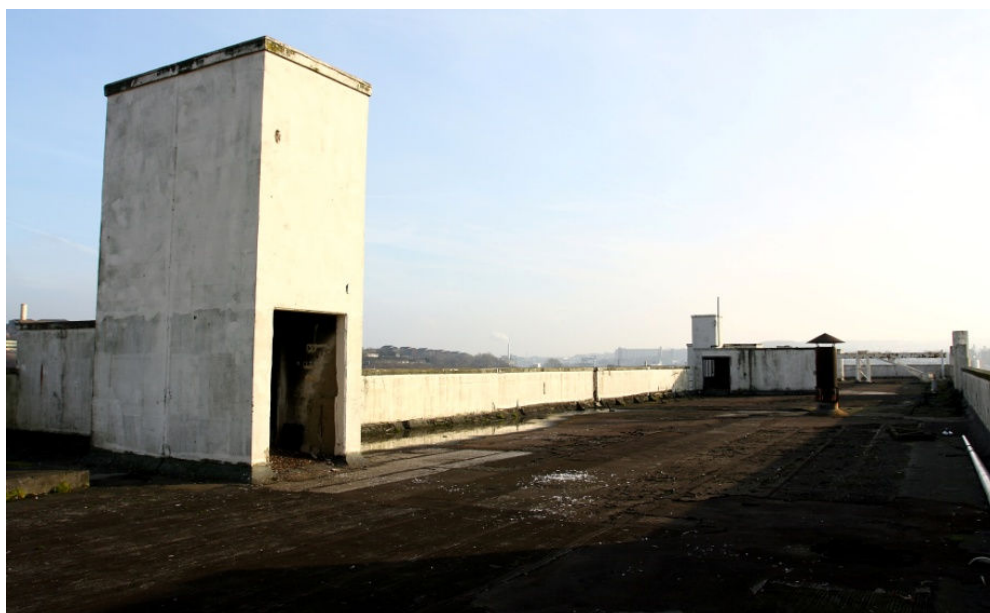
Plate 19 *View of roof, NW lift shaft in foreground, looking ESE*

The roof of the building is of the flat-type with a surface of roof felt and is surrounded by a parapet wall some 1.42m tall and 0.18m thick (Plate 19). There is a gentle roof slope from front to back (south-west to north-east) whilst a regularly spaced series of small square apertures at the base of the rear wall permit rainwater to flow into hoppers atop a series of down-pipes. The parapet wall is plain excepting the three elevated and ribbed sections of the front façade. Central to each of these sections were two metal retaining clips for flagpoles. The sawn off remnants of parts of the flagpoles were still lying on the roof at the time of

recording though these were of a plastic material and not the originals visible in a photograph of circa 1943 which were presumably of wood.

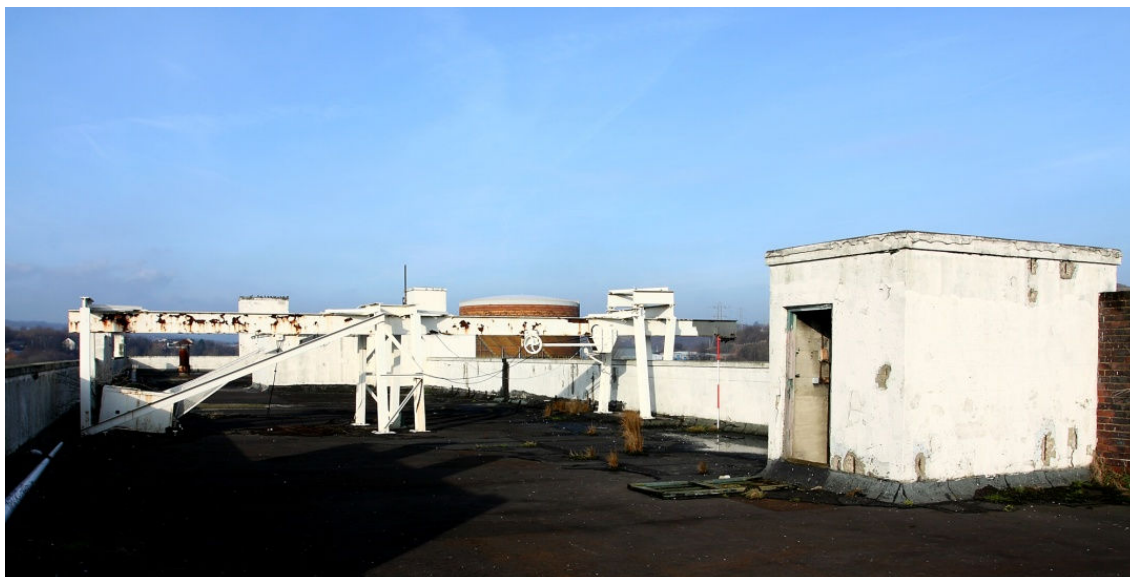
Plate 20 *Beam crane on roof, looking NW*

A large stationary beam crane of girder construction lay towards the south-east end of the roof (Plate 20). This crane, which was powered by an electric motor, will originally have been used for the hoisting of large and heavy materials in and out of the large openings to the first, second and third floors of the rear façade. There were no traces on the roof surface of a similar crane to the north-west end of the roof. However, as an identical set of large openings were originally present to the first, second and third floors in this area it seems likely that there was once one here also.

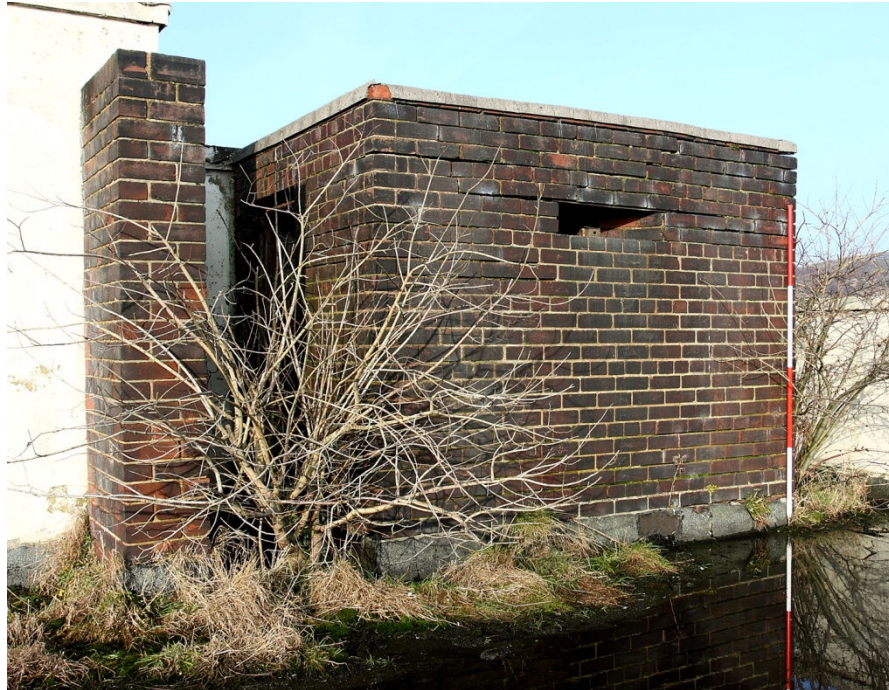
Plate 21 View of brick-built observation structure on roof, looking NNW

The most unusual structure on the roof lay close to the eastern corner where it butted up to the south-eastern side of the stairwell. This was constructed of brick and had a felt covered flat concrete roof and had the appearance of a World War II pillbox (Plate 21). The structure was accessed via a doorway to its south-west side that was shielded by a stub of brick walling butted up against the eastern corner of the lift shaft. This stub of walling appears to have served as a blast wall providing protection to the occupants of the structure. Two small externally splayed apertures were present at eye level, one to the south-east, the other to the north-east. Small metal fixtures or mountings were secured to the central lower parts of the apertures and although their precise function is uncertain they may have held some kind of optical device. It is tentatively suggested that this structure may have housed fire-watchers during World War II. There were wartime requirements for buildings where thirty or more people were employed or which were above a certain size to have fire-watchers. The role of these individuals was to extinguish fires, particularly those caused by incendiary bombs. The fixtures in the splayed apertures may suggest another role involving observation. It is interesting that the structure was not cast as an integral part of the original building; its inclusion may have been something of an afterthought.

The war-time heritage of the building is quite marked in a number of aspects and is of some historical significance. The basement was almost certainly intended from the outset to function as an air-raid shelter for the works as a whole. This basement was accessible via six entrances, two within the stairwells that presumably gave rapid access to the occupants of the building and four externally – all to the rear of the building. One of the rear entrances was accessed via a winding flight of steps surrounded by a wall which could have given protection from blast. The other three had projecting entrances that were each covered by solid steel blast doors. The requirement for secure air-raid shelters was driven home in the city at an earlier point in the war when scores of people sheltering in a basement were killed by a direct hit on the building during one of the many air-raids on the city (Healy, 1993, 234-250). The building is lit by large windows and it may have been an intention of the design to minimise the necessity of use of artificial lighting to aid both prolonged daylight production and reduce power consumption. Comment has already been made detailing the physical form of the tripartite construction of the building and how this may, in the event of severe bomb damage, have served to minimize the effect on other parts of the building thereby enabling them to continue in operation and remain as vital contributors to the war effort. The pillbox-like brick-built structure on the roof with blast wall and externally splayed aperture seems likely to relate to fire-watcher activity but perhaps also involving some sort of observation role.

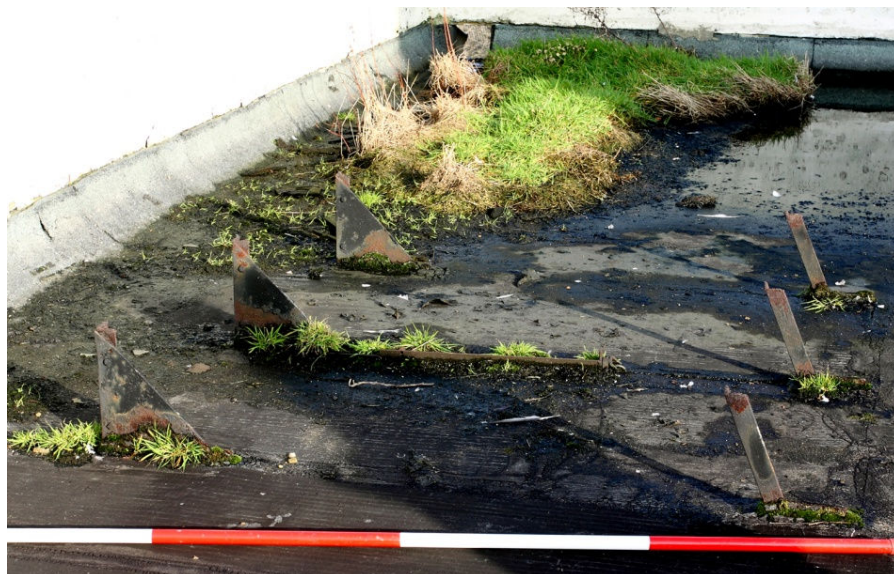
Plate 22 Mounts for signage on roof, looking NNE

What are probably later elements on the roof were a series of metal (angle iron) fixings immediately behind the parapet wall and present to much of the four sides of the roof. These had been cut off just above roof level. The parts nearest the parapet were vertical members whilst those behind were 'raking' or angled (Plate 22). It seems probable that in the post war years these supported company signage.

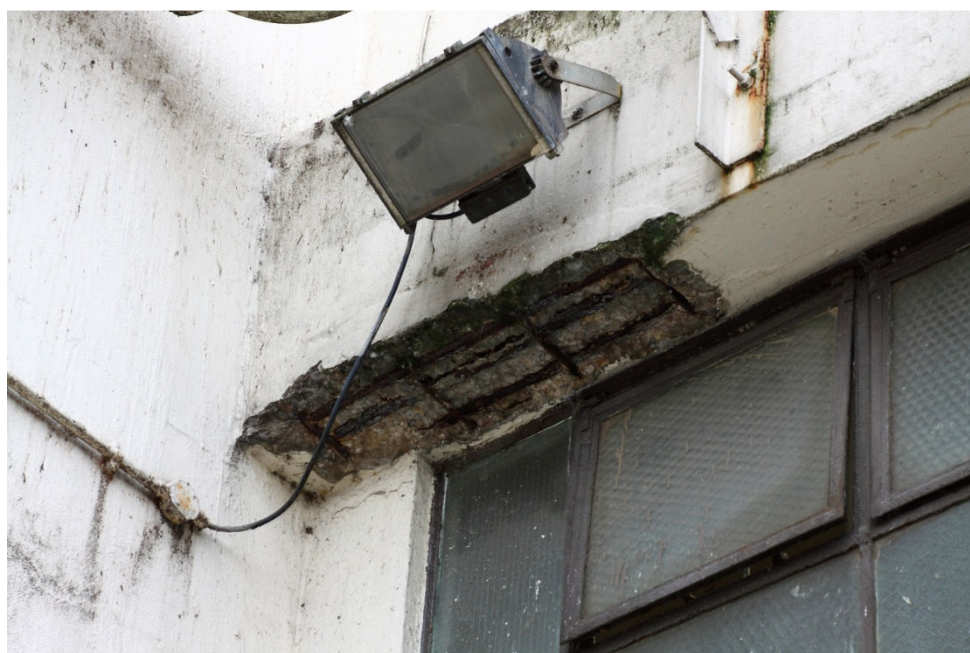
Plate 23 *Detail of steel-reinforced concrete of building shell*

The structure of the building is interesting on several counts. For one thing the neatness of its lines, symmetry and vertical ribbing to its three projecting elements of the front façade to some degree hark back to the Art Deco style. Equally, it can be conceded that the symmetry and clean lines are functional advantages in a factory in which production efficiency is paramount. Efficiency may have much to do with the provision of three lift access points and two large openings to each floor in addition to two stairwells. It is believed that movement of materials in and out of the factory would have been fairly constant with billets of Mushet Steel entering the building on all floors and after manufacturing process exiting as machine tools. The form of construction of the building is of concrete and steel. At the time of recording part of the surface concrete had spalled off the building in a small handful of places. Steel reinforcing bar was clearly present but no framework of girder steel was visible (Plate 23). Whether there is a bolted framework of girders is not known. Surface impressions on the concrete show indicate that plank shuttering had been used during the pouring of concrete. Casting in staged 'lifts' was also evident, particularly on vertical members such as columns.
