**SOUTH AISLE ROOF, RIPON CATHEDRAL,
RIPON, NORTH YORKSHIRE**

BUILDING RECORDING REPORT

REPORT NUMBER 2008/49

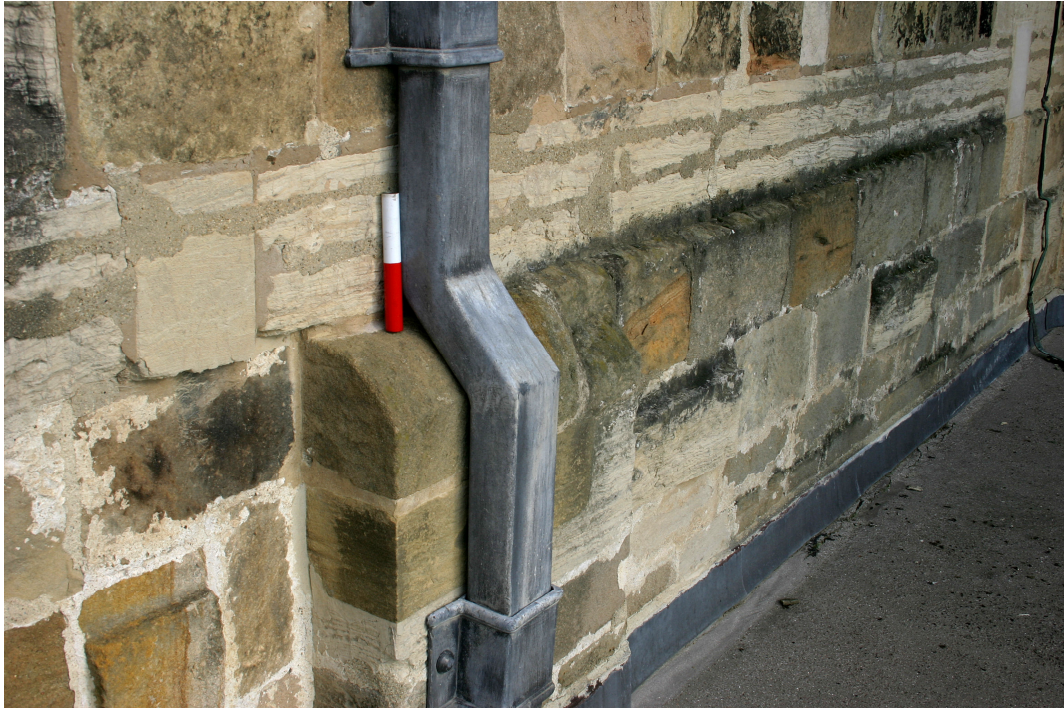
Plate 1 Scars of the original roof-line on the south face of the nave walling, behind the scale. Scale in 0.10m units

The most obvious evidence for an earlier roof of mono-pitch form to the nave south aisle is preserved within the fabric of the nave, south transept and west end complex. This takes the form of mortar-filled scars, typically between 20–50mm wide. Those at the east and west each consisted of a single scar that sloped downwards from the north to south at an angle of approximately 13.5 degrees; this represents the pitch of the original roof. That to the eastern side of the roof (on the west face of the south transept) was of a stepped plan-form owing to the necessity of following the buttressing of the transept. The evidence for the former roof-line against the nave wall was of two parallel mortar-filled scars separated by a gap generally around 0.10m wide (Plate 1). Both scars were cut into stonework above the level of weathered nave walling (i.e. into stonework thought to relate to a re-ordering of the nave), as discussed in 3.1 above. These scars represent linear slots cut into the stonework to accommodate the ends of lead sheeting that will have covered the original roof. It has been noted that whereas there is only a single scar at the east and west sides, there are two scars to the nave walling. This suggests that the upper scar held a lead flashing that masked the upper end of the sheet lead roof covering.

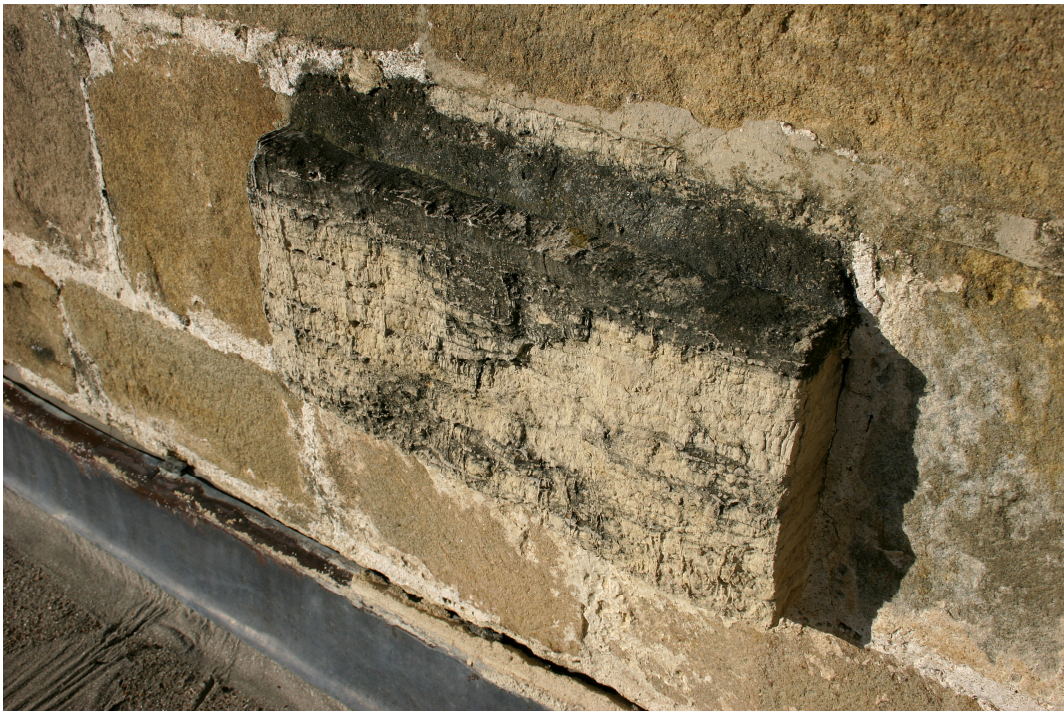
Plate 2 One of the cut-away corbels on the south face of the nave walling.

There is also some evidence for the structure of the roof below its lead covering. This takes the form of 18 corbels (3 per bay), or rather stubs of corbels that have subsequently been cut away, within the nave walling. All the corbels were of square or rectangular cross-section (between 0.21 x 0.27m and 0.48 x 0.27m in size), and set with their upper surfaces all at the same height. It was observed that the flat upper surface of the projecting part of the corbel was stepped down around 50-70mm from that part that was embedded within the nave walling (Plate 2). This flat upper surface was itself between 0.41-0.43m below the lower of the two roof scars on the nave wall. Given that all the corbels have been cut back to within around 50mm of flush with the nave walling, the extent of their original projection to the south cannot be determined, though this is likely to have been in the region of around 0.30m.

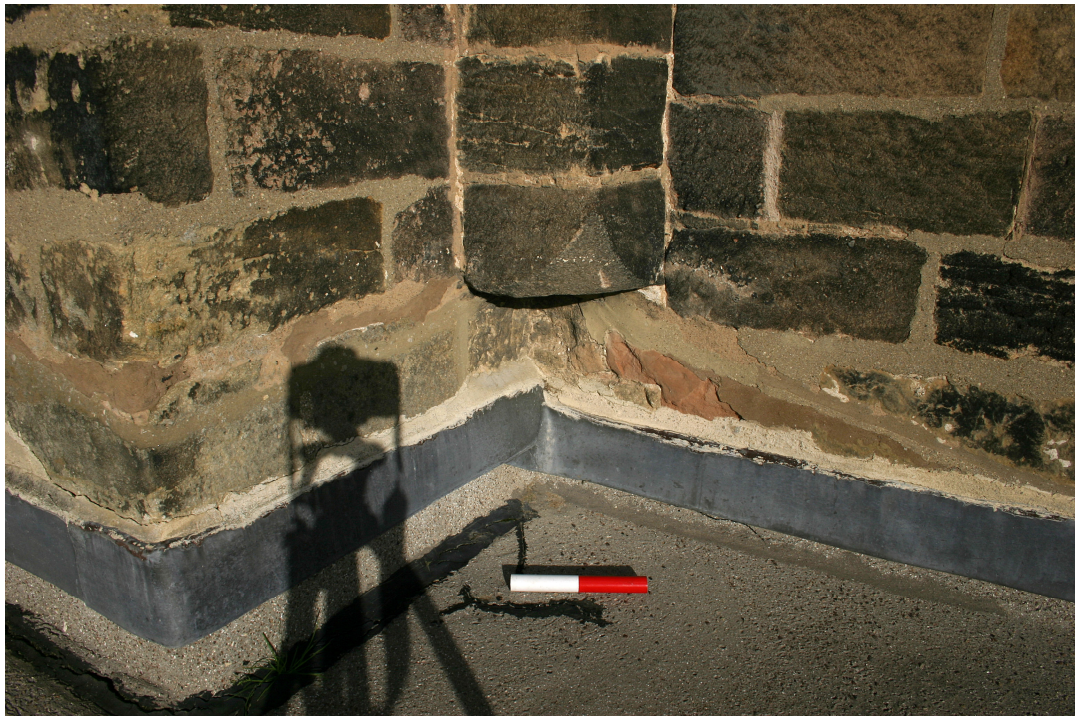
Plate 3 *Cushion moulding to base of vertical order. This order appears to have been truncated in order to ease fitting of the roof to the south aisle at the time of its construction.*

At the eastern end of the roof it was noted that a vertical order on the southern side of the northern buttress of the transept had been cut away at a point immediately above the former roof-line, possibly at the time when the aisle and this roof were added (Plate 3). Such cutting away to this level is also likely to have occurred to two identical orders on the north side of the same buttress (see Plate 4 – to either side of inserted doorway). This is suggested by the stonework of both orders below the level of the former aisle roof-line being replacements in newer stone. Truncation at these points may have served to ease the articulation between roof and transept? Curiously, the base of the partially cut away order on the south side of the buttress had been re-carved in a cushion style, entirely in keeping with the 12th-century work of the transept.

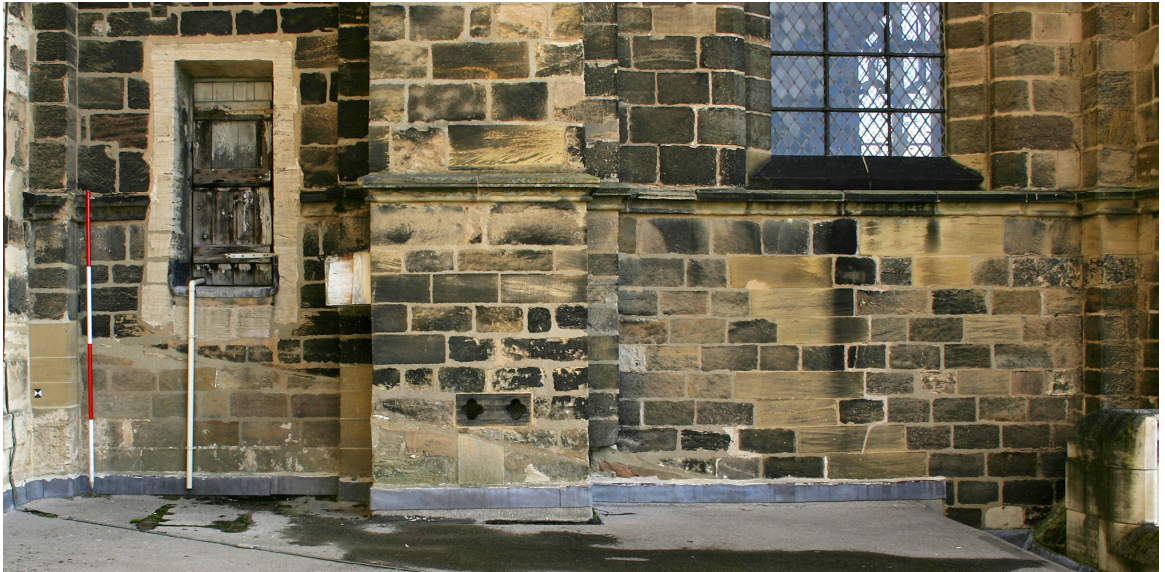
Plate 4 View of the W side of the south transept showing roof scar of original south aisle roof, the contemporary inserted doorway and cushion moulding to vertical order – immediately to right of buttress. Scale in 0.5m units

Around the time the south aisle and its roof were constructed, a low doorway was inserted into the northern part of the west face of the south transept to provide direct access onto the roof. The sill of this doorway lies some 1.5m above the existing roof, and a set of 20th-century wooden steps now provides the access between these. Like the windows at triforium level in the nave, the surround to this doorway is of limestone.

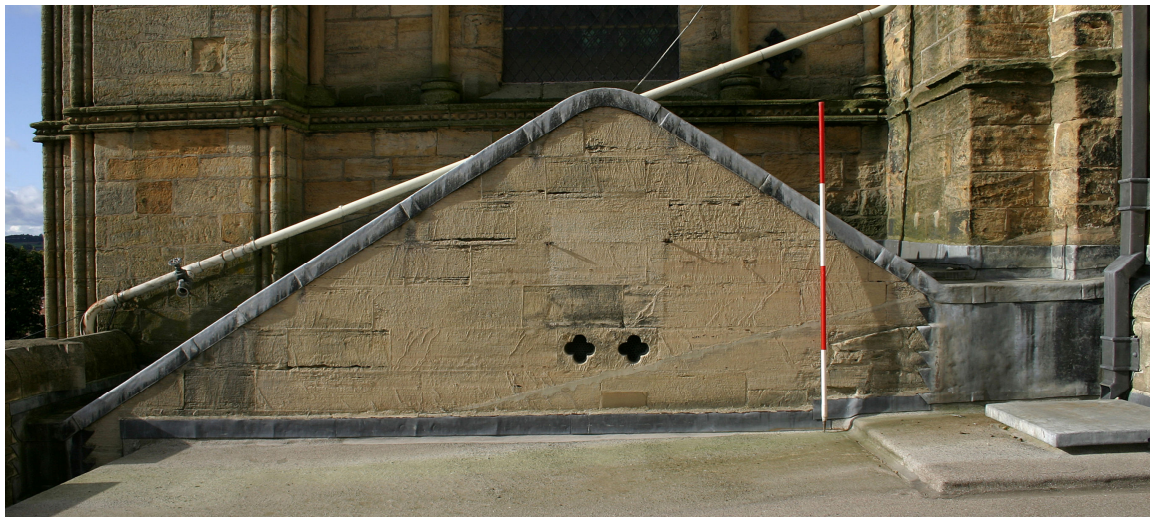
Plate 5 View of west end of south aisle roof showing roof scar of original roof-line. Scale in 0.5m units

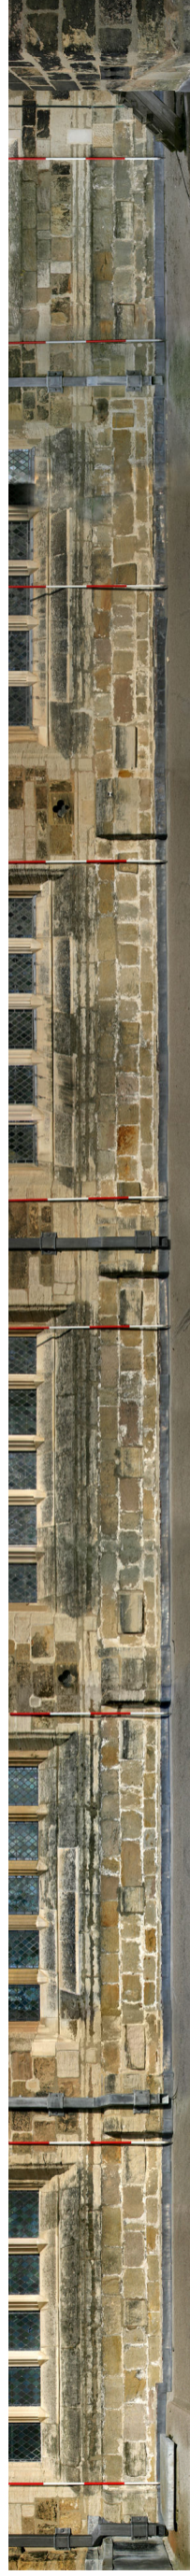
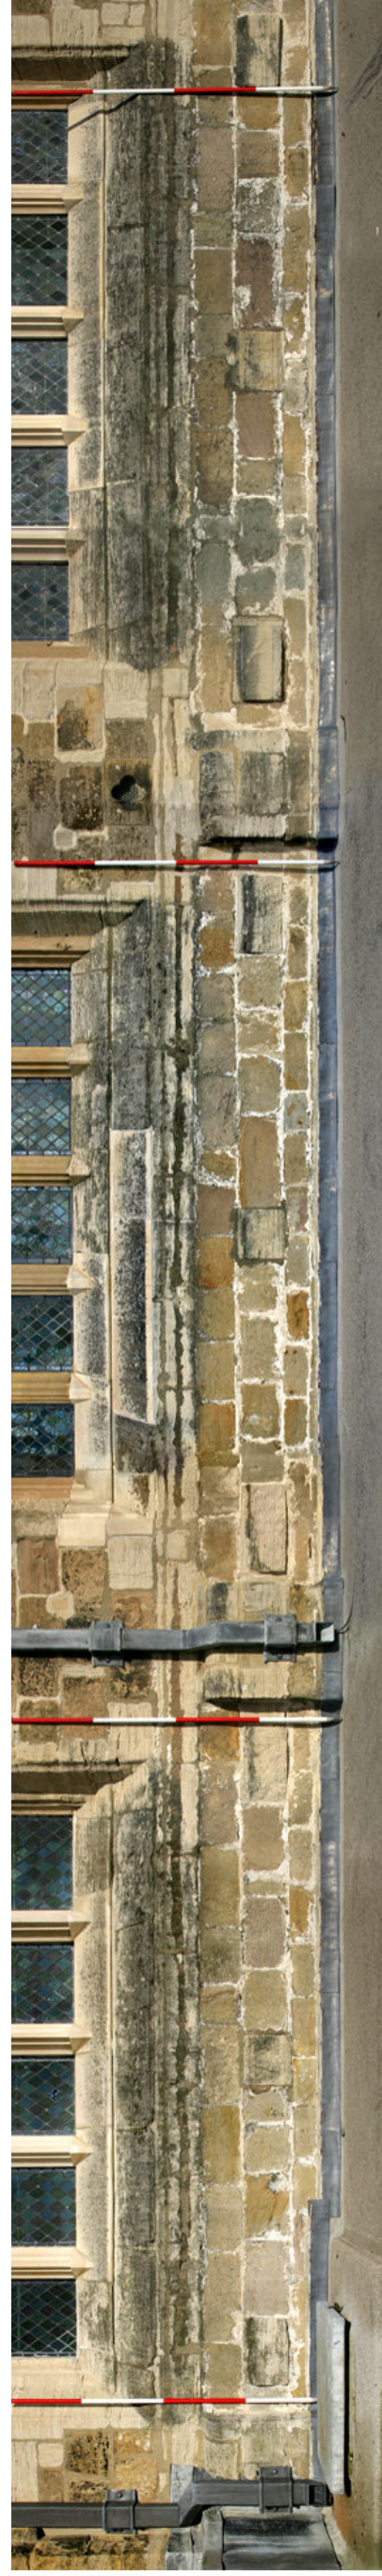
View of entirety of nave walling at level of south aisle roof, compiled from a composite of digitally rectified photographs. Scale in 0.5m units

View of western part of top photograph, showing roof scar of original roof-line (immediately below window surround) and cut-away corbels (three per bay).

View of eastern part of top photograph.

Plate 6 *Views of south wall of nave, from a composite of digitally rectified photographs. Upper photograph (A) of entirety of nave wall at level of south aisle roof, (B) detail of western part, (C) detail of eastern part.*

The scars at the east and west ends and on the nave walling provide unambiguous evidence of a former mono-pitch roof-line with a slope to the south of around 13.5 degrees, that was covered with sheet lead. The single scars at the east and west ends suggest that this roof-line remained unchanged until the 20th-century re-roofing. The corbels will have served, directly or indirectly, to support the principal rafters of the roof structure. There would appear to be two means by which the principal rafters could have been articulated with the corbels. In the first case this could have been by an east – west wall plate (or more likely by a series of wall plates, 1 per bay, between the shallow buttresses), running along the sets of corbels. In the second case this could have been achieved by the northern ends of the principal rafters resting on, or lipping over, the corbels. Any evidence for the point of junction between the south end of the original nave roof and the top of the south aisle wall, assuming it survives at all, is presently masked the southern end of the existing roof. It is probable, however, that the junction in this area was one of rafters connected to a wall plate.
