**MILL HOUSE, SETTRINGTON,  
NORTH YORKSHIRE**

**HISTORIC BUILDING ASSESSMENT REPORT**

**REPORT NUMBER 2012/49**

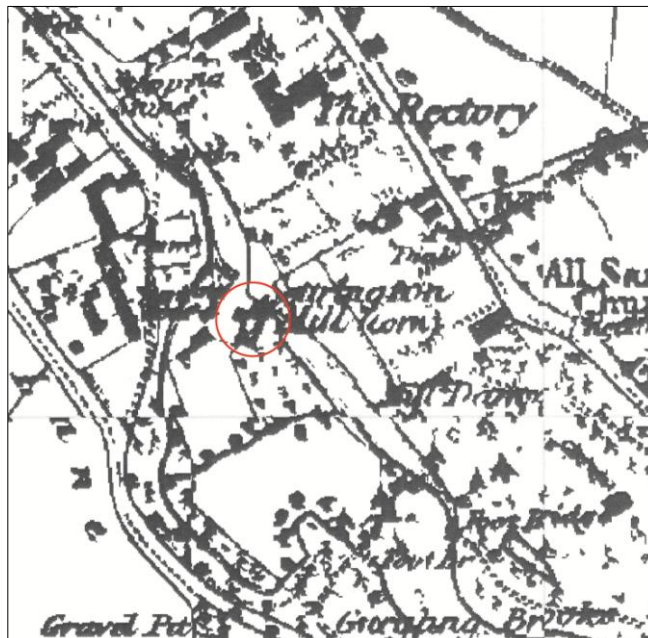
The earliest cartographic evidence for the mill and mill house is the First Edition Ordnance Survey map of 1854. The known earlier maps, Mansfield's survey of 1600 and the Enclosure Award Map of 1799, do not depict the mill in identifiable form. The map of 1854, although relatively un-detailed owing to its scale, does depict the mill (titled as a corn mill) and adjacent house with a centrally placed outshot to the rear. The only adjacent buildings are a few to the west and north-west. The water-mill is shown as being supplied with water from an elongated mill-pond that extended from the north-east corner of the mill in a south-easterly direction to the point where it was fed by a leat of curvilinear form that ran from the large pond to the south of Horse Course Lane. The flow of water along the leat was controlled by a sluice at the north-eastern end of the large pond. The outflow of spent water from the mill was via a leat that flowed north-westwards to join Settrington Beck.

Figure 3 1854 OS map, the mill is circled

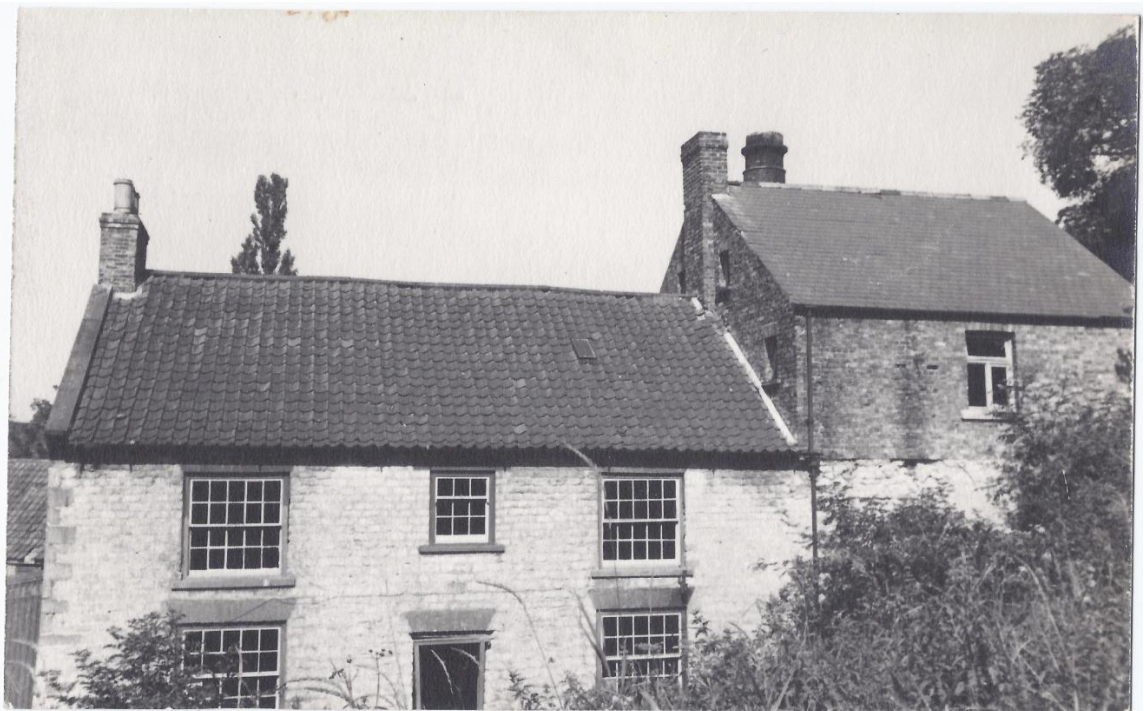
A series of monochrome photographs of the mill complex, held by the Settrington Estate are reproduced here as Plates 1-5. These are thought to date to the earlier part of the 20<sup>th</sup> century, probably the 1920s or 30s, and show the exterior of the buildings in some detail. As has been noted above the details shown in these photographs mirror the arrangements indicated on the Ordnance Survey map of 1928. Plates 1 and 2 are of the south-east (front) and south-west (end) elevation of the mill complex. The mill house can be seen to be constructed of coursed small blocks of limestone with larger stone quoins to the south-west corners, to have a brick chimney supporting three pots central to the south-west end and to have a roof of pantiles. Two single small lights appear to be present to both the front and rear sides of the roof and serve to illuminate an attic. The entrance to the house from this elevation is via a central doorway with stone lintel. To either side of the doorway there is a symmetrical arrangement of two, twenty pane, sash windows with stone cills and lintels. A smaller window of nine panes is located above the doorway. All openings to this elevation are set at ground and first floor levels. The south-west elevation is of plain stonework, save for a round-headed window set at a second floor, attic, level. A small lean-to structure, with mono-pitch roof and seemingly constructed of corrugated iron, is situated against this elevation. The depth of the house, together with the window arrangements to the front and rear of the building, indicate it to have been double pile, or two rooms deep.

*Plate 1 Front, SE facing, elevation of Mill House and adjacent mill*

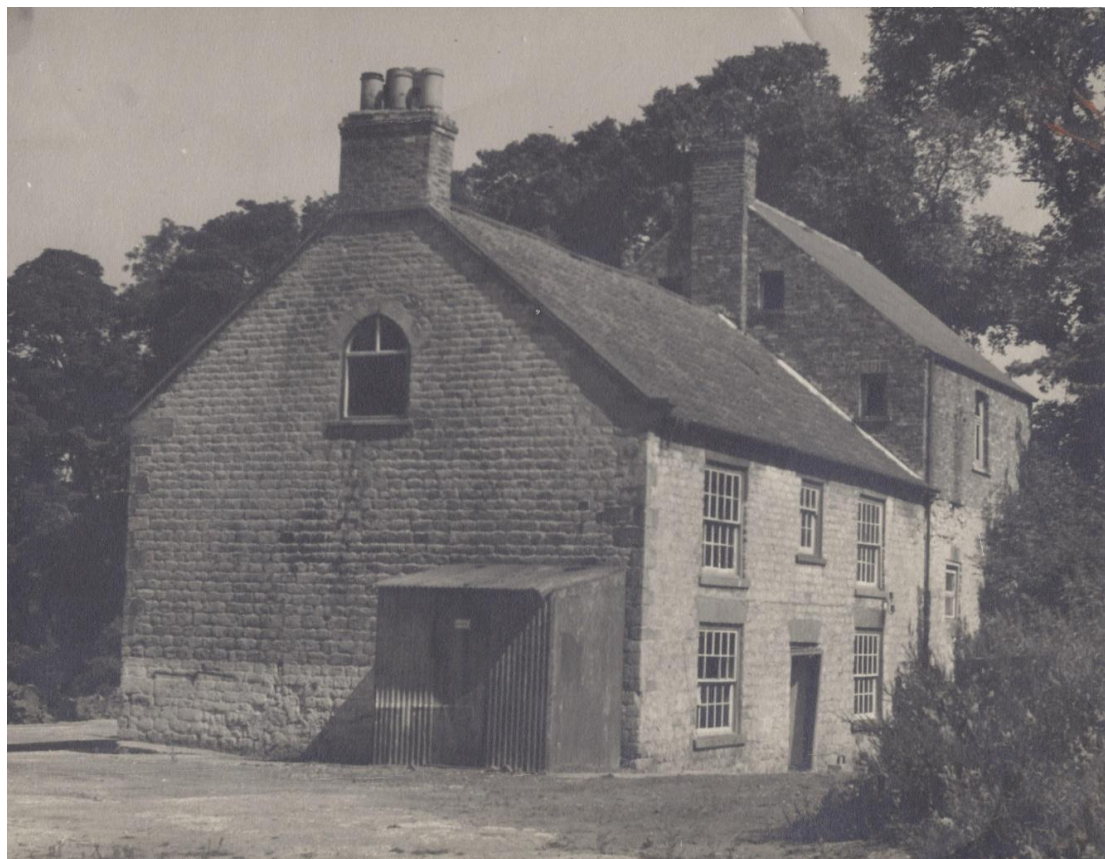
Many details of the mill building are not visible in the photographs although it is clear that it was constructed of limestone blocks to a height corresponding to the eaves of the adjacent mill house. Above this level the mill is constructed of brick and has a roof cover of slate rather than pantile. A brick chimney is present to the south-west side. The brick element of the mill is almost certainly a later heightening of the original building, a notion not just supported by the use of different materials but also by the staggered arrangement of small windows to the south-west elevation of the mill just above the level of the mill house roof.

*Plate 2 SE and SW facing, elevations of Mill House and adjacent mill*

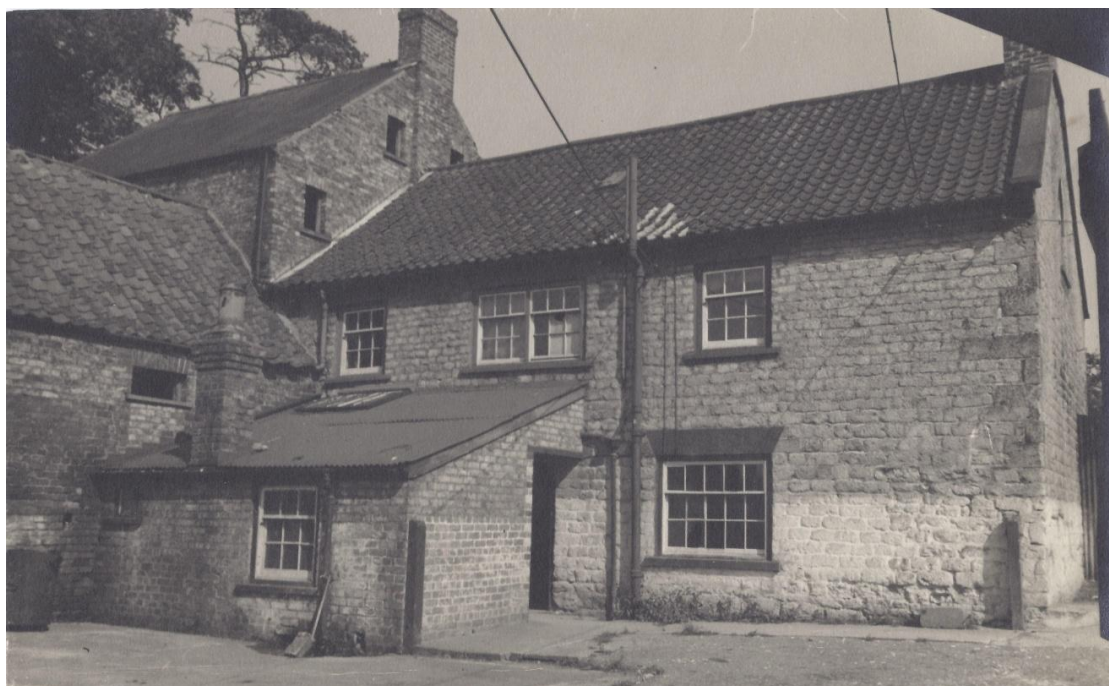
The rear, north-west facing, elevation of the mill house appears to lack the symmetry of the front, though it is partly masked by a single storey mono-pitch extension. However, to the ground floor a fifteen pane sash window is present, any further windows and the doorway lie behind the extension. To the first floor there are two nine pane sash windows, with a wider eighteen pane sash window between these. The mono-pitch extension can be seen to have been constructed of brick and to have had a roof cover of corrugated iron. Entrance to this extension is via a doorway on its south-west side, immediately adjacent to the rear wall of the house. Lighting is provided by a nine pane sash window as well as by a roof-light. A brick chimney supporting a single pot is present to the south wall. The spatial relationship of this extension to the house and the presence of the chimney suggest that one function of this structure may have been as a wash-house.

A substantial extension is evident to the rear of the mill. This was constructed of brick with a roof cover of pantiles. Plate 3 shows a high level window to be present to the south-west elevation that appears to have been reduced in height, this seemingly being owed to the later addition of the lean-to at the rear of the mill house. Plate 4 shows a large ground floor opening and small high level window to the south-western part of the north-western elevation. Further high level windows are also shown at the north-eastern end of the extension. These observations strongly suggest that parts, if not all, of this large extension was of two storeys. The large opening to the north-west side will probably have been provided to permit the access of carts of carts into the building. At the time of the photograph this had been bricked up and a narrow doorway and window inserted. An apparent change in brickwork is suggested by a vertical line extending upwards from the north-eastern side of the old large doorway. This almost certainly relates to the extension of the block depicted on the Ordnance Survey maps around the cusp of the 19<sup>th</sup>-20<sup>th</sup> centuries. Plate 5 shows what appear to be two entrances at the north-east end of the extension.

*Plate 3 Rear, NW facing, elevation of Mill House and parts of NW facing sides of mill*

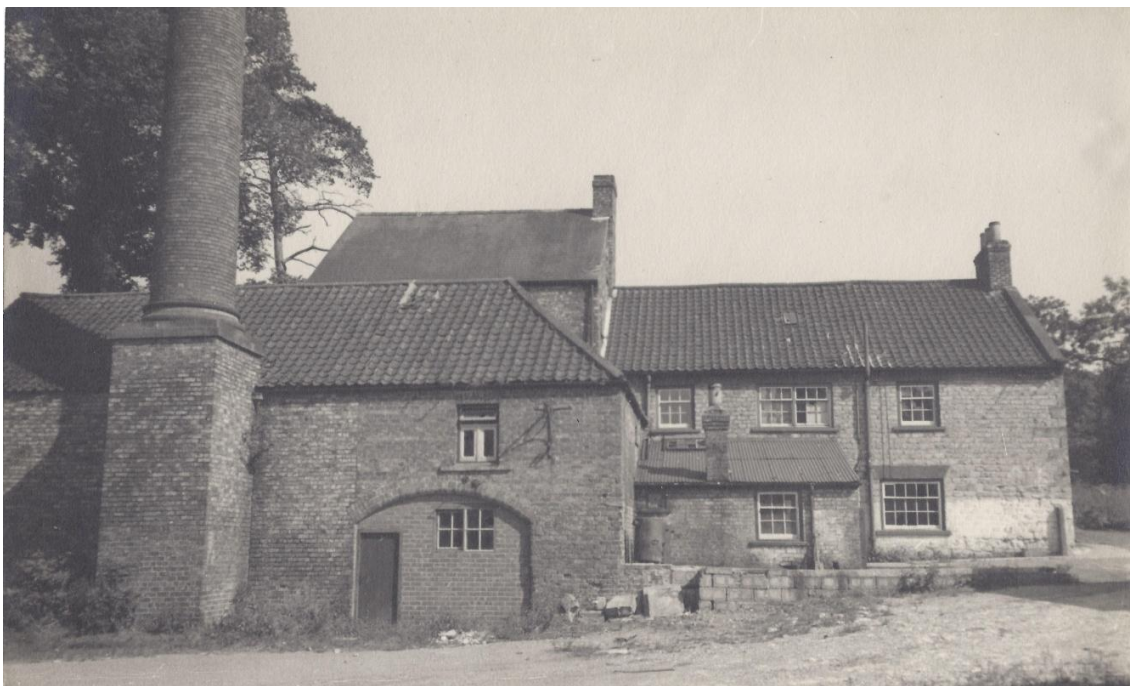
A large brick-built chimney dominates the rear elevation of this extension to the mill. It is known from cartographic evidence that this chimney was in place by 1928. It is also known from documentary sources that an oil engine was introduced to the mill in 1925. However,

*Plate 4 Rear, NW facing, elevation of Mill House and adjacent mill*

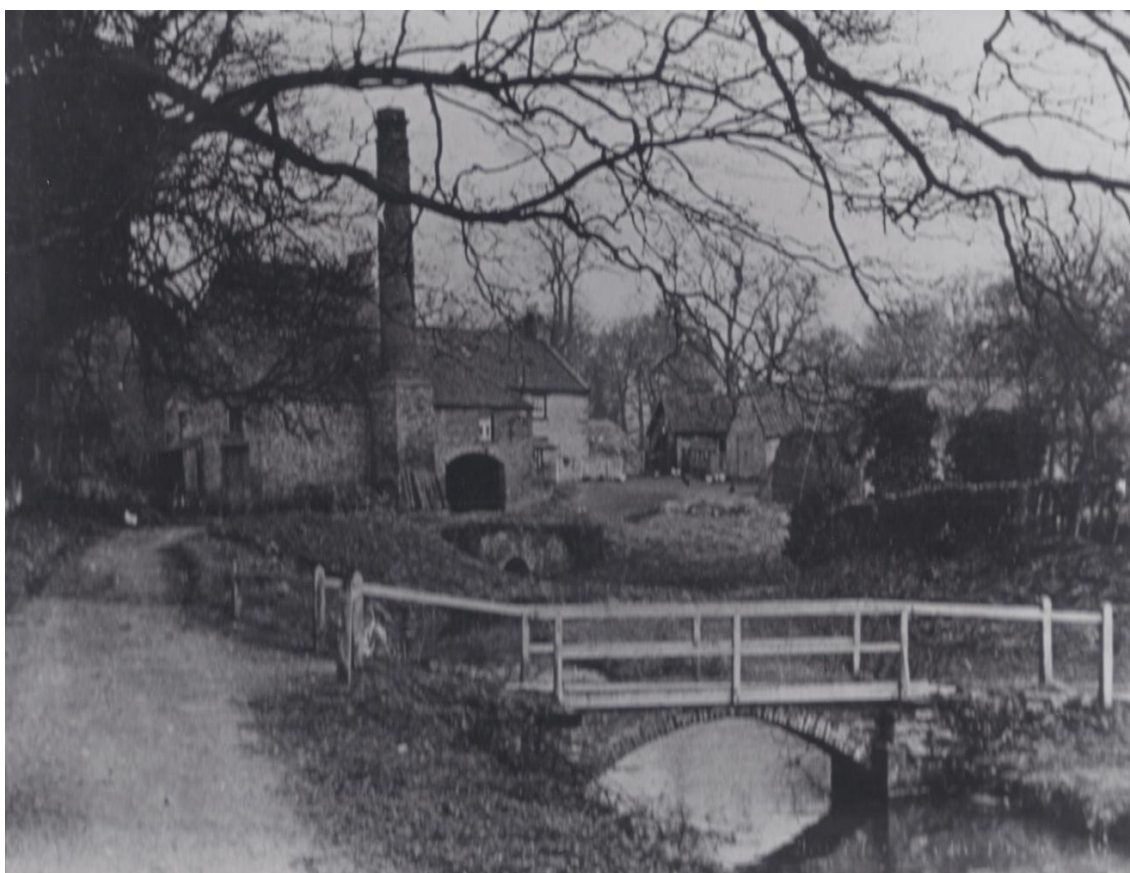
*Plate 5 View of the rear of Mill House and adjacent mill*

ground floor, remove the incongruous flat roofs and in many respects return this rear part of the complex to an appearance akin to that of the historic photograph of Plate 5. Such a scheme could be seen as maintaining the integrity of the older parts of the mill complex and enhancing the somewhat presently disfigured character of the later brick additions.

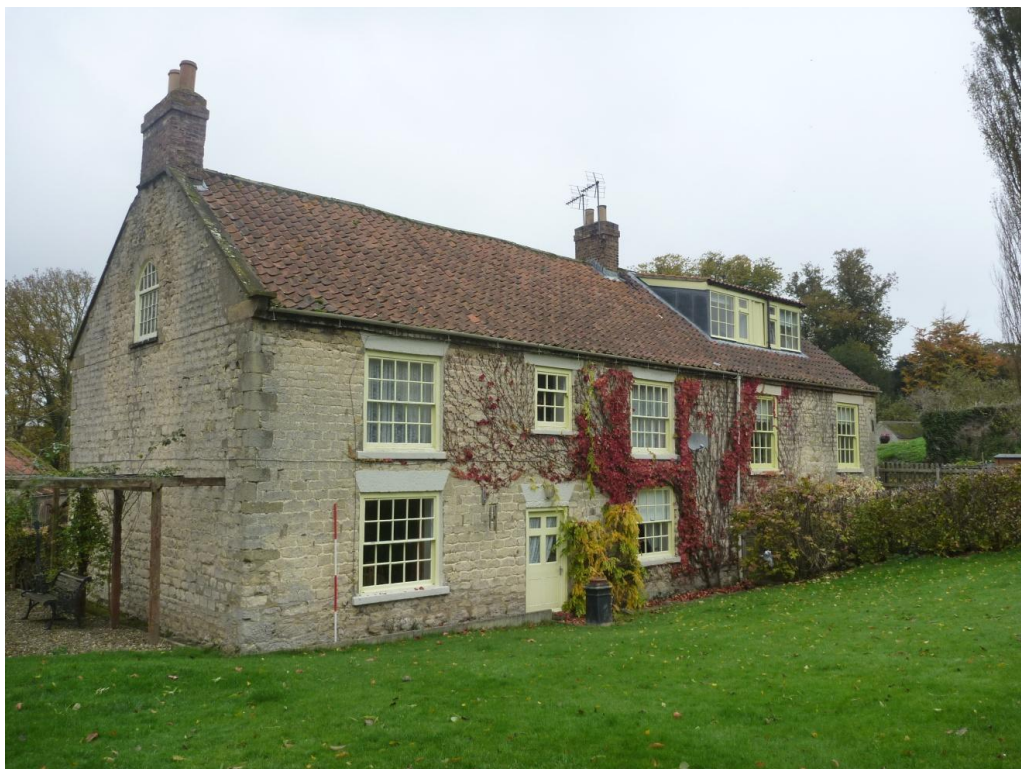
Mill house and the main body of the mill are constructed of oolitic limestone with quoins and dressings of larger blocks of a finer grained limestone. There is no building break, or vertical scar, between the house and mill, the coursing of the stonework runs uninterrupted between the two and quoins are present only at the corners of the combined complex. It is clear from these observations that the mill house and the mill were constructed at the same time as part of a single build. A date stone above the original entrance to the rear of the mill bears the date 1790. The date stone is remarkably crisp and fresh, though this is likely to be the result of its having been protected from the elements by the later brick extensions. In terms of architectural style there seems little to dispute a late 18<sup>th</sup> century date for mill house and the mill.

The appearance of mill house is remarkably unchanged from that of the earlier 20<sup>th</sup> century photographs, save for the loss of the corrugated iron lean-to against the south-west elevation and the re-configuration of the out-shots to the rear, north-west elevation, which are predominantly of later 20<sup>th</sup> century origin. A further change is apparent towards the north-eastern end of the rear elevation. Here a former narrow between floors window has been blocked-up (see Plate 9). These minor alterations aside, the present, and early photographic, external appearance of the mill house is essentially that of the late 18<sup>th</sup> century build. Again, although subject to limited internal inspection, it is understood that the internal configuration of mill house is, for the most part, structurally that of the original build. Such survival with only minor change is largely owed to the unchanged use of mill house as residential accommodation.

*Plate 6 Front (SE) elevation of Mill House and adjacent mill*

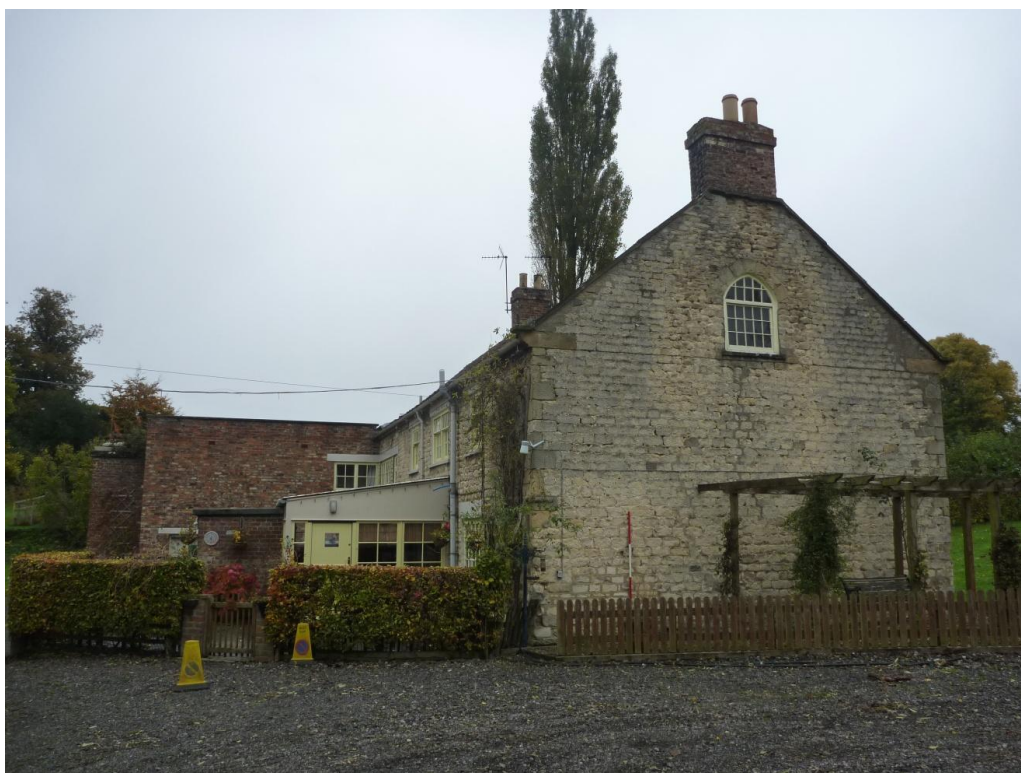
*Plate 7 End (SW) elevation of Mill House. Note the truncated remains of the brick extensions including chimney.*

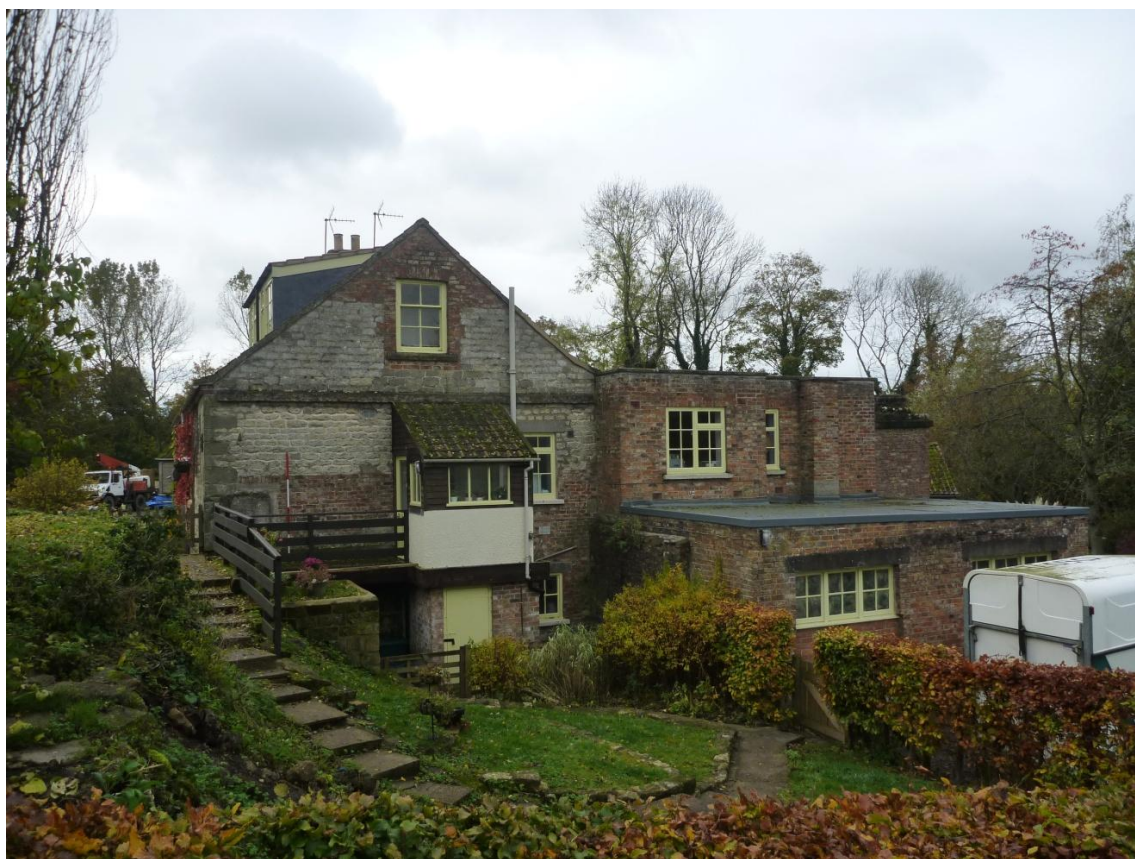
The mill part of the building has undergone a greater degree of change than the mill house, this being owed to the alterations made during its life as a working mill and subsequently by its conversion to domestic accommodation. The height of this part mirrors that of the mill house and in all probability this was the height to which it was originally constructed as the historic photographs show the former upper storey's to have been built in brick. The now demolished upper storey's are likely to have been added around the time elements of the brick extensions to the rear were built. The present arrangement of sash windows to the front, south-east, façade of the mill are very much in keeping with those of the mill house. However, this arrangement is quite different from that in the historic photographs and is clearly the result of 20<sup>th</sup> century alterations, all be they sympathetically formed. The dormer arrangement to the front elevation is of later 20<sup>th</sup> century date and relates to the provision of accommodation at this level, presumably when the building was converted to residential usage.

The location of the water wheel powering the mill was originally have been located against the end (north-east) wall of the mill. Such wheels were more often than not located externally and this position is also attested by the cartographic evidence. The wheel, its pit and mill race no longer survive in this area and the lower parts of this elevation are now formed of brickwork of late 19<sup>th</sup> – earlier 20<sup>th</sup> century date. The existing entrance to the mill via a lean-to timber arrangement is again of 20<sup>th</sup> century date and is likely to be contemporary with the conversion of the mill to domestic accommodation.

*Plate 8 Side (NE) elevation of the mill. The present entrance to the former mill building is via the timber lean-to. Note the altered brick extensions now covered by flat roofs*

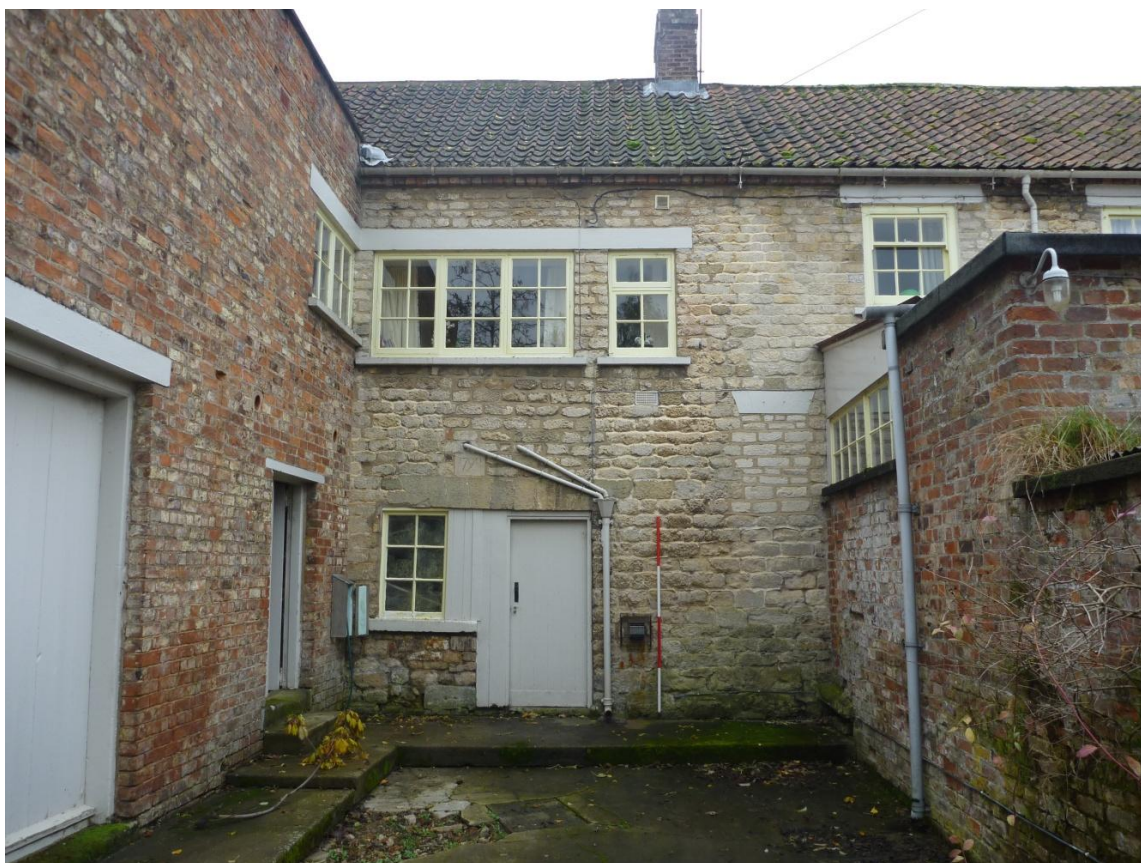
The rear, north-west elevation of the mill is partly obscured by elements of the later brick extensions, though the parts so obscured do survive within these later additions. Throughout much of the 20<sup>th</sup> century this rear elevation was completely obscured by the brick extensions. In those parts presently visible we can see the wide original entrance to the mill, with date-stone above. This opening has subsequently been partially infilled and a narrower door with side light inserted (see Plate 9). First floor windows are present above this doorway and the form and arrangement of these, together with their concrete lintels, suggests that they are insertions of the 20<sup>th</sup> century.

*Plate 9 View of the rear of mill showing the narrowed original entrance with date-stone above and brick extension to left. Parts of the brick wall to the right once formed part of an extension also. Note the blocked-up window to the mill house and later windows at first floor level within the mill.*

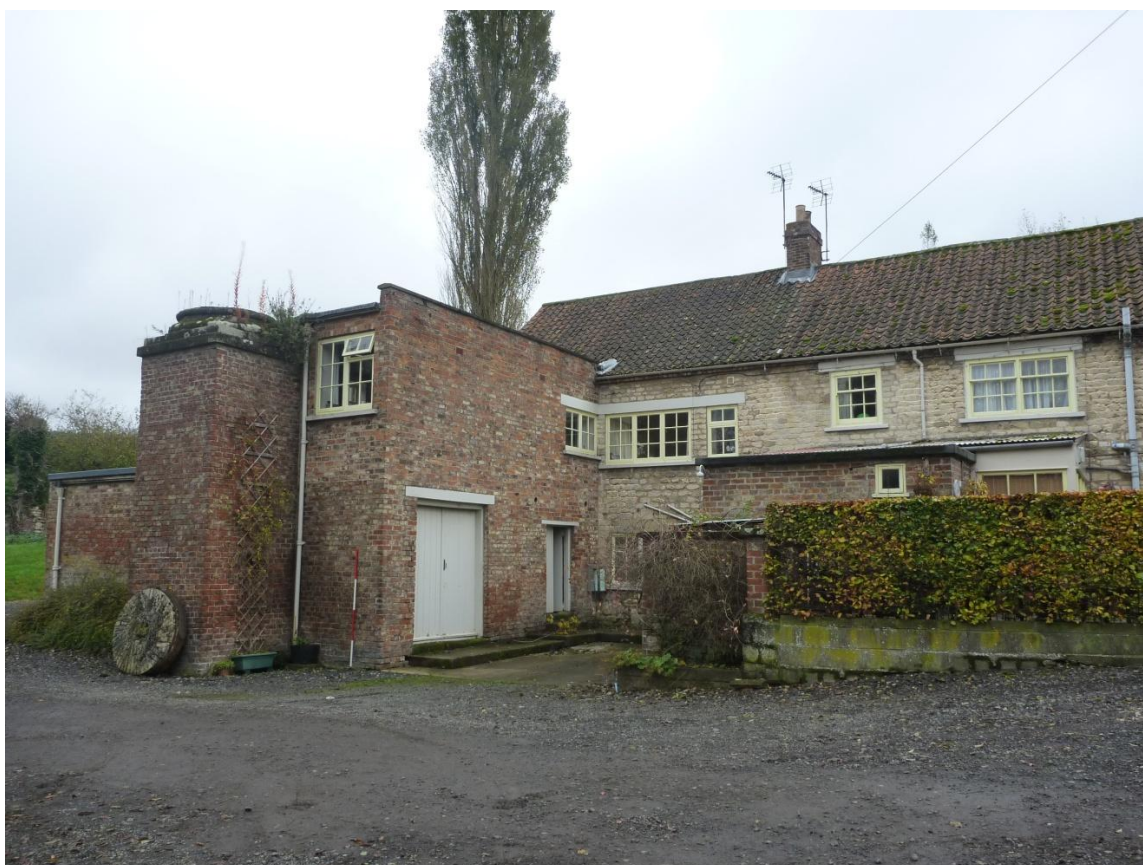
Elements of the later 19<sup>th</sup> and 20<sup>th</sup> century brick additions to the rear of the mill complex, including the lower parts of the chimney, still survive. In the earlier 20<sup>th</sup> century these covered the entirety of the rear of the mill and stood to a height greater than today. Those parts in the area of the main entrance to the mill have been removed (though the lower parts of the south-western wall of this are incorporated in the existing lean-to at the rear of the mill house) as have the upper parts at their north-east end that are now covered by flat roofs.

The two openings to the north-east elevation of these extension works appear to correlate to the present two openings that have been bricked up in their lower parts and had windows inserted above this (see Plate 8). At the present time the ground floor elements of the brick additions form two concrete floored spaces of equal size separated by a brick wall whilst the smaller first floor part is comprised of two rooms forming part of the accommodation of the mill building.

*Plate 10 Rear of the mill complex. Note the truncated chimney and brick extensions.*

It is understood that proposals for the mill complex do not involve alteration to the mill house. Changes to the former mill building are to involve only the re-integration of the ground floor to the rest of the mill. A third unit of accommodation is to be formed of the rear brick extensions. Works to this unit will involve the re-building of a first floor (in areas where presently absent) and see the flat roofs replaced by a pitched roof.

The absence of external works to the mill house and mill that form the older original part of the complex will not involve any significant alteration to their external appearance. The re-integration of the ground floor to the rest of the mill will involve some internal alterations. Given the absence of original fittings and features the impact on the historical fabric of the mill will be minimal, though it will serve to give new life to a part of the building that is presently neglected. The proposals for the existing brick rear additions to the mill will involve the re-building of a second storey, where presently only part of this survives, and the covering of this with a pitched roof. These latter works will secure a long-term use for the

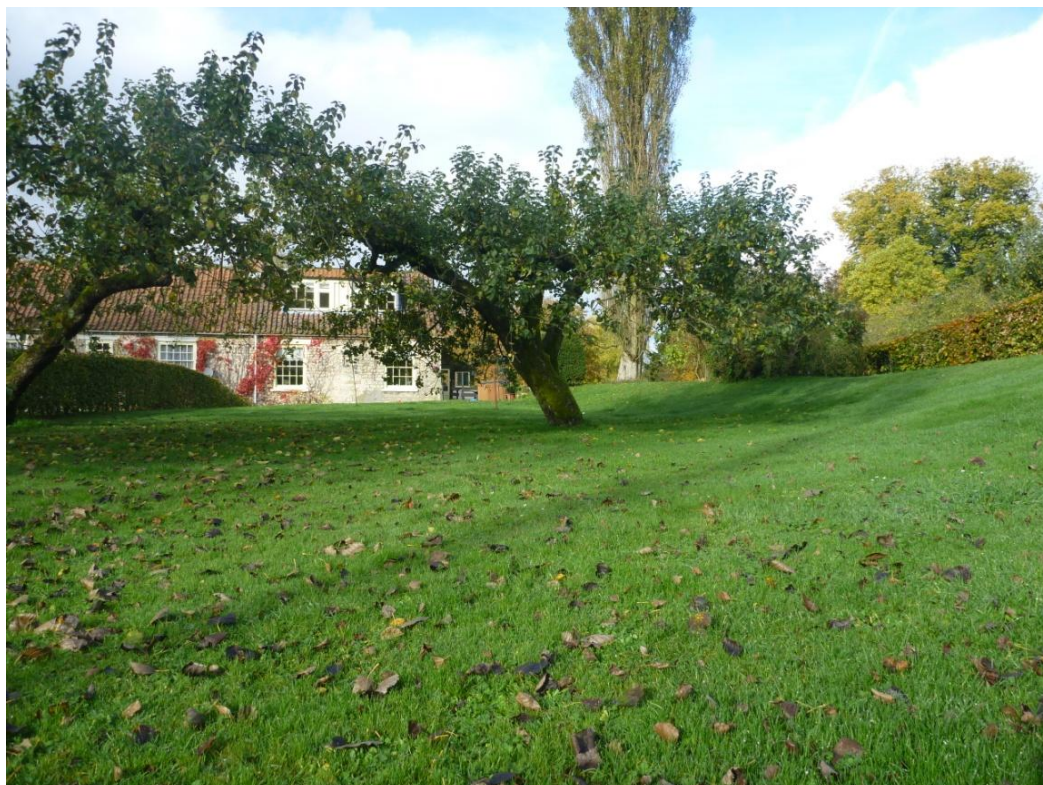
Within the wider landscape setting of the mill complex it was noted during the inspection that traces of former mill pond and the outflow leat to the Settrington beck still survive (see Plates 11 and 12).

*Plate 11 View of upper part of mill pond (right), looking NW*

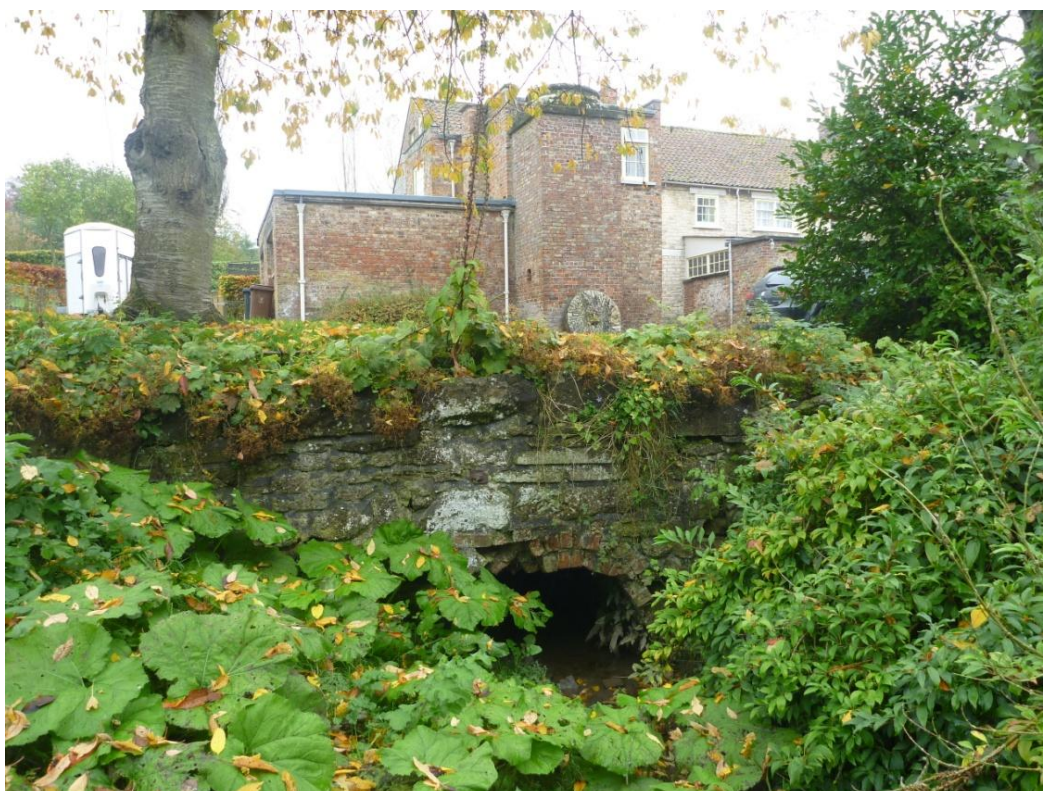
*Plate 12 View of outlet leat to Settrington Beck, looking SE (compare to historic Plate 5)*
