**ARCHAEOLOGICAL INVESTIGATIONS AT  
32 LAWRENCE STREET, YORK**

*EXCAVATION AND WATCHING BRIEF REPORT*

Report Number 2014/23    May 2014

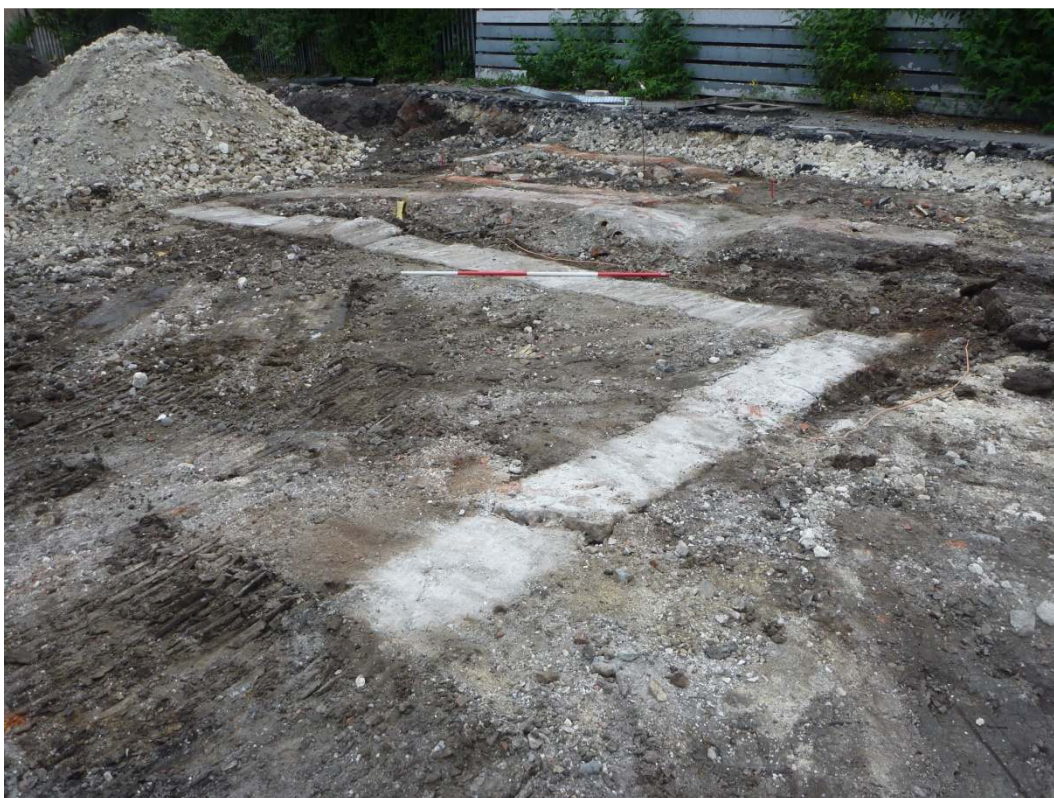
**Plate 1: Modern structures (1242, 1243 and 1244) in area A, viewed from the north east.**

In this area the initial strip removed between c.0.3m and c.1m of material. A small number of modern features (plate 1), wall 1242, ceramic pipe 1243 and brick inspection chamber 1244, were all that were noted, all sealed below modern overburden 1000.

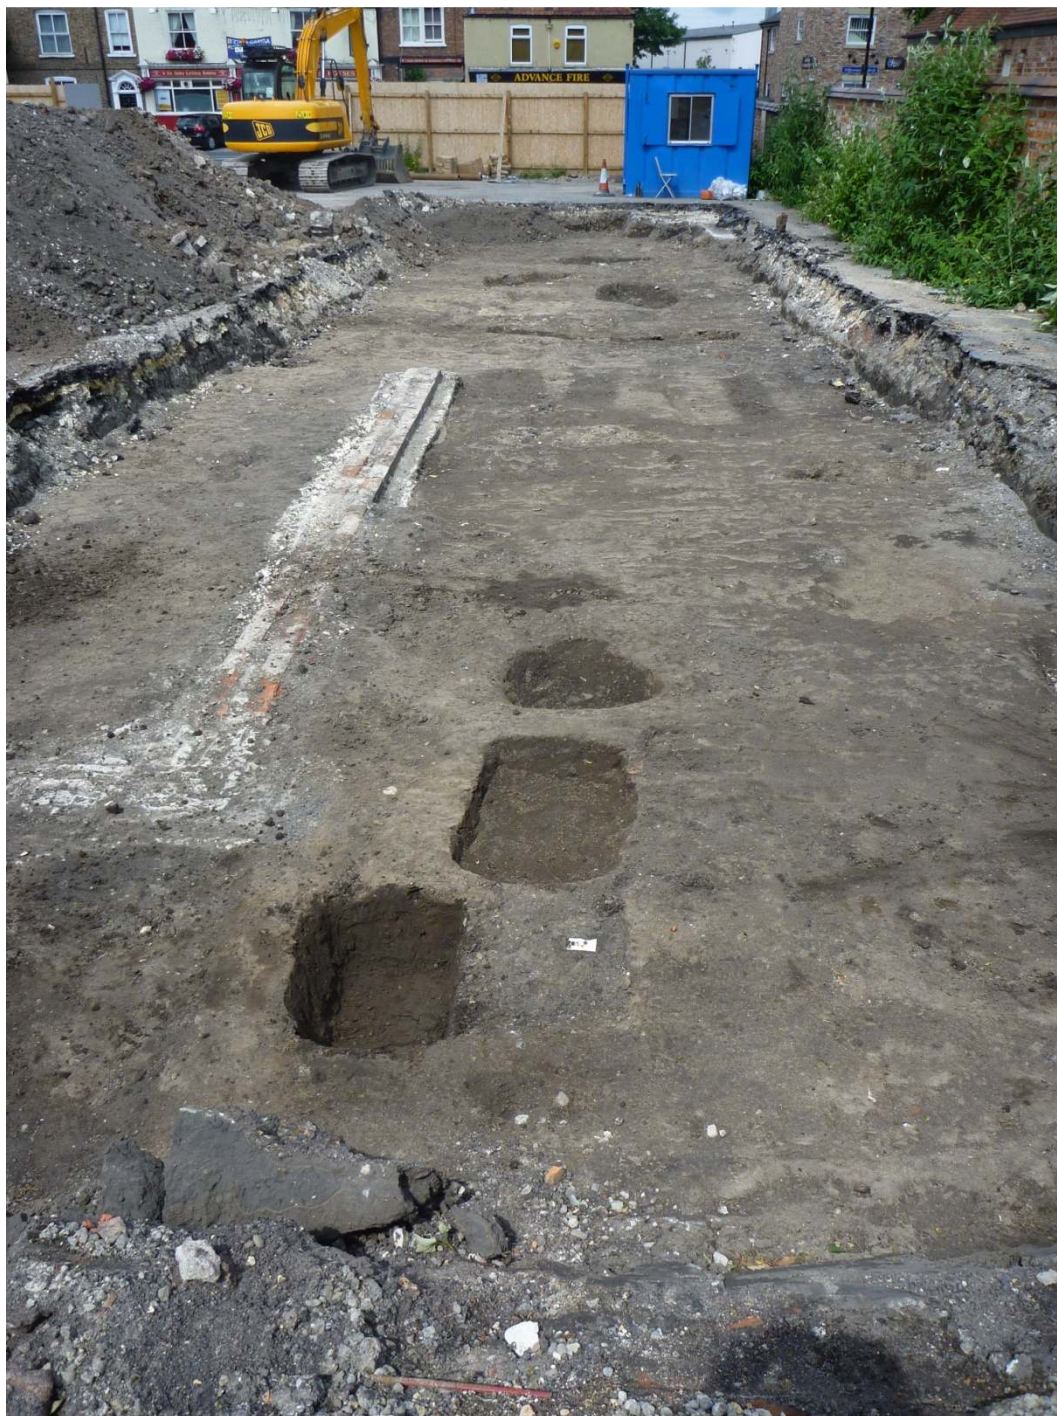
**Plate 3: Post excavation shot of features later than plough soil in attenuation tank, viewed from the south west.**

After the initial strip of Area A, a further excavation for the tank was made at the eastern side of the area. This trench was c.25m x 5m and was c.2m deeper than the already stripped area. Although largely excavated by machine a reasonably clear stratigraphic sequence was recorded from the trench. The earliest context noted was natural sand, 1199. In this there was a natural depression filled with 1198 and an area of disturbed natural, 1212. The depression, and possibly the disturbed natural, were sealed by a deposit interpreted as plough soil, 1196. Cut into this was a probable cess pit, 1236, and probably roughly contemporary, a feature described as an extraction pit (plate 4), 1237. Above these was a clear horizon of features including pits 1240, 1241, 1235, 1232, 1233, 1217, 1234, 1229, 1224 and 1225, postholes, 1231 and 1223, natural depressions 1216 and 1219 and a possible pit backfill, 1214. These were all clearly sealed by another overall spread of plough soil, 1195. Cutting this was another series of features (plate 3) including pits, 1170, 1169, 1187 and 1173. This horizon also produced a cow burial, 1171, a dog burial, 1185, and walls 1151 and 1152. The sequence above these was the same as that for Area A.

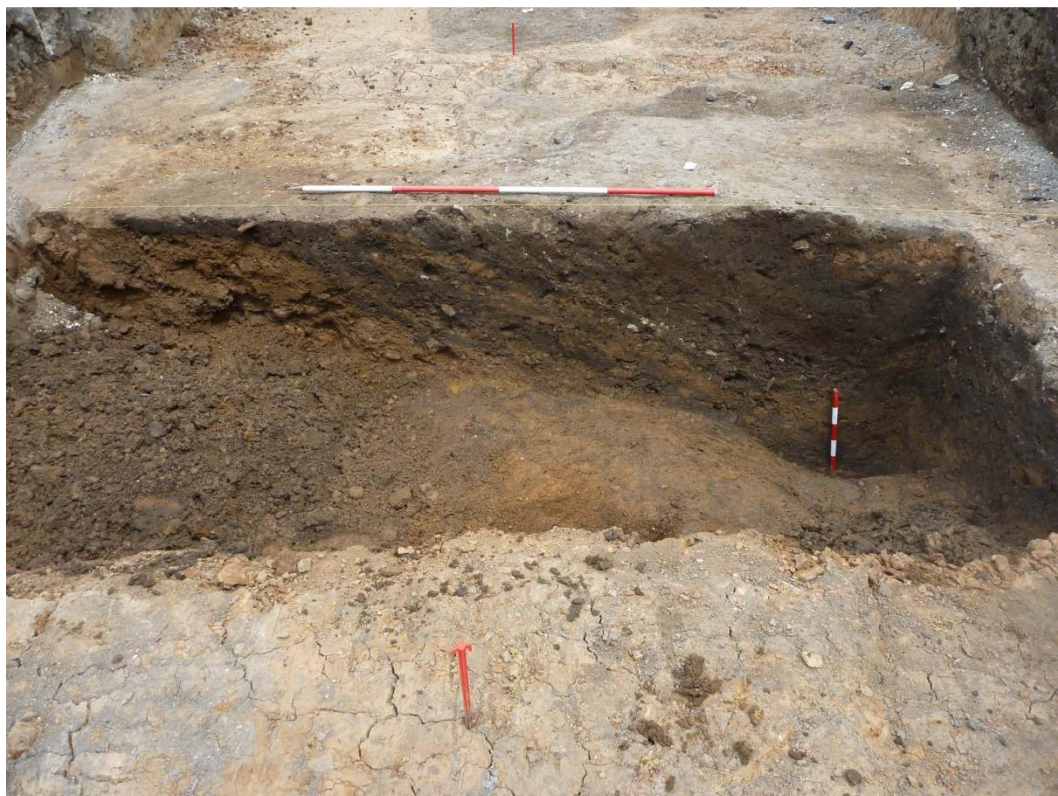
**Plate 4: Early medieval extraction pit (cut 1237) in attenuation tank trench, viewed from the south west.**

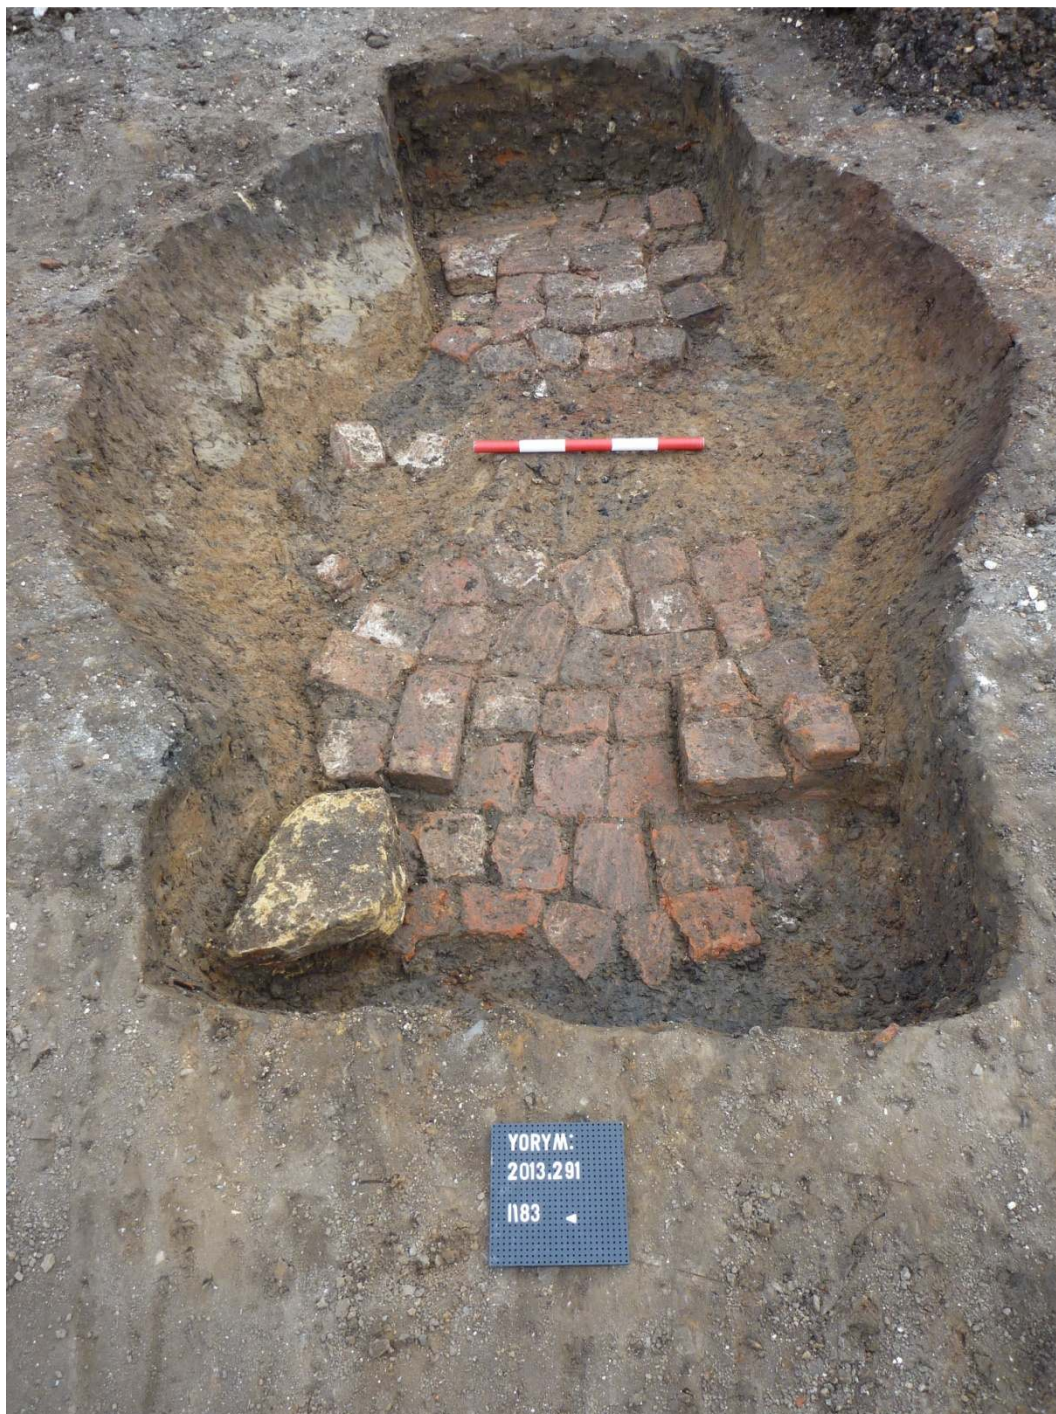
**Plate 5: Post medieval oven feature 1183 in area B, viewed from the west.**
