## **ARCHAEOLOGICAL INVESTIGATIONS AT LEISURE WORLD, BRIDLINGTON**

### ***ASSESSMENT REPORT***

Report Number 2014/34      October 2014

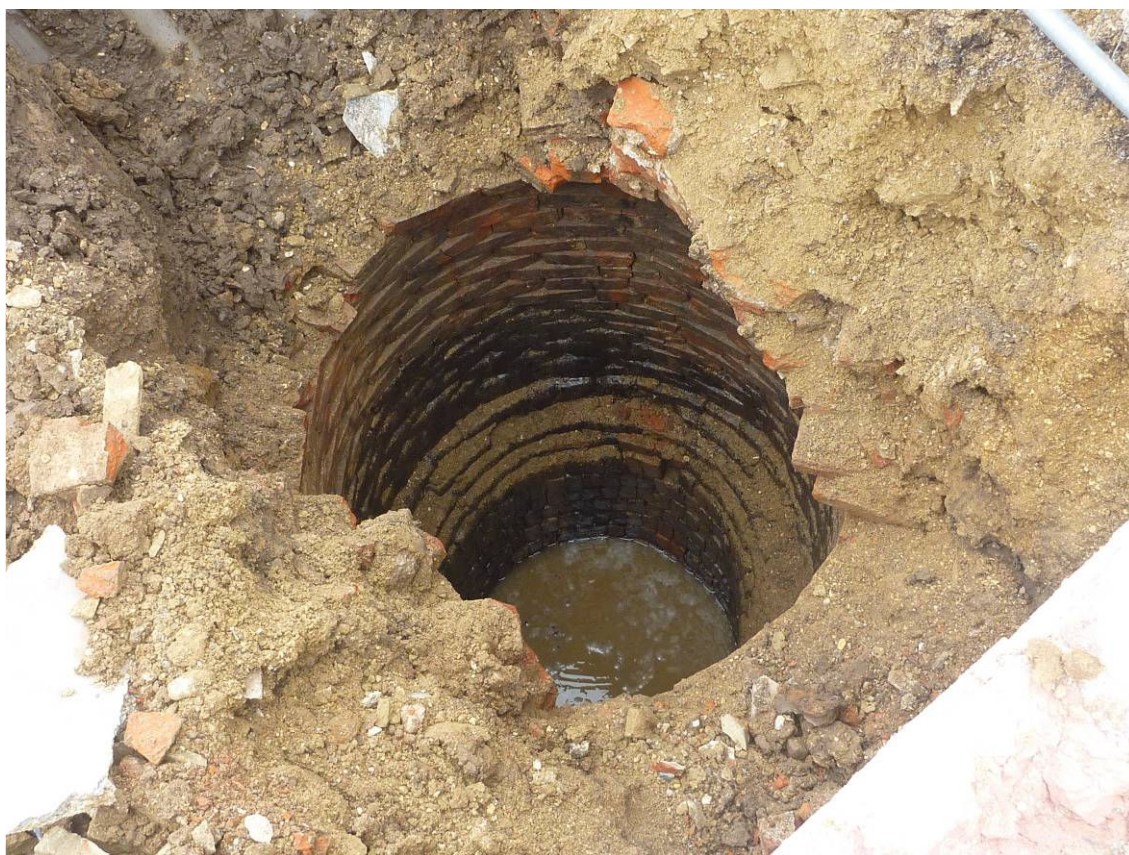
Plate 1 Well 5025, looks north-west

Three brick-lined wells were found beneath the building (Fig. 4). Two are thought to be associated with the building and are discussed below (see Rooms 6 and 10). The third (5025), towards the north-east corner, was a circular well at least 6.9m deep (down to at least 5.25m

OD). It was situated close to the fireplace in Room 5 and so almost certainly could not have been contemporary with the building. The lowest observable part of the well comprised headers on edge and with an internal diameter of about 0.7m. About 2m from the top it widened out in 4 stretcher courses, so that the well above was 1.3m in diameter internally. Although the brickwork was generally un-mortared, the uppermost 0.45m of the structure was formed by 6 courses of mortared brick corbelling and a sandstone slab cap; this is thought to be an alteration in order to support the floor of the later building.

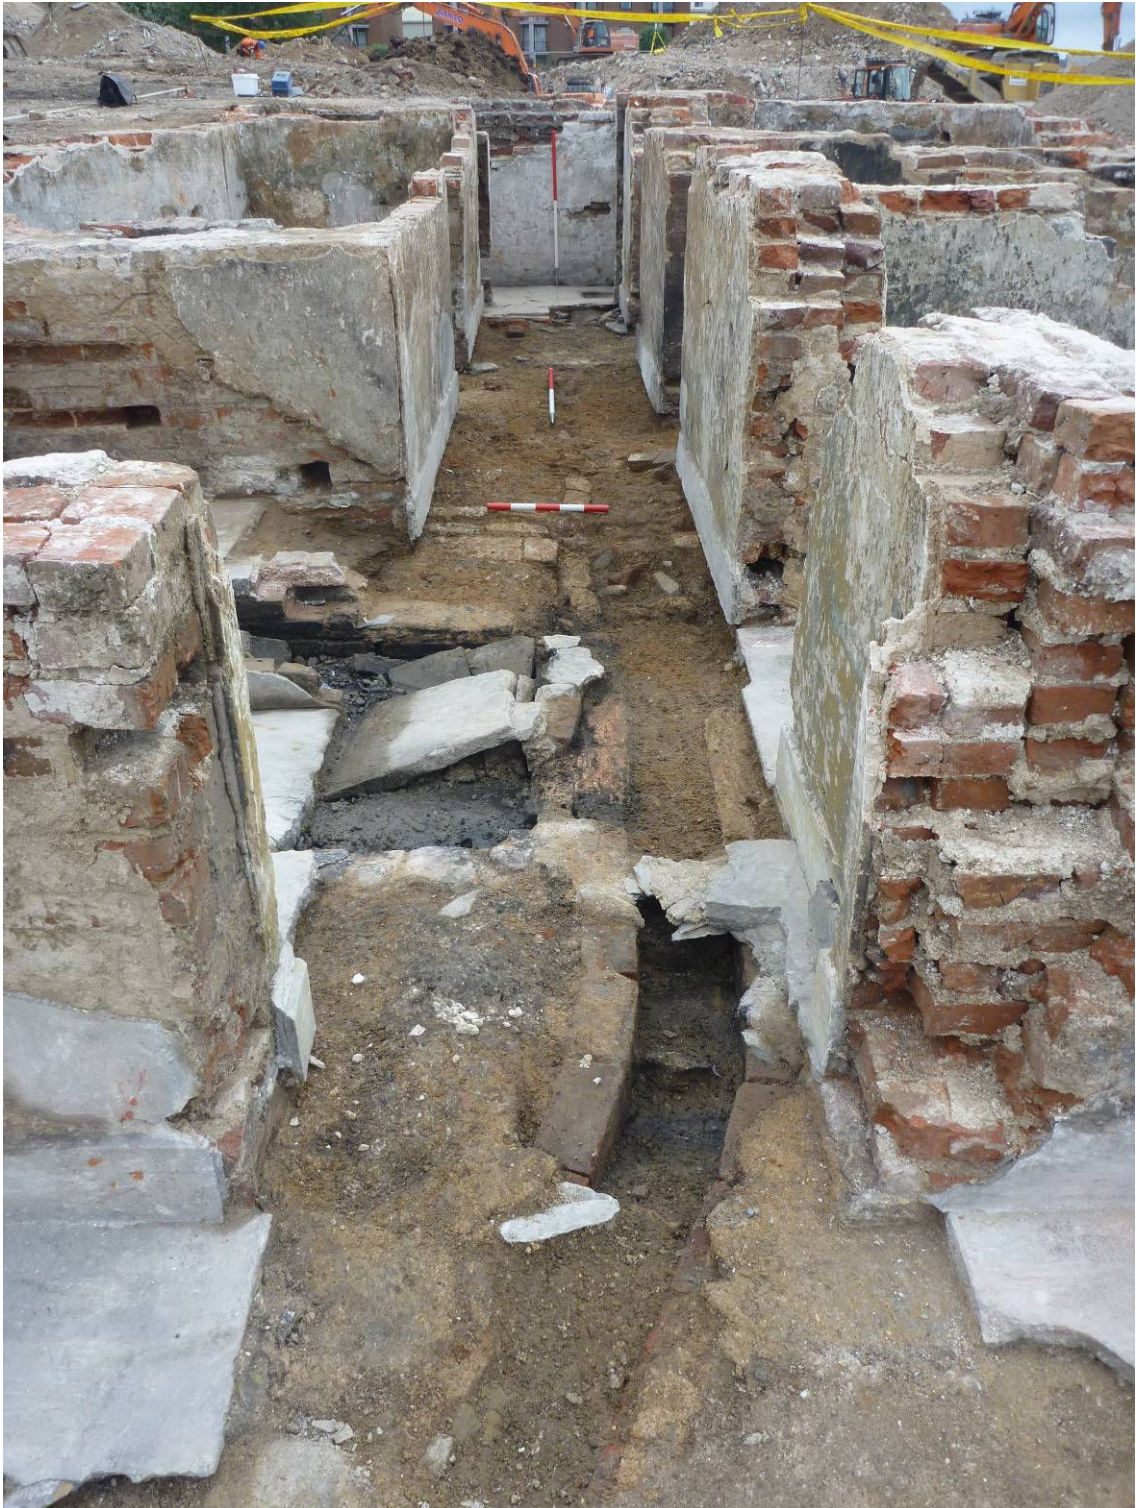
Plate 4 Room2 looking north

North range, east of Room 1. 8m long (north-south) by 1.1m wide, extending from the external north door to Room 10. Part of the same space as Room 6, and of Room 1 prior to the latter's partition. The sandstone slab floor overlaid a layer of flat-laid brick. There was a plaster skim over mortar, painted yellow. A shallow brick-lined drain with slate capping ran down the middle of the room (5005); in places, the drain lining had been rebuilt using hard pink mortar or had been replaced with a salt-glazed ceramic pipe, suggesting at least two repairs.

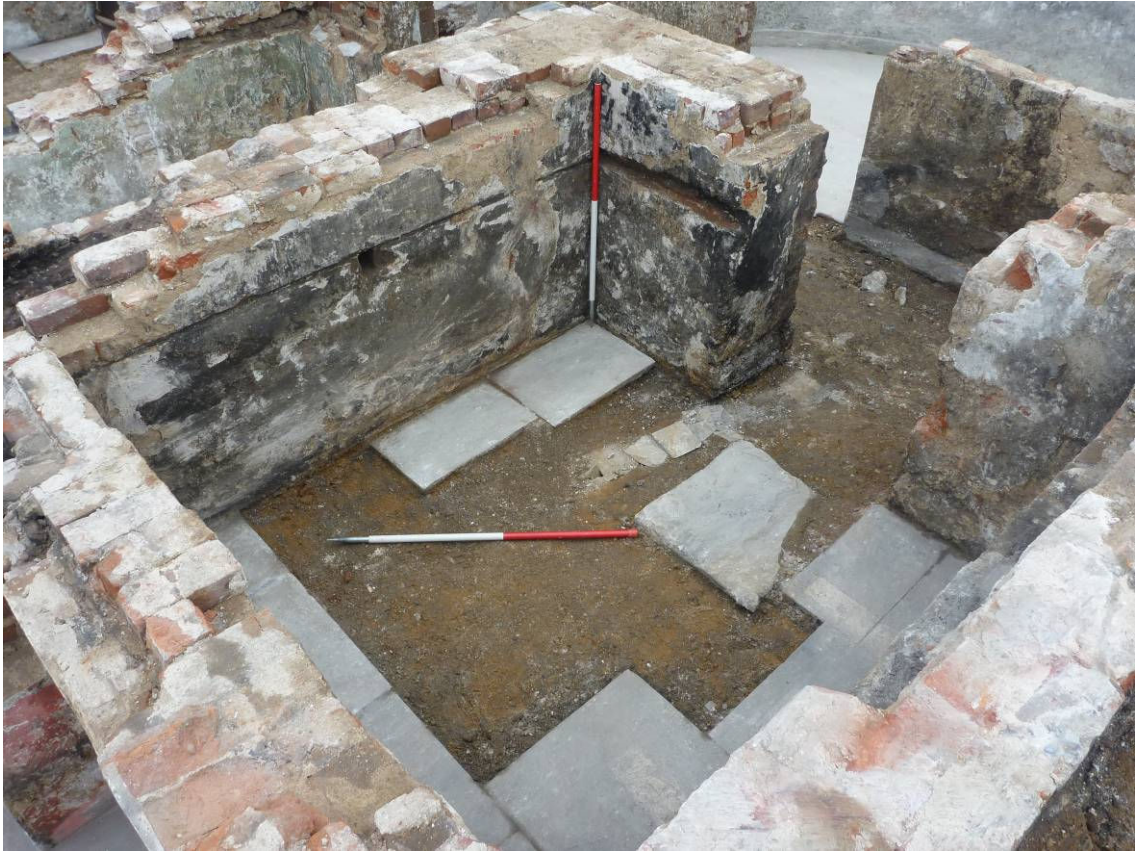
Plate 5 Room 3 looks south-west

North range, east of Room 2. This was a small room, 2.2x2.3m maximum, with a doorway in the centre of the west wall, and a wooden window sill in the centre of the north (external) wall. It had a sandstone slab floor; part of a brick lined drain with slate capping was observed running west to connect with the drain in Room 2. The limewashed mortar walls had a patchy concrete skim. Scars in the floor and on the north wall indicate the position of brick wall supports for a work surface below the window. This feature continued eastwards clockwise round the room as far as the south side of the doorway, presumably as a shelf of more than one build, in the form of scars in the paintwork and a recess in the mortar, with at least two voids for timber supports.

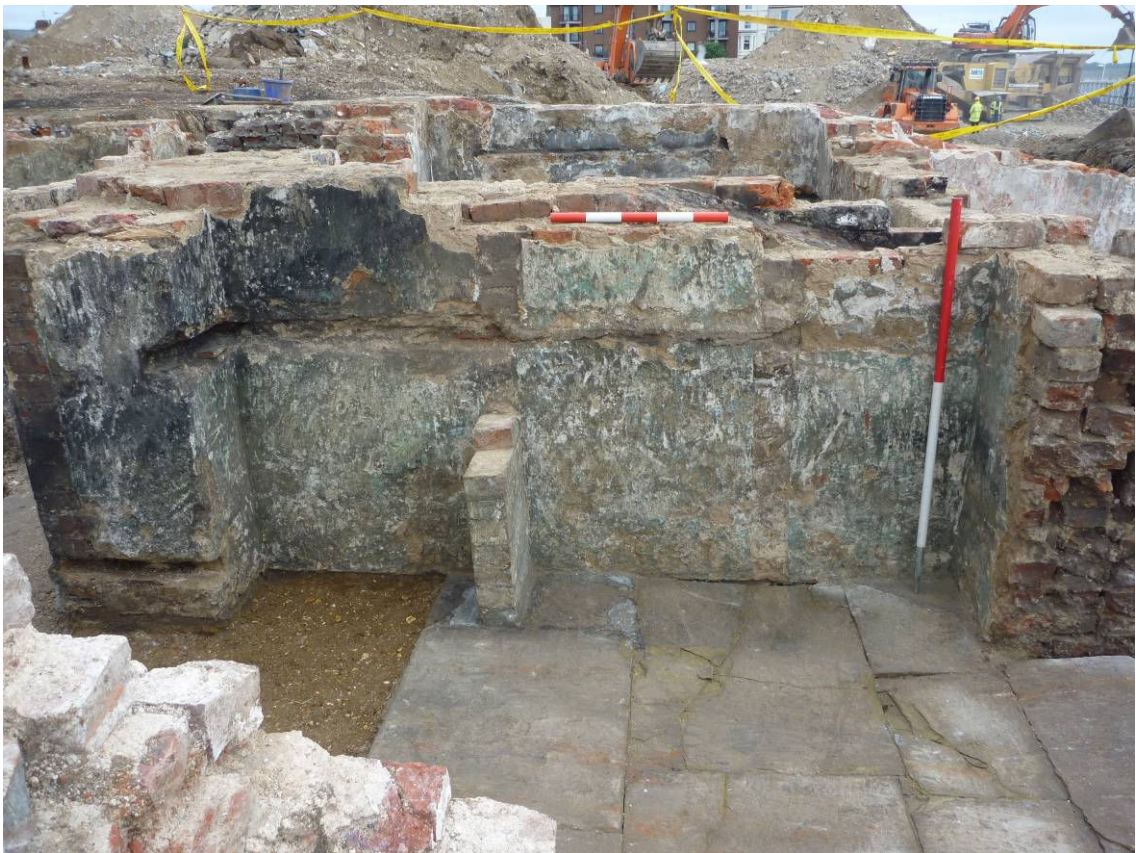
Plate 6 Room 4, north wall

South of Room 3. Another small room, 2.2x1.75m, with doorways in the west and east walls. The sandstone slab floor was over bricks, with a probable brick-lined drain that presumably connected with the drain in Room 2 to the west. There was a mortar coat overlaid with limewash on the walls, with traces of green paint over. A brick base (5009) and a parallel mortar scar in the floor indicate a low shelf on the north side of the room. A timber strip in the thickness of the wall on the north side of the west door relates to a door frame). A door frame

in the east doorway is indicated by voids in the concrete floor that extended into the doorway from Room 5. The south part of the east wall appears to have been removed subsequently, so that the room was almost completely open to Room 5; this wall is not on the same alignment as the wall to its south, nor is it bonded to it, but the reason for this is unclear.

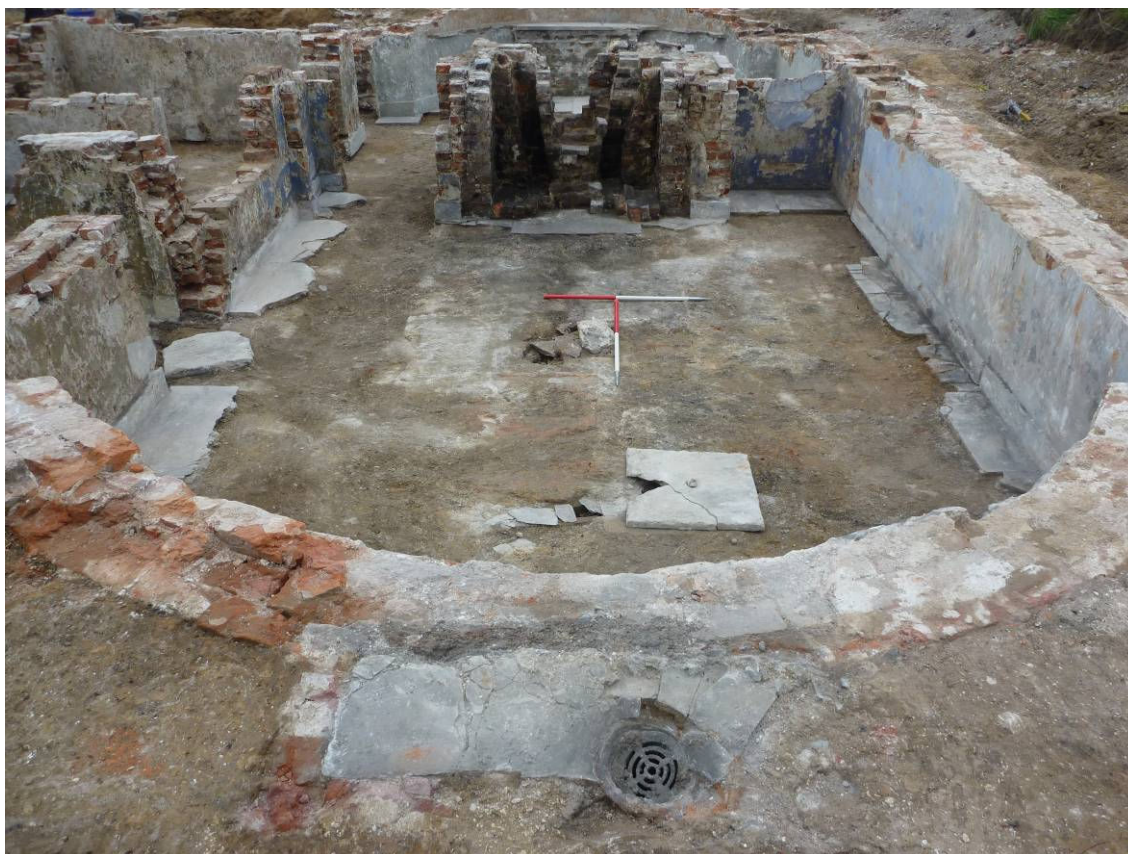
Plate 9 Room 10 looks east, with external drain in foreground

In the western part of the room a circular brick lined well was found (5002); it was at least 1.7m deep, built of headers with occasional tile fillers and unbonded. Diameter 0.4m at the top, widening to at least 1m. It was probably capped with a stone slab (disturbed when found). A shallow brick-lined drain with slate capping ran for at least 1m north from the well, forming another element of the under-floor drainage. There were traces of a drain running to the well from the south-west corner of the room.

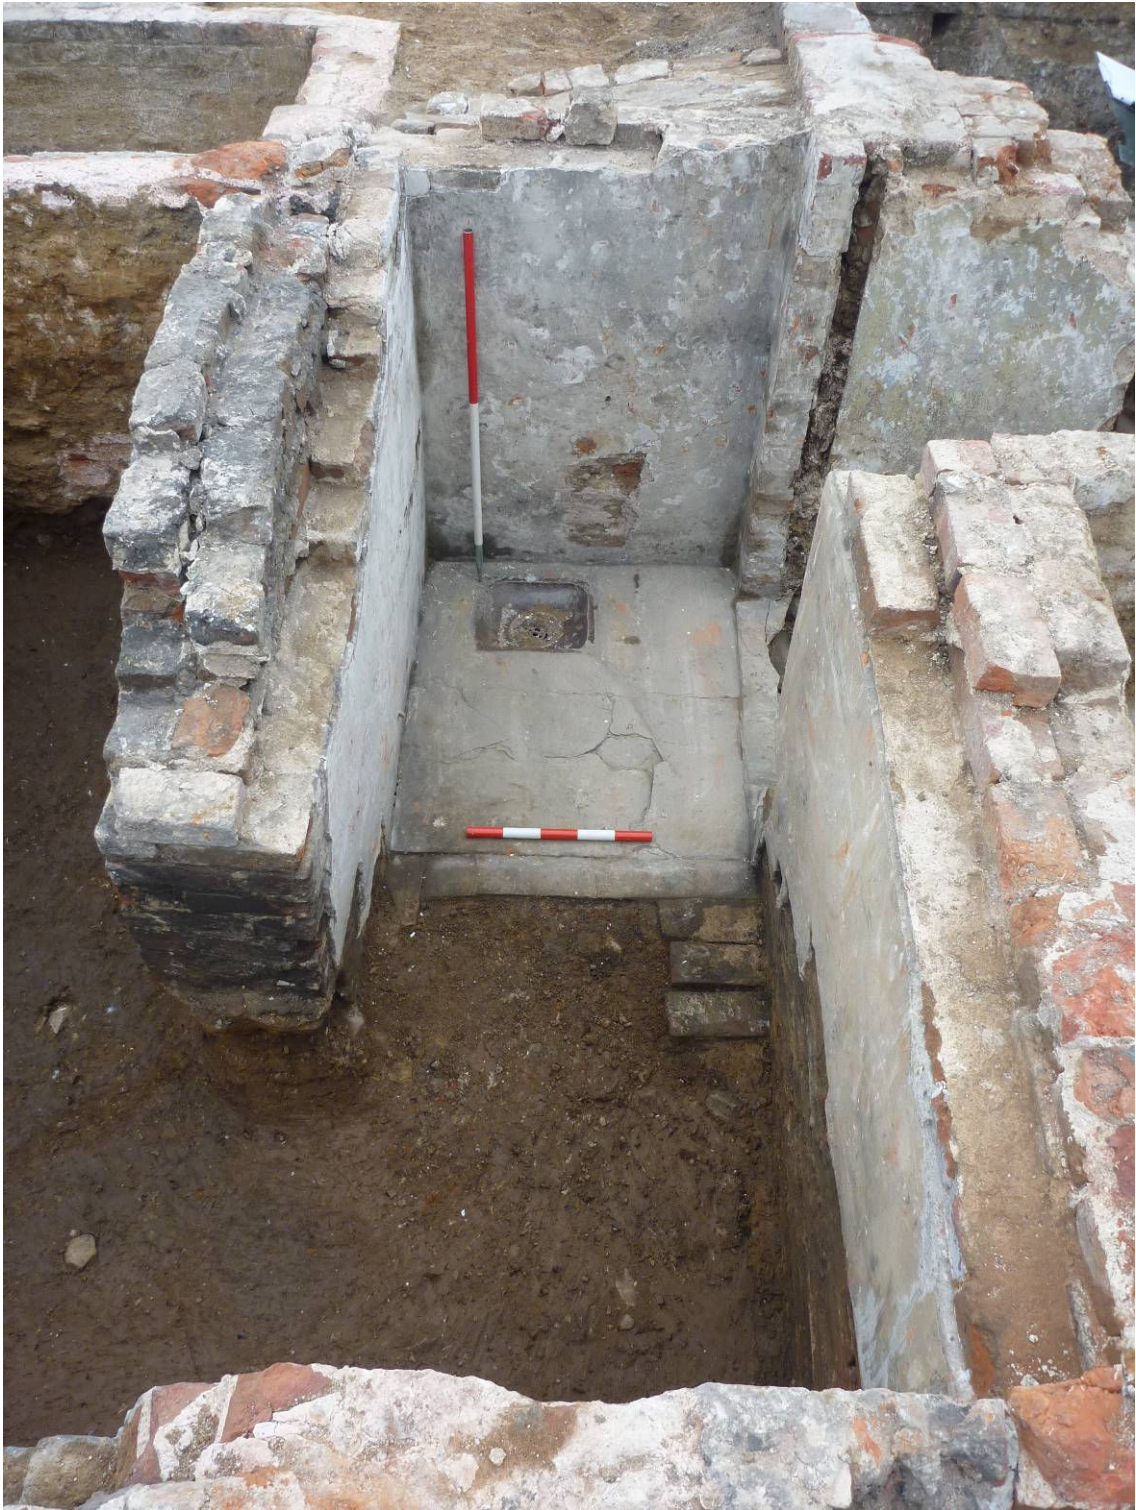
Plate 14 Room 12 looks east

East of the bottom step, the floor was stone slabs with a cement skim; a ceramic seating for a grate towards the north-east corner would have taken rainwater away, probably to a brick sewer observed running east down to the sea about 1m north of the house. A shallow channel in the concrete, running from the south-west corner to the grate, appears to have taken waste water from the postulated sink outlet in Room 1 (see above), the hole through the wall from Room 1 opening on to the top of the first step.

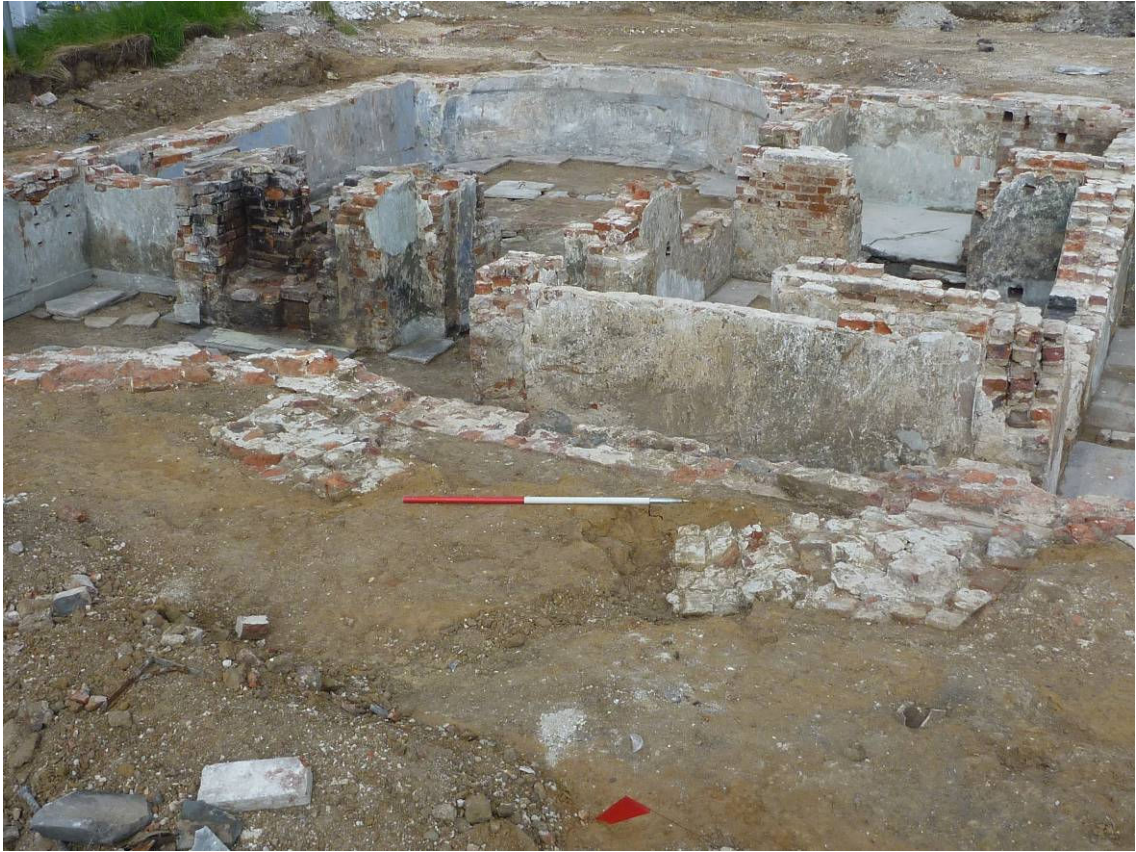
Plate 17 entrance bay foundations, looks west

Outside the building along the middle of the south-east side and so set into the external ground surface, between the two bays of the main structure, were two brick features that extended from the wall of the building and returned towards each other, almost forming a central bay but terminating 1.2m apart. Overall this feature measured 3.7m wide and projected a maximum of 0.8m from the building. It is interpreted as the base of an entrance bay.
